**Pavement Demonstration Program Project Finalization
Perpetual Hot Mix Asphalt Pavement Over Rubblized
Concrete Project –
I-75
(MDOT Job Number 90279)**

Final Technical Report

Report No. OR23-304, C

July 2024

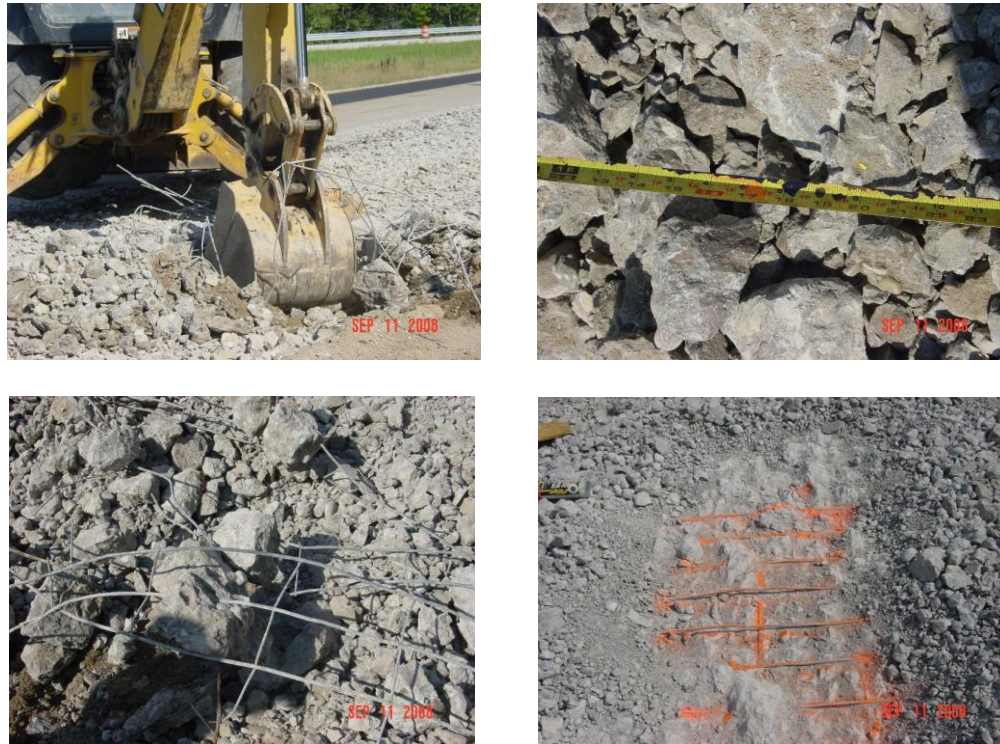
Figure 8. Field rubblization process for the I-75 NB project

According to the field evaluation report during the construction in 2008 (shown in Appendix E, Figure 39), a Multi-Head Breaker (MHB) was used for rubblizing, requiring a second pass to cover the full lane width. Observations included a contractor's backhoe dig at Sta 621+20, revealing larger pieces stuck. A subsequent hand dig exposed steel and mesh near the contractor's hole. Samples were collected from rubblized material at Sta 621+15, and the MHB operator noted "moon-shaped" cracks due to insufficient shoulder support during the rubblizing process. Additional digs at Sta 631+60 and 625+83 displayed painted steel with effective debonding. The MHB operator reported that full-depth repairs were rubblizing well, similar to the old concrete,

but the operator sometimes faced challenges in breaking the material further at the shoulder due to the lack of shoulder support. This is likely because the shoulder material was different (existing HMA that was crush and shaped) from the mainline lanes, so the edge was less confined for rubblization and had less support. Some field rubblization pictures for the I-75 NB perpetual pavement project are provided in Figure 8.

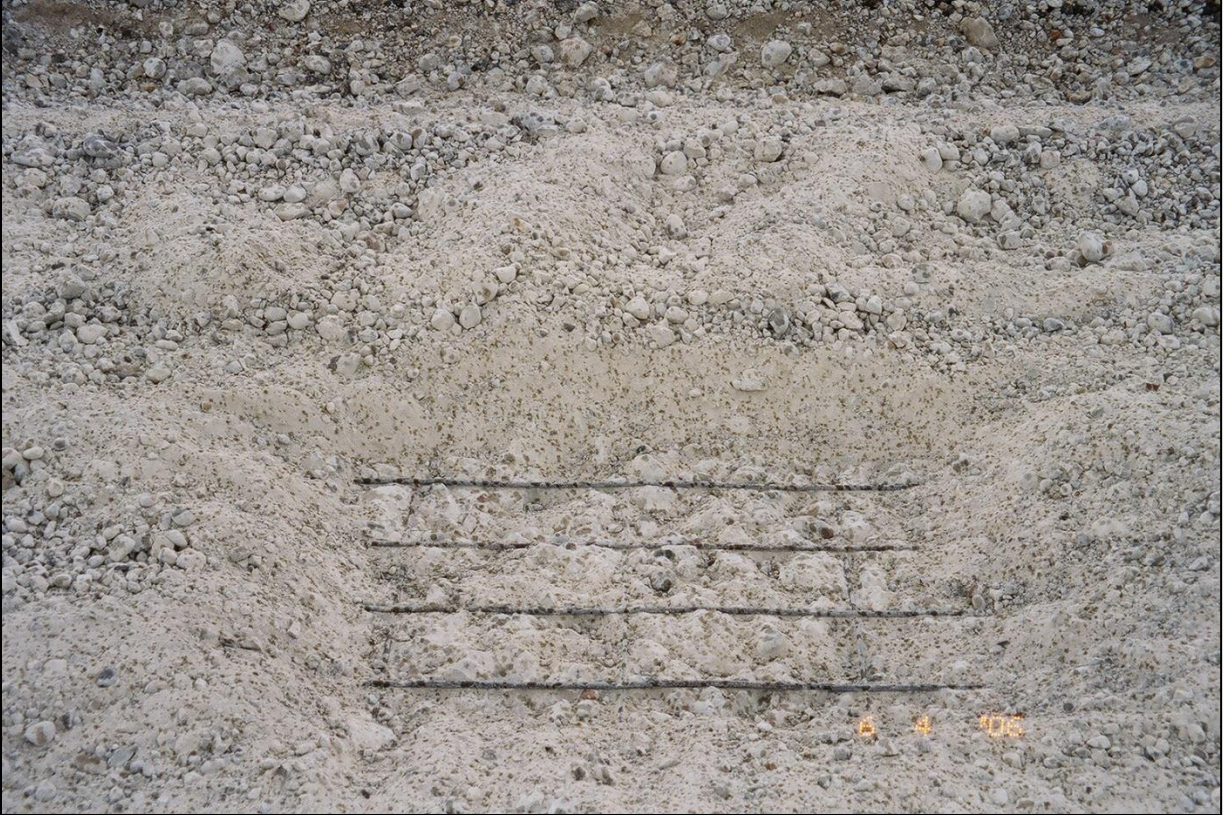
Figure 33. Photo of rubblized PCC for which the elastic modulus back-calculated from deflection basins is low, ranging from 25,000 to 50,000 psi

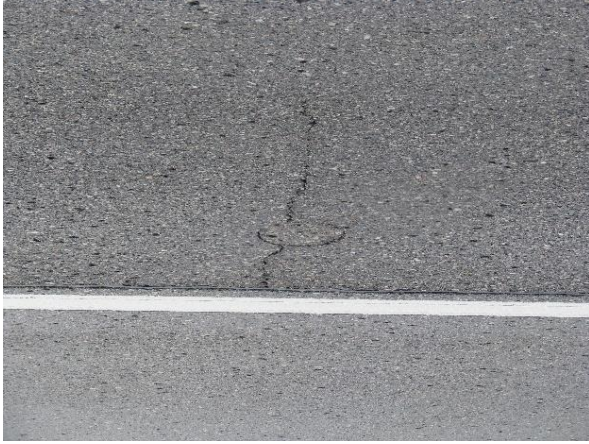
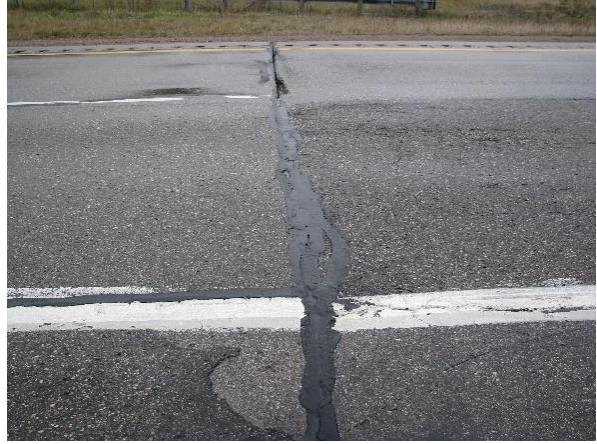
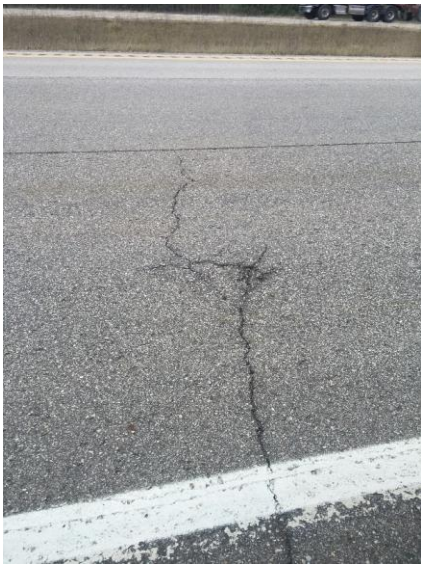
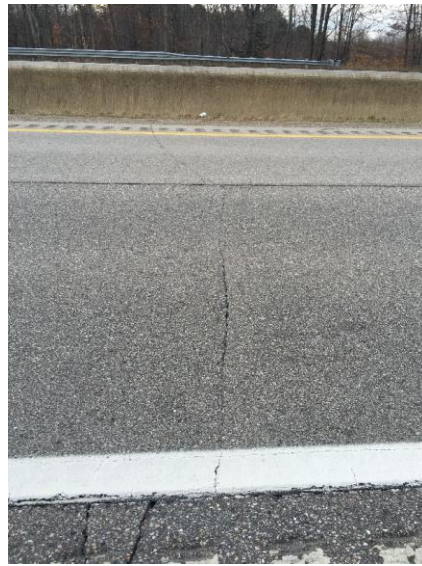
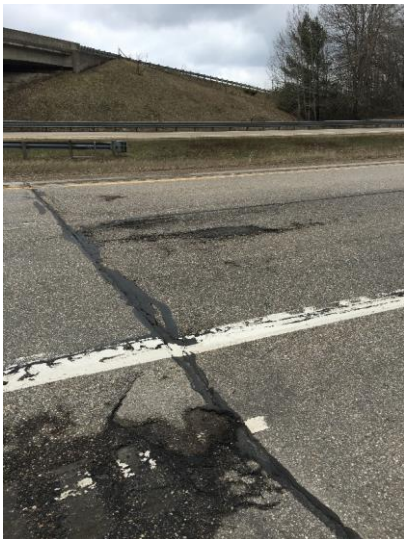
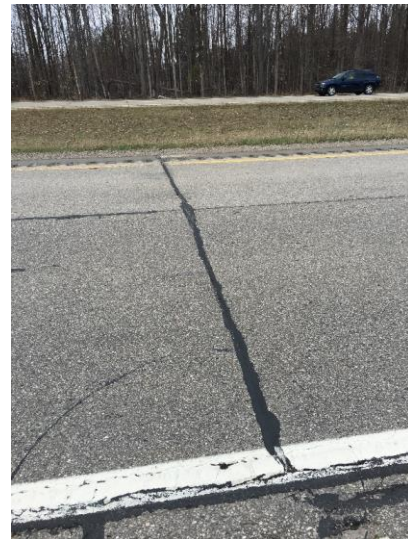
Rutting tenth mile data was inconclusive and did not indicate any unique trends. However, the IRI tenth mile data was found to be significantly higher at the start and end of the project. This corresponds with the project construction joints and field investigation pictures, as shown in Appendix F, Figures 47 to 49. As shown, these joints display cracking and raveling distress.
