MDOT RC-1412  
CSD-2002-02

# CAUSES & CURES FOR PRESTRESSED CONCRETE I-BEAM END DETERIORATION

AUGUST 2002

TESTING AND RESEARCH SECTION  
CONSTRUCTION AND TECHNOLOGY DIVISION  
RESEARCH REPORT NO. RC-1412

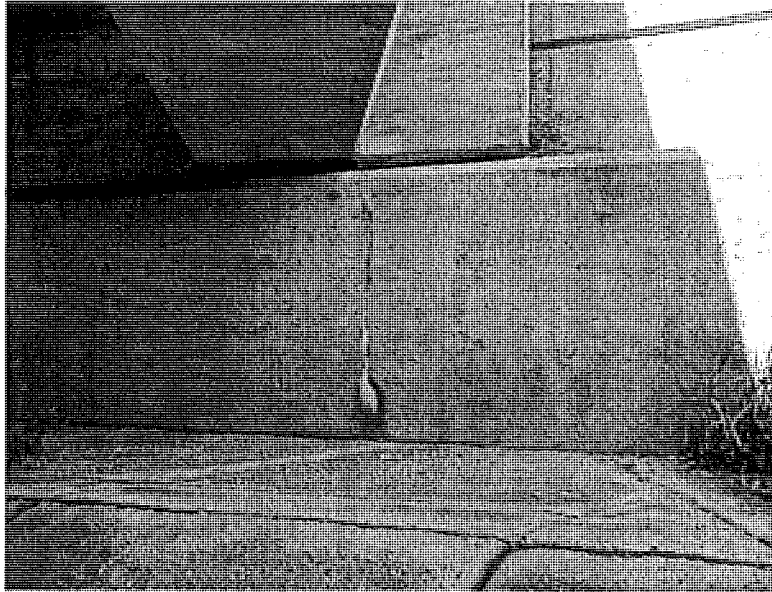
Both abutments have vertical hairline cracks through the walls and wet cracks, some with efflorescence stains, at South and North corners (see Photo 3-58).

**Photo 3-58. Cracks with evidence of moisture and efflorescence at the abutments**

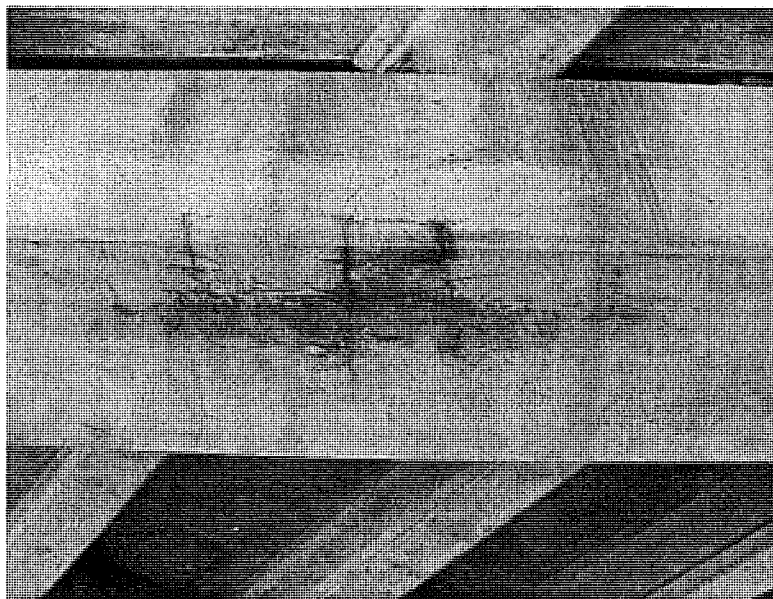
The piers have rust and water stain. The East fascia of pier W1 and the West fascia of pier W2 are cracked and delaminated. The West fascia of pier W2 displays exposed shear reinforcement, rust and efflorescence stains (see Photo 3-59).

**Photo 3-59. Exposed reinforcement, rust and efflorescence at W. fascia of pier cap beam W2**

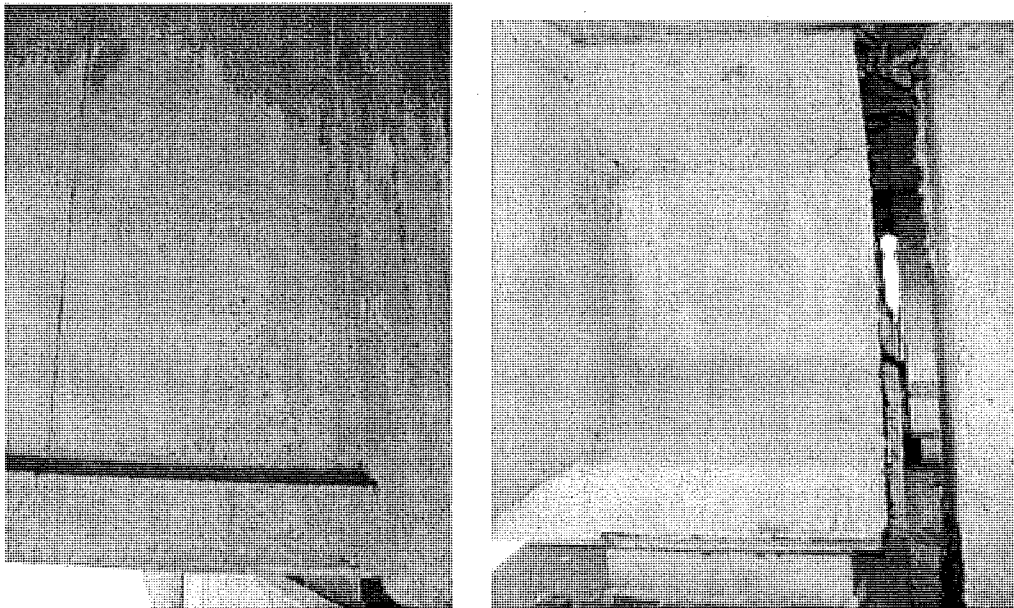
**Photo 4-1. “Not vulnerable” Prestressed Concrete I-Beam**

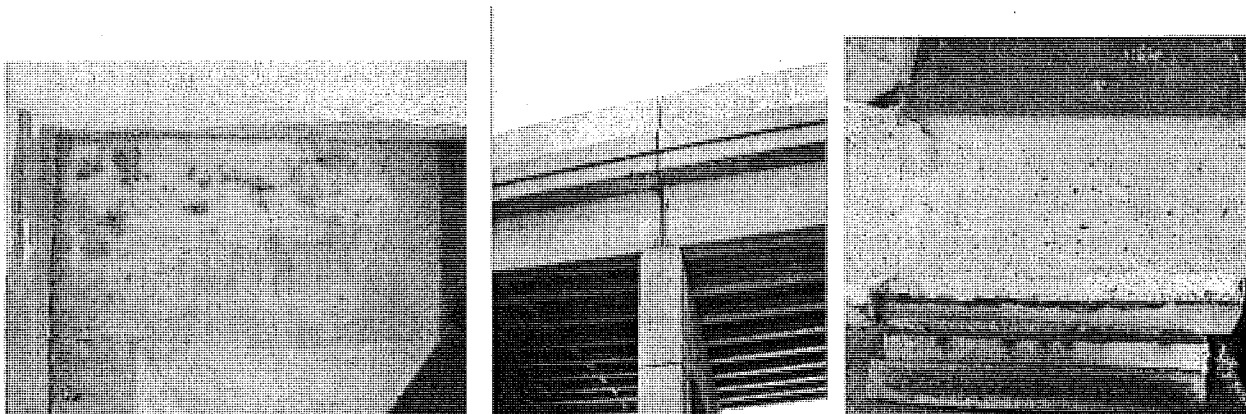
If the inspection indicates any one of the above conditions, the beam is considered as “vulnerable” to end deterioration (see Photo 4-2).

**Photo 4-2. (Left and Middle) Wet stain at beam-end (Right) Sole plate corrosion**

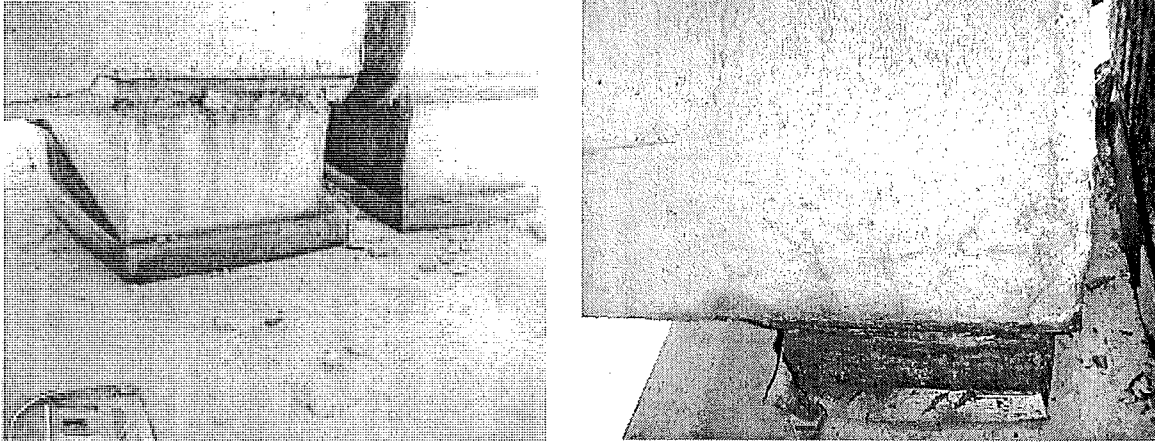
**Photo 4-3. (Left) Sole plate corrosion and bulging at the sides of bearing pad, (Right) Sole plate corrosion and splitting, tearing and bulging at bearing pad**

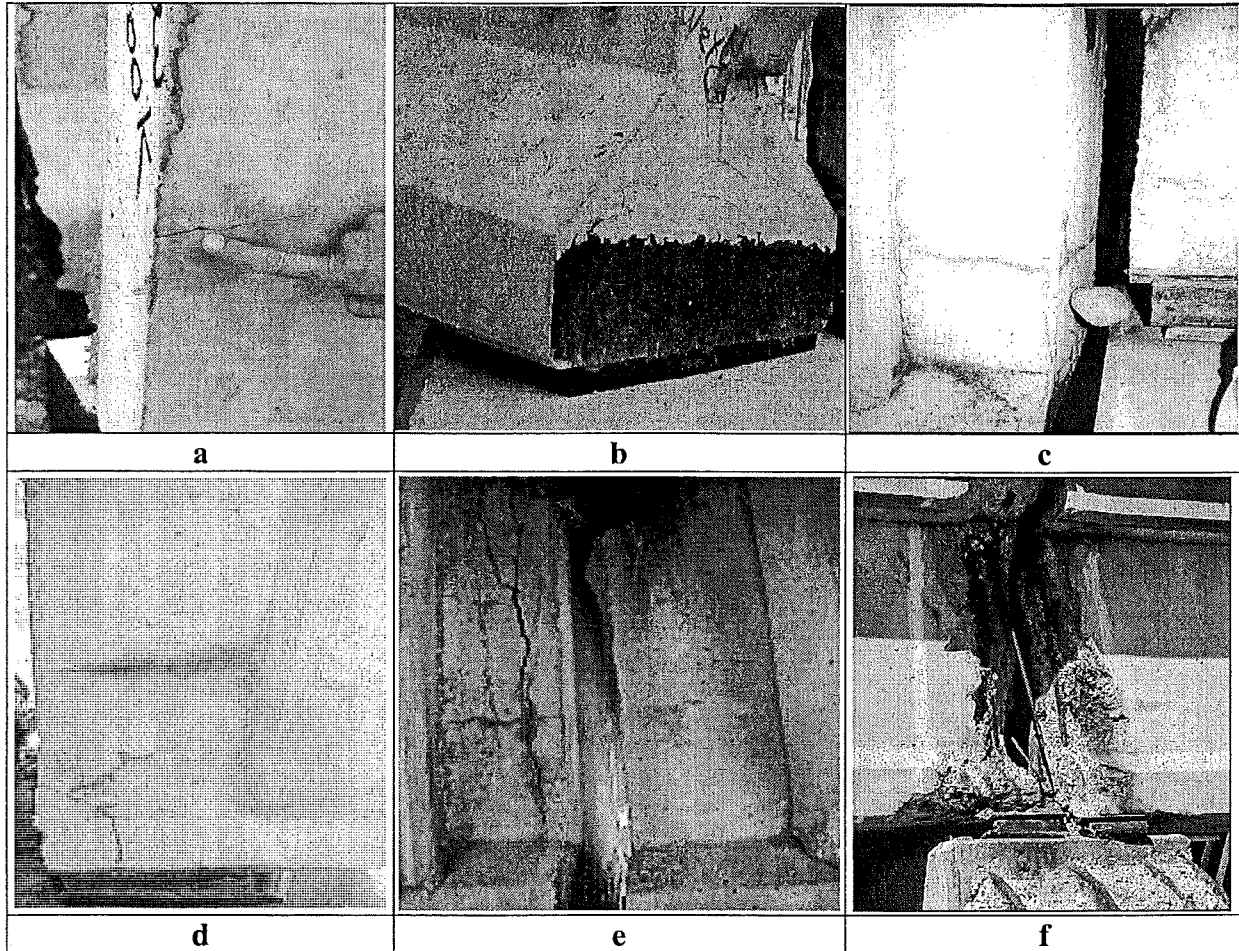
delamination, Figure 10-2-e, and spall of concrete cover, Figure 10-2-f, reducing the durability of the girder by a significant amount. Consequently, cracking prevention or reduction during manufacture, construction, and operation is the proper way to increase the durability and the lifetime of the PC I-beams.

**Figure 10-2. (a) Cracking at the Web Zone at the Precast Plant; (b) Cracking within the Proximity of Bottom Flange of a Girder in a Bridge under Construction; (c) Cracking Observed on the Web and Around the Bottom Flange of Girders in-Service; (d) Moisture Presence Around Cracking on the Web; (e) Delamination and Spalling on a Girder; (f) Spalling of Cover Concrete and Exposed Rebar**

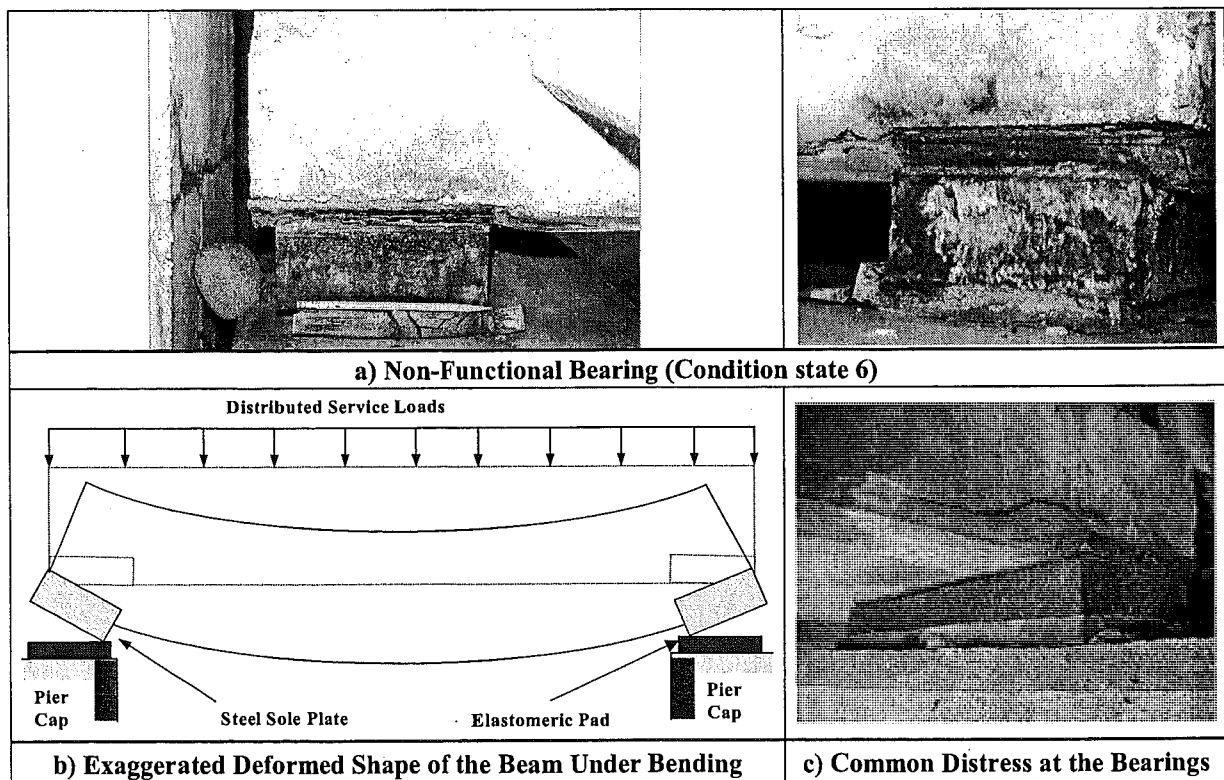
Figure 10-33. a) Condition of the Elastomeric Bearing Pads; b) the Exaggerated Deformed Shape of a Girder under Flexural Bending; c) Common Distress Observed at the Bearings

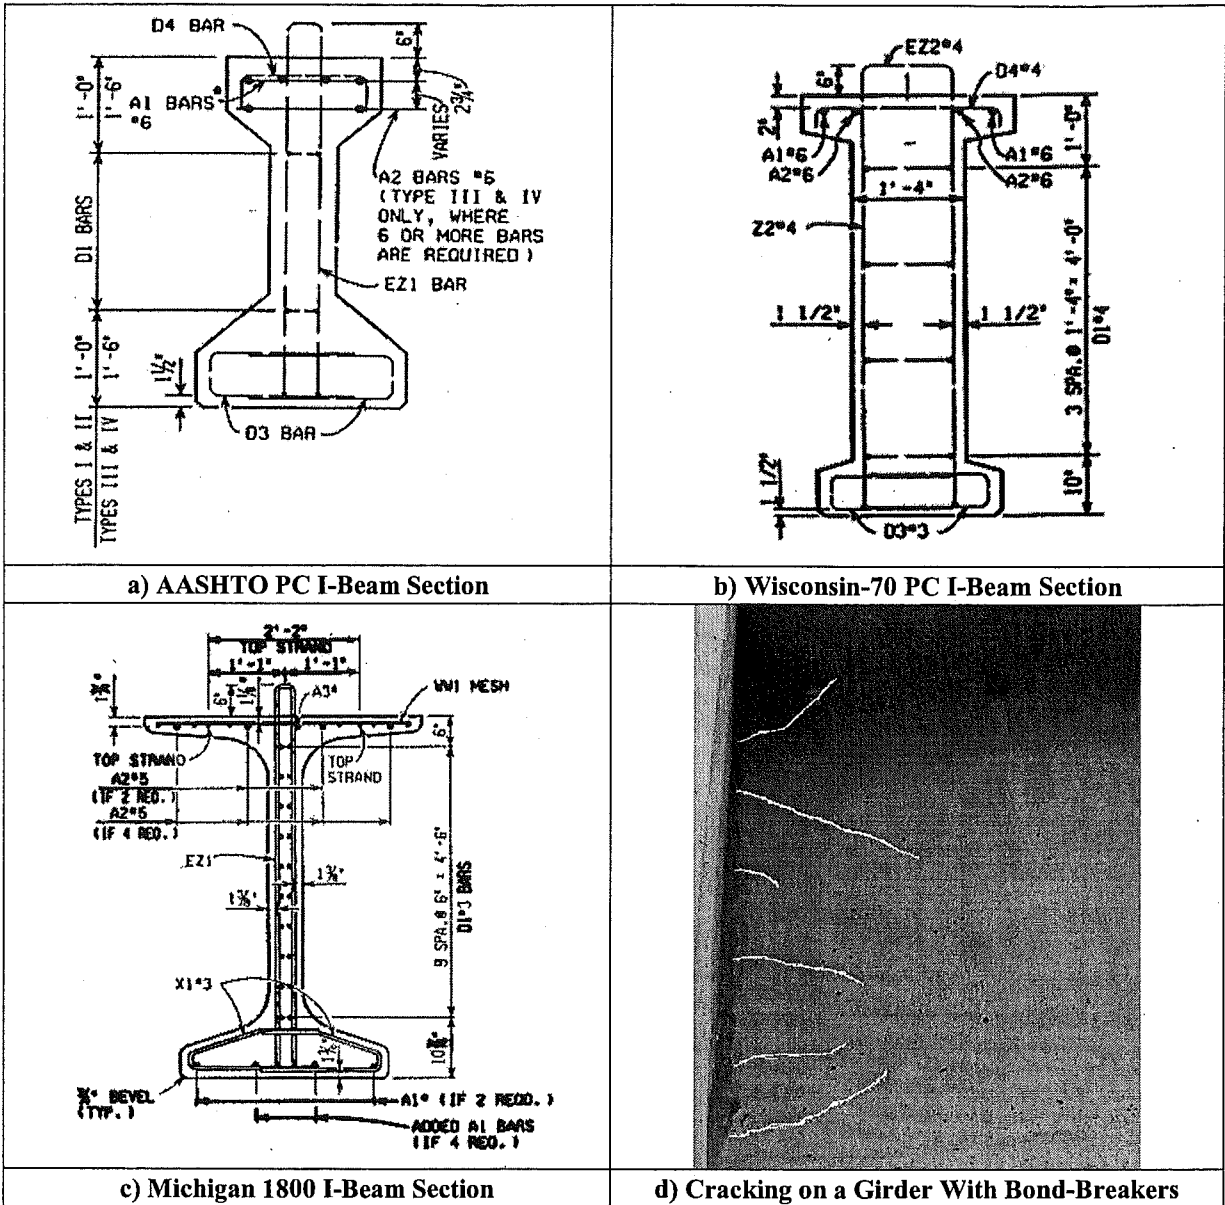
Figure 10-46. Shear Reinforcement used in Newly Manufactured Girders and Web Cracking Observed during Field Inspection on a PC I-Beam with Bond-Breakers

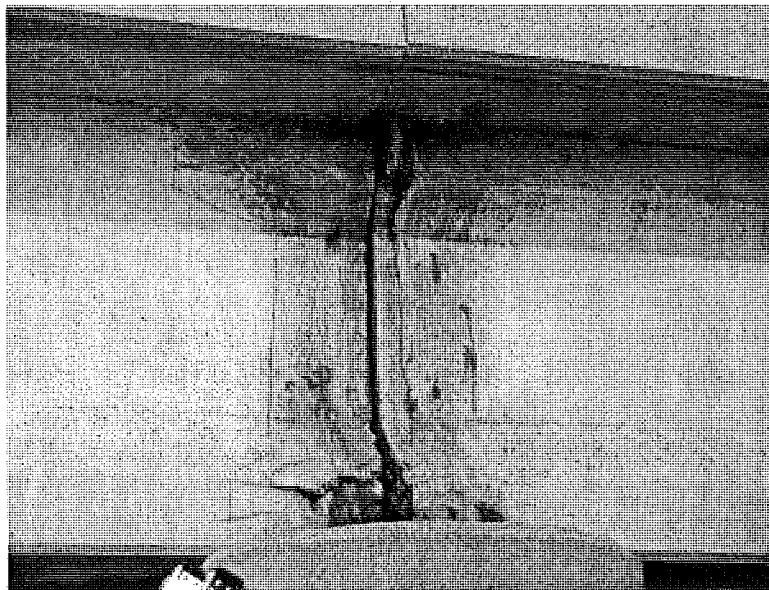
Photo 11-1. Typical beam-end deterioration

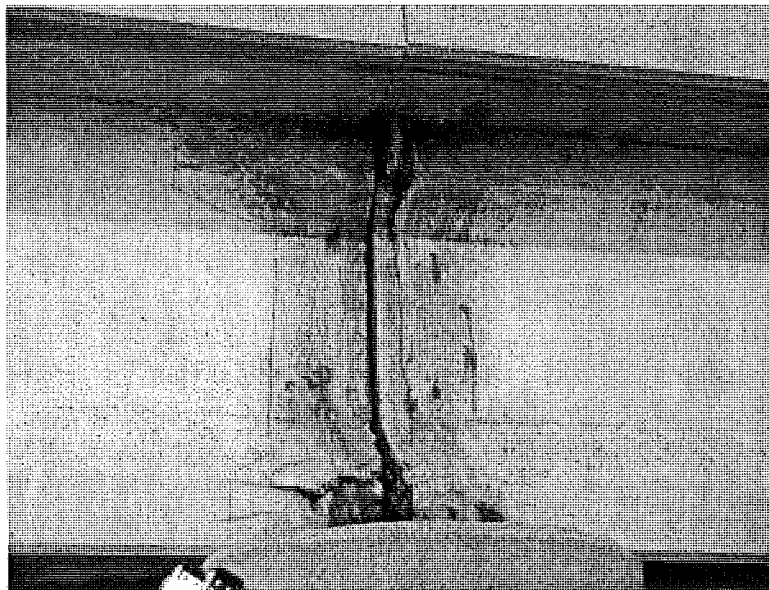
Photo 11-1. Typical beam-end deterioration

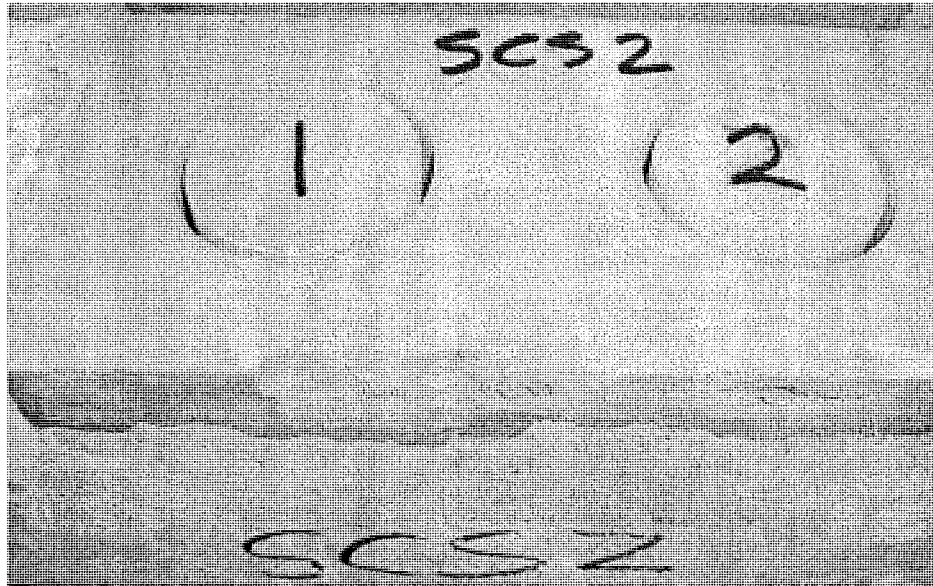
Photo 11-25. Typical edge spalling on repair specimens

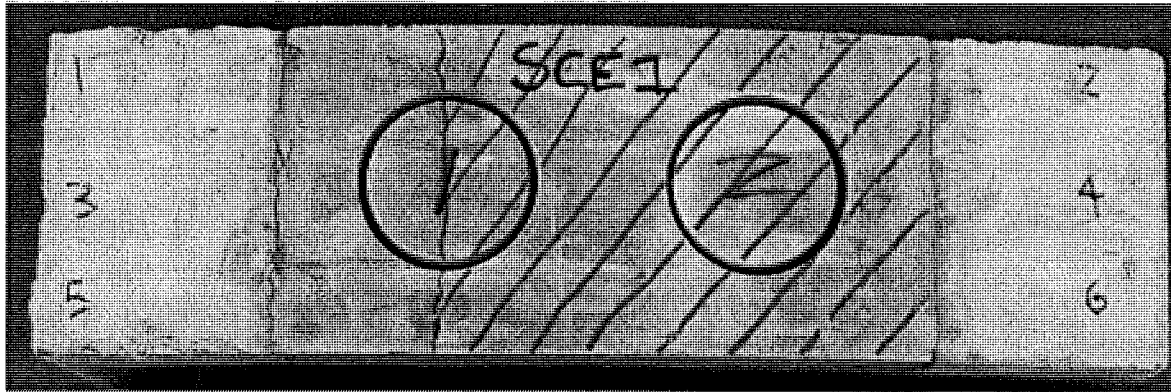
Photo 11-27. Hatched, delaminated region of specimen SCE1

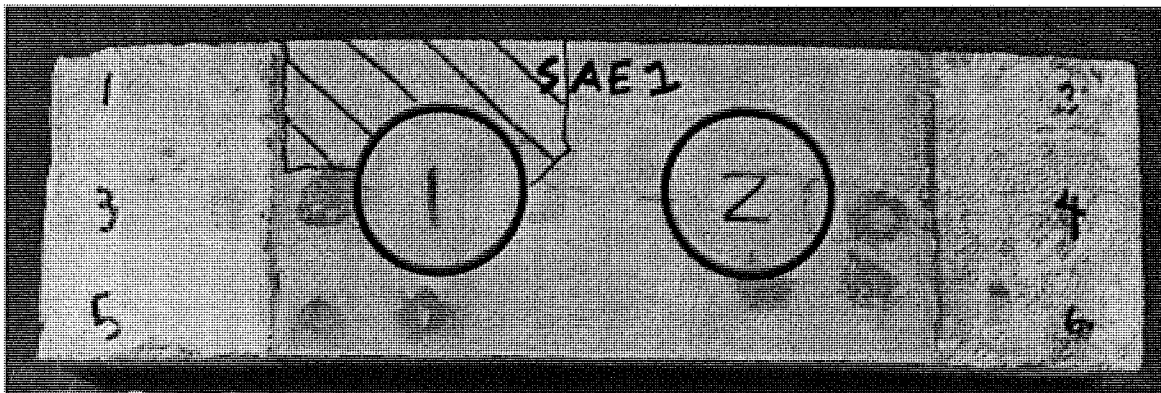
Photo 11-28. Hatched, delaminated region of specimen SAE1

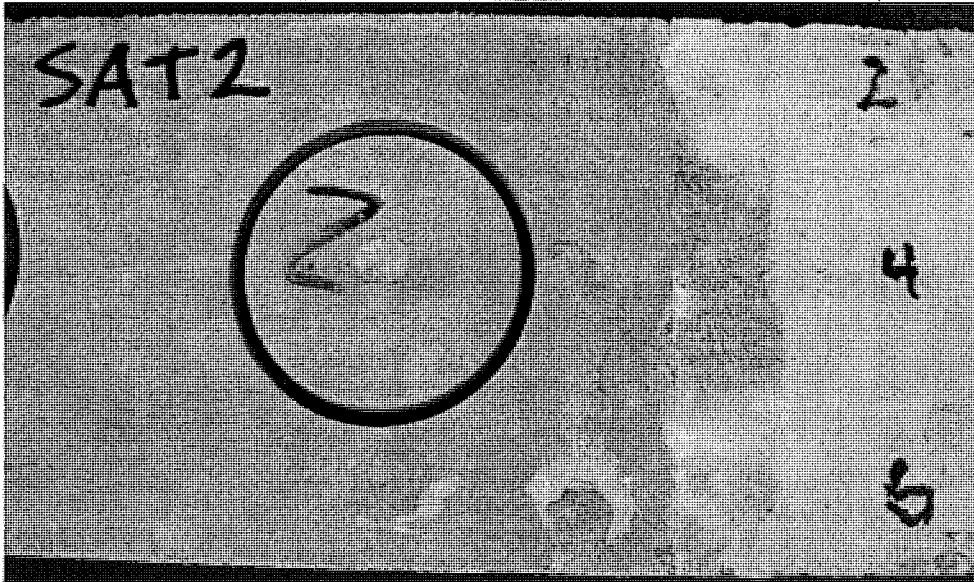
Photo 11-29. Typical white precipitate leaching from the bottom repair-substrate joint
