INVESTIGATION OF THREE SPALLED JOINTS
Norton-Glade Expressway, Muskegon
US 16 (Project 61-47, C7)

Research Laboratory Division
Office of Testing and Research
Report No. 350
Research Project 39 F-7(14)

Michigan State Highway Department
John C. Mackie, Commissioner
Lansing; February 1961

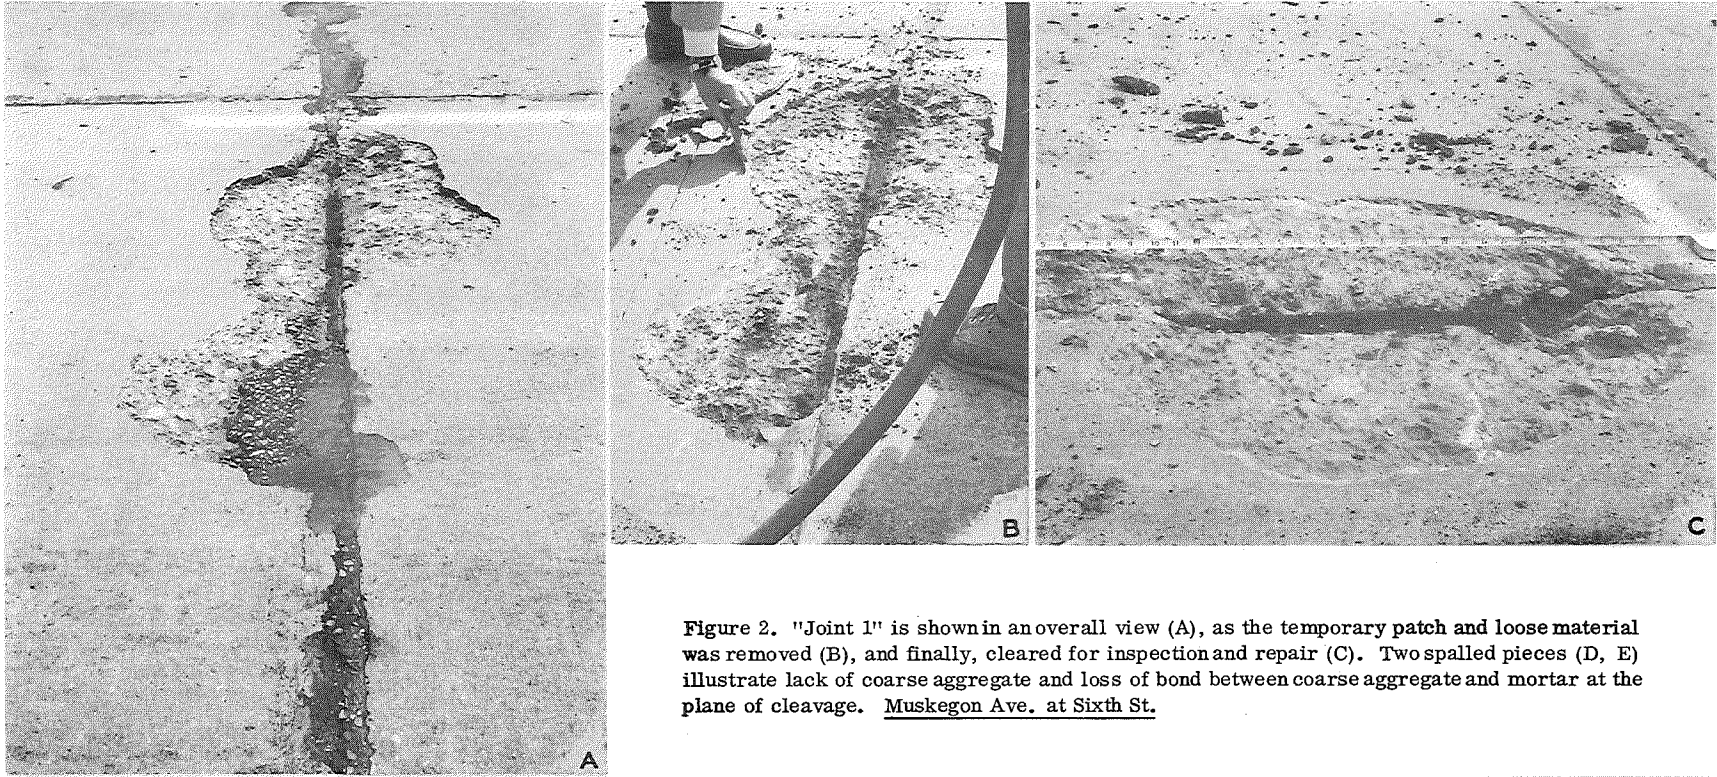
Joint 1--Muskegon Ave. at Sixth St.

At the first location, the joint had extensive surface spalling, extending downward into the pavement no more than 2 in. at the joint face, and back from the joint groove about 15 in. where spall depth was about 1/2-in. (Fig. 2).

Since the spalling was not deep, the load transfer system was not exposed and therefore its influence in this spalling could not be determined. However, it was noted that near the surface the spalled concrete was chiefly mortar, with very little coarse aggregate. In addition, over a considerable area, the plane of cleavage between the sound pavement and the spalled surface showed no evidence of broken aggregate, but rather of bond failure between coarse aggregate below and the mortar in the upper surface.

Generally, this indicates that mortar is weak, for bond strength between mortar and coarse aggregate is proportional to mortar strength.

Figure 2. "Joint 1" is shown in an overall view (A), as the temporary patch and loose material was removed (B), and finally, cleared for inspection and repair (C). Two spalled pieces (D, E) illustrate lack of coarse aggregate and loss of bond between coarse aggregate and mortar at the plane of cleavage. Muskegon Ave. at Sixth St.
