Report TSD-223-73

A TRAFFIC ACCIDENT ANALYSIS  
OF HIGH ACCIDENT LOCATIONS  
IN THE CITY OF MARQUETTE

August 1974

Traffic Engineering Services  
Traffic and Safety Division  
Michigan Department of State Highways and Transportation

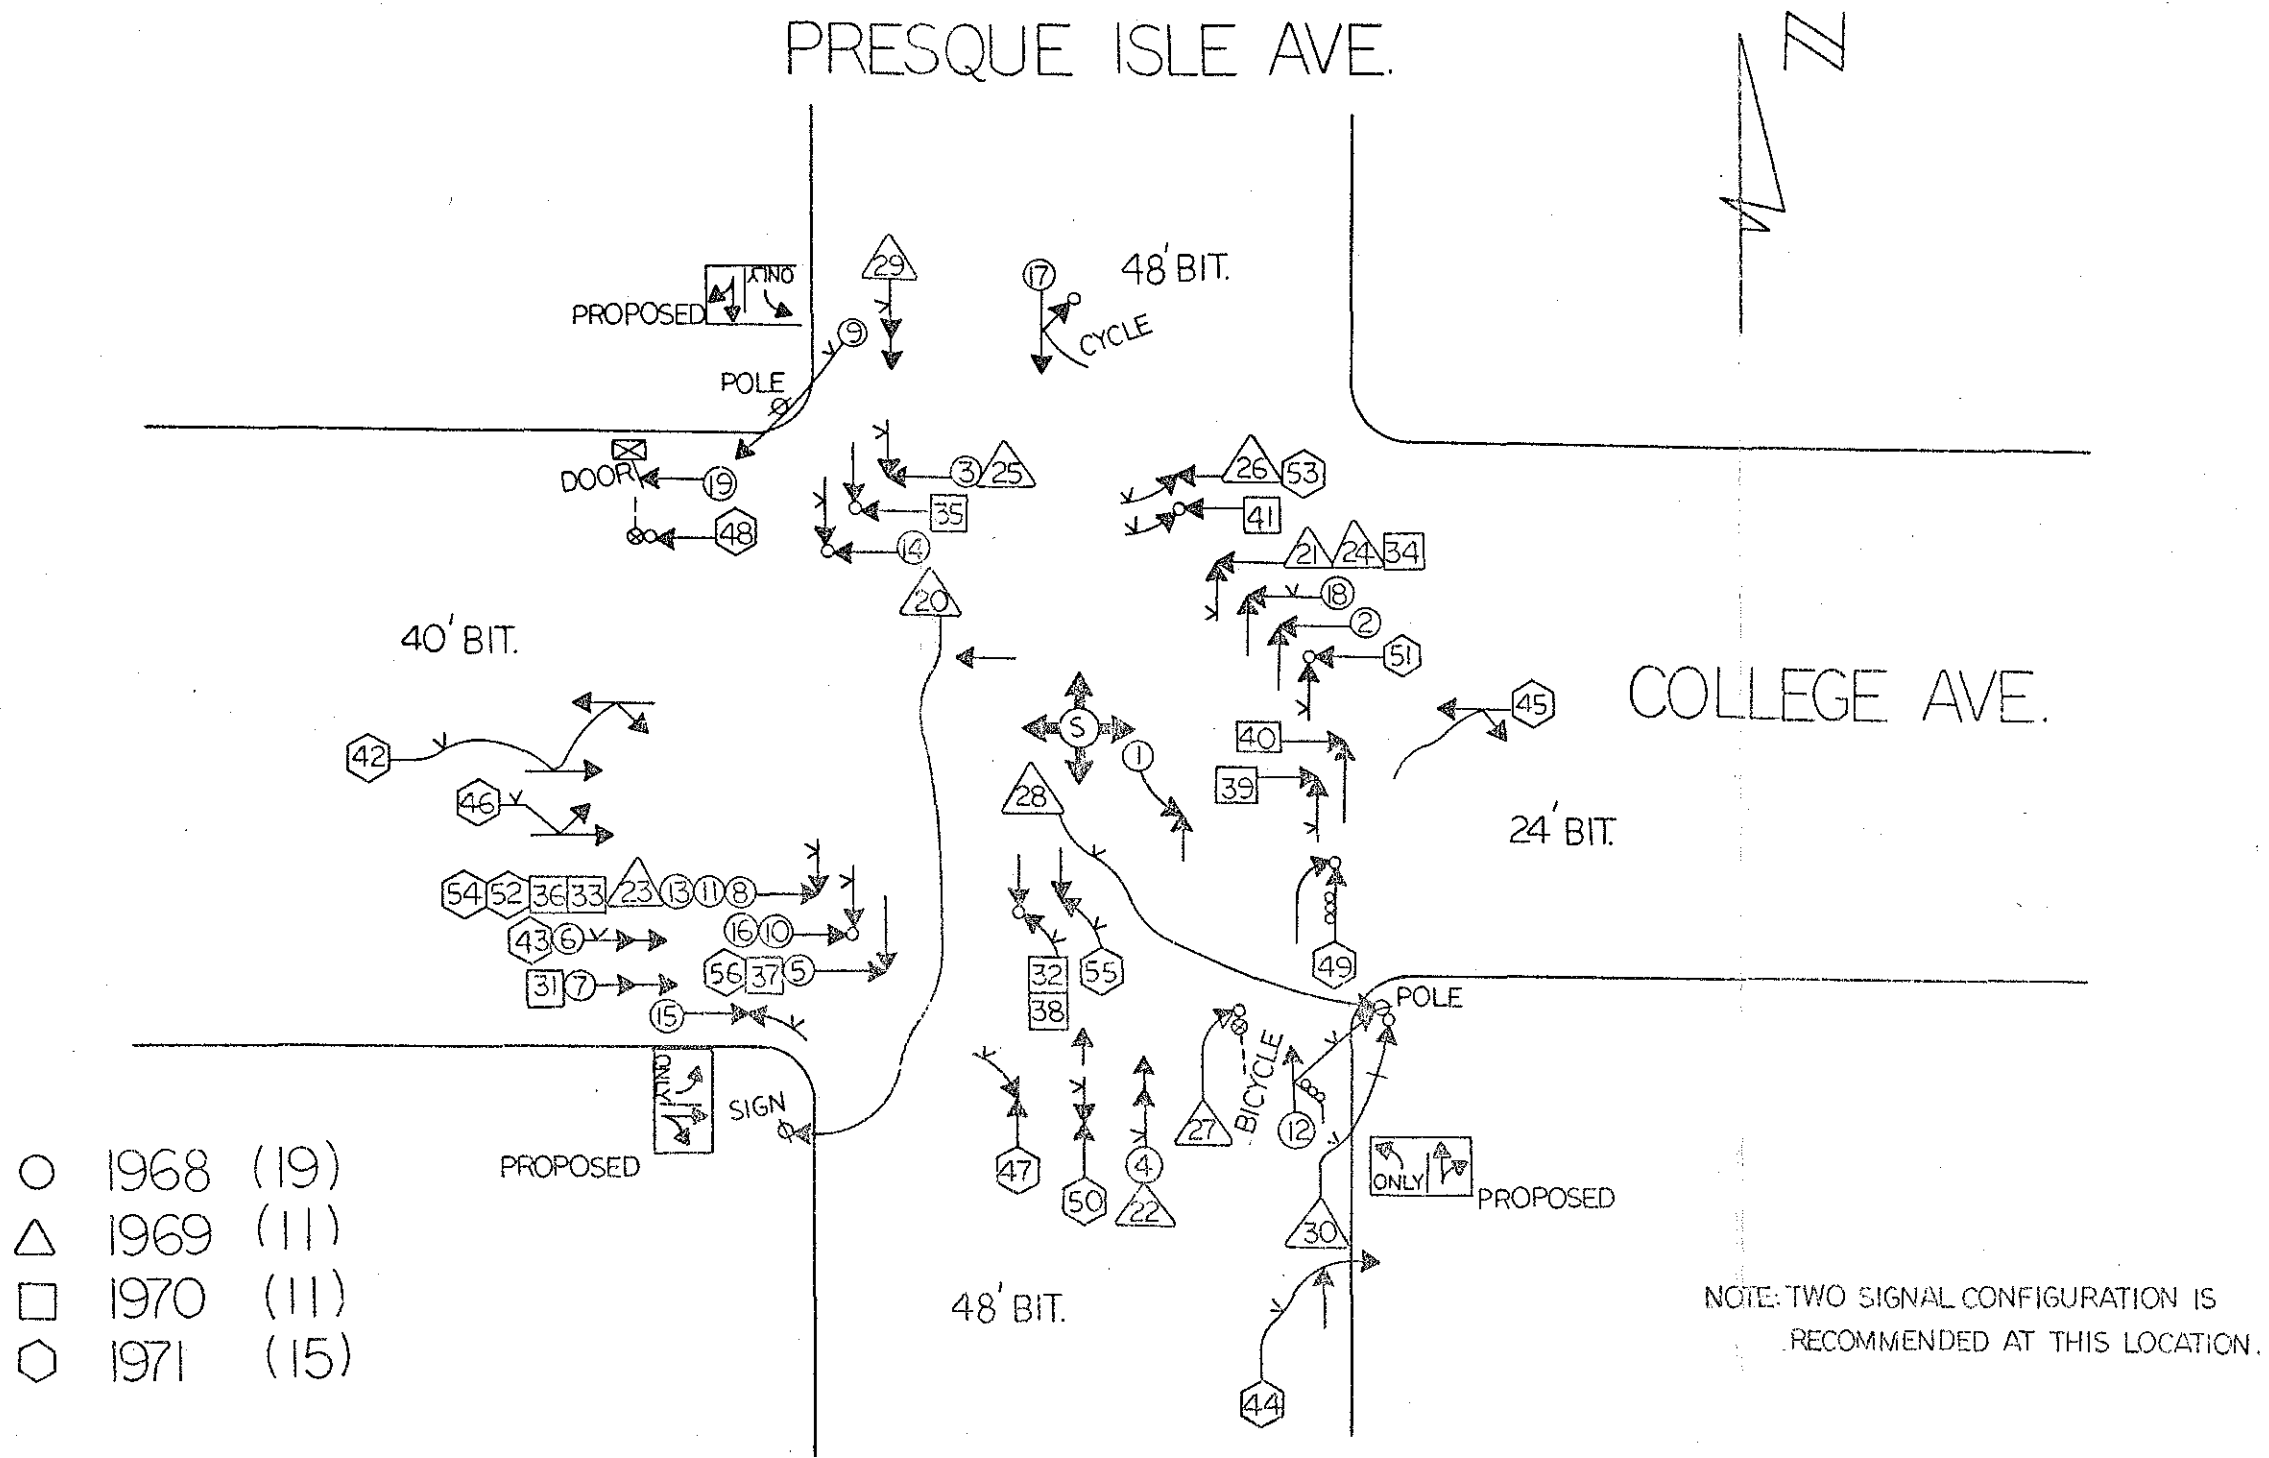
The critical problem at this intersection involves the high incidence of right angle accidents at a signalized intersection. The existence of a single signal head, the short clearance interval and the standard lens size were all contributing factors to the right-angle pattern. It is mandatory in the 1973 edition of the Michigan Manual that at least two signal faces be provided per approach. Therefore, it is recommended that a second signal head be employed at this intersection and furthermore, that each signal should have 12 in. lenses. The problem involving the short clearance interval will be relieved through the adoption of the 70 second cycle and six percent clearance interval already recommended. If right-angle accidents continue in the future, consideration should be given to incorporating an all-red clearance interval into the signals' cycle length.

NOTE: TWO SIGNAL CONFIGURATION IS RECOMMENDED AT THIS LOCATION.

The signals at Presque Isle Avenue and College Avenue should be interconnected with the signals at Lincoln Avenue and College Avenue (Location 2) and the signals at Seventh Street and College Avenue (Location 11). A Time-Space Diagram has been prepared to establish progression through the three intersections (Figure 10, p. 19). At a speed of 27 mph a cycle length of 70 seconds provides College Avenue with the greatest band of green time through the three intersections. Thus, it is recommended that a 70 second cycle with a six percent clearance interval (4.2 seconds) be established at this intersection.

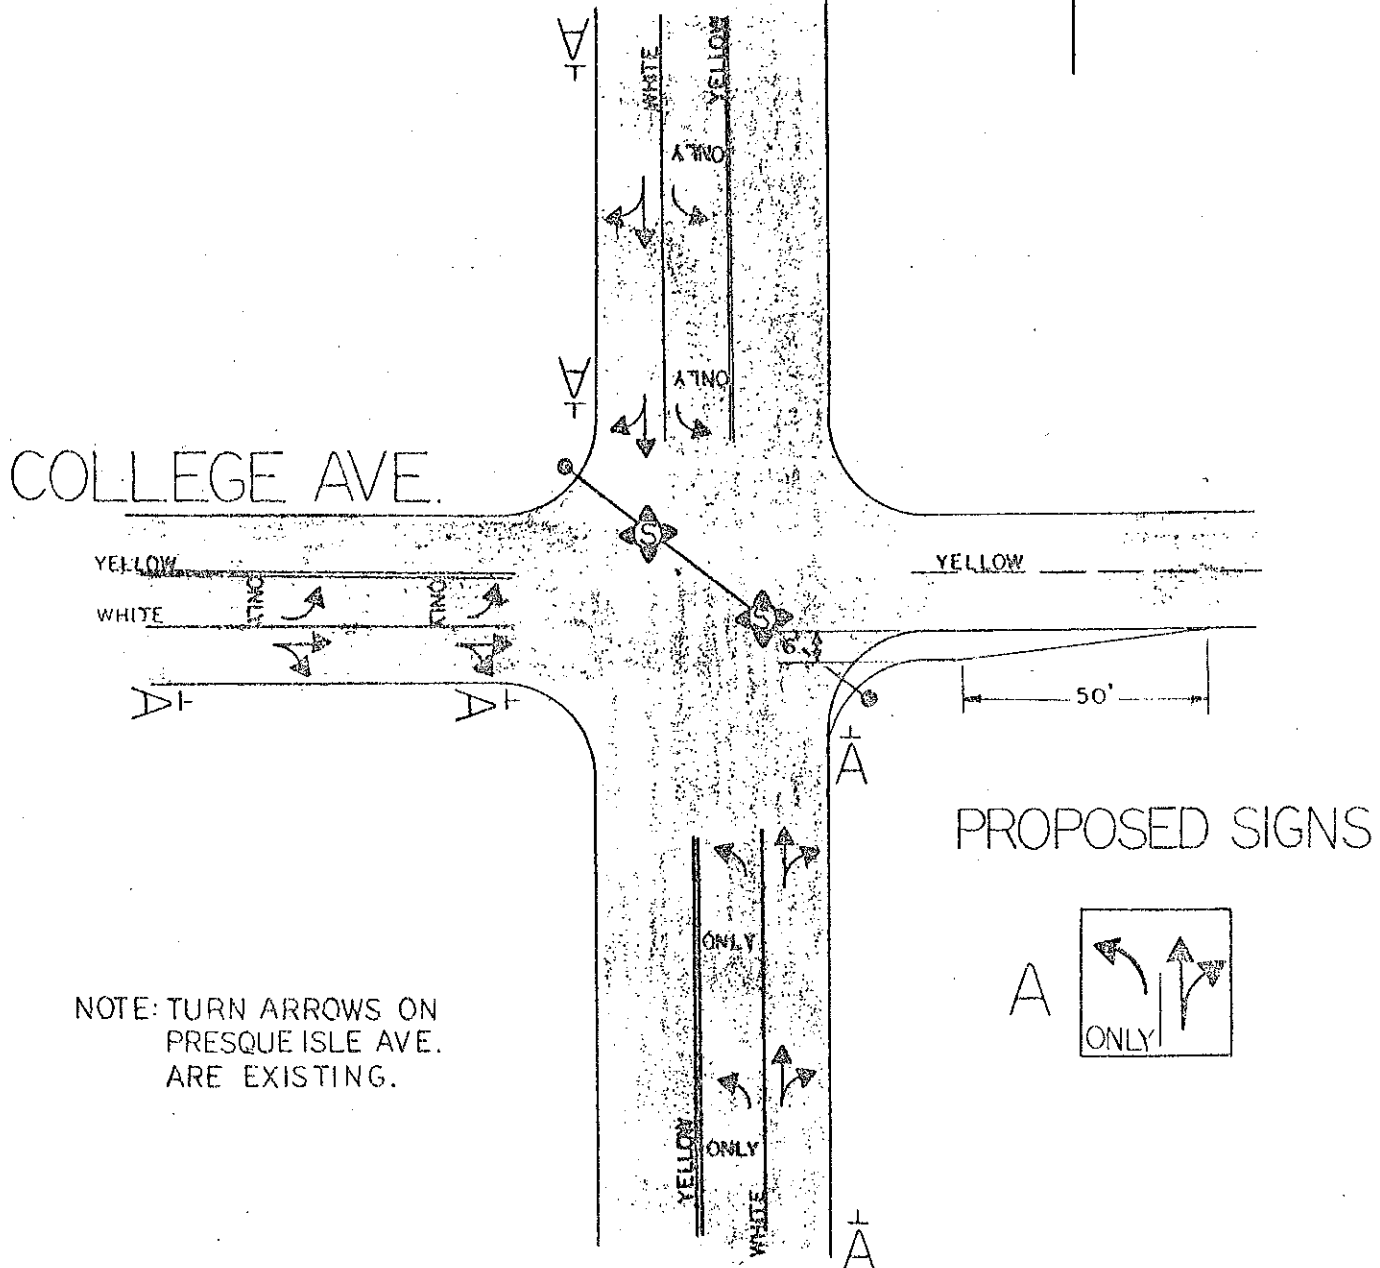
NOTE: TURN ARROWS ON PRESQUE ISLE AVE. ARE EXISTING.

Roadside Lane-Use Control signs should be erected on the west leg of College Avenue and on the north and south legs of Presque Isle Avenue. These signs should be erected both in advance of the intersection and at the intersection. These Lane-Use Control signs will supplement the existing pavement markings to better inform the vehicle operator which direction he is allowed to travel from any given lane. A detail drawing of the recommendations at this intersection can be found on p. 18 .

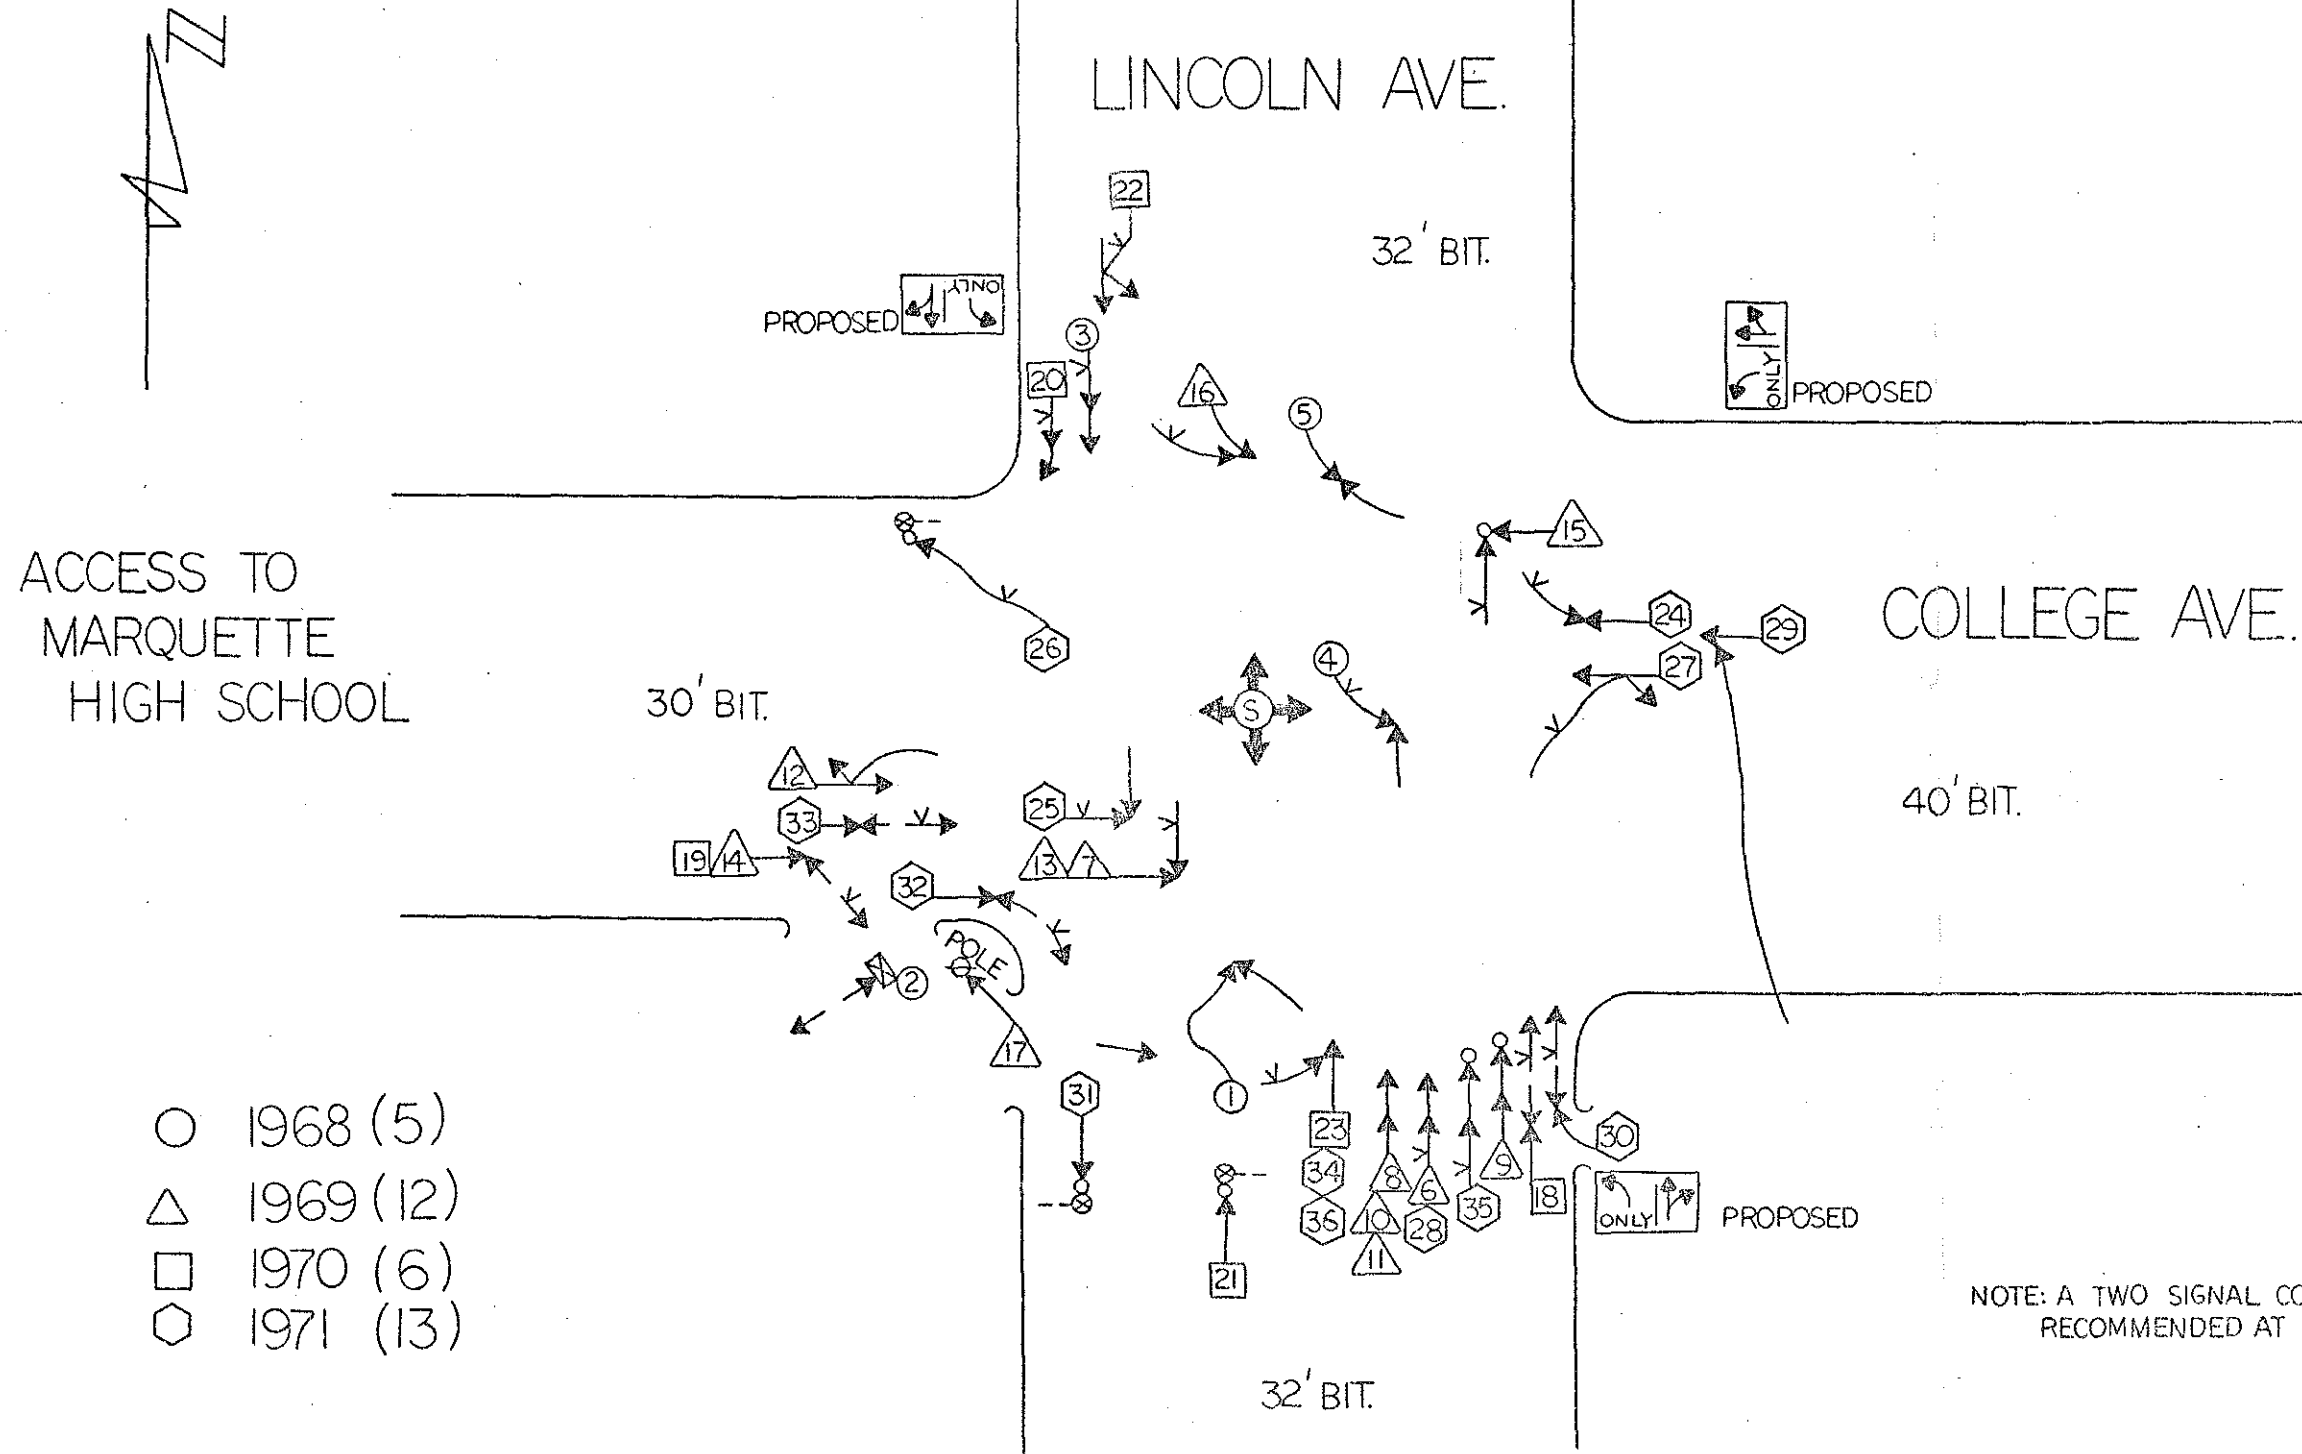
FIGURE 11

The left turn lanes on Lincoln Avenue are offset in relation to each other which creates a sight distance problem for opposing left turning vehicles. The operators of these vehicles cannot see approaching through traffic. To alleviate this situation it is recommended that the left turn lanes be aligned directly across from each other. This can be accomplished by restriping Lincoln Avenue for two 11 ft through lanes and a 10 ft center lane for left turns (Figure 13, p. 24 ). Realigning the left turn lanes will make it necessary to increase the radius in the northeast and southwest quadrants to 40 ft to accommodate right turns from east and westbound College Avenue.

NOTE: A TWO SIGNAL CONFIGURATION IS RECOMMENDED AT THIS LOCATION.

The signals at Lincoln Avenue and College Avenue should be interconnected with the signals at Seventh Street and College Avenue (Location 11) and the signals at Presque Isle Avenue and College Avenue (Location 1). A Time-Space Diagram has been prepared to establish progression through the three intersections (Figure 10, p. 19). At a speed of 27 mph a cycle length of 70 seconds provides College Avenue with the greatest band of green time using the existing cycle split. Thus, it is recommended that a 70-second cycle with a six percent clearance interval (4.2 seconds) be established at this intersection.

It is required in the 1973 edition of the Michigan Manual that a minimum of two vehicular signal faces be provided per approach. It is recommended that the requirements of the Manual be complied with at this intersection by erecting a second signal head.

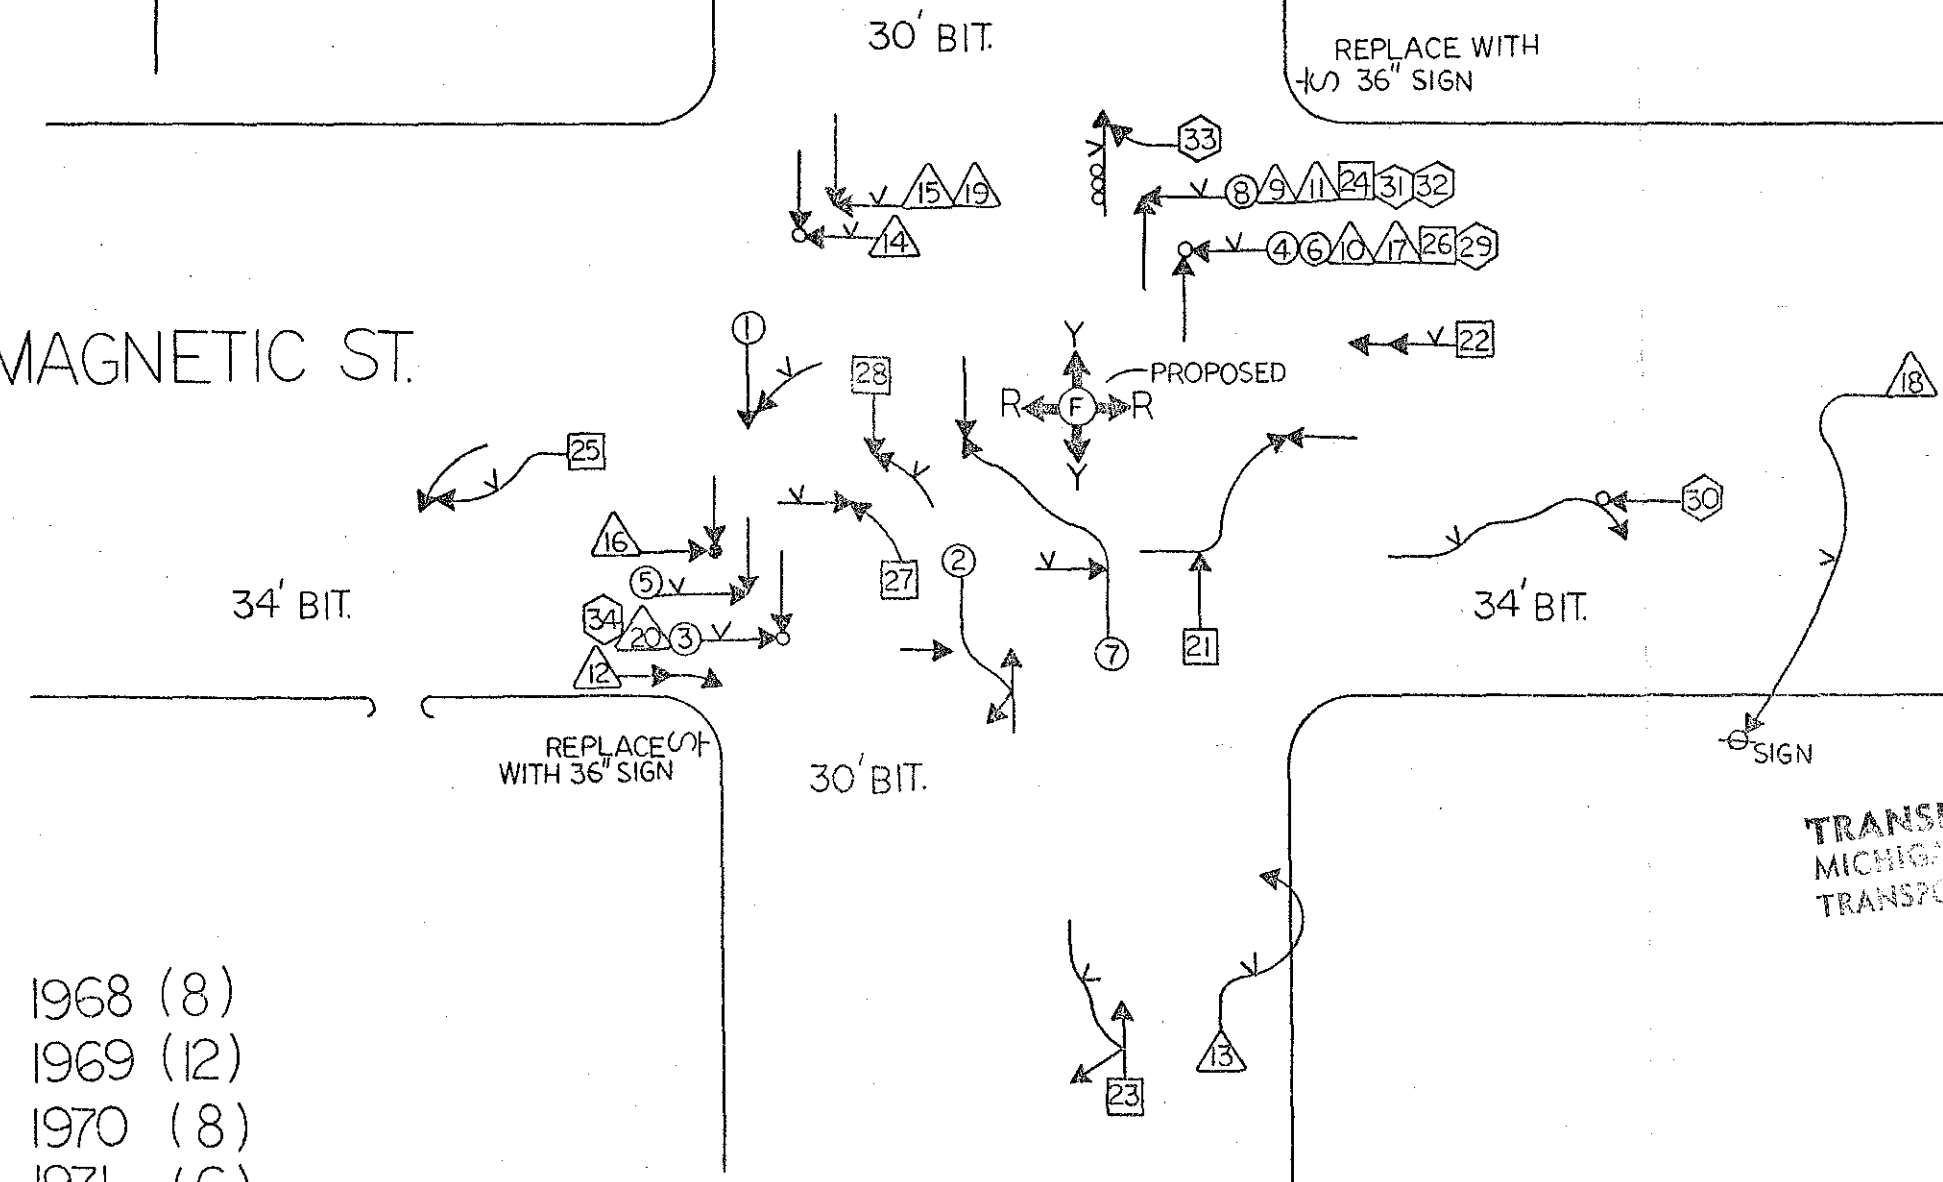
The critical problem at this intersection is the occurrence of right-angle accidents. Of the 25 right-angle accidents 12 operators stopped at the "Stop" signs on Magnetic Street and then failed to yield to Seventh Street traffic. Six of these operators indicated that their vision was obstructed by high snow banks while one other operator indicated that a pine tree in the southeast corner obstructed his vision. The remaining 13 right-angle accidents involved operators who ran through the "Stop" signs. It appears from the high number of "Stop" sign violations that a more pronounced warning is needed to inform Magnetic Street traffic of the impending stop at Seventh Street. The minimum accident warrant for a flashing beacon, according to the Michigan Manual, is satisfied when six or more accidents which are susceptible to correction by the cautioning or stopping of traffic occur over a two year period. The highest two-year period occurred between 1968 and 1969 when there were 16 right-angle accidents. The smallest two-year period occurred between 1970 and 1971 when there were nine right-angle accidents. Due to the high number of right-angle accidents at this location it is recommended that a flashing beacon be installed. Furthermore, the flashing beacon should be accompanied by 36 in. "Stop" signs for Magnetic Street.

Almost 27 percent of the accidents at this location occurred on wet pavement. Altogether 73.5 percent of the accidents occurred on wet, snowy or icy pavement. These figures indicate that the pavement at this intersection becomes slippery when wet. For this reason it is recommended that skidometer tests be conducted.

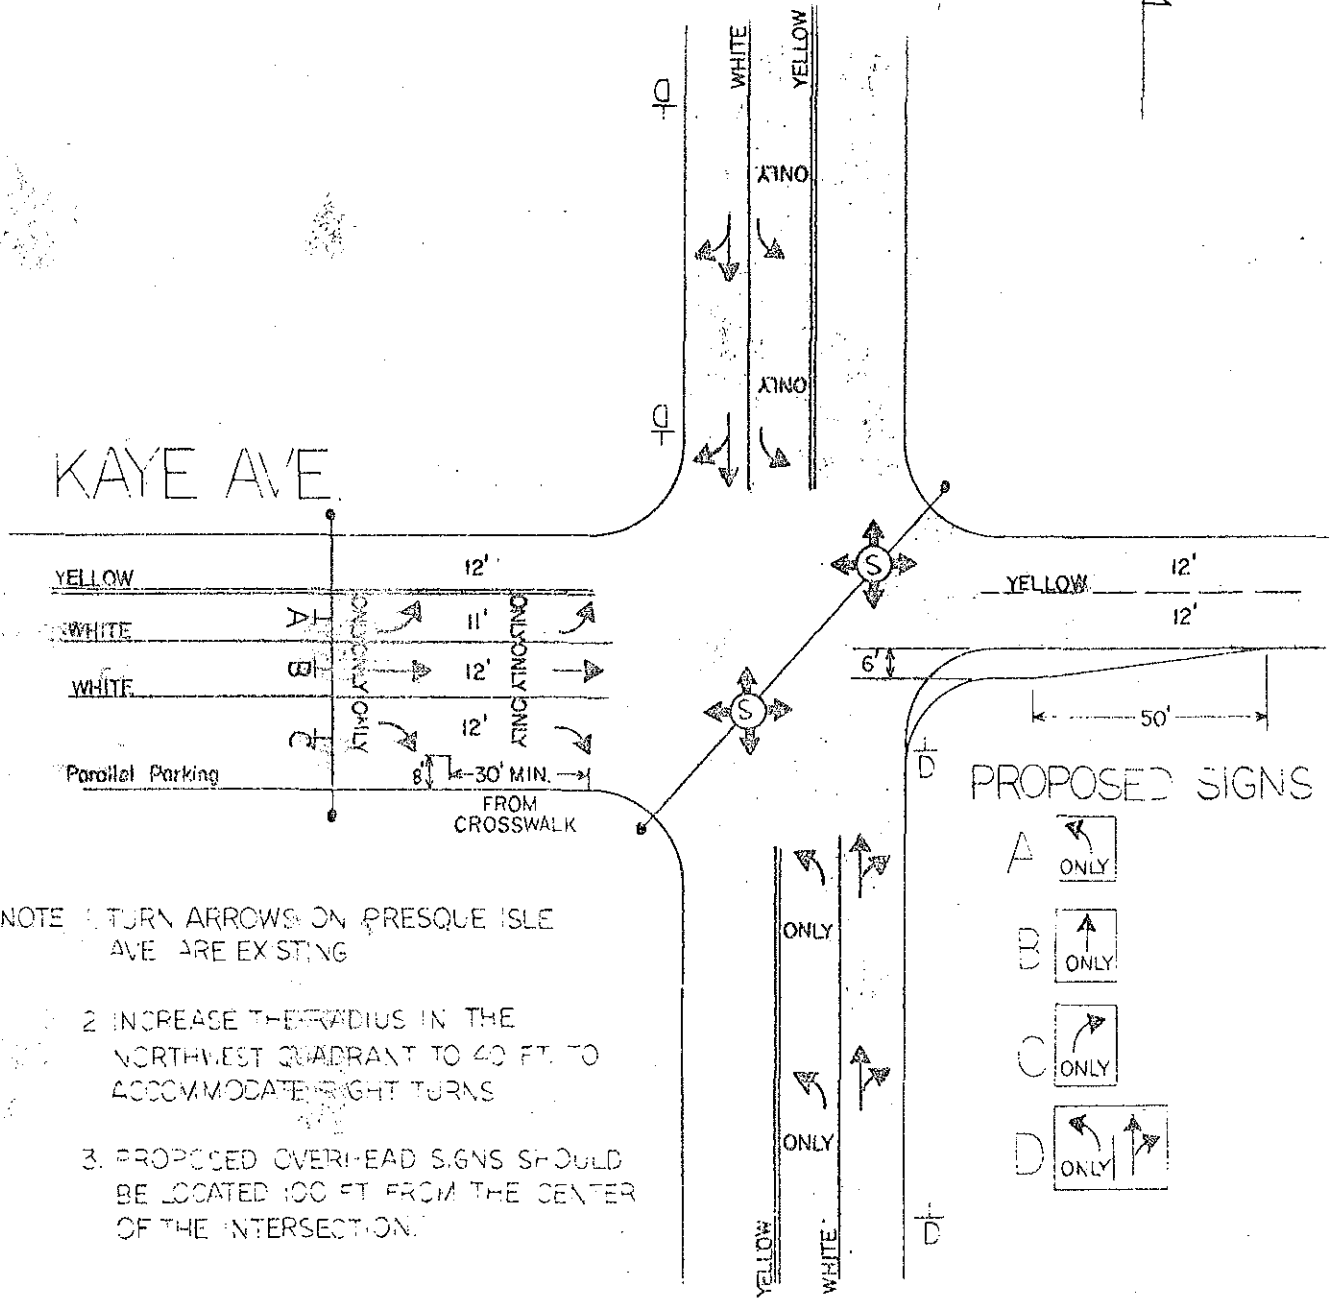
FIGURE 21

NOTE 1. TURN ARROWS ON PRESQUE ISLE AVE ARE EXISTING

2. INCREASE THE RADIUS IN THE NORTHWEST QUADRANT TO 40 FT. TO ACCOMMODATE RIGHT TURNS

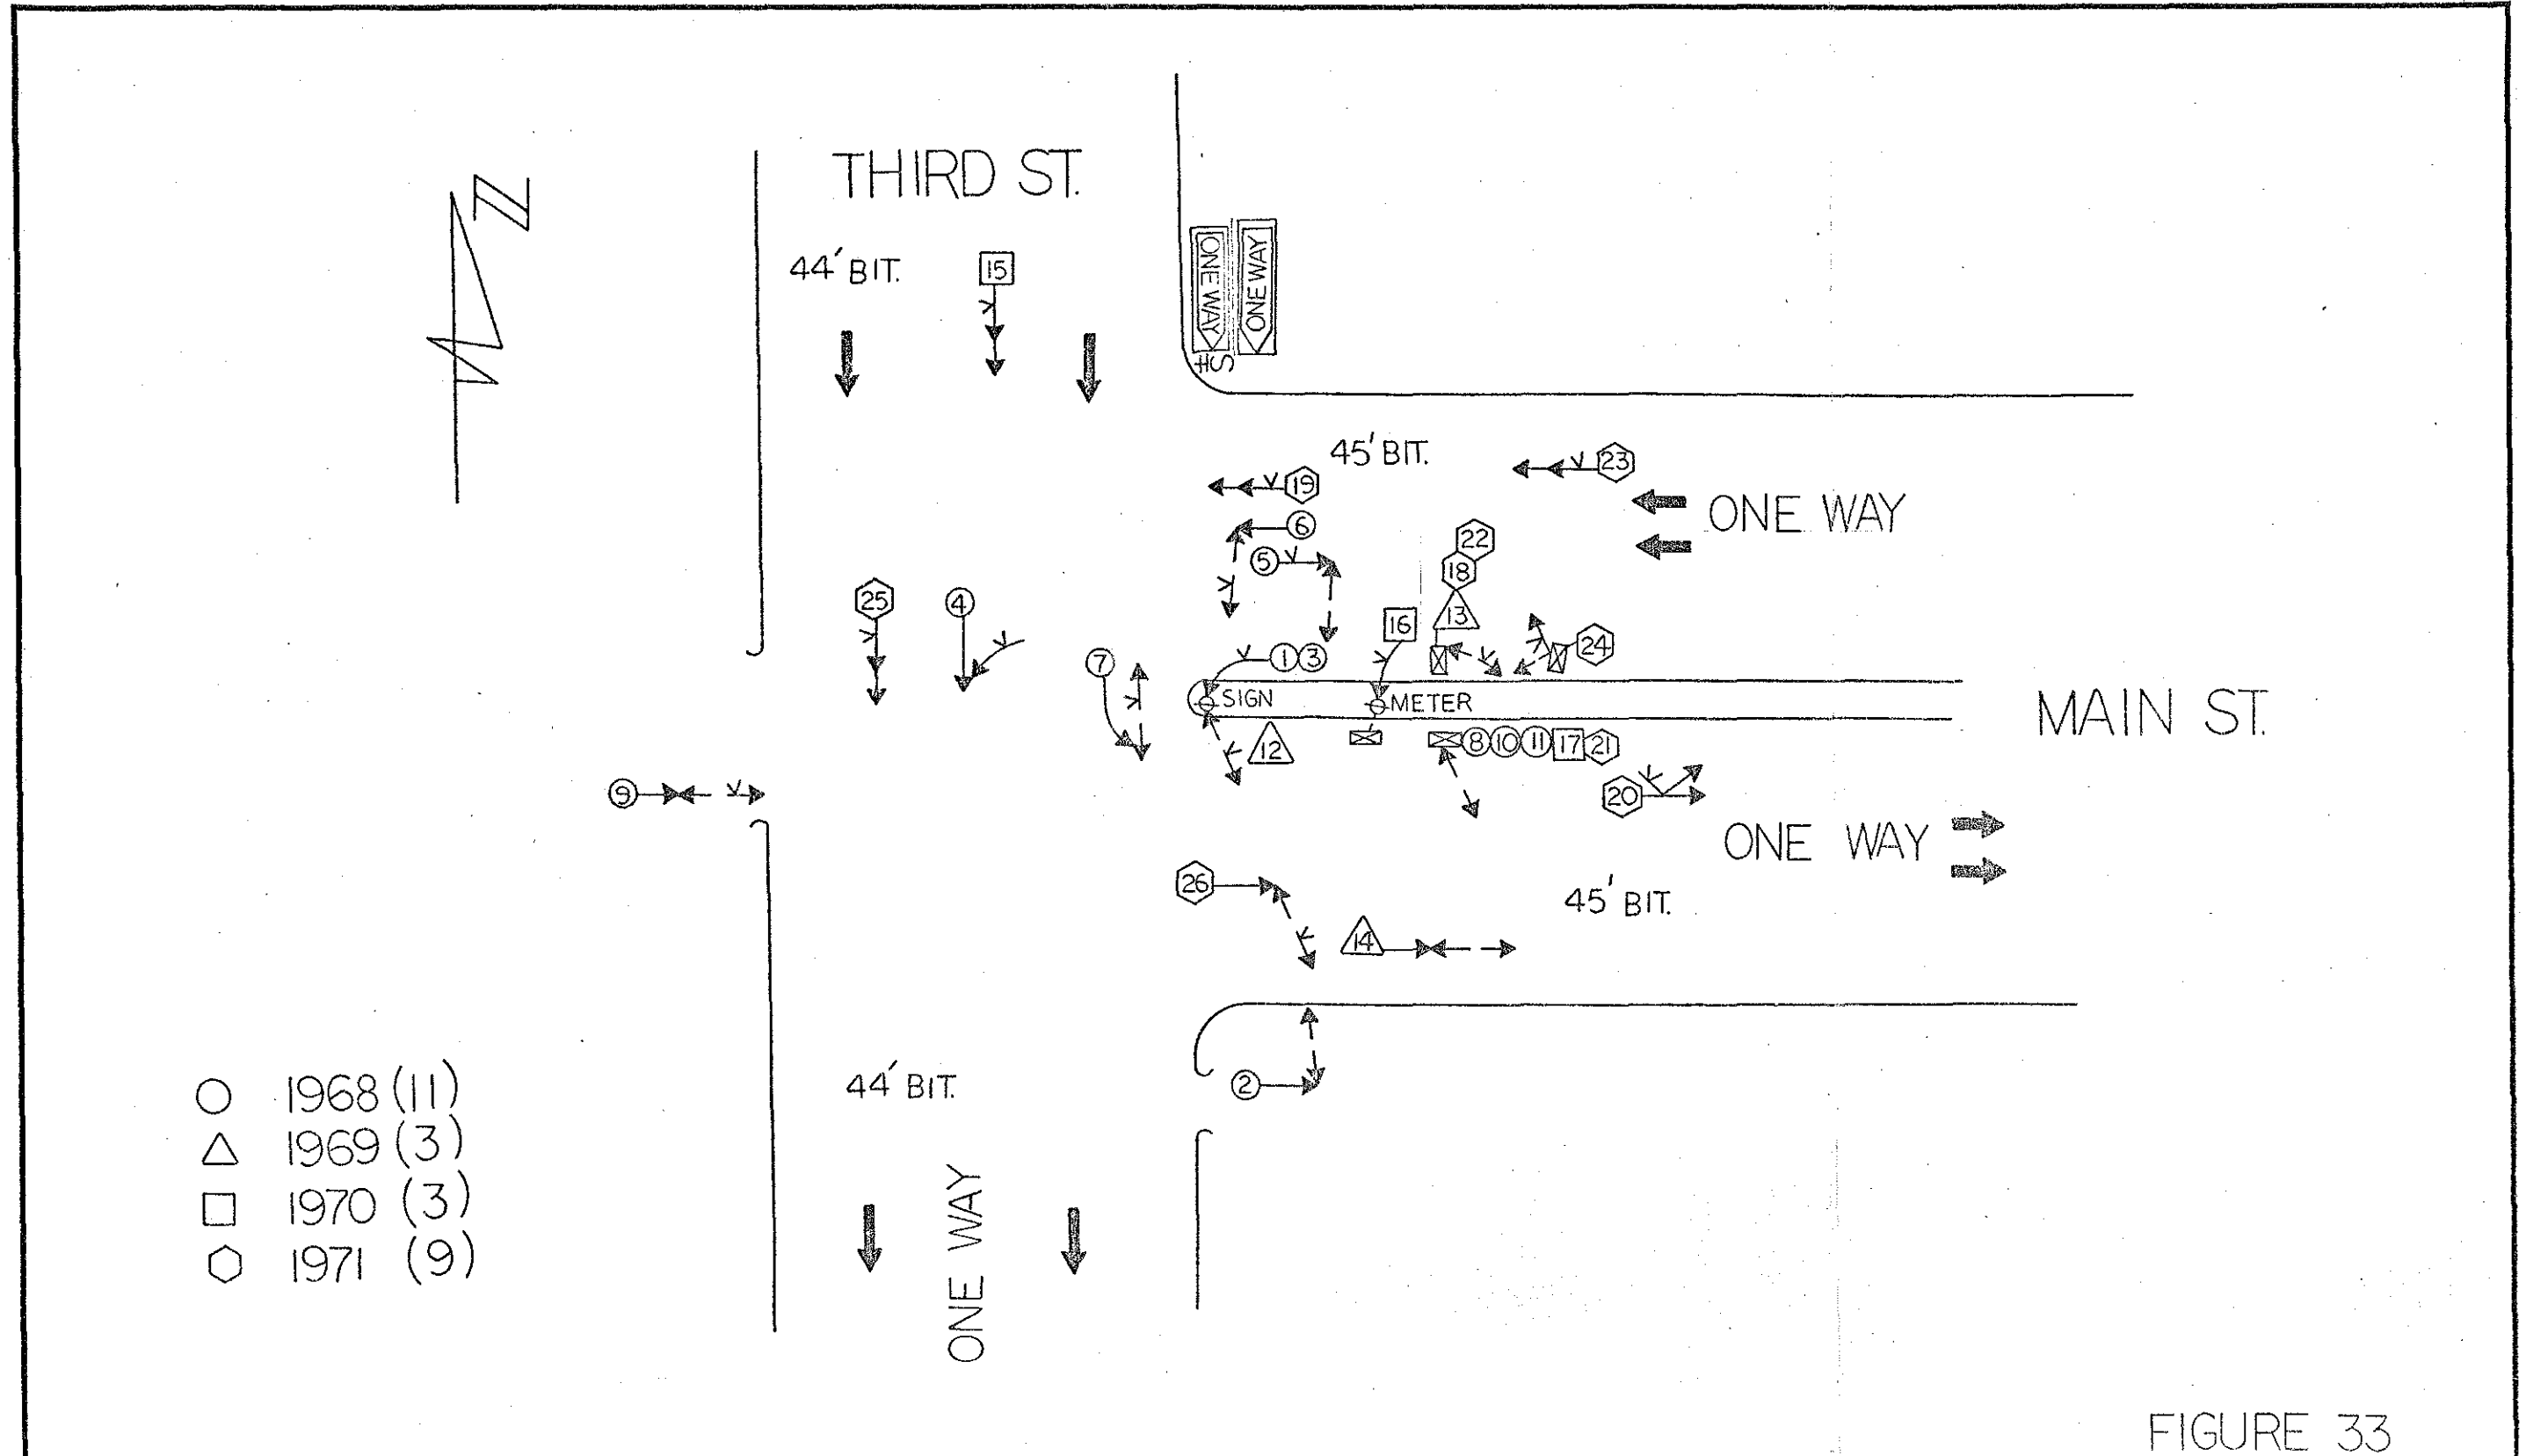
FIGURE 33

The south side of eastbound Main Street has 90 degree angle parking. Vehicles leaving these parking stalls are striking the parallel parked vehicles located along the north side of eastbound Main Street. To alleviate this problem it is recommended that the 90 degree angle parking be changed to 45 degree angle parking. Reduction of the parking angle will provide greater maneuverability for vehicles leaving the parking area. If the parallel parked vehicles continue to be hit in the future it is recommended that the parallel parking be removed.
