# OFFICE MEMORANDUM

MICHIGAN  
DEPARTMENT OF STATE HIGHWAYS

Subject: 1970 Performance Tests of "Fast-Dry" White Traffic Paints Plus Comparative Paints. Research Project 47 G-36(23a). Research Report No. R-760.

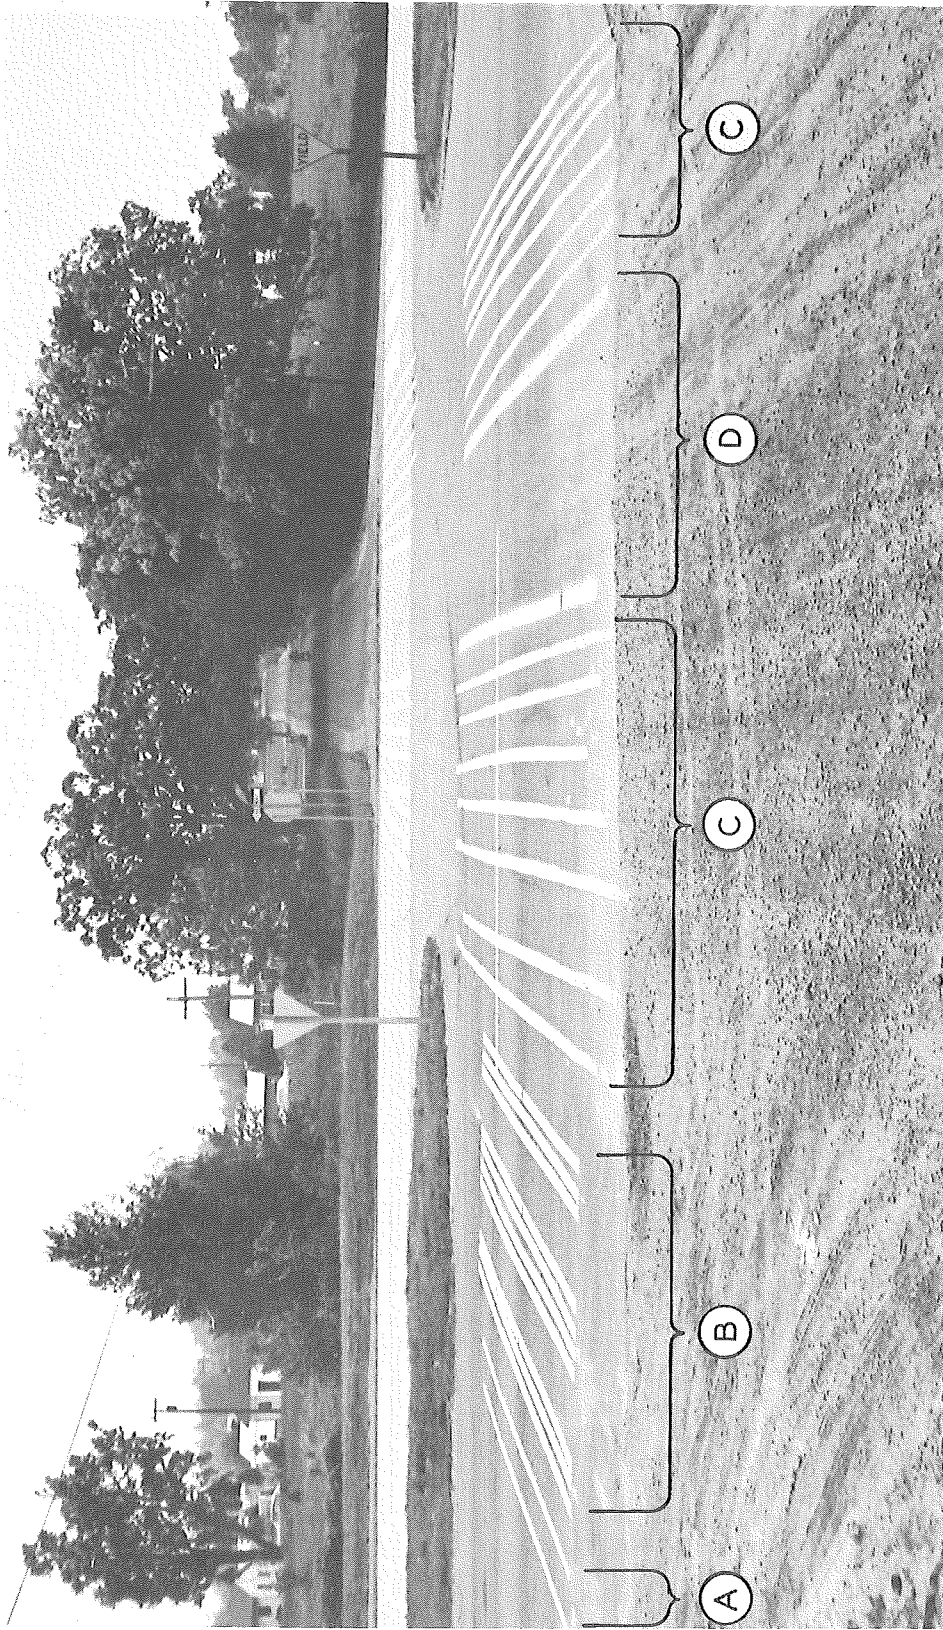
Figure 1. Test striping area showing: (A) tape, (B) regular dry paints, (C) 7 fast-dry paints (center and right), (D) "Instant Set." Two more "Instant Set" and "Cataquik" lines were applied after this photograph was taken. Foreground shows the black top area, with the concrete area in the background.

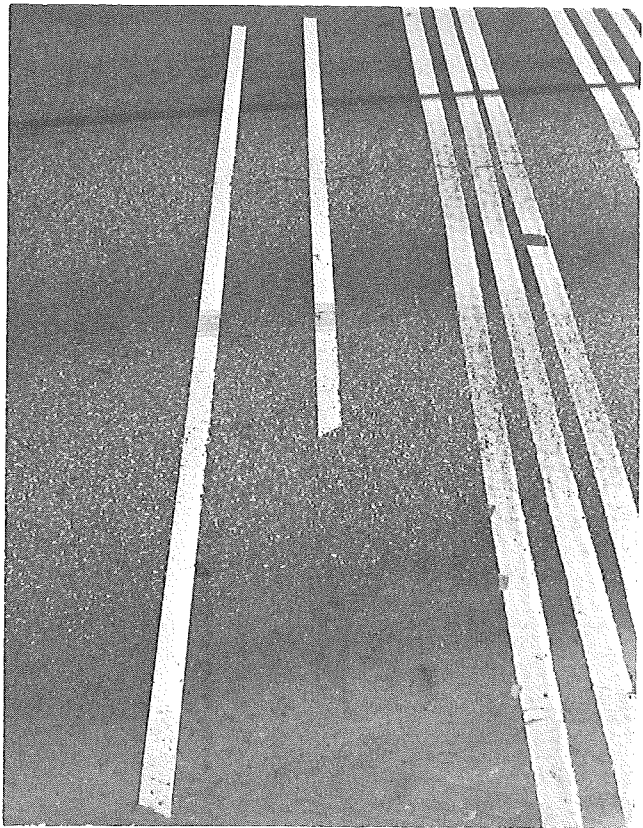
Two preformed tapes (left); short line vandalized shortly after application. Triplicate stripes of regular-dry paint (right) on bituminous area.

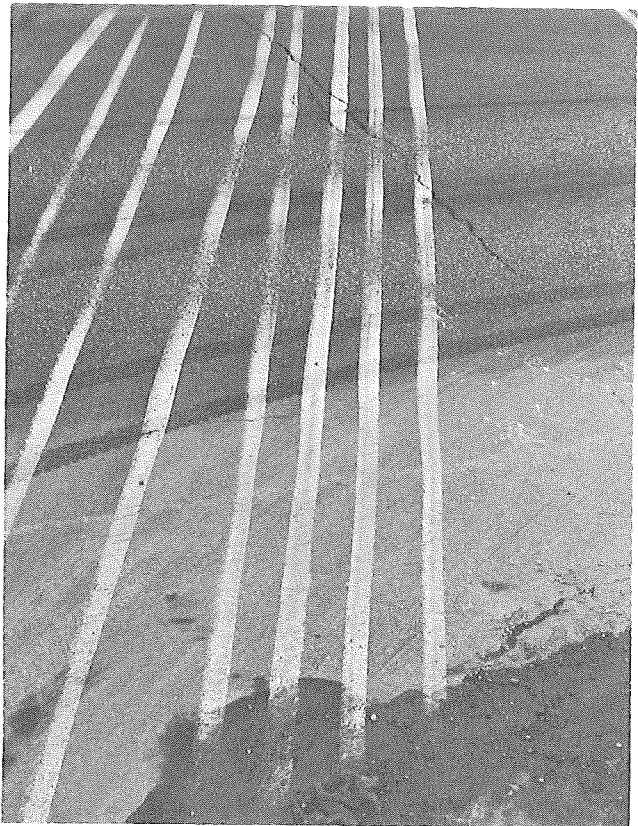
East group of fast-dry stripes on bituminous area, showing the 7 test paints plus wider Instant-Set (left).

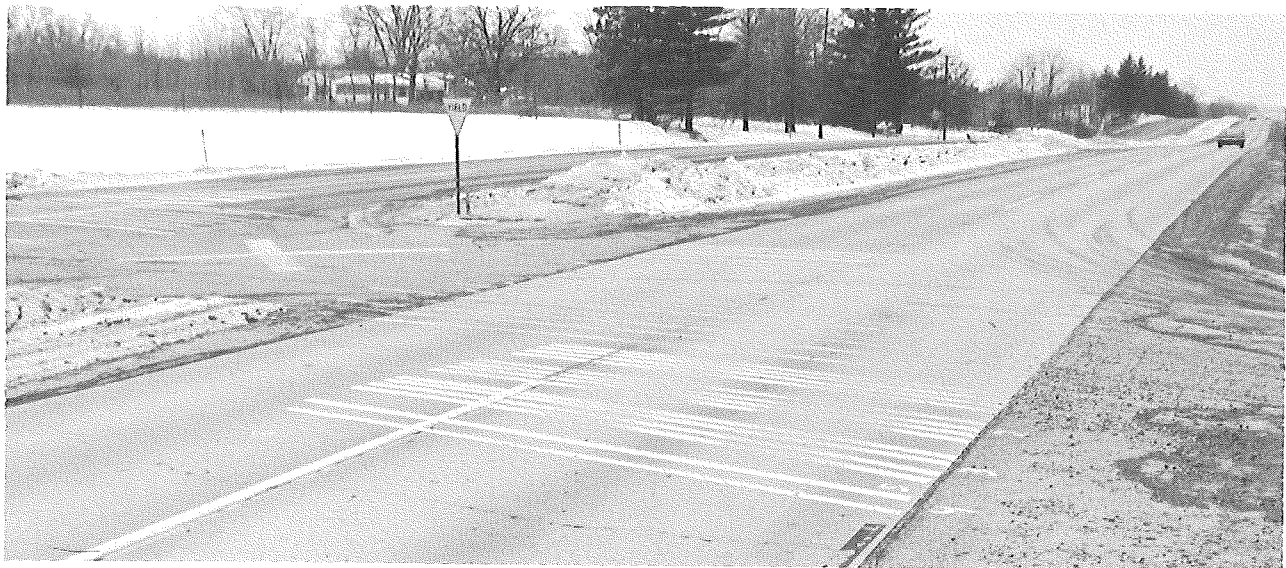
Figure 2. Terminal condition of test lines after 6-1/2 months of service.

The tests verified previous experience that the "Fast-Dry" paints are outperformed by the regular-dry types.

Fast-dry test lines (background) are almost worn away on concrete of WB M 78, while regular-dry and tapes (foreground) are less affected.

This matter should be corrected in future tests by selecting a more suitable roadway area and application equipment. The latter should be smaller equipment having good control of stripe thickness and beading ratio.
