A STUDY OF
CONCRETE PAVEMENT CRACKING ON PROJECT 42-7, C1
Research Project 44 C-27

RESEARCH LABORATORY
TESTING AND RESEARCH DIVISION
September 3, 1944

A STUDY OF CONCRETE PAVEMENT CRACKING ON PROJECT 49-7, C1.

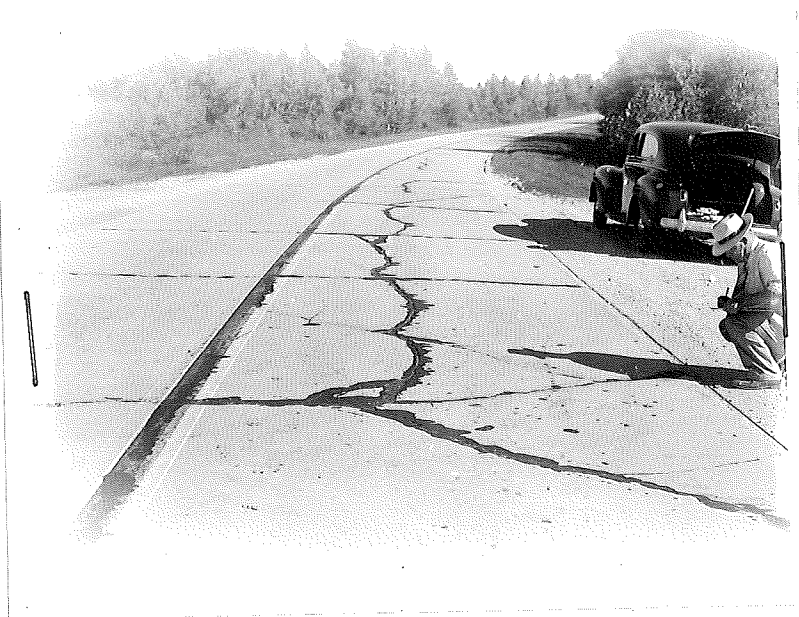
205+81 to 205+77 (R) Frost heave material was found to a depth of 3 feet below top of slab on right side. Soil on left side consisted of a sandy loam gravelly material to a depth of 3 feet. This material was evidently used in constructing the old road bed since it was found quite consistently throughout the project. Cracking in this area was apparently due to differential heaving of subgrade material. See figure 1 for general condition of slab and character of cracking.

Figure 1. 49-7, C1, General view of cracking at Station 205+00. Note concrete is in excellent condition adjacent to cracks and cracks have not faulted. View looking north.

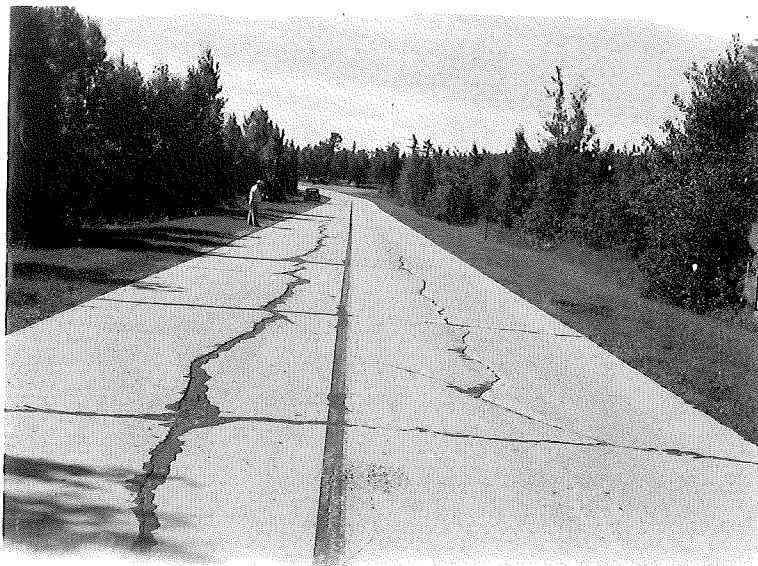
210+43 to 233+42 (RM) Subgrade conditions were fairly constant throughout this area. Cracking occurred on both sides. Left slab has raised along longitudinal cracks, while on right side the slab was depressed at the longitudinal cracks. Note in Figure 2 how snow plows have removed joint sealing compounds from longitudinal crack on left side. The slab in this area was constructed on a fill section.

Figure 2. 49-7, C1, General view of cracking at Station 211+00 to 212+50. looking south. Heaving occurred at crack on right, settlement at crack on left. Note how snow plows have scraped crack on right.

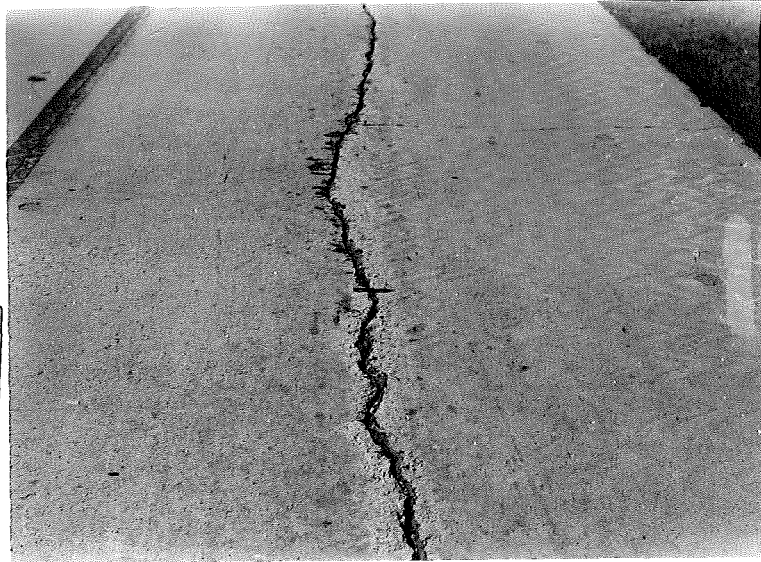
Figure 3. 49-7, C1, Close view of cracking shown in figure 2. Crack width varied from 1/2 to 3/4 inch. Note condition of concrete adjacent to crack. Looking south.

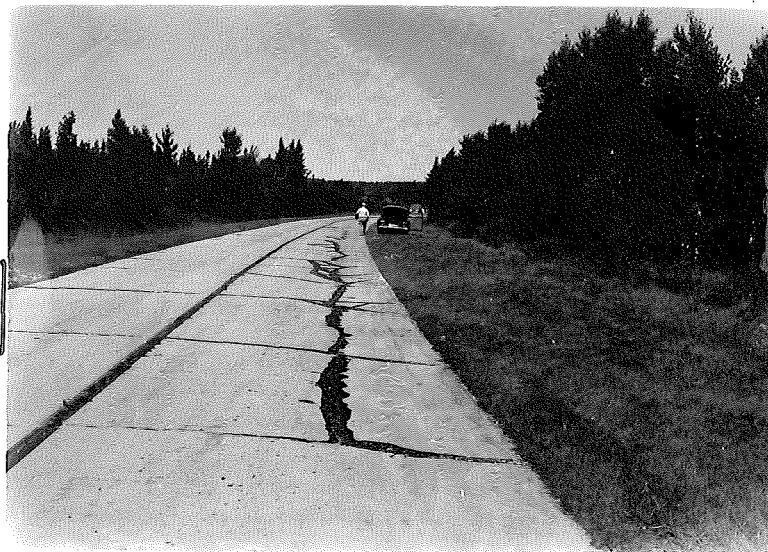
Figure 4. 49-7, C1. General view of cracking at Station 222+00. Looking north. Slabs settled along longitudinal crack, however, slabs have not faulted. Crack about 1/2 inch wide at top.

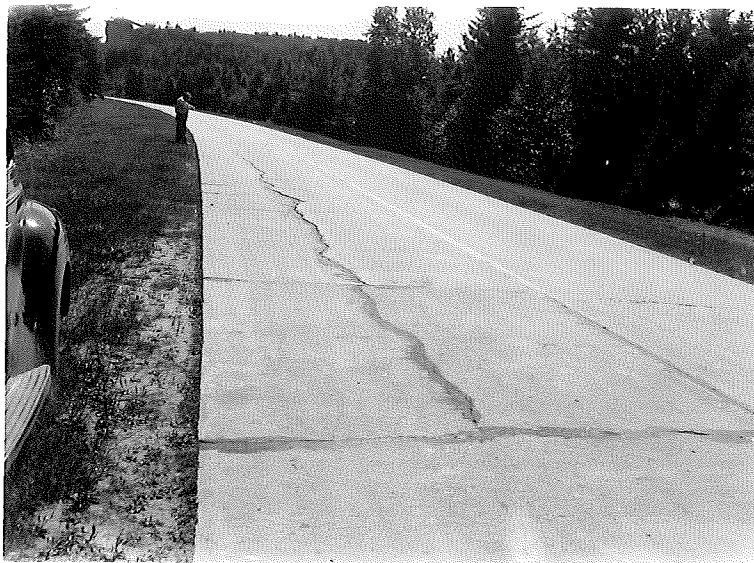
Sandy loam gravelly material was used for fill over peat, the fill varying in depth from 1 to 3 feet below top of slab. Peat varied from 0.5 to 1.0 feet in depth under fill. Water table was located at 3 feet. The old road bed on left side was also placed over peat. Cracking was apparently caused by unequal heaving and settlement of non-uniform subgrade material throughout the cross section augmented by the presence of peat and a high water table. Since major longitudinal cracks are in the center of each lane they cause no inconvenience to traffic. Figure 3 illustrates present condition of cracks. Figure 4 shows cracked area from Station 222+00 looking north. Figure 5 shows typical cracking at Station 226+00 looking south. Figure 6 shows general condition of cracked areas.

Figure 5. 49-7, C1, General view of cracking at Station 226+00 looking south. Slight faulting is noted near center of cracked area.

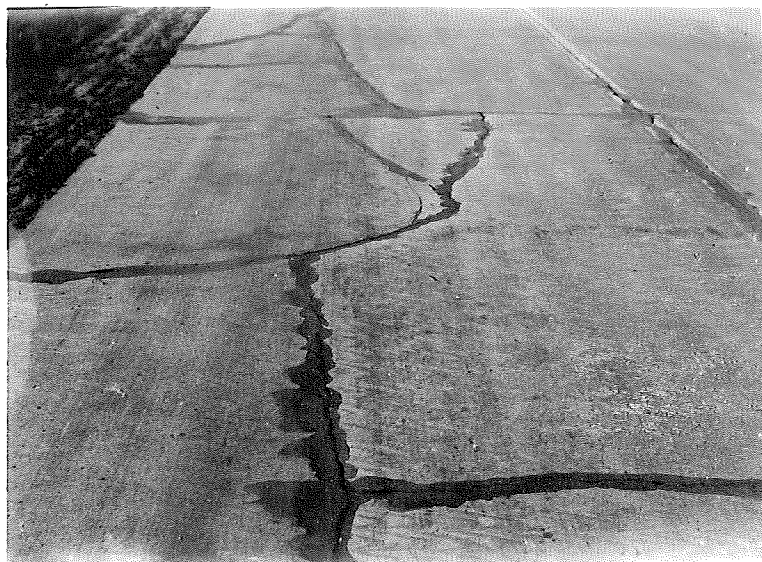
Figure 6. Typical condition of cracked areas. Station 232+00 looking south. Project 49-7, C1.

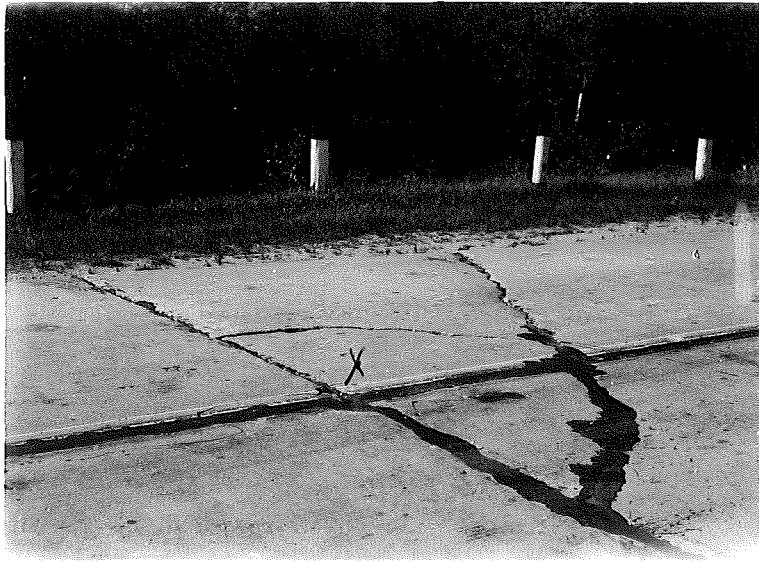
243+10 to 245+60 (RM) Cracking here was transverse and diagonal in character. The cracked area is located on high fill approaches to a culvert. One small triangular piece of concrete marked "x" in figure 7 has settled slightly below adjacent slabs. Cracking is no doubt due to settling of fill adjacent to culvert augmented by peat underneath. This spot may need attention soon.

Figure 7. 49-7, Cl, View of cracking at Station 245+52
Triangular shaped piece "x" has faulted. This area will
need attention soon.

4. However, there are at least three areas which are in need of immediate attention. At Station 207+36 to 209+11 on the right mudjacking may temporarily correct the settlement of the slab in that location. At Station 243+50 a small cracked portion of concrete slab has faulted and may be corrected with either a

bituminous or concrete patch. At Station 422+28 the pavement is badly cracked and will need a concrete patching operation within the near future.

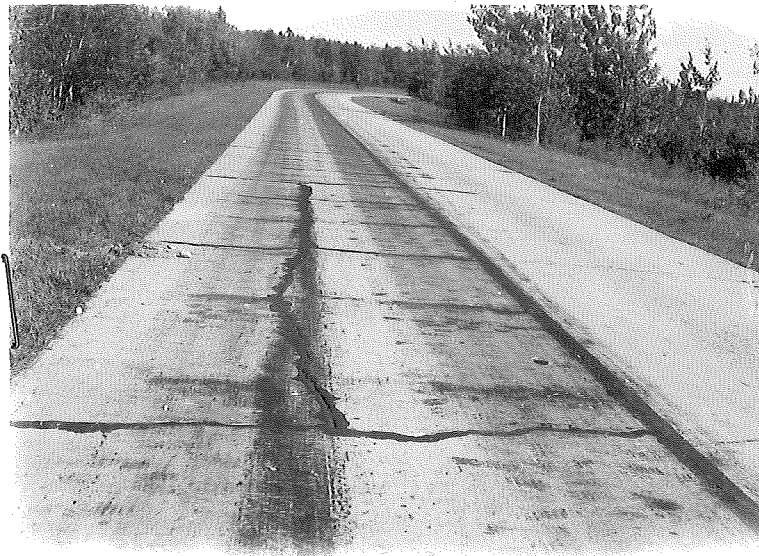
on both sides of slab. Cracking consists of short longitudinal cracks in right lane only. See figure 8. Cracking may be caused by non-uniform compaction of subgrade or the presence of small localized pockets of undesirable subgrade materials. The definite cause of cracking in this region was not ascertained. Pavement and cracks are in excellent condition.

Figure 8. 49-7, Cl, Typical cracking at Station
284+00 looking south. Pavement in excellent shape.

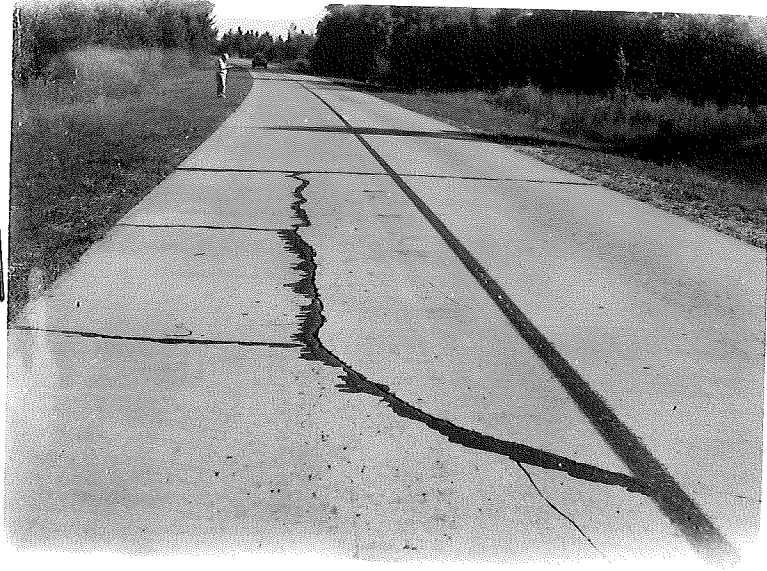
305+50 to 308+22 (R) Slab was constructed on a fill section composed of one foot of sandy loam over peat 0.5 foot to 1 foot thick, the peat overlying sand. Sandy clay encountered at 3 to 4 feet below slab. Water table at 3 feet. Cracking probably due to unequal heaving and settlement of subgrade material. Typical cracking shown in figure 9.

Figure 9. 49-7, CI, Cracking at Station 347+50, looking south.

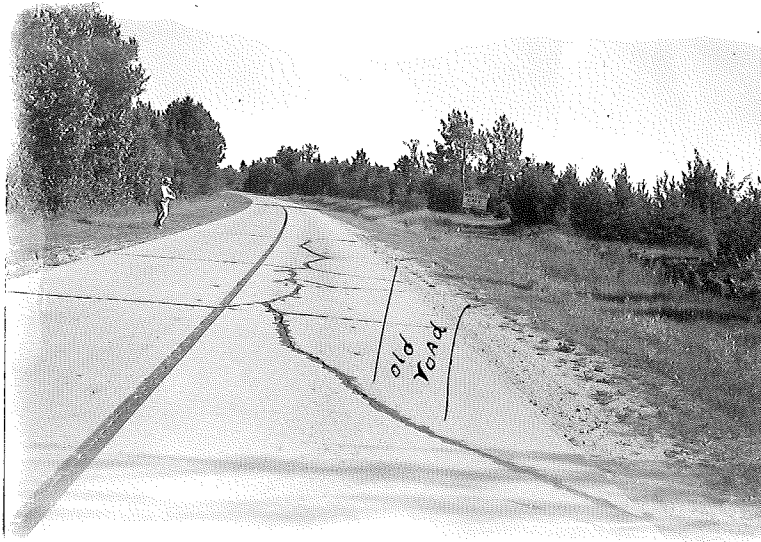
345+57 to 347+38 (RSL) On left side there was one foot of sand fill over old road bed material. Subgrade on right side consisted of a uniform sand fill. Cracking apparently due to non-uniform subgrade materials. See figure 10 for typical cracking at this location.

Figure 10. 49-7, CI, Cracking at Station 553+00, looking south. Note that this area is where old road joins new pavement.

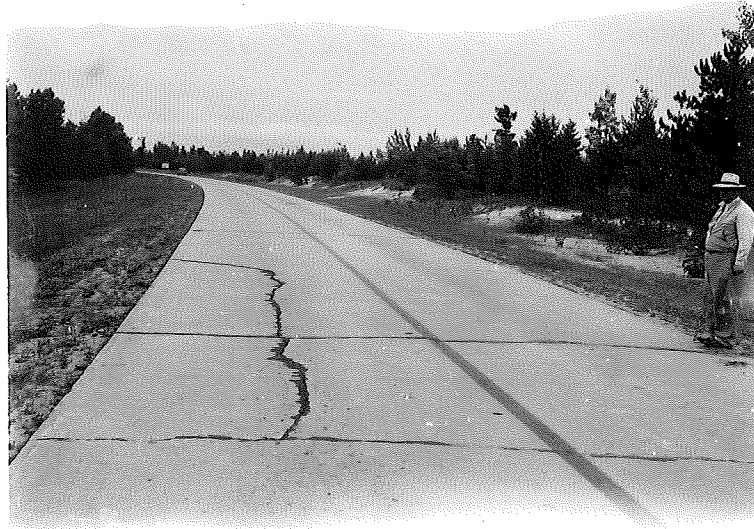
352+59 to 364+09 (RSL) Subgrade on left side consisted of 2 feet sand over old road bed material composed of sandy loam gravelly material with high clay content. Right side consisted of 2 foot ideal sand fill. Cracking eventually due to non-uniform subgrade conditions such as would exist in a side hill cut and fill section. See figure 11 for typical cracking and general subgrade conditions.

Figure 11. 49-7, C1, View at Station 384+00 looking south. Slab on side hill cut. Old road bed on left. Sand ridge on right.

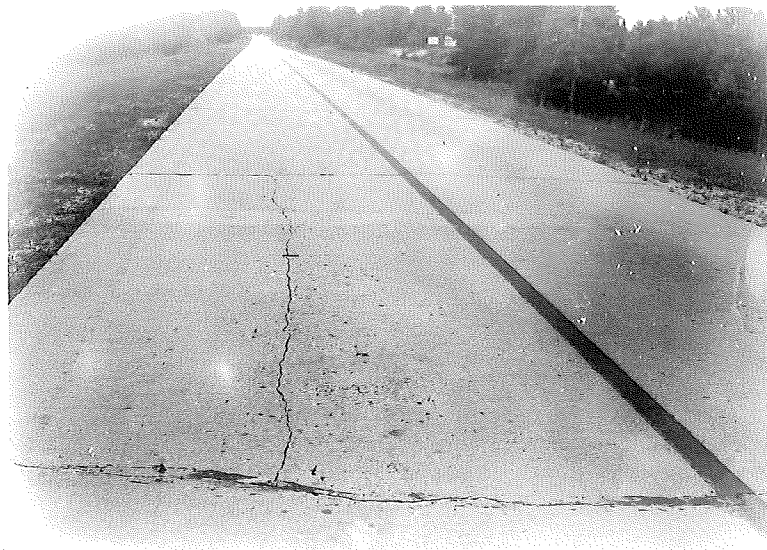
380+07 to 414+50 (R) Left side in cut section composed of Eastport sand making ideal subbase material, while right side was constructed on fill section consisting of from 0 to 2 feet of sand, silt and very fine sand fill material over sand. Cracking apparently caused by non-uniform subgrade conditions. See figure 12 for typical cracking in this area.

Figure 12. 49-7, C1, View at Station 383+00, looking south. Pavement on cut and fill section. Cracks need sealing.

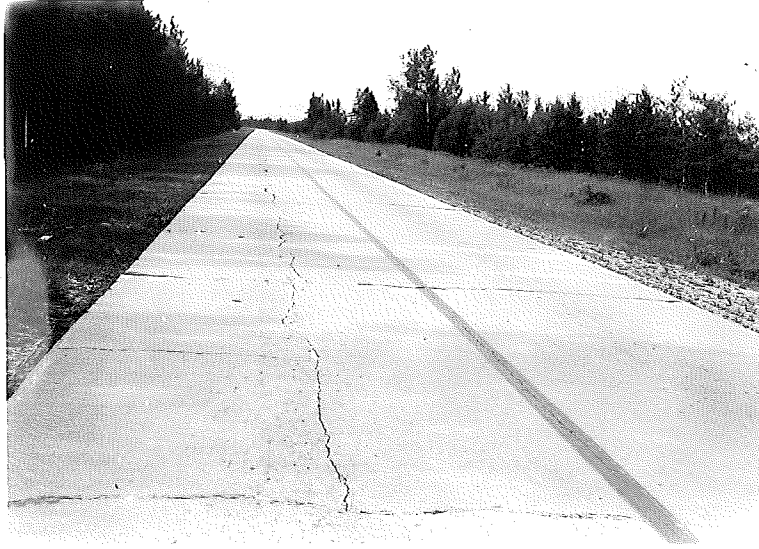
Figure 13. 49-7, C1, View of cracking looking south from Station 414+00. Slab constructed on cut and fill section.

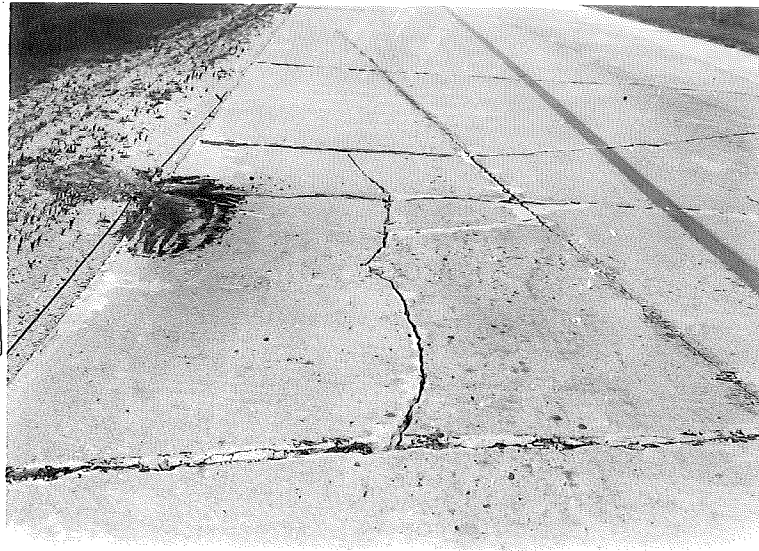
On right there was a 2 to 3 foot fill of loamy sand over a 0.5 to 1.0 foot thick layer of peat over sand. Water table was at 3 to 4 feet. Cracking apparently caused by non-uniform subgrade conditions. Pavement badly cracked at Station 422+15 near wye intersection. This area perhaps should be replaced. See figure 13 for typical cracking in this area. Figure 14 is a close view of an unusually bad area at Station 422+15 which will need attention. Figure 15 shows unusual construction procedure at wye intersection.

Figure 14. 49-7, C1, View at Station 422+10 looking south showing bad break up in this area. Note soundness of concrete adjacent to cracks.

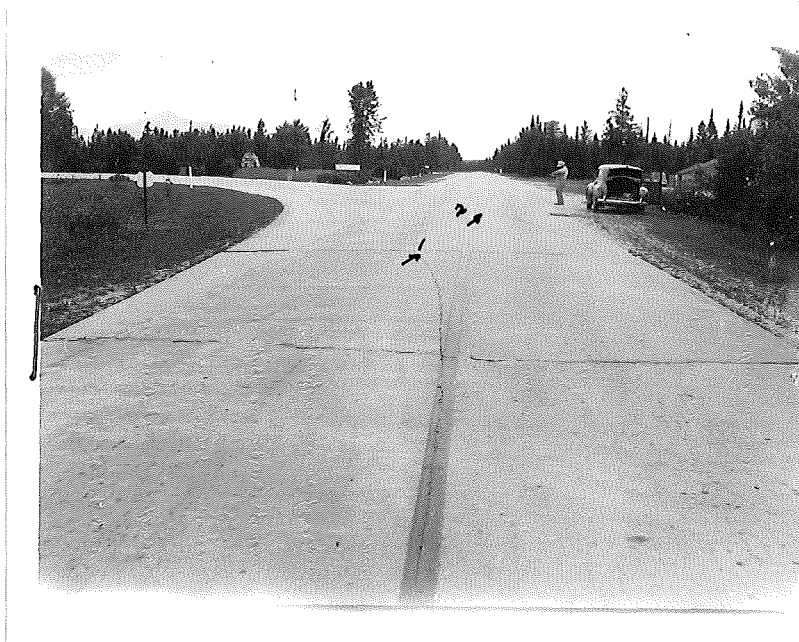
Figure 15. 49-7, C1, General view of wye looking north at Station 422+00. Note unusual construction procedure at wye emphasized by curved cracks joining the center line of US 2 with center line of County Road (1). Also note similar curved crack joining the right edge of the slab on US 2 with that on County Road (2)
