June 26, 1961

Subject: Investigation of Three Spalled Joints on US 131 South of Grand Rapids.
Construction Projects F 41-88, C1RO and M 41-88, C2.
Research Project 39 F-7(14). Report No. 359.

Reported by O. L. Lindy

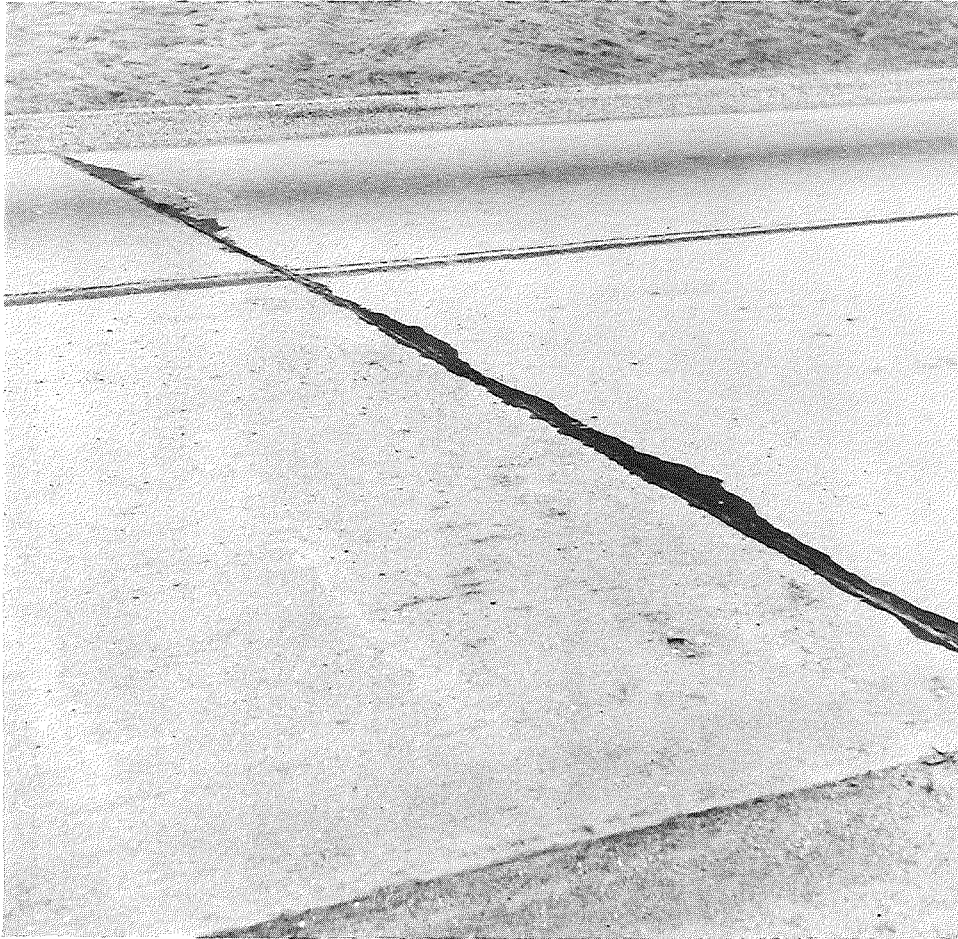
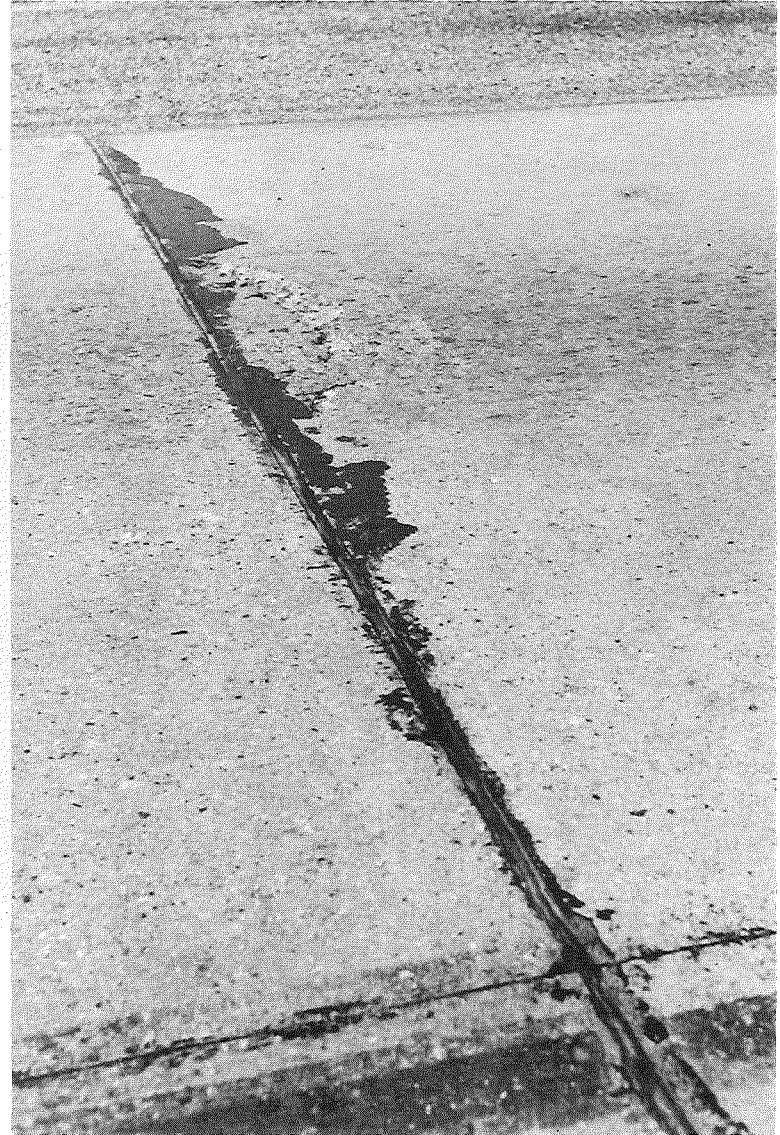
Joint 1: Station 210+25 Southbound

Spalling at this joint is located in the traffic lane (Fig. 1). Considering the angle of the plan of cleavage at the pavement surface, the break is probably 3 to 4 in. down from the slab surface at the joint. The spall is on the "night" side of this construction joint and seems to be typical of deterioration being found at this type of joint.

Figure 1. "Joint 1" exhibits deterioration on the "night" side of the joint in the traffic lane. Station 210+25 Southbound.

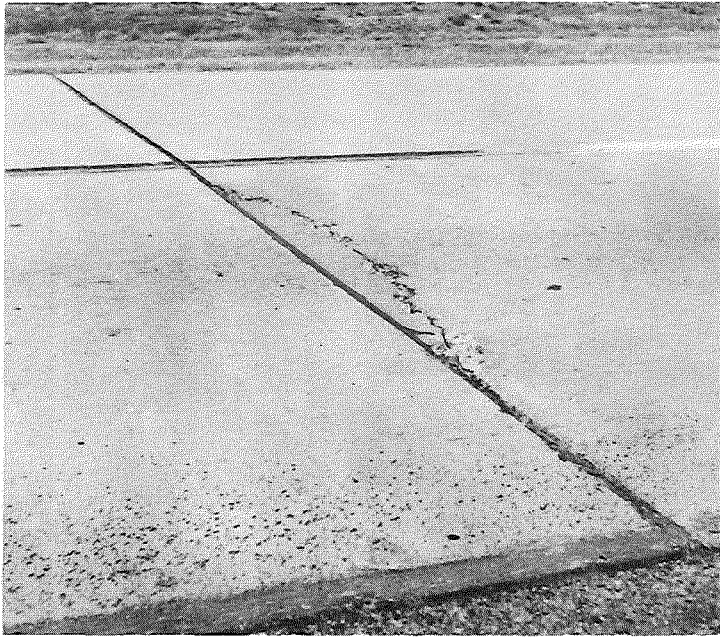
Joint 2: Station 234+83 Northbound

This contraction joint has a large break in the traffic lane (Fig. 2), on the forward side of the joint--the unbroken slab was poured before the broken one. The crack formed by the break appears to be undergoing all the movement and pressure that normally would occur at the joint. This is demonstrated by the appearance of the joint seal; although it is separate and parted from the slab along most of the transverse joint, it is still adhering and undisturbed opposite the break.

Figure 2. At "Joint 2" the sealing material is parted from the slab along most of the joint, but is intact and adhesive along the broken slab edge, where normal joint movement pressures appear to be occurring at the spall crack. Station 234+83 Northbound.

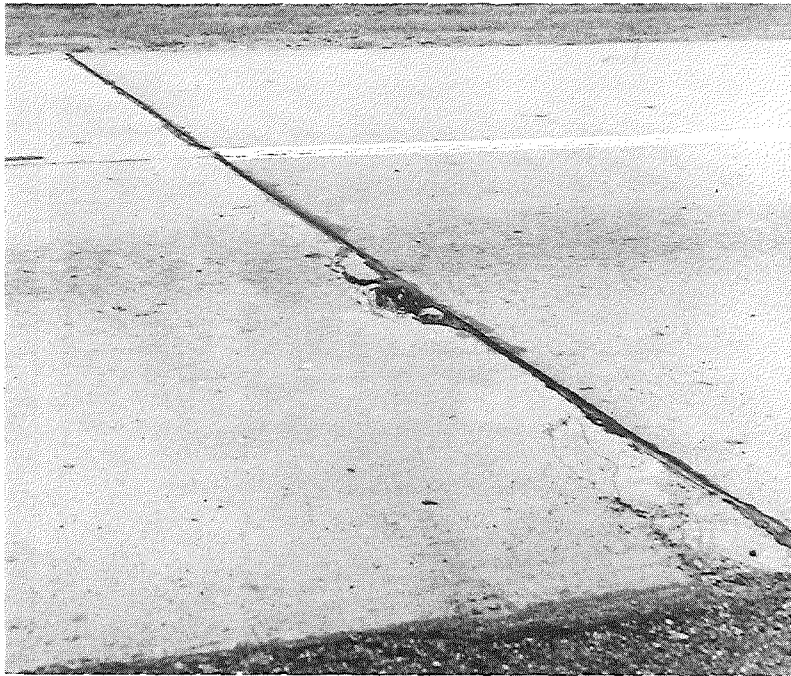
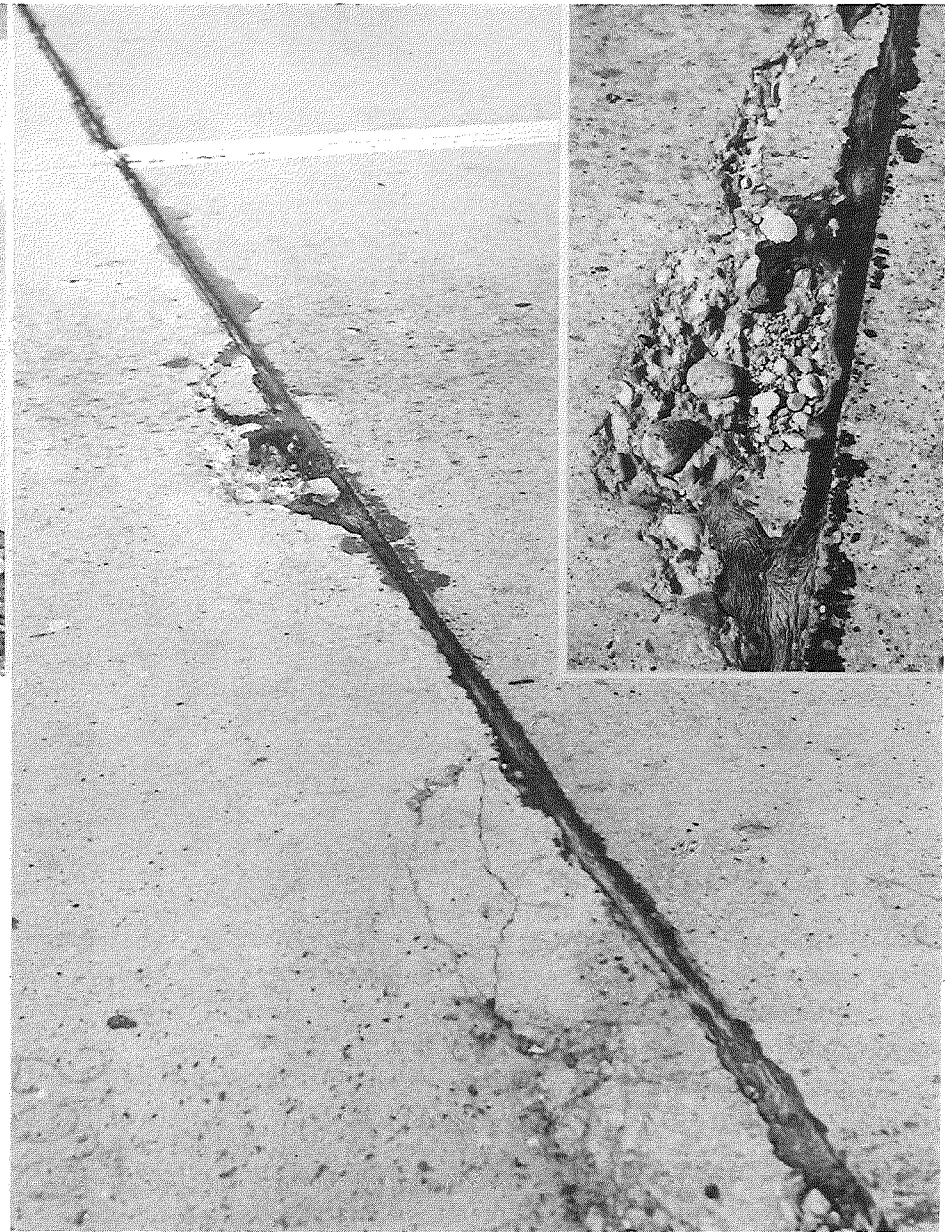
Joint 3: Station 255+02 Northbound

Spalling at this construction joint is on the "night" side (Fig. 3). Concrete in this section is of a quality permitting bond failure between coarse aggregate and the slab surface mortar layer.

Figure 3. "Joint 3" has deteriorated concrete at two points in the traffic lane, on the "night" side of the joint. Note crumbling mortar and unbroken aggregate (right) indicating bond failure. Station 255+02 Northbound.
