SECOND CONDITION SURVEY OF EXPERIMENTAL CONTRACT
RESEALING AND PATCHING PROJECT

US-16 Nunica to Fruitport
Project Mc 70-28, G3

Research Laboratory
Testing and Research Division
Report No. 225
March 31, 1955

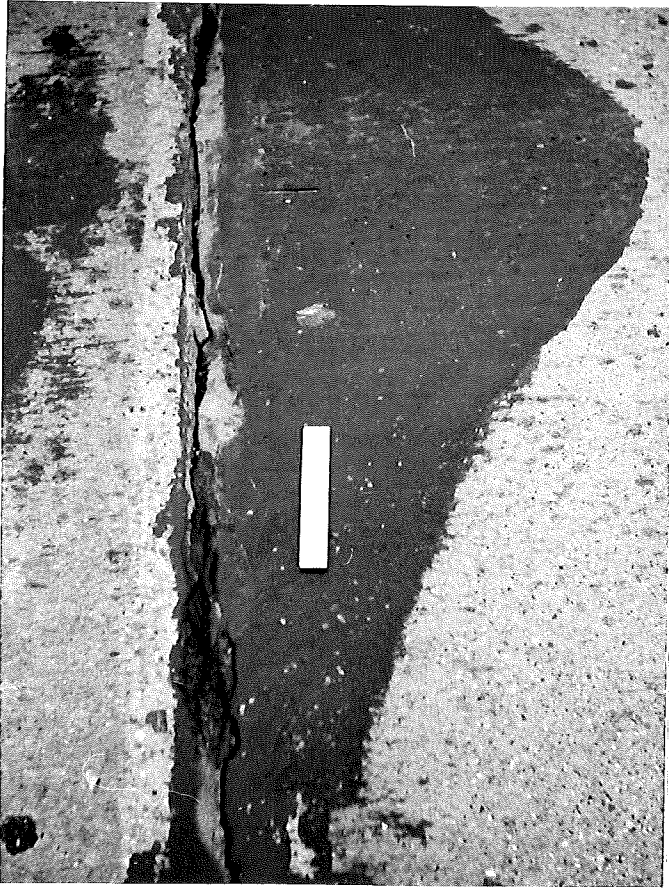
The current survey revealed that the Brand A sealer had continued to deteriorate to the point where in all transverse joints it was at least badly cracked and separated from the joint faces (Figures 1A and 1B). It was interesting to note that in spots where separation from the joint face had not occurred, the adhesion bond was very tight.

A. Station 655+50 N. Failures in Both Adhesion and Cohesion.

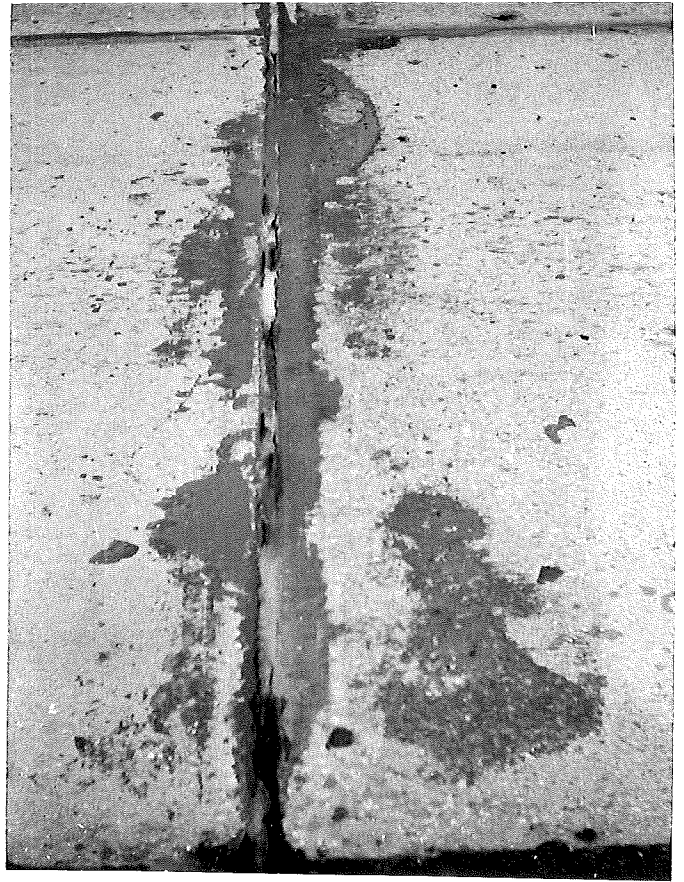
B. Station 646+45 S. Failure not as Extreme as at Left.

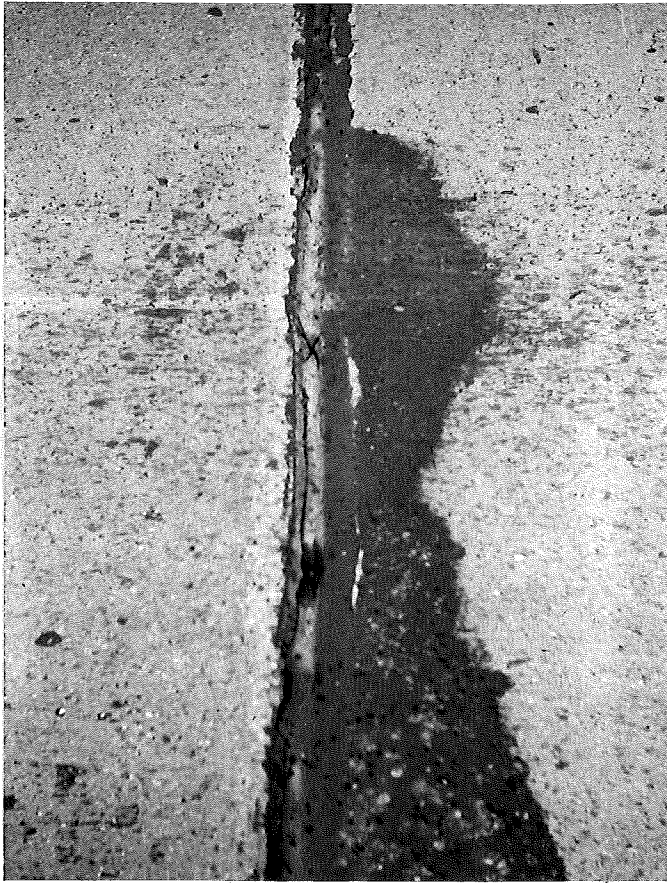
Brand B sealer has now also started to deteriorate. In about half of the transverse joints containing this material, failures have occurred in both cohesion and adhesion (Fig. 2A), while in the remainder, the sealer is intact except for a slight surface resinification (Fig. 2B).

A. Station 645+50 N. Failures in Both Cohesion and Adhesion.

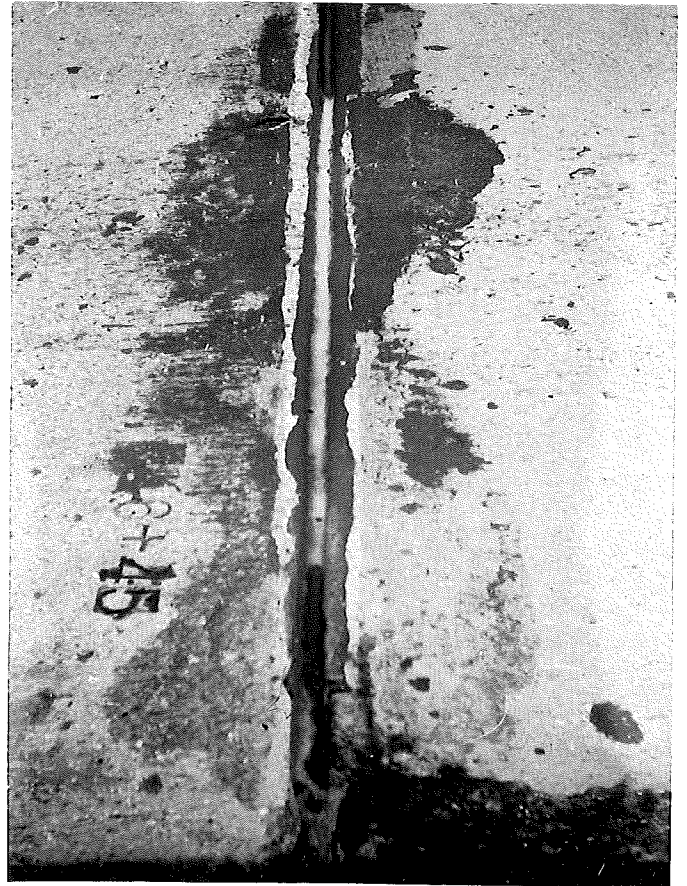
B. Station 646+45 N. Adhesion and Cohesion Good. Slight Resinification of Sealer Surface.

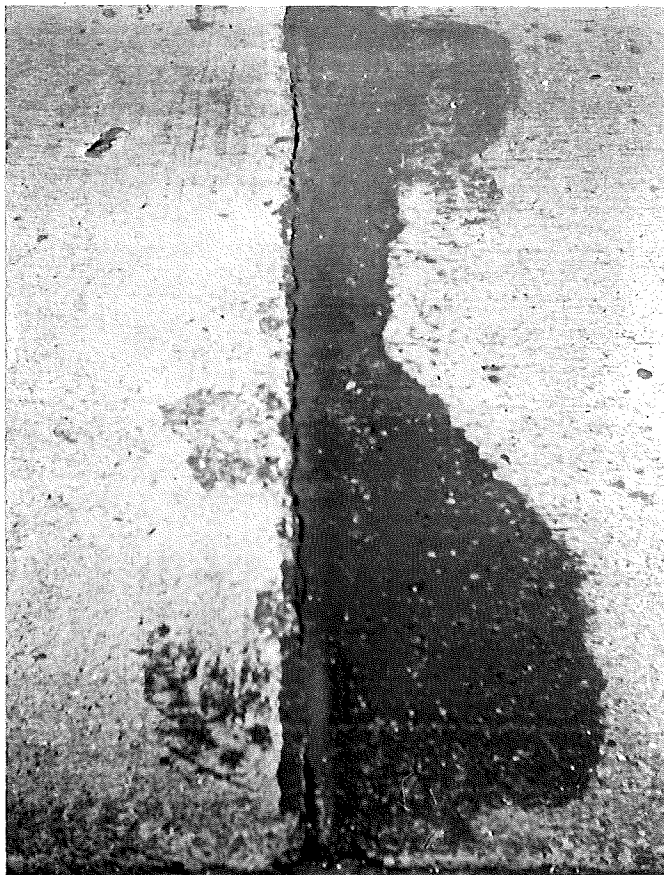
Some transverse joints containing Brand C sealer had adhesion failures in which adhesion of the sealer to one joint face was lost (Fig. 3A). Most of the joints containing this material, however, were in good condition except for a shallow checking of the joint seal surface (Fig. 3B).

A. Station 514+97 S. Adhesion to One Joint Face Lost.

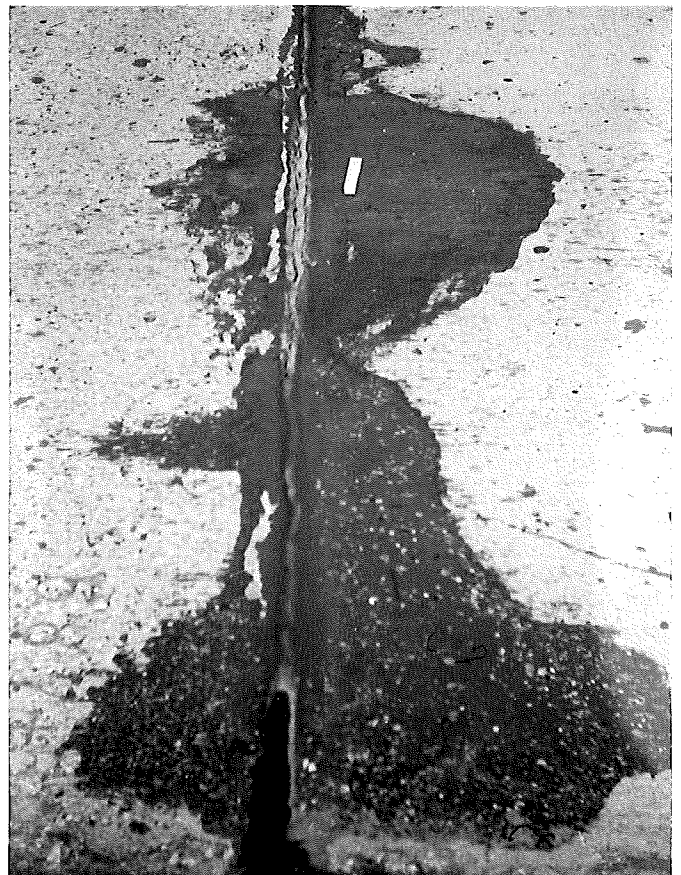
B. Station 578+52 N. Adhesion and Cohesion Good. Slight Surface Cracking Visible.

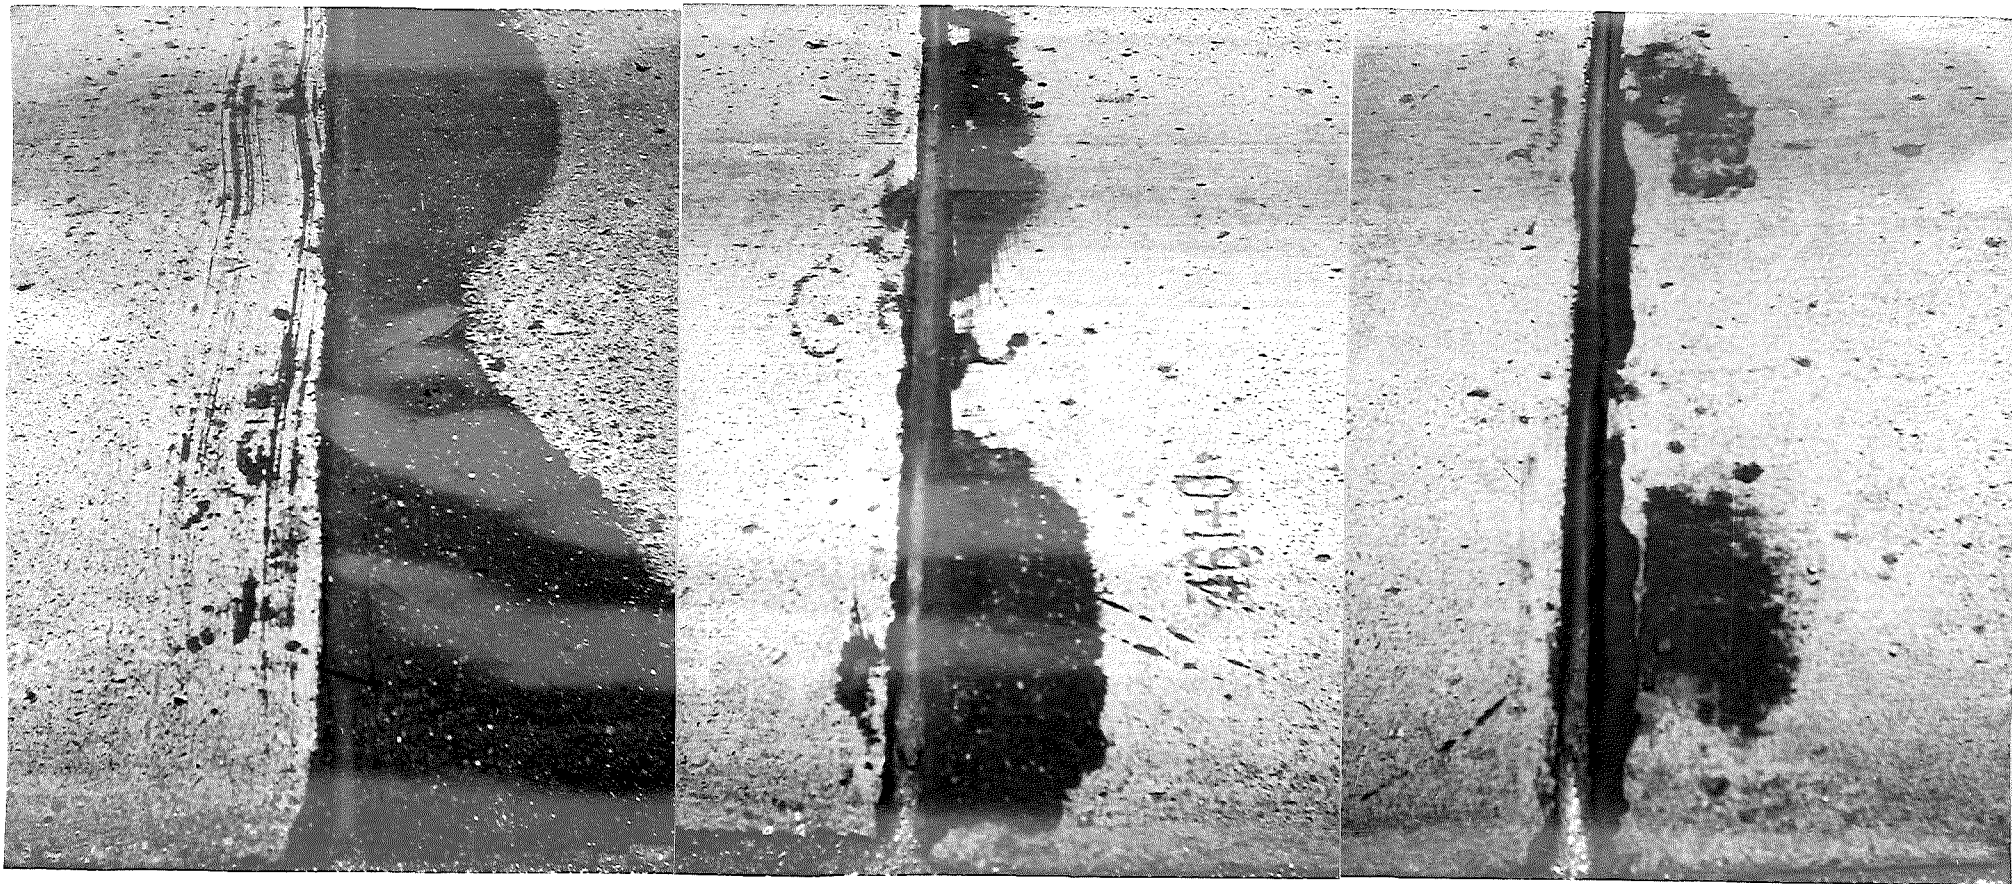
Figure 4. Transverse Joints Resealed with Brands D, E and F. Typical Appearance on March 16, 1955.

The other three materials in transverse joints were still in very good condition. Brand D sealer showed a slight adhesion failure in a few joints near the pavement edge (Fig. 4A) and a slight surface cracking or checking was apparent in Brand E sealer (Fig. 4B). Brand F sealer was in excellent condition, appearing as good as when it was first applied (Fig. 4C).

A. Station 482+50. Brand D in Good Condition Except Slight Adhesion Loss Near Pavement Edge.

B. Station 461+00 N. Brand E in Good Condition. Slight Surface Checking Present.

C. Station 430+20. Brand F in Excellent Condition.

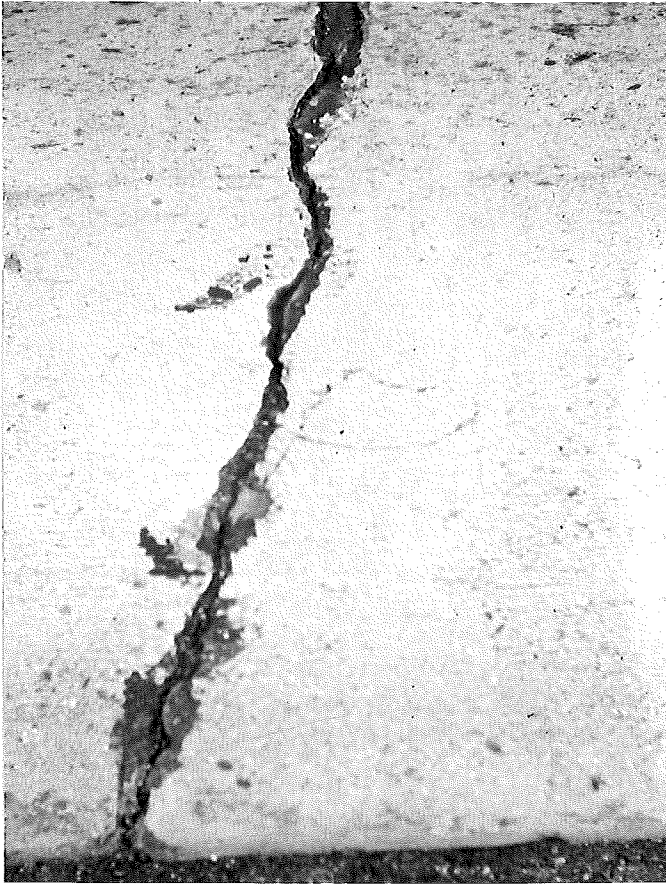
Brands A and C sealers failed in cohesion at wide cracks (See Figures 5A and 5B). The other materials were still performing satisfactorily.

A. Station 582+60 S. Sealed with Brand A. Failure in Cohesion.

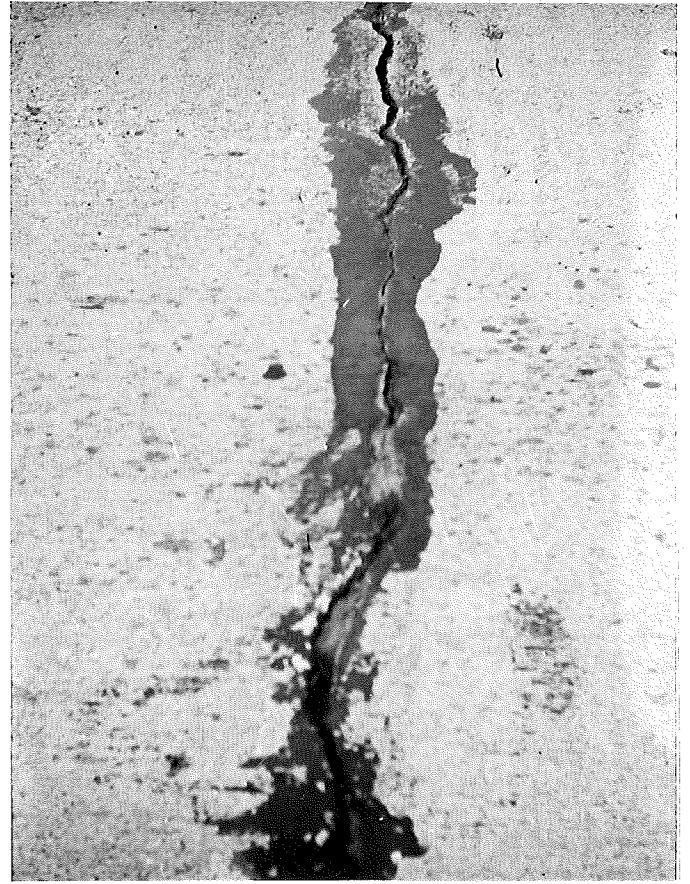
B. Station 582+60 N. Sealed with Brand C. Failure in Cohesion.

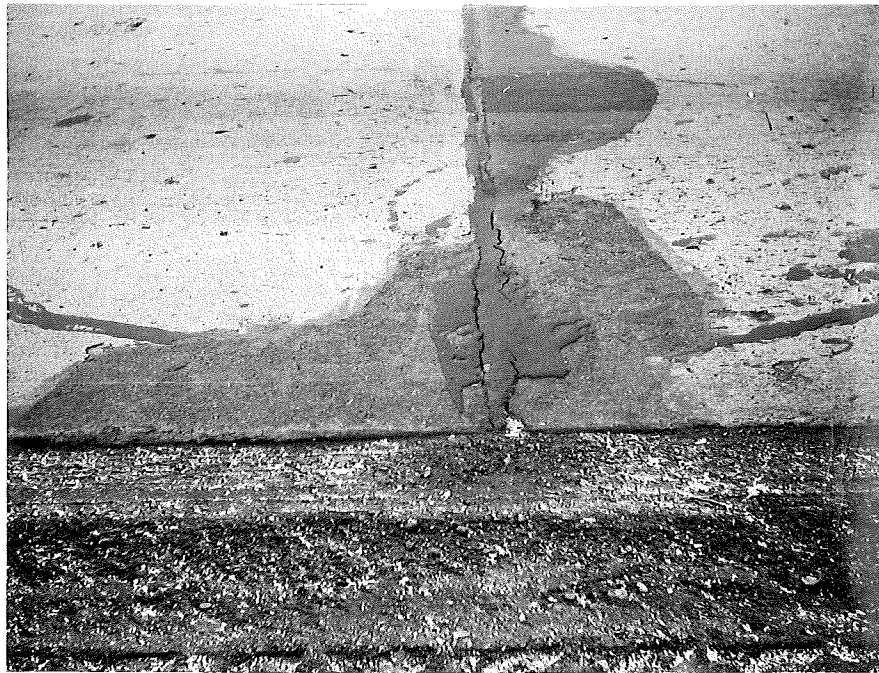
Figure 6 shows the condition of a typical concrete patch. The bond between the patching material and the old concrete is still in excellent condition. As indicated in Report 197B, there was a tendency for the joint seal to come loose from the patching material and this condition is still apparent. Two of the patched areas had been damaged by trucks going through the barricades and passing over the patching material before it was cured. This resulted in immediate cracking of the patching material and these cracks are now somewhat more apparent than during the previous survey.

Fig. 6. Typical Appearance of Repaired Corner Breaks
on March 16, 1955.
