PCC PAVEMENT JOINT RESTORATION
AND REHABILITATION
(Federal Highway Administration NEEP Project 27)
Construction Report

J. E. Simonsen
F. J. Bashore
A. W. Price

Research Laboratory Section
Testing and Research Division
Research Project 79 F-159
Research Report No. R-1179

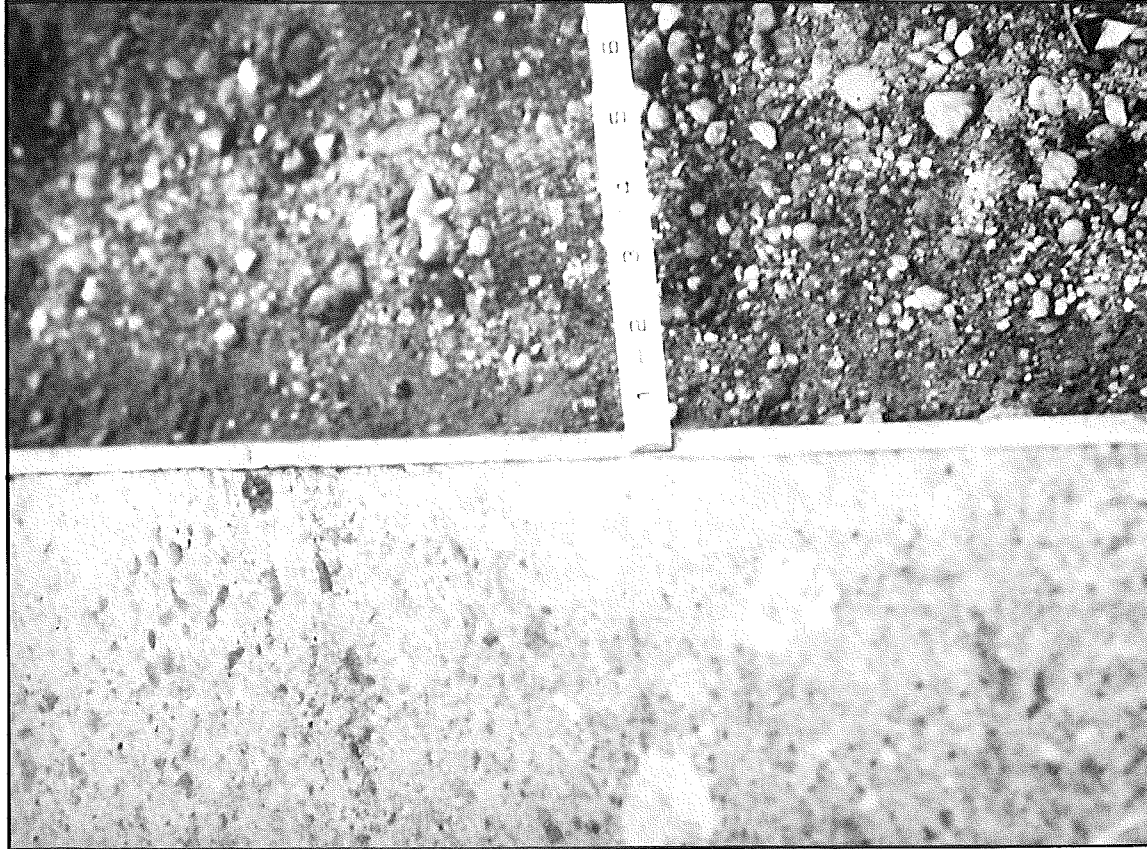
On the first step cut repair, one 18 in. blade with a spacer between it and the 26 in. blade was tried. However, the flexibility of the 18 in. blade outside the spacer support resulted in difficult sawing and a step of approximately 1/8 in. in width. Therefore, on the second repair, two 18 in. blades were mounted next to the larger blade. This set-up resulted in a step slightly over 1/4 in. wide and did not interfere appreciably with the normal operation of the saw. Figure 3 shows the blade mounting arrangement used for the second repair and Figure 4 shows the step after concrete removal.

Figure 4. View of step saw cut after concrete removal. Cut made with blade arrangement shown in Figure 3.

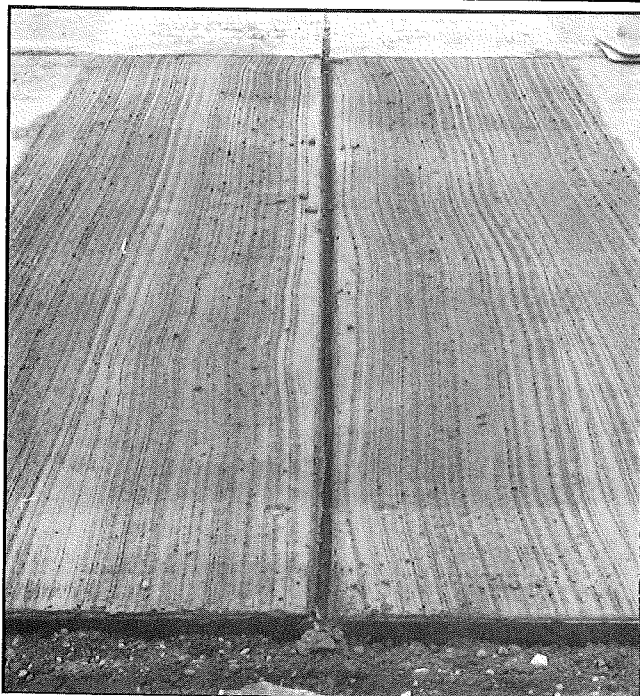
The 9-sack concrete mix was delivered to the site in ready mix trucks. Calcium chloride was added to the mix at the job site. The concrete placing and finishing operations followed normal procedures used for this type of work. Figure 10 shows a finished repair before the curing compound was applied and before sealing the joint.

Figure 10. Appearance of finished repair before applying curing compound and joint sealant.

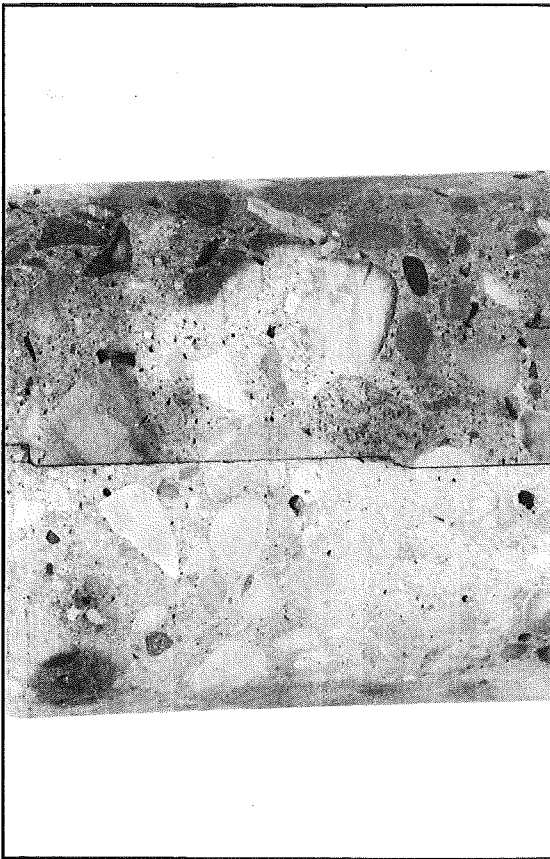
Examination of the cores revealed no evidence of failure from the step cut joints (Figs. 11 and 12). One core from an epoxy coated joint showed that the new concrete was well bonded to the existing concrete (Fig. 13) but the other core showed bond failure (Fig. 14). It appeared the epoxy did not bond to the fresh concrete. This core was taken from the tied joint that had opened 0.03 in. and it is apparent that the epoxy bond and tie bar bond resistance to the new concrete was less than the adjoining expansion joint

Figure 11. Condition of step cut (about 1/8 in. wide) joint after 24 hours service. No failure cracks are noticeable.

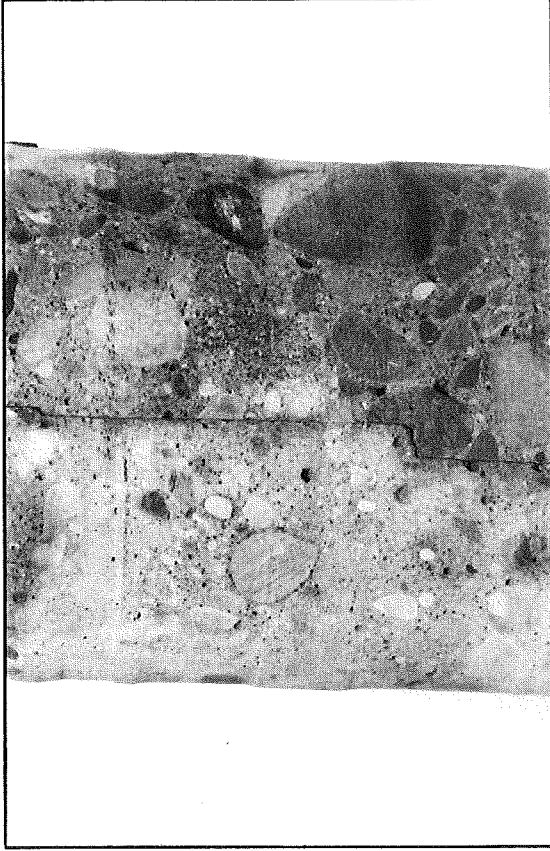
Figure 12. Condition of step cut (about 1/4 in. wide) joint after 24 hours service. No failure cracks are noticeable.

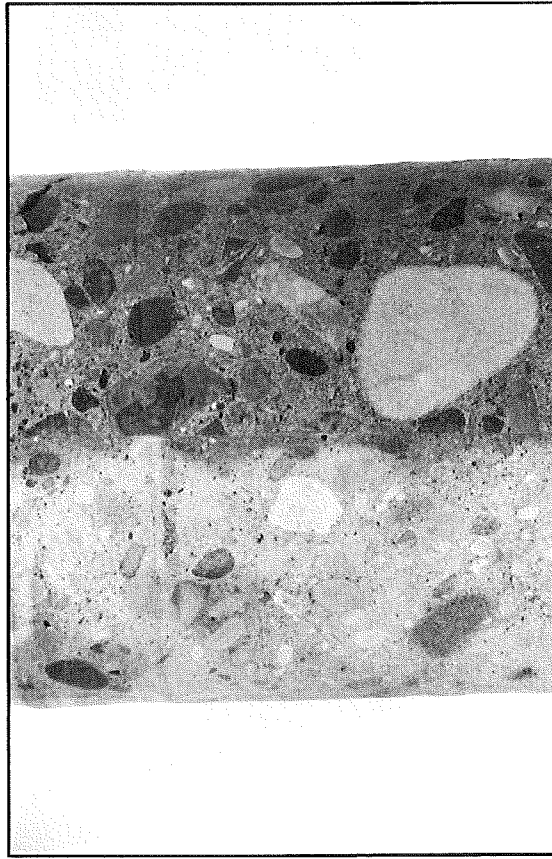
Figure 13. Condition of epoxy coated joint after about 24 hours service.

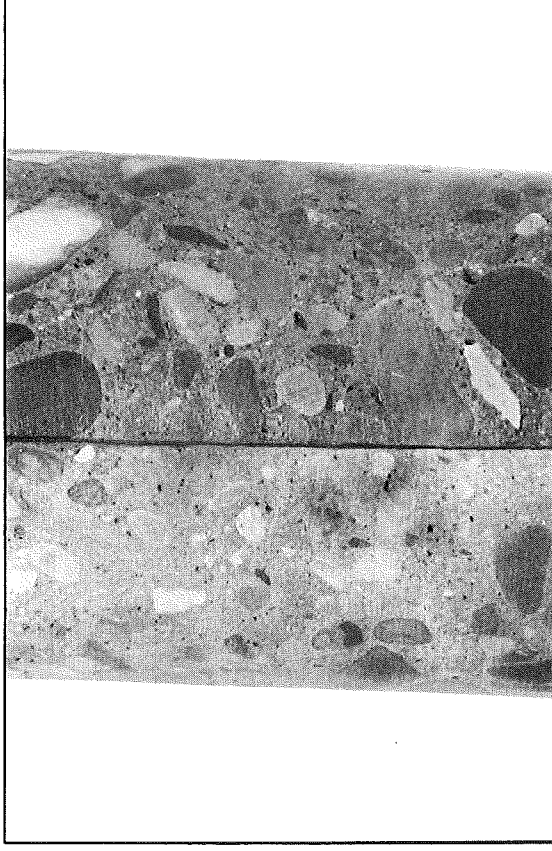
Figure 14. Condition of failed epoxy coated joint.

restraint in resisting the tensile forces during the first night's cooling period.

Early performance data indicates sufficient strength of the joints during the first 24-hr critical period while the concrete is still below the 3,500 psi compressive design strength. The one epoxy bond failure, as previously mentioned, apparently was caused by the expansion joint dowel restraint.
