LOW-SLUMP HIGH-DENSITY CONCRETE  
BRIDGE DECK OVERLAY

J. E. Simonsen

Research Laboratory Section  
Materials and Technology Division  
Research Project 75 B-93  
Research Report No. R-1294

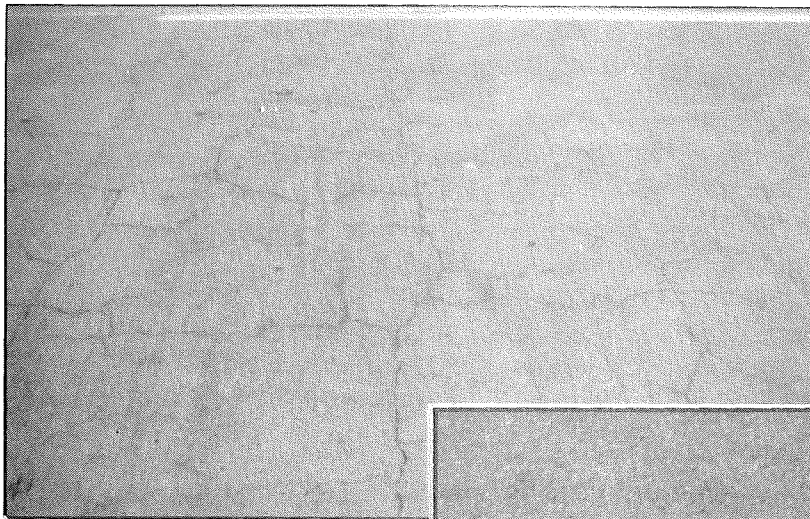
The observed defects in the overlays at the age of seven, nine, and eleven years are summarized in Table 2. All decks exhibited craze cracking which has increased in severity with time and has been present in the

surfaces since construction. The severity of the cracking at the present time is illustrated in Figure 1. Transverse cracks have developed only in the S03 overlay and currently amount to only a total of 48 ft. Spalling has also occurred only in the S03 overlay and amounts to a total of 4 sq ft. The spalling is confined to the end edges and joints in the overlay (Figs. 2 and 3).

Figure 1. Typical craze cracking of LSHD experimental overlays.

The long-time performance observations of the experimental overlays confirm earlier laboratory analysis with respect to shrinkage or craze cracking of the overlay (Fig. 1). The LSHD overlay is somewhat more permeable than the LMC overlay, but its bonding property to the underlying concrete is comparable to the LMC overlay. Based on the half-cell potential measurements there apparently has been no increase in the areas of active bar corrosion since the overlays were placed.

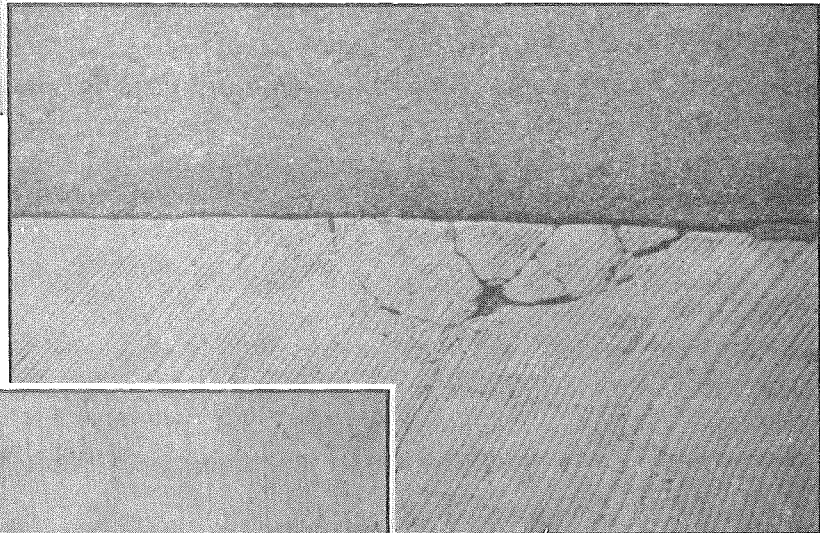
Figure 2. Spall at joint between deck overlay and pavement.

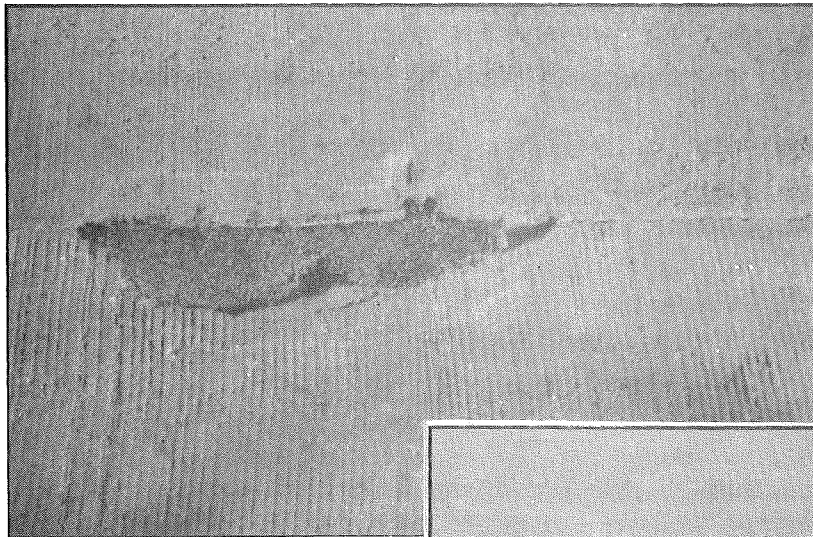
Figure 3. Spall along longitudinal joint.

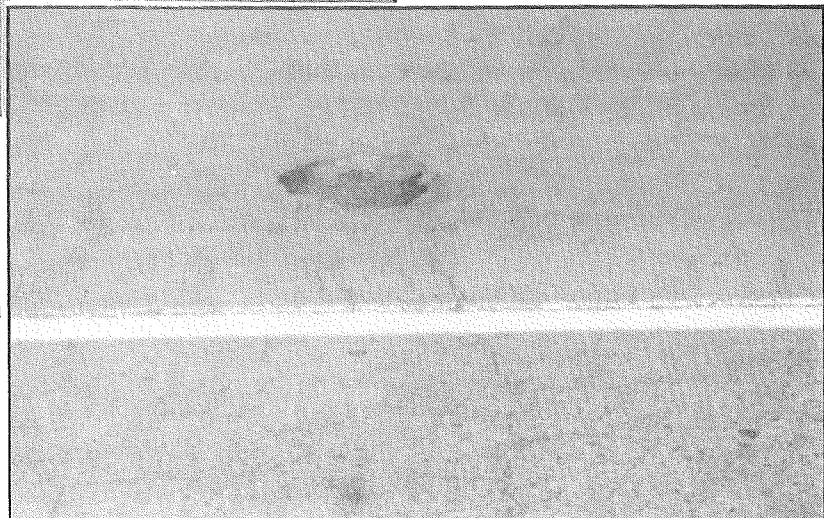
Delamination, or separation of the overlay from the original concrete, was checked using a chain drag. A total of 262 sq ft of delamination was found on S03 during the last survey conducted in 1986. The two S10 bridge overlays were free of delaminations. However, since the 1986 survey, a small area (about 4 sq ft) on S10 eastbound has broken out and is patched with bituminous material (Fig. 4).

Figure 4. Surface repair in overlay on S10 eastbound.

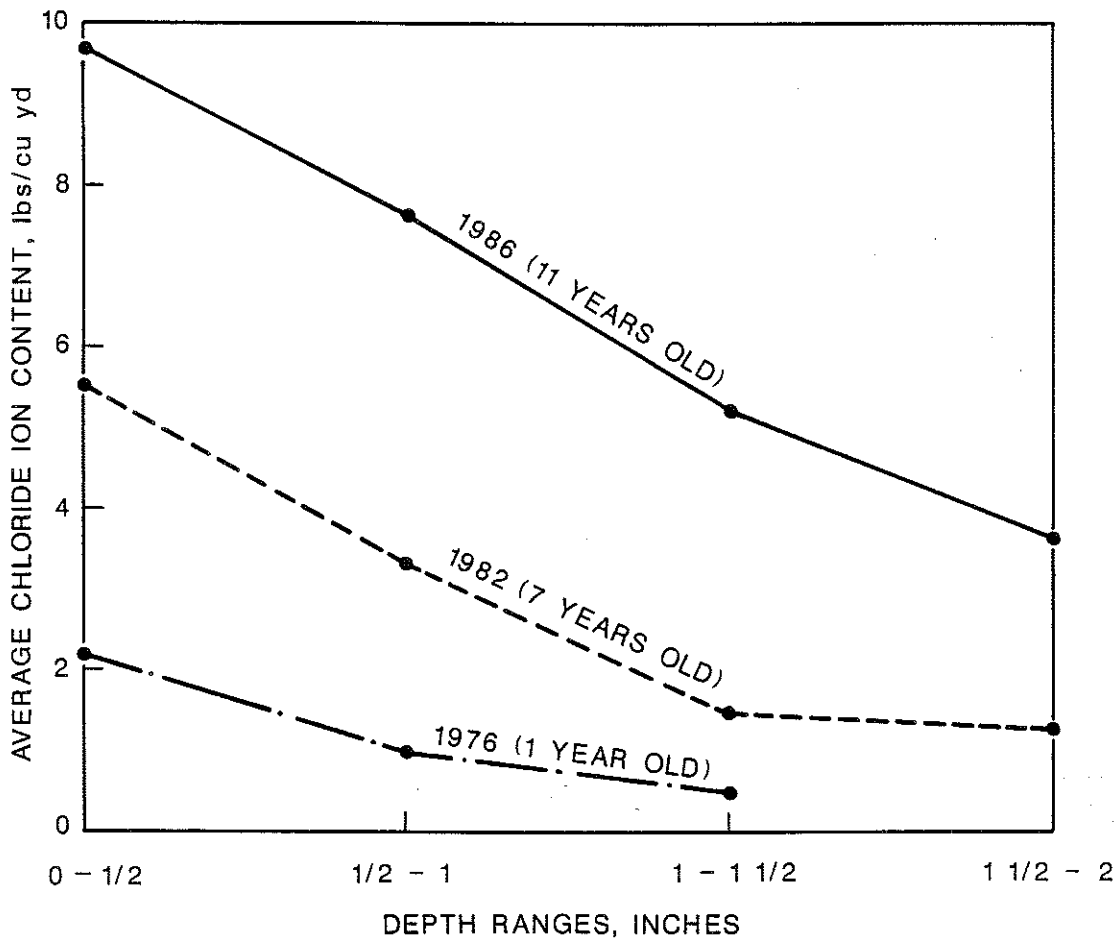
Figure 5. Progressive penetration of chloride ions into overlay.

The results of chloride analyses are shown graphically in Figure 5. The graph shows the average chloride ion content of all three decks at the different depths for each of the three sampling years. In 1976, one year after construction, it appears that the chloride had not as yet penetrated into the underlying concrete. In 1982, after seven years, the average chloride content in the lower 1/2 in. of the overlay was 1.3 lb/cu yd. By 1986 the chloride content of this level had increased to 3.7 lb/cu yd.

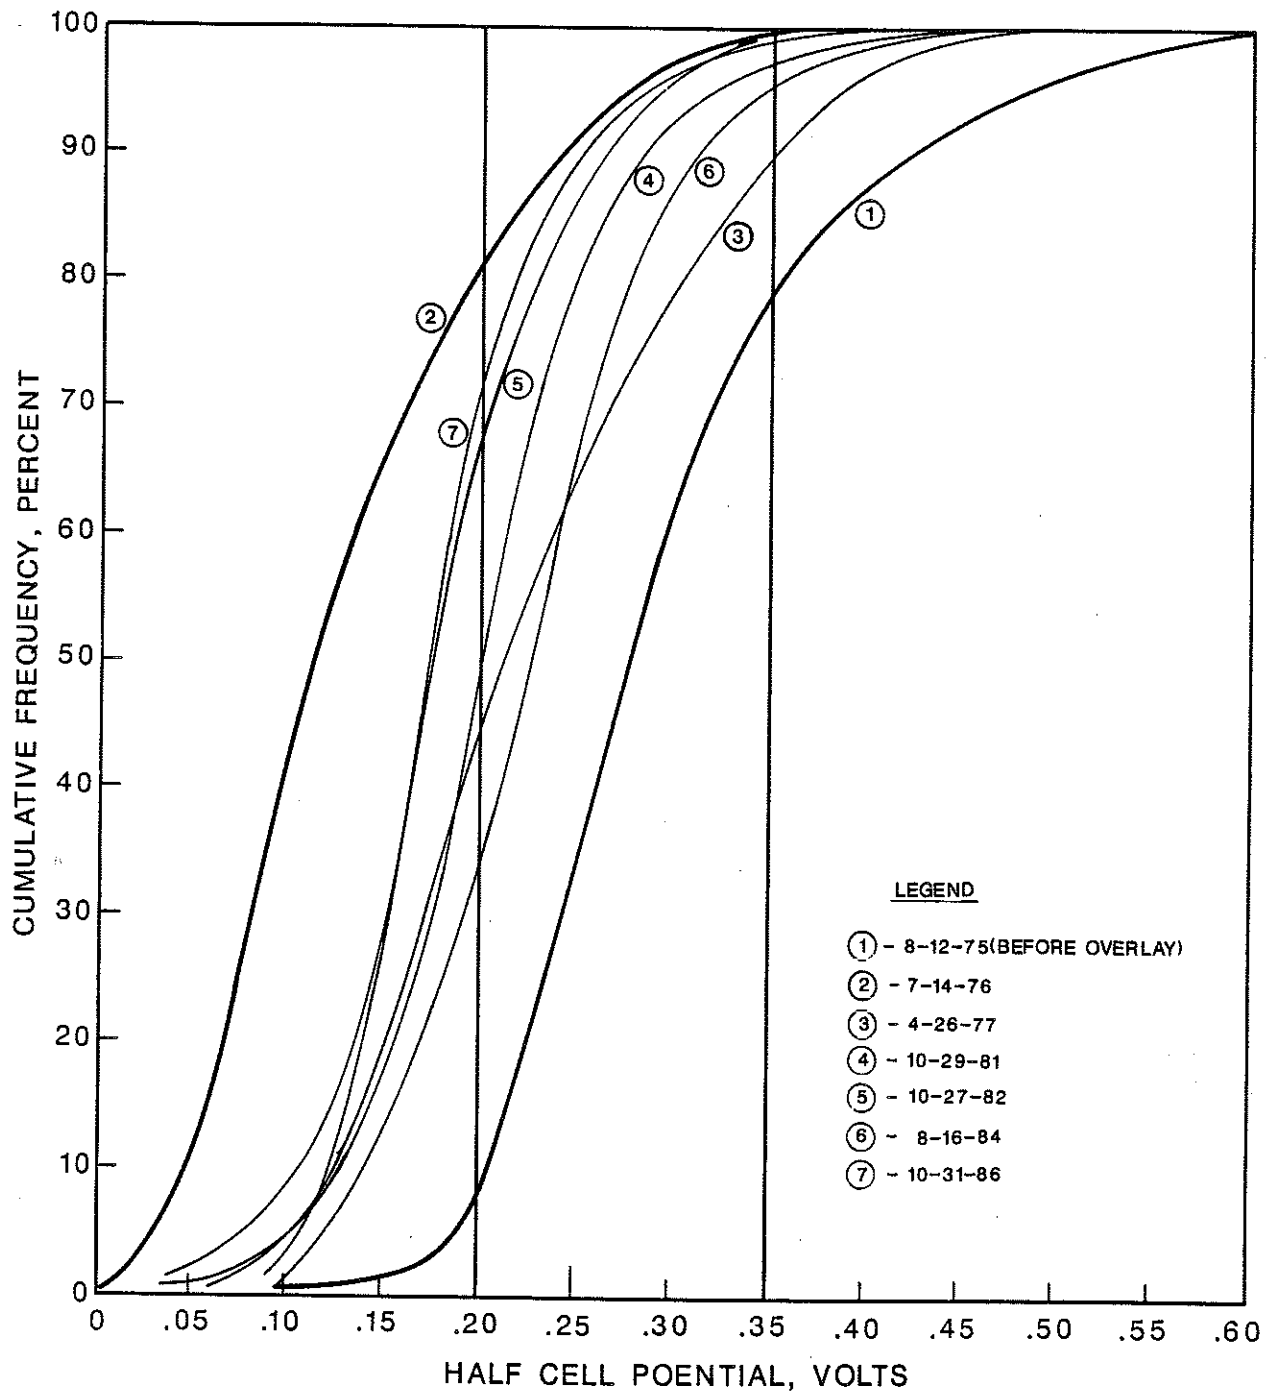
Figure 6. Cumulative frequency distribution curves of half cell potentials for S03 of 33084.

Half-cell potential measurements were made on the three decks in 1975 before the overlays were placed. Since then, six more measurements were made, one in each of the following years: 1976, 1977, 1981, 1982, 1984, and 1986. These data are presented as cumulative frequency distribution curves in Figure 6 (S03), 7 (S10 Westbound), and 8 (S10 eastbound).

The normal shift of the curves from right to left (decrease in corrosion activity) that occurs when comparing 'before' and 'after' overlay readings is noticeable on the figures. Generally speaking, subsequent readings fall between the 'before' and 'after' overlay curves indicating that the corrosion activity has not as yet reached its pre-overlay level. It can also be noted that the bulk of the readings are still below 0.35 v, the value at which active corrosion is considered to be present.

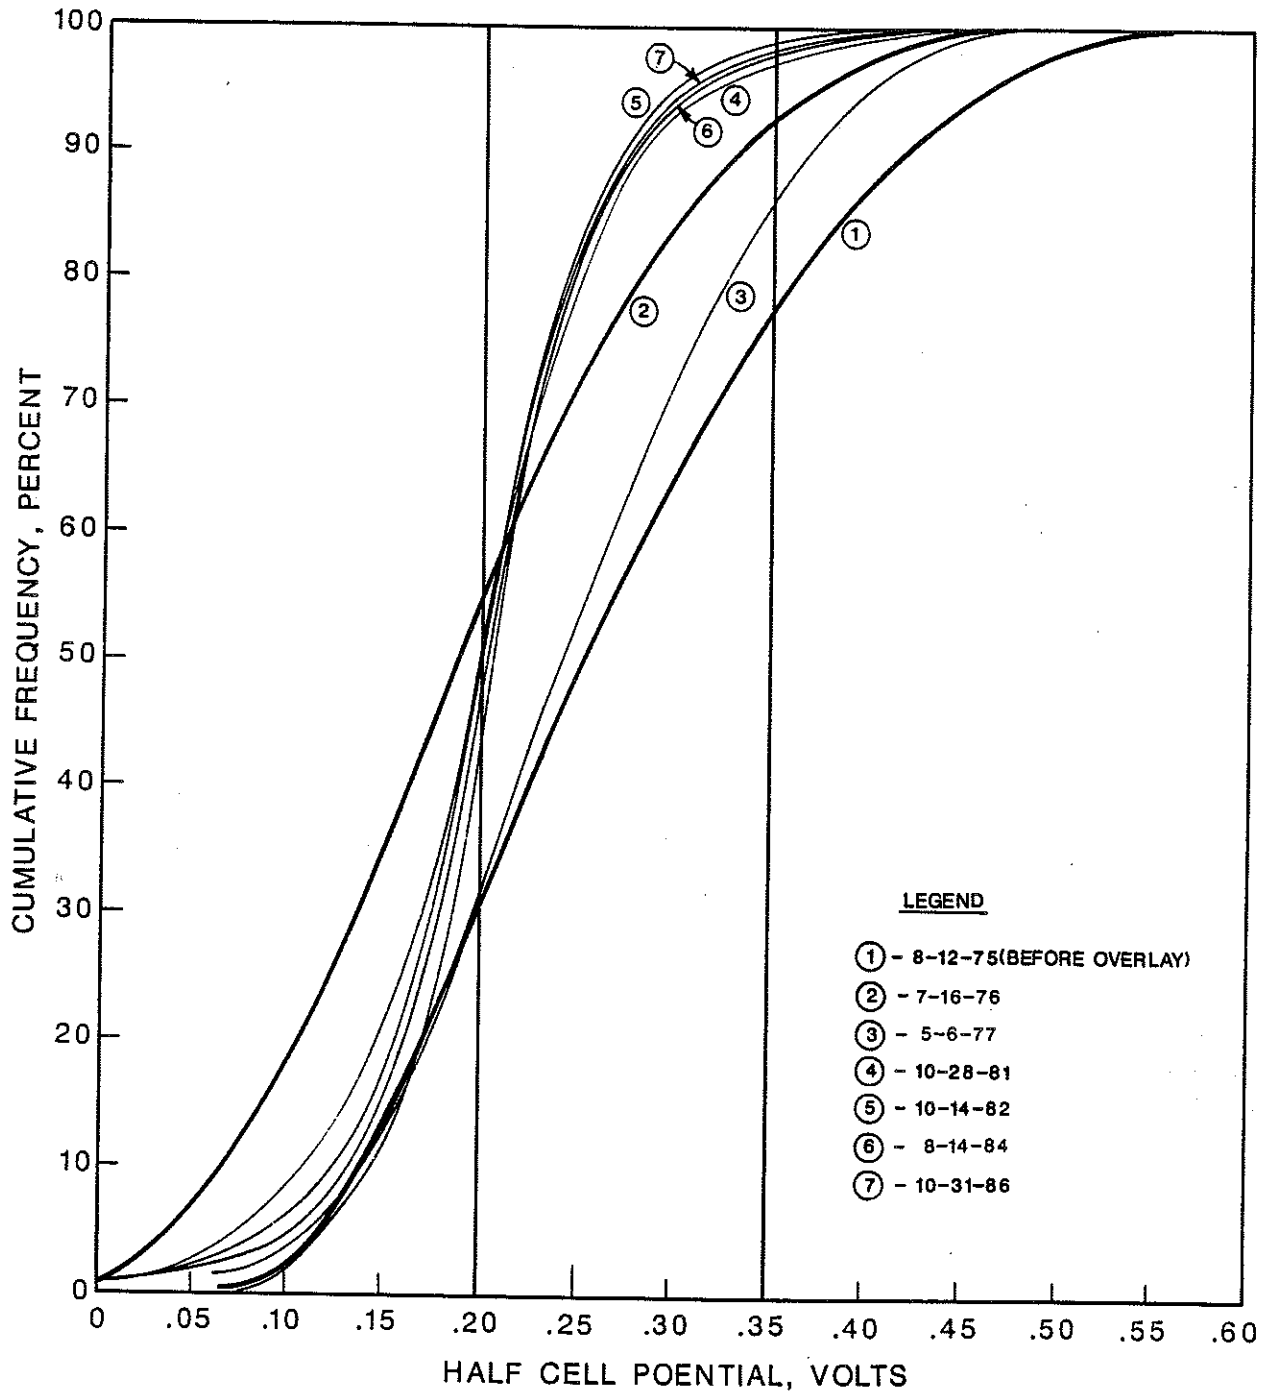
Figure 7. Cumulative frequency distribution curves of half cell potentials for S10 of 47065, westbound.

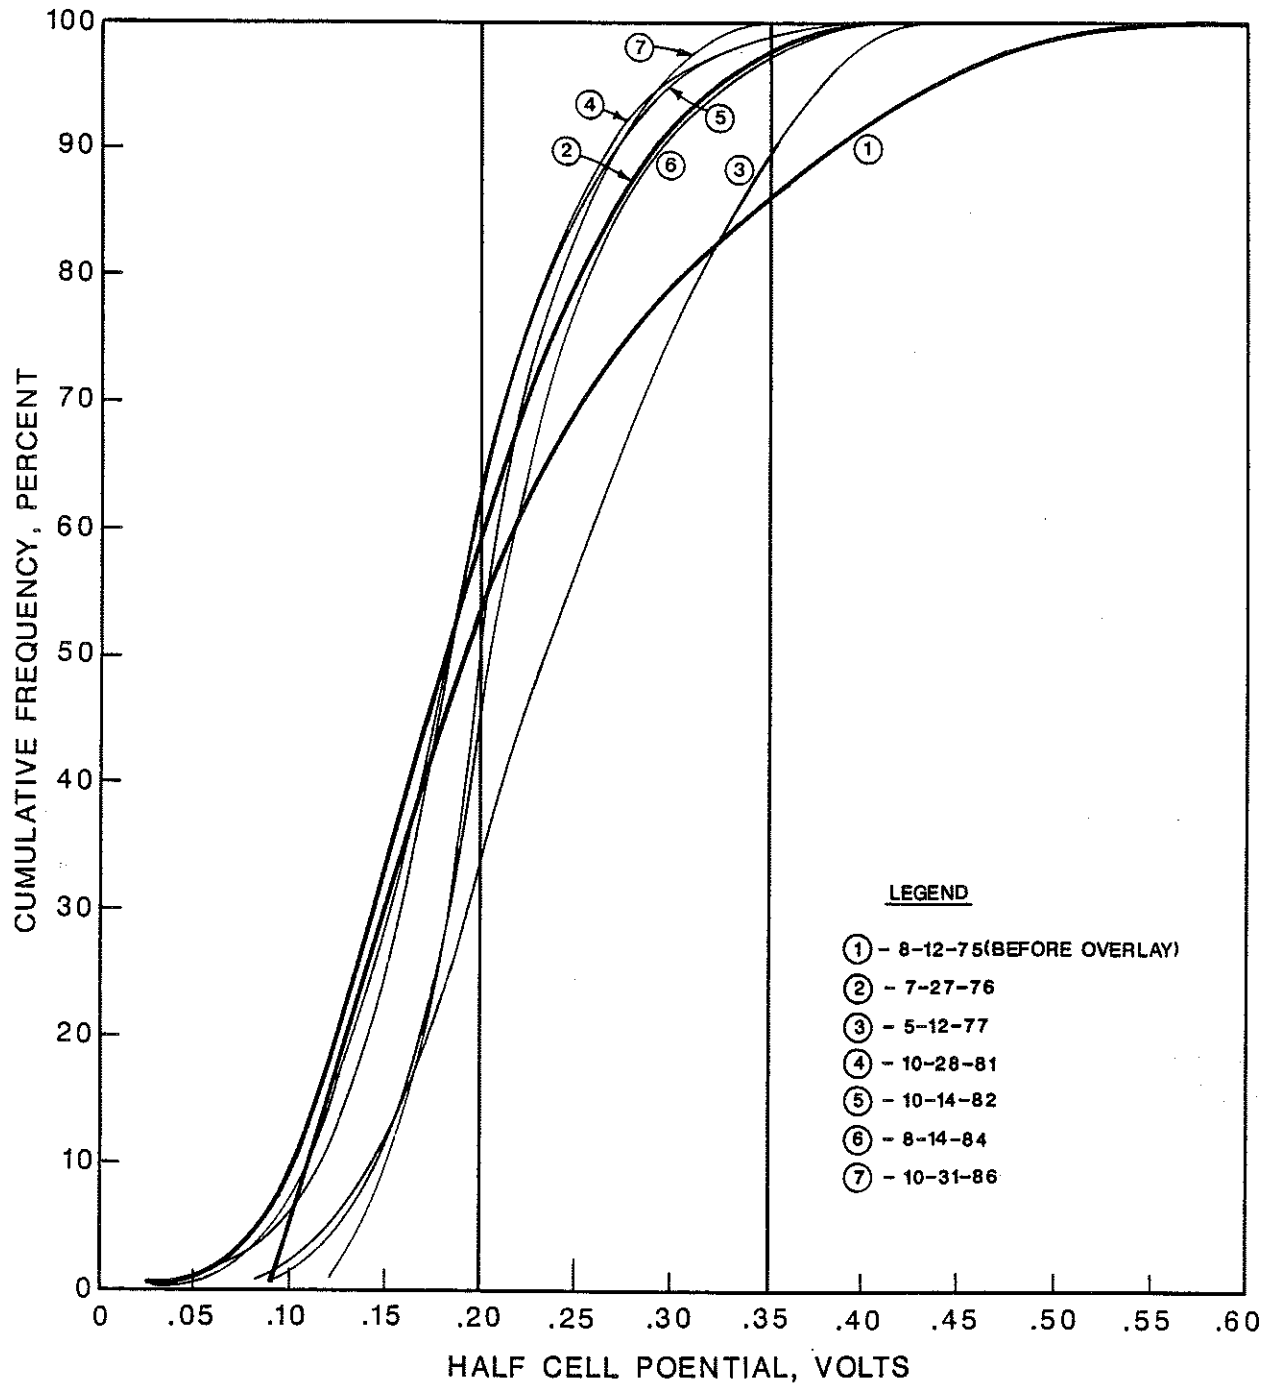
Figure 8. Cumulative frequency distribution curves of half cell potentials for S10 of 47065, eastbound.
