THE RELATIONSHIP OF AGGREGATE  
DURABILITY TO CONCRETE PAVEMENT  
PERFORMANCE, AND THE ASSOCIATED  
EFFECTS OF BASE DRAINABILITY

C. J. Arnold

Research Laboratory Section  
Testing and Research Division  
Research Project 73 F-136  
Research Report No. R-1158

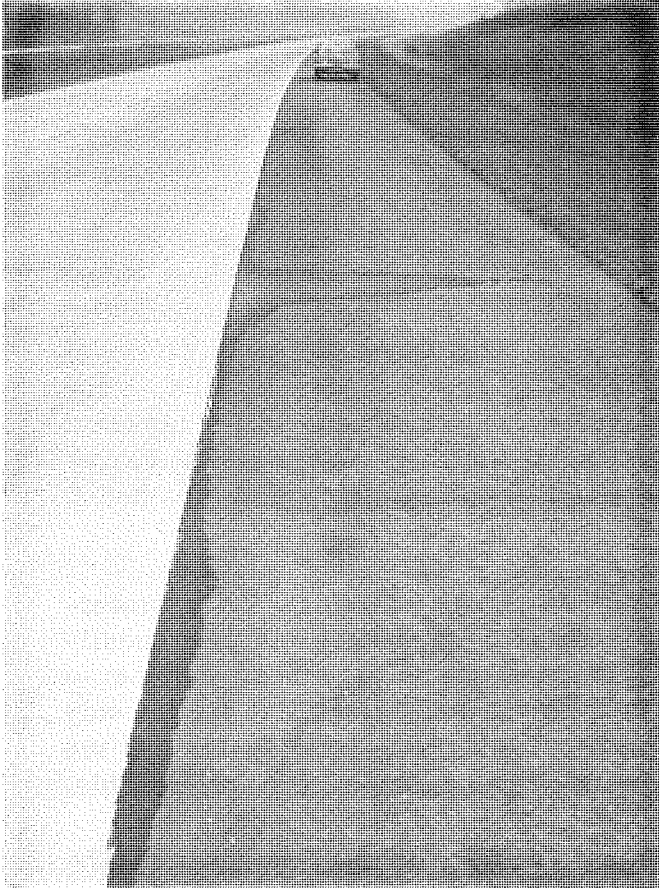
For the impervious bituminous base sections, there is nowhere for the water to go after it penetrates a joint, so the pavement sits in a 'bathtub' environment. Figure 1 shows the way in which water rises from the shoulder. The shoulder-pavement joints have deteriorated more in the non-draining base sections than in the others. Figure 2 shows the upward bubbling of water at the intersection of the transverse and shoulder-pavement joints, due to the coring operation farther out in the lane, demonstrating that the joints act as passageways for water to travel. Although the water in this case is coming from the 'bathtub' below, it is obvious that it could go in the other direction as well, if the 'bathtub' beneath were not full. (In contrast, the core cutting water all drained away on the ATPM base sections, and pails of water poured into the open core holes vanished quickly as well.) It is also obvious from the cores, that water has penetrated considerable distances between the slab and the base. Where faulting has developed, there are voids for passageways as well.

Figure 1. Eastbound superelevated bituminous base section. After rainstorm, water rises through shoulder-pavement joint and drains across surface of shoulder.

Investigation and evaluation of the experimental pavements near Clare will continue for several more years. Recommendations have been made and approved by the Department to add edge drains and shoulder-pavement joint seals to the non-draining base sections. However, it is obvious at this time that the longevity of those sections will be less than the more drainable sections of the project.

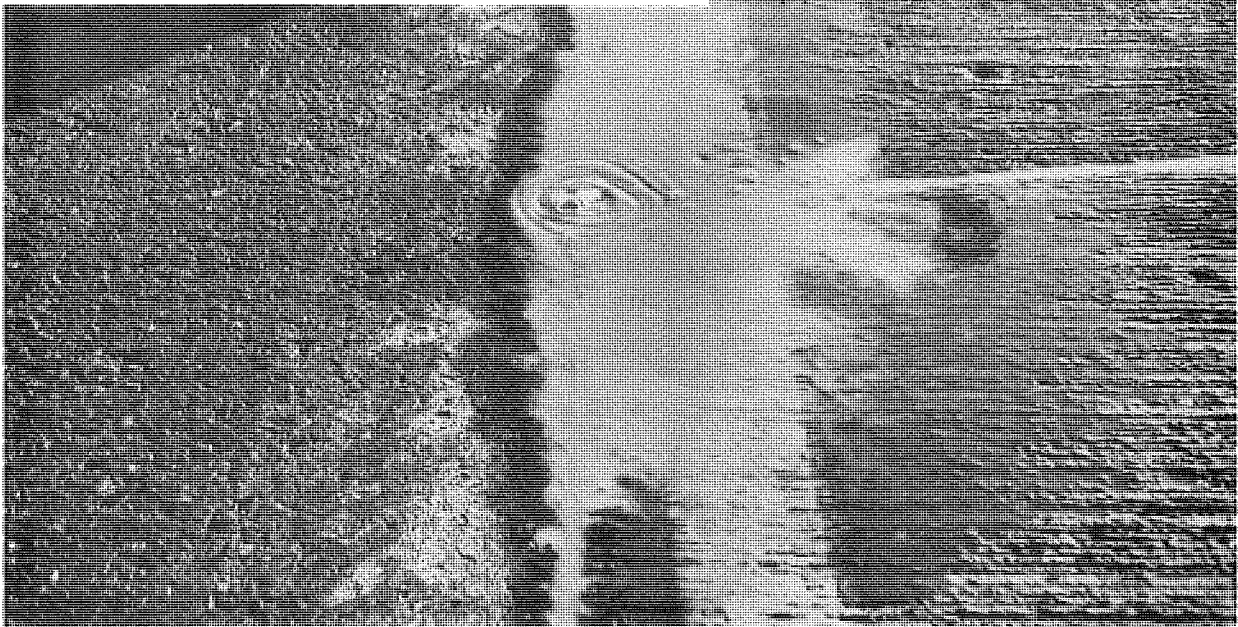
Figure 2. Water from the coring operation bubbling up at intersection of the transverse pavement joint and the longitudinal shoulder-pavement joint, on a non-draining bituminous base section. The core was being cut to the right, out of the picture. This demonstrates the ready pathway for water to penetrate around the edges of the slabs. It also demonstrates that in this particular case of impervious base, water cannot drain away. Conversely, on ATPM base, all core-cutting water disappeared, and pails of water dumped in the core hole quickly vanished.

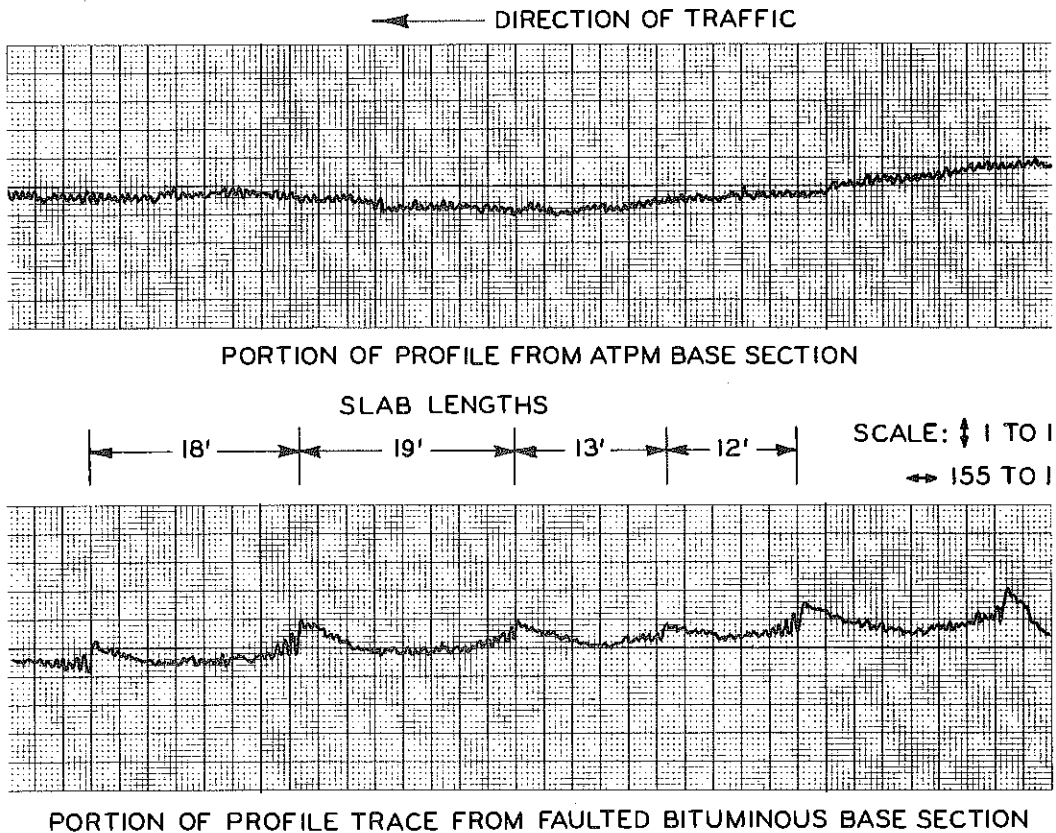
the opposite direction, keeping the traffic lane drier. All three sections with ATPM base and the six gravel-based sections continued to perform well. Figure 3 shows portions of Rapid Travel Profilometer traces from the faulted bituminous base section and a section with ATPM base. This early information clearly demonstrates the deleterious effects of water in the pavement system.

Figure 3. Comparison of profiles: Rapid travel profilometer traces from Clare test road.

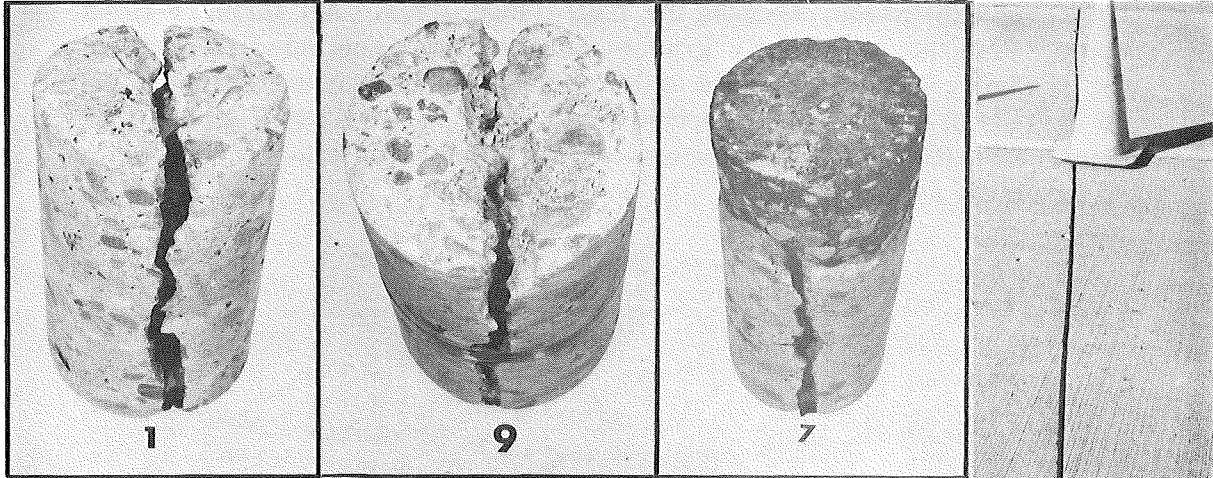
Faulting has now increased to as much as  $3/4$  in. at some locations. Cores were cut through the pavements and bases to determine the source and location of the material being pumped which caused the faults. Figure 4, Core No. 1, (shown upside down) was cut from an unfaulted joint in the bituminous base section on the westbound roadway. It was immediately obvious that serious deterioration is occurring on the joint faces and the bottom of the slab. The bituminous base was not cracked. Figure 4 also shows the faulted transverse joint, the ravelled shoulder-pavement joint, and the core (labeled No. 7) taken from the eastbound section where super-elevation causes more ponding of water under the truck lane. Figure 4, Core No. 9 is from a nearby joint in the same section, showing even more

Figure 4. Cores taken from the non-draining bituminous base sections of the Clare Test Rd. The pavement was four years old when sampled. Core No. 1 is from an unfaulted westbound section, the other two are from the faulted eastbound section. All show the same heavy surface deterioration, evidently due to freeze-thaw action while standing in water. The faulted joint shown is the one from which Core No. 7 was taken. Note also the open shoulder-pavement joint.

severe deterioration of the bottom and joint face surfaces. Again, the bituminous base was intact. Here we have the reason for faulting; concrete debris from the deteriorated faces and bottom of the slab, being pumped by truck traffic, because of the captive water between the pavement and base. Figure 5 shows cores removed 1, 5, and 9-ft away from the transverse joint, showing the slab to be bonded to the base only at the 9-ft distance. Figure 6 shows typical pavement surface, concrete and base cores from the ATPM base sections. These sections do not show the concrete deterioration or faulting that was so evident on the non-draining bituminous base.

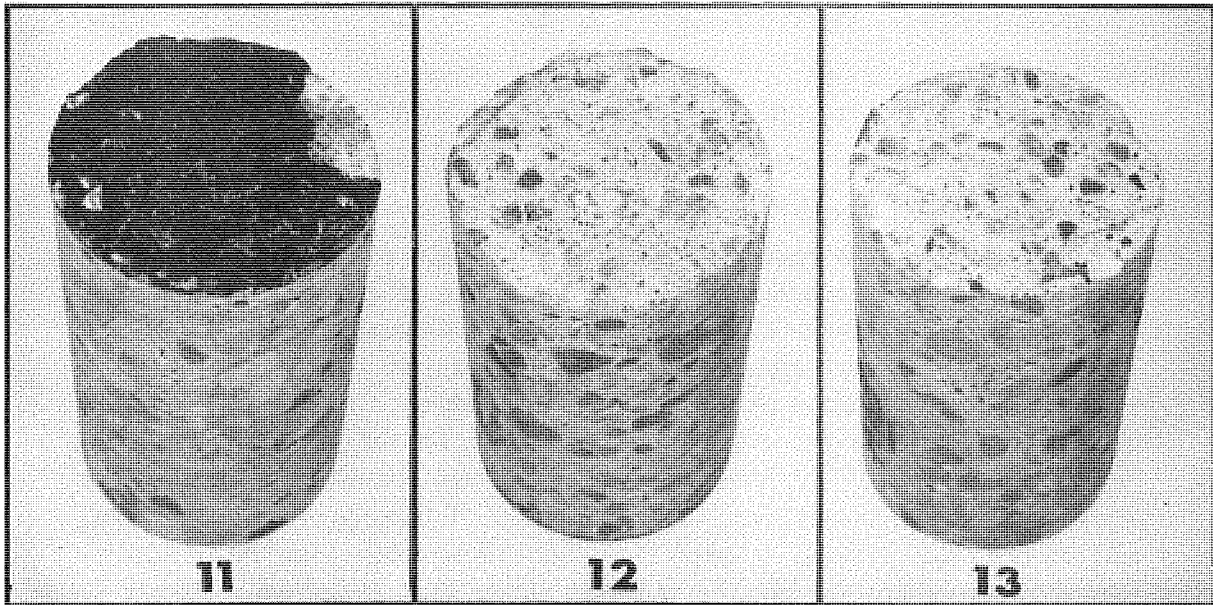
Figure 5. Cores cut from the faulted section to determine condition of the bottom of the slab at locations away from joints. Core No. 11 was cut 9-ft from transverse joint, Core No. 12 at 5-ft, and Core No. 13 at 1-ft.

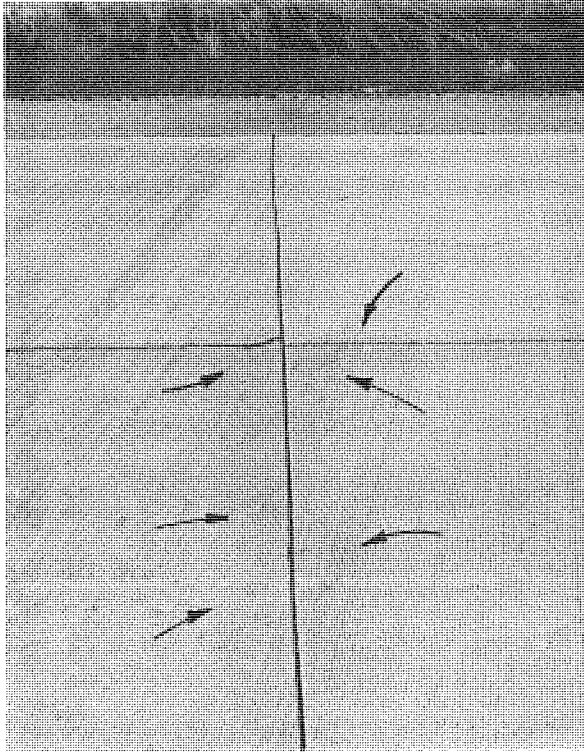
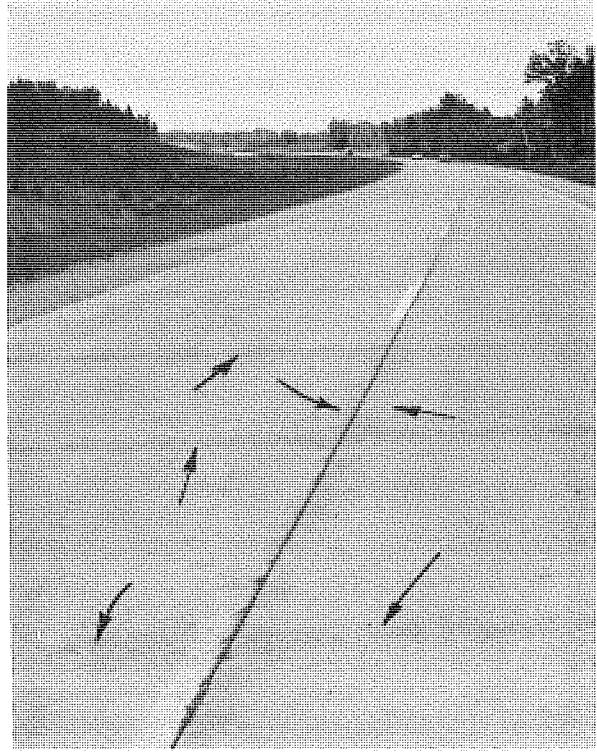
Figure 7. Staining, early stage of D-cracking, showing up on surface of US 10 black base sections at about five years of age. All coarse (6A) aggregates from Source A.

scaling. However, whatever the basic problem with the mix, it is obvious at this point that this problem is seriously aggravated by the continuing presence of water under the pavement. Close inspection of the pavement surface at four years of age, showed early stages of discoloration and very fine cracking near joints in the non-draining base sections; factors that are typical signs of deterioration commonly referred to as D-cracking. More recent inspections show the staining to be more obvious in the impervious bituminous base sections (Fig. 7), and just beginning in some other sections, including those on ATPM base. Figure 8 shows the type of corner fractures that are starting to occur in the non-draining sections. This is the beginning of the second stage of deterioration, and is progressive. This stage has not yet become evident on the sections with other types of base. The severe surface attack on the joint faces and bottoms of the slabs in the non-draining sections appear to be related to the mortar fraction of the mix rather than to the coarse aggregate. Therefore, it appears that the retention of water, including deicing salts, combined with Michigan's relatively harsh climate, have caused the early onset of two separate types of concrete deterioration in the sections built on non-draining bituminous base. Another look at the pavement surfaces shown in Figures 4 and 6 show the pop-out characteristics normally associated with porous stone contained in the coarse aggregates. This top surface defect appears throughout the project, giving an indication of the presence of non-durable aggregate particles in the mix as well. However, recent work completed by the Portland Cement Association indicates that materials normally classified as soft or non-durable (many of which can be removed by heavy media separation) are not the only ones that cause problems (1, 2, 3, 4). Many heavier types of rock can and do lead to D-cracking. Their results seem to indicate that, at the present time, the only known evaluation that dependably identifies and separates aggregates that D-crack in service and those that do not, is the measured expansion of specimens subjected to severe freezing and thawing.

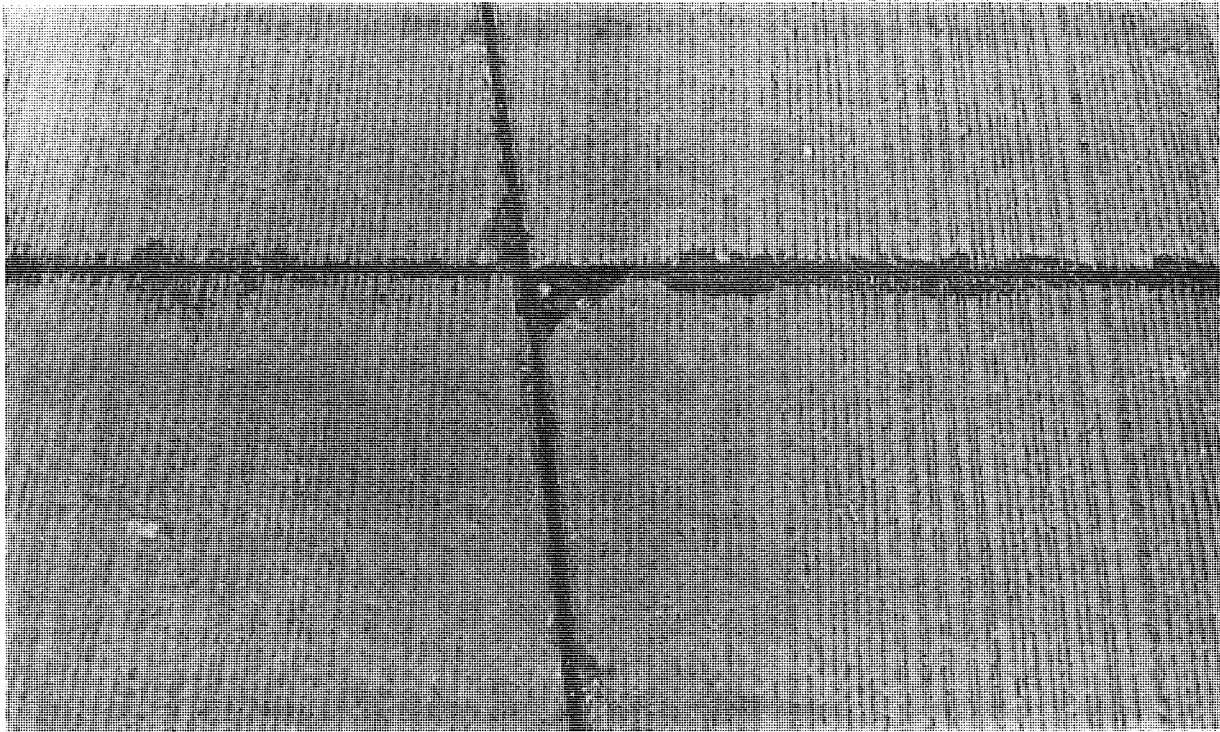
Figure 8. Corner fractures; the beginning of the second stage of deterioration, on the non-draining sections.

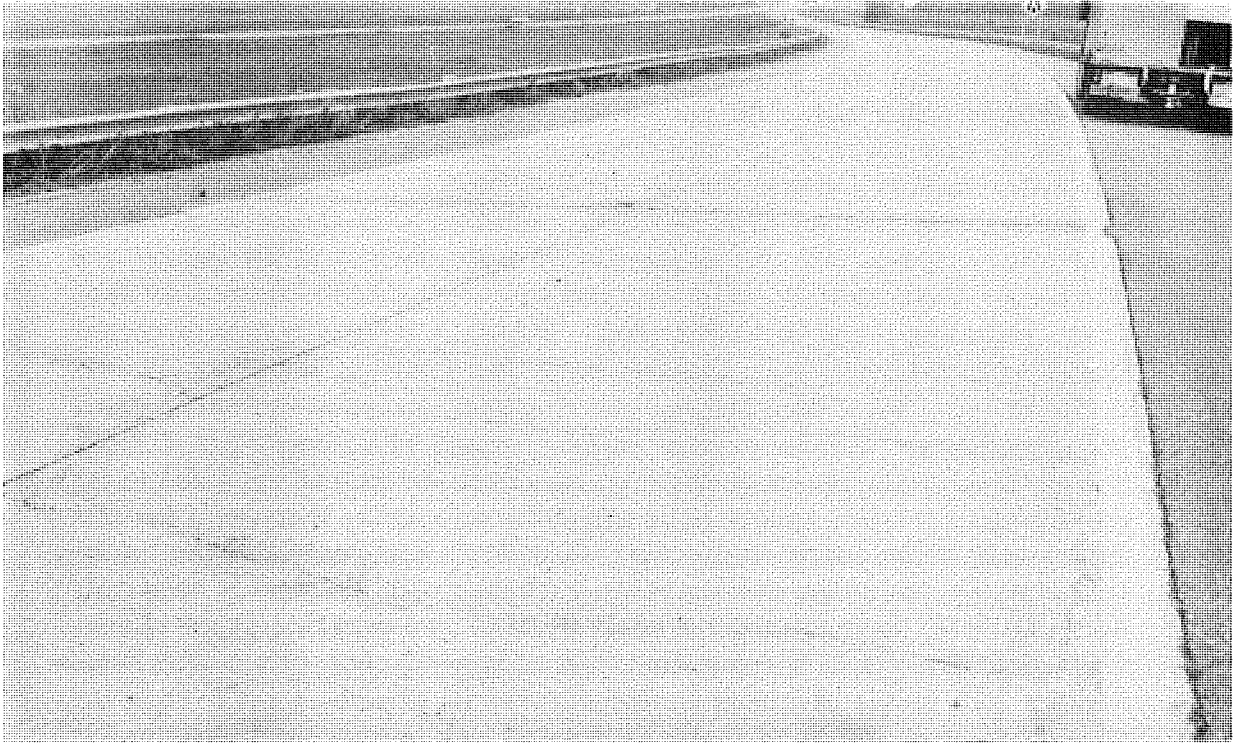
Figure 9. General view of the northbound US 27BR ramp near Mt. Pleasant. Note staining of surfaces near joints and cracks. Pavement was built in 1961, and was 18-1/2 years old when photographed. It has 99-ft slab length; base plates, and poured sealants (4A aggregate from Source C, substituted for high-grade from Source B; 10A from Source A). The nearby ramp shown in the background, contained a premium quality coarse aggregate, and shows no D-cracking at the surface

Figure 9 shows a general view of the northbound ramp with the dark staining around cracks and joints, and the typical D-cracking that follows the staining. The pavement was 18-1/2 years old when photographed. Figure 10 shows the adjacent southbound ramp, built with premium quality aggregates in the coarsest (4A) fraction. Finer aggregates were all from the same source. No staining or D-cracking are evident on this pavement after 19-1/2 years of service.

paving much of the northbound expressway portion of the project, the 4A fraction of the coarse aggregate was changed to Source C, and this mix was used for paving the northbound ramp which exhibited D-cracking. Still later, 4A aggregates from the original marginal Source A were used to complete the remainder of the southbound expressway on the project. These latter pavement sections have experienced D-cracking about as much as the northbound ramp shown in Figures 9 and 11.

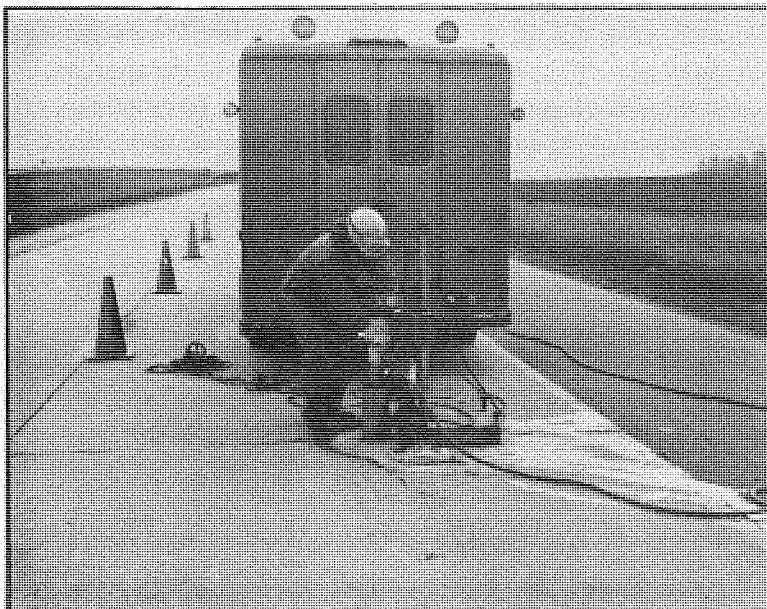
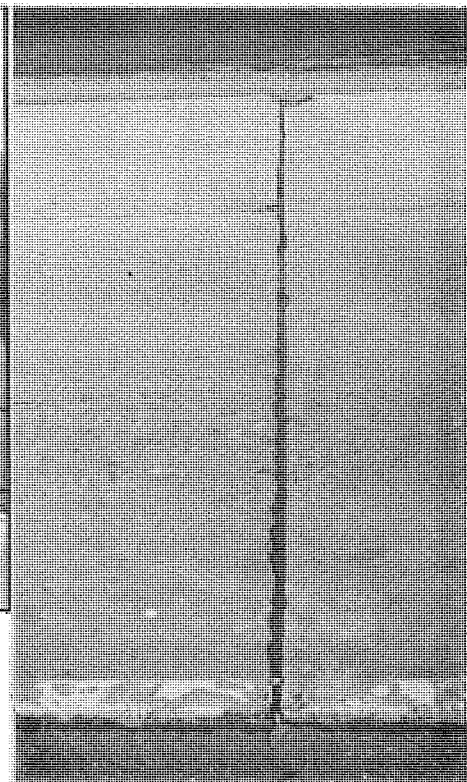
Figure 10. The southbound ramp, constructed one-half year before the northbound, using a blend with higher quality 4A aggregate from Source B, with 10A aggregate from Source A. This pavement shows no D-cracking at the surface (photographed after 19-1/2 years of service).

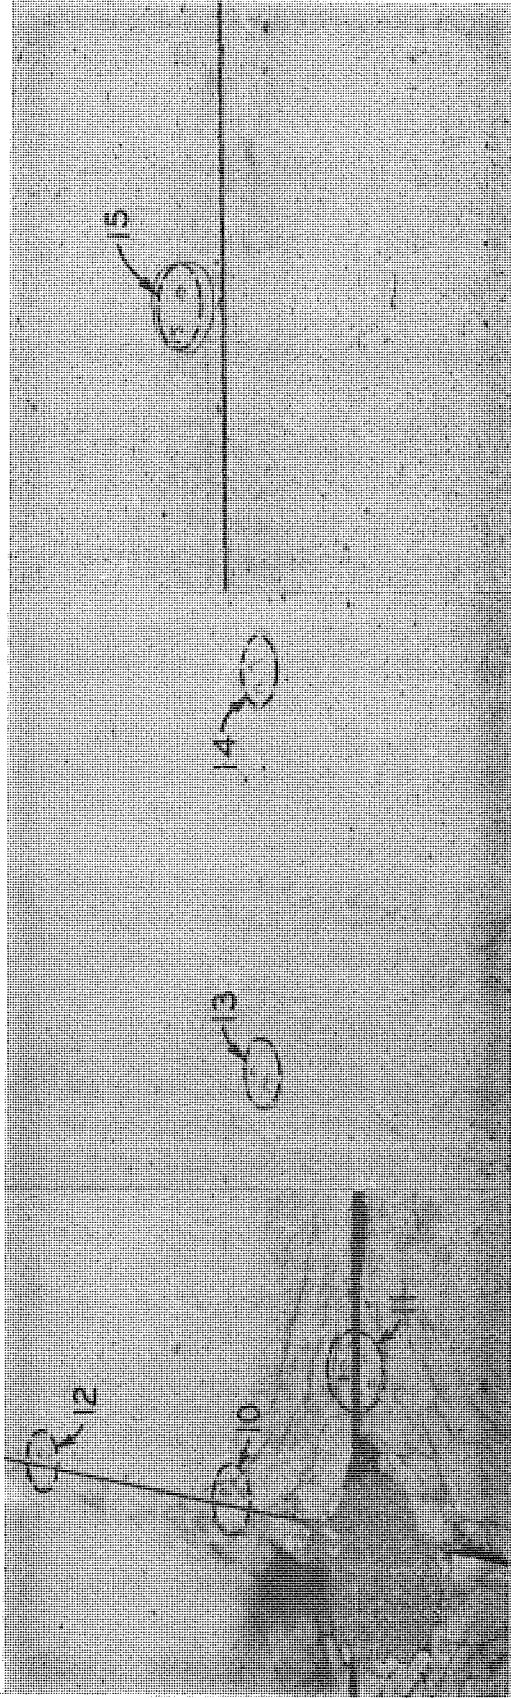
Figure 11. Location of cores removed from the northbound US 27 BR ramp south of Mt. Pleasant.

Cores were removed from the northbound ramp in the summer of 1979. Locations of various cores taken are shown in Figure 11. Core No. 11 was taken through the transverse joint, Core Nos. 10 and 12 on the longitudinal joint roughly 1-1/2 and 3 ft from the transverse joint, respectively. Cores 13 and 14 were from the unstained area 4 ft from the transverse joint, and Core 15 was taken from the junction of the stained and unstained areas adjacent to the centerline joint, about 6 ft from the transverse joint. The cores themselves are shown (upside down) in Figure 12. Core 11 from the transverse joint is riddled with cracks and the bottom part of the joint mostly turned to rubble. Core Nos. 10 and 12 from the longitudinal joint have fractures around a badly rusted longitudinal reinforcing wire, and the typical fine D-cracks at the top and bottom, but are basically sound. Core Nos. 13 and 14 from the heart of the slab are sound top to bottom, much as they were when cast. Core No. 15 shows only extremely fine cracking in the dark stained area, and is otherwise sound, indicating the first stages of the progressive deterioration.

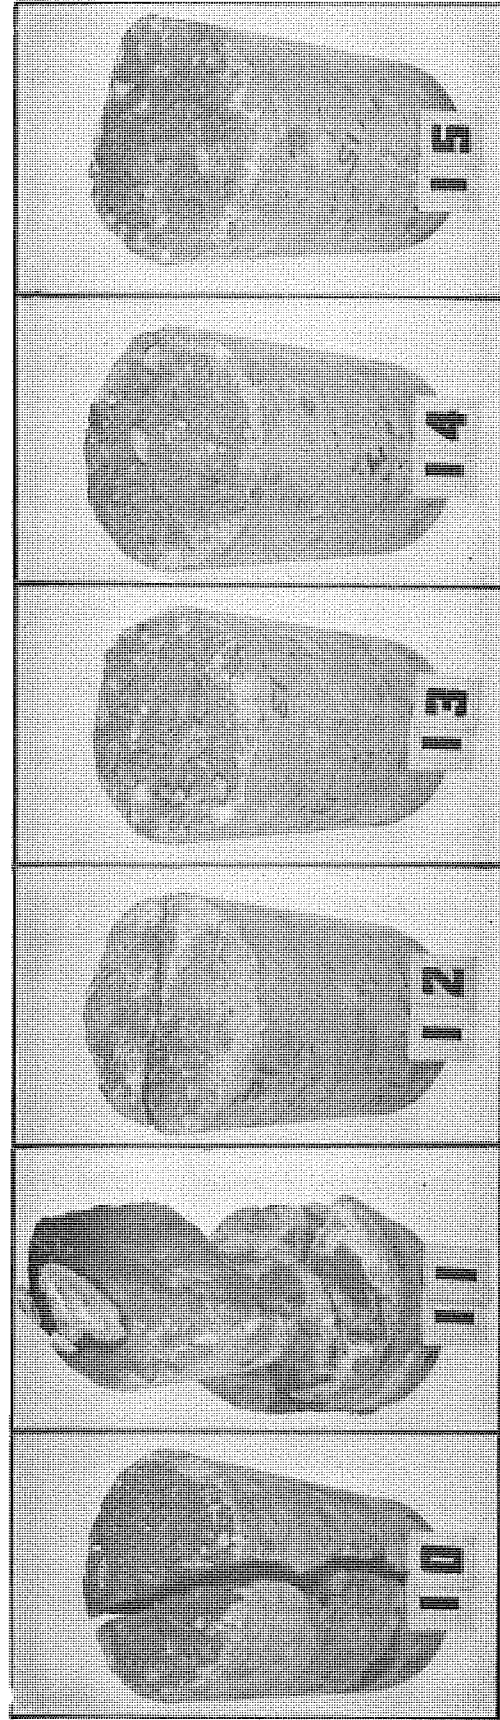
Figure 12. Cores shown here upside down, that were removed from the northbound US 27 BR ramp pavement at the locations indicated in Figure 10. The pavement was built and opened to traffic in the spring of 1961, with 89-ft slab length, poured joint sealants, and base plates under the joints. Pavement age was 18-1/2 years when cored.

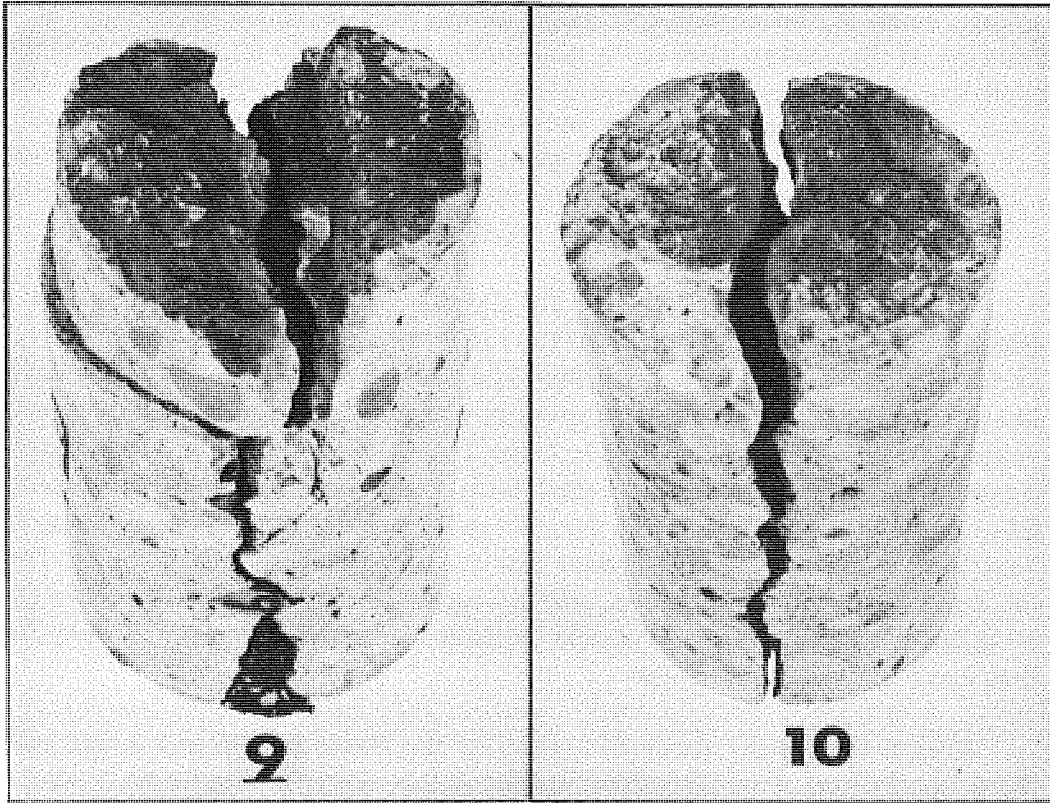
The adjacent southbound ramp was paved in the fall of 1960, and is in excellent condition for a 20-year old pavement. Cores from this pavement are shown in Figure 13. The differences between the southbound and northbound ramps are striking, and the appearance tells an obvious tale of differences in materials. The story, derived from project records, follows.

Figure 13. Cores, shown upside down, taken from the southbound ramp shown in Figure 10. Core No. 9, from the transverse joint shows some deterioration at the bottom, that is fairly typical for 'base plate' pavements of this age. Core No. 10 is from the longitudinal joint. The pavement was built and opened to traffic in the fall of 1960 with 99-ft slabs, poured joint sealants, and base plates under the joints. Pavement age was 19-1/2 years when cored.
