MICHIGAN DEPARTMENT OF TRANSPORTATION
M•DOT

ALLEGED DAMAGE TO SUSAN SHILANDER'S
HOUSE DUE TO TRAFFIC-INDUCED VIBRATIONS

Research Laboratory Section
Materials and Technology Division
Research Project 91 TI-1562
Research Report No. R-1317

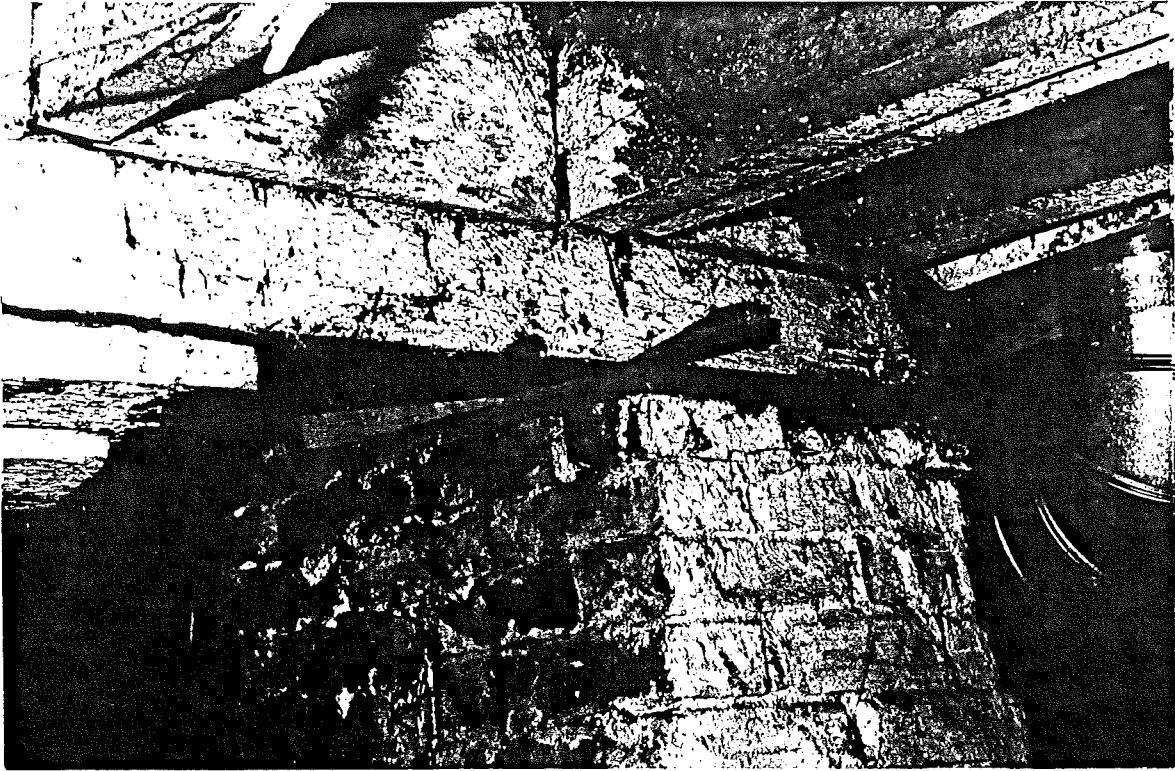
Two wooden support beams run across the basement in an east-west direction, spaced 8 ft apart. Figure 1 shows how one of the beams is supported by the chimney located in the approximate center of the basement. The beam is notched into the chimney such that the chimney actually supports some of the load of the upper floors. Two fieldstone walls that protrude inward from the outer basement walls towards the center of the room also carry some of the load. Joists running north-south support the first floor and rest on the support beams and north-south outer basement walls.

Figure 1. Wooden beam supported by chimney. Note the wooden shims installed to fill gap of missing mortar.

Another possible cause for the cracking of the plastered walls and ceilings is indicated by the chimney located in the central portion of the house. As one can see from Figure 1, the mortar and brick from the chimney has deteriorated to the point where wooden shims were installed to fill the gap between the support beam and the chimney, possibly to re-level the first floor and keep it from bowing. The chimney is in fact supporting much of the overall weight of the house. This type of support has afforded movement of the upper structure over time. There is also a hole in one fieldstone support wall which has badly deteriorated over time. This deterioration may also have brought about some movement of the supported structure. It appears that brick was installed in an effort to provide support for the beam. The broken area in the basement floor at the base of the chimney may be an indication that the chimney is overloaded as it supports much of the weight of the upper floors. The operation used to replace the stone wall may have transferred much of the load of the house to the supporting beam and therefore also to the chimney.

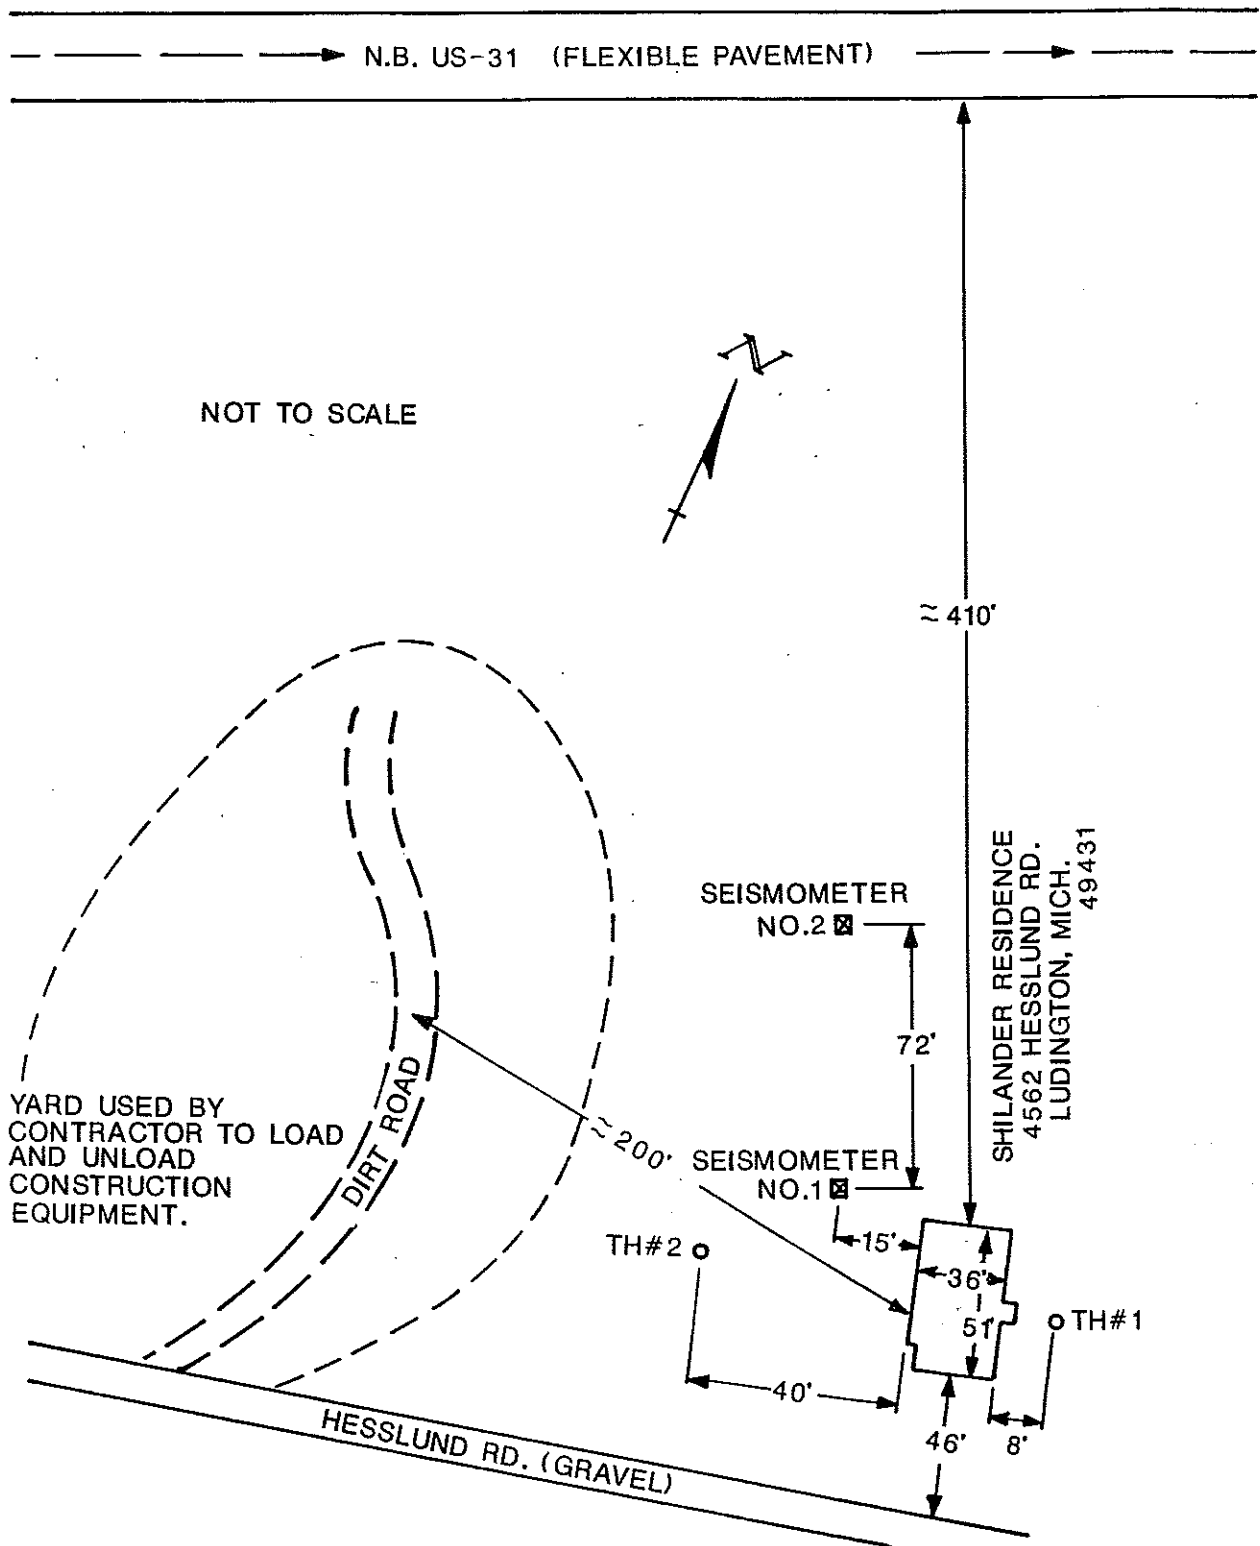
Prior to the May 29 inspection a ground vibration study had been conducted by the Structural Research Unit on May 20, 1991 at the Shilander residence (Appendix B). Vibrations were monitored between the hours of 11:25 AM and 1:30 PM. Locations of the seismometers are shown in Figure 2.

Figure 2. Location of Shilander House with respect to northbound US 31. Location of soil borings and seismometers also shown.

The highest values recorded during the monitoring period at the Shilander residence were 0.0042 in./sec of ground particle velocity for seismometer No. 1 and 0.0052 in./sec of ground particle velocity for seismometer No. 2.

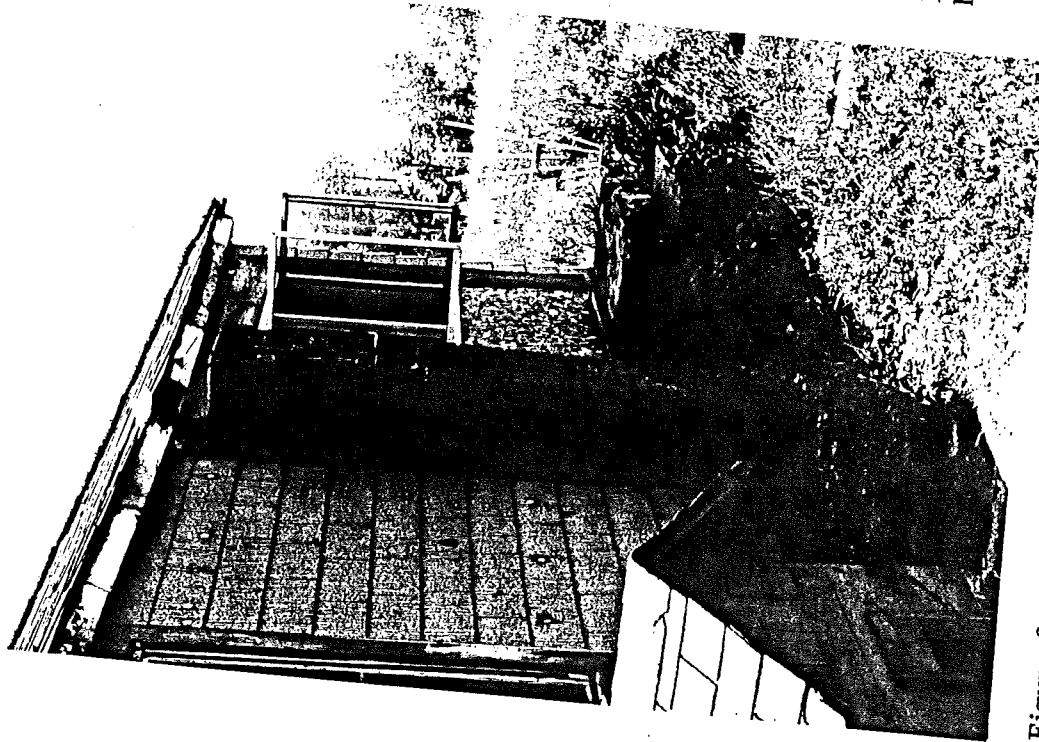
The non-functioning chimney located on the outside of the north wall of the house has mortar cracks and is pulling away from the house due to its partial collapse (Fig. 3). The chimney located in the central portion of the house is also experiencing settlement as indicated by the gaps where the chimney passes through the first and second floors. There is a section of the concrete floor of the basement near the southwest corner of the chimney approximately 10 to 15 sq ft in size that has collapsed and broken (Fig. 4). The concrete has been removed thereby exposing the sand base which is supporting the floor. It appears that the sand has either been removed or has settled over time.

Figure 3. Chimney shows signs of distress as indicated by cracking and pulling away from house.

The house contains two chimneys, one on the north side that is not currently in use and the second which is located approximately in the center of the house. The north chimney, which is constructed of brick, has been badly damaged due to settlement as indicated by cracks in mortar joints and by pulling away from the building. The other chimney, with dimensions of approximately two feet square, has a stone base four feet high with brick used for the remainder. This is experiencing settlement also as indicated by cracks located near the chimney where it passes through ceilings on the first and second floor caused by its movement with respect to the house.

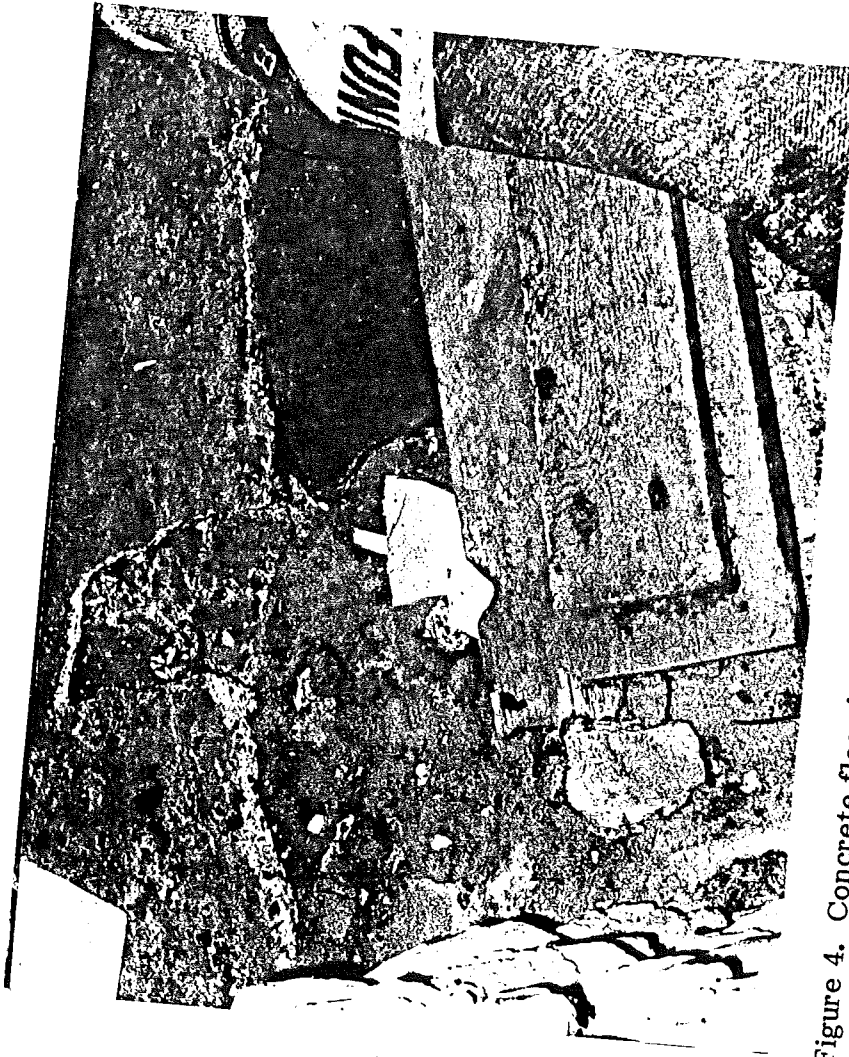
Figure 4. Concrete floor in basement next to the chimney, where floor has collapsed.

The concrete floor west and south of the chimney is badly broken. Two holes each approximately six inches in diameter southwest of the chimney show a medium to fine orange sand base. Tapping on the concrete in these areas indicate that it is hollow below the floor.

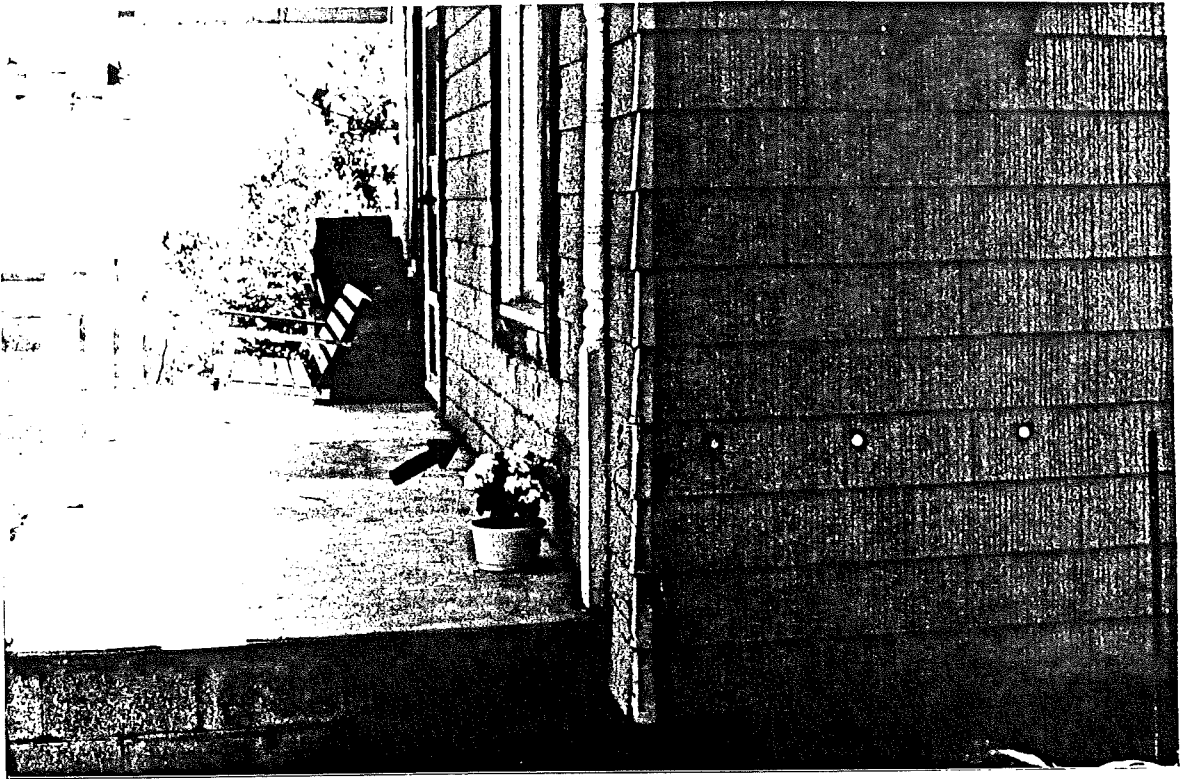
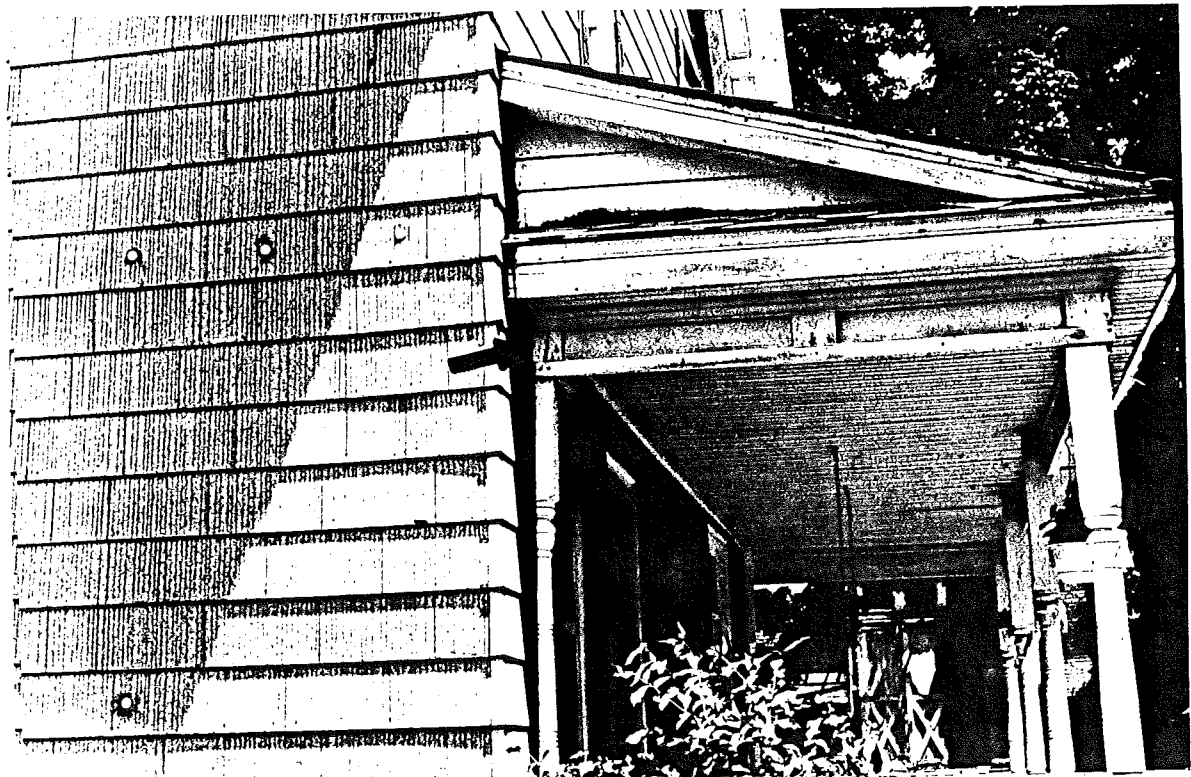
Another sign of differential settlement is indicated by the open porch located on the south face of the house (Fig. 5). The porch consists of a concrete slab floor that rests on a concrete block foundation of unknown depth with the roof supported by wooden columns that rest on the slab. It was constructed at approximately the same time the basement walls were repaired. The foundation has settled approximately 1-1/2 in. causing the porch roof to pull away from the house.

Figure 5. Porch pulling away from house approximately 1-1/2 inches due to settlement of its foundation.

The most obvious case of differential settlement involves the open porch located on the south side of the house. The porch is constructed of a concrete slab supported by concrete block walls with columns resting on the slab to support the roof. The base has settled approximately 1-1/2 inches causing the porch roof to pull away from the house.
