**CRASH TESTING OF MICHIGAN'S
TYPE B (W-BEAM) GUARDRAIL
SYSTEM – PHASE II**

MwRSF Research Report No. TRP-03-104-00

December 13, 2000

TESTING AND RESEARCH SECTION
CONSTRUCTION AND TECHNOLOGY DIVISION
RESEARCH PROJECT NO. RC-1398B

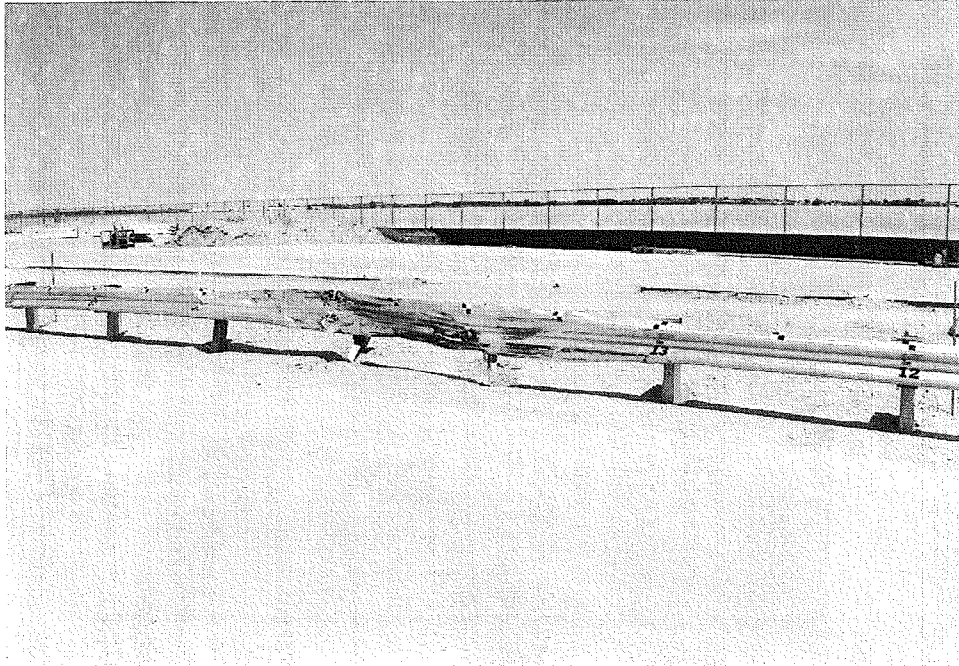
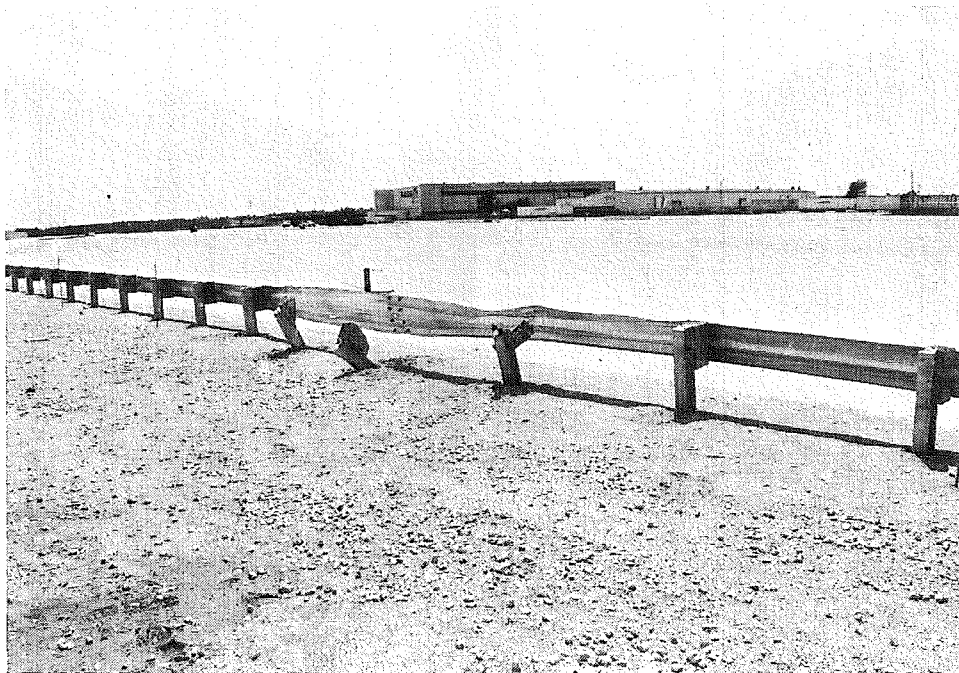
Figure 17. Type B Longitudinal Barrier Damage, Test MIW-2

Damage to the barrier was moderate, as shown in Figures 17 through 25. Barrier damage consisted mostly of deformed W-beam, contact marks on a guardrail section, and deformed guardrail posts. The W-beam damage consisted of major deformation and flattening of the impacted section between post nos. 13 and 15. Contact marks were found on the guardrail between post nos. 13 and 17. The top of the W-beam rail, downstream of post no. 21, was damaged from the truck riding along the rail. A 559-mm long cut was found on the bottom peak starting 76-mm upstream of post no. 14.

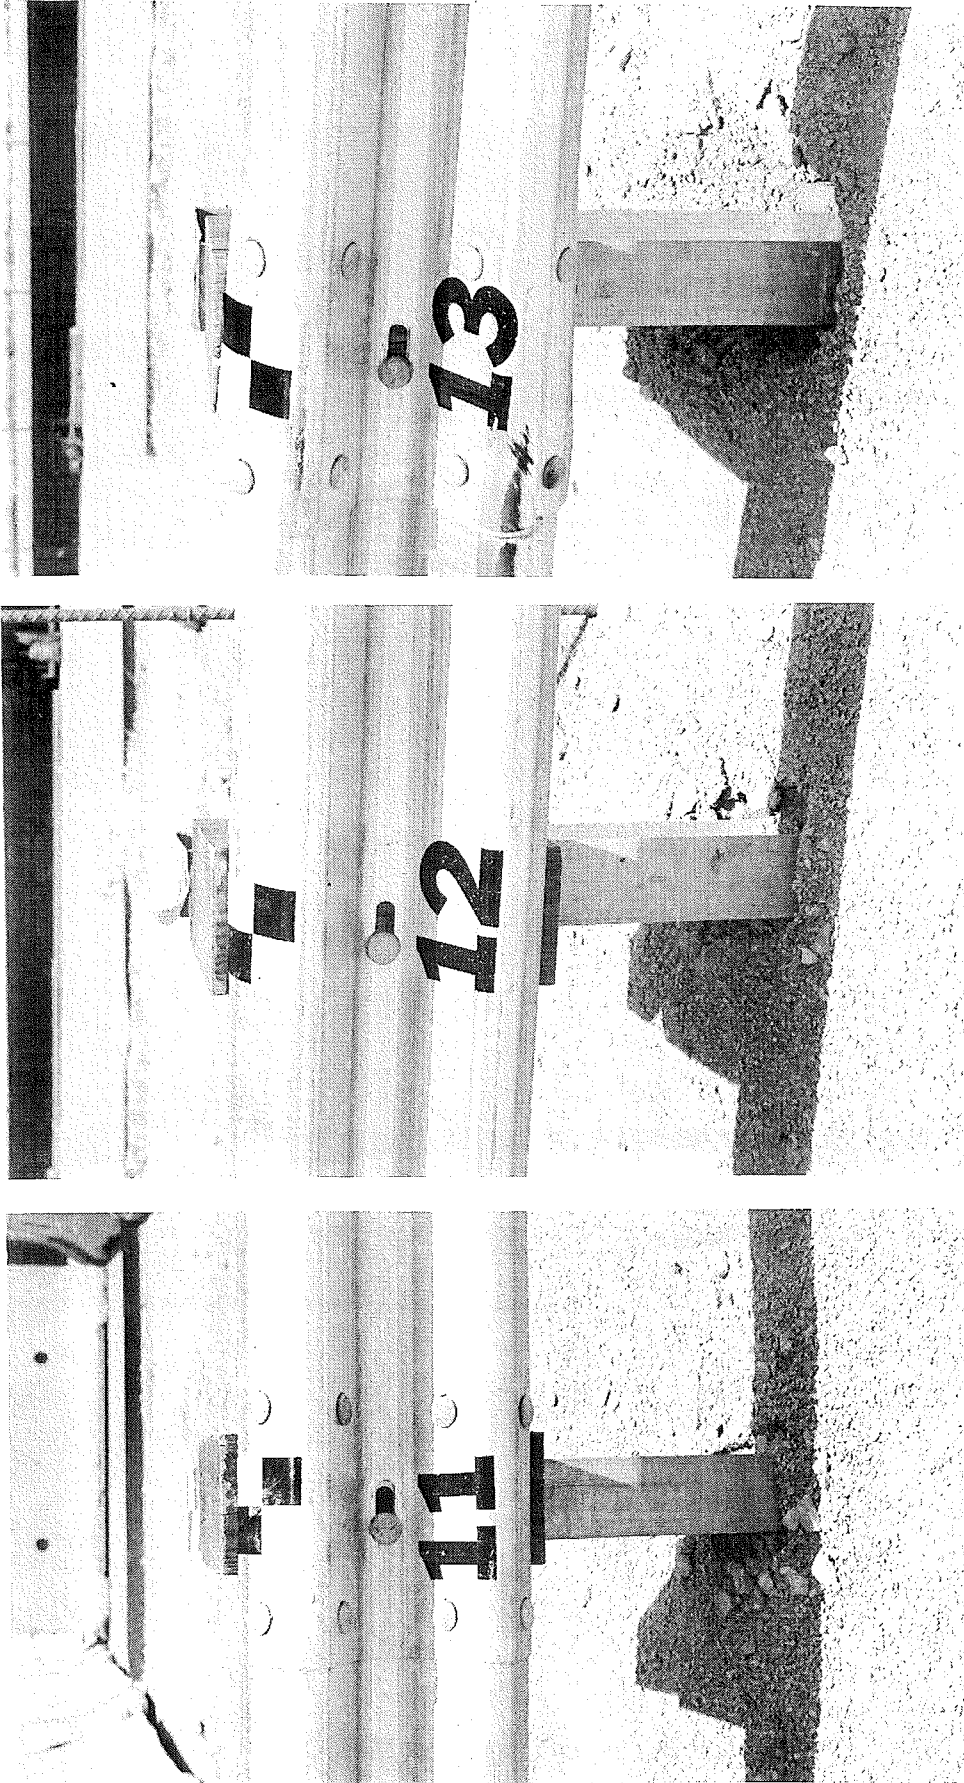
Figure 19. Type B Longitudinal Barrier Rail and Post Damage, Test MIW-2

Steel post nos. 3 through 13 and 17 through 19 moved backward slightly. Three steel posts, post nos. 14 through 16, rotated in the soil and bent toward the ground. A 406-mm long tire contact mark was found along the front face of post no. 14. The top of post no. 15 was also slightly

damaged. The tops of steel post nos. 20 through 27 were contacted and damaged extensively by the vehicle. The wooden blockout at post no. 14 split down the middle but was still attached. Contact marks were found on the wooden blockout at post no. 15. A piece of the wooden blockout at post no. 16 was removed. Both the upstream and downstream anchorage systems move slightly, but the posts were not damaged, except for post no. 28 which was split along its length.

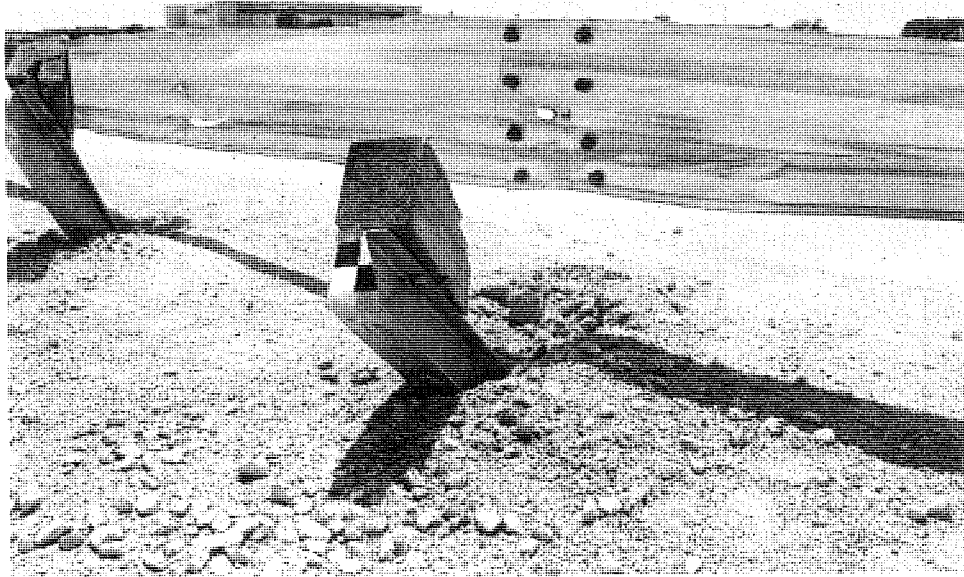
Post No. 15

The cause of this unacceptable behavior is attributed to the failure of the W-beam to release quickly from the guardrail posts. The splice in the W-beam rail element remained attached to post

no. 15 until the right-front tire contacted the post. During this time, the post rotated downward approximately 250 mm. Although the blockout reduced the magnitude of the downward motion, this post attachment caused the W-beam to be pulled down during a period when it is normally lifted up to retain the impacting vehicle's front tire. As a result, the tire was forced out from under the guardrail when it struck post no. 15, and the wheel began to climb the barrier as the test vehicle progressed. This wheel climb led to vehicle vaulting and the failure of the system to successfully redirect the test vehicle.

Careful inspection of the damaged guardrail system and photos of the barrier prior to impact revealed that the post bolts were installed near the downstream end of the slot in the rail element. Testing of the post bolt pullout strengths has shown that bolts installed near the end of the slot generate higher forces before being pulled through the rail. This installation detail may have helped prevent the post bolt from becoming detached from the rail element.

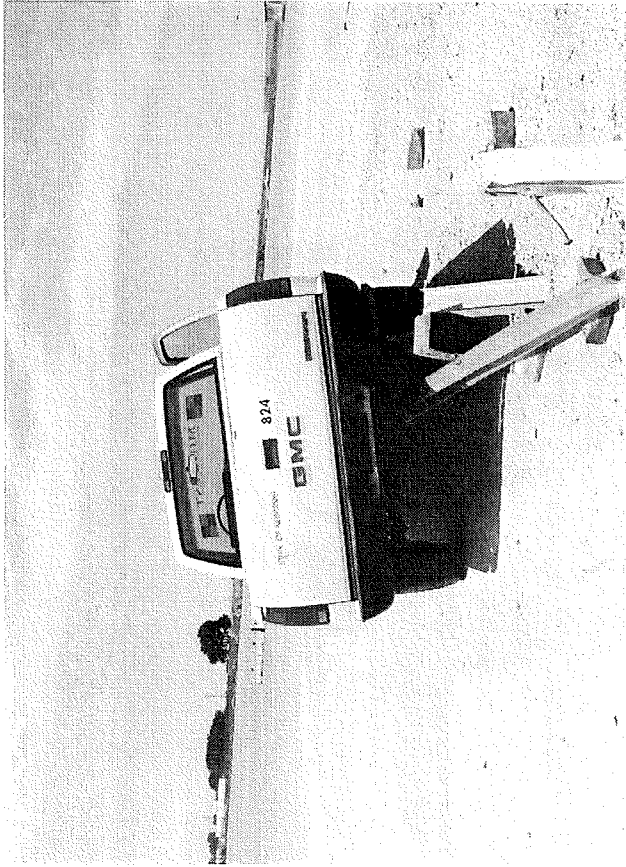
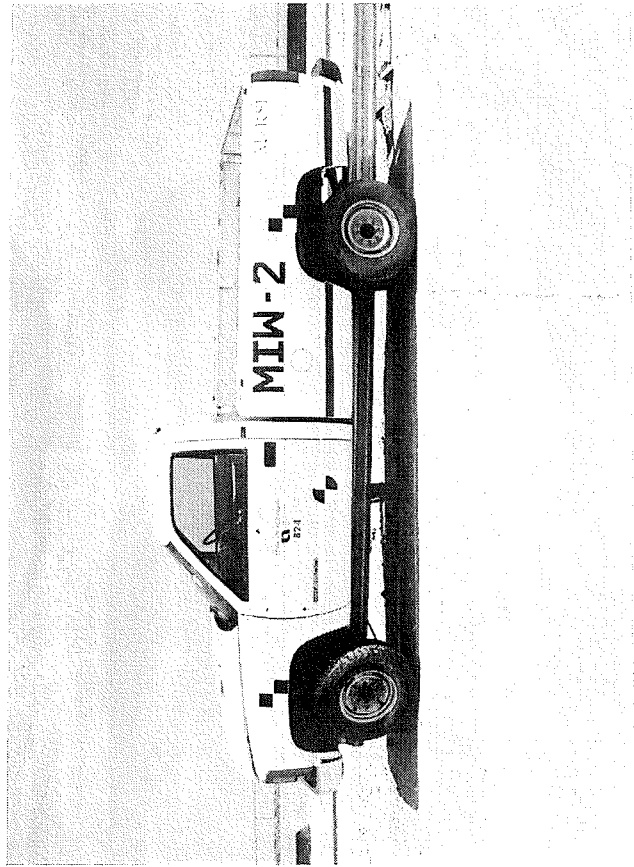
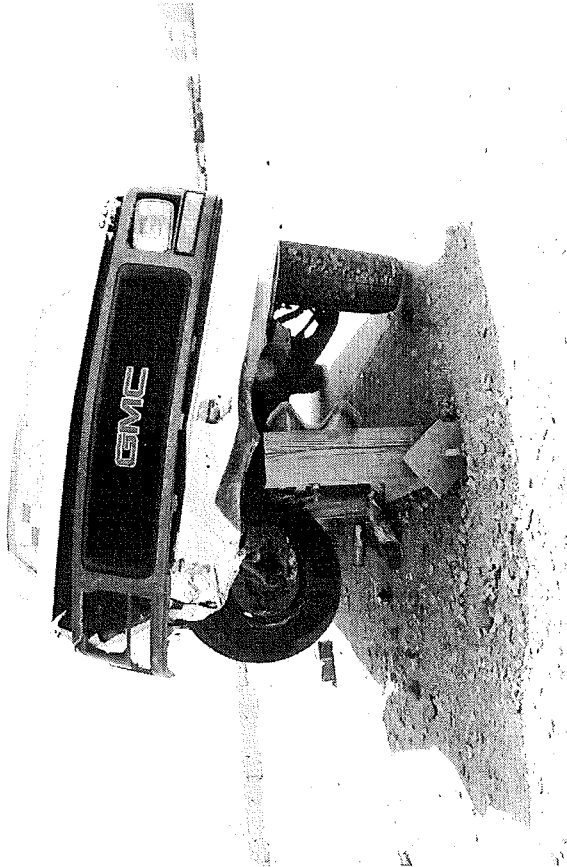
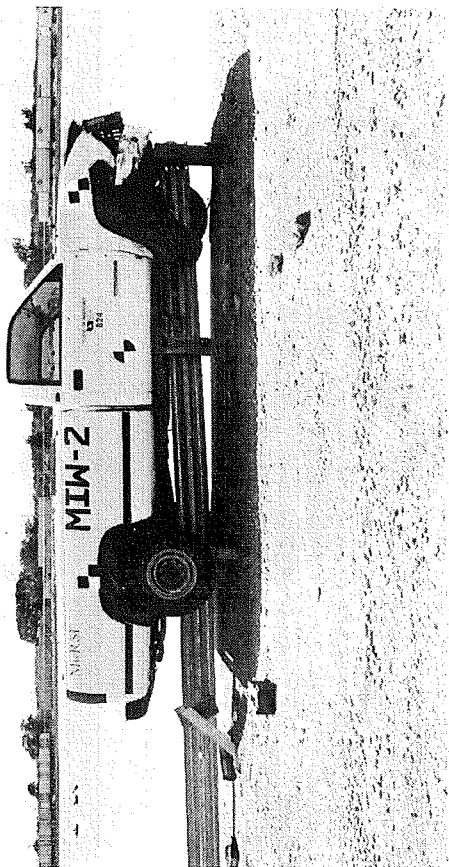
Figure 26. Vehicle Damage, Test MIW-2

Exterior vehicle damage was moderate, as shown in Figures 26 and 27. Interior occupant compartment deformations were determined to be negligible. The majority of the vehicle damage occurred to the vehicle's right side. The right-front fender was crushed inward and downward, and the right side of the front bumper was also bent toward the engine compartment. The right-front wheel assembly was deformed to approximately a 90 degree bend and pushed toward the firewall. Major damage was found on the inside of the right-front tire rim as well as tie-rod disengagement. The lower ball joint connection and the sway bar connection to the A-frame were deformed. The right side of the vehicle's frame was deformed extensively from the rear fender to the rear bumper. In addition, contact marks were observed on the inside of the right-rear wheel well. The outer side wall of the right-rear tire and the inner side wall of the right-front tire were slashed. Wood pieces were embedded into the A-frame and the connection between the drive shaft and rear end. Small

contact marks were found on the outside surface of the right-front tire and the lower front corner of the right-side door. The headlight, parking light, and fog light on the right-side broke. Minimal damage was found on the right side of the grill. No other damage to the vehicle was observed.
