CONCRETE ARCH RIB CONDITION SURVEY, M 99
(LOGAN ST) OVER THE GTW RR AND THE
GRAND RIVER, CITY OF LANSING (X01 of 33011)

**TESTING AND RESEARCH DIVISION
RESEARCH LABORATORY SECTION**

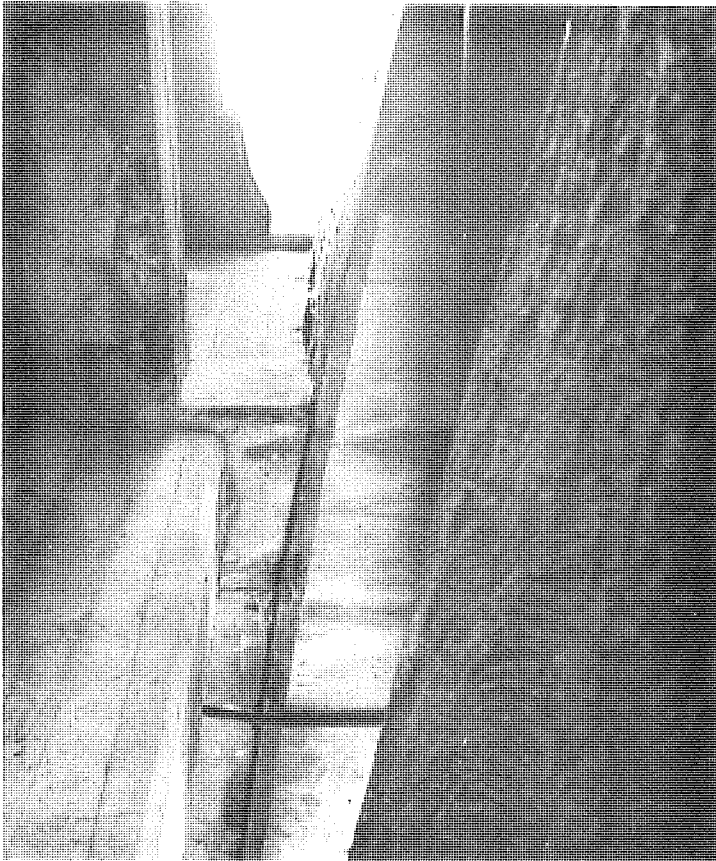
Figure 2 (above). View of header wall of west fascia rib at north end of Span 3. Note weep holes through header and salt stains down inside face of rib caused by drainage from deck construction joint.

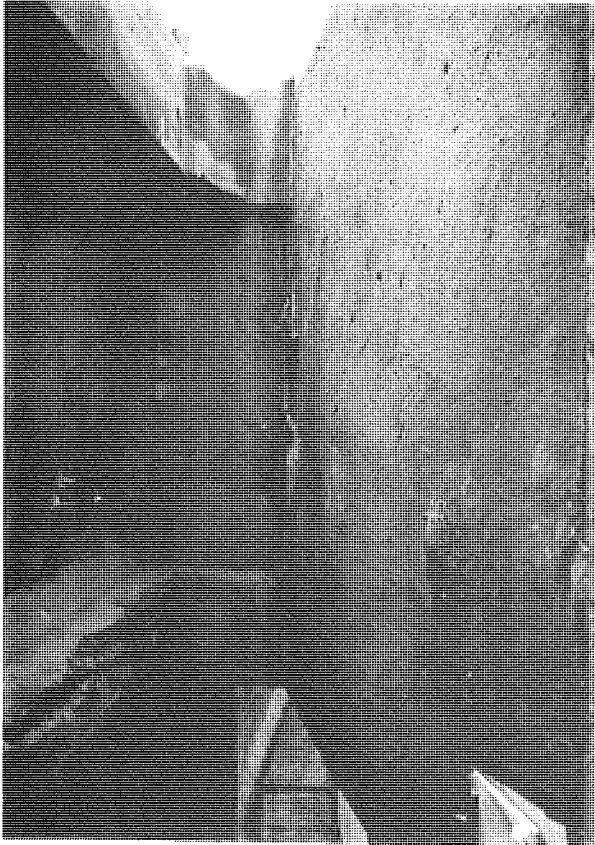
Figure 3 (right). General area and close-up views of header wall of west fascia rib in north half of Span 3. Note salt discharge residue that plugged weep holes and left residue line along entire length of construction joint between rib surface and header wall.

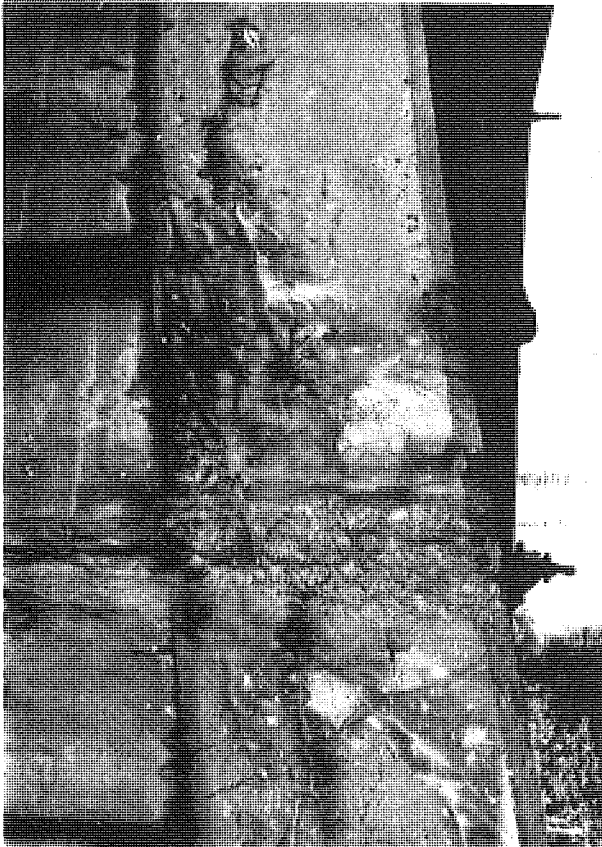
Figure 5 (below). Close-up view of weep holes through header wall at west interior rib in north half of Span 3. The lack of a salt deposit build-up indicates that very little surface water seeped through the construction joint at this location.

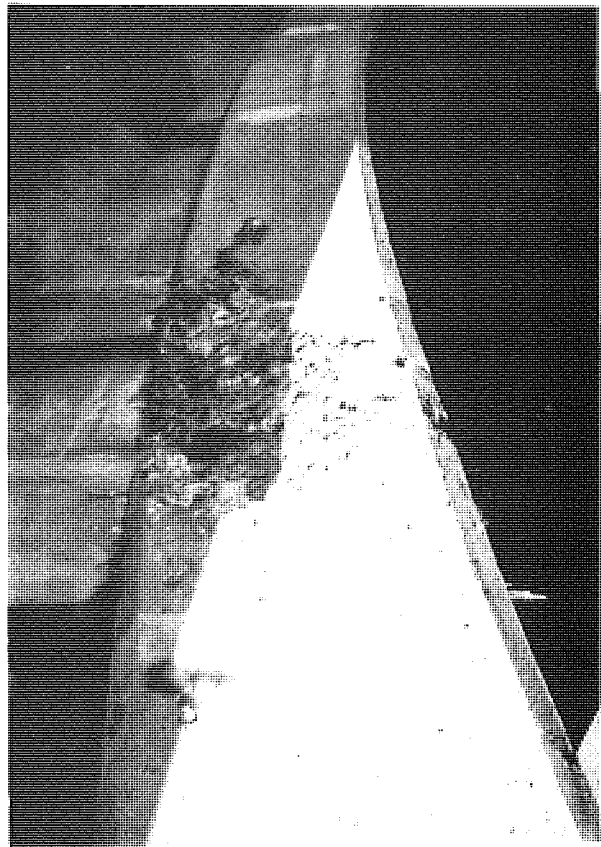
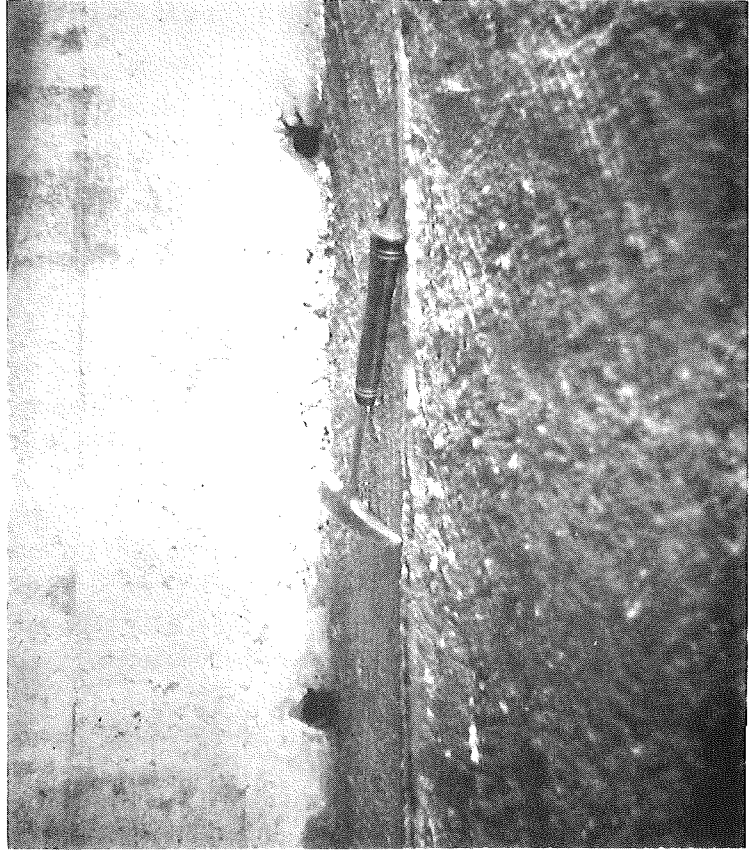
cate that little water seeped through at their location. It would appear that all six interior ribs are free from the serious type of damage sustained by the six fascia ribs in the three arch rib spans.

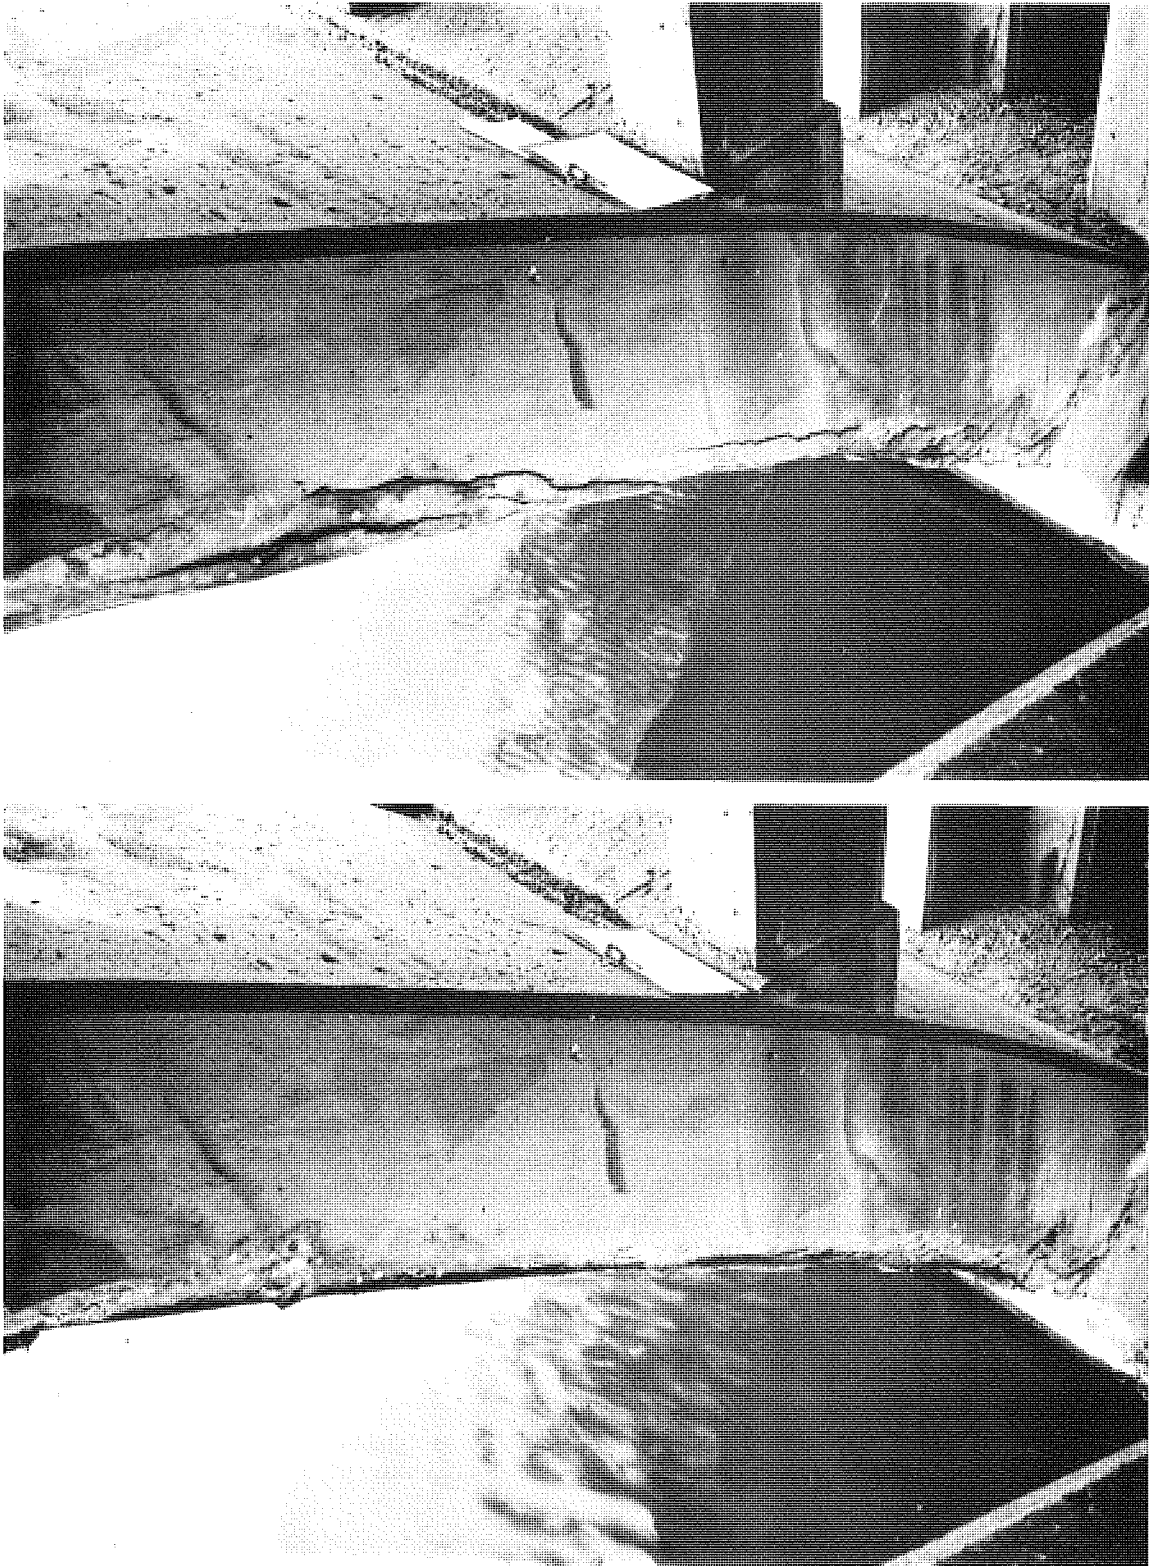
Figure 6. Before and after removal views of distressed concrete at lower edge of rib. View shows east side of west fascia rib in north half of Span 3. Some patching was placed where reinforcing bars made original placement and consolidation difficult.

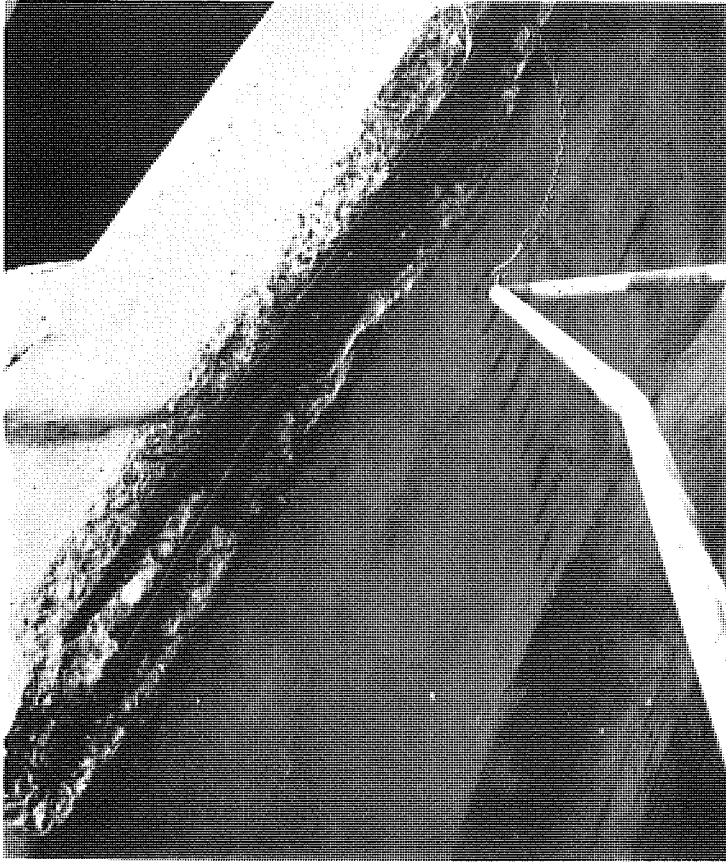
Figure 7. Before and after removal views of distressed lower arch rib corners in vicinity of bar splice. Note weep hole discharge stains down side of rib below top pedestal. Close-up view at left shows the delamination existing along line of interior bars.

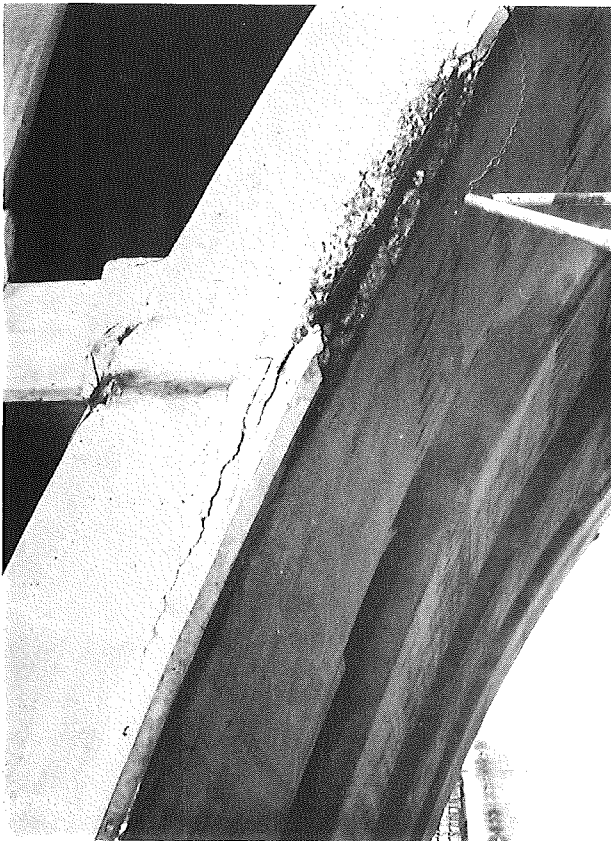
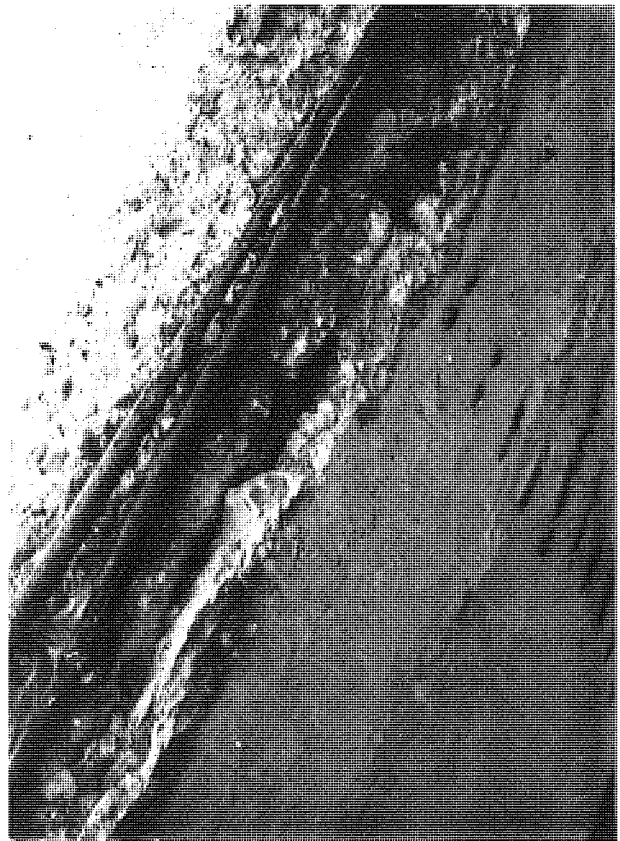
Figure 8 (left). View of an apparent honeycombed area caused by placement difficulties during construction. Located at south end of Span 3 on west fascia rib.

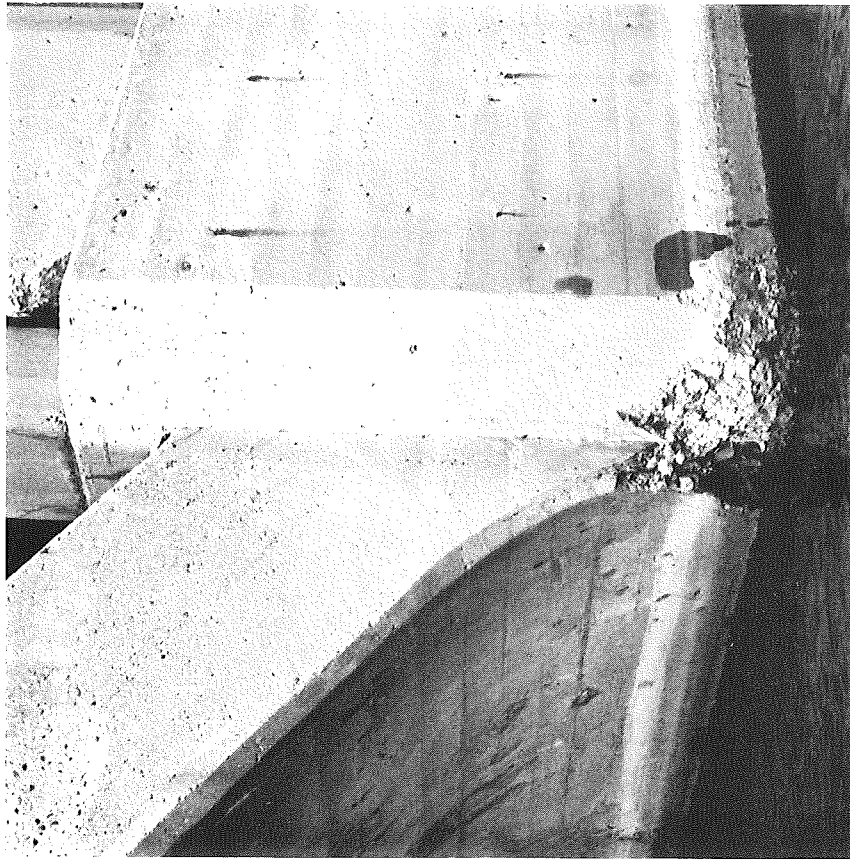
Figure 9. View of honeycombed area at the southeast corner of the north pier. This is the only blemish around the entire pier.

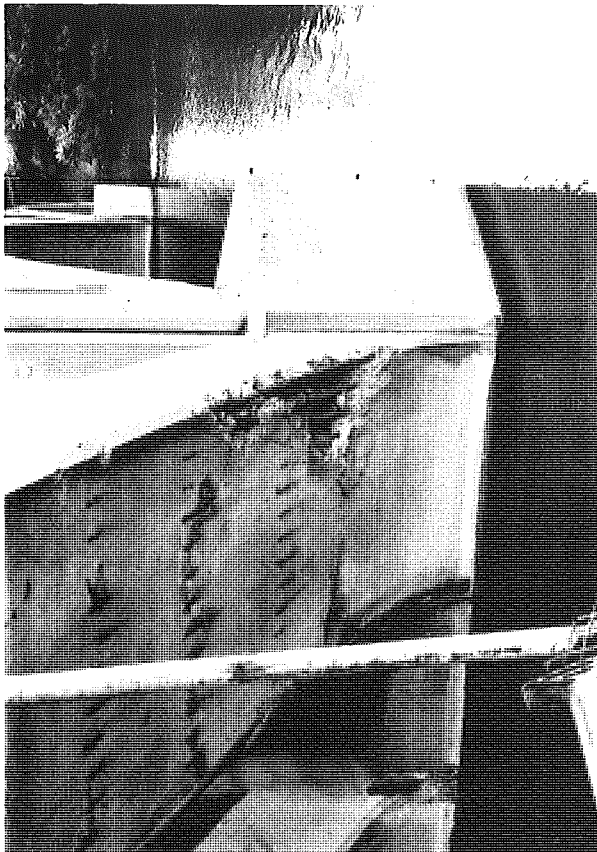
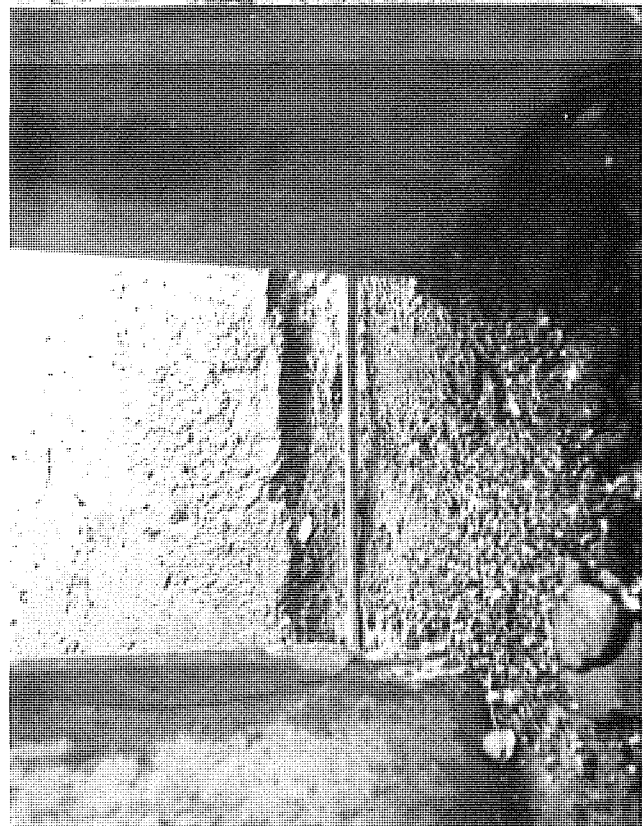
Figure 10 (left). View of deteriorated area at north abutment and west fascia rib prior to removal of dirt and rubble.

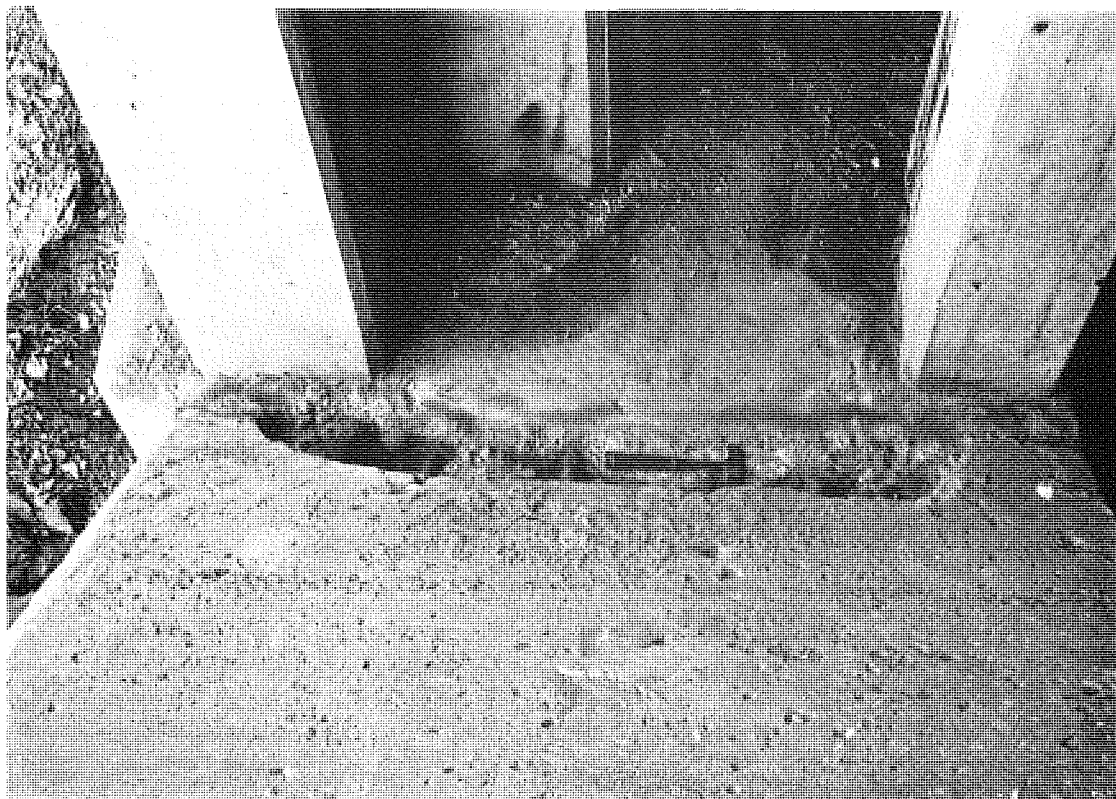
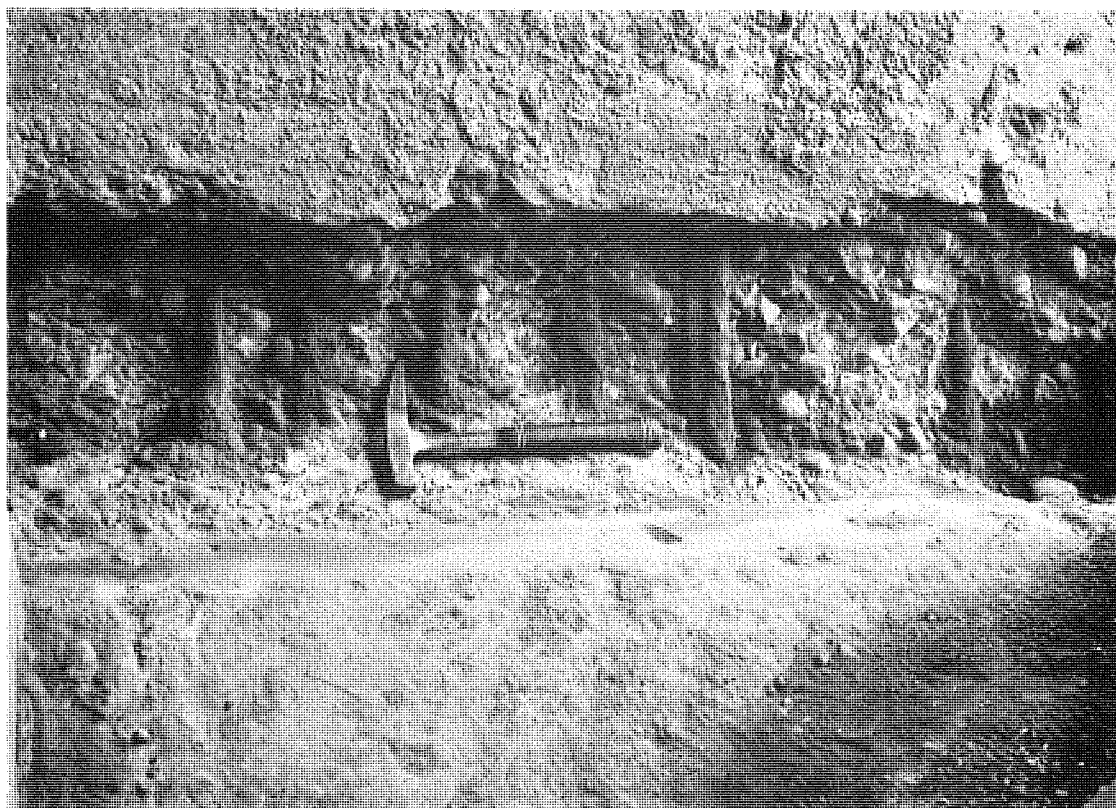
Figure 11. Overall and close-up views of spalled area at base of west fascia rib at north abutment.

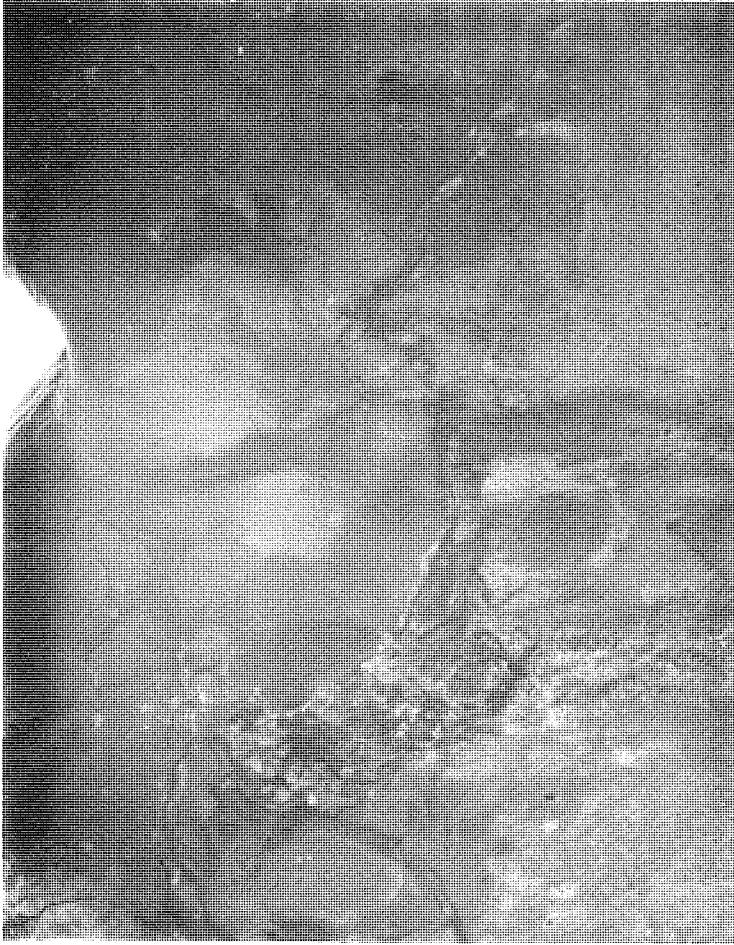
Figure 12. General area and close-up views of east side of west fascia rib at north abutment. Note severity of disintegration on side of rib. Presence of patch indicates that consolidation problems were encountered.
