PERFORMANCE OF A FIBERGLASS REINFORCED PLASTIC  
EXPERIMENTAL OVERHEAD SIGN SUPPORT STRUCTURE

Research Laboratory Division  
Office of Testing and Research  
Research Project 54 G-73  
Report No. 363

Michigan State Highway Department  
John C. Mackie, Commissioner  
Lansing, August 1961

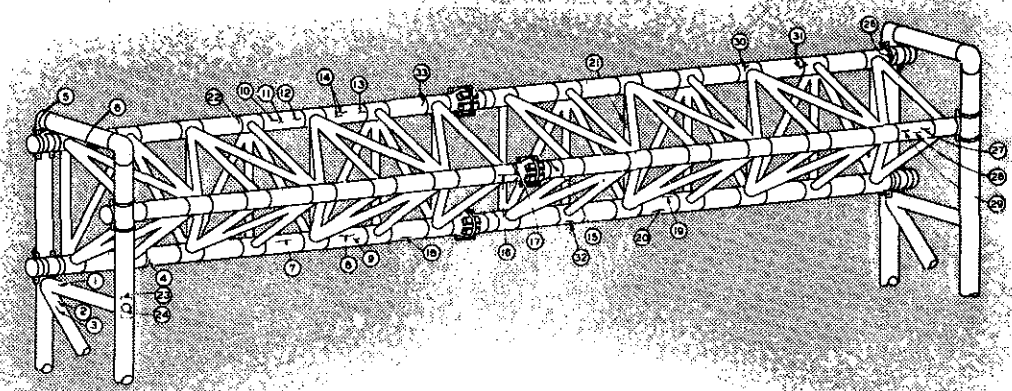
The structure was first inspected February 27, 1959, as reported in Test Report No. 32 (March 20, 1959). Cracks were found in three of the four joint fittings between the top horizontal member and the vertical tubes, and short longitudinal cracks were also discovered in the main chord members where sign clamps were mounted.

Cracks found in these inspections are shown and described in Fig. 1 as Nos. 1 through 25.

Frequent spot checks of the vertical trusses and lower chord members of the horizontal span unit between June 20, 1960, and May 19, 1961, showed little visible or apparent change in existing cracks. In the fourth thorough inspection, on May 19, it was found that cracks noted before were growing no longer or wider, but that eight new cracks had formed (Nos. 26 through 33 in Fig. 1).

Crack No.	Date* Observed	Length in.	Width, in.	Location
1	6-1-60	1.6	0.010	S column, middle horizontal member (longitudinal)
2	6-20-60	2.5	0.006	S column, top diagonal near SW tube (longitudinal)
3	6-20-60	3.0	0.011	Same as 2
4	6-20-60	2.5	hairline	Bottom chord, 1st joint from S column (circumferential)
5	2-27-59	---	seam split	Top horizontal member at junction with S column (SW tube)
6	2-27-59	---	seam split	Same as 5 (SE tube)
7	2-27-59	7.6	hairline	Bottom chord, at 2nd sign clamp from S column (longitudinal)
8	2-27-59	4.6	hairline	Bottom chord, at 3rd sign clamp from S column (longitudinal)
9	2-27-59	1.6	hairline	Same as 8
10	2-27-59	6.0	hairline	Top chord, at 2nd sign clamp from S column (longitudinal)
11	2-27-59	2.1	hairline	Same as 10
12	6-1-60	1.4	hairline	Top chord, between 2nd sign clamp and 5th vertical strut from S column (longitudinal)
13	6-1-60	3.4	hairline	Top chord, at 6th vertical strut from S column (longitudinal)

14	2-27-59	1.5 & 2.0	hairline	Top chord, at 3rd sign clamp from S column (longitudinal)
15	6-20-60	3.5	hairline	Back chord, in fillet north of center casting (circumferential)
16	6-20-60	---	seam split	Back chord, south of center casting (longitudinal)
17	6-20-60	11.0	hairline	Same as 15 (S casting)
18	2-27-59	3.0	hairline	Bottom chord, at 4th sign clamp from S column (longitudinal)
19	2-27-59	4.3	hairline	Bottom chord, top at 7th sign clamp from S column (longitudinal)
20	2-27-59	3.3	hairline	Same as 19 (chord bottom)
21	6-20-60	1.8, 1.0, 0.5	hairline	10th vertical strut from S column (group of 3, circumferential)
22	6-1-60	2.3	hairline	Top chord, at 4th vertical strut from S column (circumferential)
23	6-20-60	0.8	0.020	S column, top of fillet at junction of middle horizontal member & SE tube
24	6-20-60	0.8	0.015	Same as 23 (at bottom of fillet)
25	6-20-60	2.0	hairline	S column, bottom horizontal member

26	5-19-61	1.9	hairline	NW column, top of clamp to bottom chord (vertical)
27	5-19-61	2.5	hairline	Back chord between 1st & 2nd joint from N column (longitudinal)
28	5-19-61	2.4	hairline	Same as 27
29	5-19-61	1.1	hairline	Same as 27
30	5-19-61	1.0	hairline	Top chord, 3rd joint from N column (longitudinal)
31	5-19-61	5.5	hairline	Top chord, 1st sign clamp from N column (longitudinal)
32	5-19-61	11.5	seam split	Bottom chord, 6th joint from N column (longitudinal)
33	5-19-61	1.9	hairline	Top chord, S of center casting (circumferential)

Figure 1. Location and description of cracks. Sign clamps not shown. South column at left.

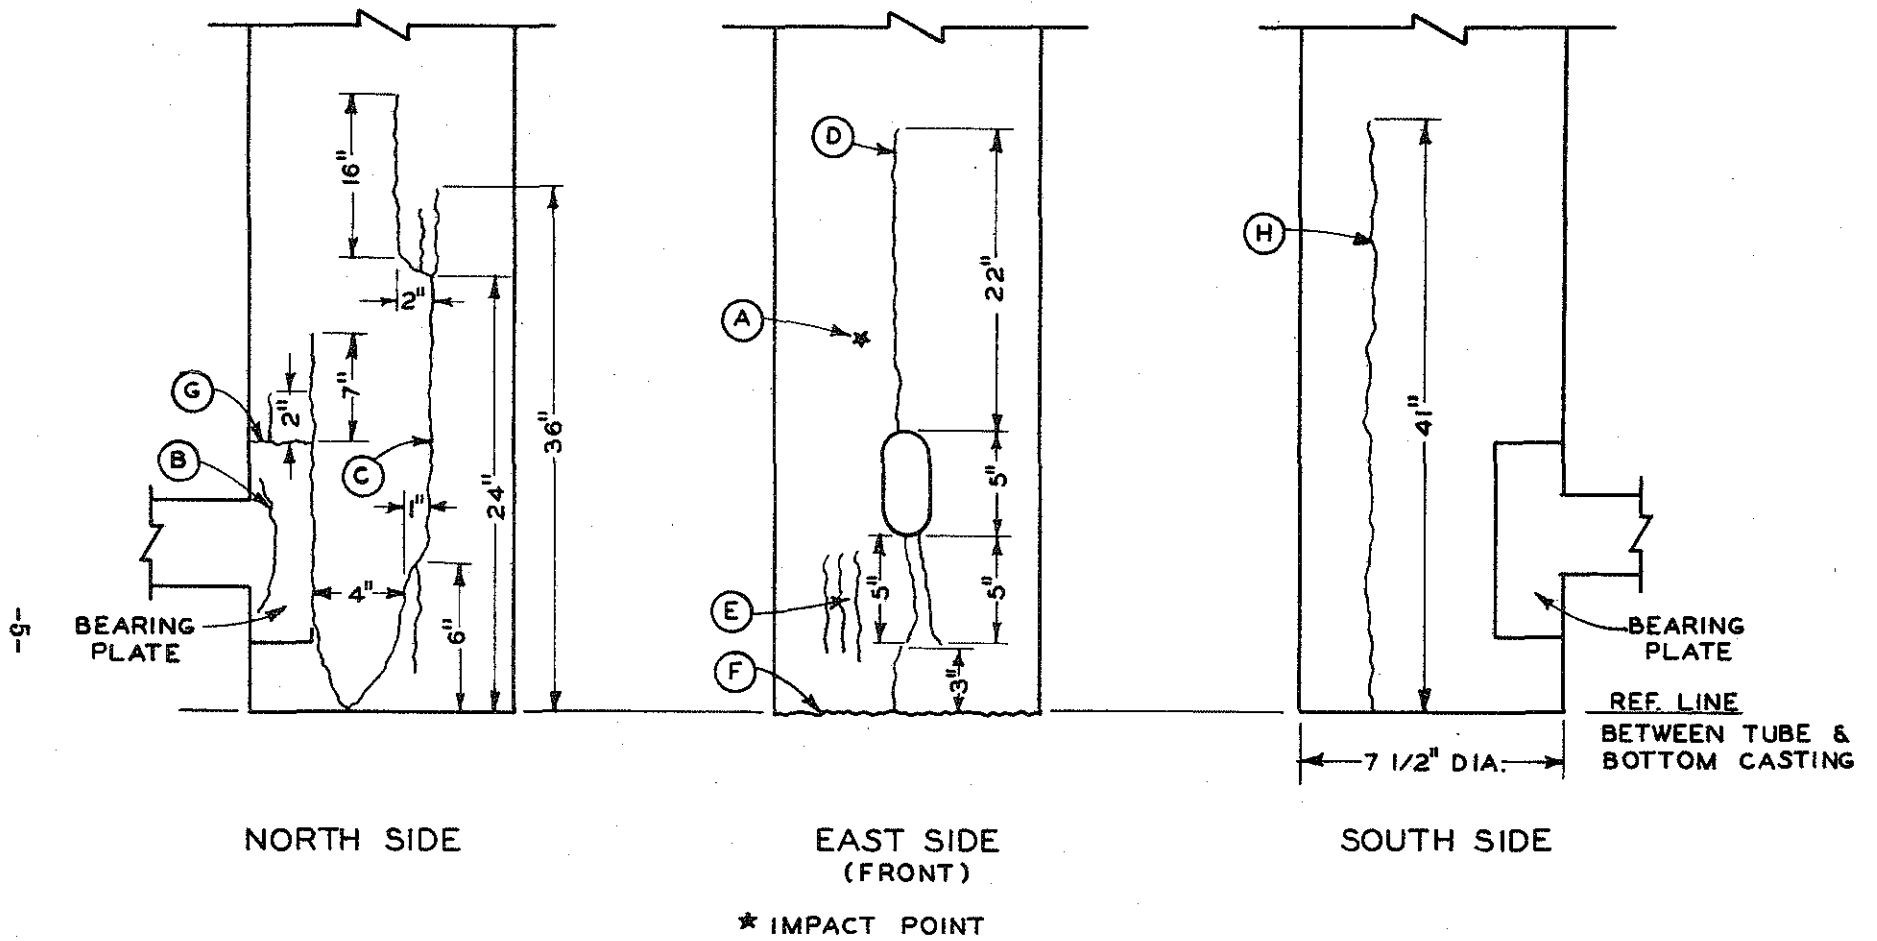
On July 7, 1961, following the accident damage to the structure, Robert Harp of the Office of Maintenance Sign and Signal Section requested investigation of the structure's condition. Major damage was concentrated in the impact area on the southwest vertical tube member (Figs. 2 and 3). The horizontal span unit was not inspected, but Mr. Harp was immediately advised that because of severe longitudinal splitting and the circumferential seam split extending halfway around the tube at its base, the structure should be taken down. It was removed on July 10.

Figure 2. Damage to southwest vertical tube.

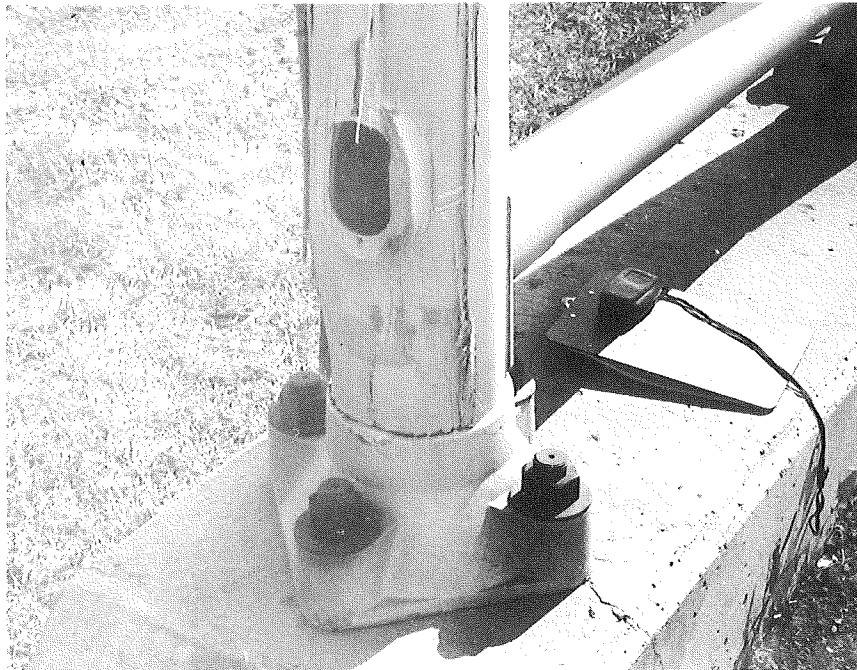
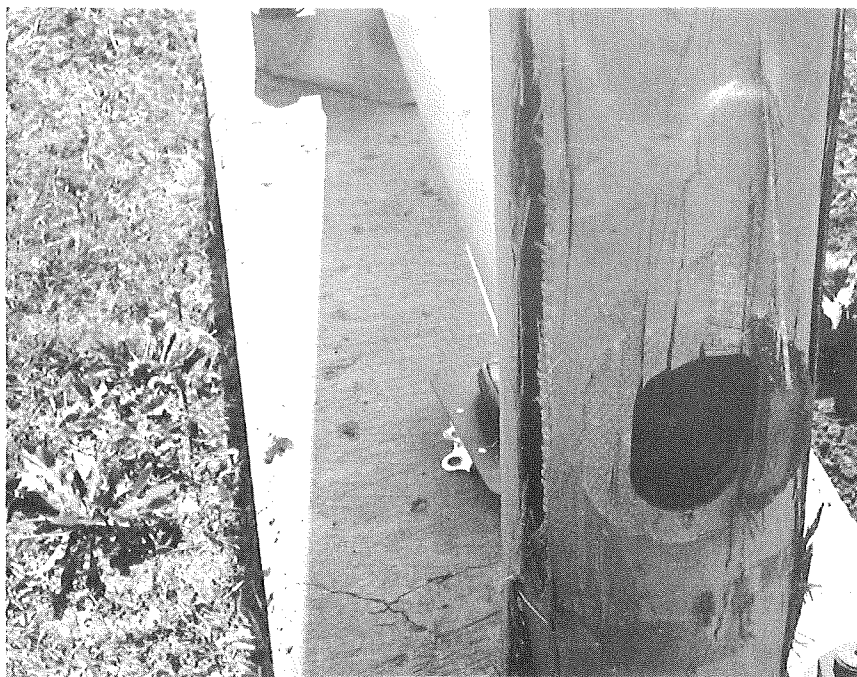
Figure 3. Accident damage to southwest vertical tube.
