FAILURE OF EXPANSION JOINT FILLER ON

JOHN C. LODGE EXPRESSWAY: CONSTRUCTION PROJECT 82-127, C27

Research Laboratory  
Testing and Research Division  
Report No. 183  
September 30, 1952

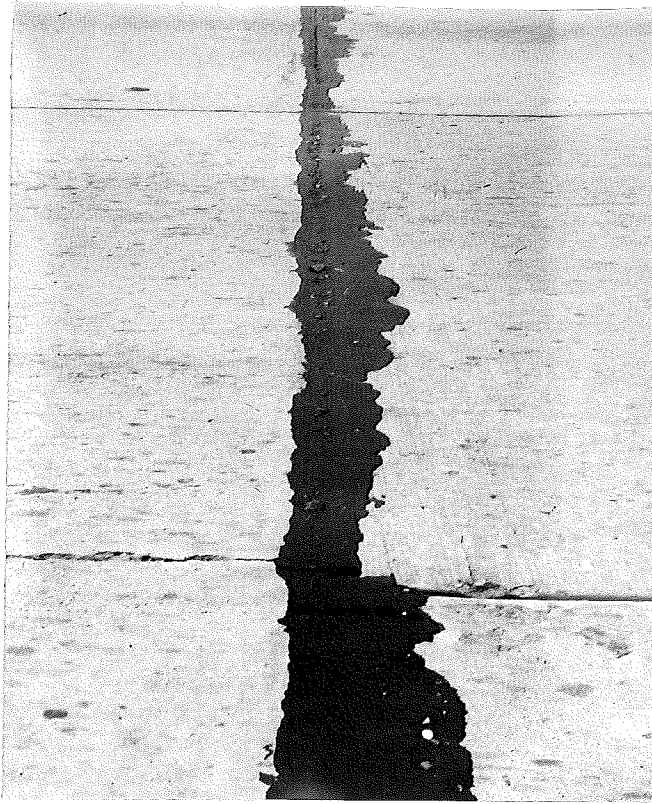
A. View of joint at Station 633+20, Northbound lane, showing extruded and displaced filler.

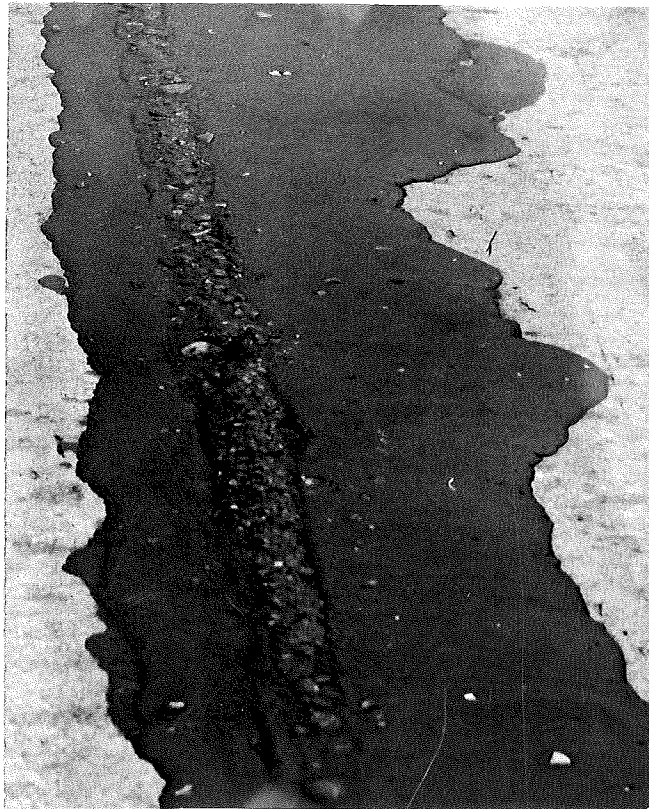
B. Close-up of joint at Station 633+20, Southbound lane, to show extrusion and displacement of joint material.

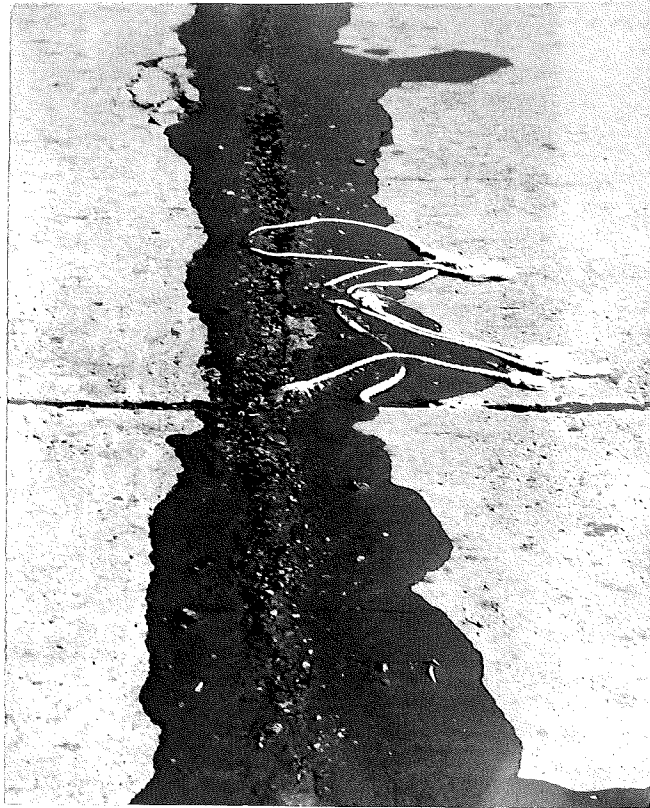
A. Joint in southbound lane, Station 637+20.

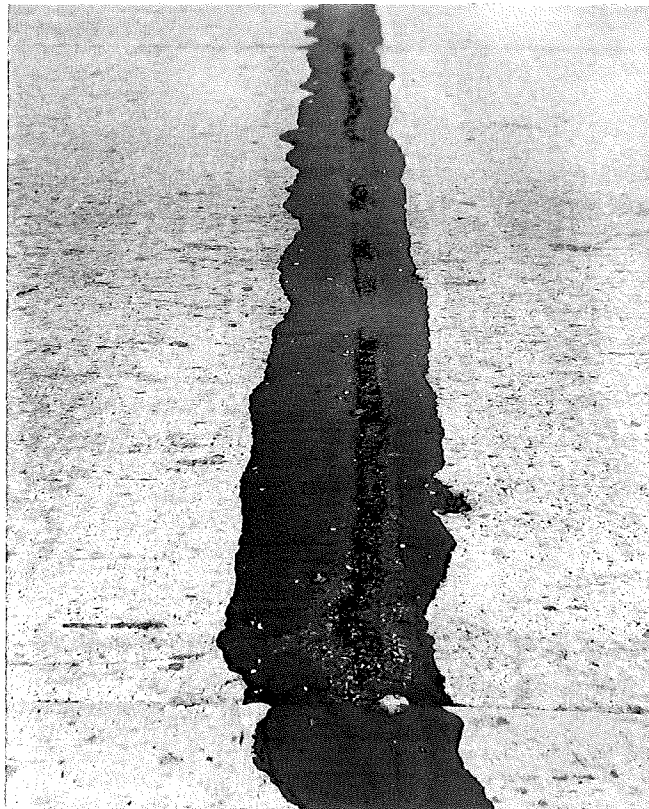
B. Joint in southbound lane, Station 639+80.

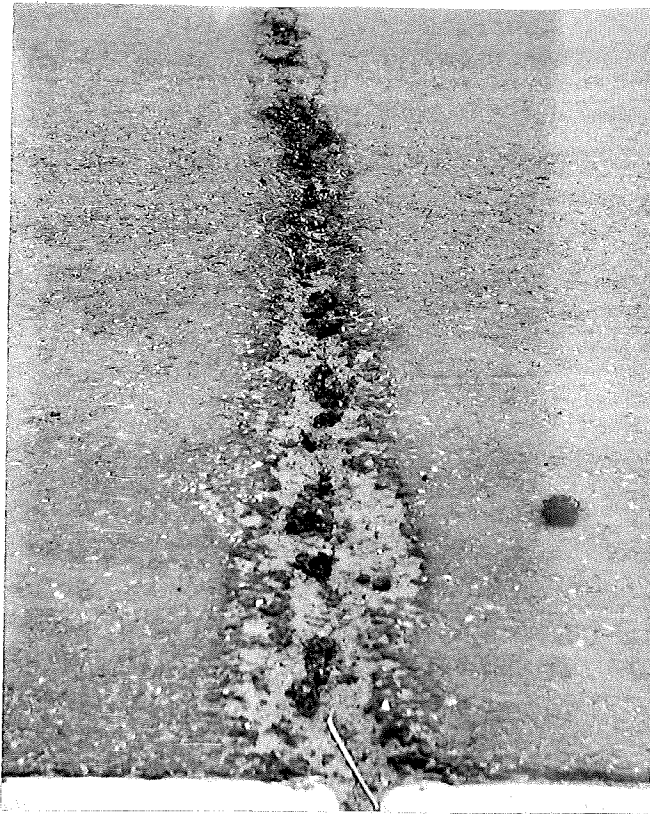
The results of the survey are presented pictorially in attached Figures 1 through 5. In all cases, failure of the joint filler material is exemplified by abnormal extrusion of the material above the surface of the pavement, displacing the joint sealing material. The extruded joint filler is, in turn, flattened out or worn away under traffic. Where this material has been used in concrete base course under bituminous surfacing, the extruded joint filler has ruptured the bituminous surfacing along the joint causing the bituminous surfacing material to ravel. This condition is clearly demonstrated in Figure 3.

A. View of joint at Station 649+90 of approach showing effect of joint filler extrusion on bituminous surfacing.

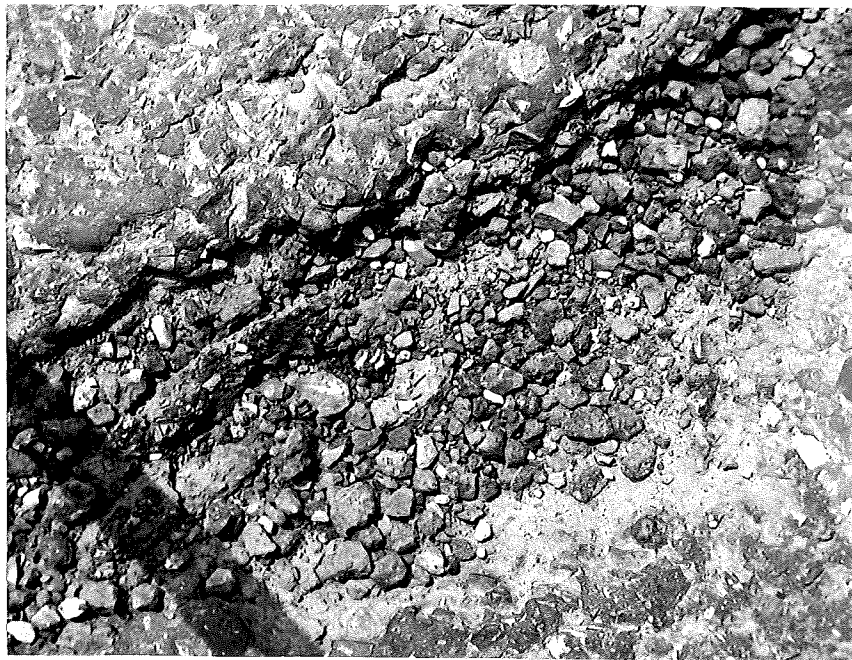
B. Close-up of a section of above joint showing destruction of bituminous surface by extruded filler.

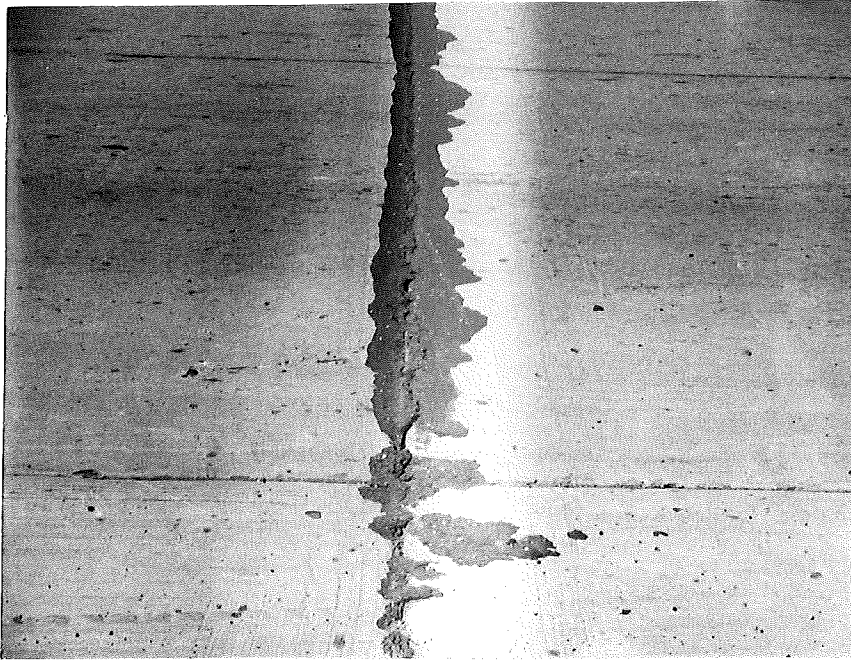
A. View of joint on northbound lane, Station 649+90, showing extrusion and displacement of joint filler.

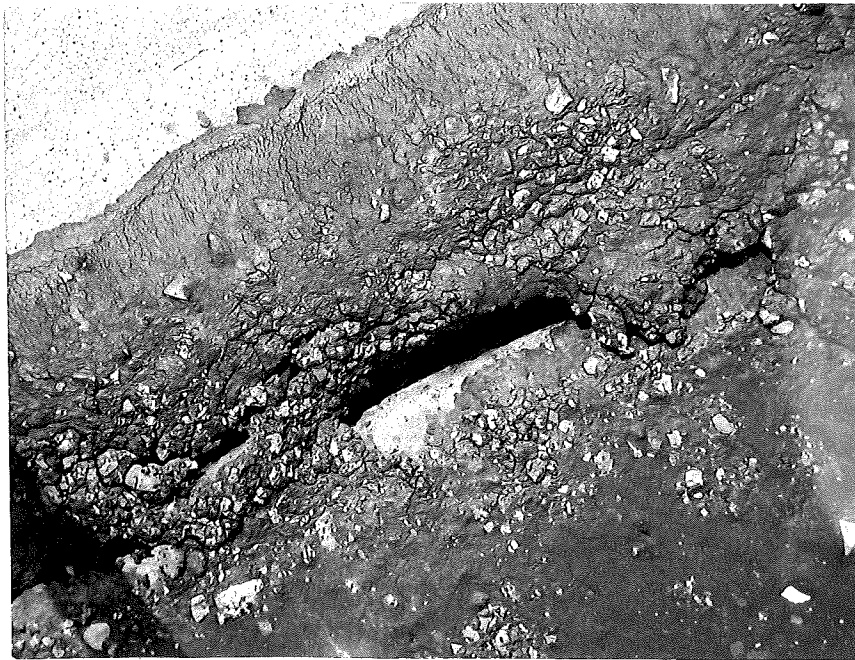
B. Close-up of section of above joint to show extruded joint material.

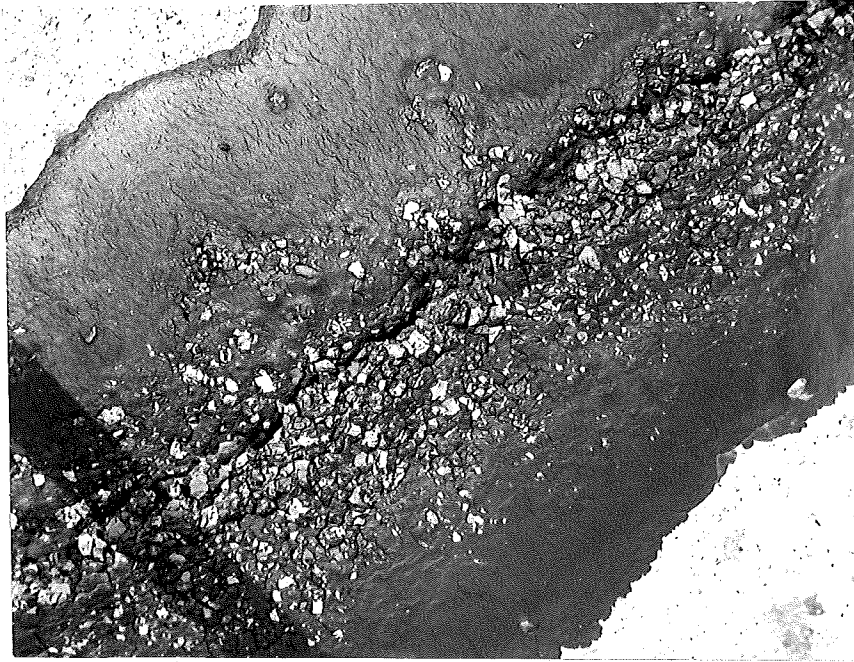
A. Close-up of section of joint, southbound lane, Station 650+1.0, showing extrusion and displacement of filler material.

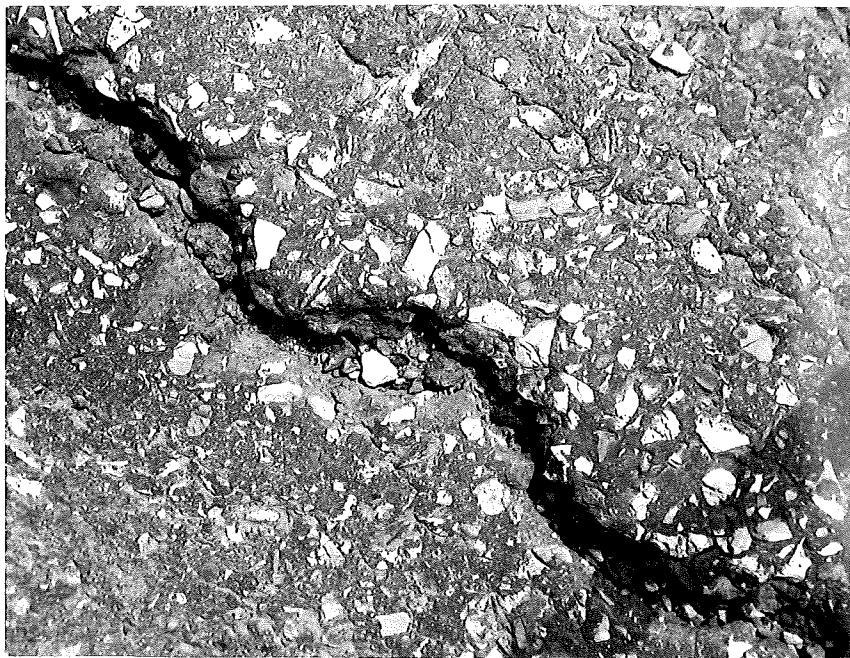
B. Close-up of section of joint in approach ramp from Milwaukee Avenue to southbound lane to show joint destruction, Station 650+10.

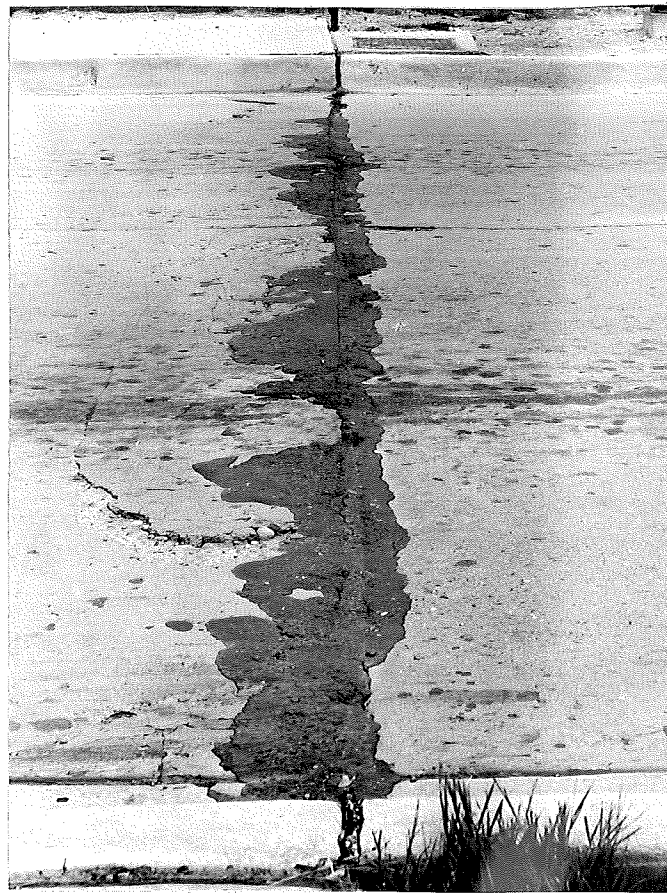
Subsequent to the survey on the Lodge Expressway, similar failures of the same type of filler installed in other locations have come to light. One example of such failure is illustrated in Figure 6, which shows filler extrusion from a joint on the South approach to the Main St. bridge in Lansing. Other examples could also be cited.

A. Expansion joint in south approach to Main St. Bridge, Lansing; Project U 33-66, Cl. Note extrusion and breakdown of filler.

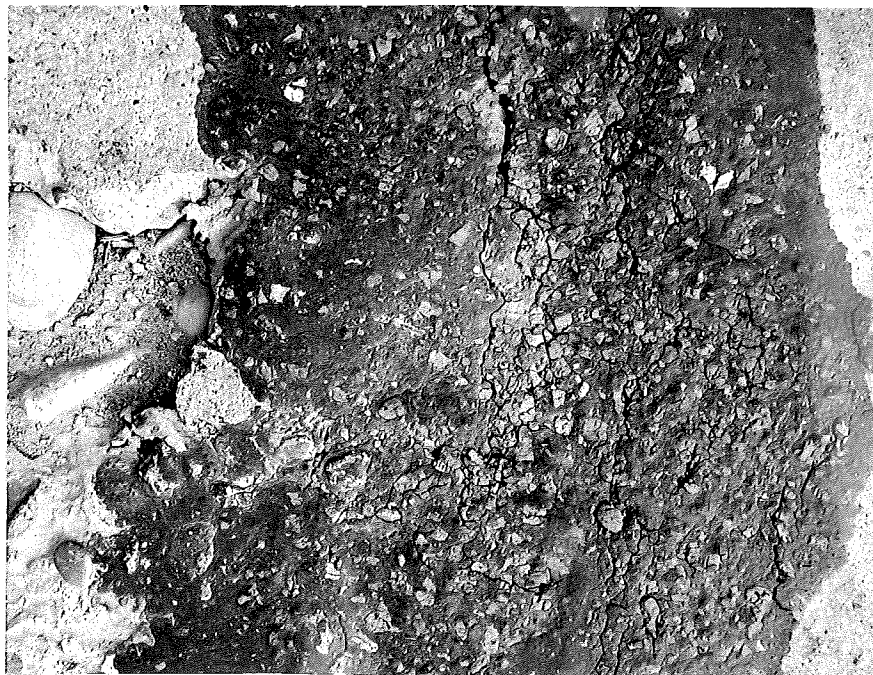
B. Close-up of above joint,
