Improved Performance of JPCP Overlays

Final Report

July 2013

A joint UM-MDOT forensic investigation was initiated in 2009 with the major objective to determine the causes of poor performance of some of Michigan's concrete overlays. The major areas of concern included longitudinal cracking starting year one (I-75, West Branch), in the undoweled test sections, and rapid distress development in some recent projects. To accomplish the objectives from a forensic investigation, eight projects were selected based on age and varying performance levels (good to poor). Finite element modeling was used to understand the longitudinal cracking phenomenon found in the I-75 NB, West Branch project, and hot weather construction related early cracking that developed in another project (US-131, Kalamazoo). Laboratory testing was undertaken to assess the frost durability resistance in one project (US-131, Rockford), which had

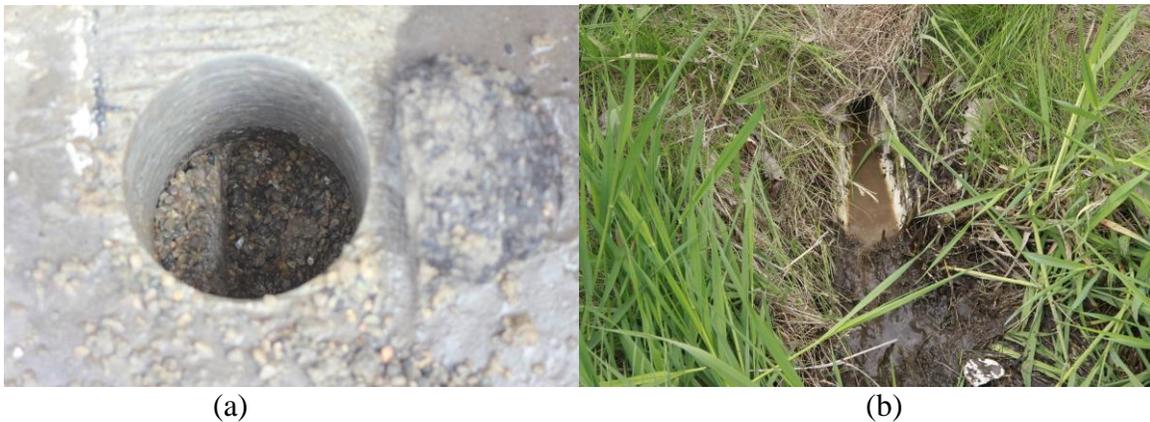
Figure 3.1 (a-b). US-23 NB, with capped drainage trench (a). Once opened water drained quickly (b).

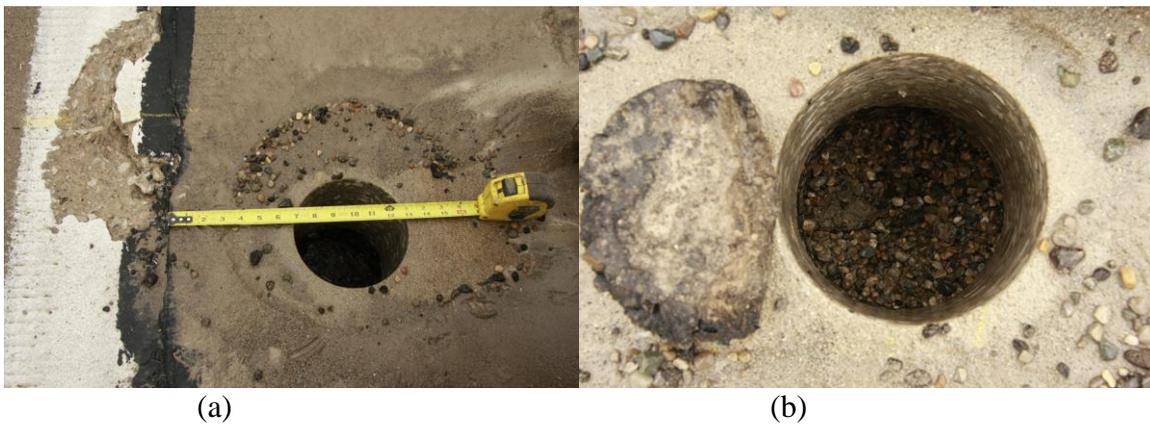
Figure 3.2 (a-b). Edge-drain location (a) and close-up of HMA cap over the pea-stone drain trench (b) (I-69 NB, Charlotte).

The I-69 NB Charlotte overlay has developed major HMA erosion along the outer edge due to capped drains (Figure 3.2) consistent with loss of joint support and high edge deflection values (Table 3.1). Pumping has lifted the shoulder edge about 0.5 inches (Figure 3.10a). Despite the slab distresses (Figure 3.10 a-f) from pumping, joint faulting is insignificant (Figure 3.11b). It is likely that sealing the joints and cracks in years 8 and 9 has had a beneficial effect with respect to joint faulting. These distresses are similar to those found in the I-75 NB West Branch overlay sections 3 and 4, consistent with loss of slab support (Appendix A).

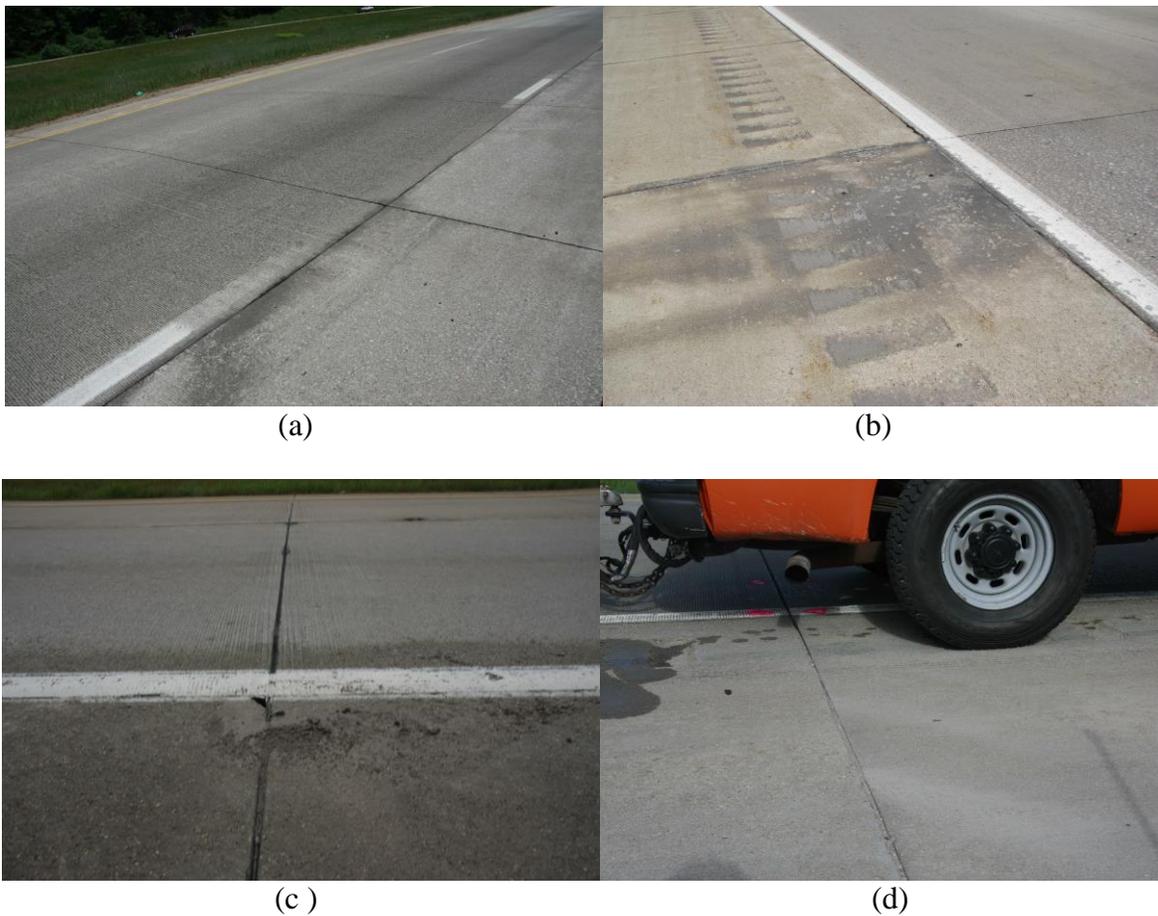
Figure 3.3 (a-d). Typical pumping observations following a heavy rain-fall.

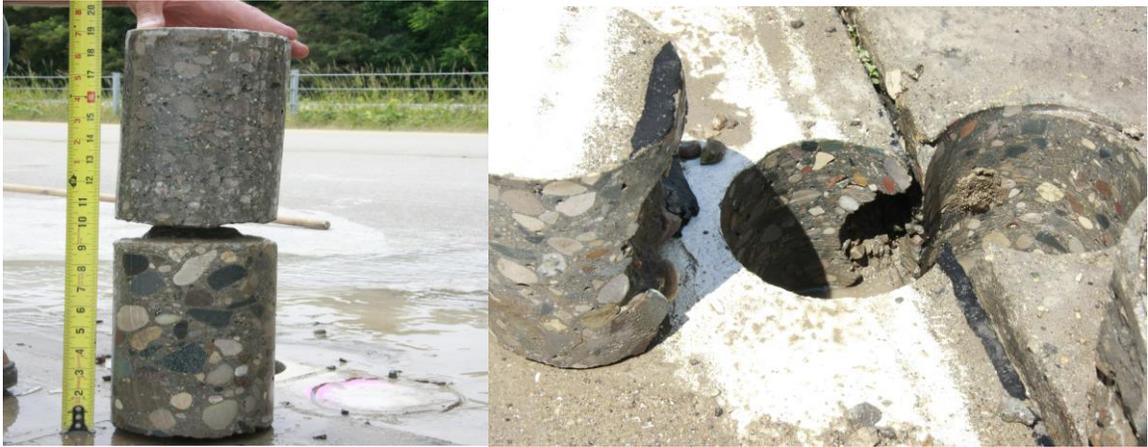
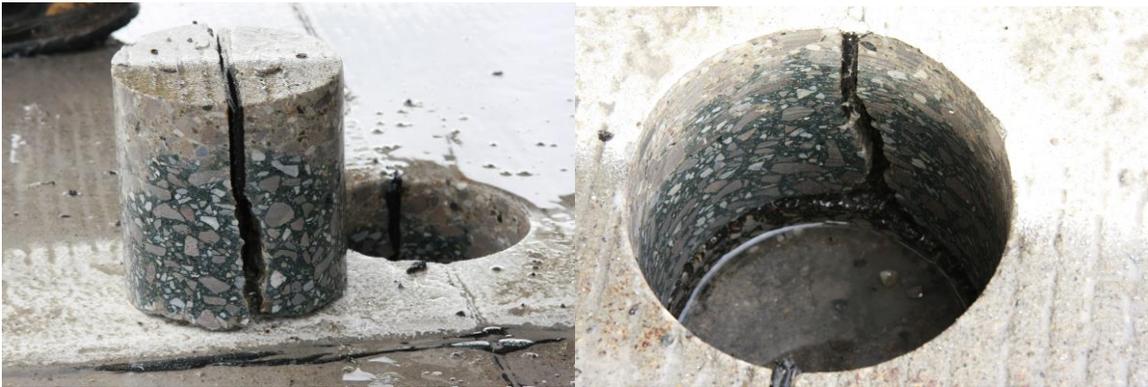
Figure 3.4 (a-d). Pumping erosion at joints.

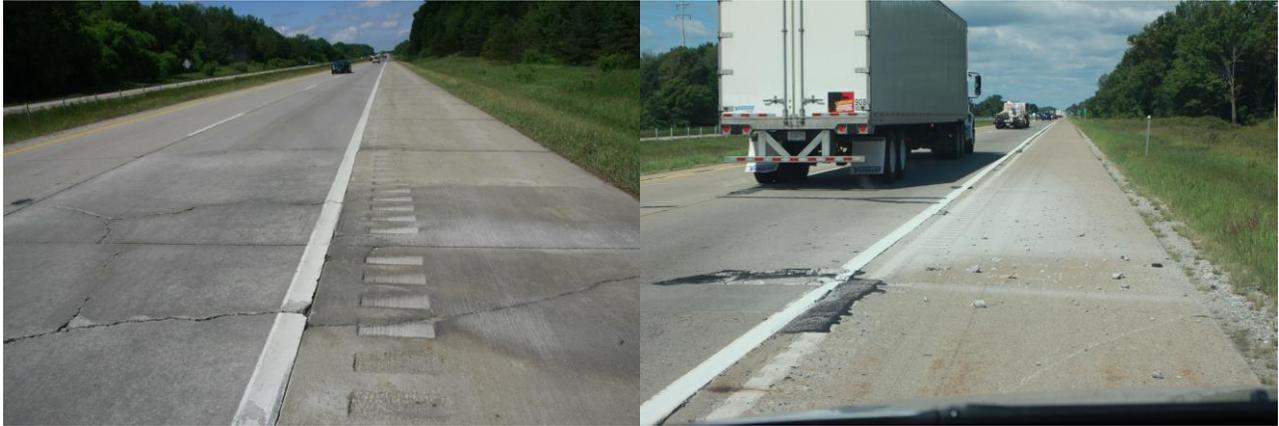
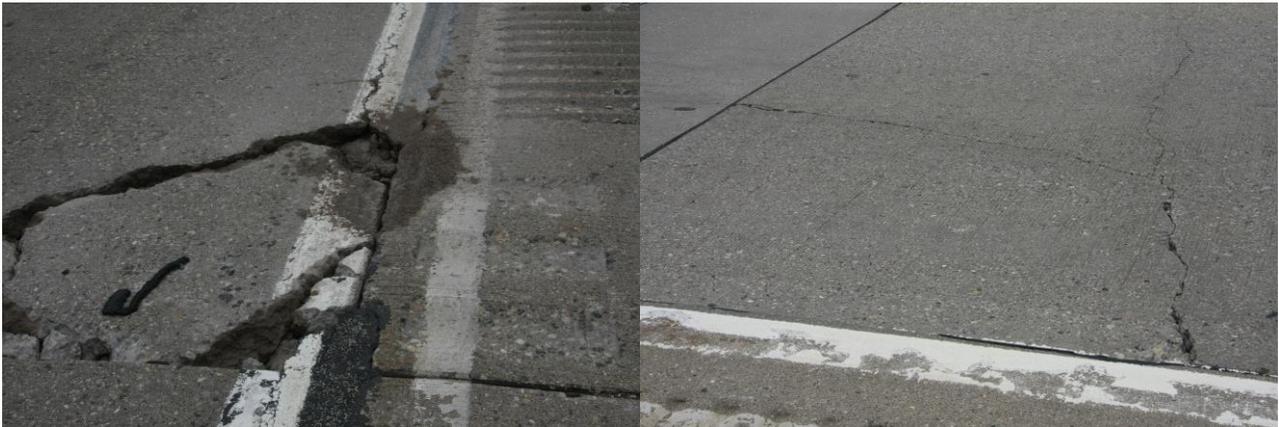
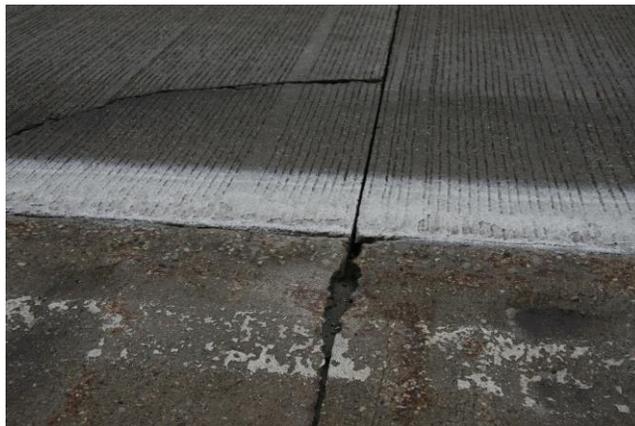
Figure 3.5 (a-e). Examples of pumping related slab cracking.

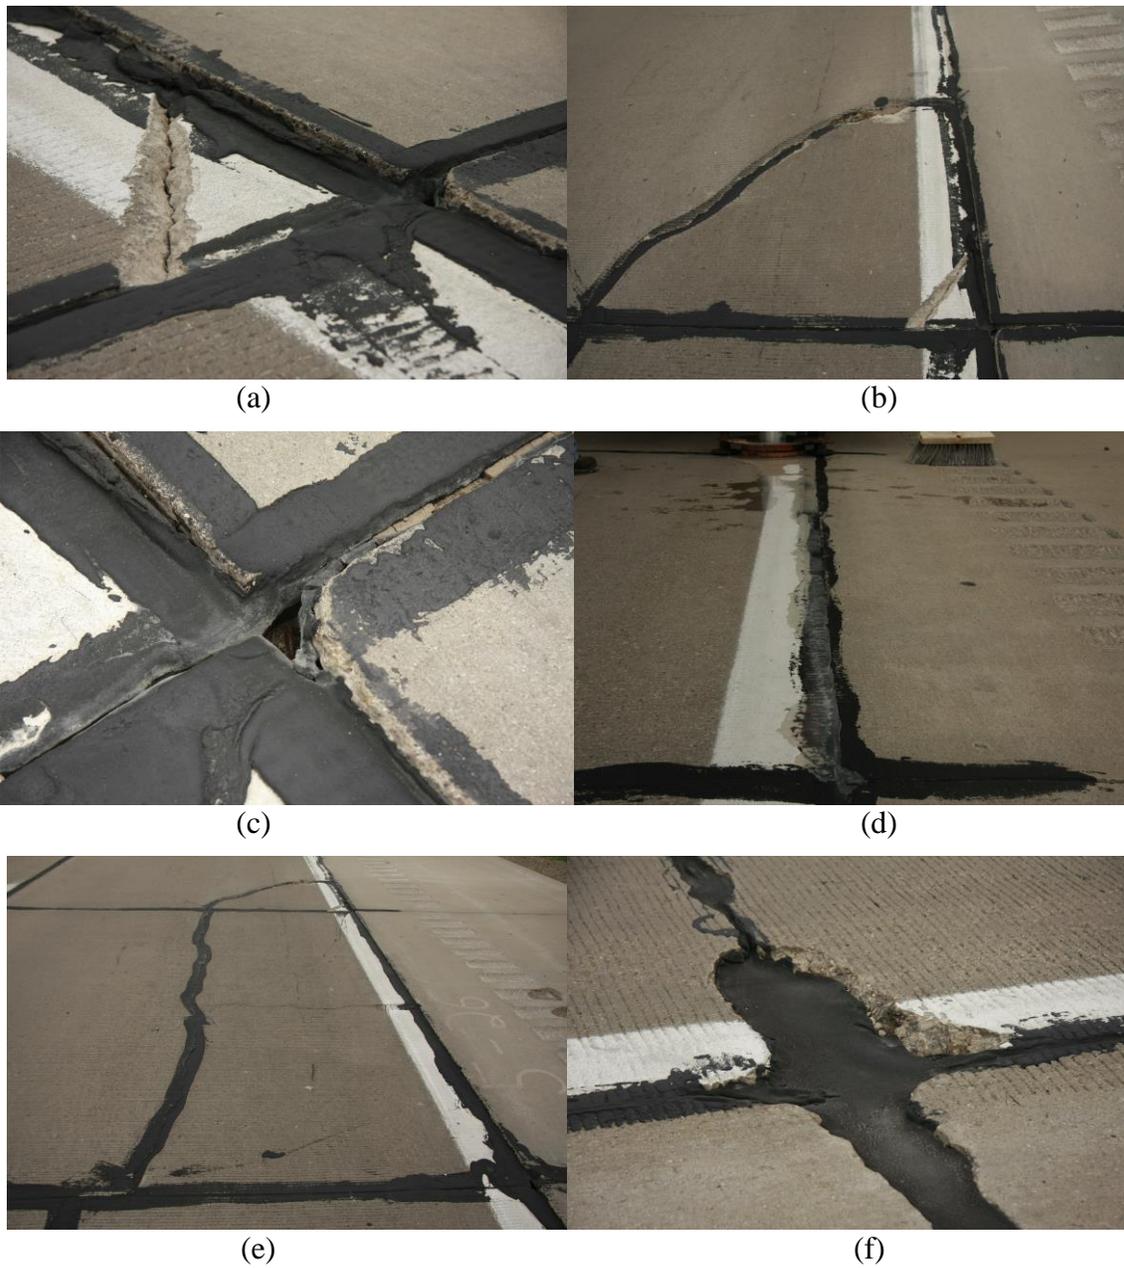
Figure 3.10 (a-f). Slab distress found in the NB I-69, Charlotte overlay.

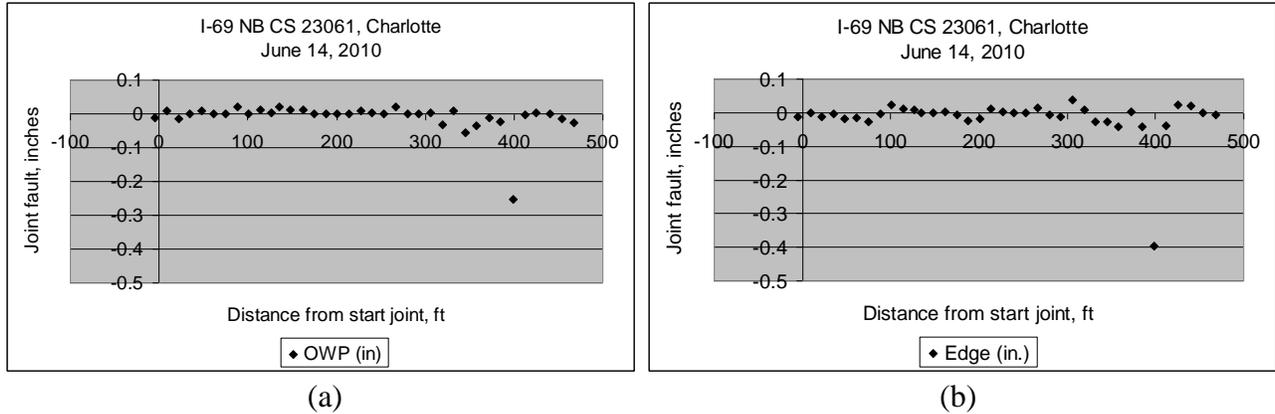
Figure 3.11 (a-b). Joint fault in I-69 NB, Charlotte overlay

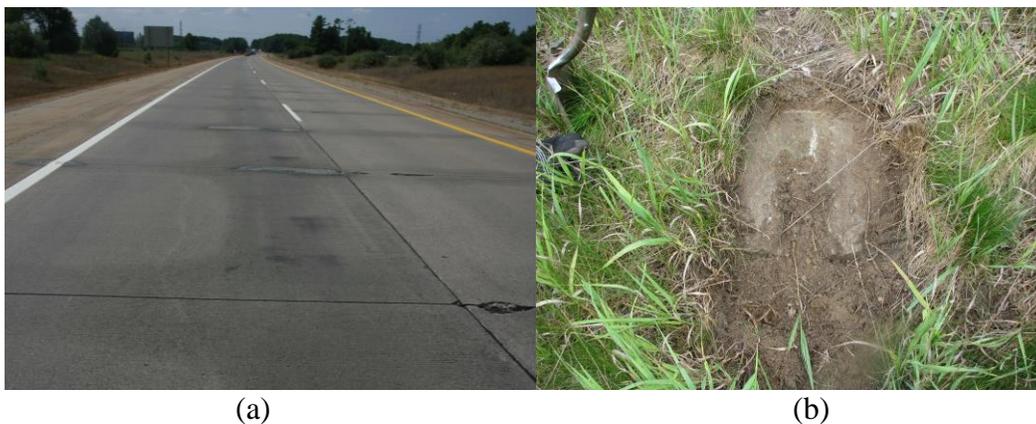
Durability related joint distress has developed (Figure 3.12 a) in the NB direction, consistent with spalling due to poor salt scaling resistance. This condition points towards poor joint drainage and low air content in the concrete. Low air content was confirmed from laboratory test results (Appendix B) which show that total air in the field concrete is about 3% or less. Laboratory freeze-thaw tests confirmed poor salt-scaling resistance. The test results and mitigation by surface sealant coating are discussed further in section 3.3.

During field investigation, several drain outlets were found to be blocked and full of sand (e.g. Figure 3.12 b). A non-working drainage system for this project is consistent with plan details showing that the drainage trench was paved over (Table 2.2).

Figure 3.12 (a-b). Joint staining and spalling in NB US-131, Rockford and drain outlets were clogged with sand.

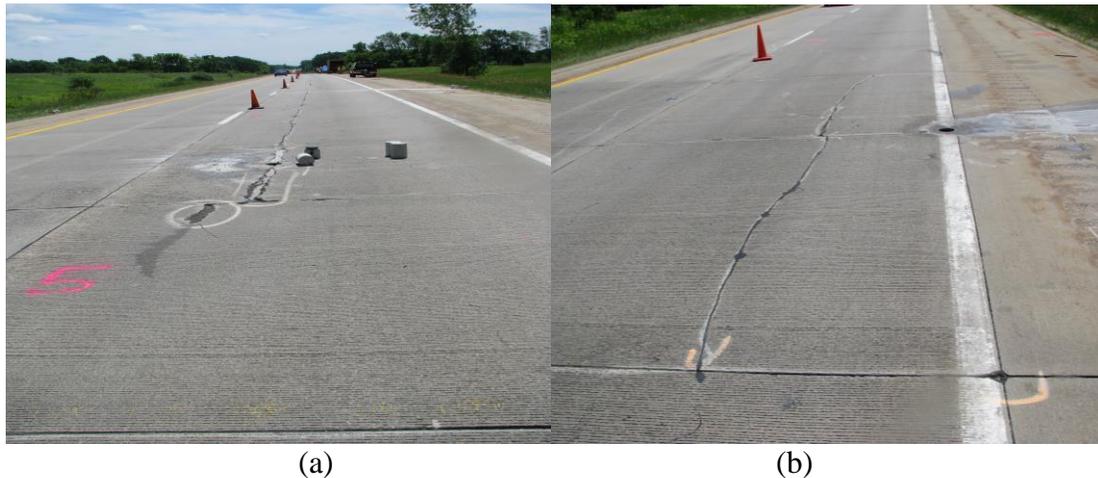
The SB overlay section had developed straight-line longitudinal cracking in the vicinity of the wheel-paths. Coring showed that cracking had developed bottom-up. This type of cracking is consistent with vibrator trails due to over-vibration during concrete placement (Figure 3.13). Over vibration will increase the mortar content where the vibrator is placed.

Figure 3.13 (a-b) Longitudinal cracking in the SB direction, US-131, Rockford.

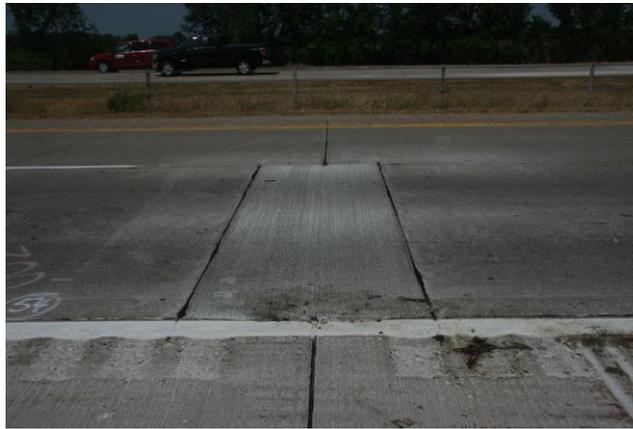
Figure 3.16. Joint repairs in year 28 (2012) for the I-96, Portland overlay.

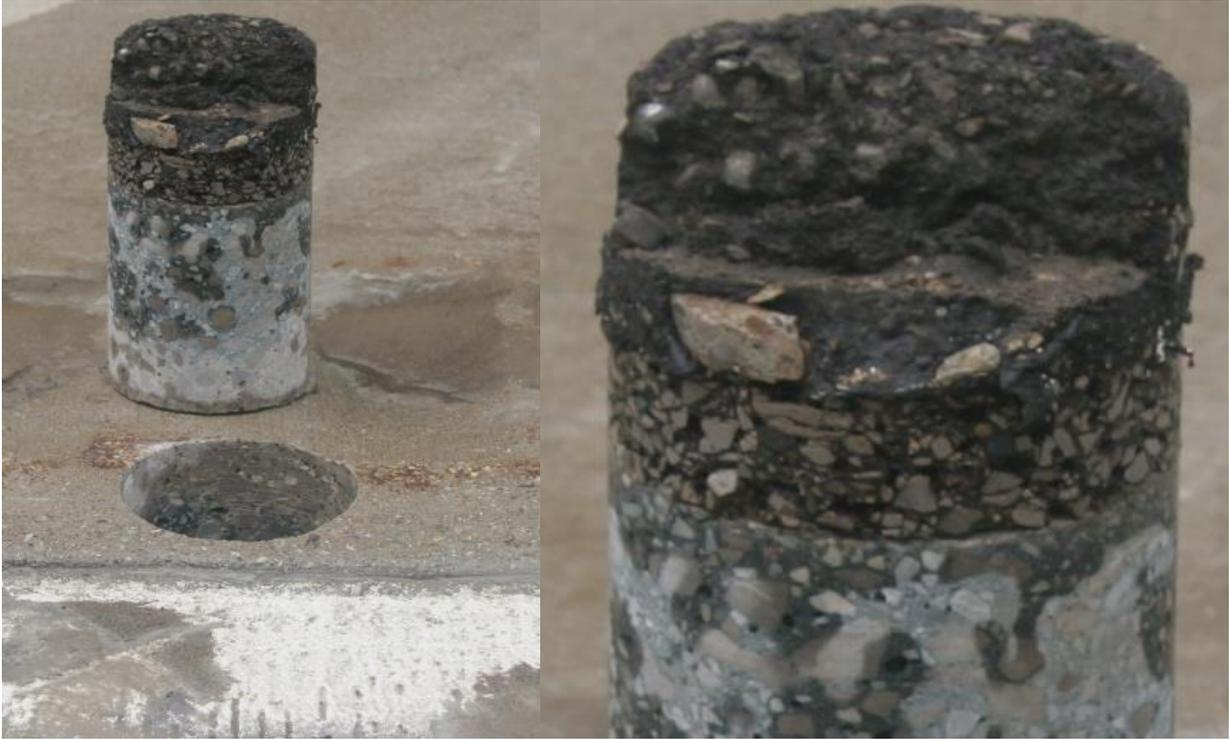
Figure A3. Dense-graded HMA not milled off during construction.

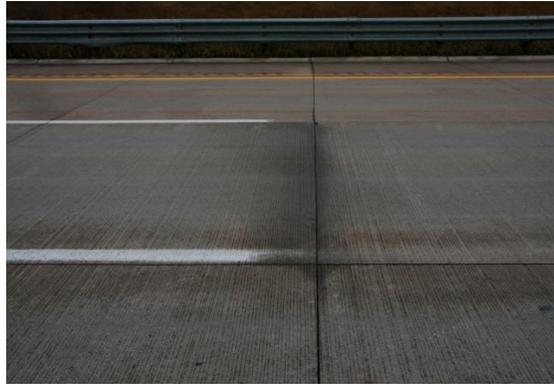
Figure A4. Pumping in super elevation part of section 1 sloping to the west.

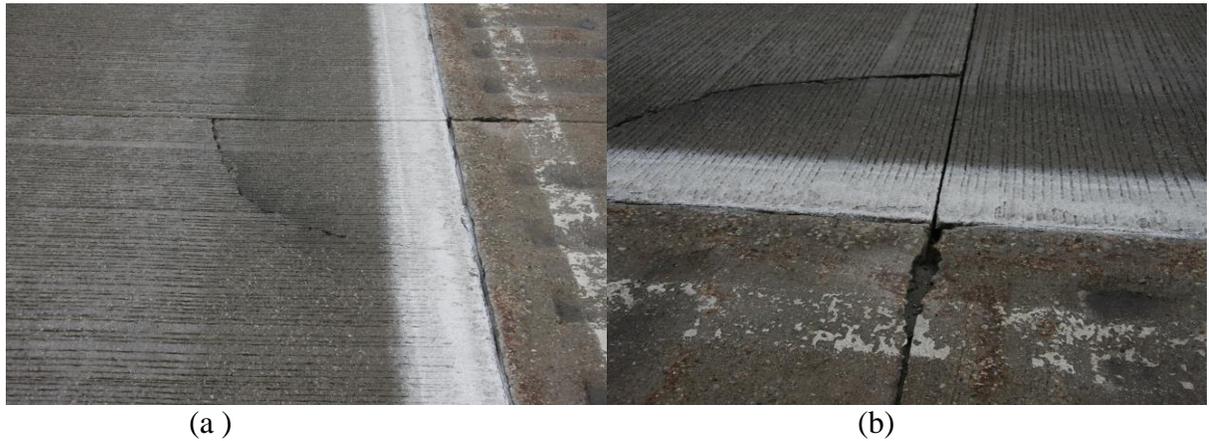
Figure A5 (a-b). (a) Section 3 (station 699+86) with corner-break due to HMA pumping erosion at locations of water entry point along joint edge corner (b).

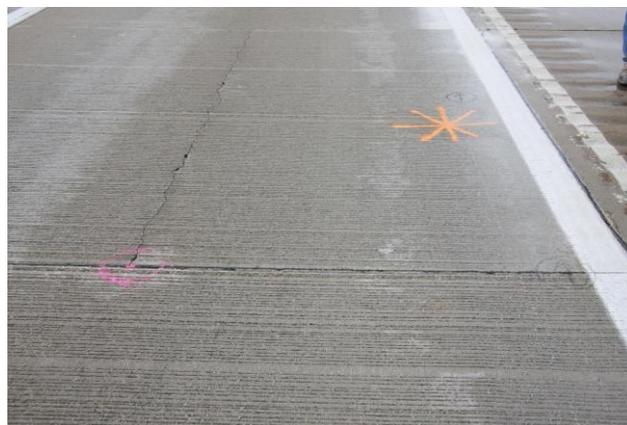
Figure A6. Full slab length longitudinal cracking at mid-panel (Section 3).

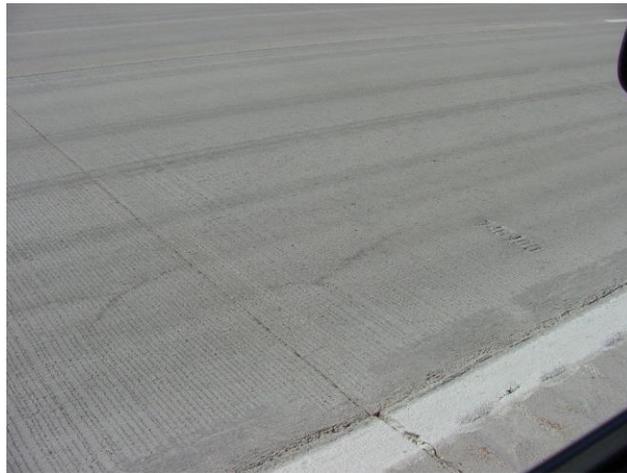
Section 3 has been exposed to the worst case scenario of pumping as a result of no joint seals. This section developed longitudinal cracking at the transverse joints in year one (Figure A11), rapidly propagating into full length cracks such as shown in figure A6. During the field investigation in November of 2009 a core taken at the transverse joint over a partial length crack illustrates that longitudinal cracking is top-down (Figure A12), consistent with loss of joint support at the outer pavement edge.

Figure A11. Start of longitudinal cracking at joints in section 3 within year 1 (October 2004).

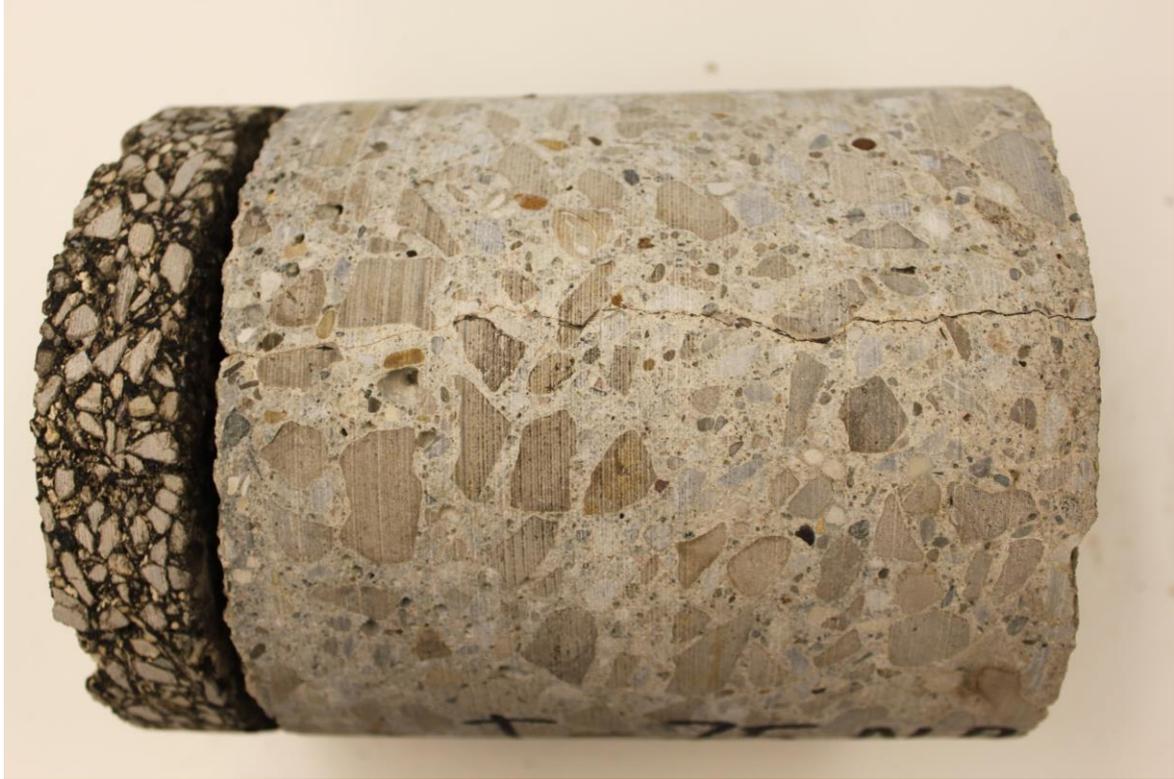
Figure A12. Top-Down longitudinal cracking starting at transverse joint station 709+08 (section 3)
