PERFORMANCE EVALUATION OF AN
EXPERIMENTAL SLURRY SEAL EMULSION AS FILLER
OF DETERIORATED LONGITUDINAL JOINTS IN
CONCRETE PAVEMENT BEING PREPARED
FOR ASPHALTIC CONCRETE RESURFACING

Research Laboratory Section
Testing and Research Division
Research Project 78 TI-467
Research Report No. R-1237

Michigan Transportation Commission
William C. Marshall, Chairman;
Lawrence C. Patrick, Jr., Vice-Chairman;
Hannes Meyers, Jr., Carl V. Pellonpaa,
Weston E. Vivian, Rodger D. Young
James P. Pitz, Director
Lansing, October 1983

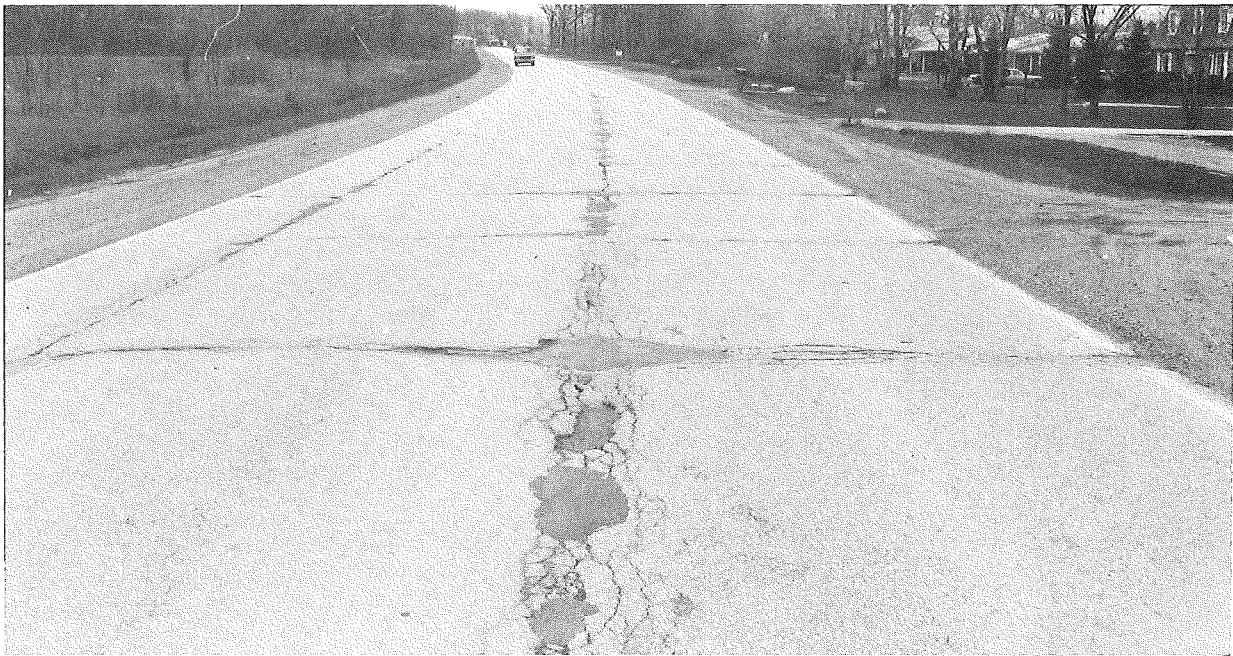
Figure 2. Typical distress conditions of the existing 49 year old concrete pavement on M 15, south of M 21.

Old patching and open cracks, 1/4-in. or more in width on both sides of deteriorated longitudinal joints were frequently found over the test area. The performance of these joints (treated and untreated) following asphalt resurfacing is being periodically monitored.

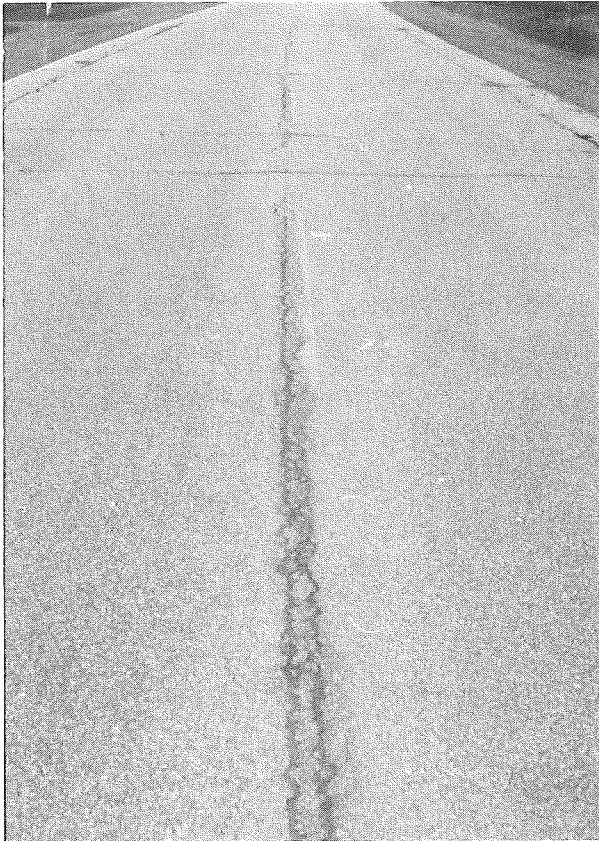
◀ Figure 3. Low-Severity Longitudinal Joint Reflection Cracking.

1) Low-Severity Reflection Cracking (Fig. 3) - A nonfilled longitudinal crack, opened less than 3/8 in. and extending roughly parallel to the pavement centerline, or a longitudinal crack, filled but opened to any width with the filler in good condition.

After three winters of pavement service, all visible longitudinal cracking reflecting through the asphalt overlay was rated as Low Severity Reflection Cracking (Fig. 3).

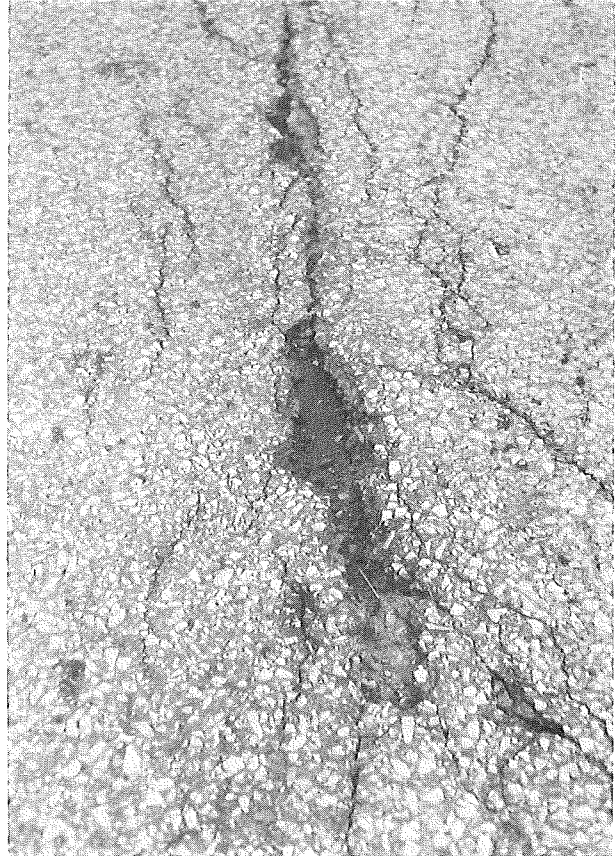
▲ Figure 4. Medium Severity Longitudinal Joint Reflection Cracking.

2) Medium-Severity Reflection Cracking (Fig. 4) - A nonfilled longitudinal crack, up to 3 in. wide, possibly surrounded by light random cracking and extending roughly parallel to the pavement centerline; or a longitudinal crack, filled but opened to any width and surrounded by light random cracking.

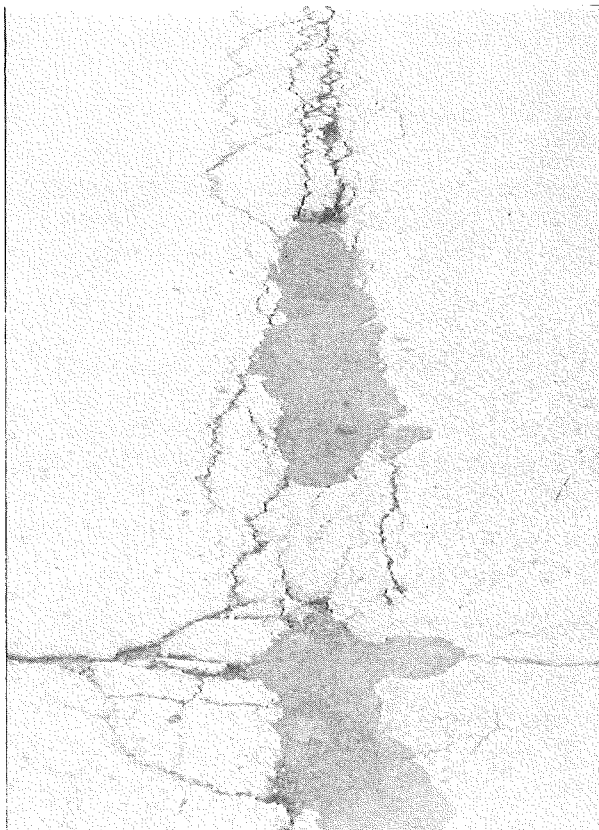
◀ Figure 5. High-Severity Longitudinal Joint Reflection Cracking.

3) High-Severity Reflection Cracking (Fig. 5) - A filled or nonfilled longitudinal crack opened to any width and surrounded by major or severe random cracking or broken pavement, or a longitudinal crack, nonfilled and opened more than 3 in.

3) Ten locations totaling 5,319 lin ft of deteriorated longitudinal joints were cleaned out and repaired with conventional 31A bituminous material 4.12 as described in Appendix A. The 31A bituminous repaired longitudinal joints covered surface cracking conditions exhibiting a high distress severity level (Fig. 5). Figure 1 shows the experimental layout.

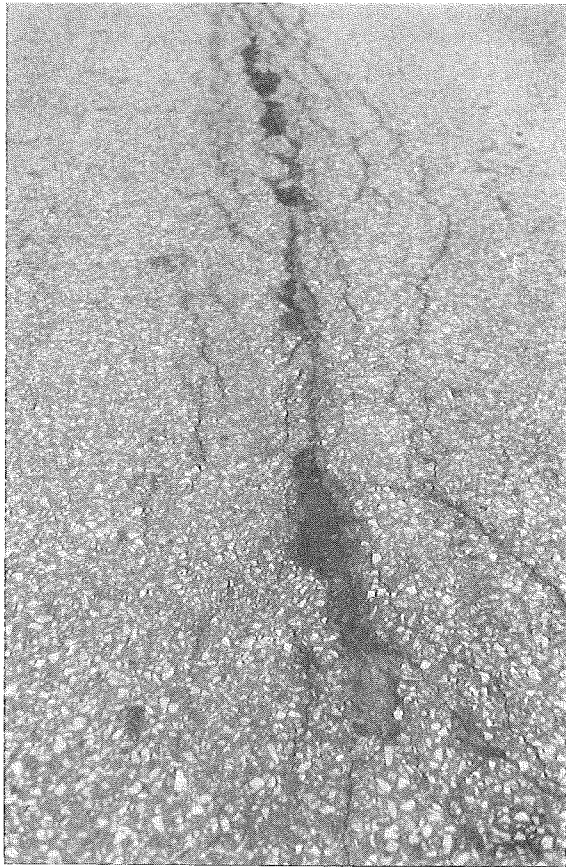
◀ A deteriorated longitudinal joint already clean for slurry seal application. Dust, dirt and other foreign material were removed from the failed area by compressed air.

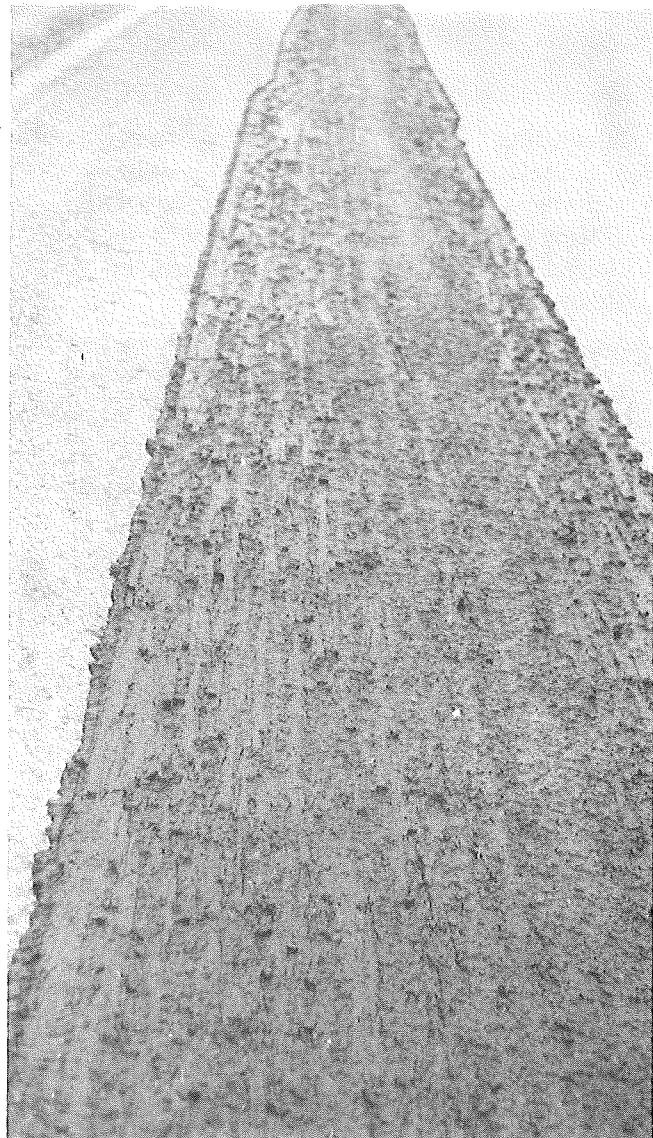
Figure 7. Typical faulted longitudinal joint before and after slurry seal treatment. Twelve of these treated joints, each 32-in. wide and 0.25 miles long, are being periodically observed following asphalt resurfacing of the test area.

The distressed longitudinal joint after the slurry seal application. In a single pass at an application rate of about 8 lb/sq yd; the slurry machine covered 3.0 miles of test strips the same day as planned. Traffic control was maintained for at least two hours until the slurry was sufficiently cured to prevent pick-up of the mixture. ▶

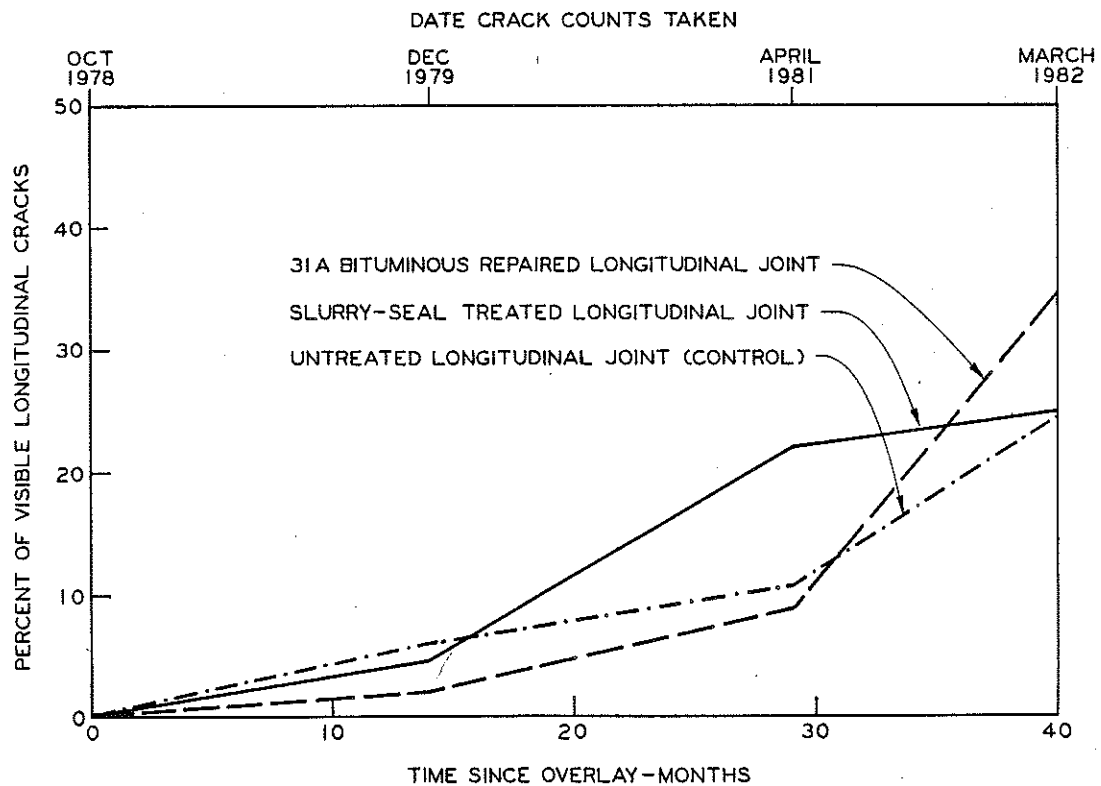
Figure 8. Rate of increase of visible longitudinal cracks through asphaltic concrete resurfacing after the third winter of 1981-82.

Longitudinal reflection cracking visible under dry surface conditions and located directly over the underlying joints, was expressed in terms of percentages of the length of longitudinal joints in the old surfaces. After three winters of pavement service, the resurfacing project has developed visible longitudinal cracking as follows: a) The crack growth shows an average yearly increase in longitudinal reflection cracking of about 10.5 percent for 31A bituminous repaired joints and about 7.5 percent for slurry seal treated joints and also for untreated, control joints; b) The longitudinal cracks which have reflected through the new overlay, were classified as low severity reflection cracking as defined earlier (Fig. 3).

After three winters of pavement service, both slurry seal treated and untreated longitudinal joints (control) have shown similar crack-resistance properties with an annual increase in crack formation averaging 7.5 percent. On the other hand, 31A bituminous repaired joints have shown a 3.0 percent greater annual crack growth than that for either slurry-seal treated or untreated longitudinal joints (10.5 percent vs. 7.5 percent). This might be expected since the 31A bituminous repair areas covered surface cracking conditions of greater severity (Fig. 5) than the slurry seal treated areas or the untreated repair areas (Figs. 3 and 4). At this point, there does not appear to be any advantage in placing the slurry seal, since the unsealed cracks are reflecting at an equal proportion.

Finally, condition surveys of the test site should be continued for the next year or so or until enough data is obtained to determine whether there is any longer term merit of slurry seal treatment (\$0.15/lin ft) compared with no treatment, or with the conventional practice of longitudinal

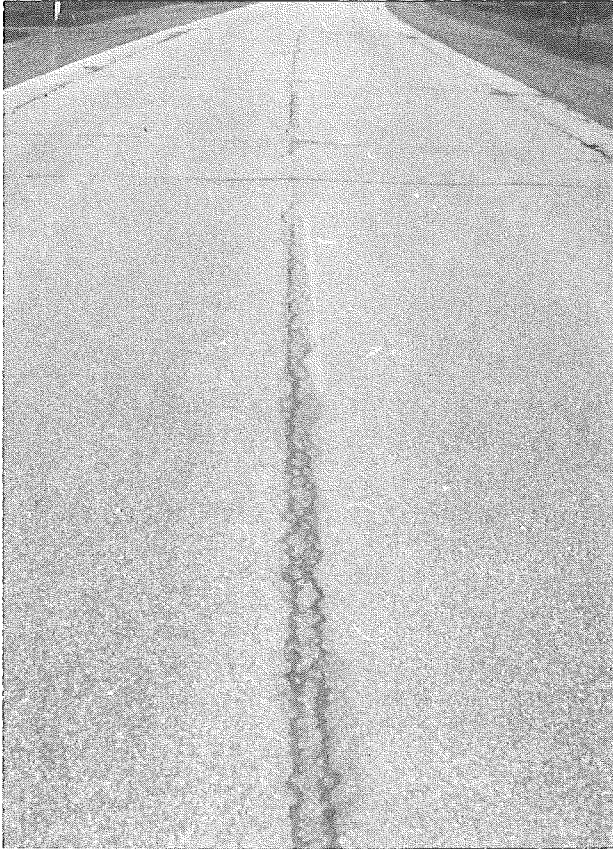
◀ Figure A1. Low-Severity Longitudinal Joint Reflection Cracking.

A - Low-Severity Reflection Cracking (Figure A1)

A nonfilled longitudinal crack, opened less than 3/8 in. and extended roughly parallel to the pavement centerline; or a longitudinal crack, filled but opened to any width with filler in good condition.

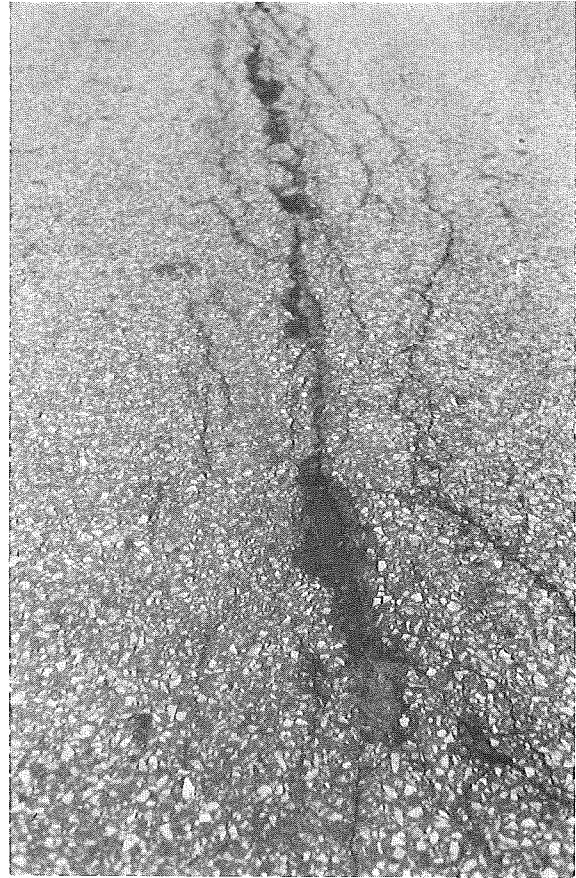
▲ Figure A2. Medium Severity Longitudinal Joint Reflection Cracking.

B - Medium-Severity Reflection Cracking (Figure A2)

A nonfilled longitudinal crack, opened up to 3 in., possibly surrounded by light random cracking and extended roughly parallel to the pavement centerline; or a longitudinal crack, filled but opened to any width and surrounded by light random cracking.

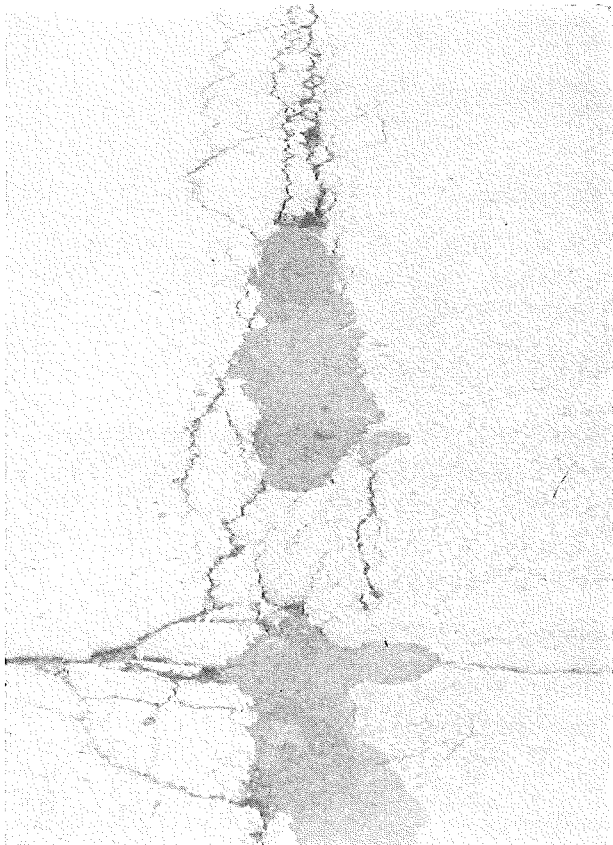
◀ Figure A3. High-Severity Longitudinal Joint Reflection Cracking.

C - High-Severity Reflection Cracking (Figure A3)

A filled or nonfilled longitudinal crack opened to any width and surrounded by major or severe random cracking or broken pavement; or a longitudinal crack, nonfilled and opened more than 3 in.
