LIGHTNING DAMAGE TO CONCRETE PAVEMENT
US 10 Bypass, Midland (Project 56044, C9)

Research Laboratory Division
Office of Testing and Research
Report No. 352
Research Project 60 B-52

Michigan State Highway Department
John C. Mackie, Commissioner
Lansing, March 1961

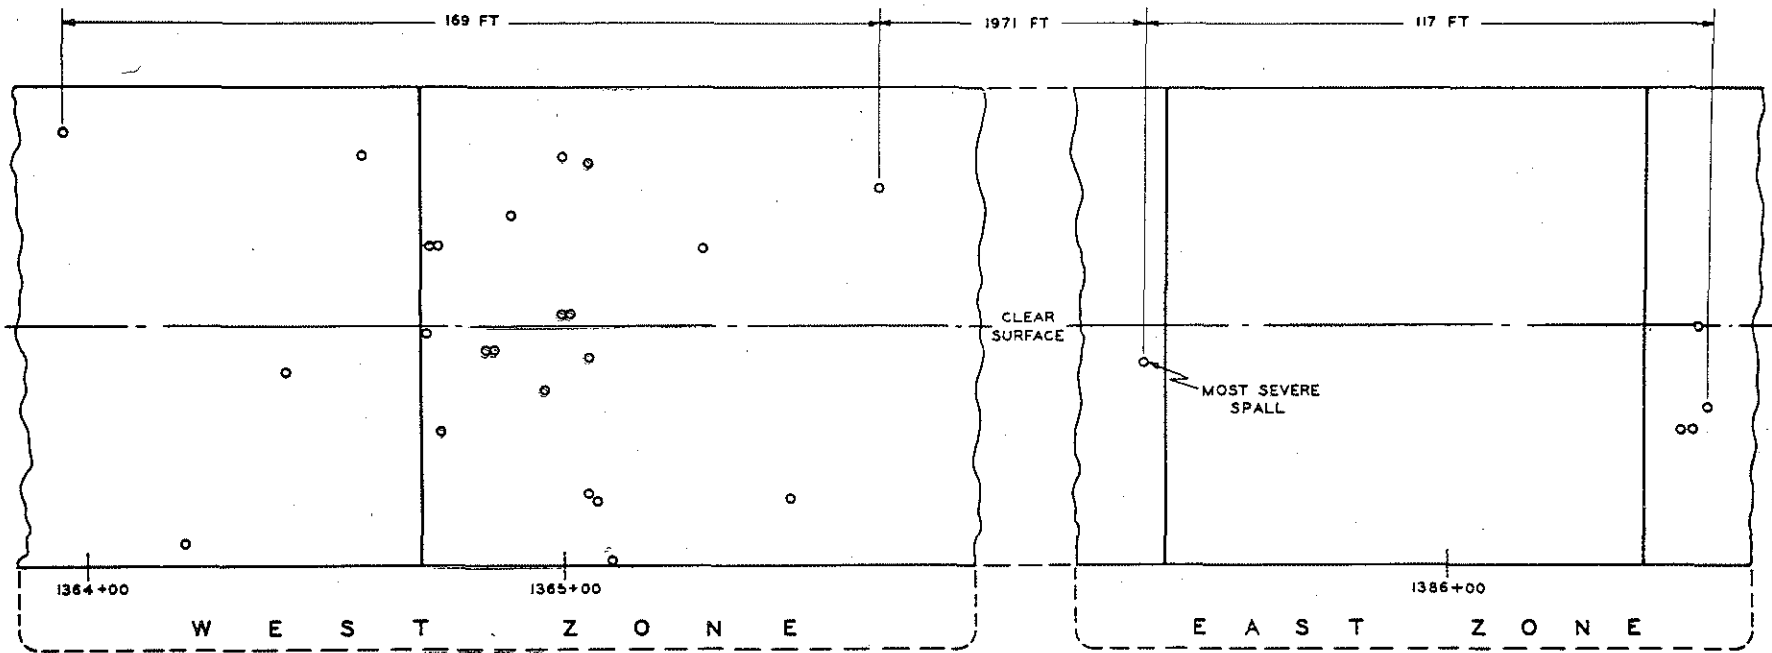
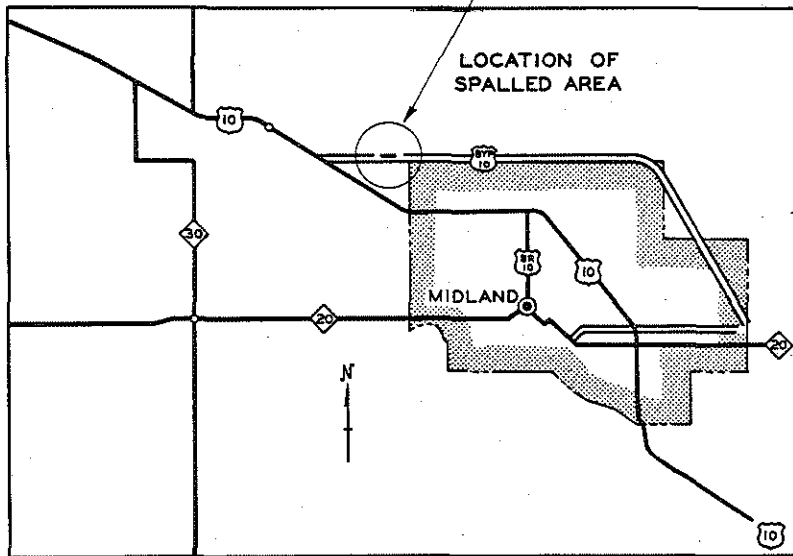
The damaged pavement included two distinct zones of spalling (Fig. 1). At the west, 23 shallow spalls and burns, none more than 4 in. in diameter, were broadly distributed over 169 lineal feet poured in October 1959 (Figs. 2 and 3). Nineteen of these points were concentrated within 25 ft of a single transverse joint.

Figure 1. Schematic drawing of the damaged pavement, showing distribution of spalls. Western spalls were small and shallow, eastern were wide and deep.

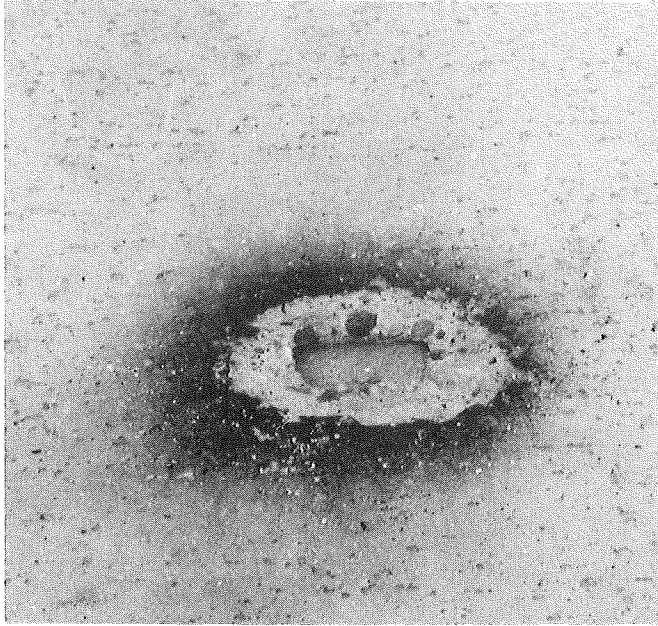
A popout fringed at the surface with scorched mortar and membrane, suggesting heating effects of electrical energy (popout: 4-in. diam).

Figure 2. Typical appearance of spalls found in the western zone of damage, an area of small, shallow, closely spaced popouts. Note widespread minute pits and stains on the pavement surface, probably resulting from the heat of current flow.

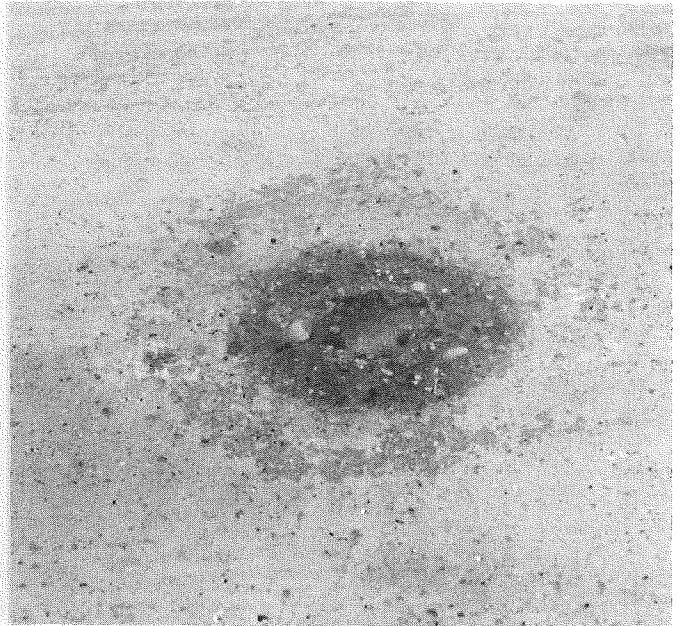
A popout showing a ring of mortar and membrane damaged by heat of current flow (popout: 4 in. diam).

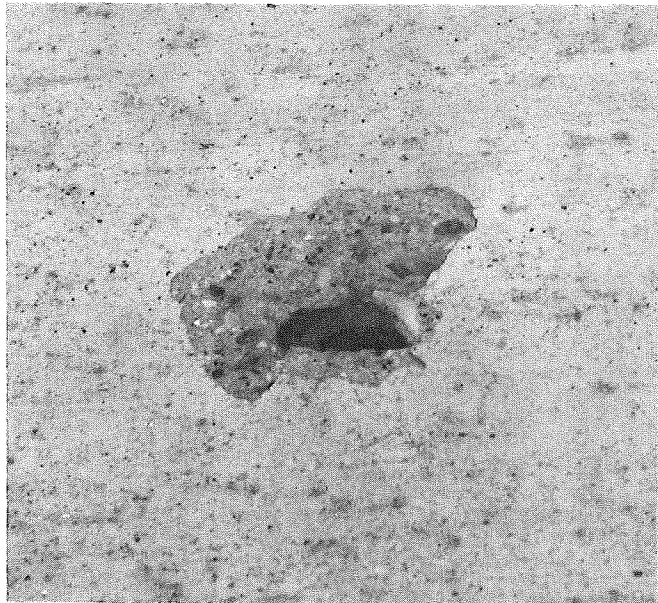
A popout with clear breakaway of overlying mortar due to pressure associated with heating effects just below the surface (popout: 3-1/2 in. diam).

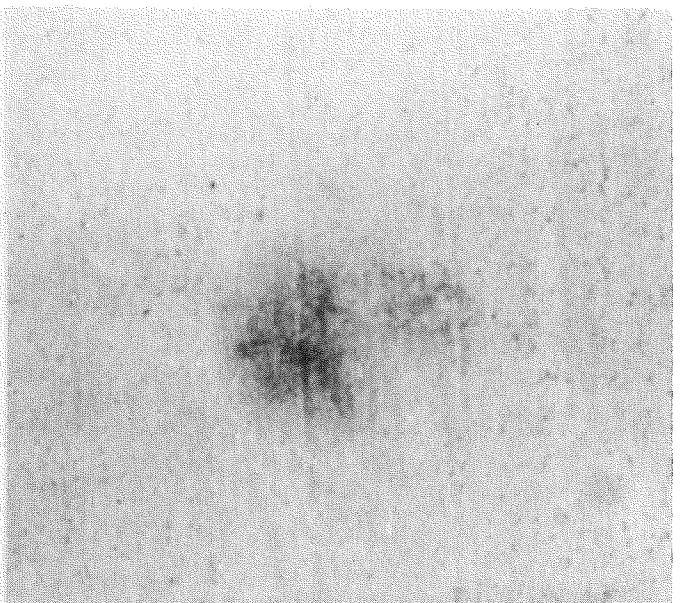
Discoloration of curing membrane without spalling, due to heat at or just below the surface (scorched area: 2 to 3 in. diam.)

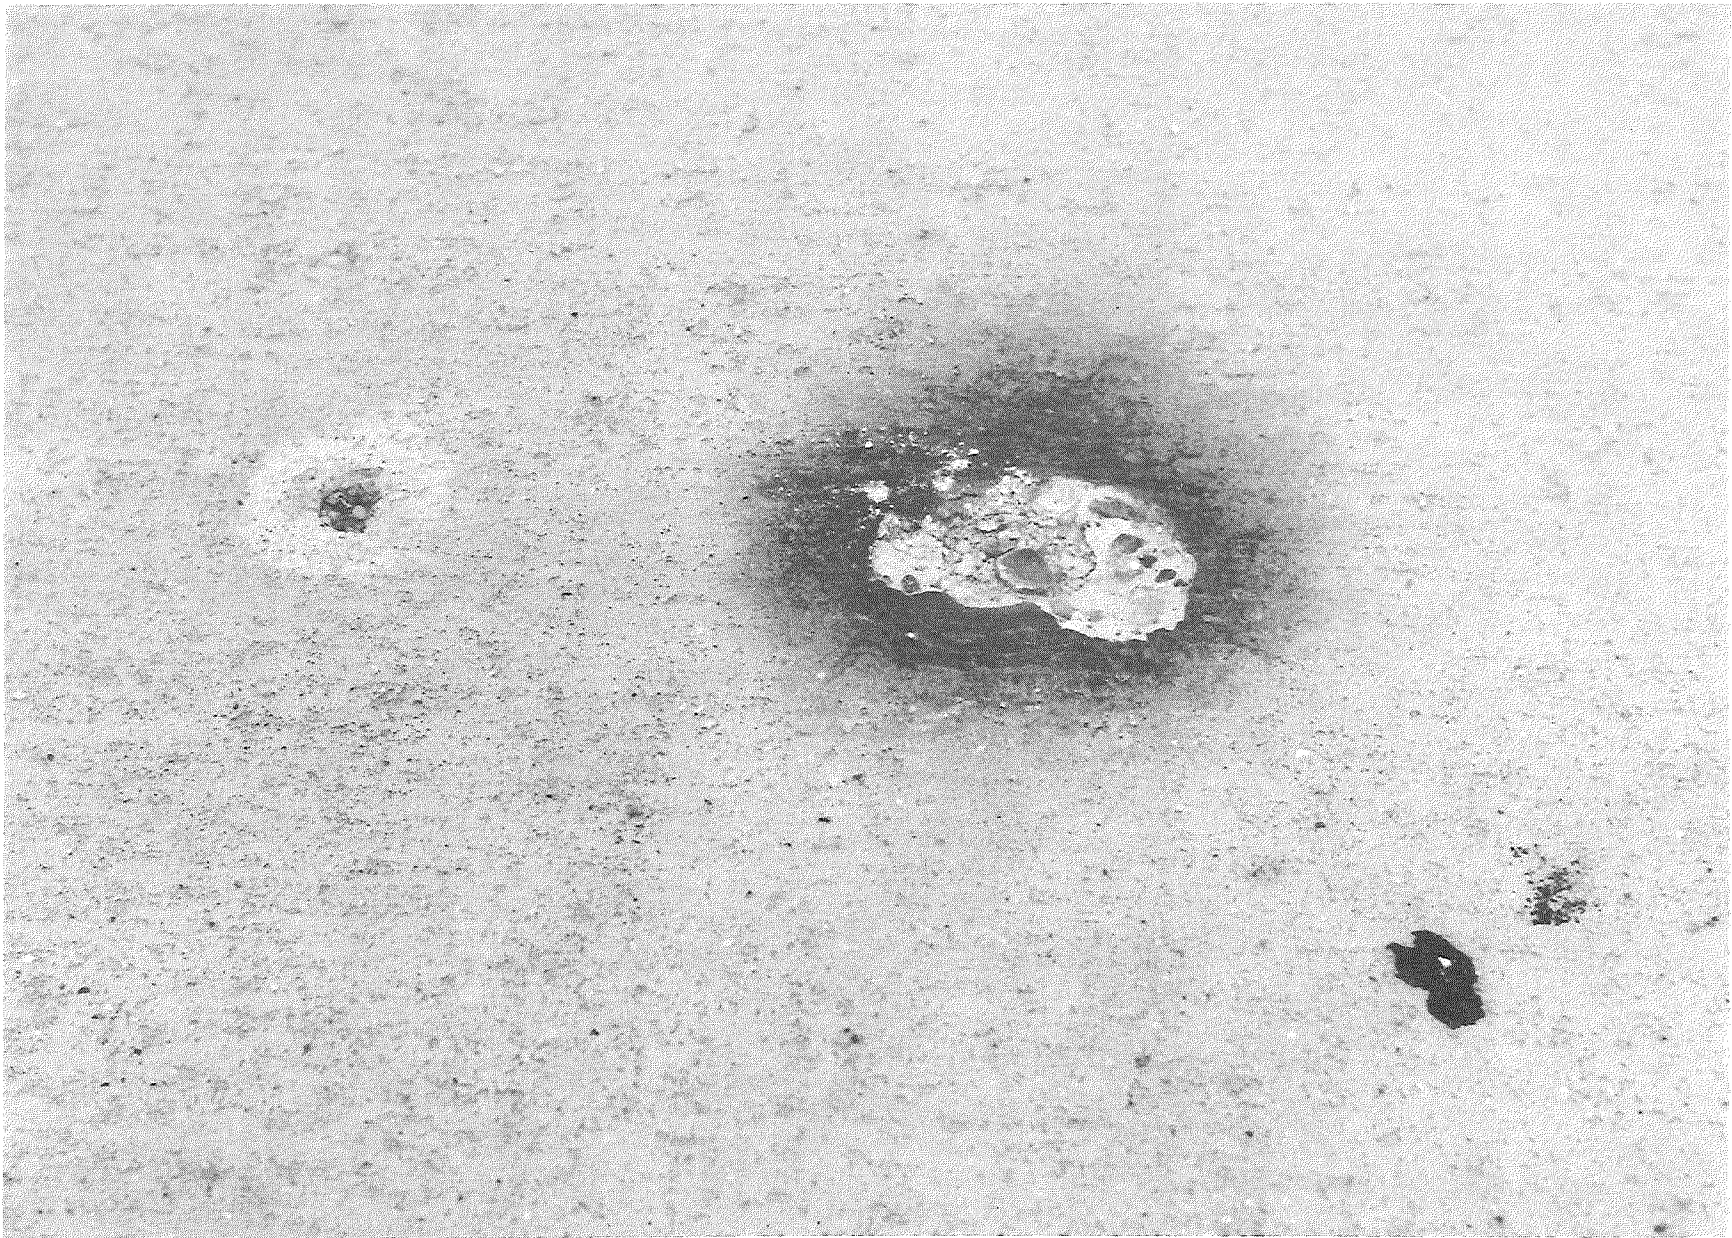
Figure 3. In the western zone of damage, adjacent spalls occasionally exhibited different types of damage, suggesting varying reactions of aggregates of different conductivity, chemical composition, and moisture absorption properties.

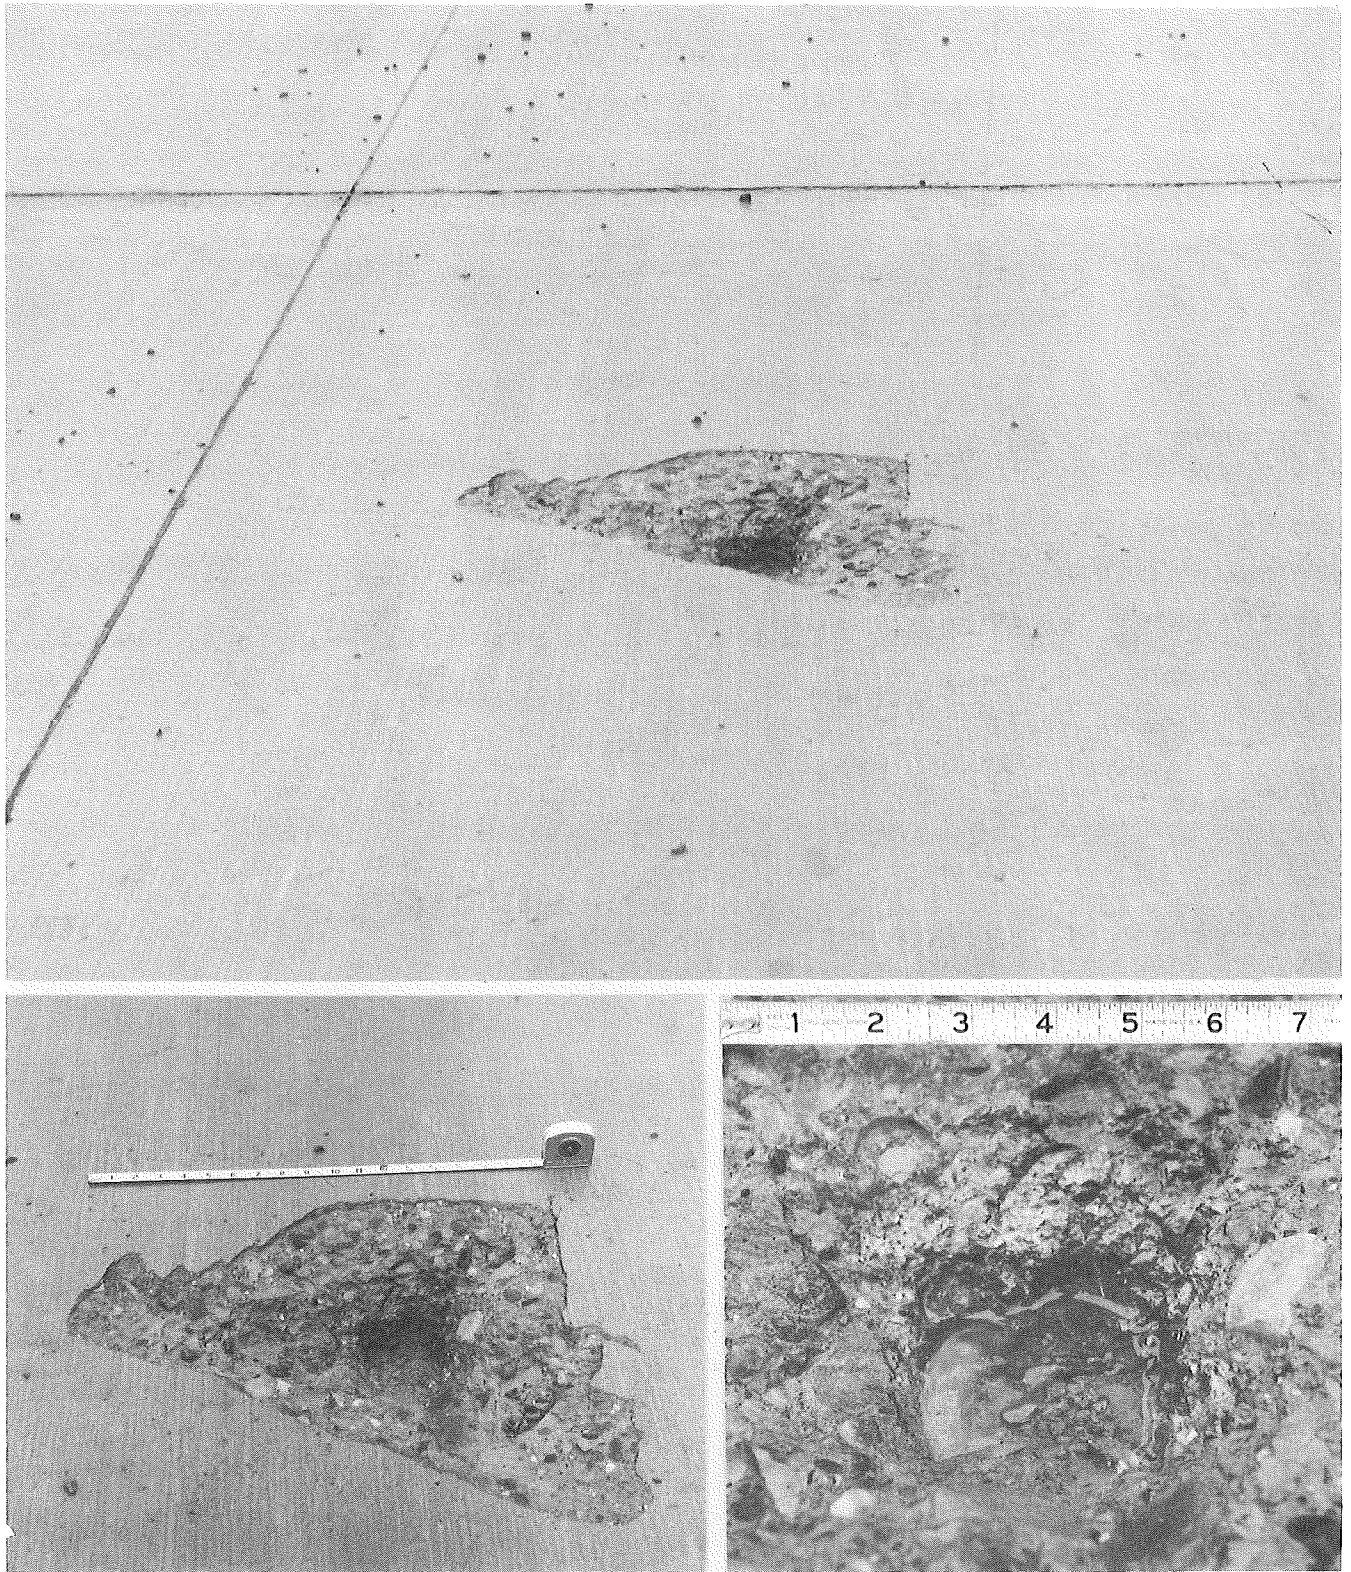
At the east, in pavement poured in May 1960, the single point of most severe damage, roughly a foot in diameter and 4 in. deep at its extreme depth, was about 4 ft on the right side of a construction joint (Figs. 4 and 5). Four more spalls, all broader and deeper than those in the west zone, were found 117 ft farther east of the largest spall. These four spalls were also near a transverse joint (Fig. 6).

Figure 4. Three views of the point of greatest spall damage. Note burned concrete at center of hole--material was shattered and charred to a depth below the reinforcing steel. Surface dimensions: 18 by 10 by 14 in.

On August 15, a follow-up condition survey of the spalled area revealed no further deterioration. Early in September, the contractor filled the spalls with a fine-mix bonding cement which has held well since then. The project was opened to traffic November 4, 1960.

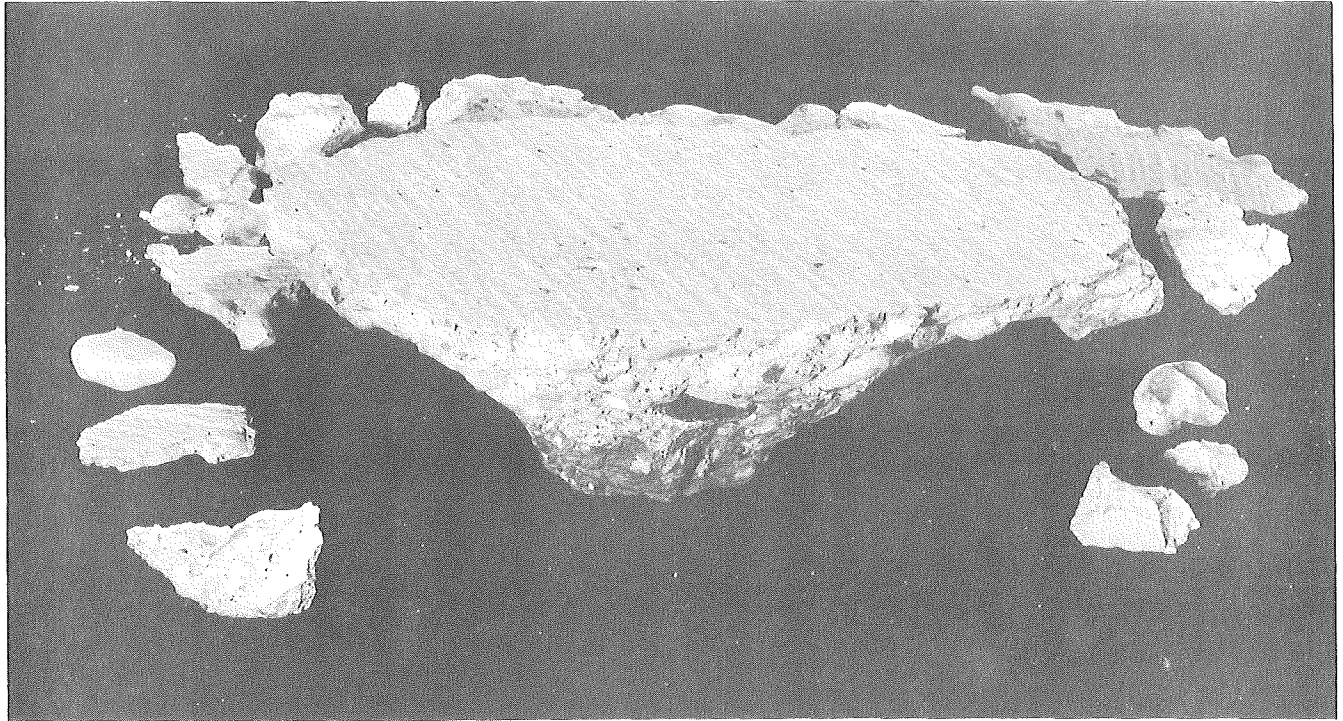
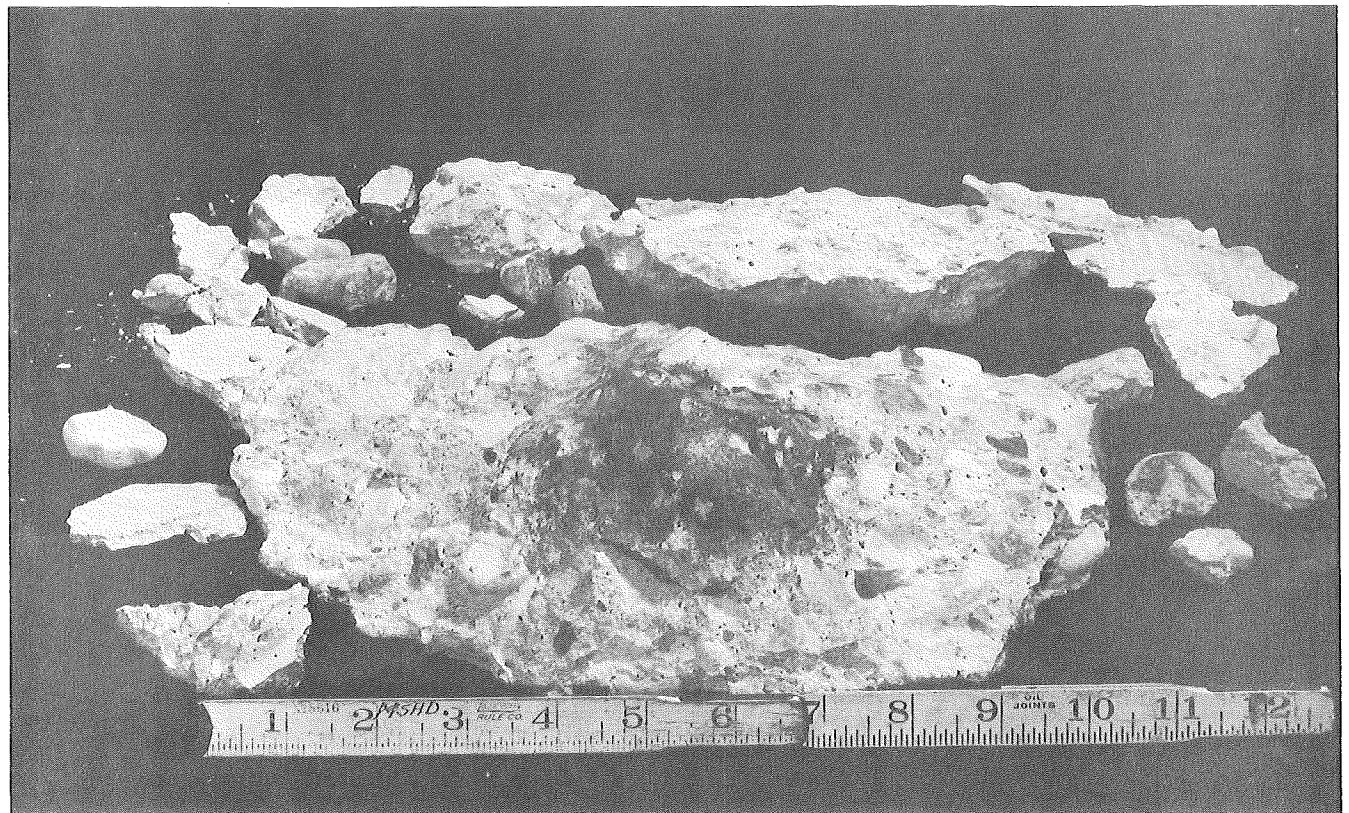
Figure 5. Displaced material from the point of greatest spall damage, showing intact mortar and curing membrane at the top surface and the burnt tip, suggesting generation of high gas pressures in association with extreme heating effects at the reinforcement level.

The big, roughly conical section of concrete from the largest spall was taken to the laboratory for chemical analysis of its blackened apex. This analysis was limited to establishing the presence of iron.

A blackened stone was removed from the concrete and submerged in hydrochloric acid until the blackened area dissolved. The stone was then submerged in another hydrochloric acid bath for an equivalent time.

Colorimetric results obtained on the two fractions indicated that iron was present in the blackened area. The concentration of iron found in that fraction was approximately ten times greater than the iron content of the stone. A high iron content was also found in darkened portions of the mortar. The iron was assumed to be present in the blackoxide form, presumably produced by a high energy electrical discharge from the pavement reinforcing wire.

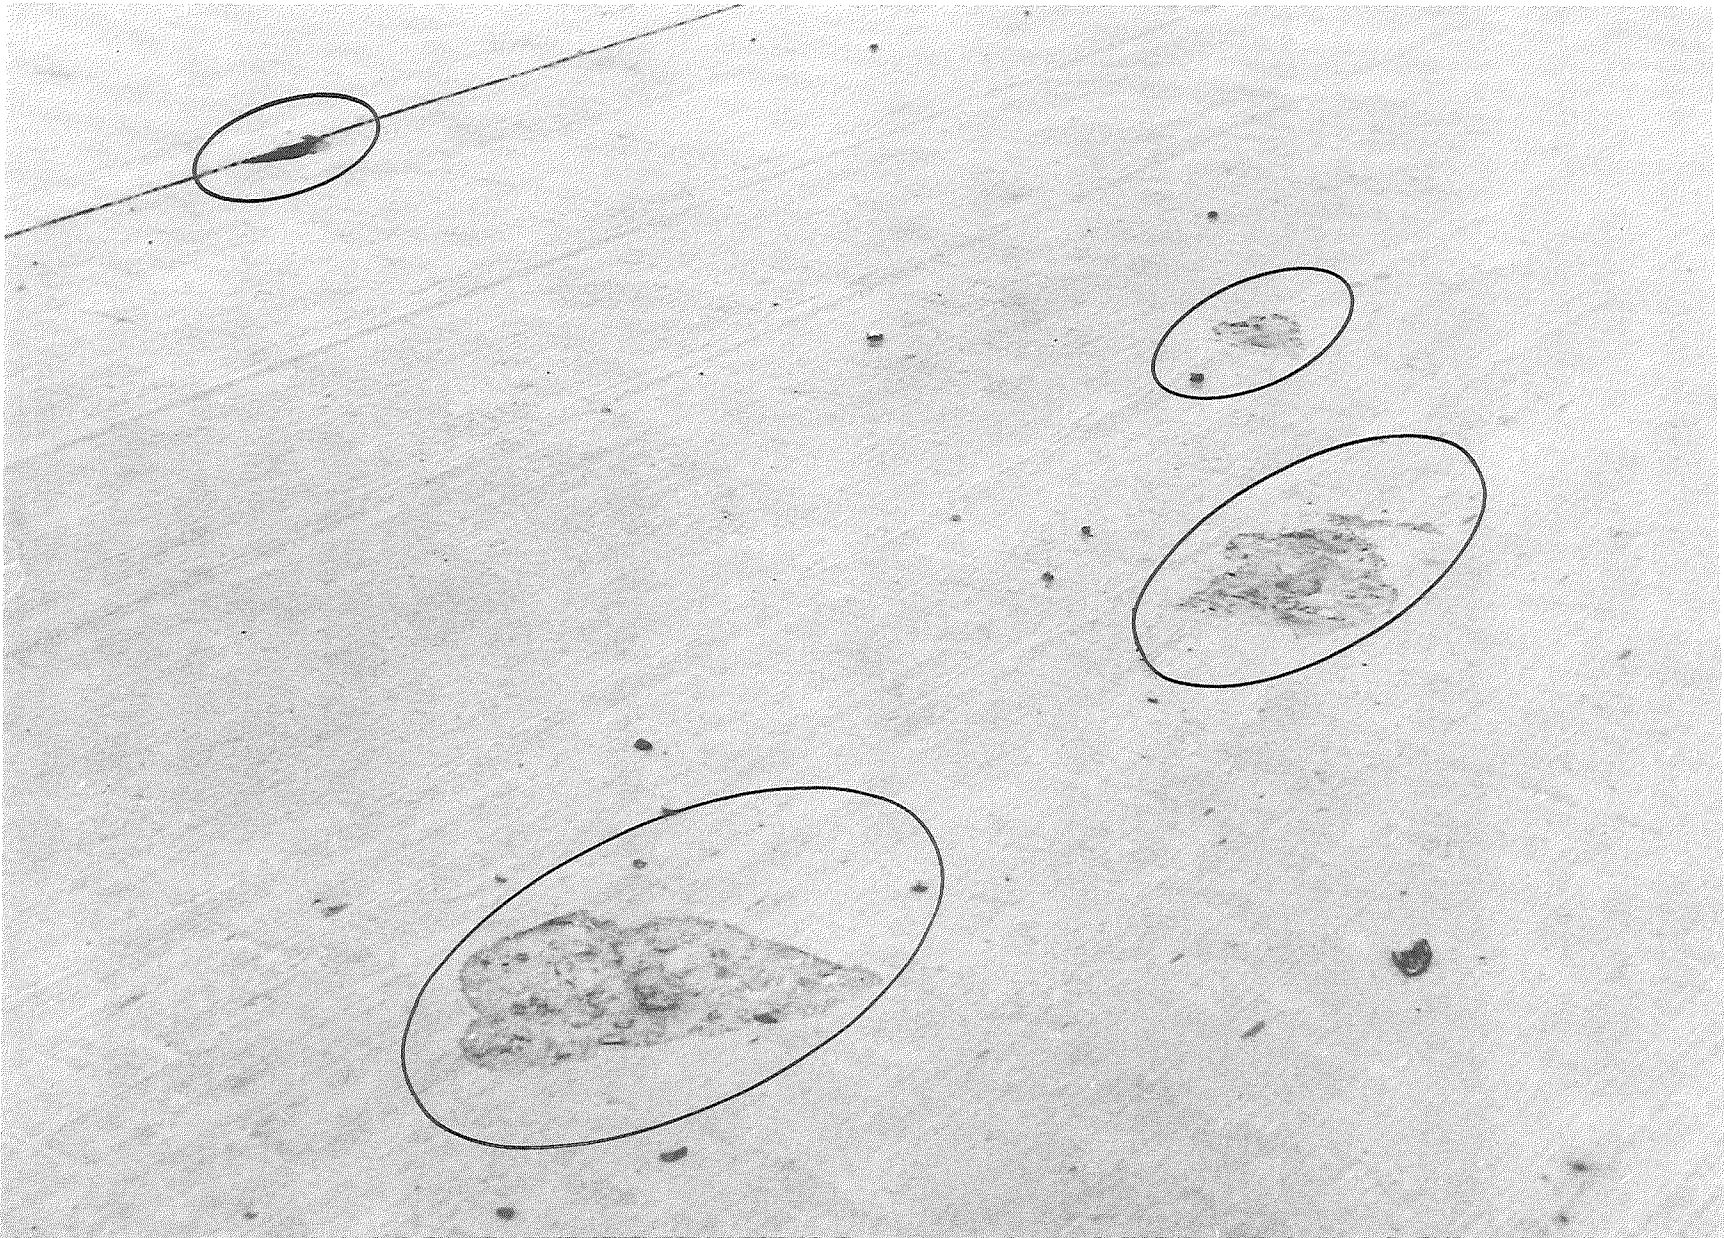
Figure 6. General view of spalling in eastern zone of damage, an area of broader, deeper and fewer spalls than at the west. Note scattering of ejected pavement material.
