MICHIGAN
STATE HIGHWAY DEPARTMENT
Charles M. Ziegler
State Highway Commissioner

MID-WINTER INSPECTION
OF
PAPER SNOW FENCE INSTALLATIONS
1951-1952

Snow Fence Material Investigation
Research Project 36 G-3(10)
Progress Report No. 2

Research Laboratory
Testing and Research Division
Report No. 174
March 1952

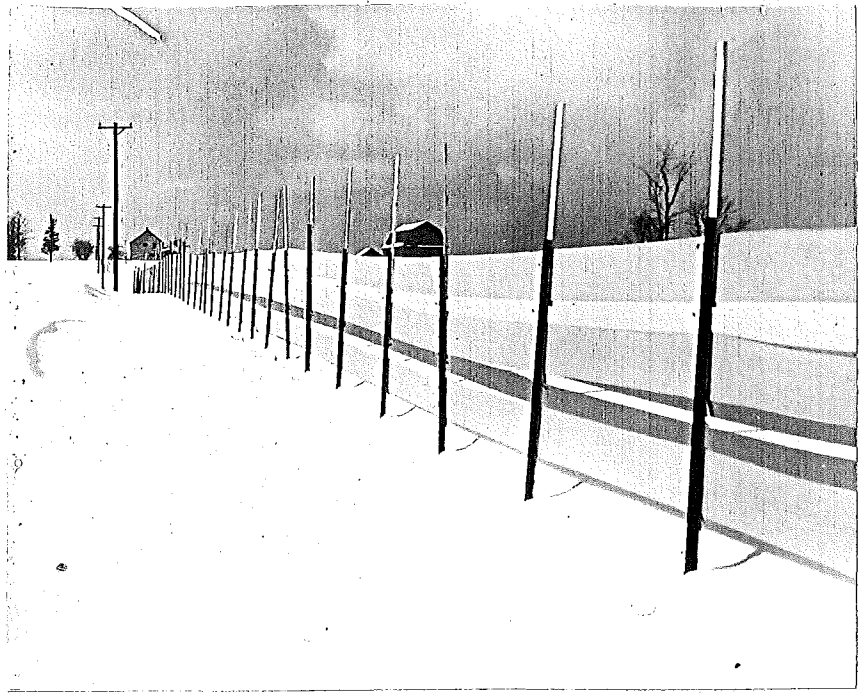
Pictures in Figures 2, 3, and 4 show the paper fence installed by Roscommon County Maintenance forces. Interviews with maintenance men brought out the fact that they have had snowfalls up to 18 inches this winter but no appreciable blowing has occurred to date (1-29-52). They also have had sleet and rain storms since putting up this fence, and all stretches are in excellent shape at the present time.

Figure 2. On north side of M-144 N.E. of Roscommon - 3-panel fence with provision for raising. Roscommon 1-29-52

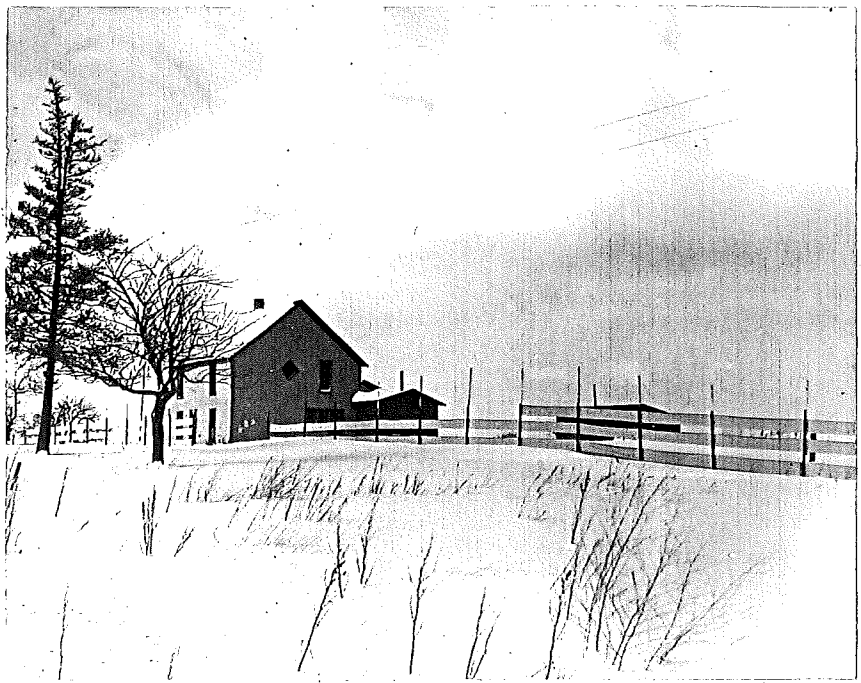
Figure 3. On north side of M-144 N.E. of Roscommon - 2- and 3-panel fence with provision for raising. Roscommon 1-29-52

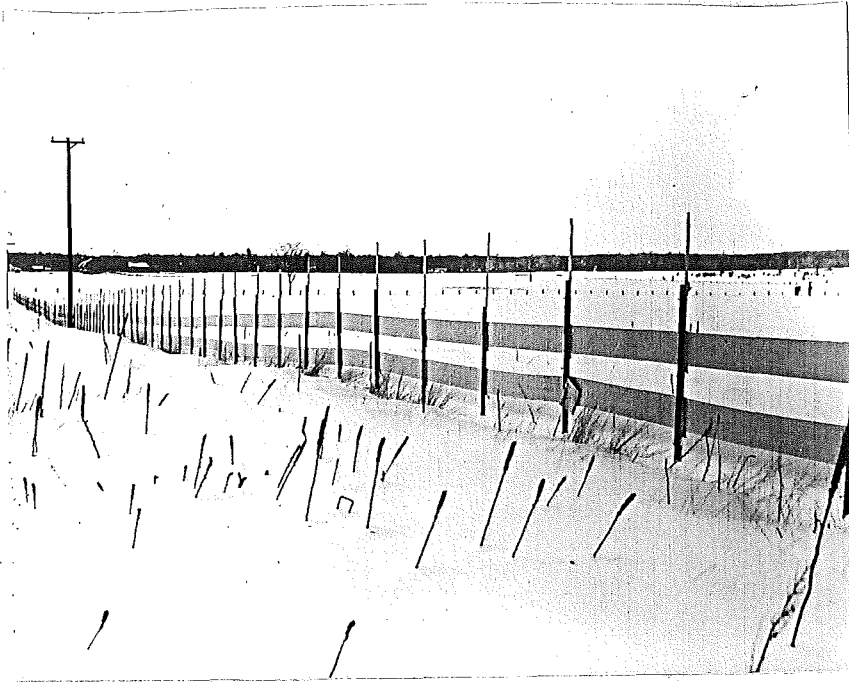
Figure 4. North side of M-144, N.E. of Roscommon.
Roscommon County, 1-29-52

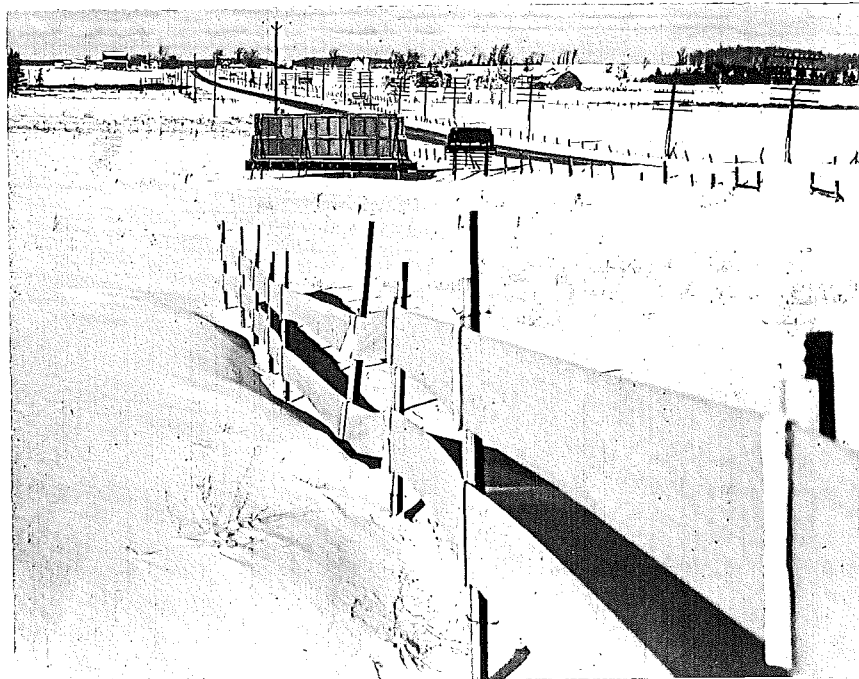
Figure 5. 2-panel fence on west side of US-131, N. of Cadillac.
Note uneven setting of posts.
Wexford County, 1-29-52

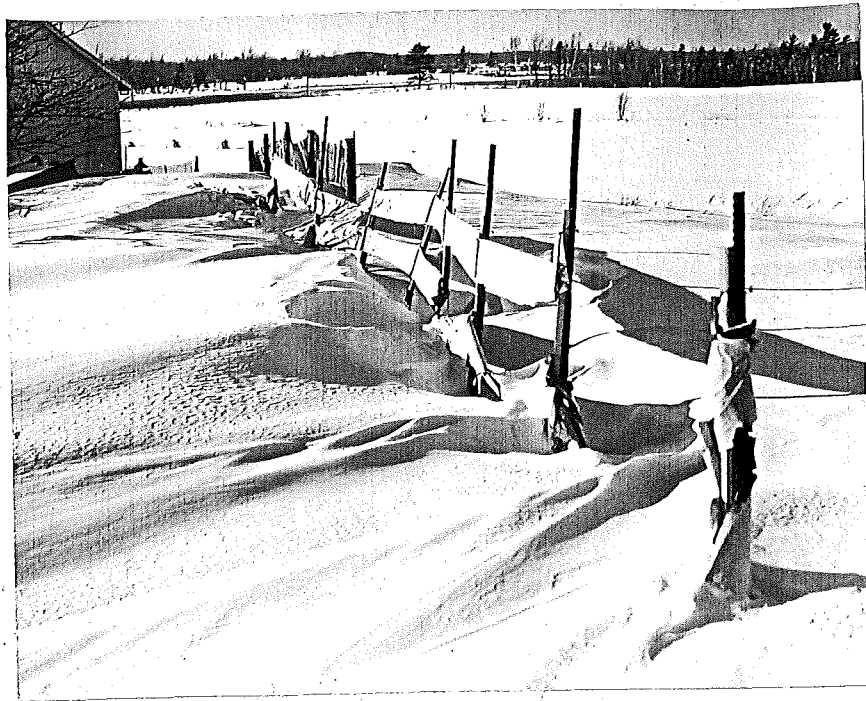
Figure 6. 2-panel fence, west side US-131 N. of Cadillac. Posts used were very badly bent at time of use. Wexford County, 1-29-52

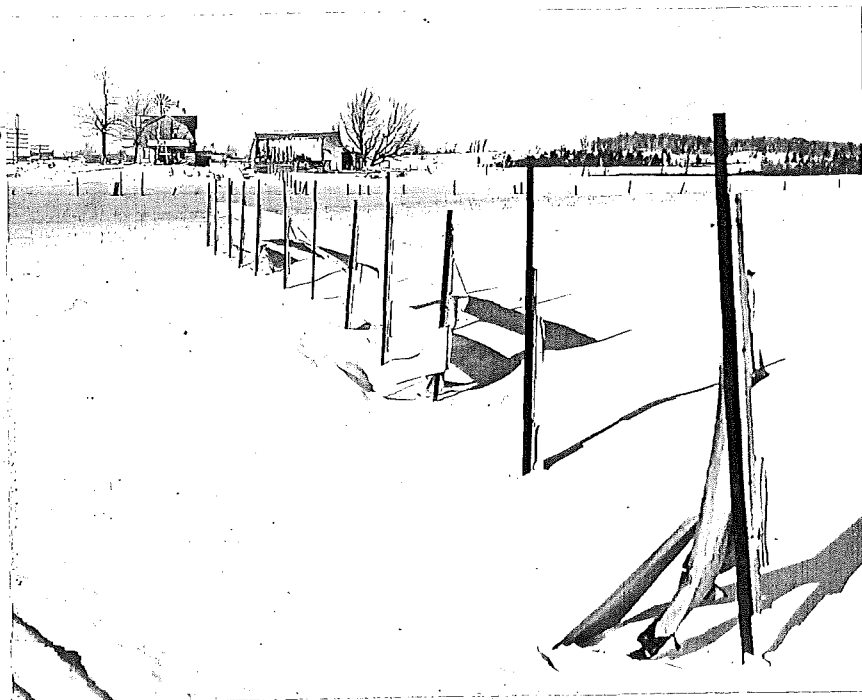
Figure 7. 2-panel fence, east side US-131 N. of Cadillac, showing damage done by children. Wexford County, 1-29-52

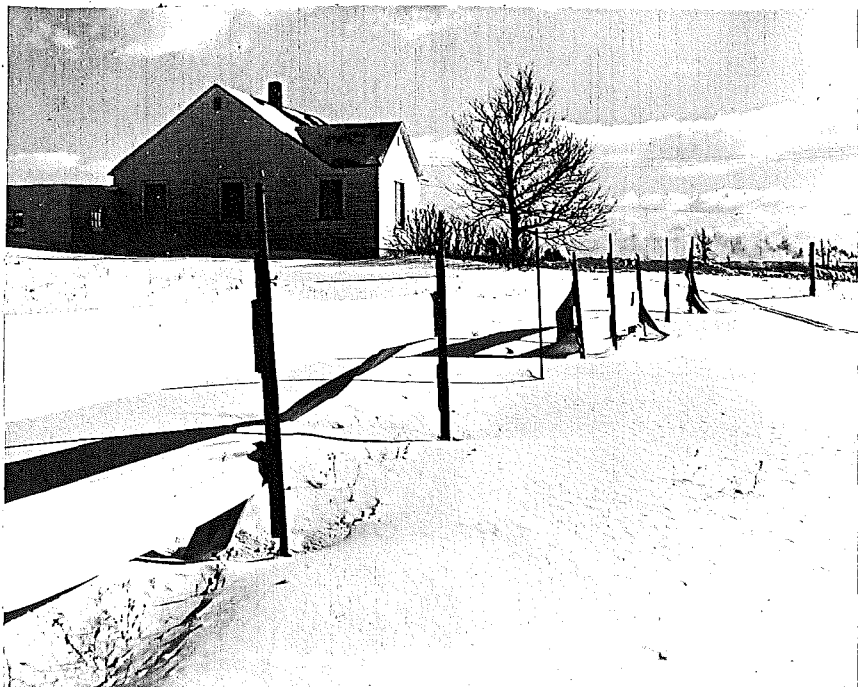
Figure 8. Another view of 2-panel fence on east side of US-131 N. of Cadillac, showing damage caused by children. Wexford County, 1-29-52

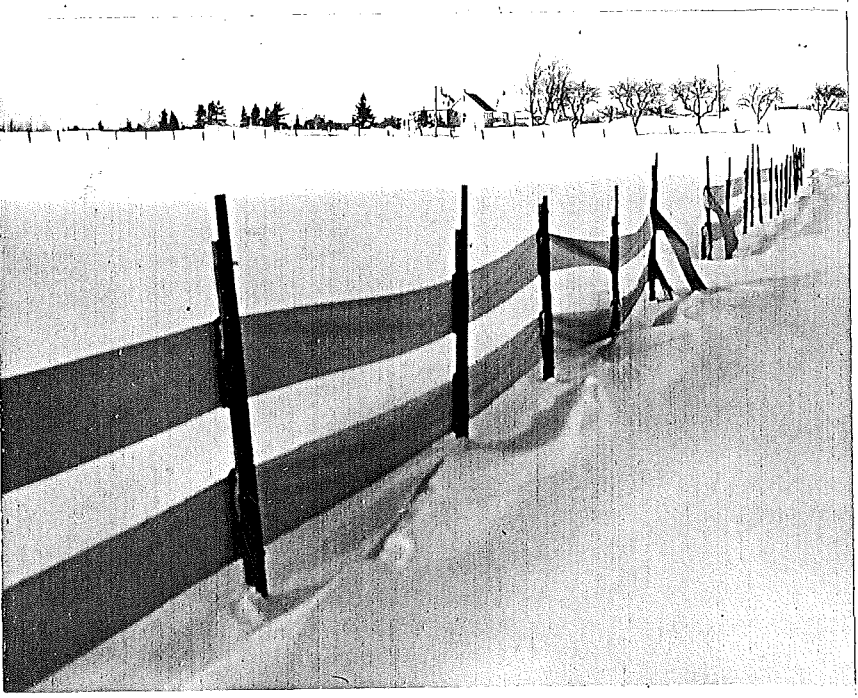
Figure 9. 2-panel fence on west side of US-131 N. of Cadillac, one post gone and fence broken, but functioning well.

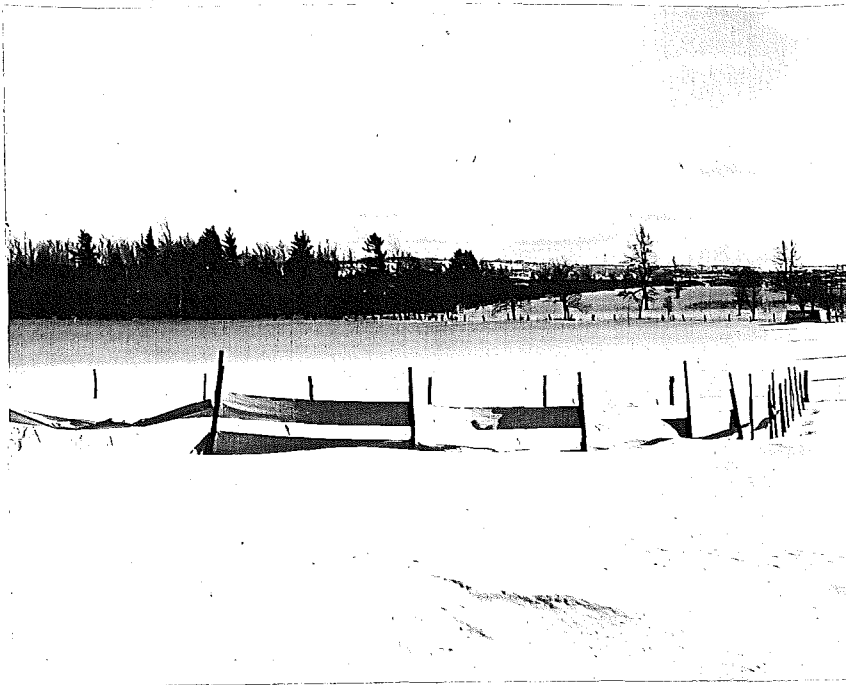
Figure 10. 2-panel fence on E. side of US-131 N. of Cadillac, posts unevenly spaced but fence functioning well.

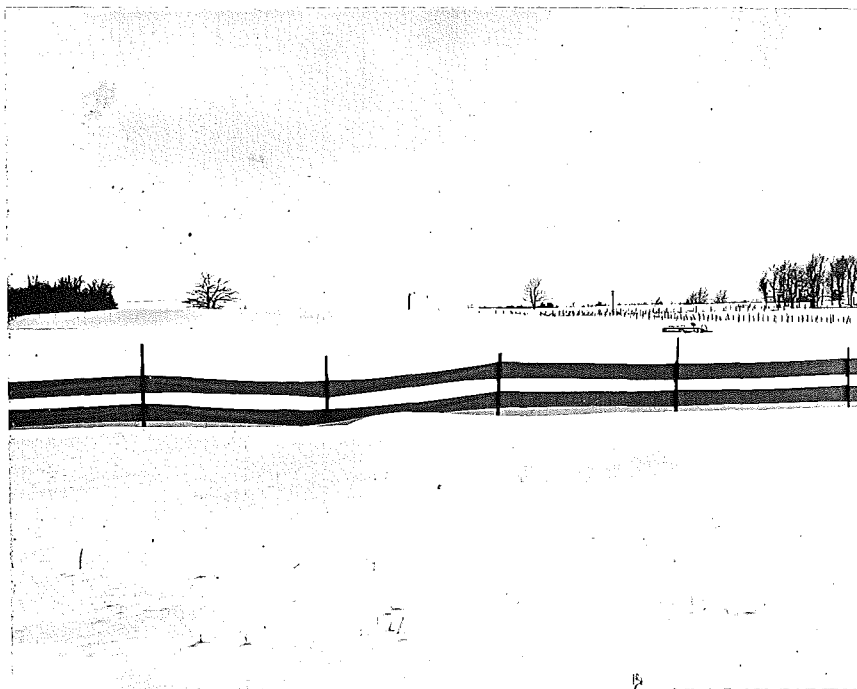
Figure 11. 2-panel fence on west side of US-131 N. of Cadillac, functioning well. Wexford County, 1-29-52

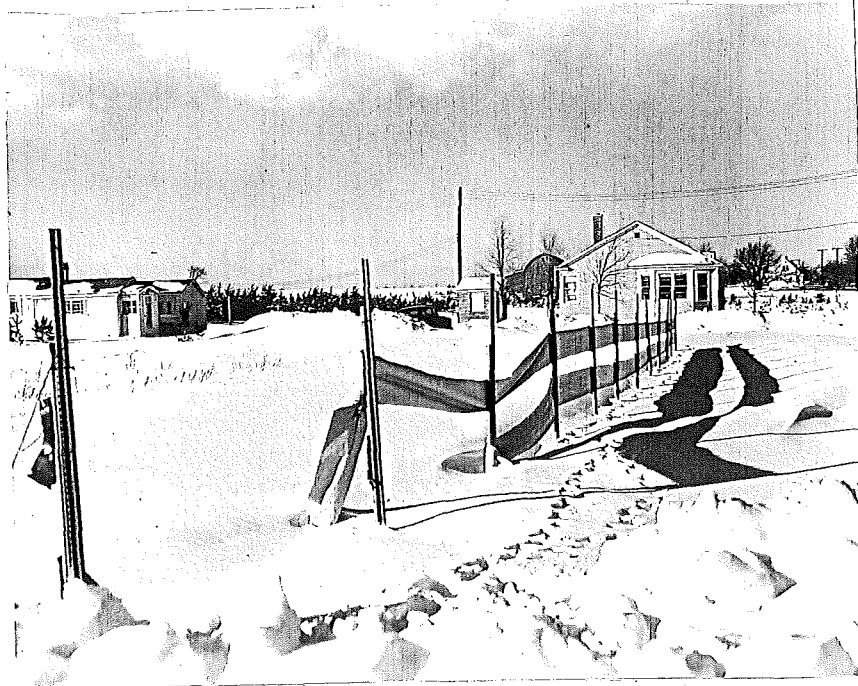
Figure 12. 2-panel fence on west side of US-131 N. of Cadillac;
reported broken by children.
Wexford County, 1-29-52

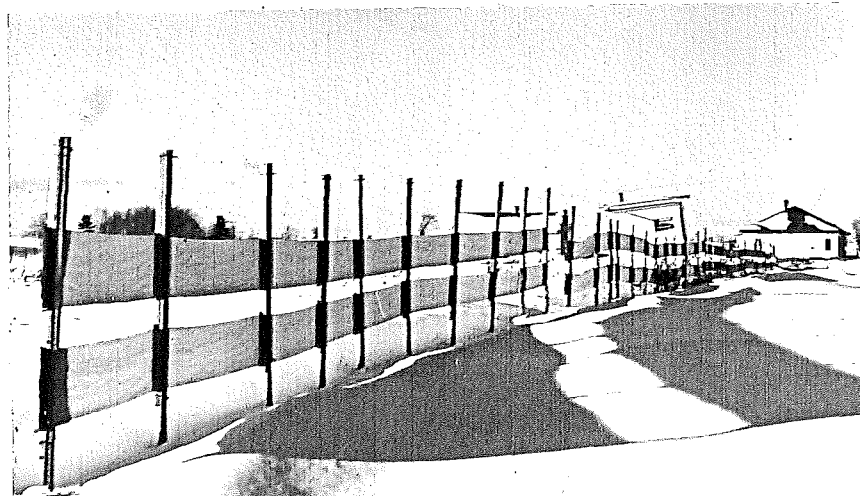
Figure 13. Fence on west side US-131 North of Cadillac, installed under
supervision of Sisalcraft Co. representative. This has been
up 60 days longer than strips shown in Figures 6 to 11, inc.
Wexford County, 1-29-52

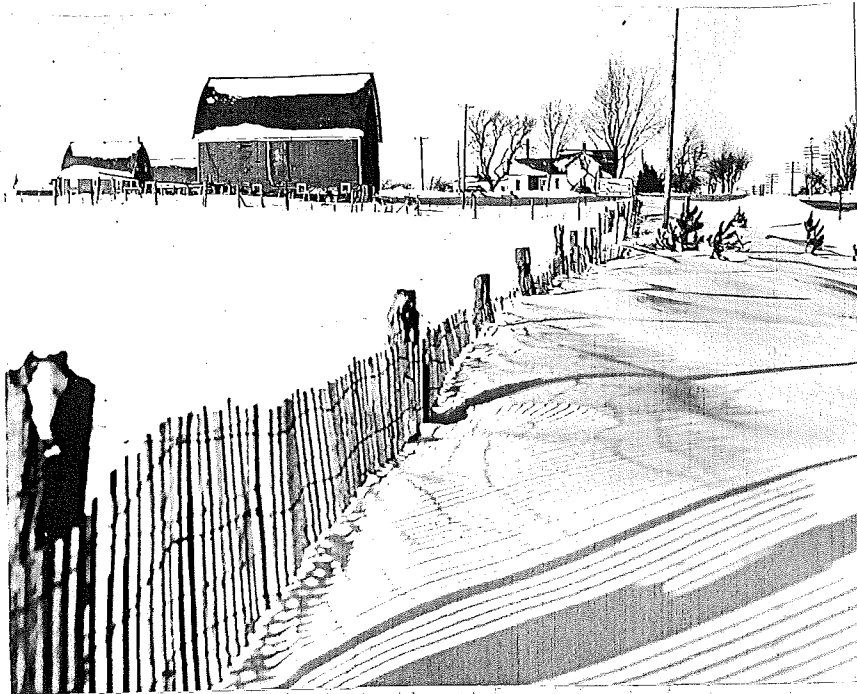
Pictures in Figures 5 to 15 inclusive show paper and wooden snow fences installed along US-131 north of Cadillac. The pictures in Figures 14 and 15 show picket fences which have stopped functioning, and the County expects to experiment here by installing a 12" strip of paper above the fence. The County Superintendent stated that the paper fence is functioning better than picket fences had in previous years. Several breaks shown in this group of fences have definitely been caused by children.

Figure 14. Picket fence on west side of US-131 N. of Cadillac, in same general location as paper fence.
Wexford County, 1-29-52

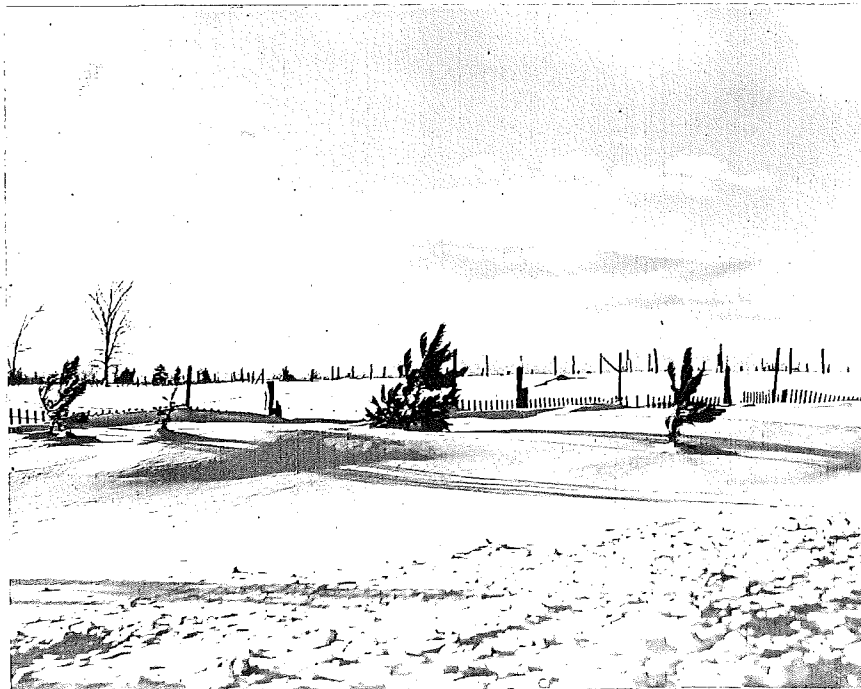
Figure 15. Picket fence that has stopped functioning, along US-131 N. of Cadillac.
Wexford County, 1-29-52

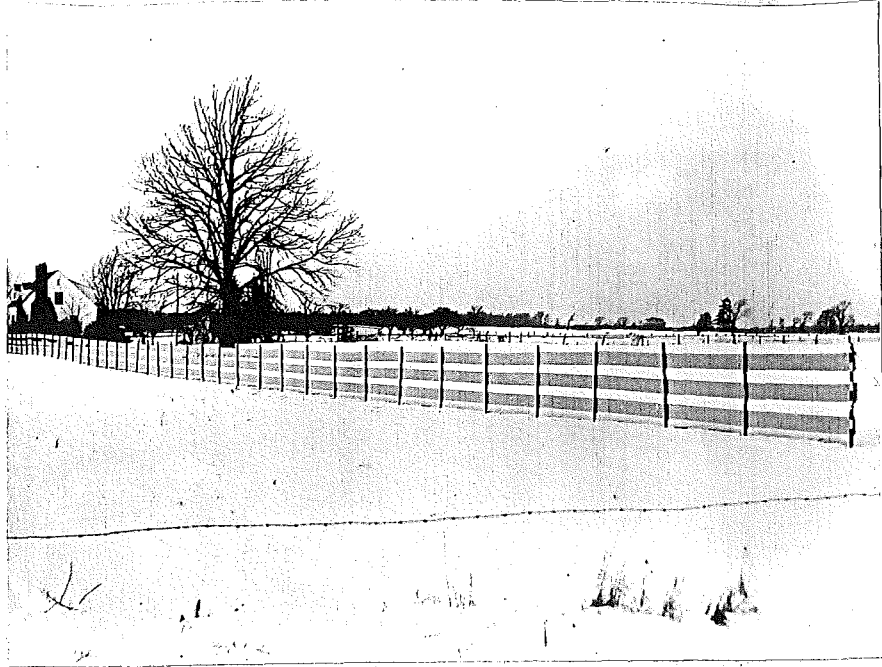
Figure 16. 3-panel fence on north side of M-46 just west of Saginaw. Excellent condition. Saginaw County, 1-30-52

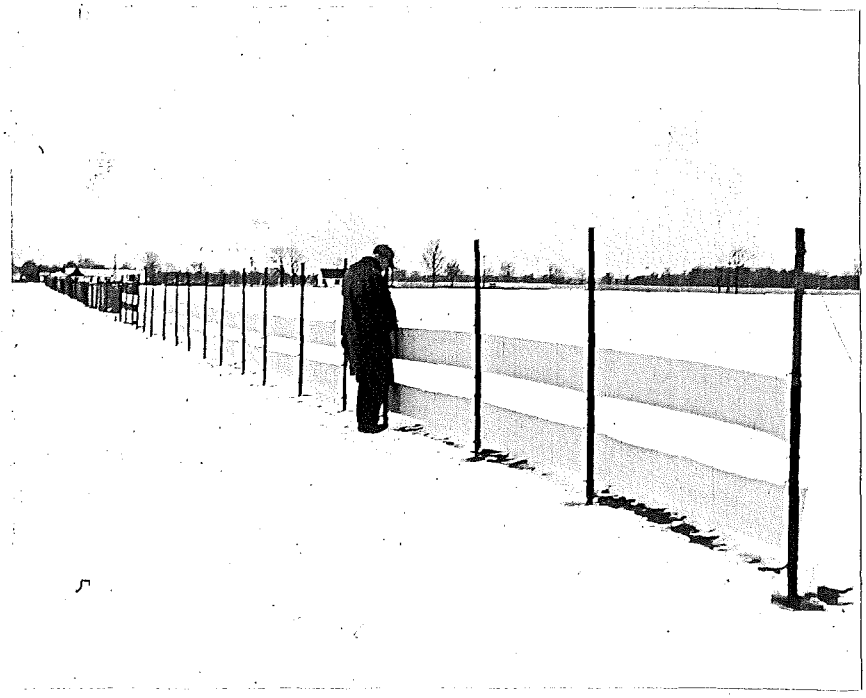
Figure 17. Special method of installing paper used here on north side of US-10 and M-47 in Saginaw. See Figure 18 for close-up. Excellent condition. Saginaw County, 1-30-52

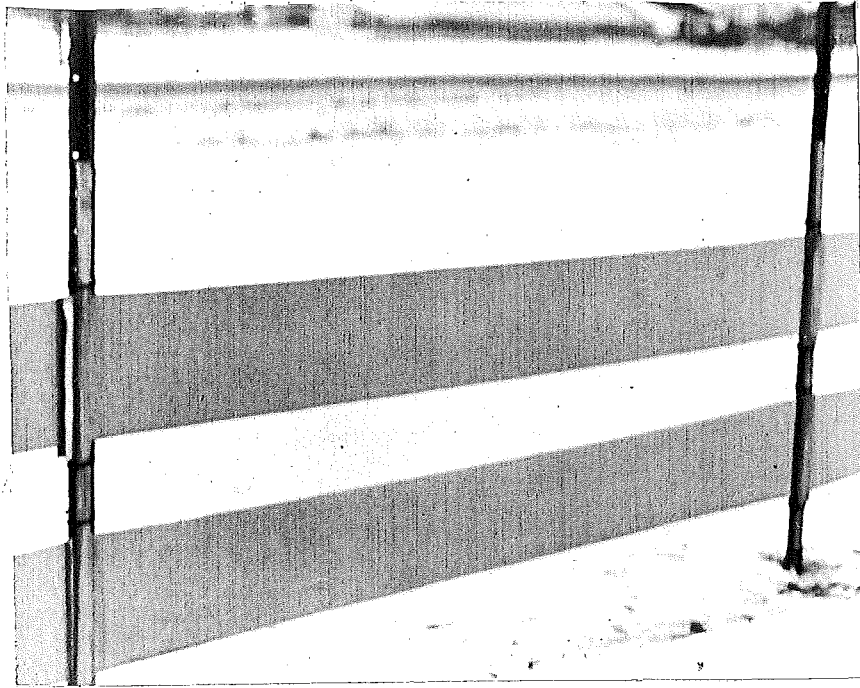
Figure 18. Paper installed between metal post and wooden strip without using staples.
Saginaw County, 1-30-52

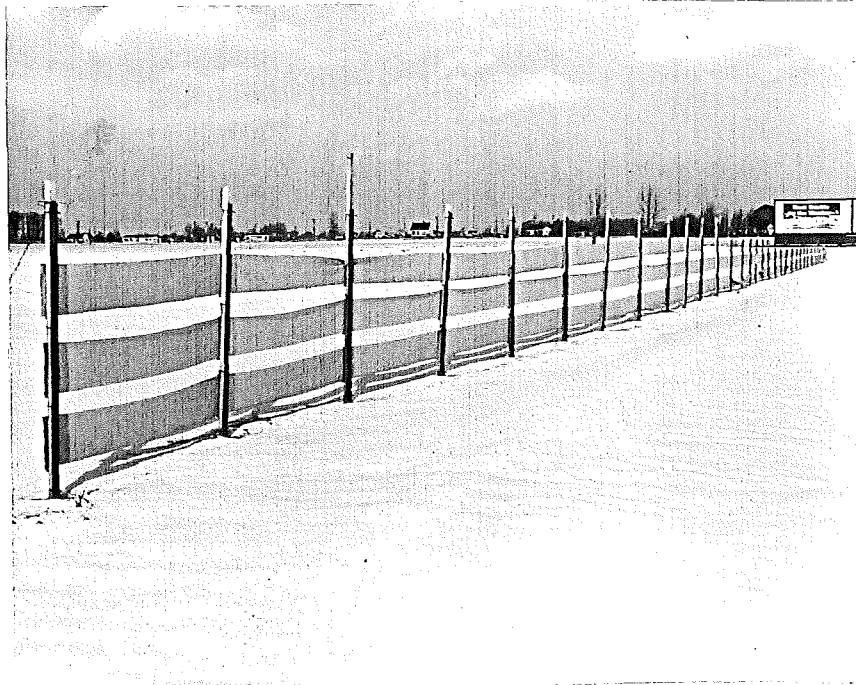
Figure 19. 2-and 3-panel fence on west side of M-47 just N. of Saginaw.
Saginaw County, 1-30-52

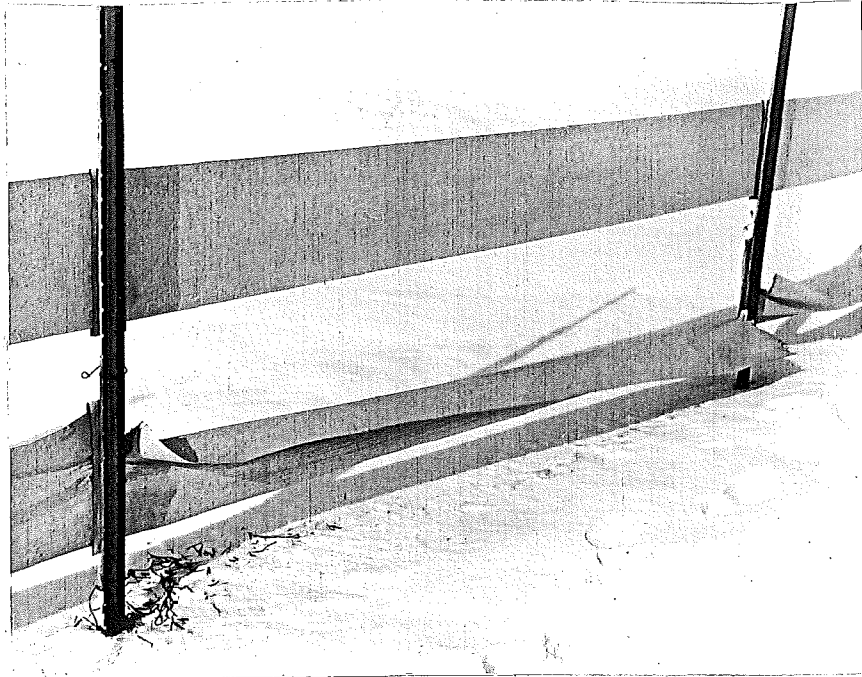
Figure 20. Detail of break shown in distance, Figure 19. 2-panel fence. Saginaw County, 1-30-52

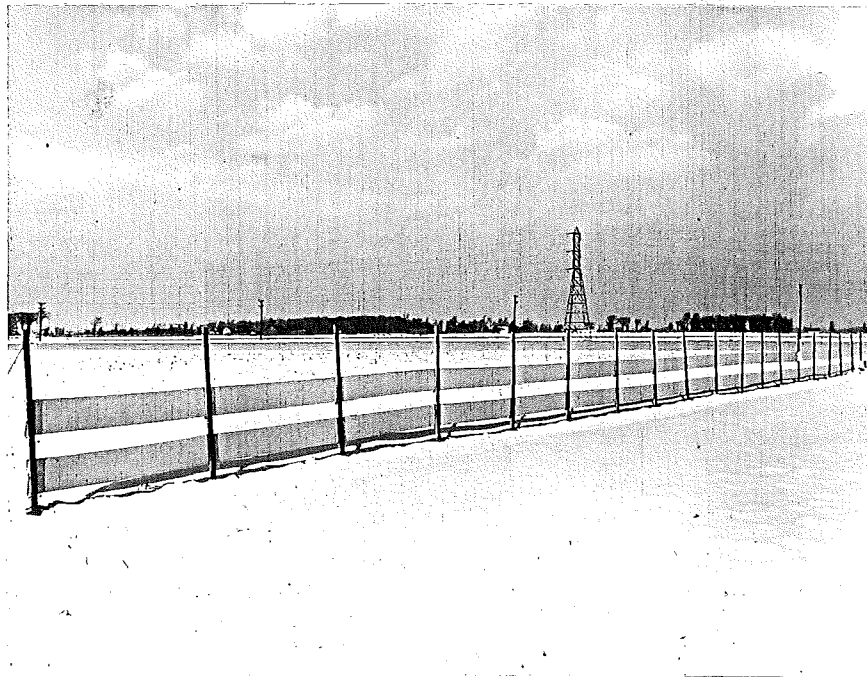
Figure 21. 2-panel fence on west side of M-47. N. of Saginaw. Saginaw County, 1-30-52

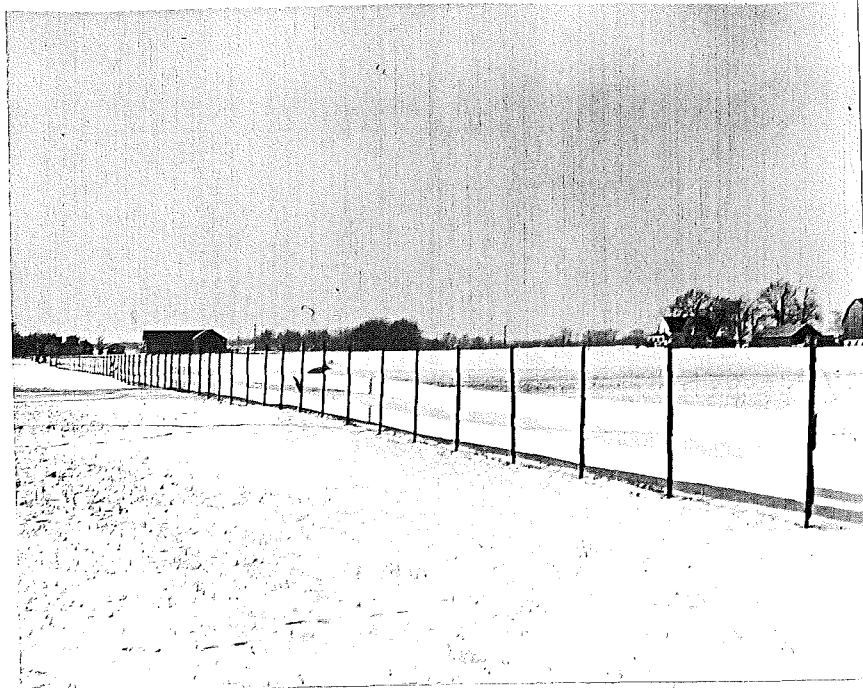
Figure 22. Long stretch of fence on north side of M-46 W. of Saginaw.
 Excellent condition.
 Saginaw County, 1-30-52

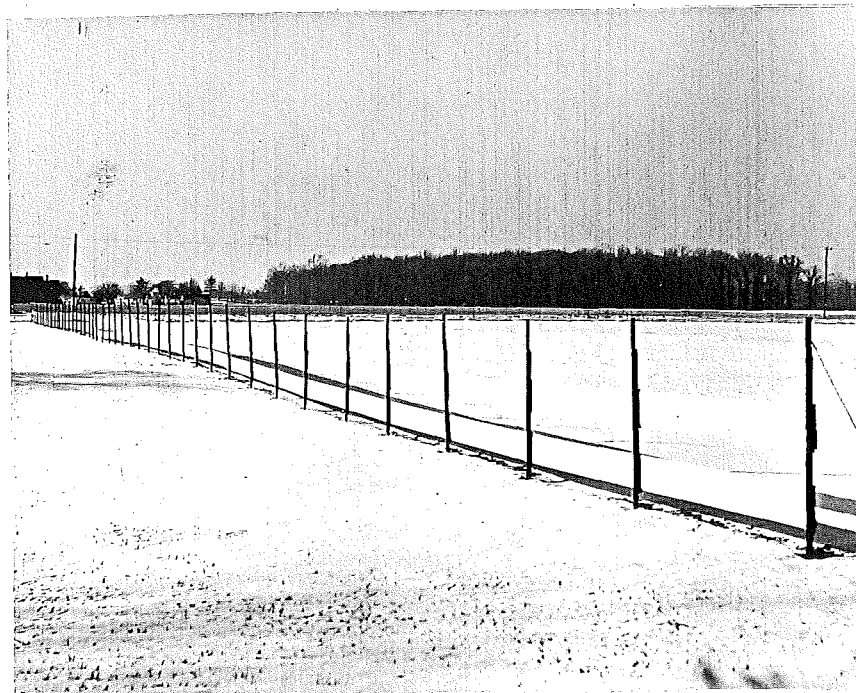
Figure 23. Long stretch of fence on north side of M-46 west of Saginaw
 at junction with M-47 to south. In excellent condition.
 Saginaw County, 1-30-52

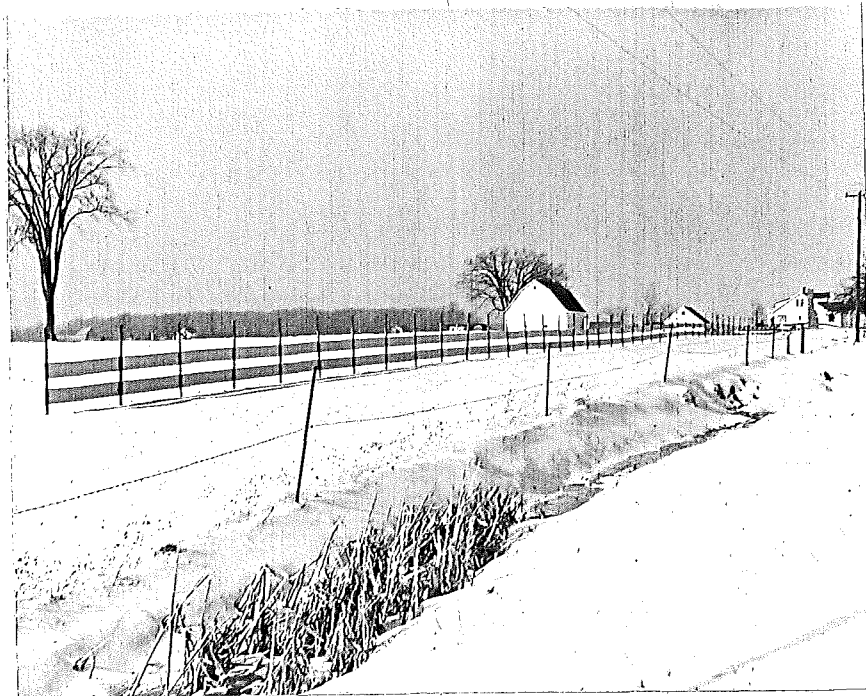
Figure 24. 2-panel fence on west side of M-47 just south of junction with M-46. Saginaw County, 1-30-52

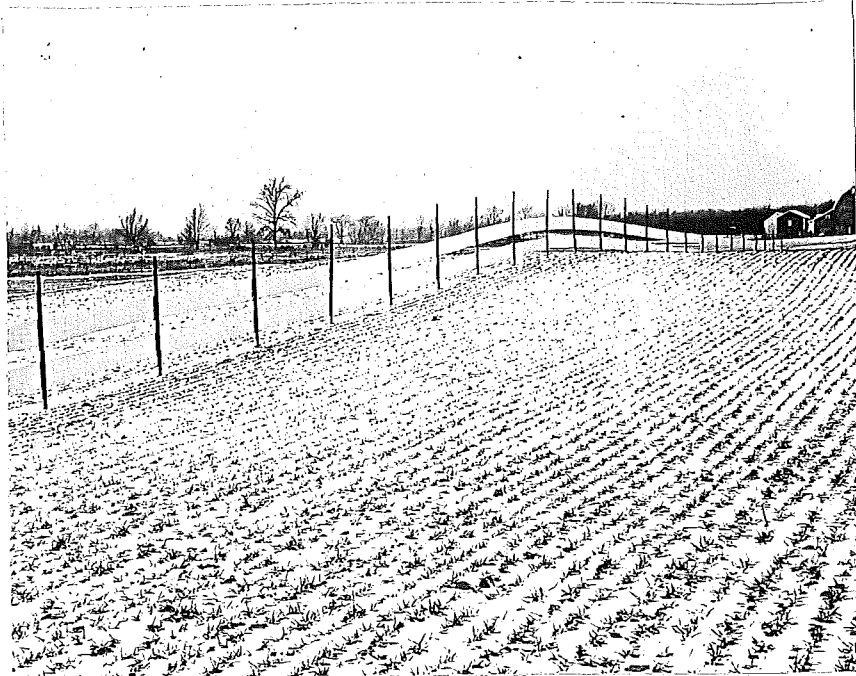
Figure 26. North section of 2-panel fence on west side of US-127 in Jackson County just south of Ingham County line, showing installation in rolling topography.
2-7-52

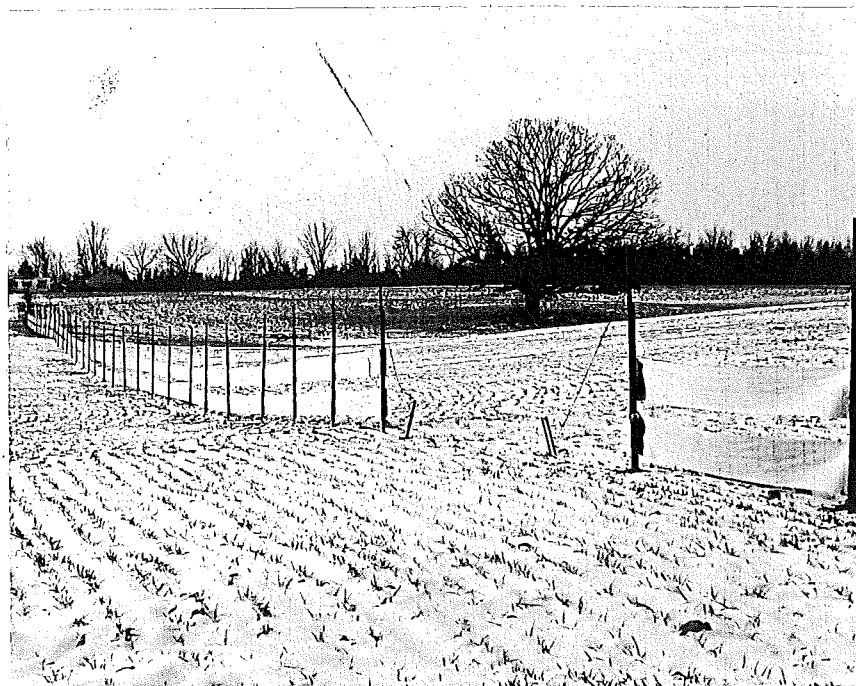
Figure 27. Shows gap in 2-panel section on west side of US-127 in Jackson County, just south of Rives Junction Road. Fence follows ground contour very well.
2-7-52

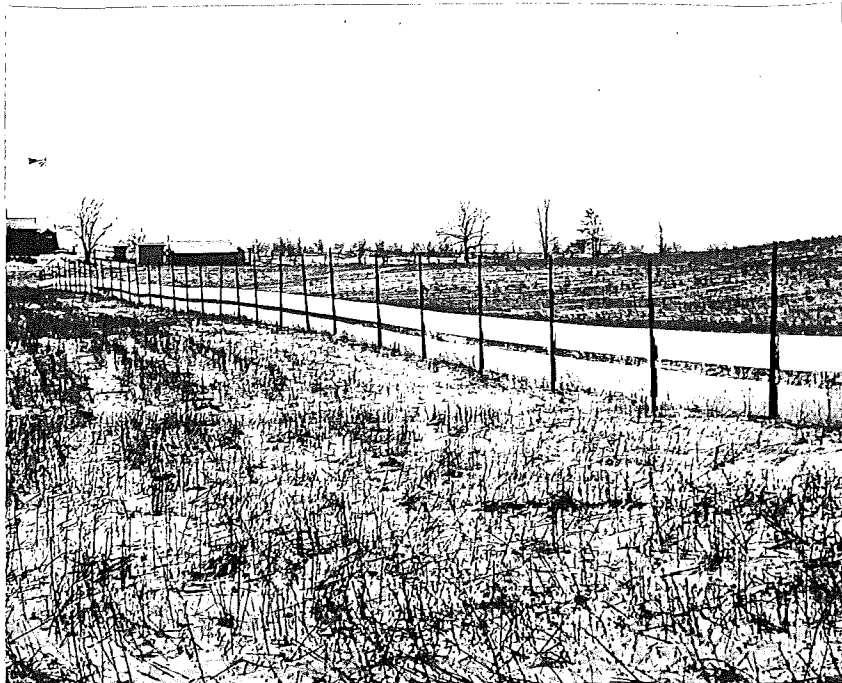
Figure 28. 2-panel fence on west side of M-50 in Jackson County,
south of Cunningham Road.
2-7-52

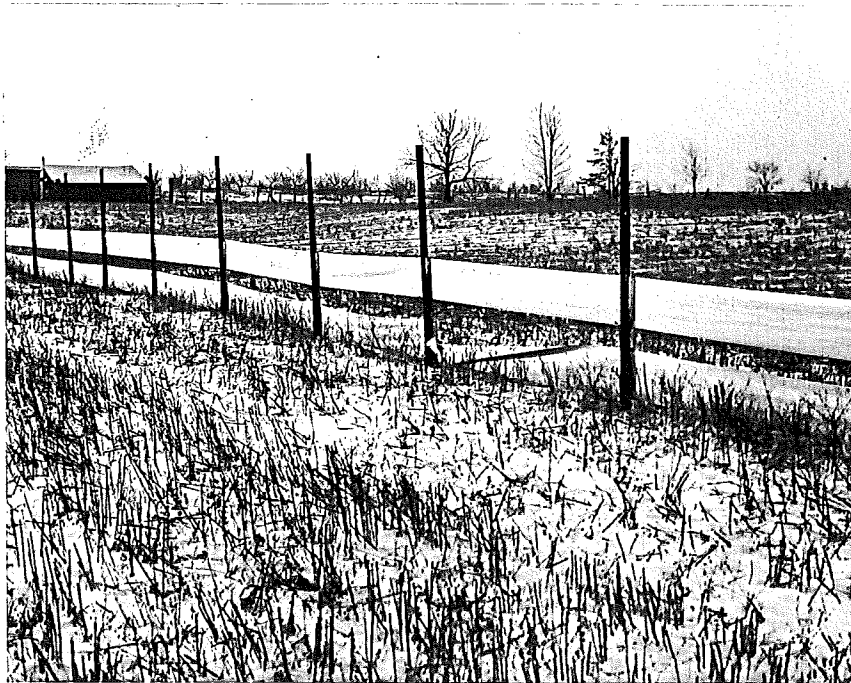
Figure 29. Close-up of break in stretch of fence shown in Figure 28.
Jackson County, 2-7-52

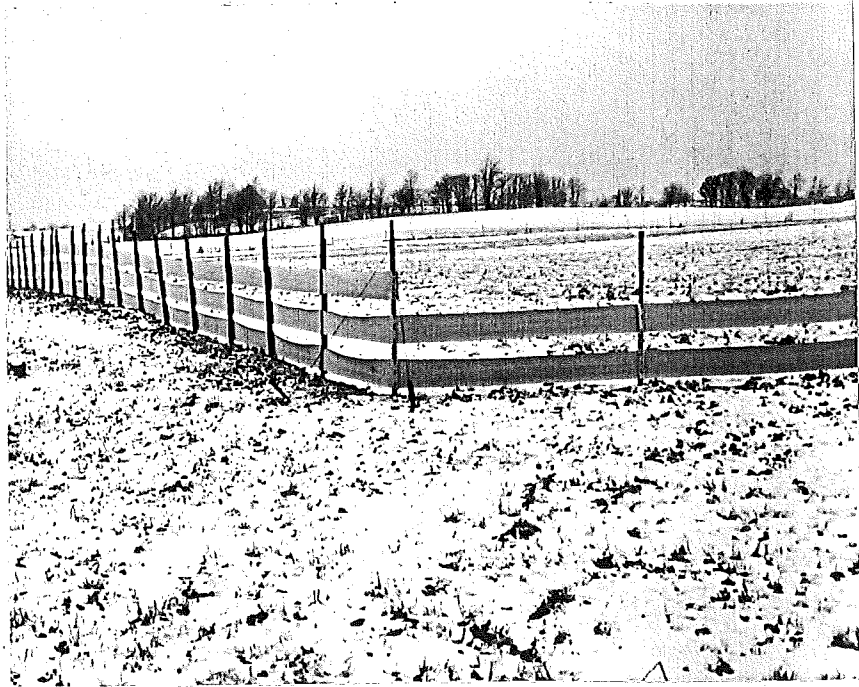
Figure 30. 2- and 3-panel stretch of fence on north side of US-12 in Jackson County east of Ludlow Road, showing method of taking fence around corners.
2-7-52

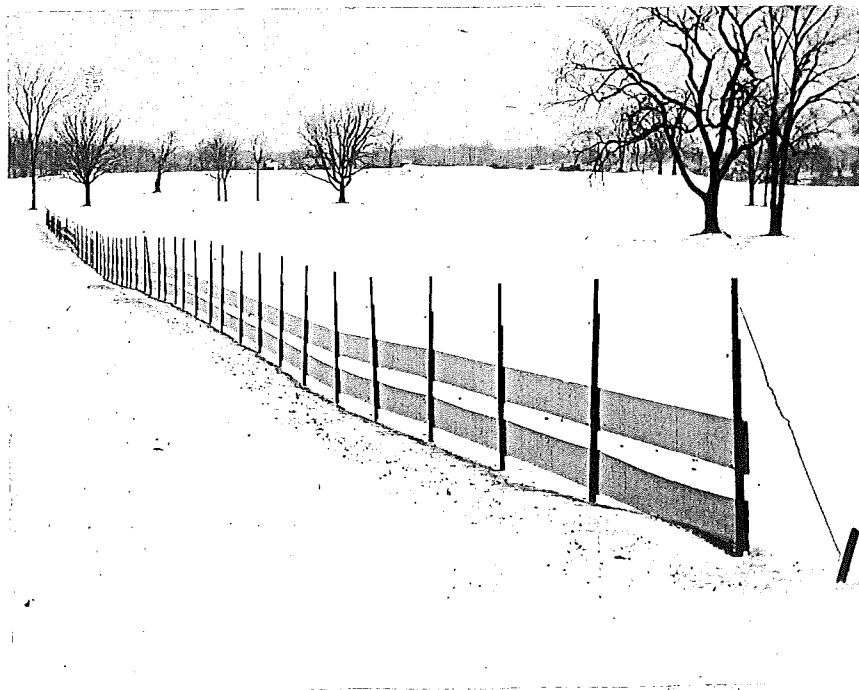
Figure 31. 2-panel fence on north side of M-60 in Jackson County east of Reynolds Road.
2-7-52

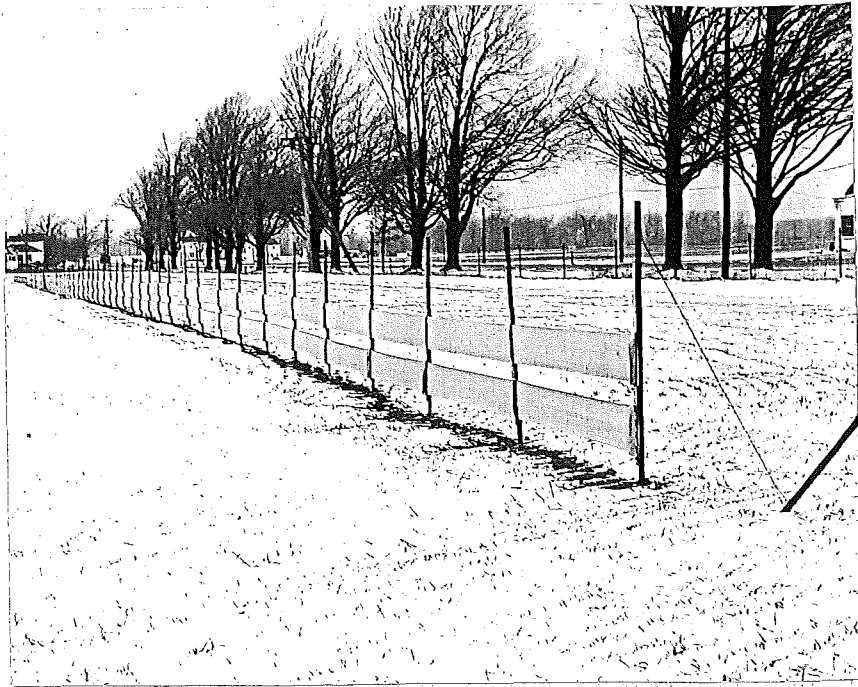
Figure 32. 2-panel fence on S.W. side of M-50 near Napoleon, in Jackson County.
2-7-52

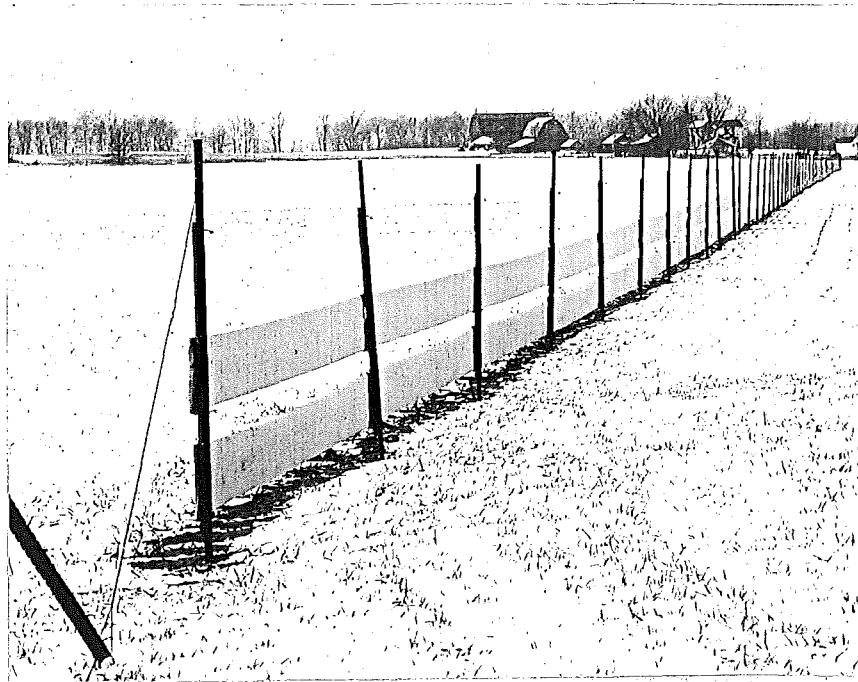
Figure 33. Another view of fence shown in Figure 32.
2-7-52

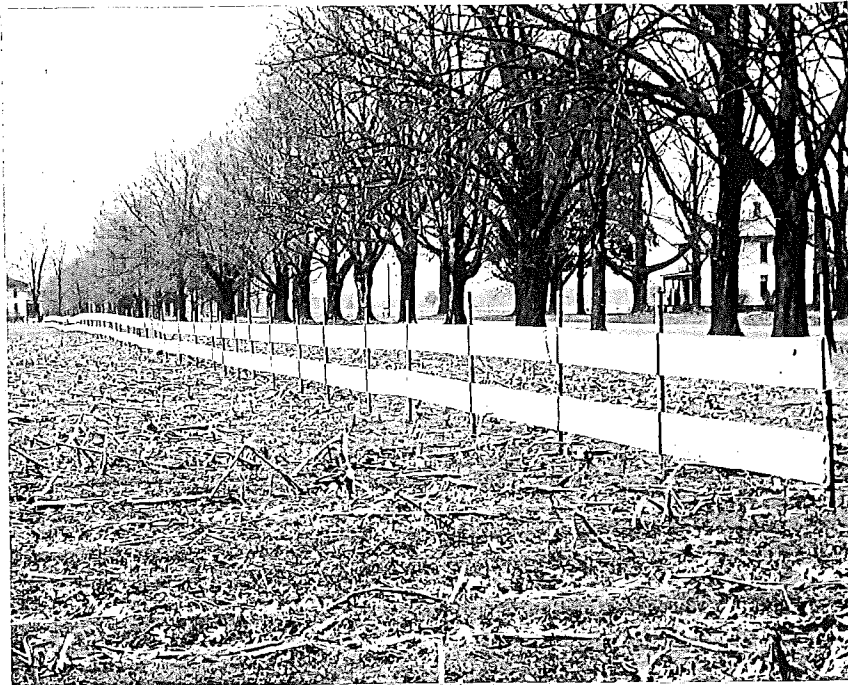
Figure 34. Long stretch of 2-panel fence on west side of M-40 between Dowagiac and Decatur. Van Buren County, 2-7-52

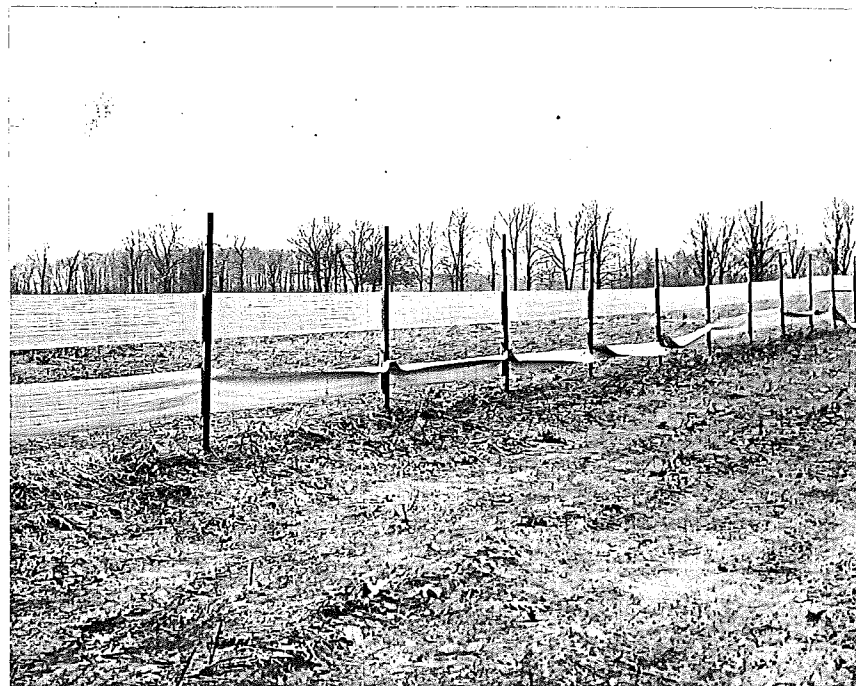
Figure 35. Next stretch north on west side of M-40 near Decatur. Van Buren County, 2-7-52
