TRANSVERSE CRACKING OF NEW CONCRETE PAVEMENT  
M 37 from Ballards to Casnovia  
(Projects BF 41033D, C7U & C8R; BF 41033E, C9U & C10R; BF 61171A, C1U)

Research Laboratory Division  
Office of Testing and Research  
Research Project R-39 F-7(14)  
Research Report No. R-427R

Michigan State Highway Department  
John C. Mackie, Commissioner  
Lansing, December 1963

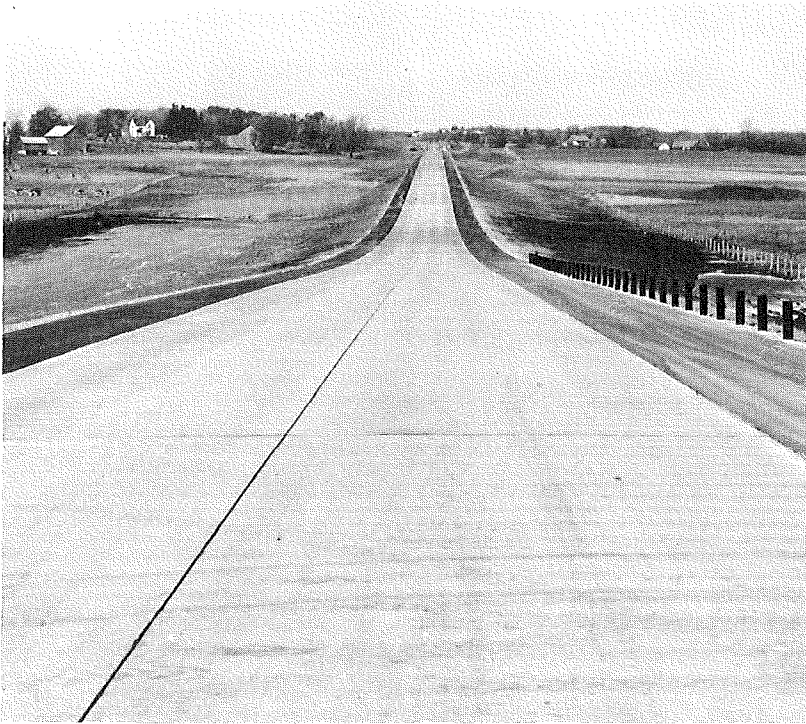
Pour 14, looking north from Sta 782+00

Figure 2. General views of project (upper left and lower left); dark areas beside shoulders indicate muck excavations.

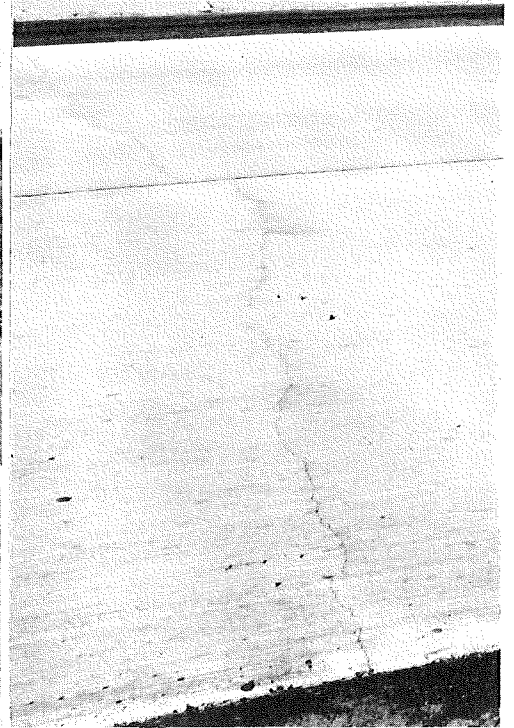
Pour 5, Sta 613+00

Figure 3. Typical transverse cracking (upper right and lower right).

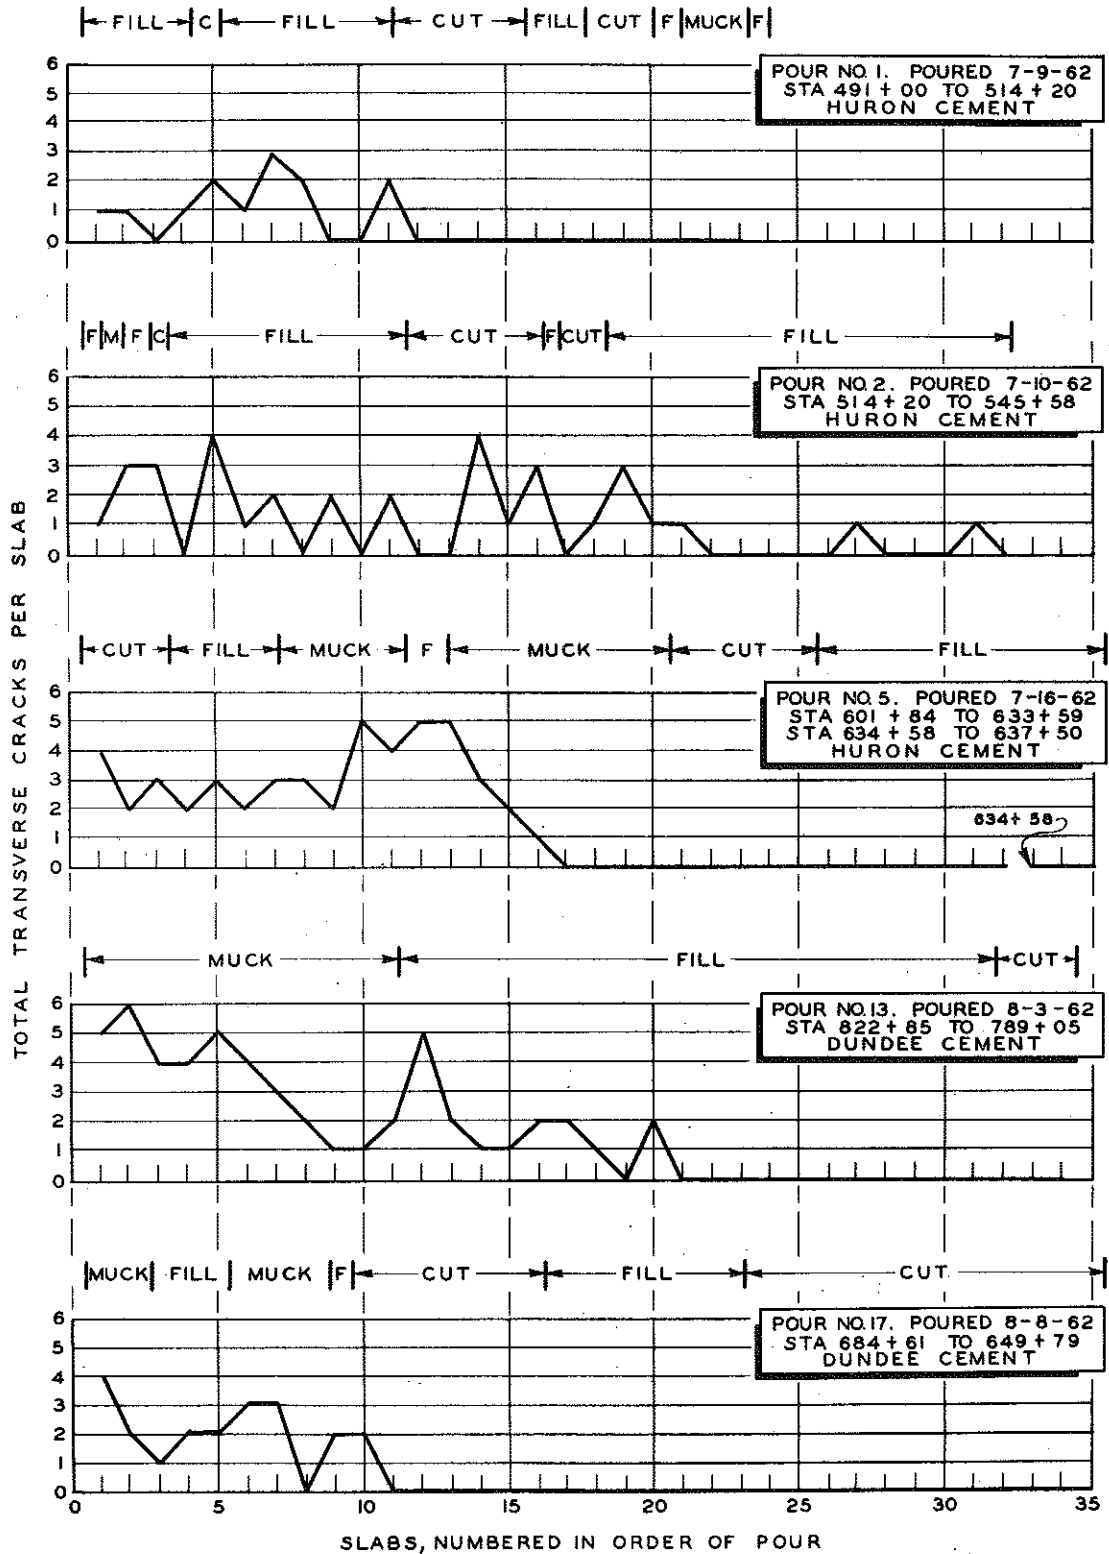
Figure 4. Transverse cracking in relation to sequence of slab construction within the five worst-cracked pours (arranged by pour number, or construction date). "Transverse crack" is defined for these graphs (and Table 3) as any continuous crack, regardless of whether one or two lanes in length.

Fig. 4 shows that foundation conditions are diverse beneath five of the pours where worst cracking occurred, and that no apparent relationship existed between grading area and cracking. Fig. 4 also shows that similar patterns of transverse cracking appear for concrete containing both Huron and Dundee cements. Table 2 indicates no correlation between cracks and foundation conditions, for all cut, fill, and muck areas along the length of the project.

Fig. 4 shows positions of cracked slabs in relation to sequence of construction within the five worst-cracked pours. It is apparent that the badly cracked slabs, in almost all cases, were those constructed during the first part of the day's operation. This indicates that something must have detrimentally affected the first slabs constructed each day, causing them to crack transversely. Since the cores do not show any significant difference in strength for the cracked sections, it appears that the concrete as mixed on the job was satisfactory, so that certain conditions encountered during the setting period must have been responsible for the subsequent excessive shrinkage.

1. The cracked slabs were almost always the first ones poured during a day's construction (Fig. 4).
