MICHIGAN
STATE HIGHWAY DEPARTMENT
Murray D. Van Wagoner
State Highway Commissioner

FIELD STUDY OF JOINT SEALERS

Research Project 36 G-4(2)

Research Laboratory
Testing and Research Division
Report No. 2
October 10, 1940

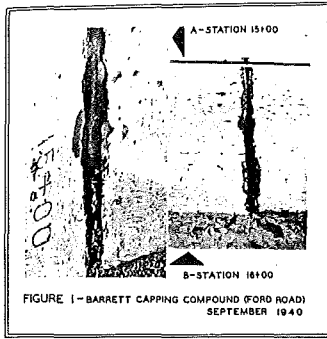
Barrett Capping Compound - stations 15+00 and 16+00. At both stations it was found that the joints were open practically the complete length. The material was much harder than when placed and was crumbled quite easily. This observation bears out the conclusions made after two weeks from the date of placement.

FIGURE 1 - BARRETT CAPPING COMPOUND (FORD ROAD) SEPTEMBER 1940

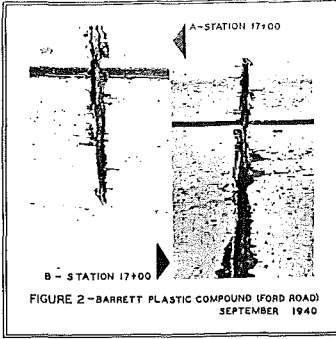
Barrett Tarvia Plastic - station 17+00. Material was open at both sides of joint resulting in an ineffective seal. This material was softer than the Barrett Capping compound and possessed only a small degree of suitable characteristics superior to the capping compound.

FIGURE 2 - BARRETT PLASTIC COMPOUND (FORD ROAD) SEPTEMBER 1940

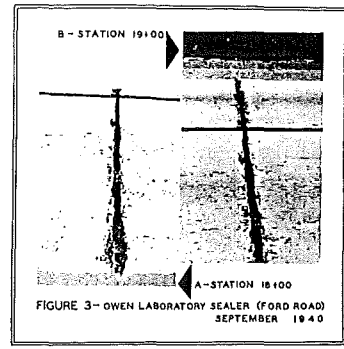
Owen Laboratories Sealer - stations 18+00 and 19+00. A large amount of the sealer at these joints had disappeared. The material in place was easily crumbled and there was no adherence to the concrete.

FIGURE 3 - OWEN LABORATORY SEALER (FORD ROAD) SEPTEMBER 1940

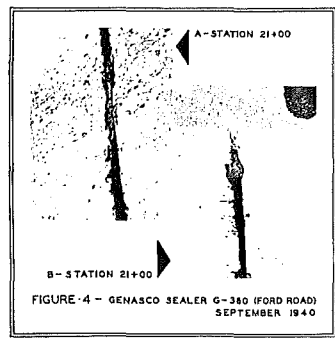
Genasco G-360 - stations 20+00 to 25+00 inclusive. The material had hardened considerably and presented a cracked surface in weathering. The joints appeared to be about 80% sealed at this time.

FIGURE 4 - GENASCO SEALER G-380 (FORD ROAD) SEPTEMBER 1940

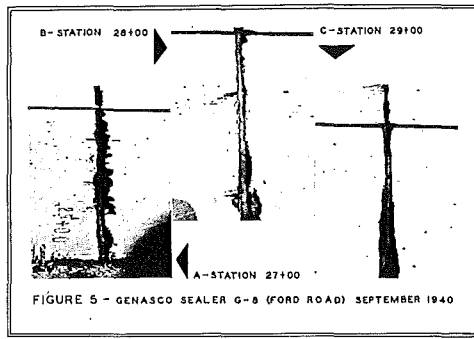
Genasco G-8 - stations 26+00 to 31+00 inclusive. This material seemed to provide a better seal than the G-360 giving about 95% effective seal

along the joint. The material was harder than when placed and had settled down from the surface of the pavement. There were indications that the material was shoved out of the joint to some extent during warm weather.

FIGURE 5 - GENASCO SEALER G-8 (FORD ROAD) SEPTEMBER 1940

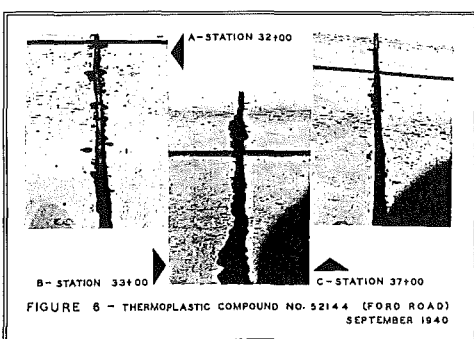
Rubber Associates Thermoplastic No. 52144 - stations 32+00 to 38+00 inclusive. Two of these joints showed rather satisfactory sealing, but the material did show insufficient adhesion, with surface cracks in the material which would allow infiltration of water. The failure is caused by the soft grade of material seeping along the premolded filler and also being carried by traffic leaving insufficient material for a proper seal.

FIGURE 6 - THERMOPLASTIC COMPOUND NO. 52144 (FORD ROAD) SEPTEMBER 1940

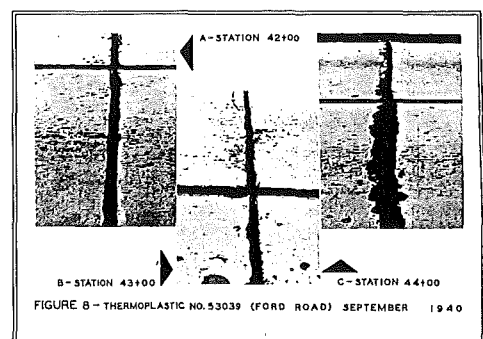
Rubber Associates Thermoplastic No. 53039 - stations 40+00 to 46+00 inclusive. These joints varied as to efficiency of seal but on a whole could be called fairly satisfactory. In some cases, the material was not thick enough and did not possess sufficient elasticity to completely seal the joint. This material has a tendency to be spread by traffic on the concrete adjacent to the joint but the semi-firm grade material proves a more effective sealer than No. 52144.

FIGURE 8 - THERMOPLASTIC NO. 53039 (FORD ROAD) SEPTEMBER 1940

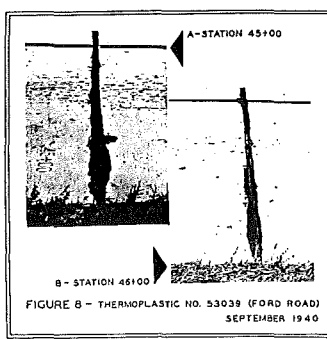
FIGURE 8 - THERMOPLASTIC NO. 53039 (FORD ROAD) SEPTEMBER 1940

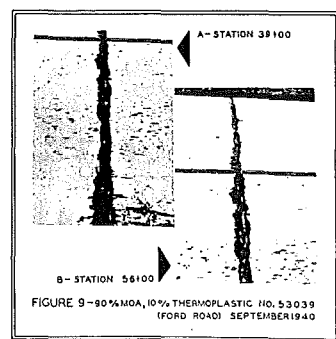
90% MOA and 10% Thermoplastic No. 53039 - stations 39+00 to 56+00 inclusive. These joints were particularly bad from the standpoint of seal and it appears that such a small addition of the thermoplastic compound is not effective in improving the qualities of the MOA.

FIGURE 9 - 90% MOA, 10% THERMOPLASTIC NO. 53039 (FORD ROAD) SEPTEMBER 1940

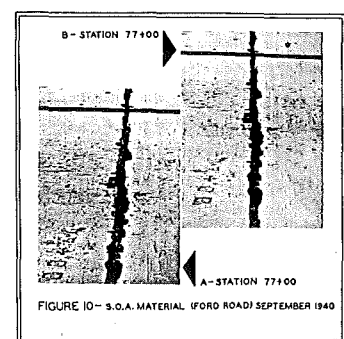
SOA - stations 77+00 to 101+00 inclusive. Practically all of the sealer had disappeared in one year.

FIGURE 10 - S.O.A. MATERIAL (FORD ROAD) SEPTEMBER 1940

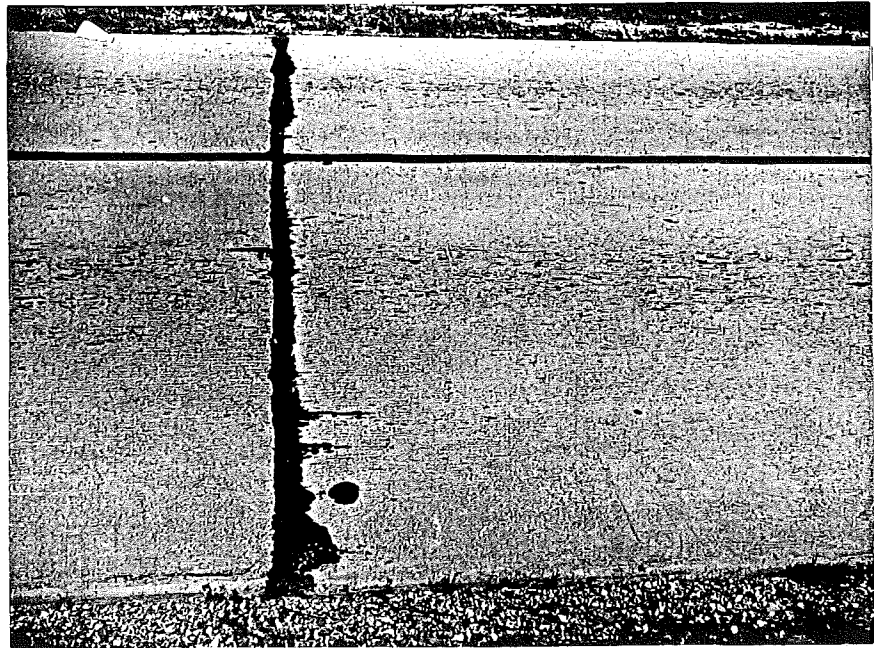
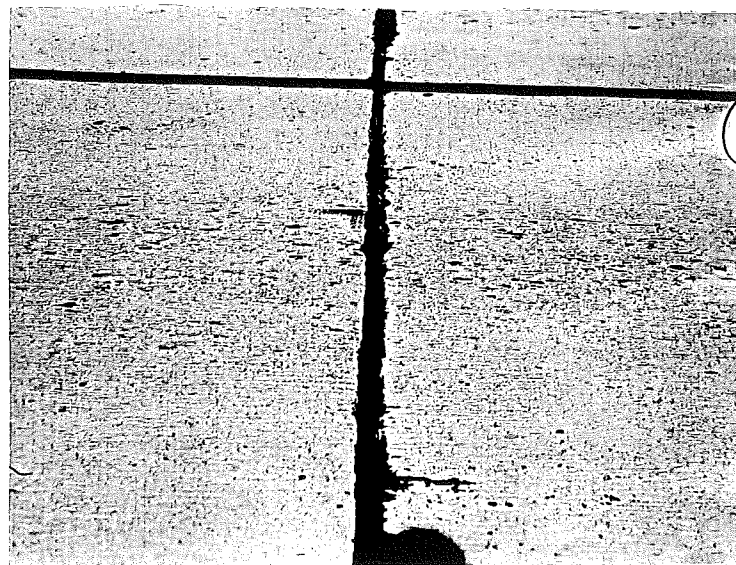
A - Station 115+00

CFA - stations 102+00 to 161+00 inclusive. At the temperatures at the time of year which this survey was made, the material was open on both sides of the joint. This material may be satisfactory seal at warmer temperatures when kneaded into the joint opening by traffic, but with lower temperatures it cracks, possessing little elasticity.

Figure 11 - C.F.A. Material (Ford Road) September 1940

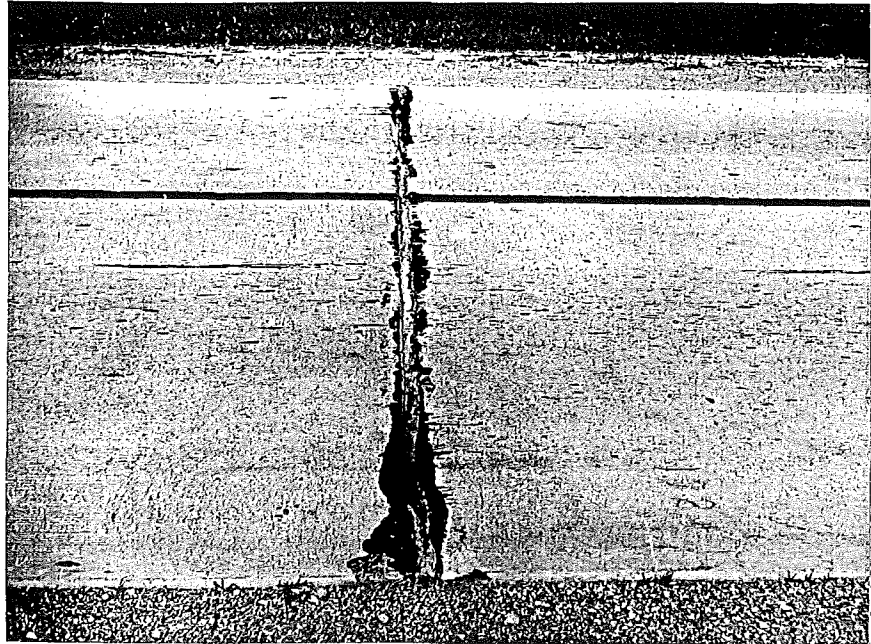
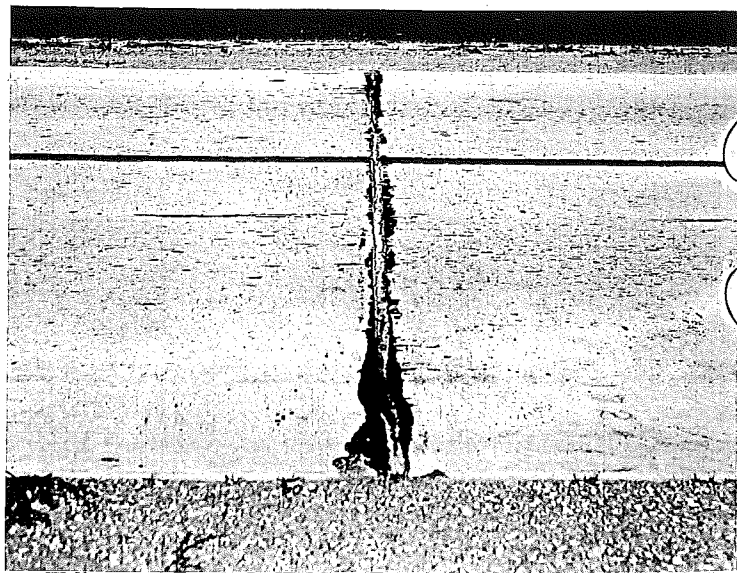
A - Station 172+00

MOA - stations 162+00 to 188+00 inclusive. This material has been used for some time by the Michigan State Highway Department. Its character-

istics have not been satisfactory and the results in this instance where most of the material had disappeared does not recommend it for a joint sealer.

Figure 12 - MOA Material (Ford Road) September 1940

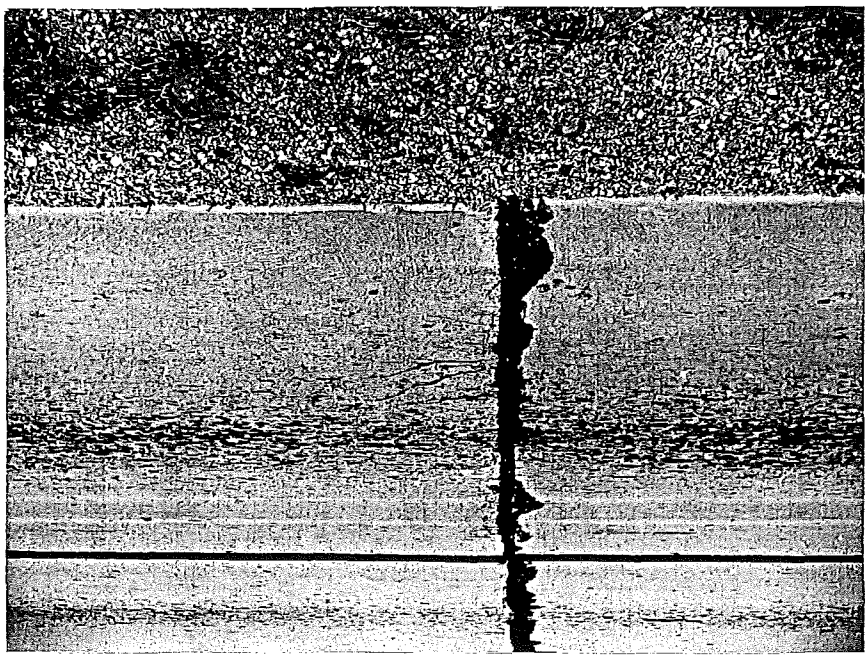
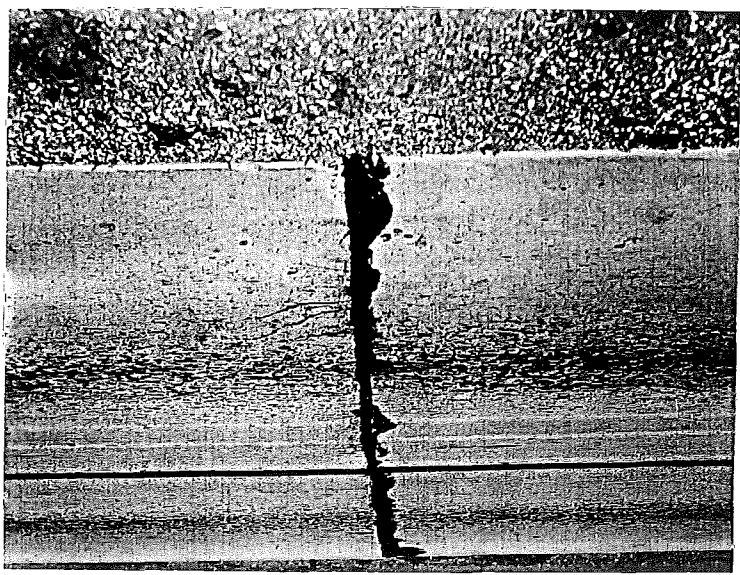
A - Station 196+00

TP-2 - stations 189+00 to 247+00 inclusive. Although this material possesses slightly better adhesion qualities than MOA, it is hard and semi-brittle with no effective seal.

Figure 13 - T.P.-2 Material (Ford Road) September 1940

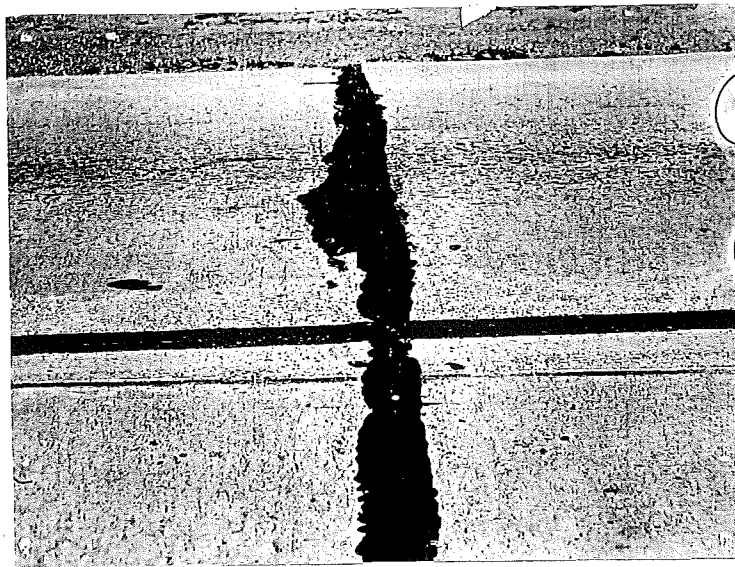
A - Station 272+00

Oil-Latex Sealer - stations 248+00 to 276+00 inclusive. Although in the majority of cases this material provided a fair to satisfactory seal, the results were not as good as have been obtained on other experimental projects. It is apparent that a sufficient amount of the material must be used in order to obtain a completely satisfactory seal.

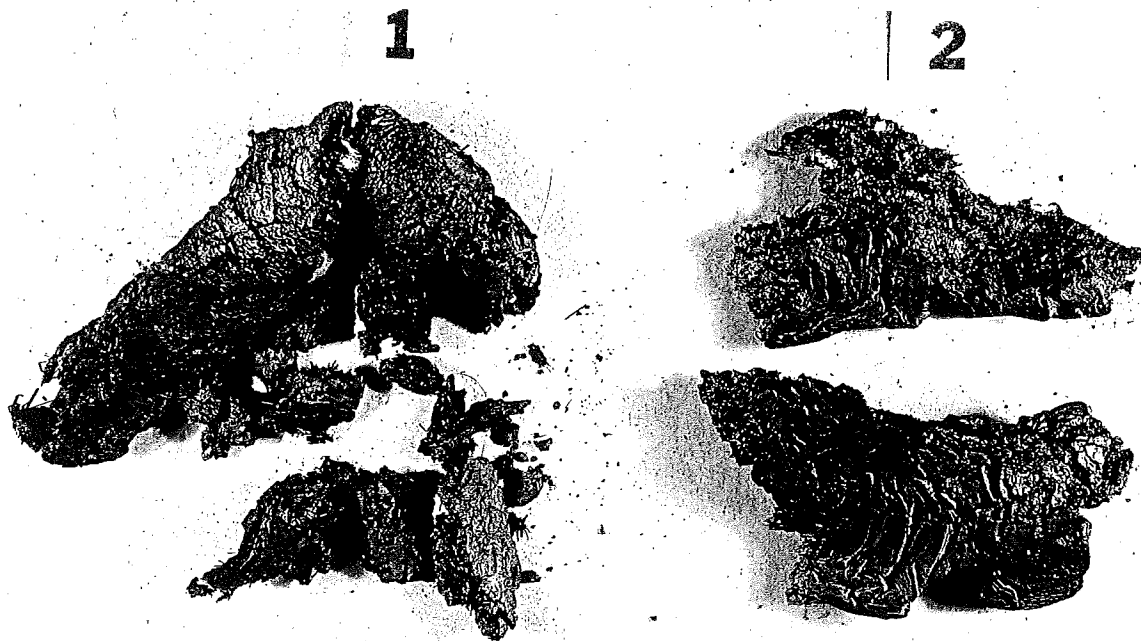
A - No. 1 Barrett Capping Compound, station 15+00
 No. 2 Barrett Plastic Compound, station 17+00

Figure 16 - Condition of joint sealers (Ford Road) September 1940

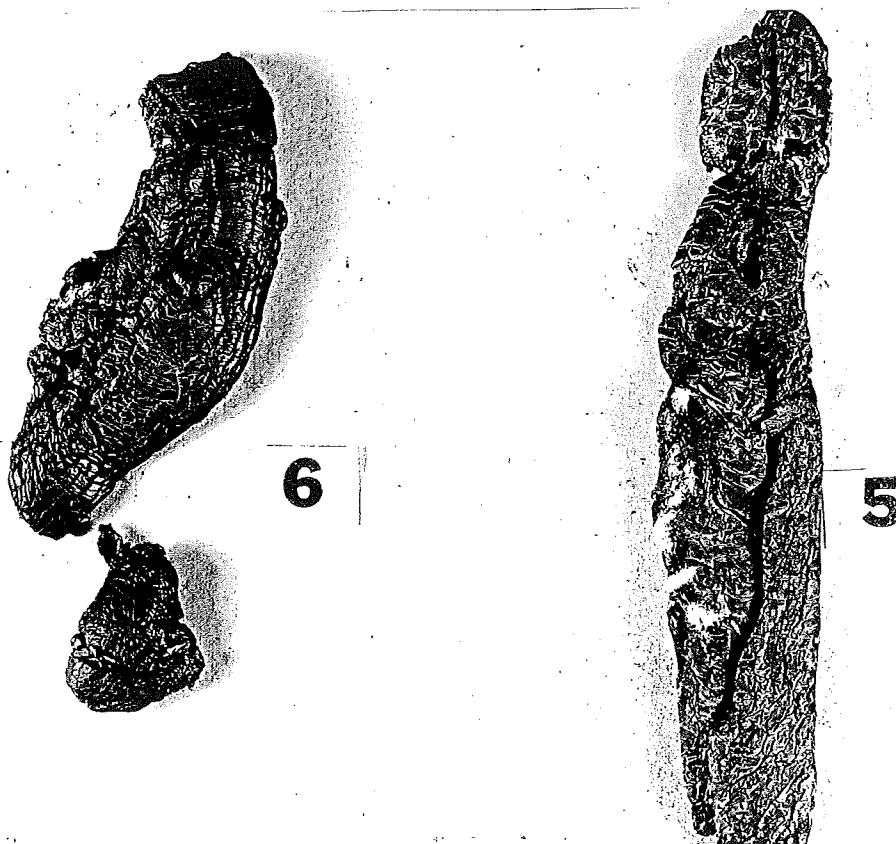
B - No. 5 Genasco G-360, station 21+00
 No. 6 Genasco G-8, station 27+00

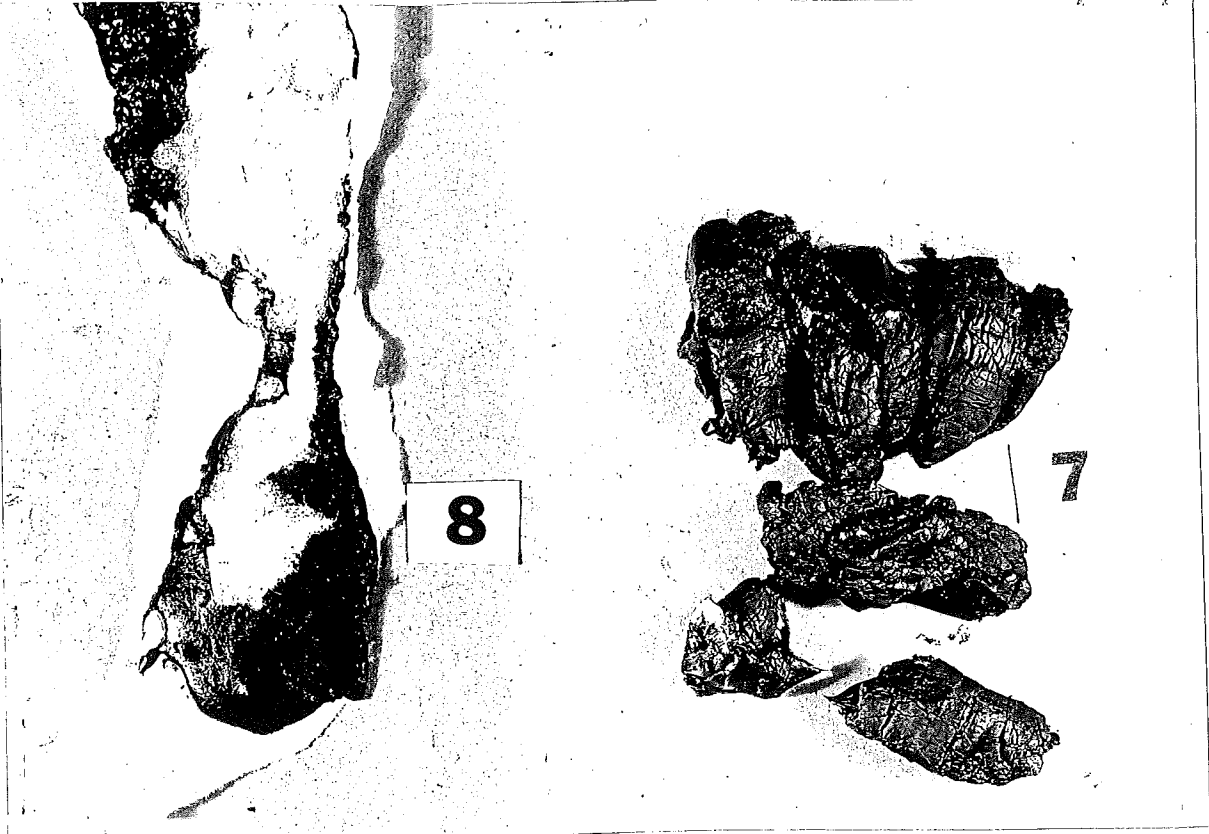
A - No. 7 C.F.A. material, station 115+00
No. 8 Thermoplastic No. 52144, station 32+00

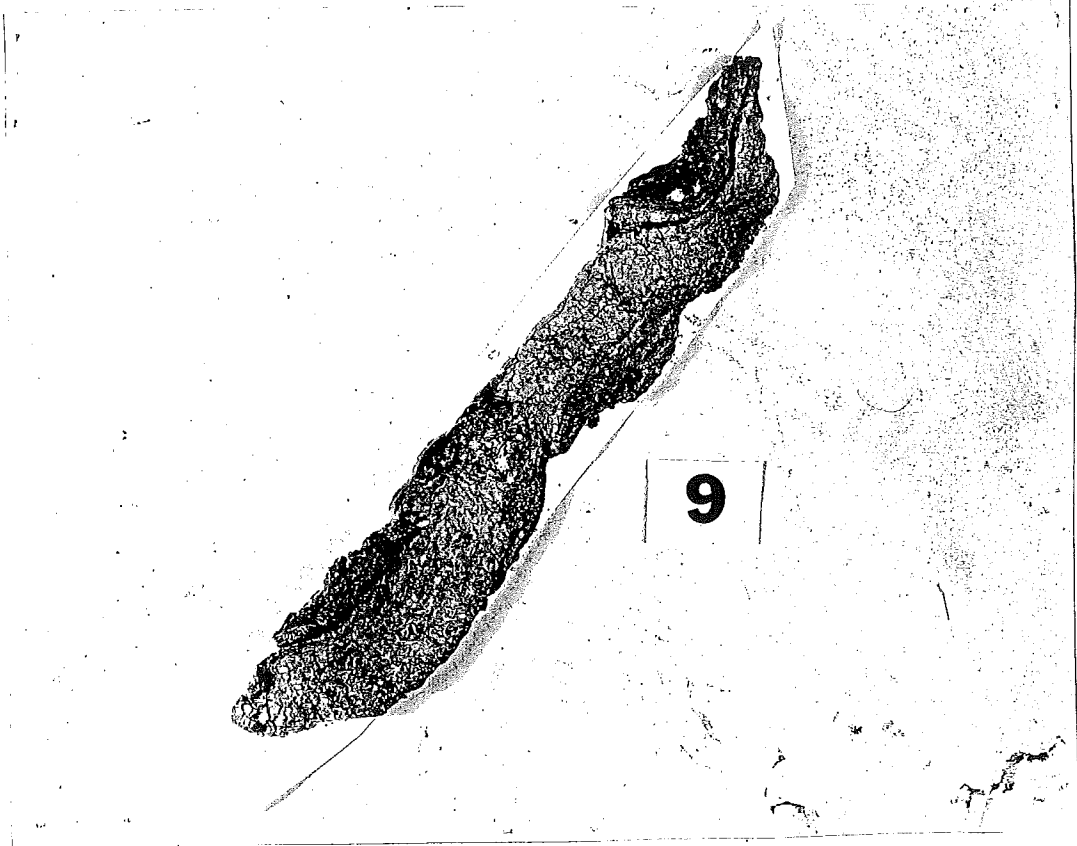
B - No. 9 Thermoplastic 53039, station 45+00
