DEPARTMENT OF STATE HIGHWAYS

Subject: Joint Repairs on M 59 Near Howell. Research Project 39 F-7(14).
Research Report No. R- 693

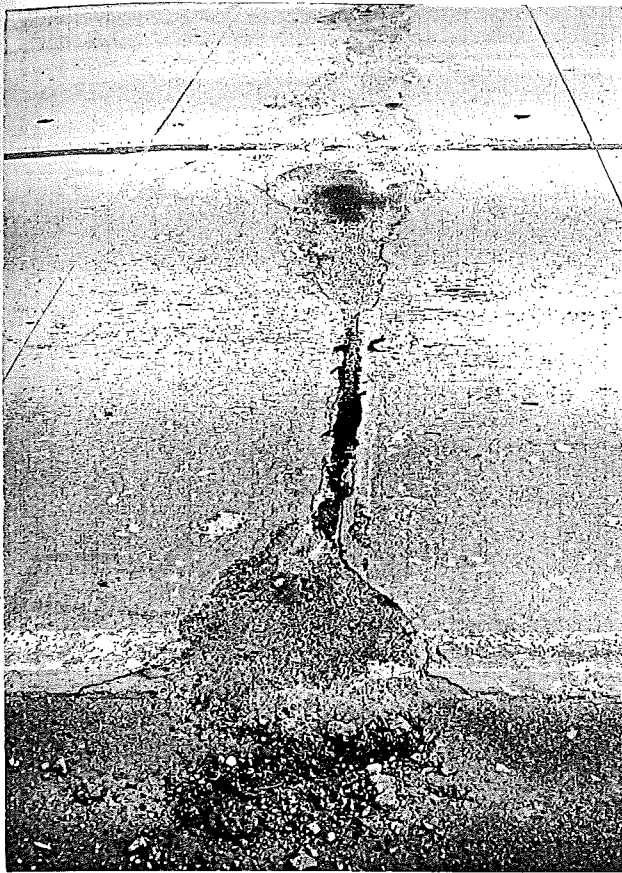
All surface deterioration was similar to that shown in Figures 1-5. The depth of deterioration was difficult to ascertain because of extensive bituminous patching. Condition surveys were taken on 47082, C1 & C2 at initial, six, and ten year levels. These surveys show deterioration on 0, 27, and 86 percent of the joints, respectively, at the time of the surveys. Project 47-26, C6 was surveyed at one, five, ten and nineteen year levels and showed 2, 52, 88, and 97 percent, respectively, of the joints had developed deterioration. Project 47-26, C8 was surveyed at initial, four, ten, and fifteen year levels and showed 4, 18, 81, and 90 percent, respectively, of the joints had developed deterioration. This indicates the deterioration began to develop early in the life of the pavement.

Figure 1. Typical joint condition showing extensive spalling. This joint is to be repaired. Project 47-26, C6.

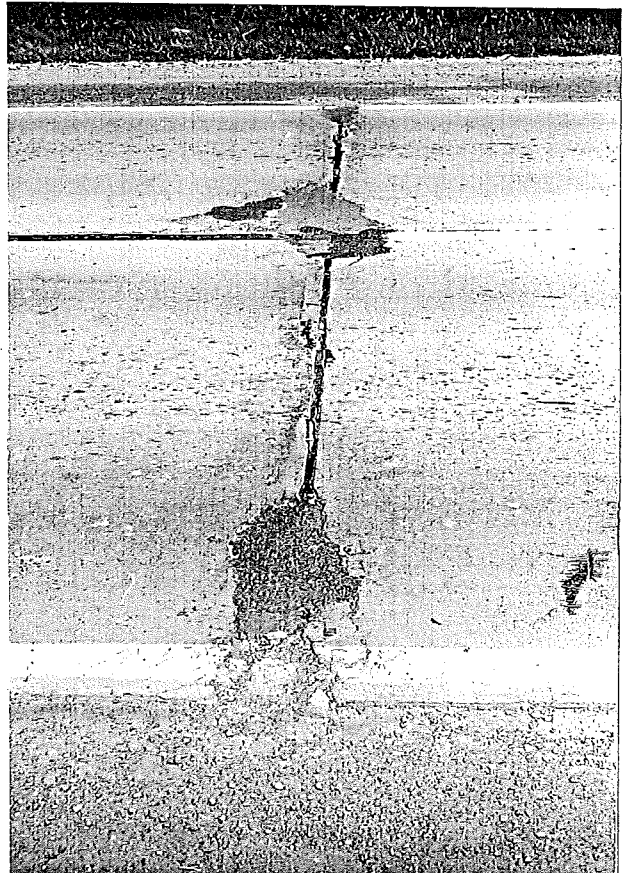
Figure 2. Typical joint condition. This joint is not to be repaired but will probably need attention in the near future. Project 47-26, C6.

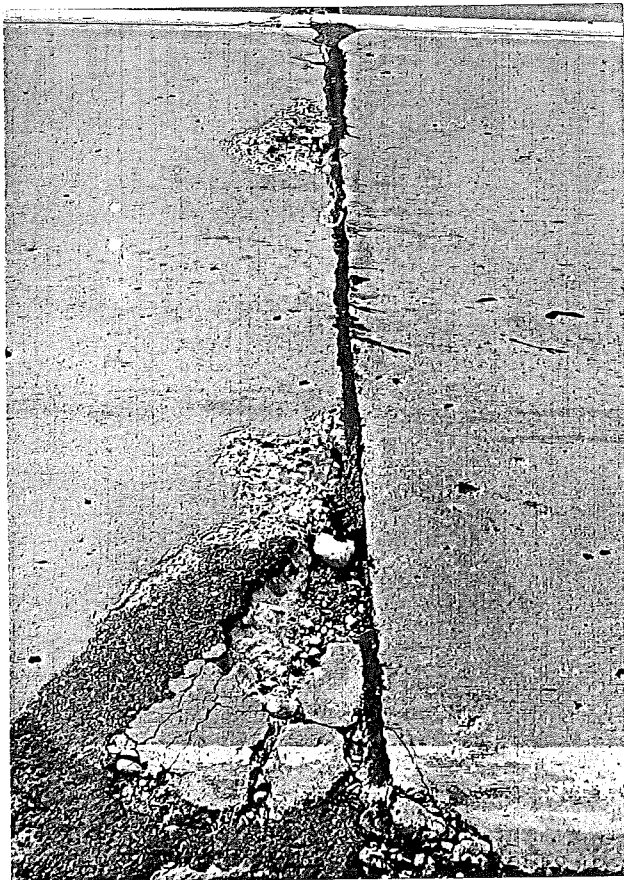
Figure 3. Typical joint condition. Note extensive deterioration and spalling of concrete. Project 47082, C2.

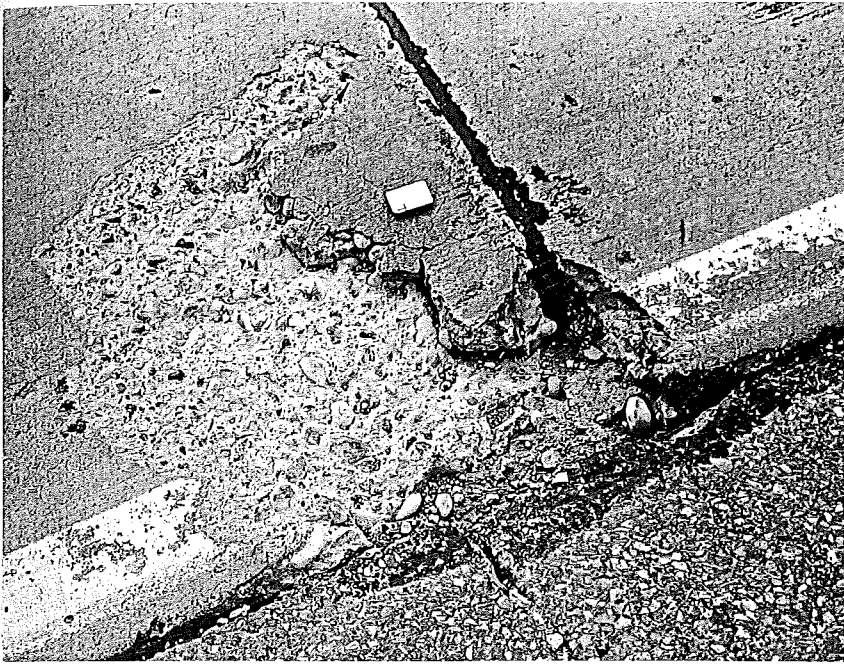
Figure 4. Typical failure indicating possible overfinishing of concrete near joint. Project 47082, C2.

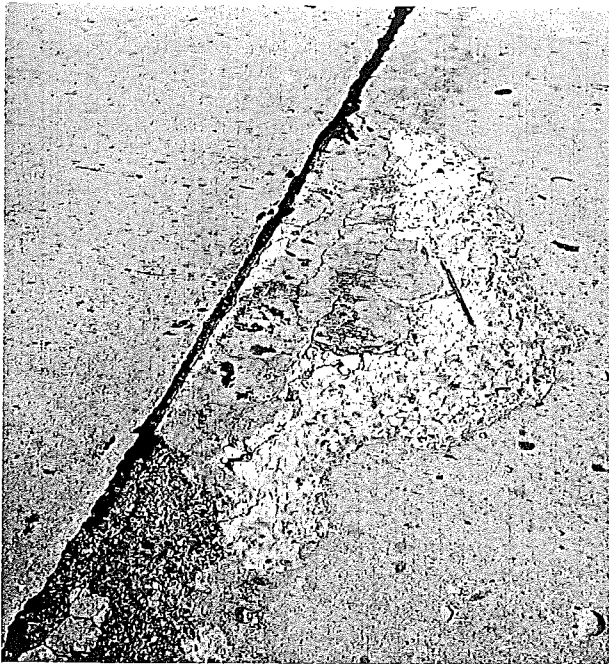
Figure 5. Typical failure indicating possible overfinishing of concrete. Project 47082, C1.

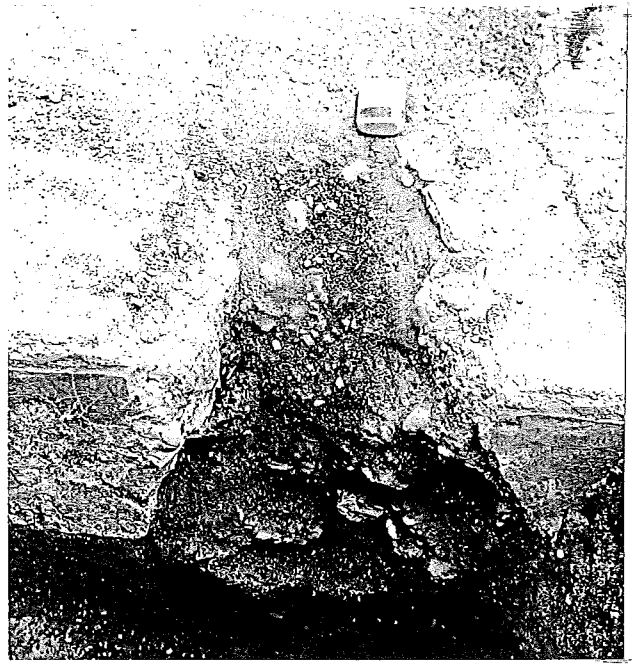
Two joints were investigated by removing shoulder material at the end of the joint. The first of these joints was a contraction joint which was scheduled to be repaired. Figures 6-8 show the condition of this joint. The concrete was found to be extensively deteriorated throughout its depth. Dowel bars were corroded (Fig. 9) and the wire mesh near the joint was rusted through. Condition surveys taken by this unit at the four-year stage note

Figure 6. Joint at 316+00. Note deteriorated concrete at bottom of joint. Project 47-26, C6.

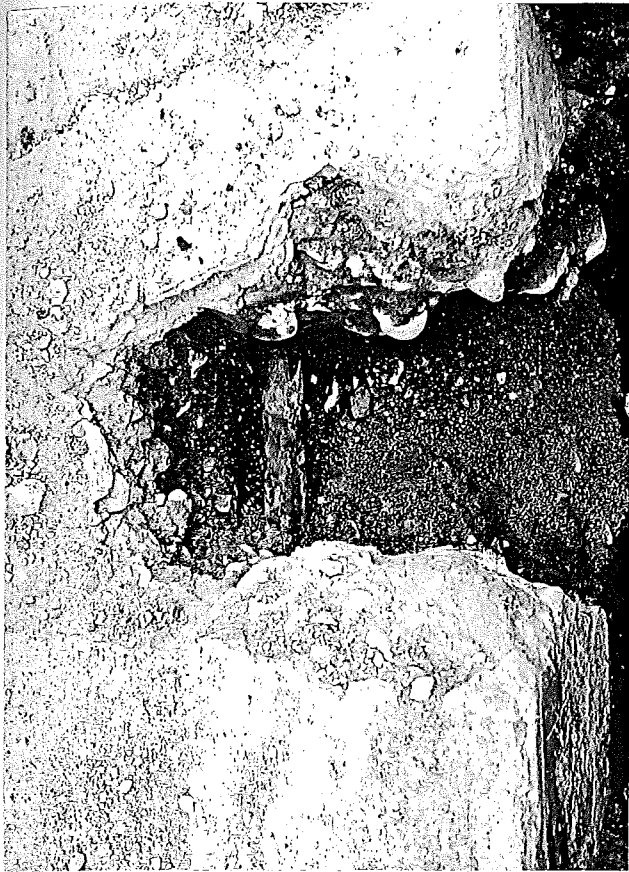
Figure 8. Joint at 316+00. Note deteriorated concrete and corroded dowel bar. Project 47-26, C6.

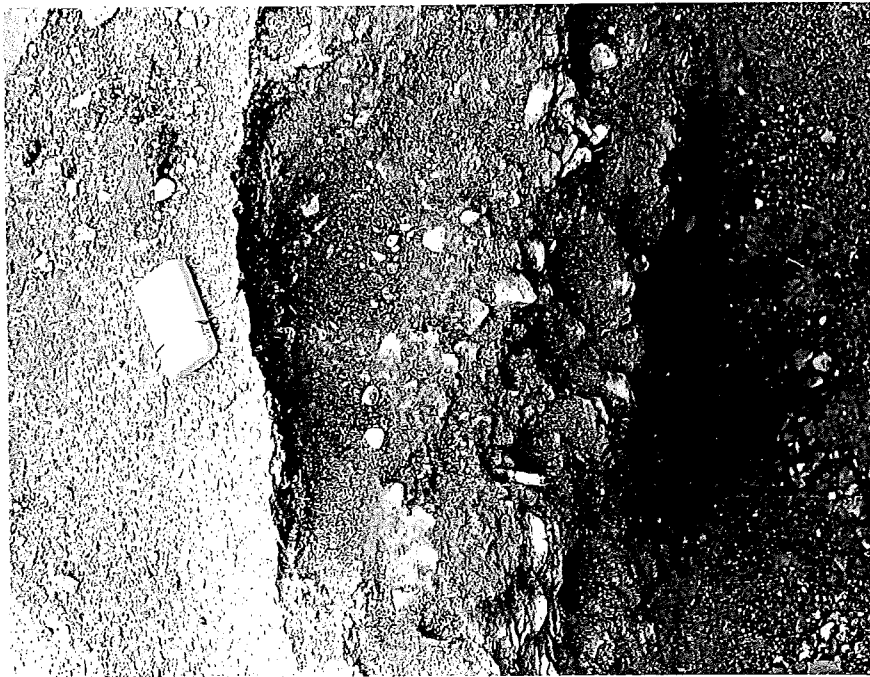
Figure 7. Joint at 316+00. Note deteriorated concrete and exposed wire mesh. Project 47-26, C6.

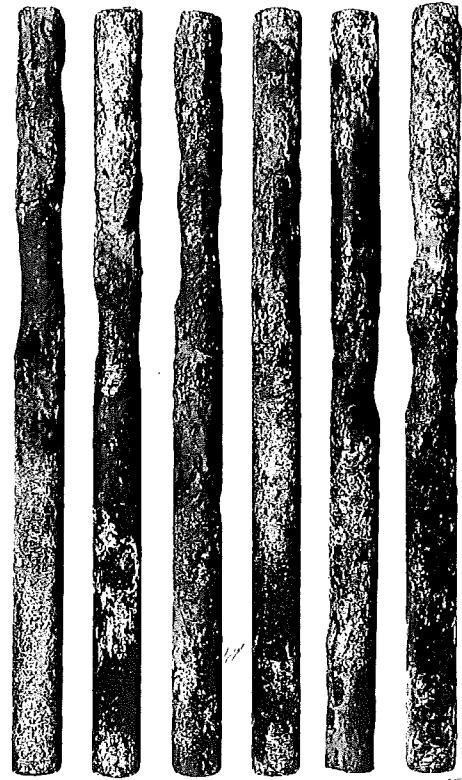
Figure 9. Typical condition of dowel bars showing extensive corrosion which has taken place. Taken from Project 47-26, C6.

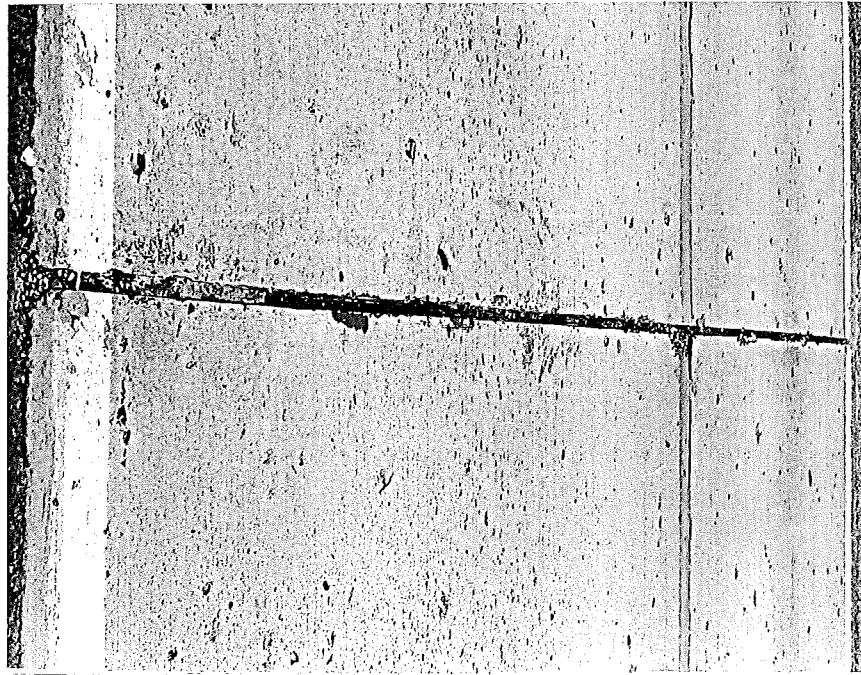
Figure 10. Expansion joint at 568+49. Note failure of joint material and the intrusion of foreign particles. Project 47-26, C8.

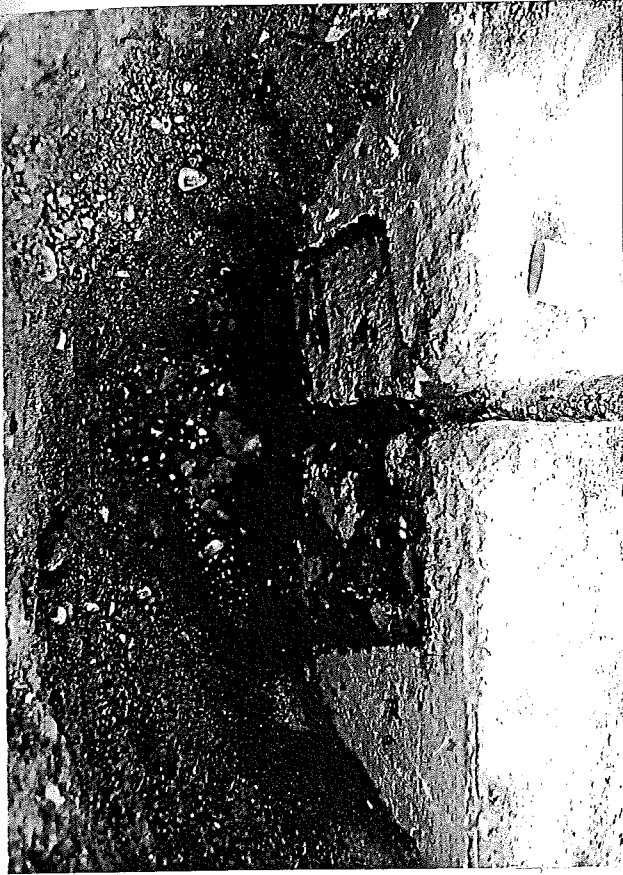
Figure 11. Joint at 568+49. Note presence of much sounder concrete and lack of surface deterioration. Project 47-26, C8.

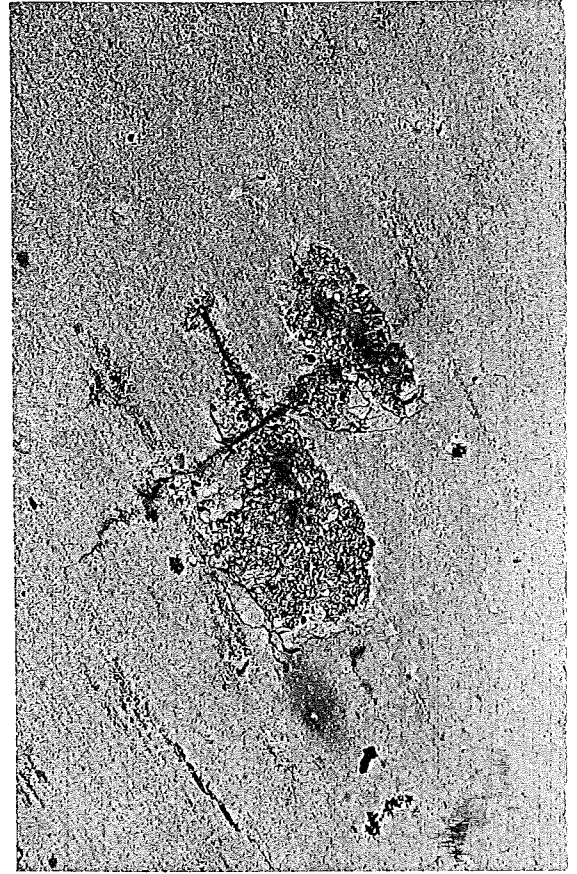
Construction records for 47-26, C8 note that a problem was encountered with the wire mesh sliding during the pouring of concrete. It was not stated how many joints were effected by this but steps were being taken to eliminate the problem. This left a length of mesh near the joint which was pulled up, cut off, and forced back into the concrete by hand. This process suggests the possibility of overworking the concrete near the joint and also the possibility of disturbing the alignment of the dowel bars. Either of these conditions would increase the susceptibility of the joint to damage. Due to the method used in removing the concrete in the area to be repaired, it was impossible to determine the alignment of the dowel bars. Hand forcing the wire mesh into the concrete also left the steel at random depths throughout the slab, with several locations where the steel is visible at the surface (Fig. 12).

Figure 12. Wire mesh exposed in concrete surface. Project 47-26, C2.

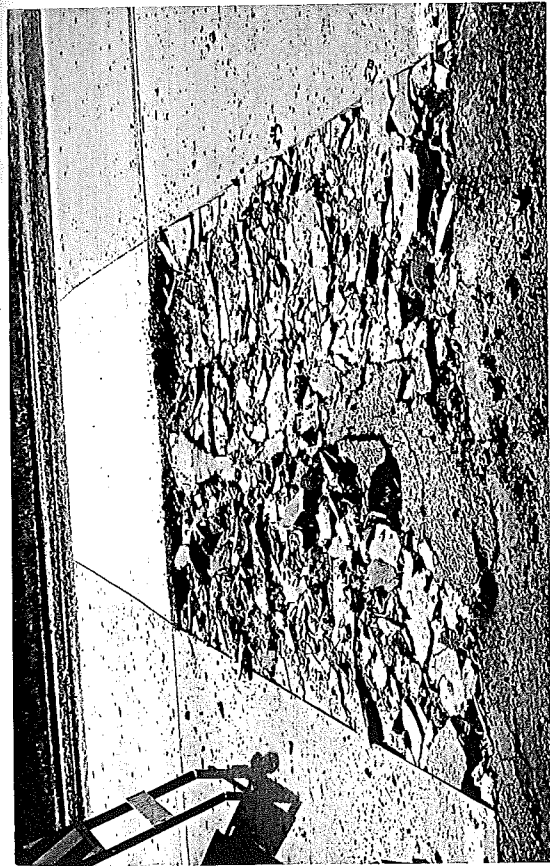
Figure 13. Joint repair in progress. Saw cuts have been made and concrete broken with drop hammer. Project 47-26, C6.

The repair of these joints as prescribed by the Maintenance Division and Project Engineer P. W. Bergmann, has been completed. The process involved sawing to a five inch depth along each end of the area to be removed. The concrete was then broken-up using a drop hammer and removed (Fig. 13). This drop hammer technique of removal resulted in damage of the remaining concrete below the saw cut as shown in Figure 16. A form was placed at the outside edge of the pavement and the subbase was filled and compacted to allow a nine-inch pour of concrete. No ties were provided to the existing pavement. In cases where the entire 22 ft width was to be replaced, it was done in two 11 ft pours (Fig. 17), with tie bars placed transversly at the centerline joint. Measurements are presently being made on a similar repair job on US 127 south of Hudson to determine the effectiveness of this form of concrete patch.

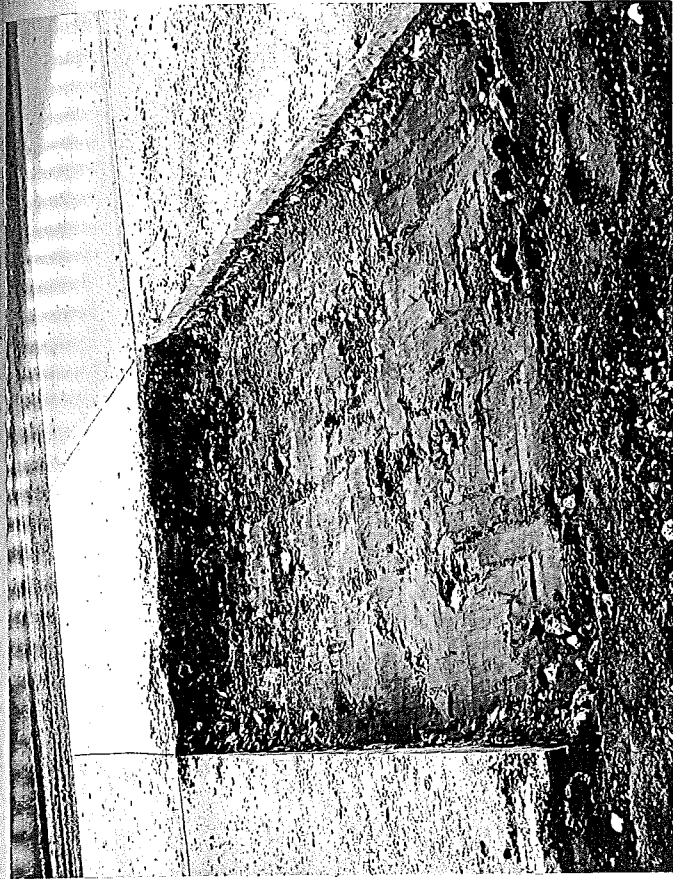
Figure 14. View after concrete has been removed. Project 47-26, C6.

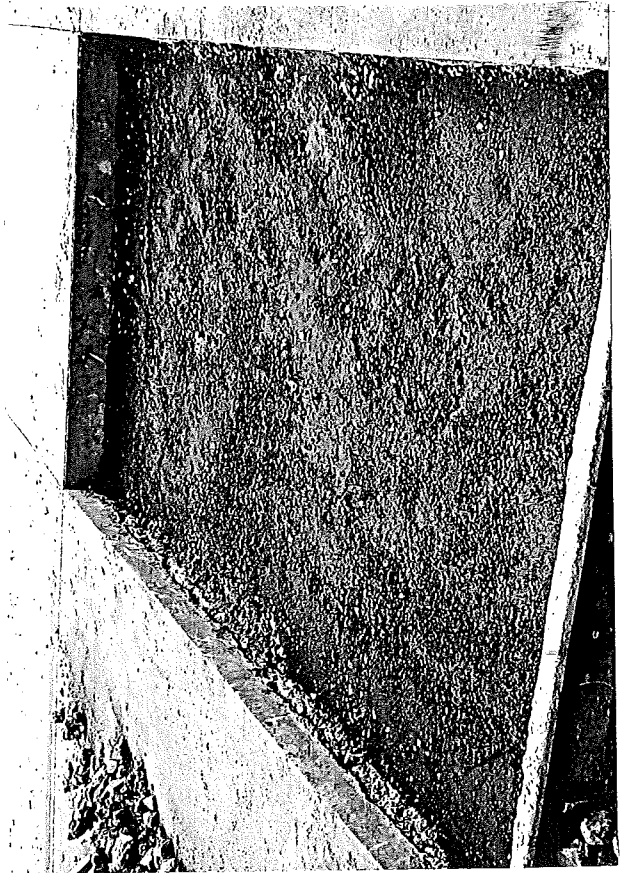
Figure 15. Form in place and subbase filled, leveled, and compacted. Note tie bars to previously poured section. Project 47-26, C6.

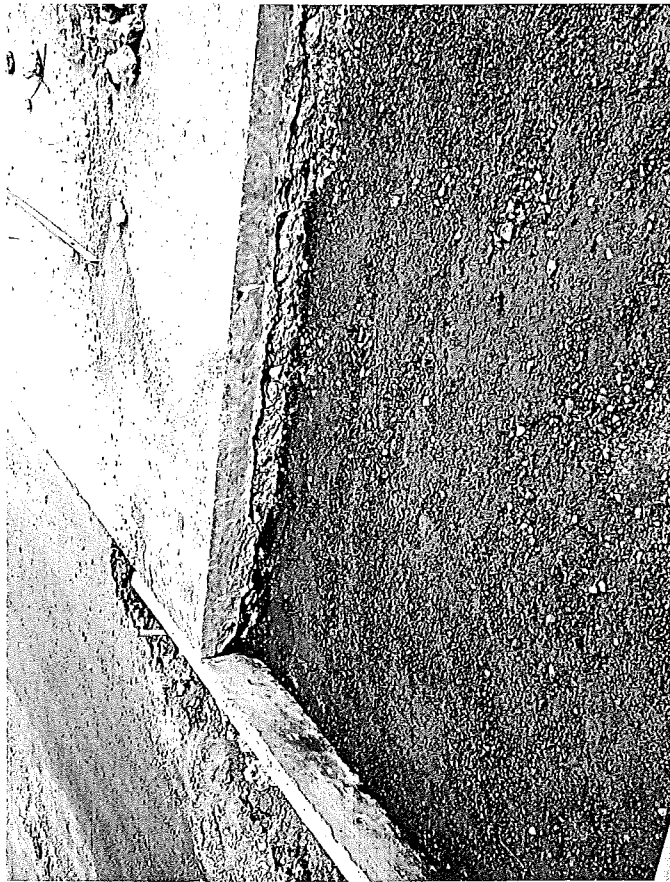
Figure 16. View of damage to remaining pavement caused by breaking out the concrete to be removed. Project 47-26, C6.
