1962 OBSERVATIONS ON CONDITION OF  
EXPERIMENTAL POZ-O-PAC SHOULDER CONSTRUCTION  
Construction Projects BU 56044, C3UN and C4UN

Research Laboratory Division  
Office of Testing and Research  
Research Project R-59 E-18  
Report No. R-410

Michigan State Highway Department  
John C. Mackie, Commissioner  
Lansing, January 1963

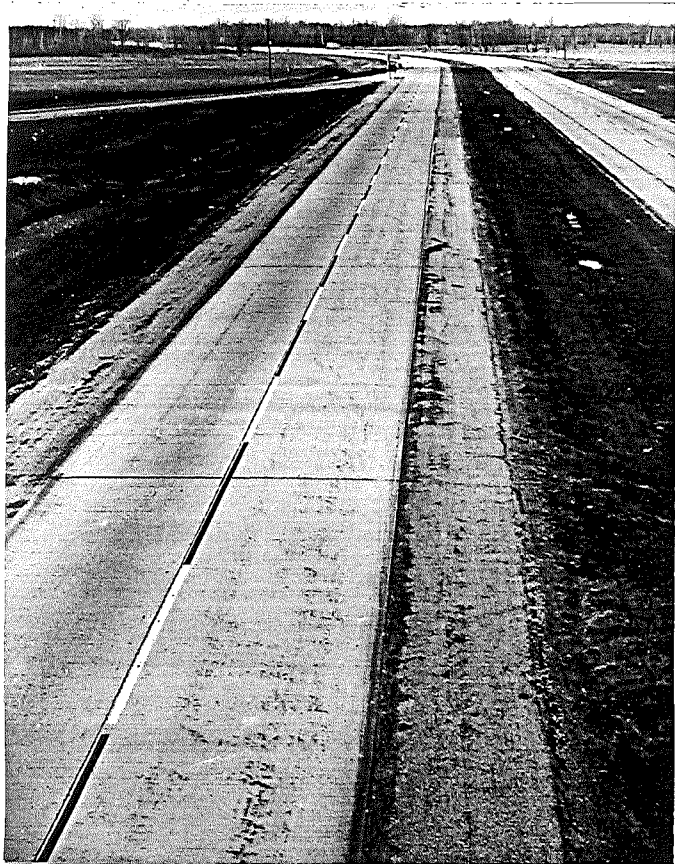
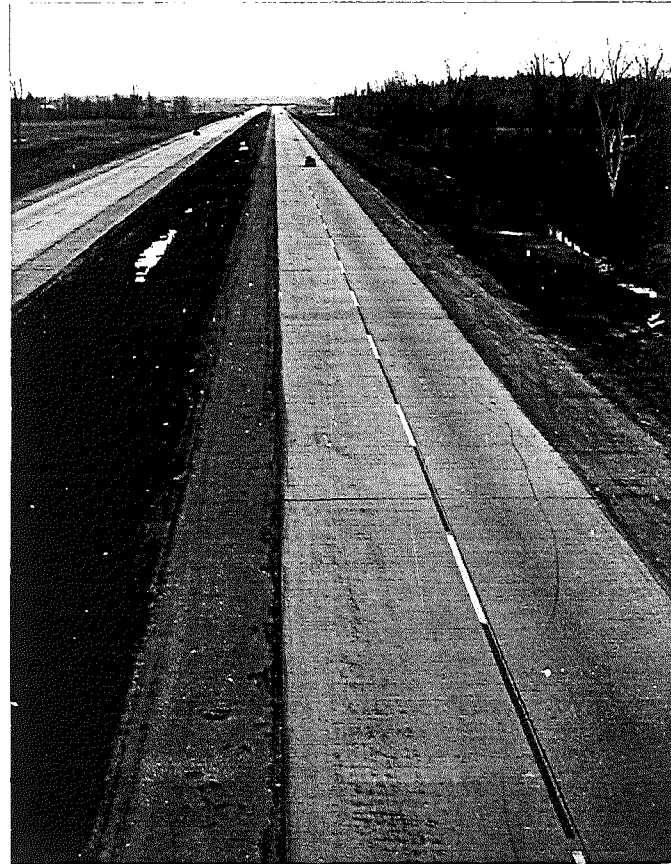
The project was inspected and cores obtained during February and March of 1962. Figs. 1 through 4 show the general appearance of the surfacing at that time. The asphalt seal was poorly bonded to the Poz-O-Pac base and in many areas had been torn by snowplow blades. The top 2 or 3 in. of Poz-O-Pac was very soft and loose even in areas where the seal had not been damaged. The gravel Poz-O-Pac areas showed the most serious surfacing damage (Fig. 5). The surface of the sand Poz-O-Pac shoulders was generally bad along the inner edge of the median shoulder. The outer shoulder, though soft, had retained most of its seal coat. Fig. 6 shows the damage observed along the edges of each type shoulder later in the spring, when the surface was somewhat drier. There was no indication of any bond between particles in the top 3 in. of the material.

Figure 1. Gravel Poz-O-Pac shoulders from Waldo Road bridge (April 1962).

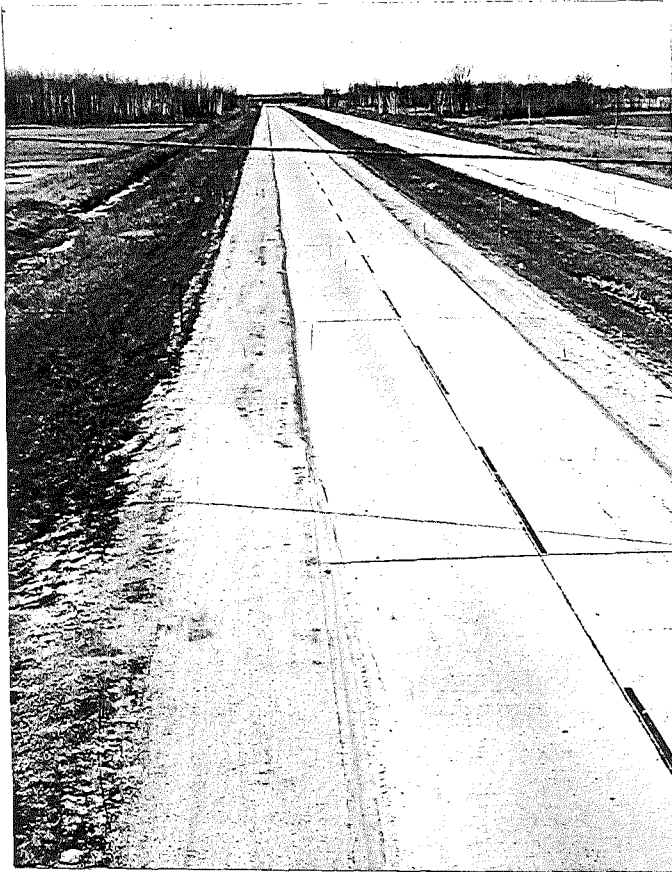
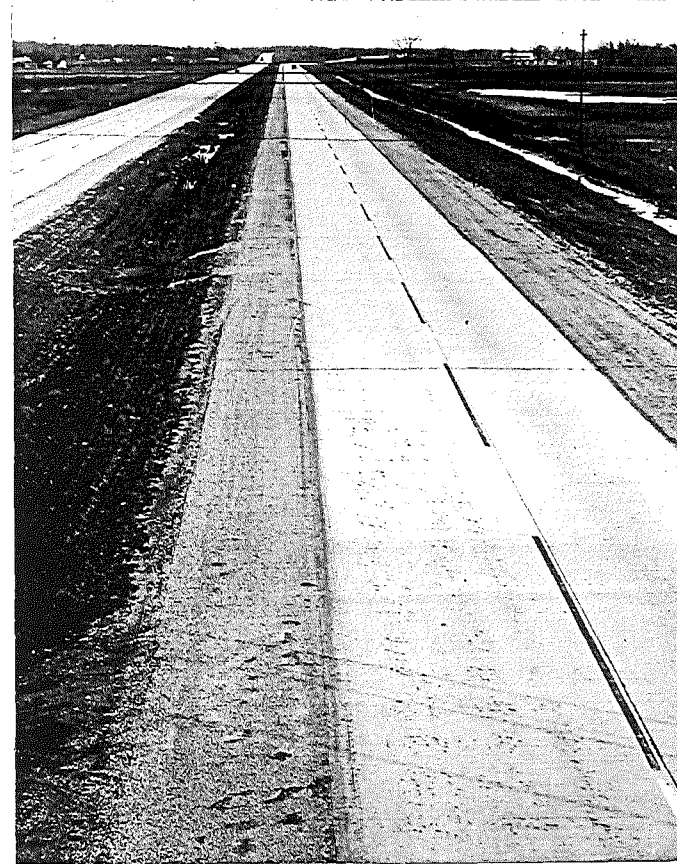
Figure 3. Gravel Poz-O-Pac shoulders from Ashman Street bridge (April 1962).

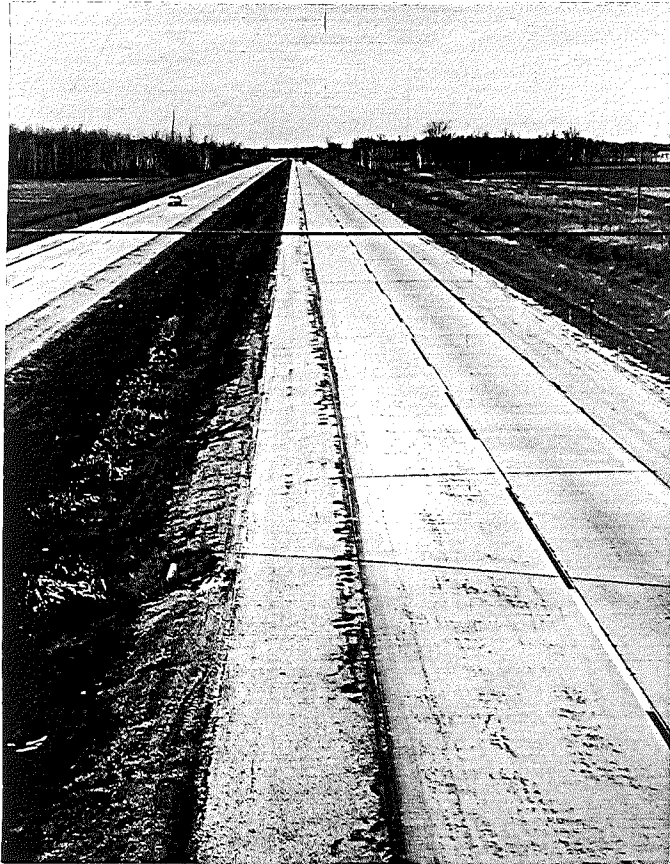
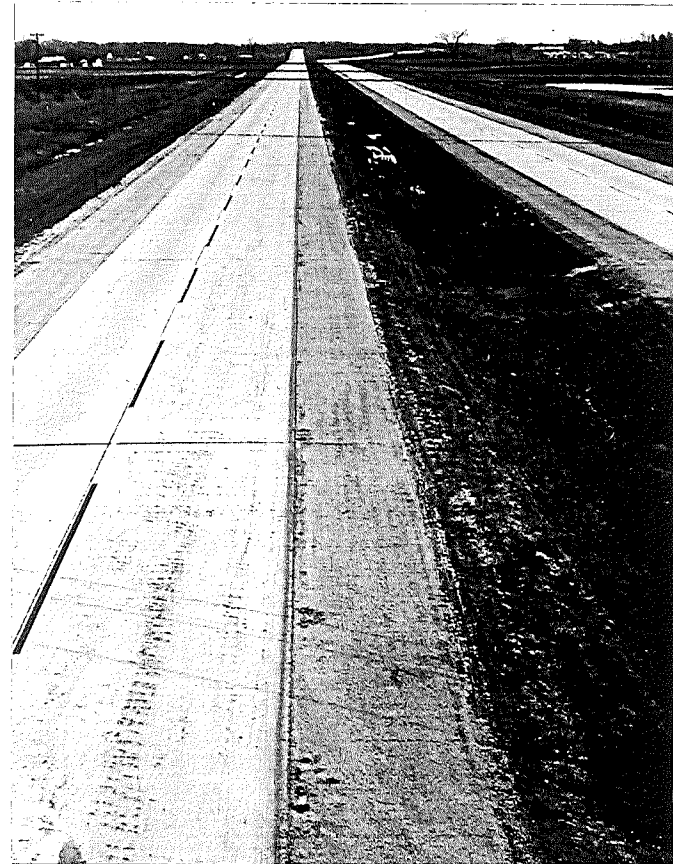
Figure 4. Sand Poz-O-Pac shoulders from Ashman Street bridge (April 1962).

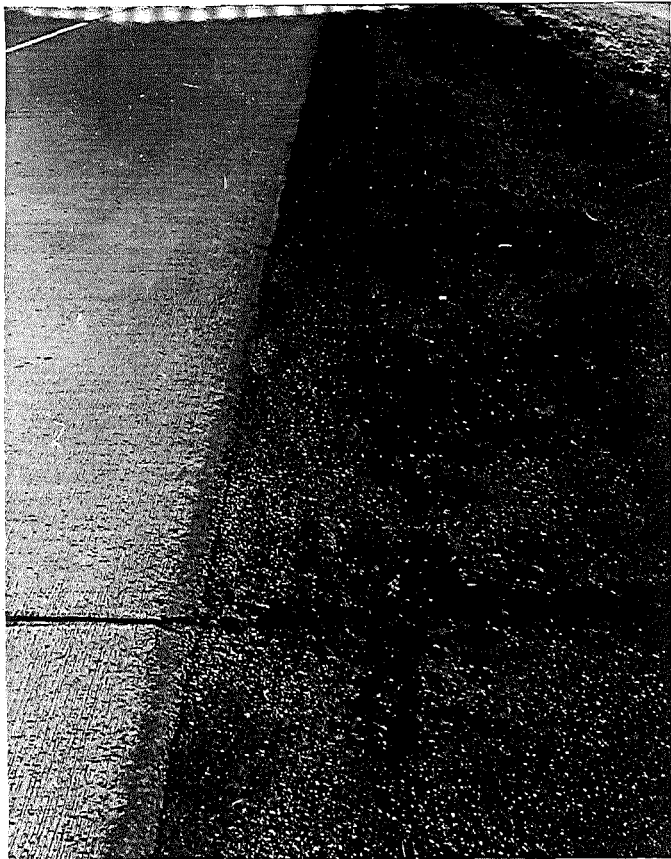
Station 1671+30 -.Inner Shoulder.

Figure 5. Loose condition of gravel - Poz-O-Pac shoulders (February 1962).

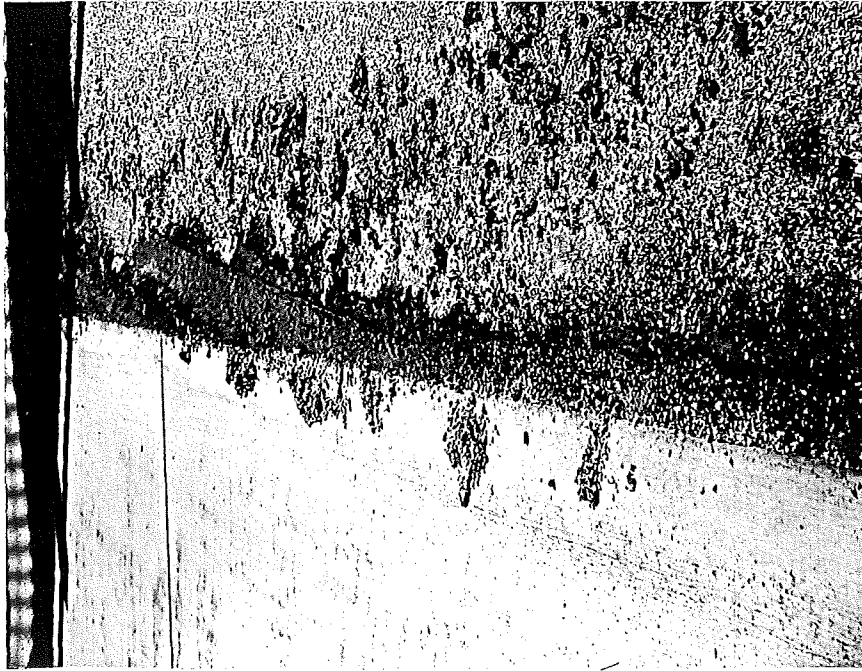
Sand Poz-O-Pac.

Figure 6. Loose Poz-O-Pac at edge of shoulders (April 1962).

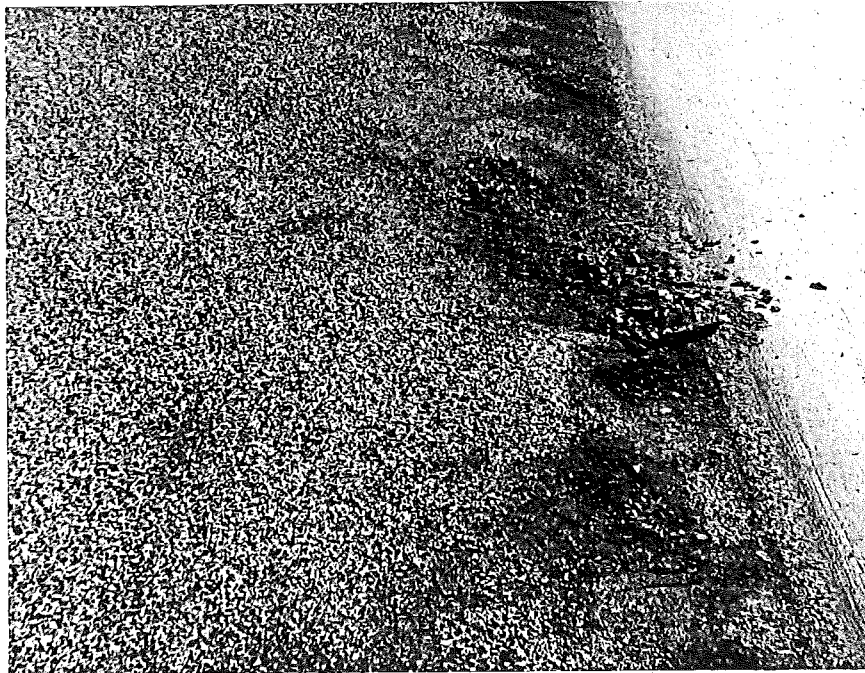
Gravel Poz-O-Pac.

Fig. 7 shows breakup of the two inner shoulders when subjected to traffic at a crossover location; it can be seen that the Poz-O-Pac areas are in poor condition.

Figure 7. Failure of Poz-O-Pac inner shoulders at crossover (April 1962).

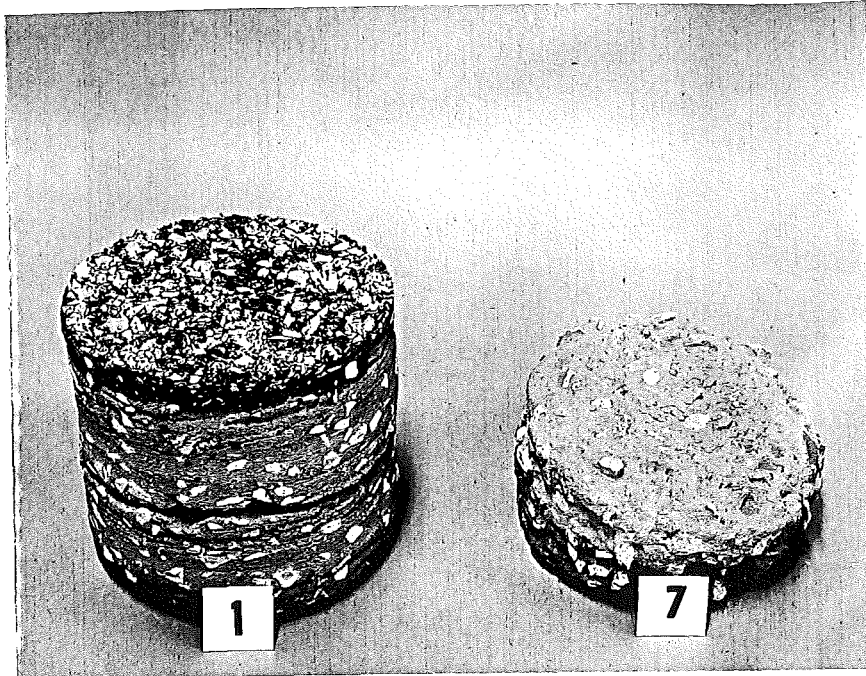
Sand Poz-O-Pac cores.

although there were a few areas where only poor cores could be secured. Average compressive strength in the sand area had increased to 400 psi and in the gravel to 1150 psi. These values compared well with similar values obtained the previous fall, indicating how summer temperatures had set up the Poz-O-Pac. Fig. 9 shows the variation in cores obtained throughout the job. Densities had stabilized during the summer and were approximately the same as the previous fall.

Figure 9. Typical good and poor cores obtained (October 1962).
