EXPERIMENTAL STEEL-FIBER-REINFORCED  
CONCRETE OVERLAY

MICHIGAN DEPARTMENT OF STATE HIGHWAYS

Research Laboratory Section  
Testing and Research Division  
Research Project 72 F-127  
(Work Plan No. 15)  
Research Report No. R-852

An Experimental Project  
By the Michigan Department of State Highways  
In Cooperation with the Michigan Concrete Pavers Association  
And the Federal Highway Administration

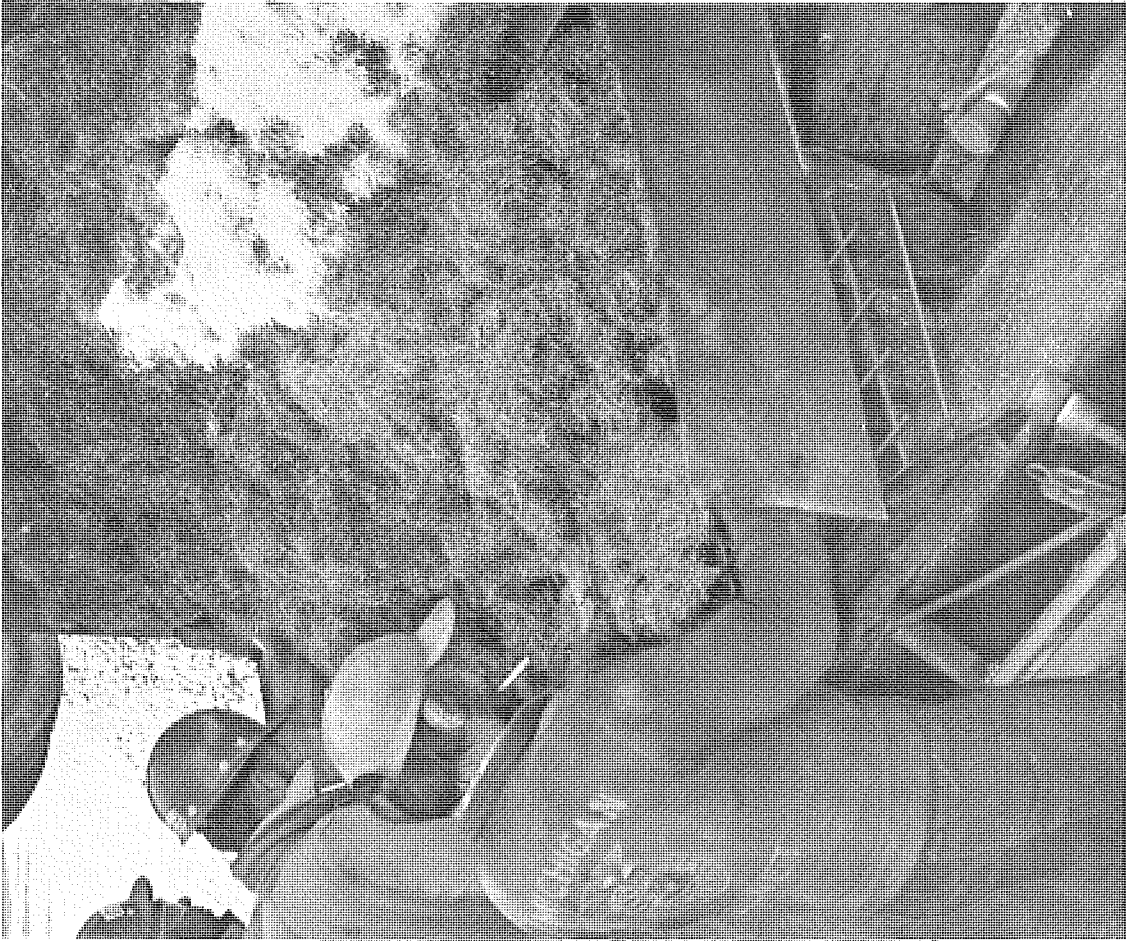
The method finally used to handle the fibers was mainly manual. Boxes of fibers were dumped by hand into an end loader. The loader then transported the fibers to a table and hopper assembly that was built over a conveyor belt. Workmen then raked the fibers into the hopper, and worked them through a wire mesh screen onto the belt, as shown in Figure 2.

Figure 2. End loader delivers fibers to table and hopper where workmen rake them through the screen.

and at one time prepared the mix at a rate equivalent to about 90 cu yd per hr, for a few loads. It seems evident that the development of specialized bulk handling and screening equipment for the steel fibers (probably vibratory in nature) would pay dividends in both quantity and quality of the fibrous mix produced.

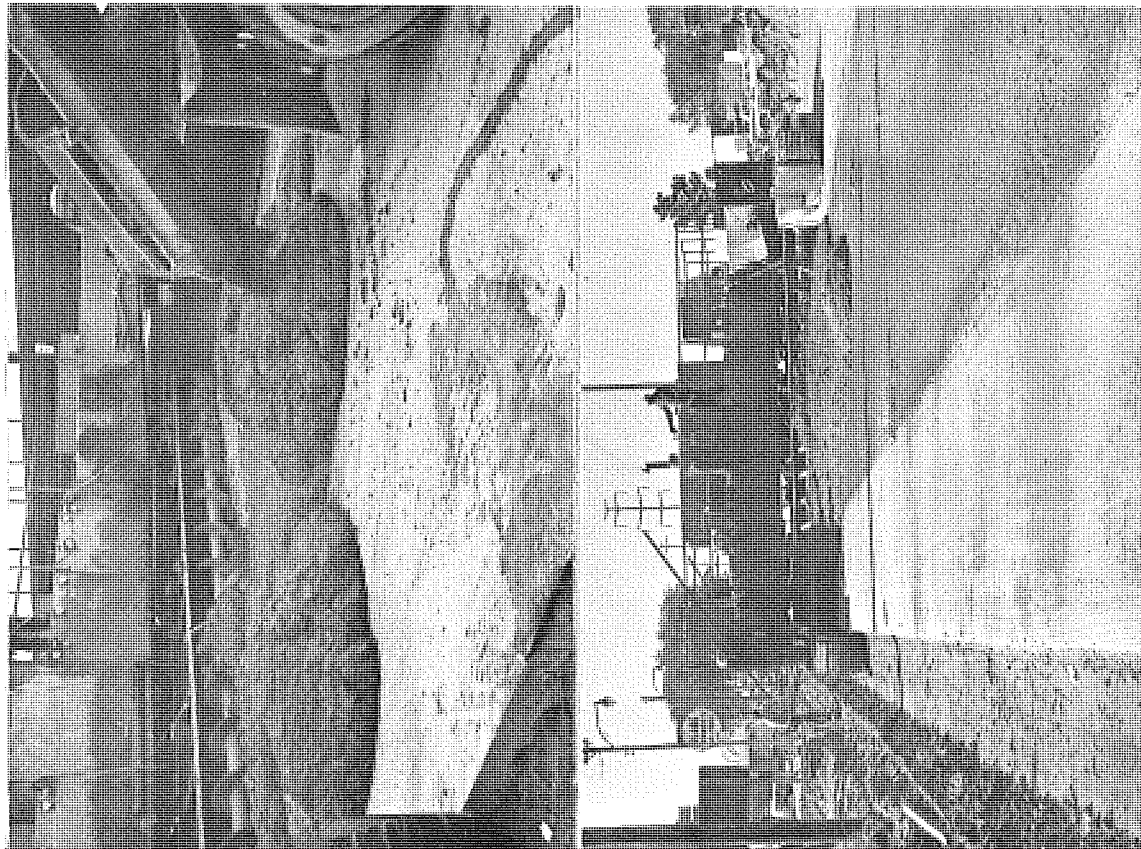
Figure 3. Slipform paver (24-ft) placing fibrous mix; second pass, outside lanes. Note new 6-ft base course widening in foreground, and tracks running on previously placed overlay at the right.

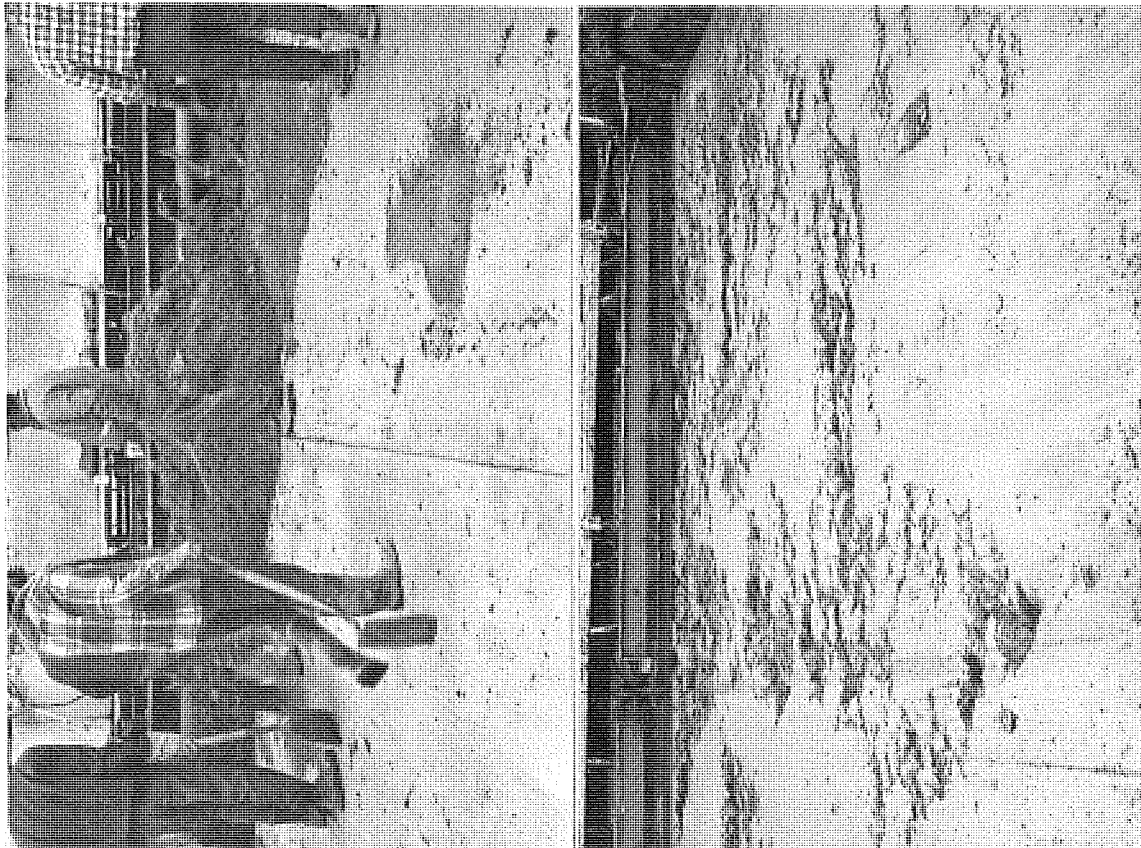
The first load of concrete was quite stiff, as shown in Figure 4. Since the fibers tend to inhibit flow of the mix, and the thickness of overlay was only 3 in., a torn surface resulted when the paver moved forward. The machine was backed over the area, some wetter concrete added, and a suitable finish accomplished. Later deliveries with slump of around 3 in. were placed and finished without problems.

Figure 4. Dry concrete mix (upper) resulted in torn surface behind the paver (lower). A second pass with wetter mix finished the area suitably.

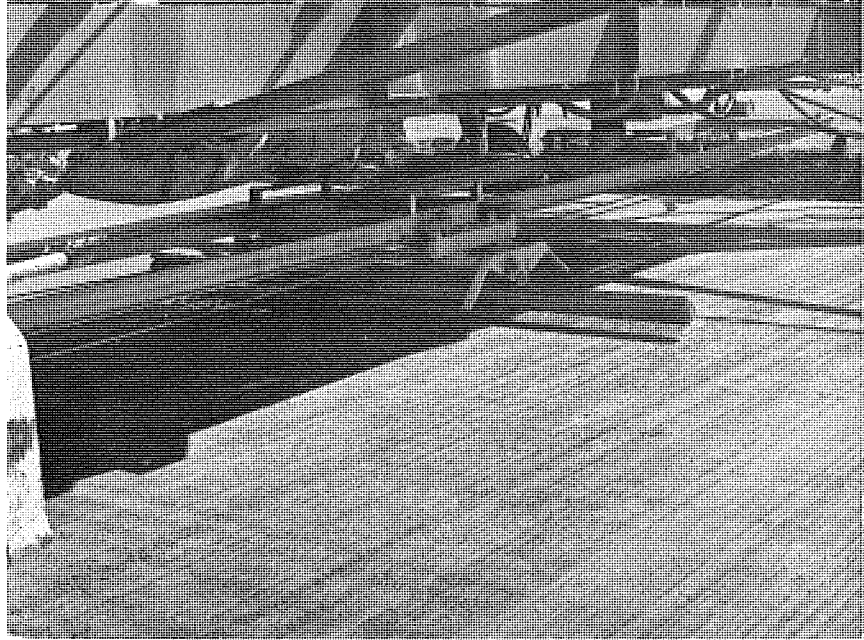
Previous mention has been made of small fiber balls in the mix. Figure 6 shows the appearance of such balls in the surface of the overlay, behind the paver. Apparently such balls absorb moisture and fines from the mix, causing small depressions in the surface that become more obvious with passing time. Some of these balls were removed by workmen during

Appearance of fiber ball in the fresh concrete. Water absorption by the balled fibers cause surface depressions that become more obvious sometime after finishing.

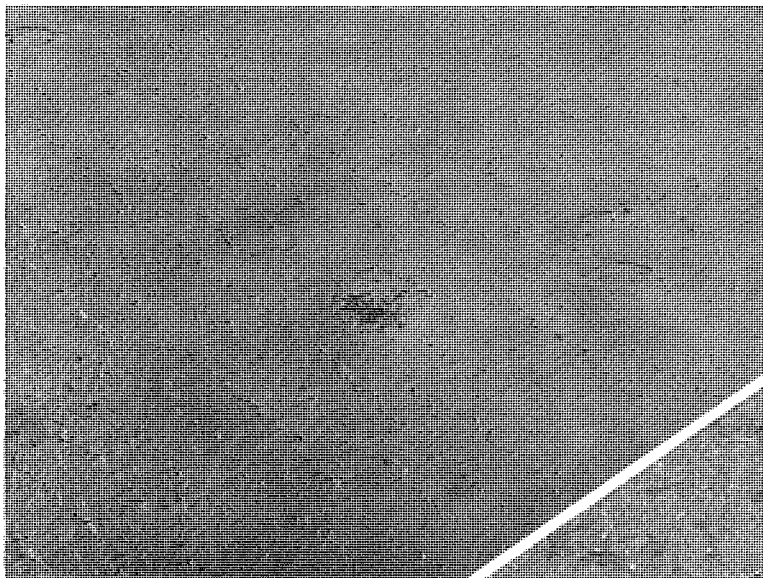
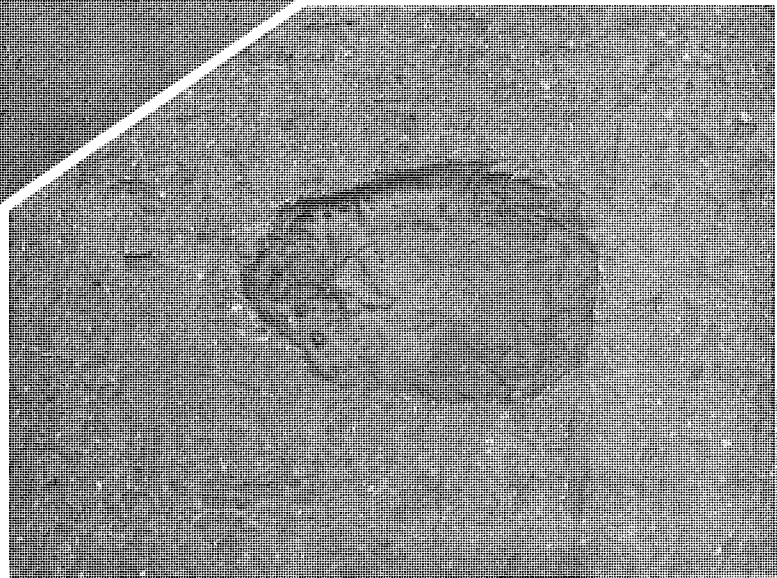
Figure 6. Fiber balls in the concrete overlay.

Appearance of surface failure after three month's service. Loose fibers are visible in water that had collected in the hole.

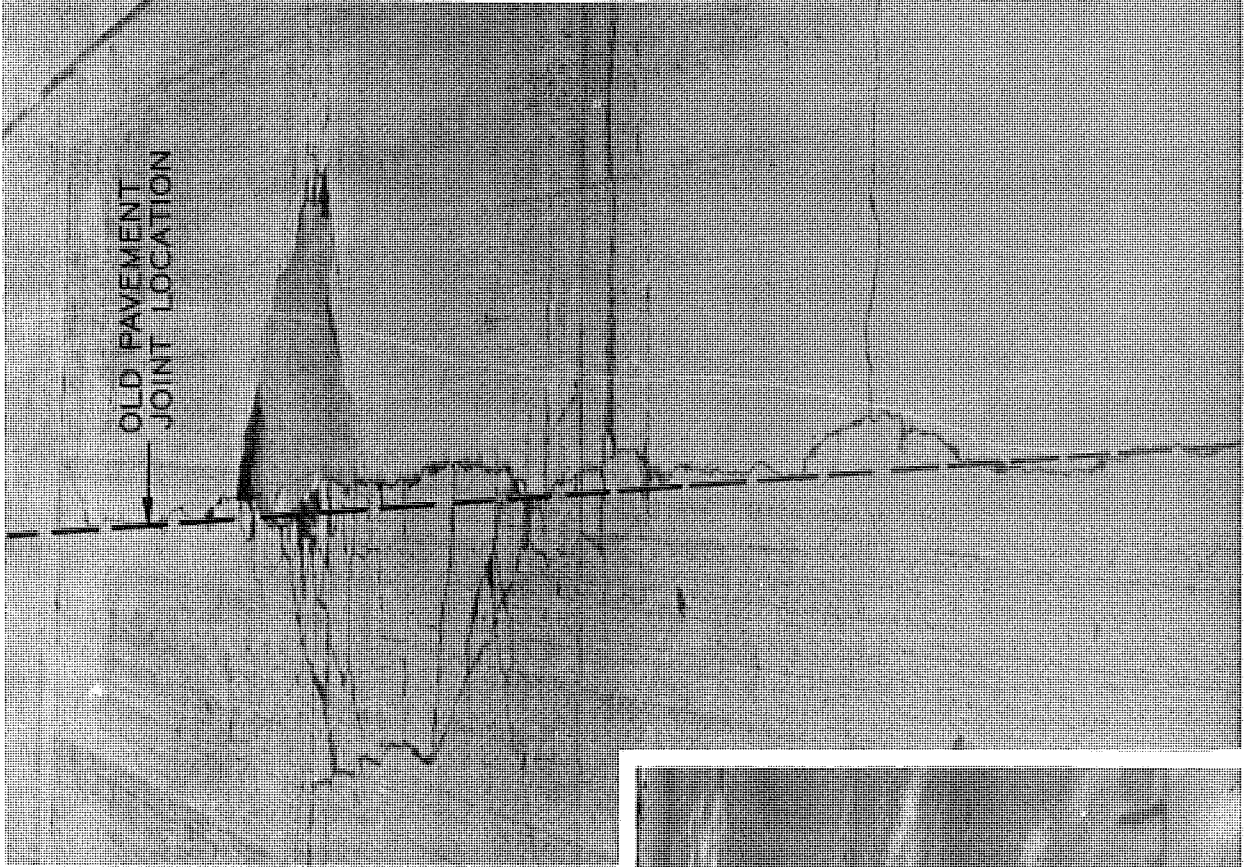
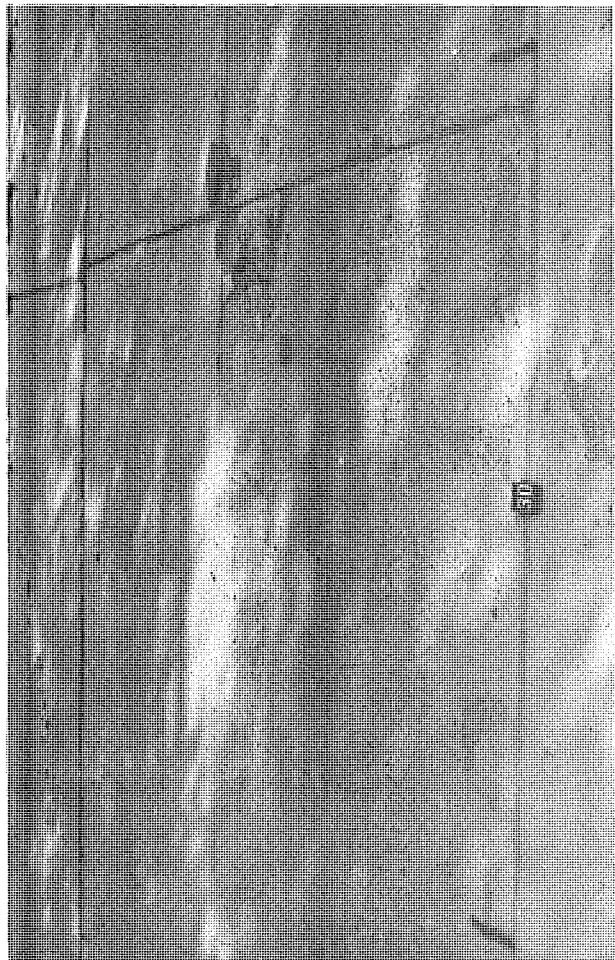
Several reflective cracks have developed over joints and cracks in the old pavement, and closely spaced fractures have developed in some localized areas. The worst deterioration that has developed to date does not appear to be totally the result of the pavement conditions underneath the overlay. Figure 8 shows the most seriously deteriorated section of the roadway, along with a view of the underlying pavement. It appears that the fractured area in the overlay exceeds the dimensions of the deterioration in the old pavement. This would seem to indicate a lack of strength or thickness of the overlay. Apparently the existing crown and grade in lanes 1 and 2 at the western end of the installation were such that the planned minimum thickness was not obtained. It appears that the overlay may be only 1-1/2 to 2 in. thick in several locations. Undoubtedly better curing conditions or longer cure before opening to traffic would have made some improvements

Figure 8. Most seriously deteriorated area of the overlay near west end of 120 lb per cu yd section, along with a view of the old pavement. Note that the fractured area extends well beyond the old corner-break.

The area shown in Figure 8 has deteriorated still more, and it was determined that the fibrous concrete thickness is only about 1-1/4 in. Also, another area known to be thin (refer to top of page 13), has developed closely spaced cracking similar to that shown in Figure 8.

Areas of such small thickness would be structurally inadequate, even if cured under the best of conditions. However, the thin section has additional adverse effects in this case. Such a thin layer of concrete would be drastically affected by the cold weather conditions that occurred during cure. Heat of hydration would be ineffective in maintaining higher temperatures, because of the high surface-to-volume ratio, and the concrete temperature at early age would have been far too low for reasonable strength gain. This has coupled an inadequate thickness with low strength, and the results are obvious to see.

Fibrous concrete appears to be a new material with considerable potential for further application in the field of heavy construction. However, early performance information clearly indicates that great care is needed to make sure that the minimum required thickness is obtained throughout the entire area. Also, insulation of the overlay seems warranted during cold weather curing, if it is necessary to obtain high-early strengths for opening to traffic in a short time.

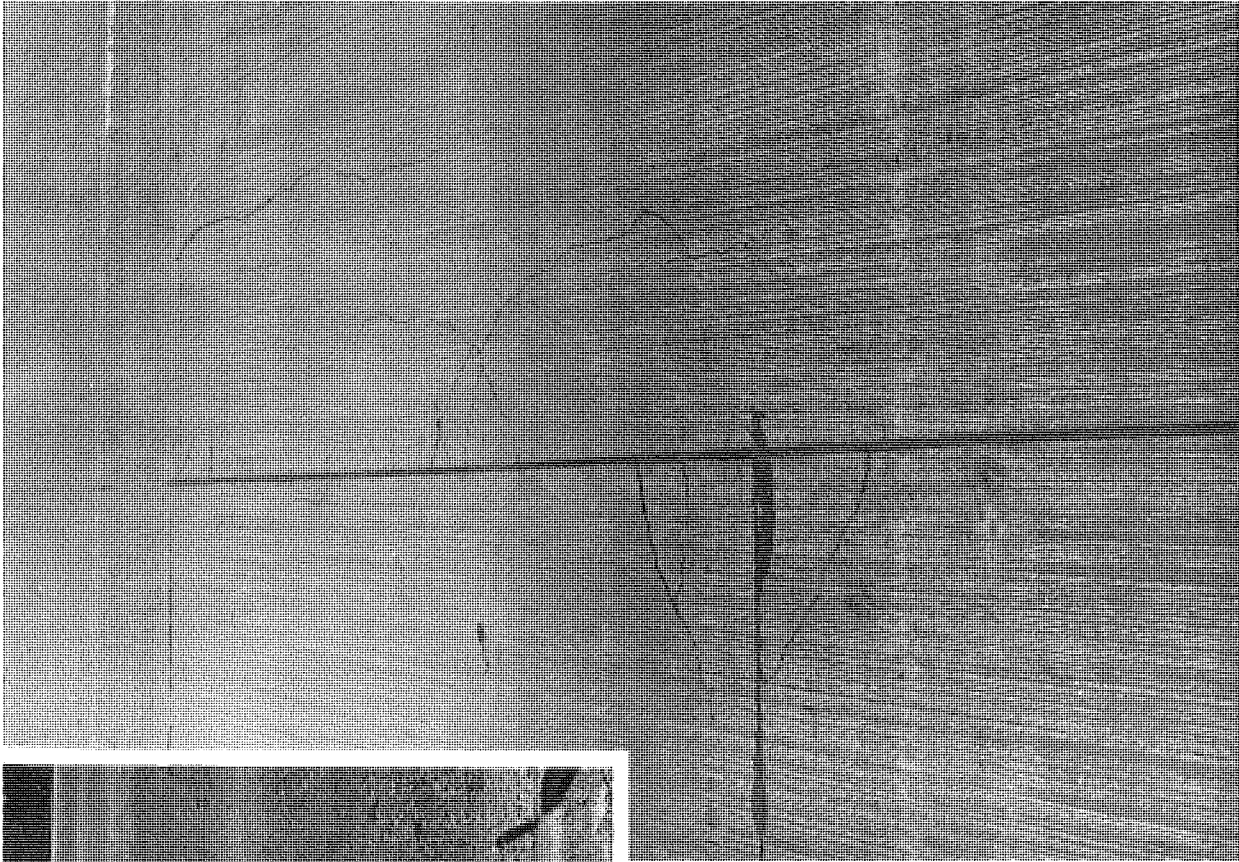
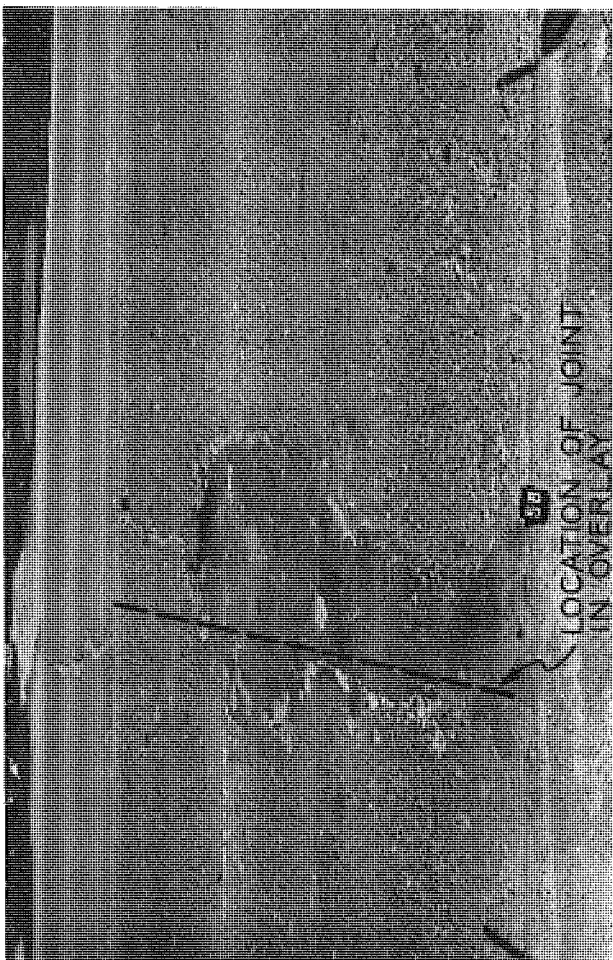
Figure 9 shows an object lesson in the location of joints in an overlay. The crack pattern in the overlay follows the pattern of the bituminous patch. Since this location is within the 120 lb per cu yd section, it may be that a crack pattern would have developed in any case. However, the ability of a given overlay to bridge such an area would be improved by removing the joint to an area with better support.

Figure 9. Deterioration of overlay due to location of joint over bituminous patch in old pavement.
