December 24, 1952

SUBJECT: Joint Failures on Construction Project 63-37, C4,
M-59 between US-24 and Auburn Heights
Research Project 39 F-7(14) - Report 185

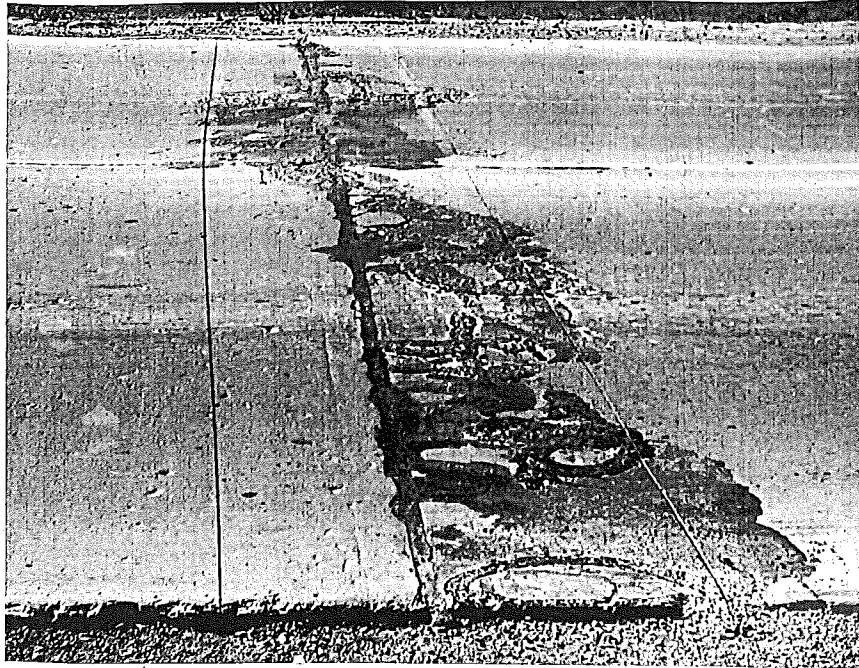
Nothing conclusive as to the cause of these failures could be learned from the usual observations or field survey, so it was decided to open a joint to determine the condition of the dowels. This was done on October 23, 1952, in the presence of C. B. Laird, LeRoy Oehler, and the writer. Pictures showing the condition of the expansion joint at Station 56+27, which was opened, are attached.

Figure 1. Showing condition of expansion joint before opening.
Sta. 56+27

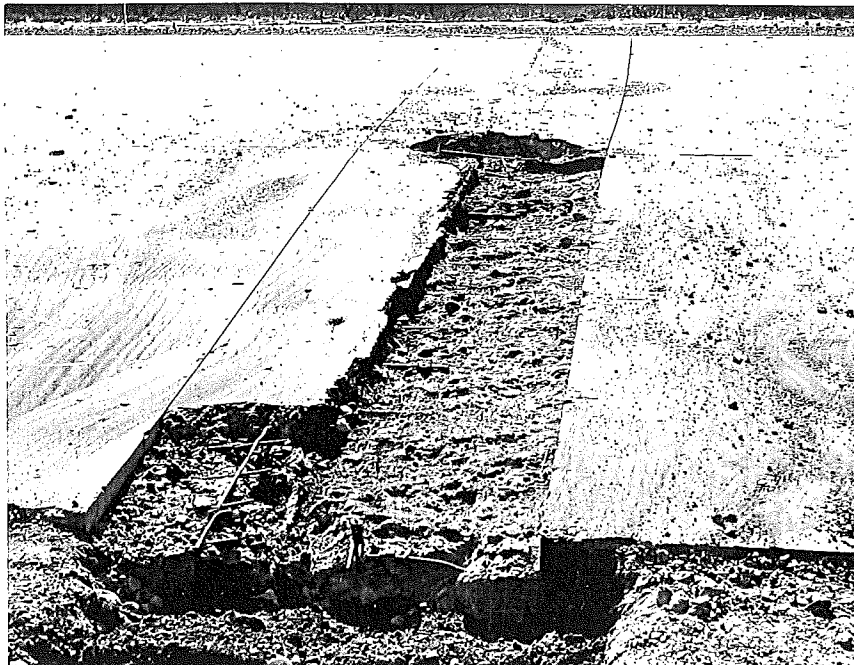
Figure 2. Same joint with spalled concrete partially removed, showing dowels.

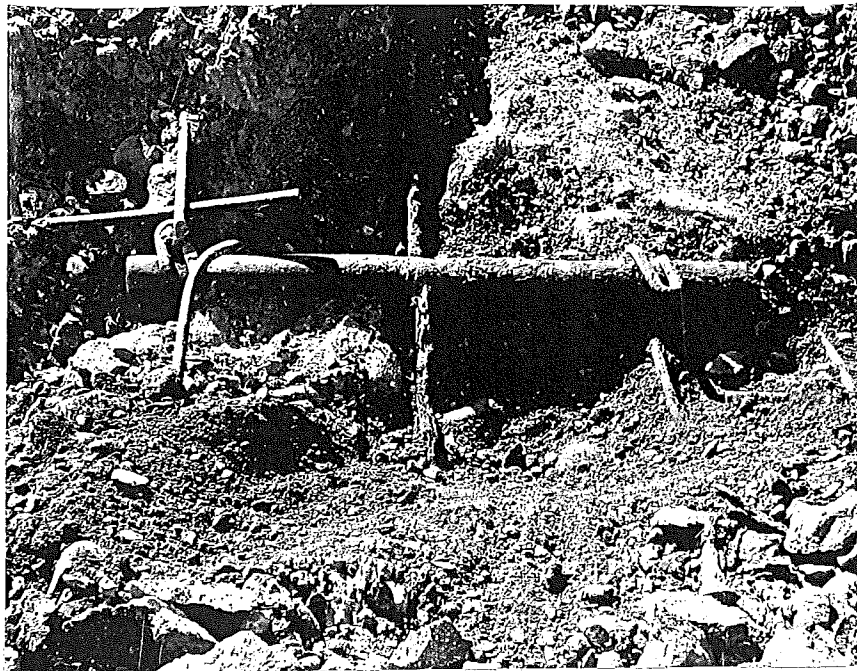
1. The metal expansion chamber caps were not installed on the dowel bars as required; therefore, the compressive force shattered the concrete and bent the dowel bars.

4. The dowel bars were badly rusted and pitted in the vicinity of the expansion joint filler. The reduction in dowel diameter due to rusting was approximately nine percent for the five-year life of the project.

Figure 3. View showing typical condition of dowels - rusted, no caps, and kinked due to excessive compressive forces.

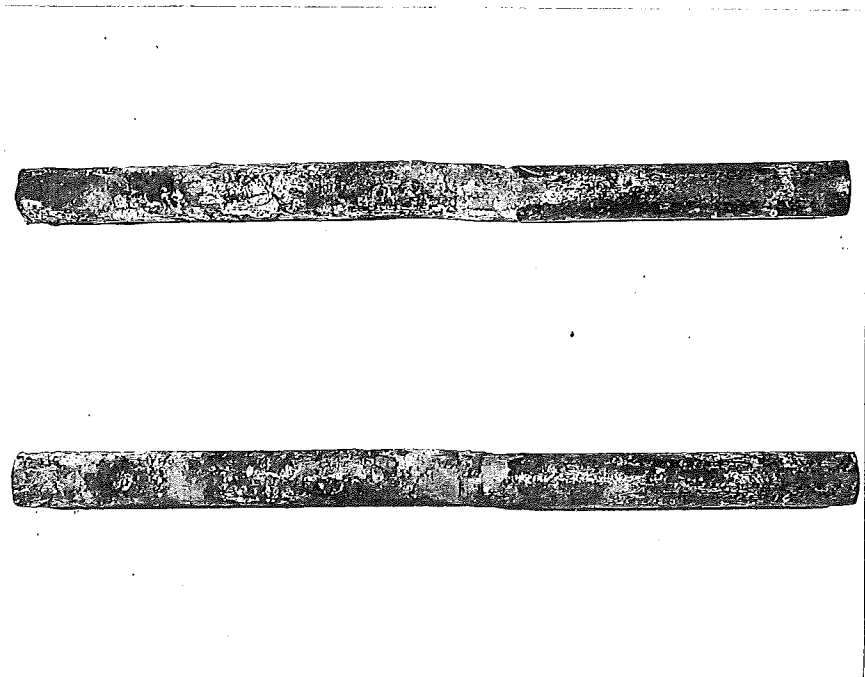
Figure 4. View of two different dowels showing physical condition and kink at center due to compressive forces.

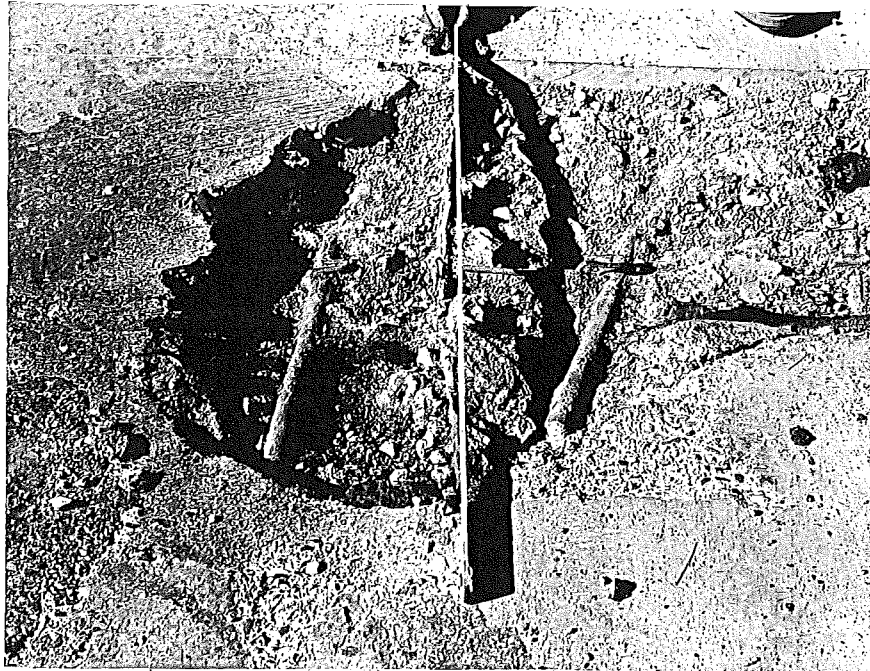
2. The alignment of the dowel bars was very bad in the vertical as well as the horizontal plane.
3. The dowel bar assembly on the west-bound lane was placed higher than the assembly on the east-bound lane. Consequently, the top of the dowels in the west lane averaged two and one-fourth inches from the surface at the joint. Due to vertical misalignment, the end of one bar was 3/4 inch from the surface. The positioning of the dowels was better in the east lane; the average distance to the top of the dowels was approximately three inches at the joint.

Figure 5. View showing horizontal misalignment of two dowels next to center joint.

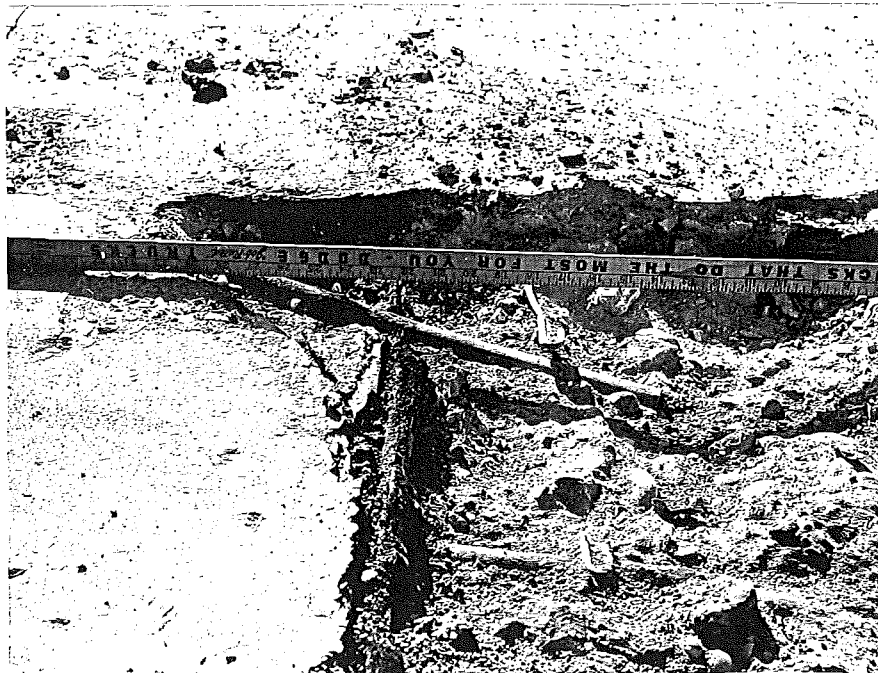
Figure 6. Side view of Fig. 5, showing misalignment in vertical direction and dowel slipped out of clip.
