DECK RIPPLING ON THE I 75-ROUGE RIVER BRIDGE (B01 of 82194G, C7)
Second Progress Report

Research Laboratory Division
Office of Testing and Research
Research Project 66 F-88
Research Report No. R-607

State of Michigan
Department of State Highways
Lansing, October 1966

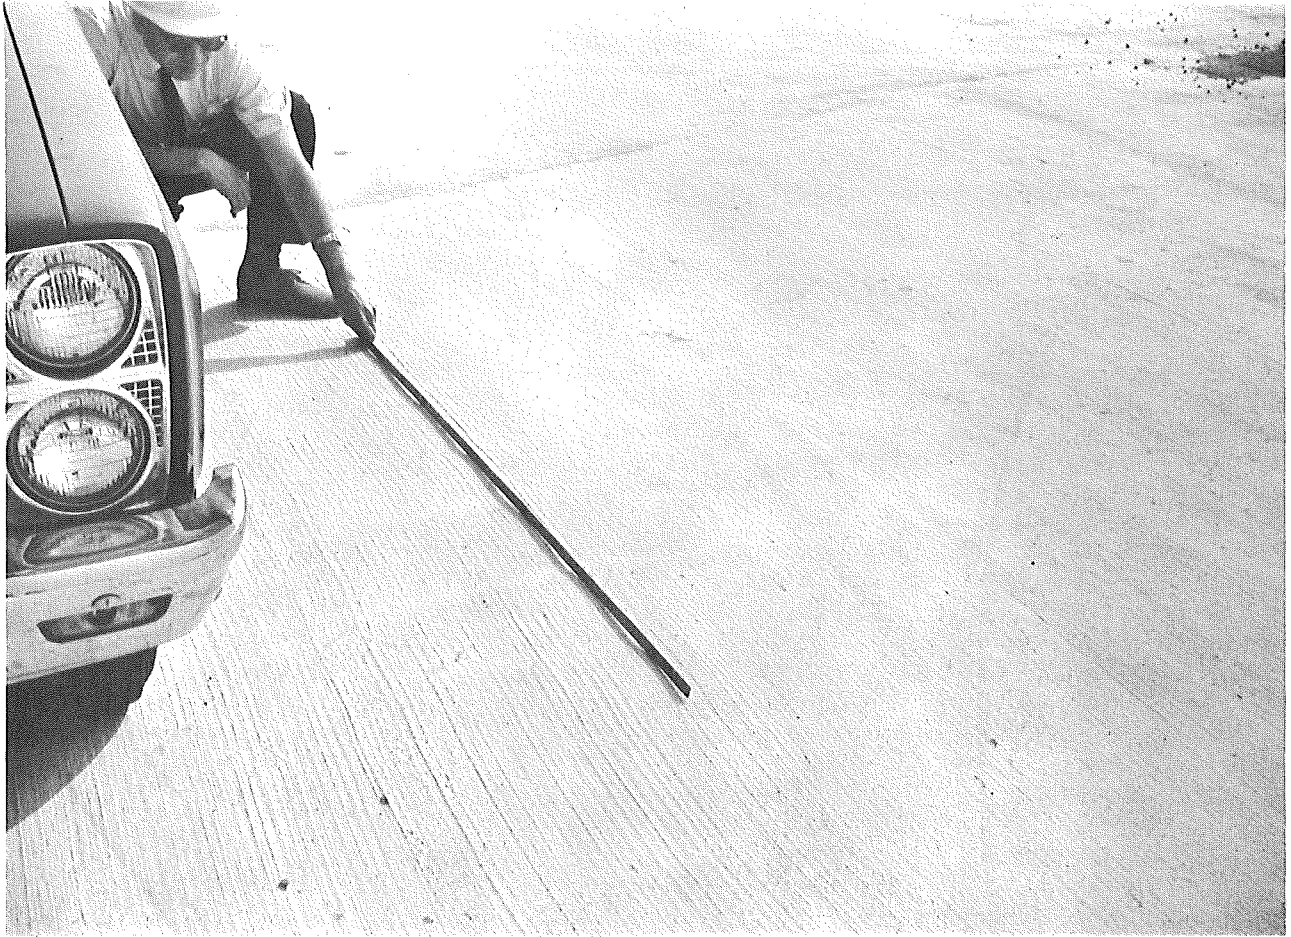
The worst example is on the main span of the welded plate girder over the river on the southbound roadway (Fig. 1). On this span, the maximum amplitude measured was $7/32$ -in. The top transverse steel spacing is 6 in. in the negative moment areas over the longitudinal beams and 12 in. between beams. At these negative moment locations, it was possible to note the 6-in. wave length, just as in the positive moment areas, it was possible to observe the 12-in. wave length. Previous observations confirmed that the valley generally coincides with the position of the top transverse reinforcing bar.

Figure 1 (above). Rippled effect on main south-bound span over river.

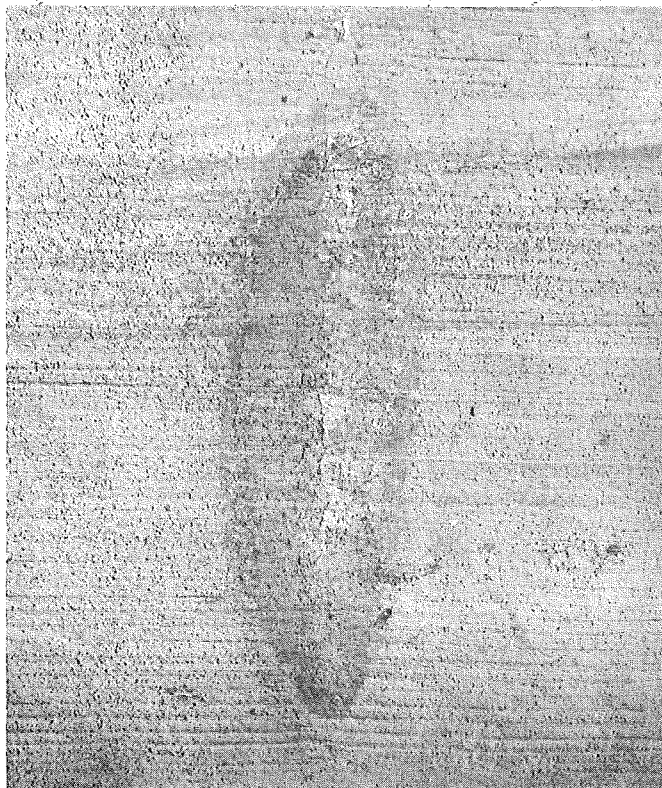
A slight crack was noted in the valley of one of the ripples (Fig. 2), leading to more extensive examination of other rippled areas on this deck. Some additional light cracking was found although it was not yet too prevalent on this span.

Figure 2 (left). Light crack developing at the bottom of a ripple, over reinforcing steel.

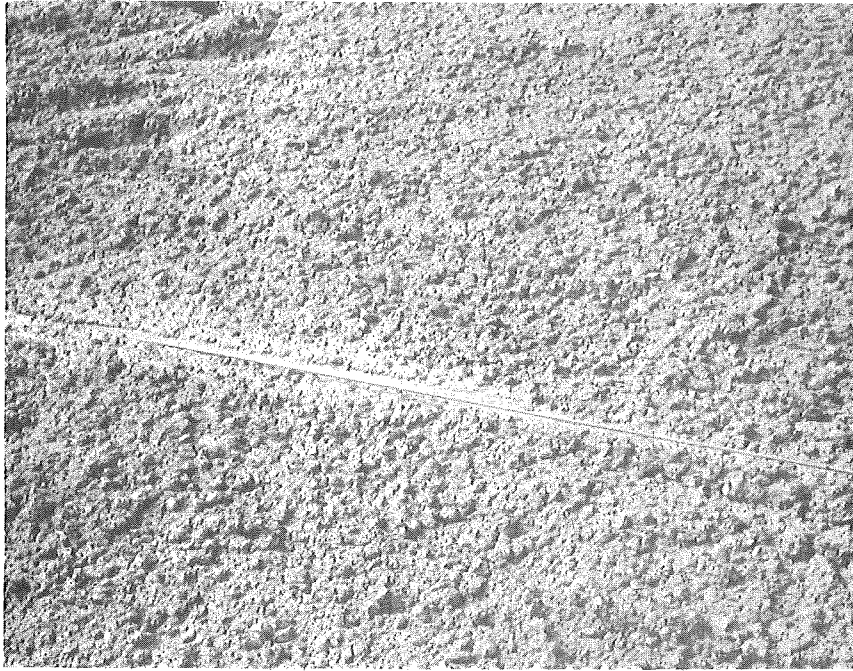
During the finishing process and longitudinal oscillation of the finishing machine, a cable running transversely and used to change the lateral position of the finishing machine oscillated back and forth through the concrete. This was noted to cause local segregation and deposition of a fluid, plastic, water-mortar component around the cable (Fig. 3). It was thought that perhaps the action of the longitudinal finishing equipment, which displaces the surface concrete several inches during the screeding process, might have a similar effect adjacent to the bar, which in this case was stationary while the concrete moved. However, removing the concrete to the bar indicated no more water or cement paste adjacent to the bar than in areas between bars. Measurement of steel depth from the preceding pour in the northbound roadway indicated concrete cover adjacent to this pour exceeded 2 in. over the transverse steel.

Figure 3 (left). Movement of cable attached to longitudinal finishing machine vibrates the concrete, causing local segregation and depositing water, cement, and fine aggregate immediately adjacent to the cable.

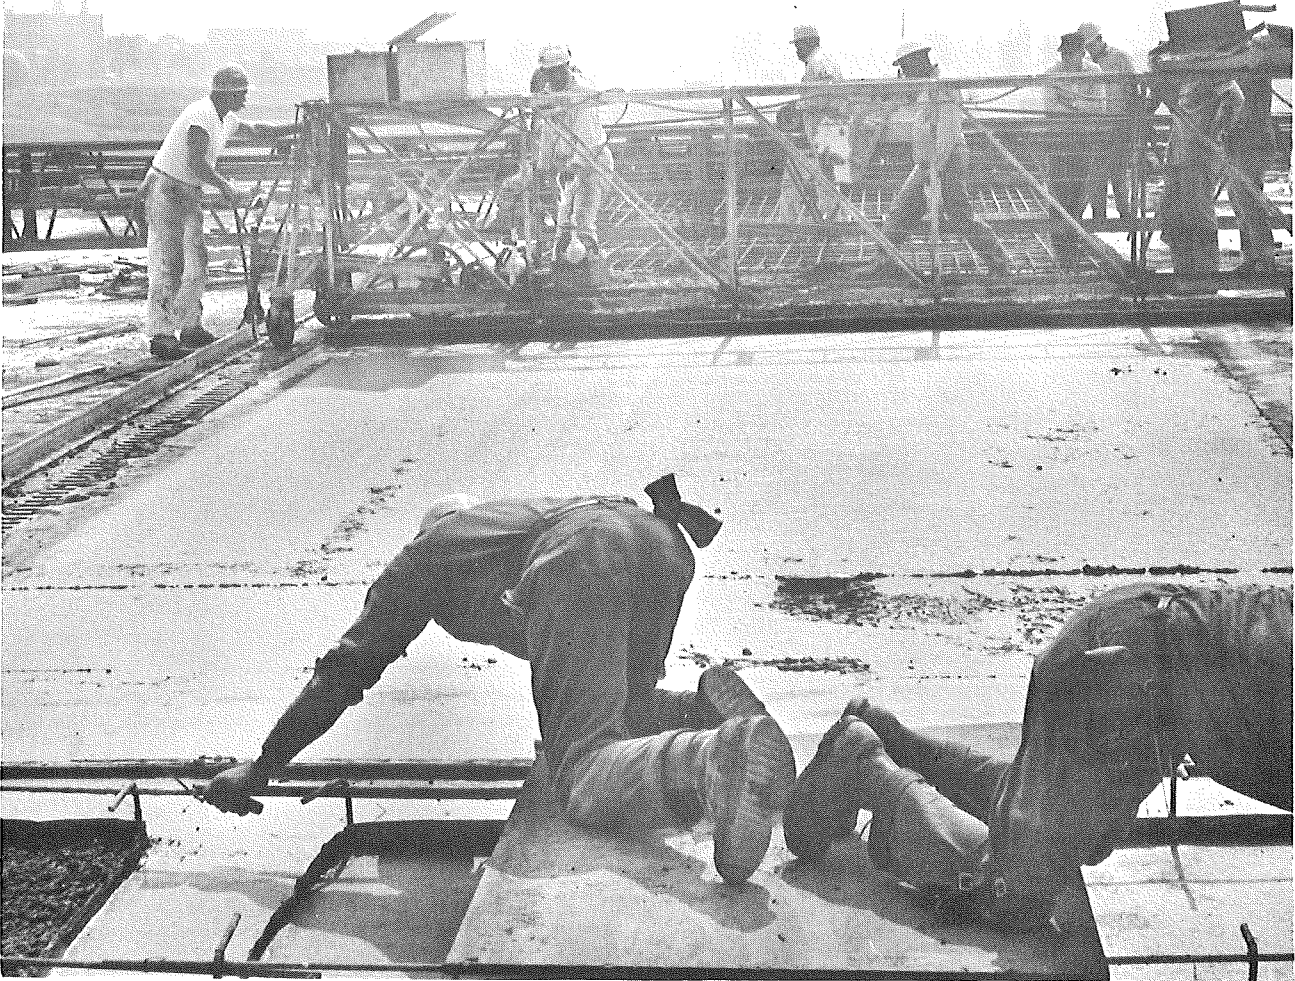
From previous discussions, it was gathered that these ripples occur and are first observed several hours after finishing. However, our observations indicated that small valleys were apparent over the bar immediately after the passage of the finishing equipment (Fig. 4). In certain circumstances they may become larger and more noticeable after a few hours.

Figure 4 (below). Depressions over the bars visible for four consecutive transverse bars, immediately after passage of finishing equipment.

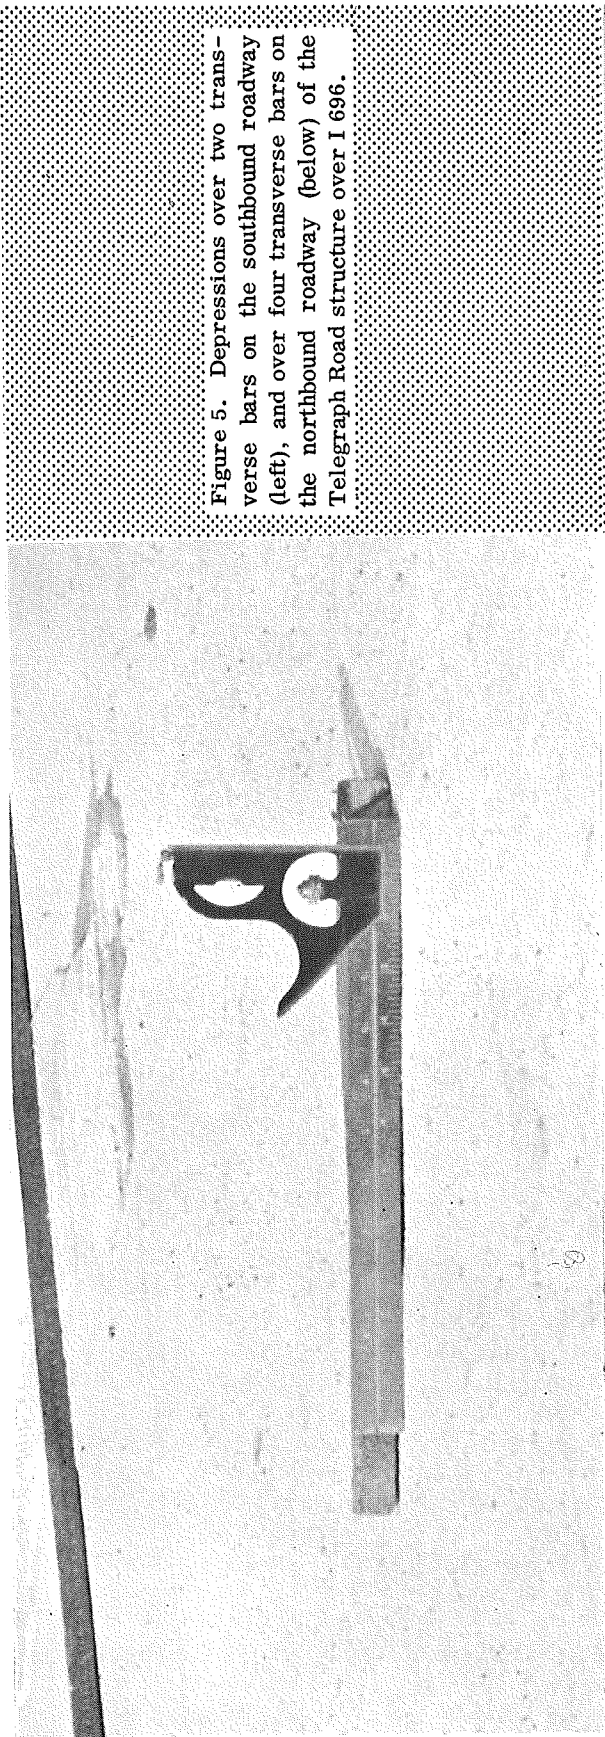
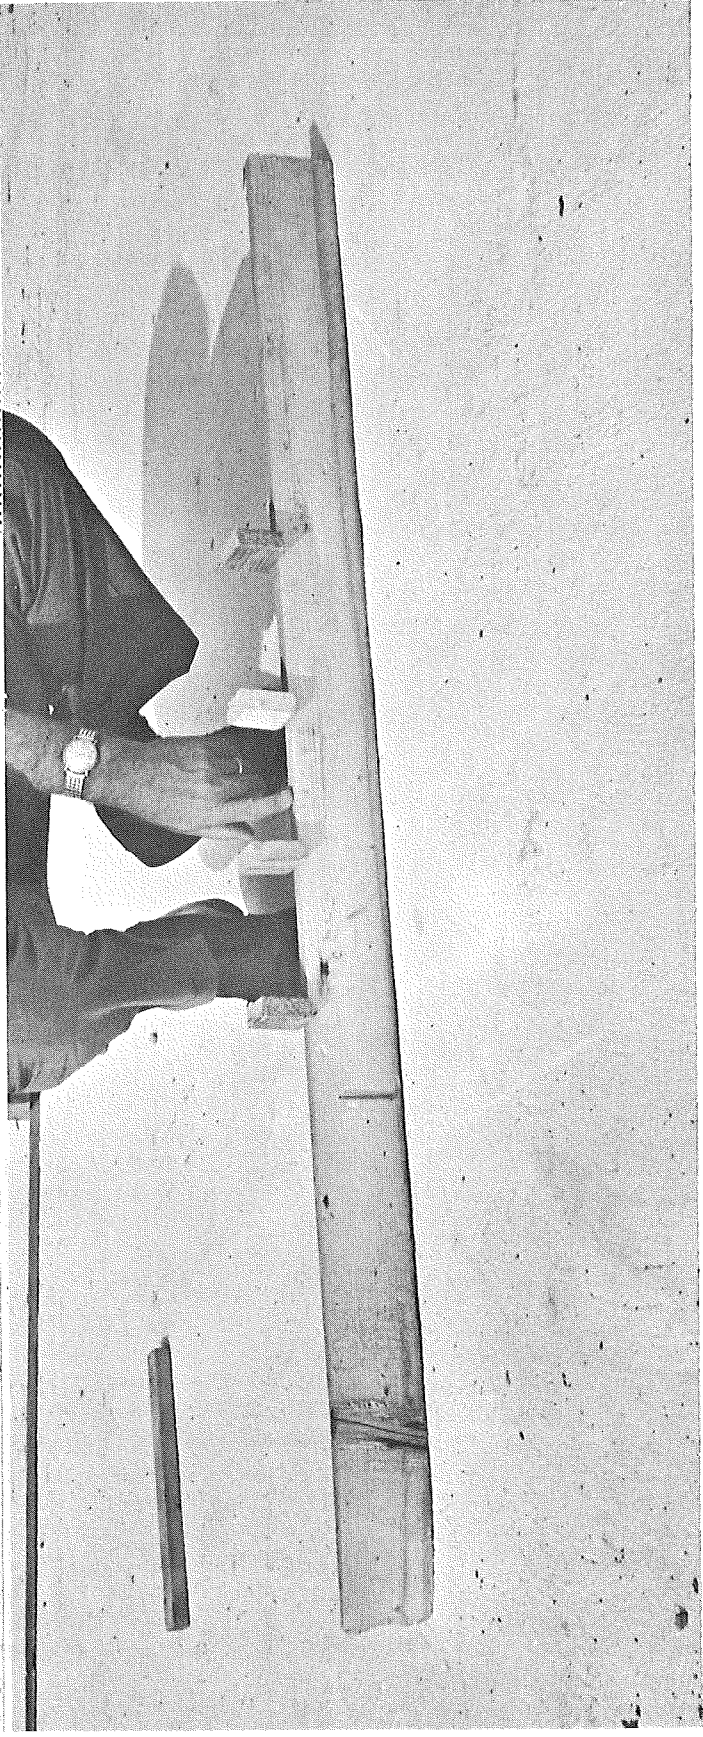
During the site visit, rippled surfaces of other bridge decks were mentioned. As a result, on the way back to Lansing, the observation party stopped at the Telegraph Road bridge over I 696, where the concrete deck had been completed two days before with a longitudinal finishing machine. Membrane curing compound had already been placed over the surface, making it more difficult to detect rippling, but by close observation it was noted that several areas of the deck had small amplitude ripples (Fig. 5).

Figure 5. Depressions over two transverse bars on the southbound roadway (left), and over four transverse bars on the northbound roadway (below) of the Telegraph Road structure over I 696.
