A STUDY OF  
BLOWUPS ON BITUMINOUS CAPPED PAVEMENTS  
Research Project 44 G-25

RESEARCH LABORATORY  
TESTING AND RESEARCH DIVISION  
JULY 26, 1944

A STUDY OF BLOWUPS ON BITUMINOUS CAPPED CONCRETE PAVEMENTS

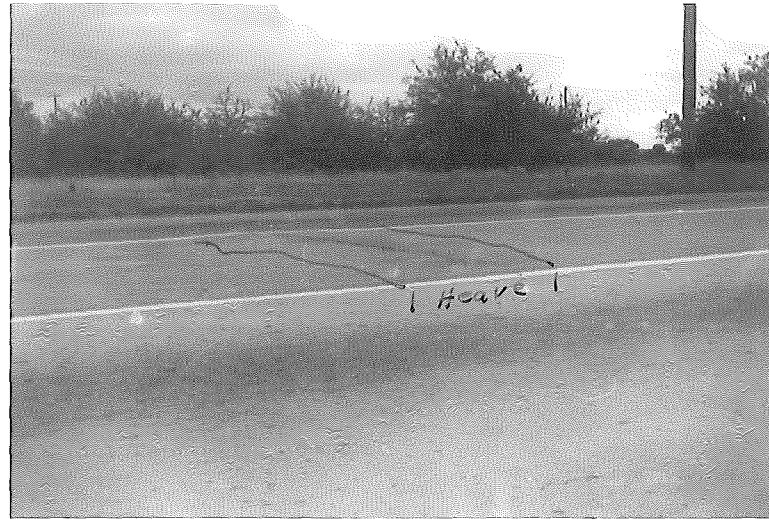
Figure 1. Heaving of bituminous surface center lane, US 16 Howell west, Project 47-14, C 5 & 6

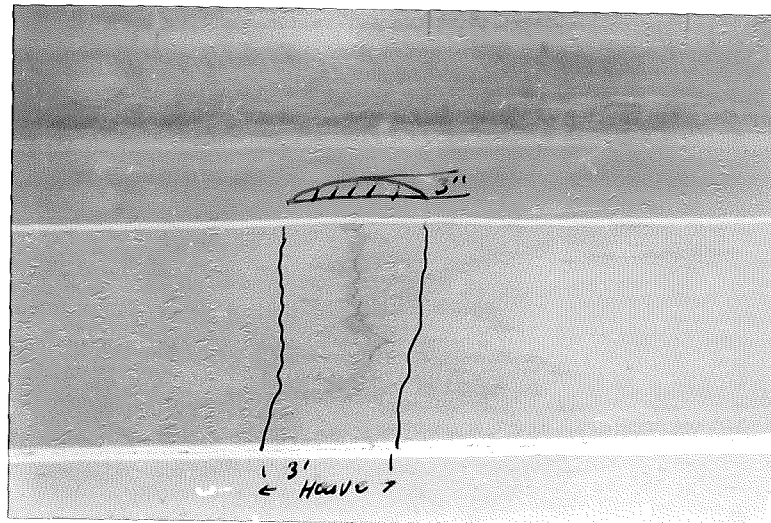
Figure 2. Close view of same heave as illustrated in Figure 1. Note characteristic crack in center of heaved area.

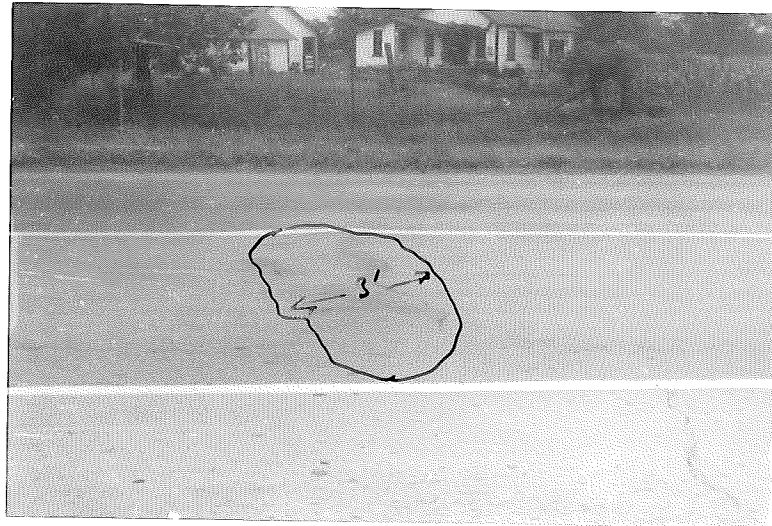
Figure 3. View of another heave of bituminous surface west of Howell. Project 47-14, C 5 & 6. Heave 3 feet wide, 1 inch high, center lane.

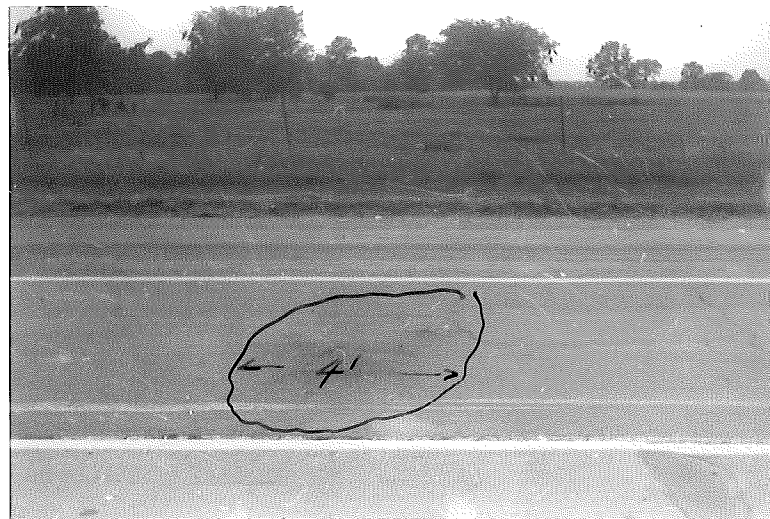
Figure 4. Circular heave area on Project 47-14 C 5 & 6 approximately 2 feet high, 4 feet in diameter. Center lane.

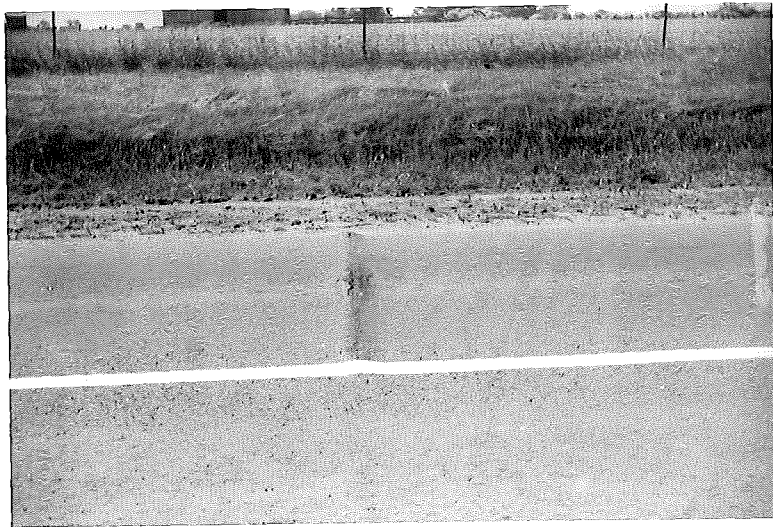
Five small surface heaves were observed on this stretch of bituminous capping. They were all of the type caused by extruding joint filler. See Figure 5. The majority of the heaves occurred in Kent County. They are listed in Table I.

Figure 5. View of typical surface heave caused by extruding joint filler. Note area is narrow, and sharp with crack at ridge. The ends are partially ironed down by traffic, Project 41-18, C3.

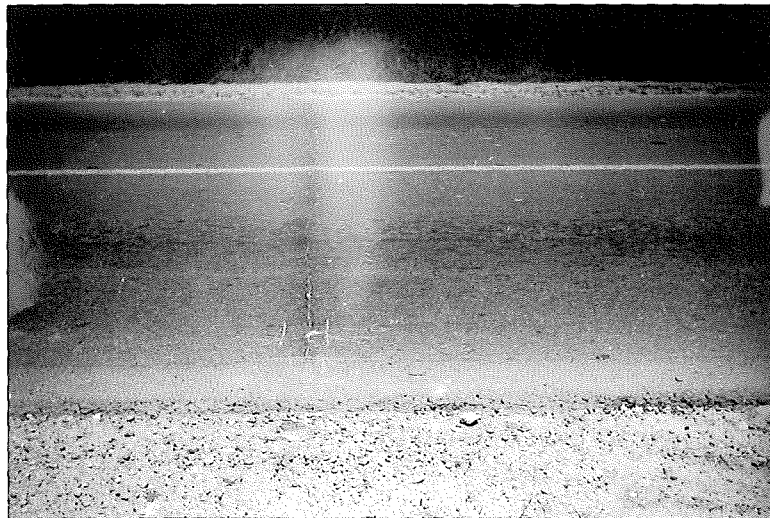
Six slight surface heaves due to extruding joint filler were observed on this project. They are listed in Table II. The average distance between heaves is 1762 feet. As illustrated in Figures 6 and 7 the heaves were about the same size, that is 8 to 7 inches in width and 1/2 to 3/4 inches in height, as those which had occurred on previous projects. They occurred most frequently in only one lane.

Figure 6. Heave due to extruding joint filler which extends entirely across pavement. Area is 6" wide and 1" high. Project 70-12, C2.

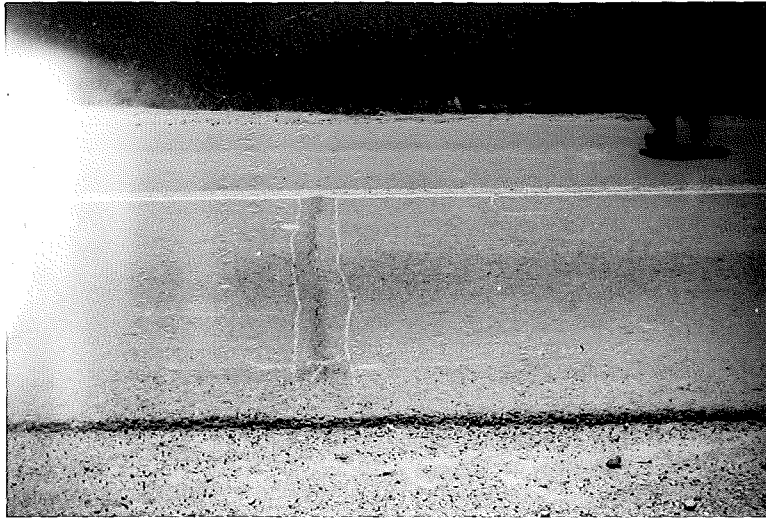
Figure 7. Another heave due to extruding joint filler on Project 70-12, 02.

Figure 7 A. A portion of heave in Figure 7 was removed to show extruding joint filler, Project 70-12, 02.

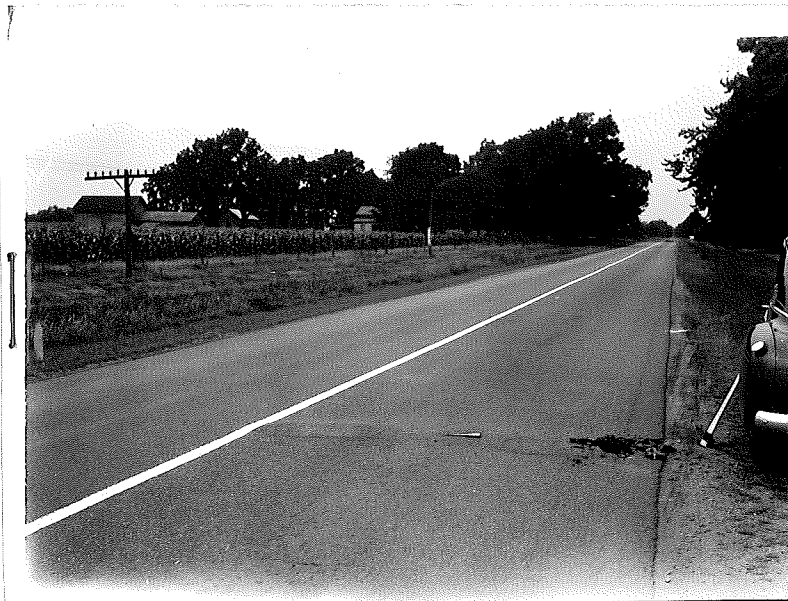
Figure 10. Project 78-14, Cl. White Pigeon Nest. Typical heave on this project. Area 24 inches wide 1 1/2 inches high, one side only.

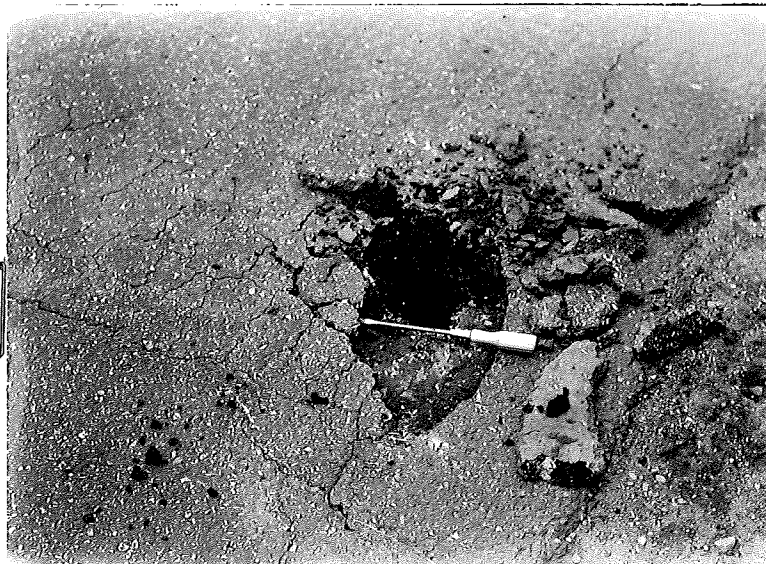
Figure 11. Close view of heave in Figure 10. Note old bituminous patch underneath which under excessive compressive forces has pushed upward causing heaving of the surface course.

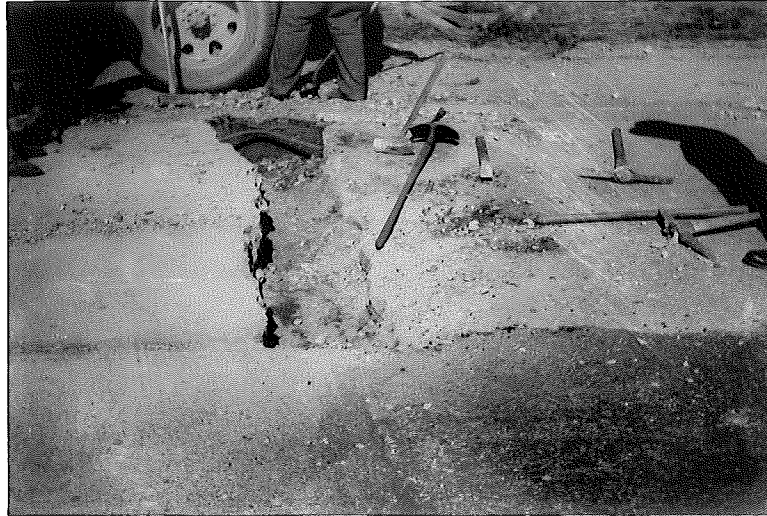
Figure 21. Project 19-3, C5 (1923) US 27 North of Lansing. Blowup in west lane cleaned out ready for filling with bituminous material. No doubt such patches on bituminous capped projects are responsible for certain surface heaves.

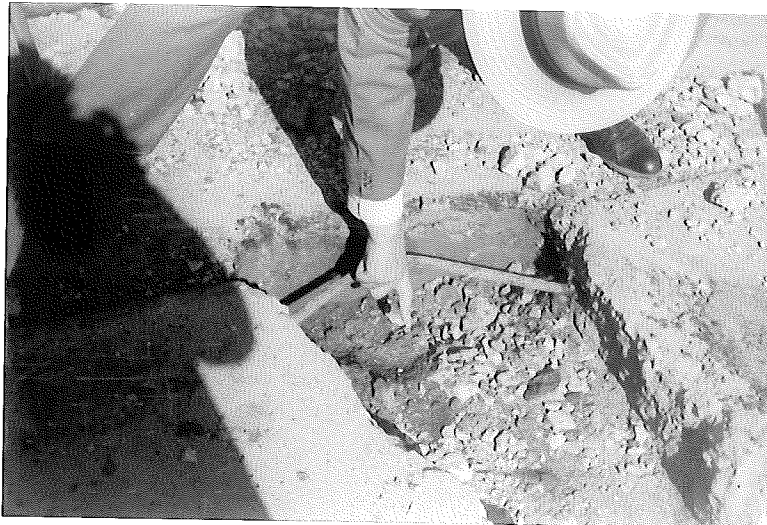
Figure 22. Close view of Figure 21 showing how longitudinal edge bar was bent during blowup. This has been observed at blowup areas on other projects.

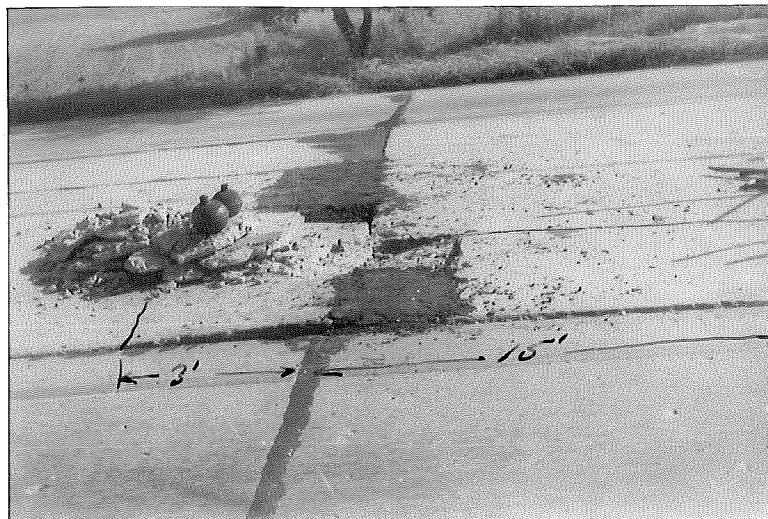
Figure 19. Project 53-24, C3 (1922) Bad blowup on US 18 near airport in center lanes on old slab. Note heaving and shattering of concrete at old expansion joint.

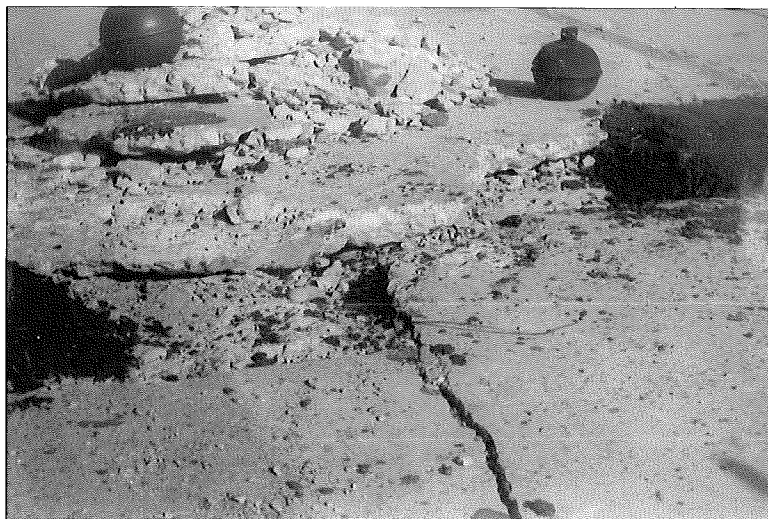
Figure 20. Project 53-24, C3. Close view of Figure 19 showing how left slab split horizontally and started to ride right slab.

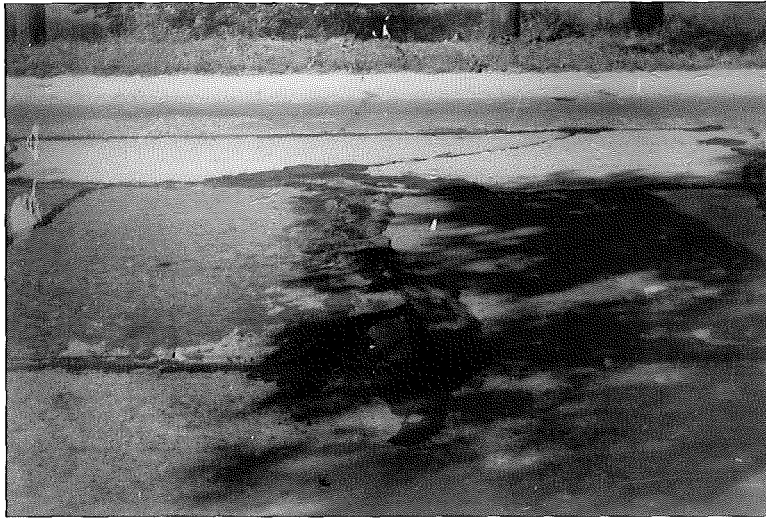
Figure 17. Project 33-24, CE, (1922). Typical blowup area at a crack which has been maintained in service by tar and chips. Such areas are weak points in old pavements and are source of many heaves on bituminous capped projects.

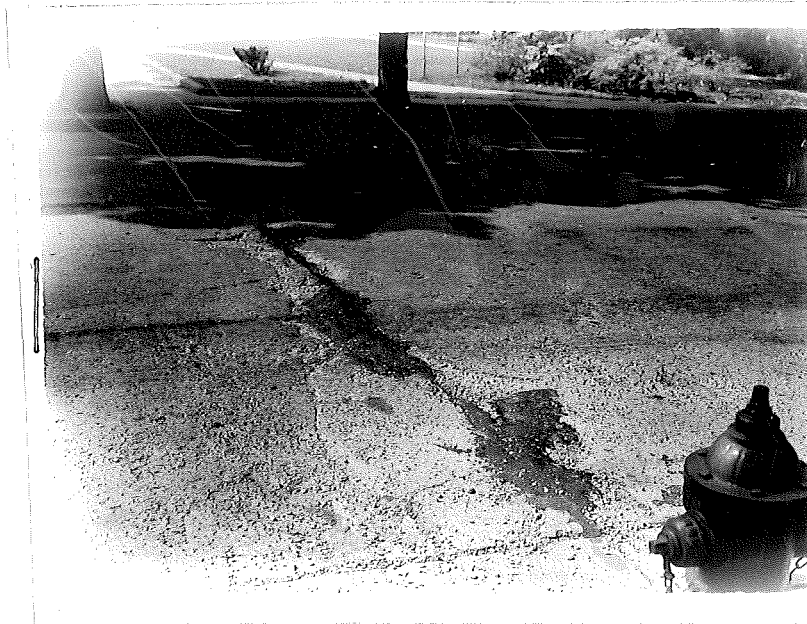
Figure 18. 73-11, C1 (1928) M 60, Three Rivers at Garden and Michigan Streets. Slight blowup at expansion joint. Note crushing and slight heaving of concrete. Similar conditions are no doubt responsible for heaving of bituminous capped projects.

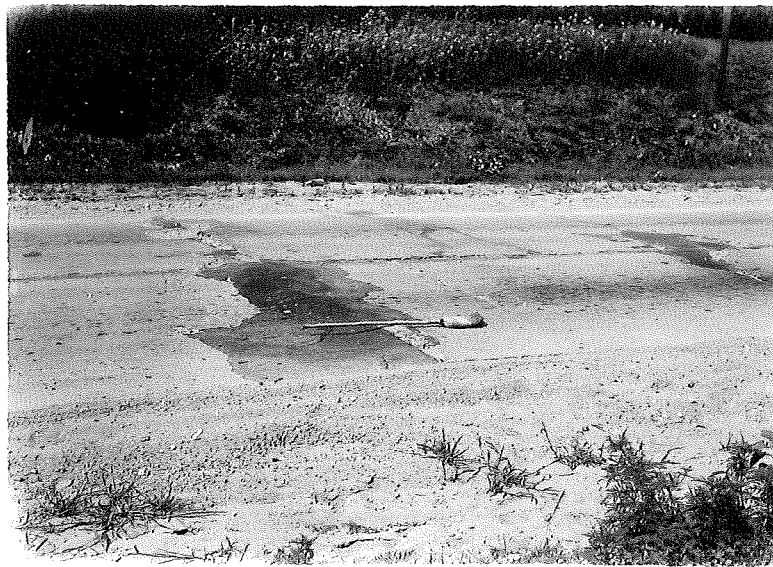
Figure 15. Project 11-3, C3, Benton Harbor East, Blowup No. 9. Note attempt of right slab to ride left slab. Right slab cracked back several feet. Difference in elevation about 2 inches.

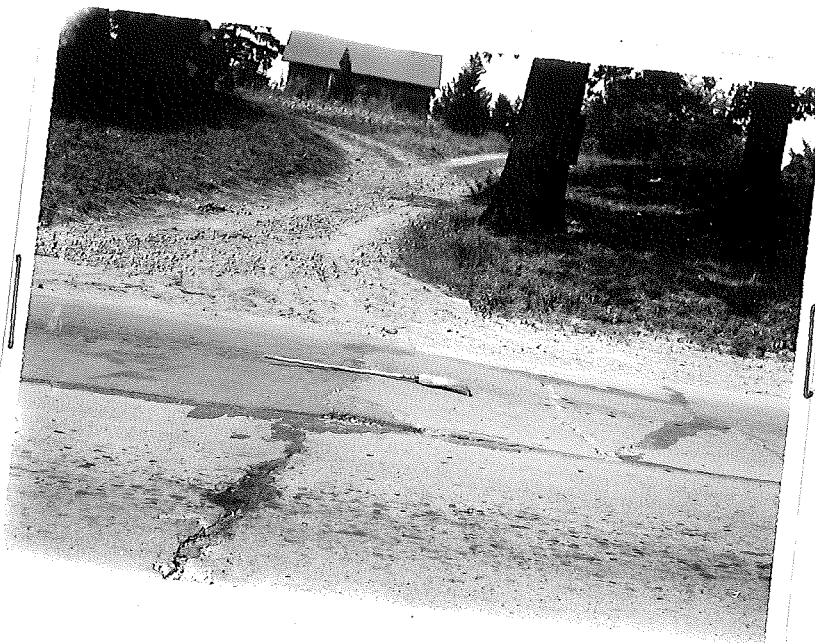
Figure 16. Project 11-3, C3. Blowup No. 10 which was located a short distance from No. 9. In this case note uniform heaving of slabs on each side of crack. Blowup occurred in one lane only.

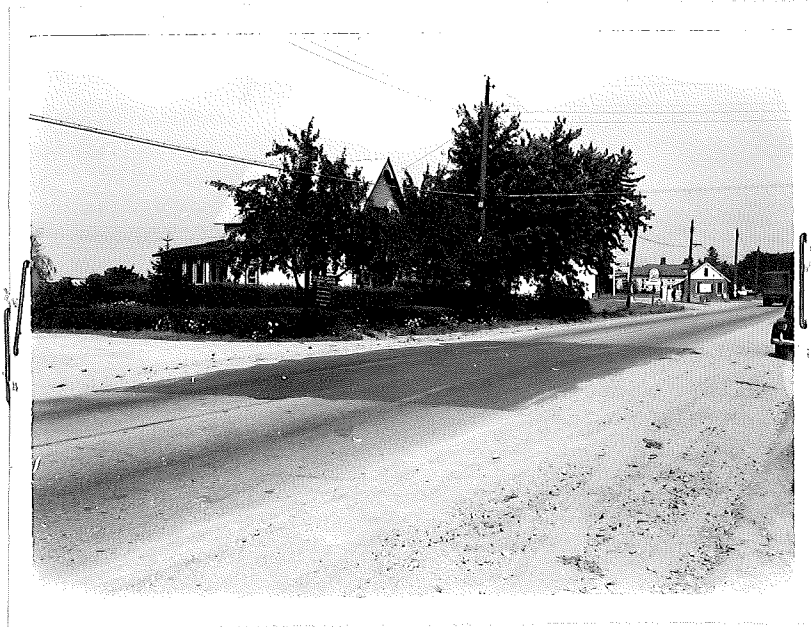
A survey was made of blowups occurring on the concrete pavement on project 11-3, US East of Benton Harbor. Sixteen blowups were observed on this project. A major portion of the blowups had been covered with a huge patch of bituminous material, as illustrated in Figure 15. This type of repair work is quite crude indeed and creates a sizable hump in the pavement.

Figure 13. Project 11-3, C3 Benton Harbor East. Several old blowup areas were repaired by simply covering area with a huge patch of oil aggregate mixture without attempting to remove heaved concrete.

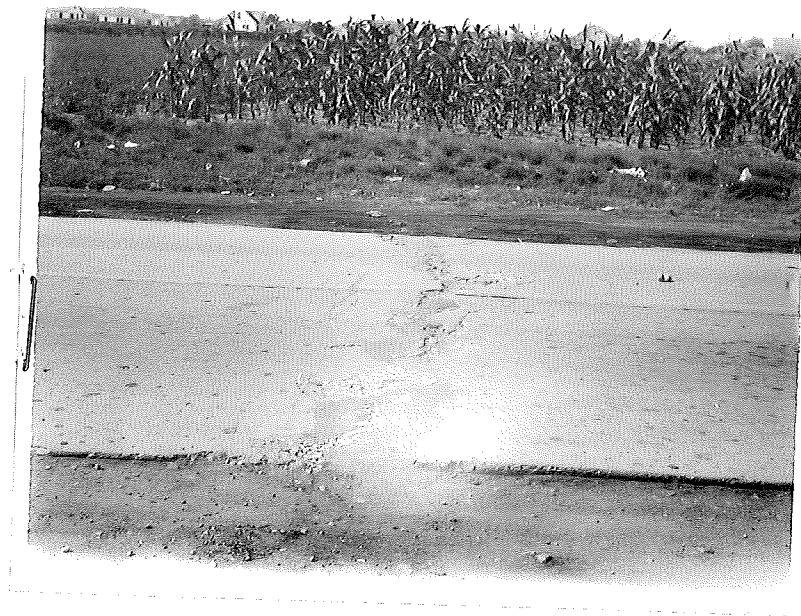
Figure 14. Fresh blowup which had occurred on Project 11-3, C3. Note typical crushing of concrete along crack. Bituminous material indicates that concrete along crack was in advanced stage of disintegration and could not sustain the abnormal compressive forces.

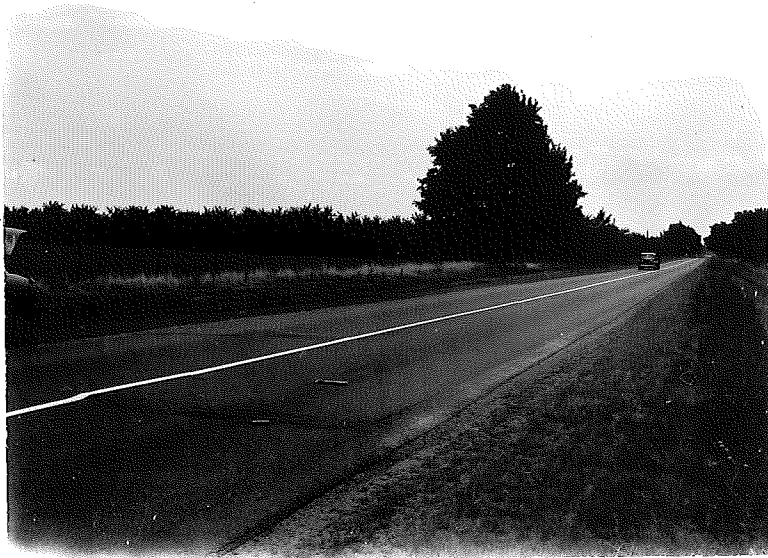
Figure 12. Surface displacement caused by pushing up of concrete slab. Project 78-14, Cl. This was the worse blowup area on project.
