EVALUATION OF ICE DETECTING SYSTEM
FLINT RIVER BRIDGE

Conducted by the
Traffic Research Section
Traffic Division
Michigan Department of State Highways
September 1966

EVALUATION OF ICE DETECTING SYSTEMS - FLINT RIVER BRIDGE

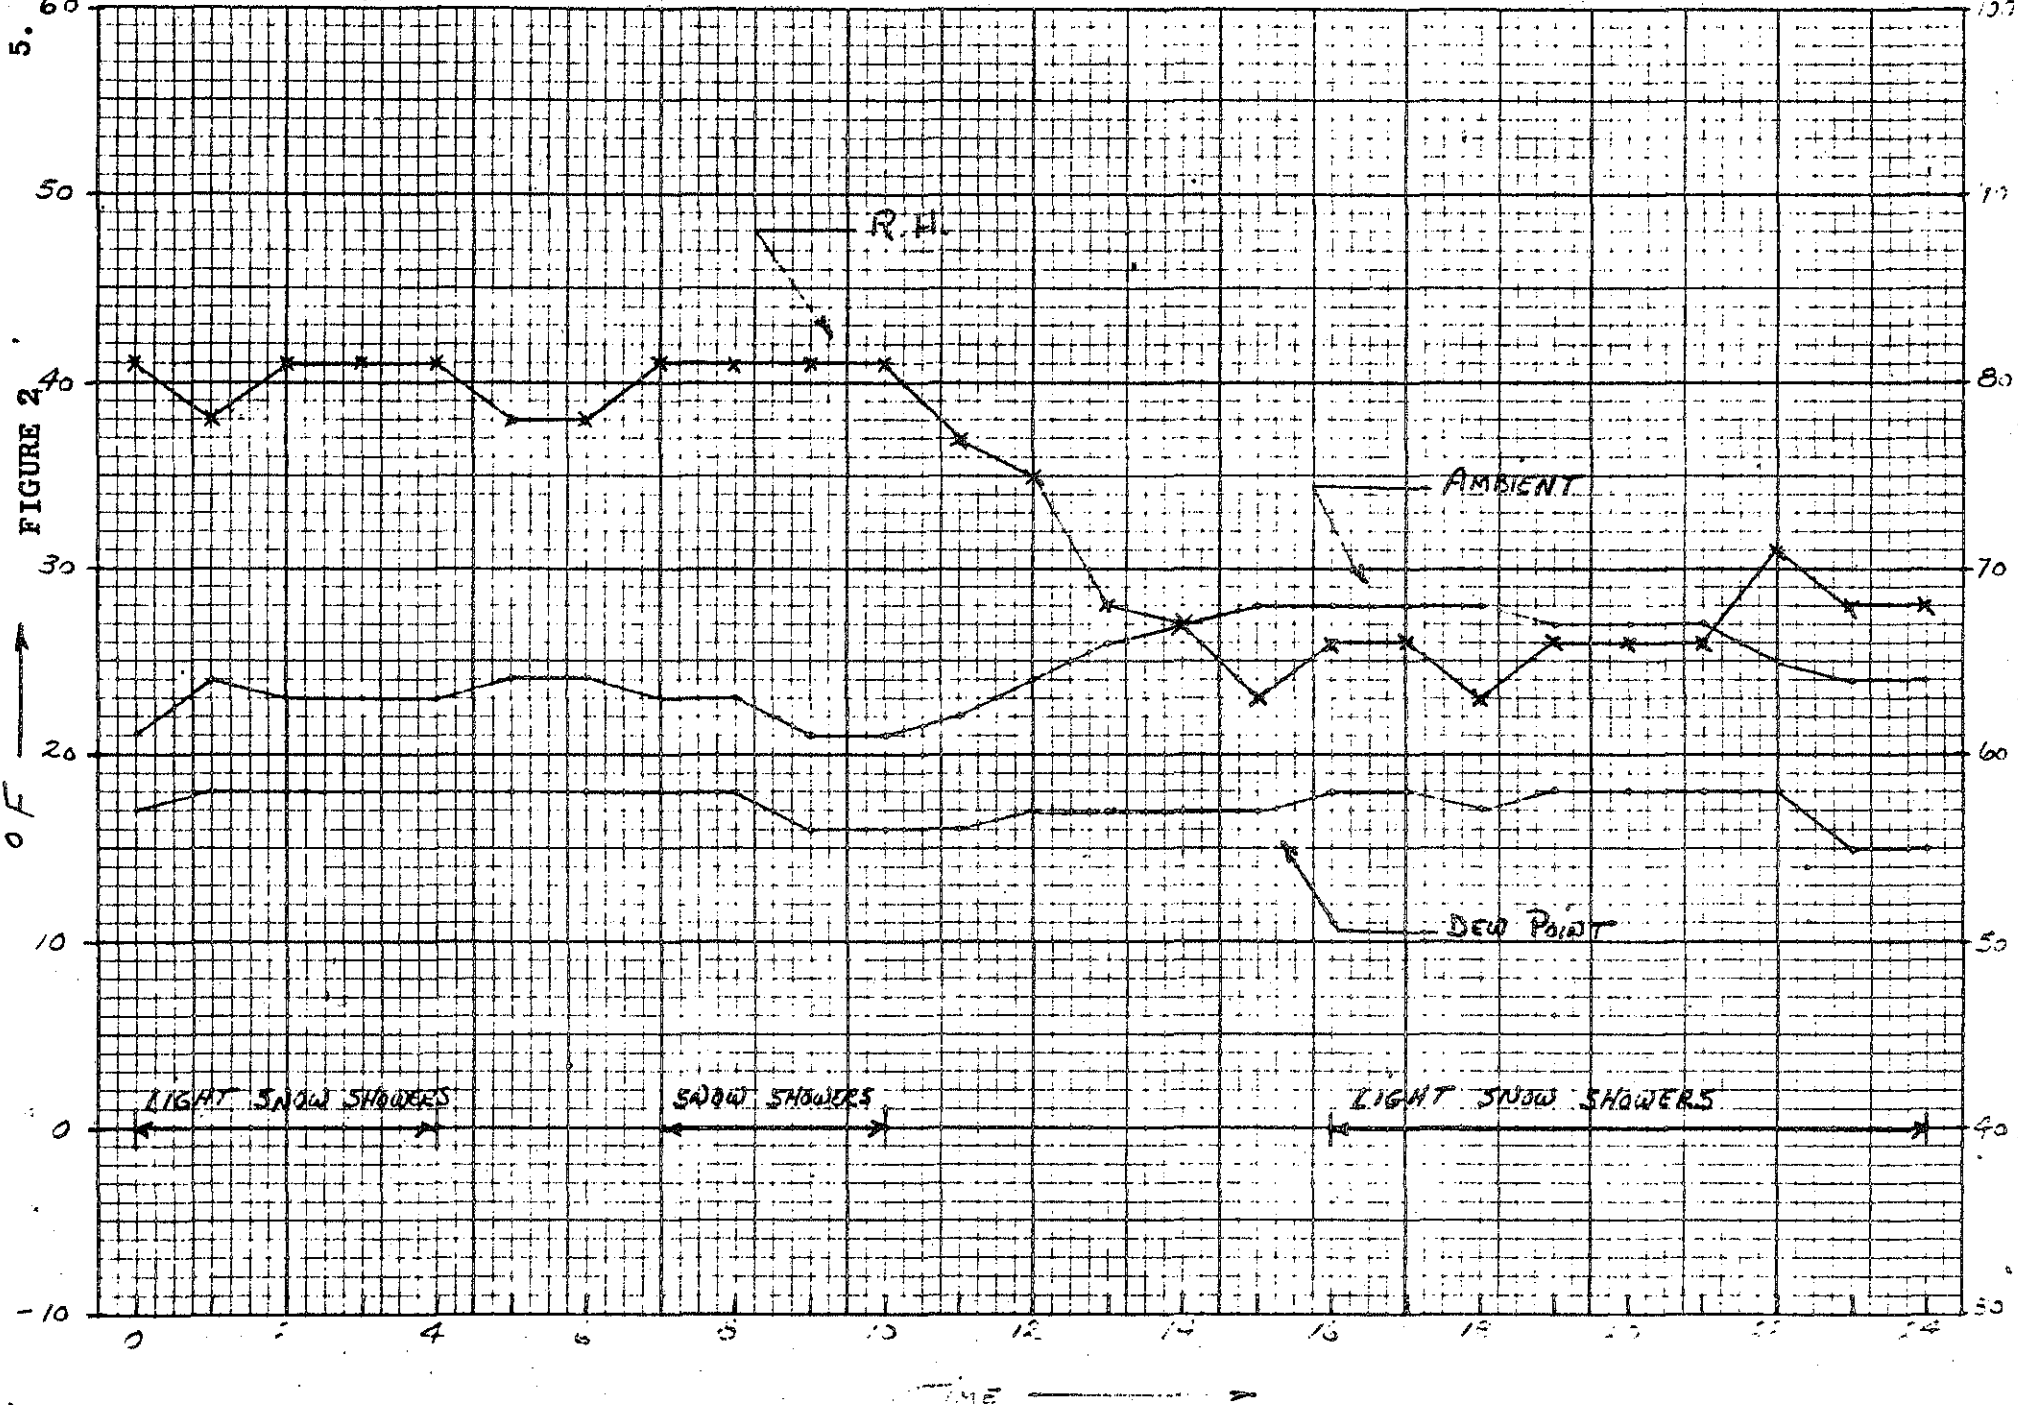
FIGURE 2

The second method used to evaluate these systems was to compare the weather bureau data from the U. S. Weather Bureau at the Bishop Airport 4 miles away to the recorded weather information at the Flint River Bridge. This output was recorded on Rustrak event recorders. An example of this tape is shown in Figure 1. This tape was for the weather on 2-3-66. Figure 2 is a plot of weather data from the U. S. Weather Bureau for the same day.* The weather data compares very favorably between the two sites. The only difference which was noted in the weather data is that regarding humidity. The relative humidity at the river appears to range about 8% above that recorded at the weather bureau. There were days, however, when the humidity at the bridge exceeded that at the weather bureau by 20-25%. This was particularly noticeable

on extremely cold days. This would indicate that moisture, which is at a warmer temperature than the air, leaves the surface of a body of water faster on a cold day. This case can be shown theoretically. The measurements of humidity at the bridge equalled those for the airport during the time the river was completely frozen over.

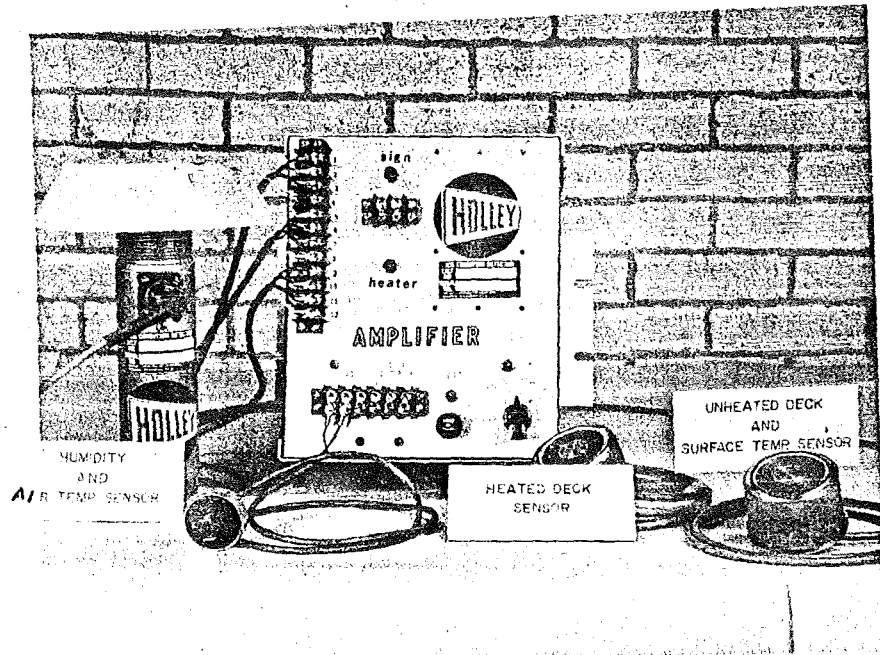
FIGURE 3

In reviewing all information about the system, it appears that system #1 is very effective in determining when icy or frost conditions occur. To date, the reliability of this system has been 100%.

System #1 - Holley Carburetor Unit (See Figure #3)

The manner in which this system activates is as follows: Deck temperature, ambient temperature, humidity and precipitation are monitored constantly by various probes and sensing devices. The output from the probes, either in the form of conductance or resistance, is transformed into logic within the system (NOR logic which acts in an either-or manner) and when certain inputs are realized, a relay is closed indicating that ice or frost conditions exist. The values of resistance or conductance for each of the conditions which must be satisfied are those simulated for deck temperature of 32° , humidity of 75% and a difference between deck and ambient temperature of 3.9°F . These values are those which will cause ice or frost to form at 32°F . The system will activate when certain two or more of these conditions exist. This system can determine saline conditions and will turn off when they exist.

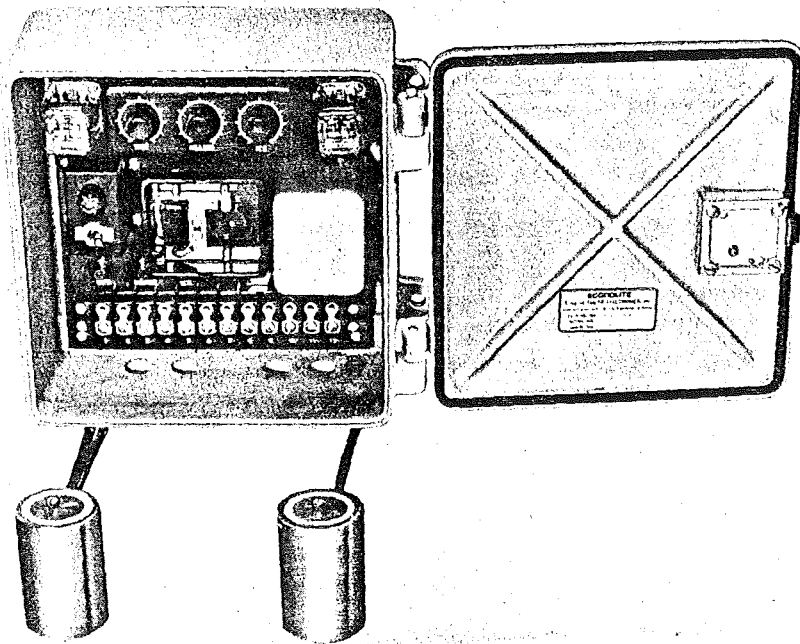
FIGURE 4

System #2 appears to need re-adjustment (something which has been done once) before any reliable data can be obtained. System #2, based upon the data to date, has not performed as well as had been expected. Continued evaluation of this system in the fall will determine whether future use of this system will be given any consideration. At the present time, system #1 seems to be functioning extremely well. The two systems will remain in operation for experimentation at this location throughout the next year to determine whether a reduction in the number of accidents caused by icy bridge decks can be reduced through the use of warning signs which were installed on 2-10-66 and were in final operation on 3-4-66. These signs are activated by the output from system #1. This information will be included in a final report on the subject.

System #2 - Econolites Kartrol Unit (See Figure 4.)

This system activates in a manner similar to system #1; however, it doesn't have the humidity sensor and cannot determine the presence of frost until there is a substantial accumulation of frost. The ability of this system to detect saline conditions has not been demonstrated as yet.
