MONITORING MOVEMENT OF THE ZILWAUKEE BRIDGE

JANUARY 1985

Research Laboratory Section
Testing and Research Division
Research Project No. 82 TI-849
Research Report No. R-1250

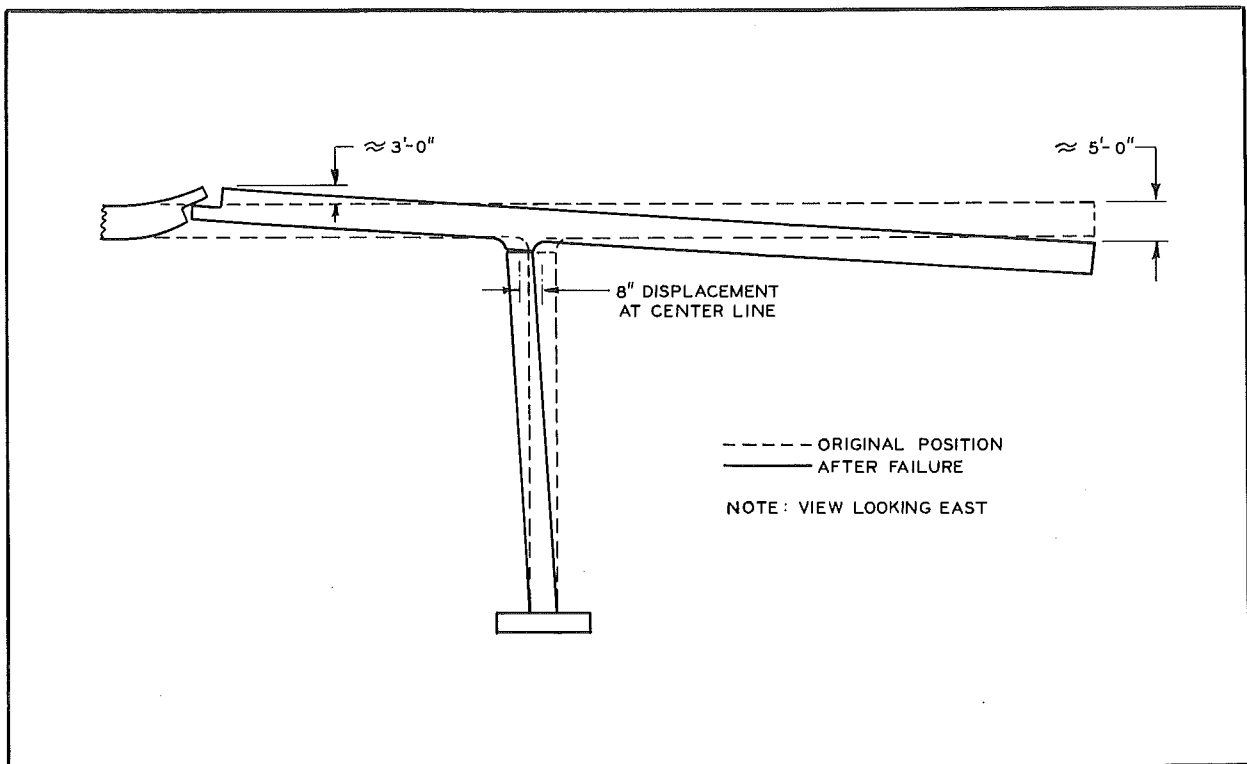
Figure 7. Position of deck before and after accident.

Crushing occurred at the expansion joint; the south end of the cantilever deck deflected downward more than 5 ft, while the other end rose about 3 ft at the expansion joint. The top of the twin columns moved longitudinally to the north about 8 in. (Fig. 7). Excavation around the base of the footing and columns revealed that the footing had failed. Overall damage to the bridge is shown in Figure 8.

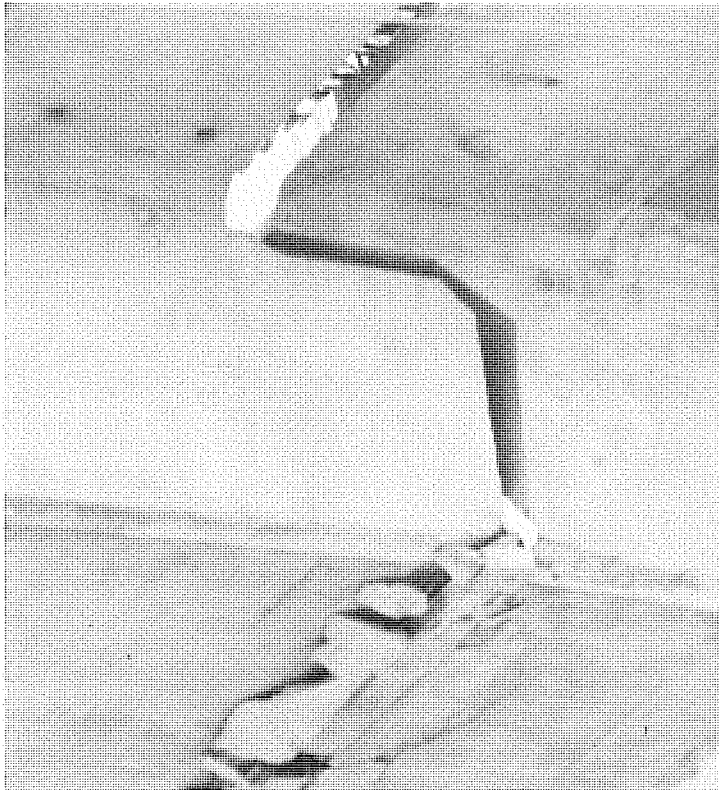
Physical damage to the superstructure included severe crushing of the spacer blocks and adjacent concrete located in the span 12 expansion joint (Fig. 9). Cracking occurred in the bottom of the box section between the expansion joint and pier 12N, and in some cases, cracking extended upward through the shear key. Cracking and spalling were evident on the bottom outside of the segments located at the damaged expansion joint (Fig. 10). The full extent of the damage to the expansion joint bearings was not determined at this time, but some plate bending in the pot bearings did occur.

Figure 9. Crushing adjacent to spacer block in the bottom of the span 12 expansion joint.

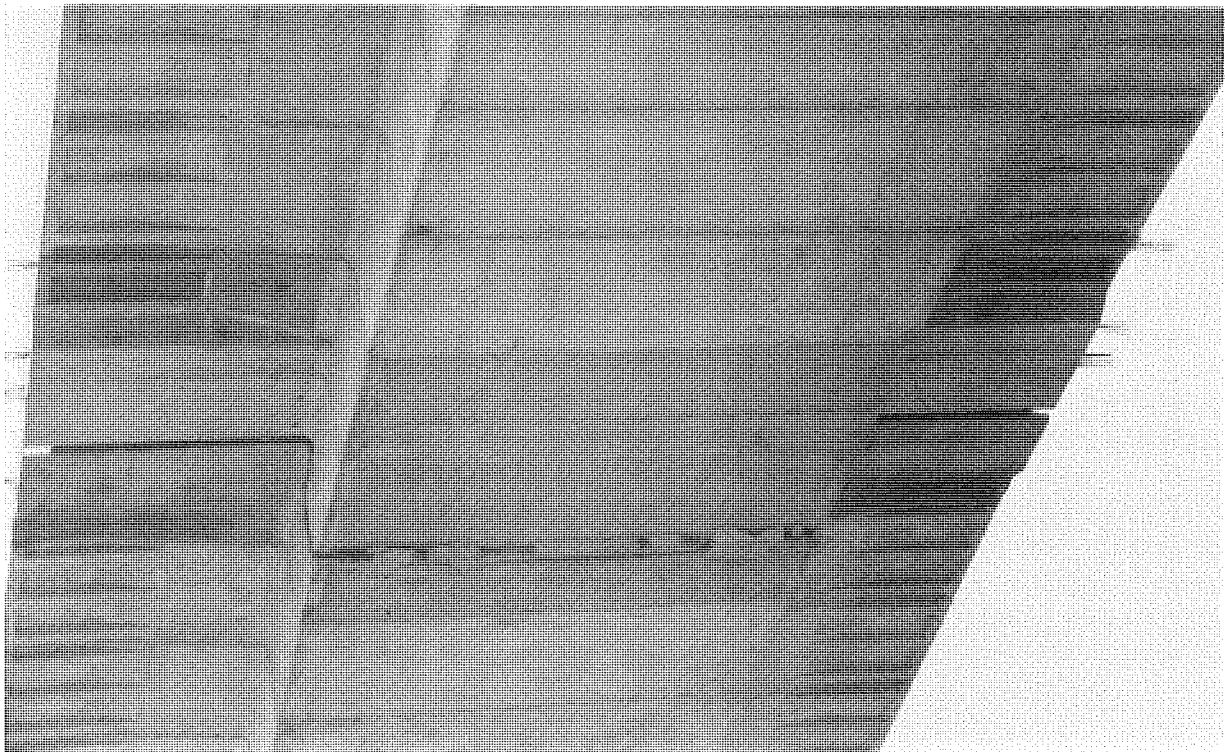
Figure 10. Spalling at the bottom of segments at the damaged joint.

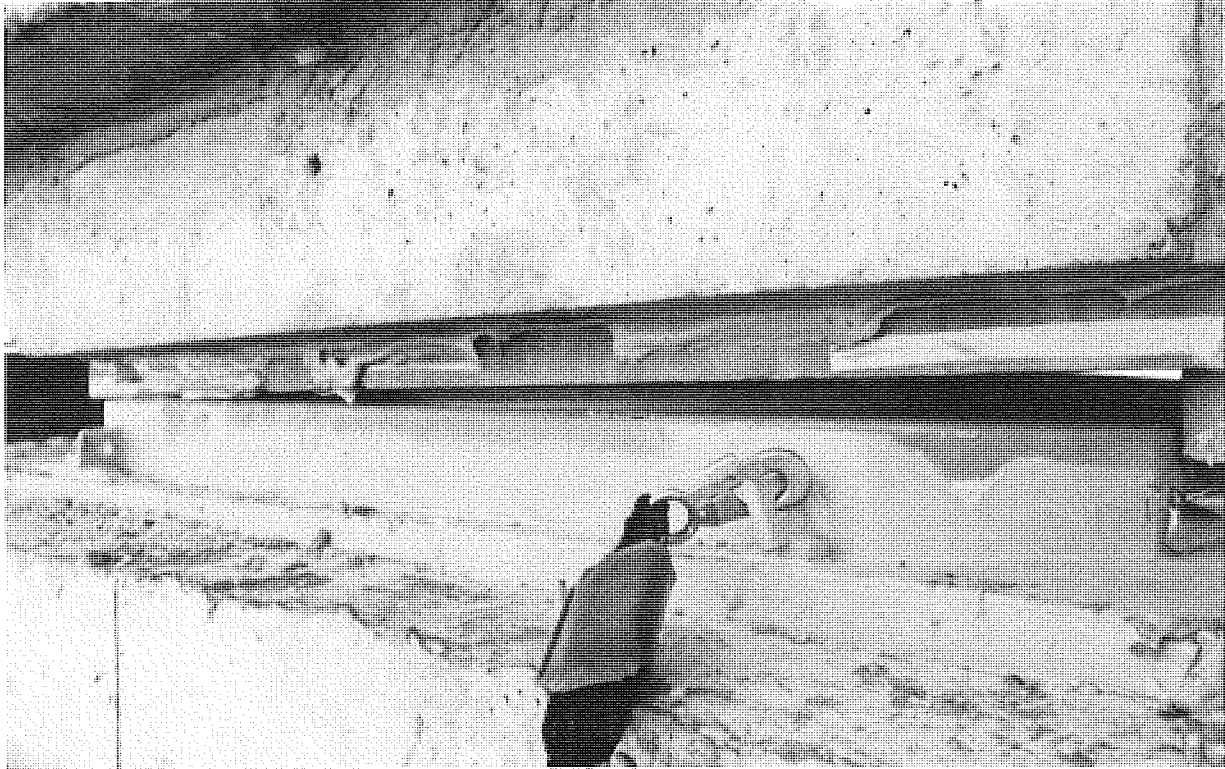
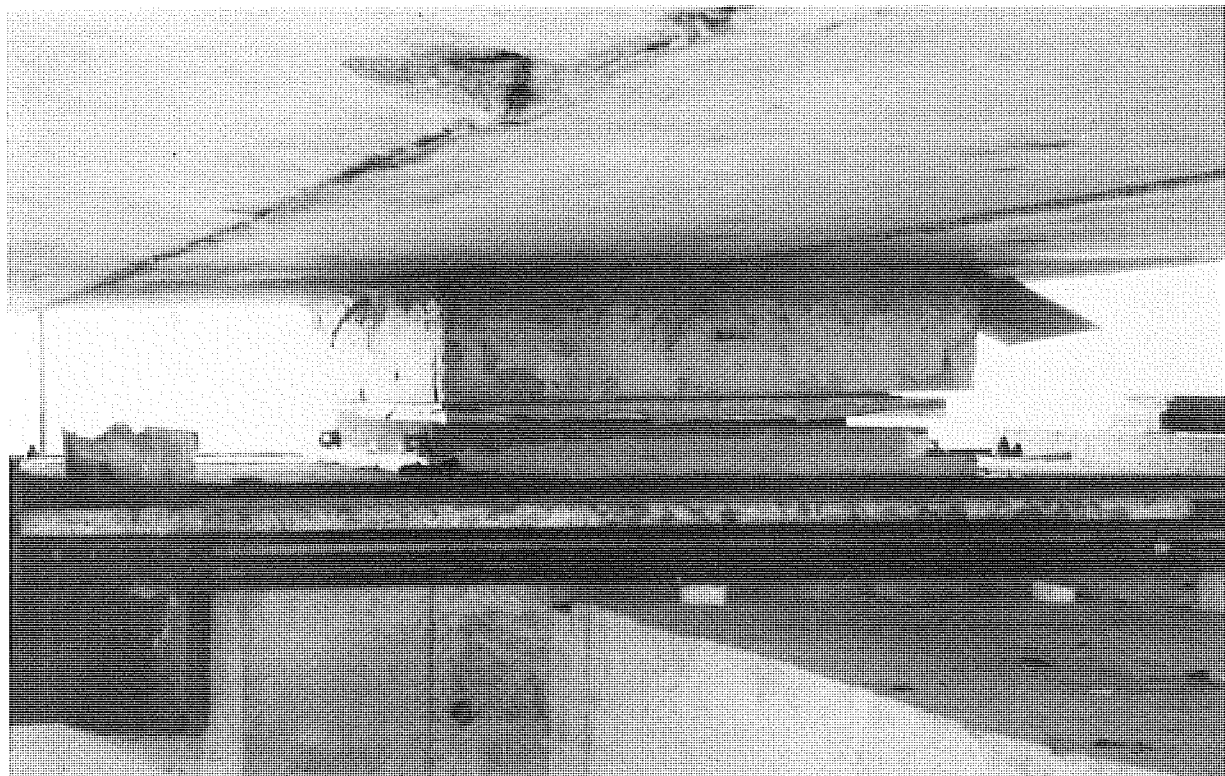
The columns did not appear to be damaged, other than being out of plumb. The bearings at the top of the column were severely damaged and would have to be replaced (Fig. 11).

Figure 11. Damaged bearings over east (above) and west (below) columns.

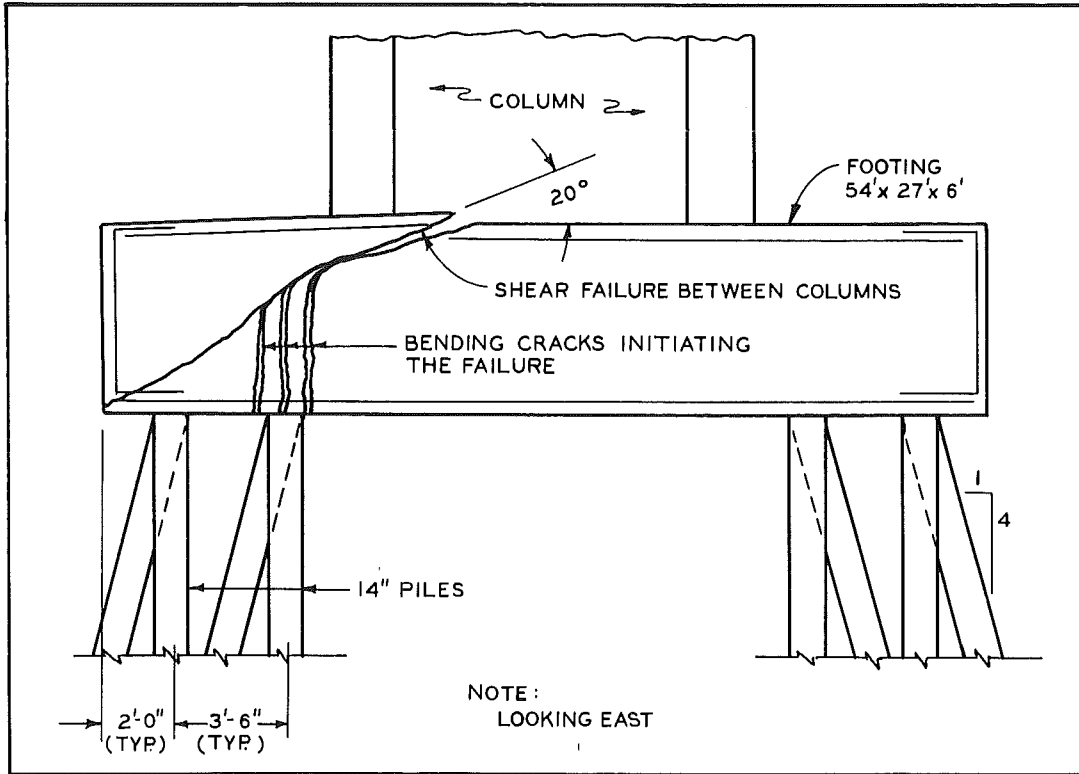
Through visual observation and ultrasonic testing, a crack on the top surface of the footing between the two columns appeared to run downward at a slight incline for several feet and then turned sharply downward to the bottom of the north edge of the footing (Fig. 12). Cracking was apparent on all four of the 6-ft high vertical faces of the footing. Downward slanting fractures of the footing were also found at the column-footing intersections proceeding down and away from the columns (Fig. 13).

Figure 12. Diagram showing damage to footing of pier 11.

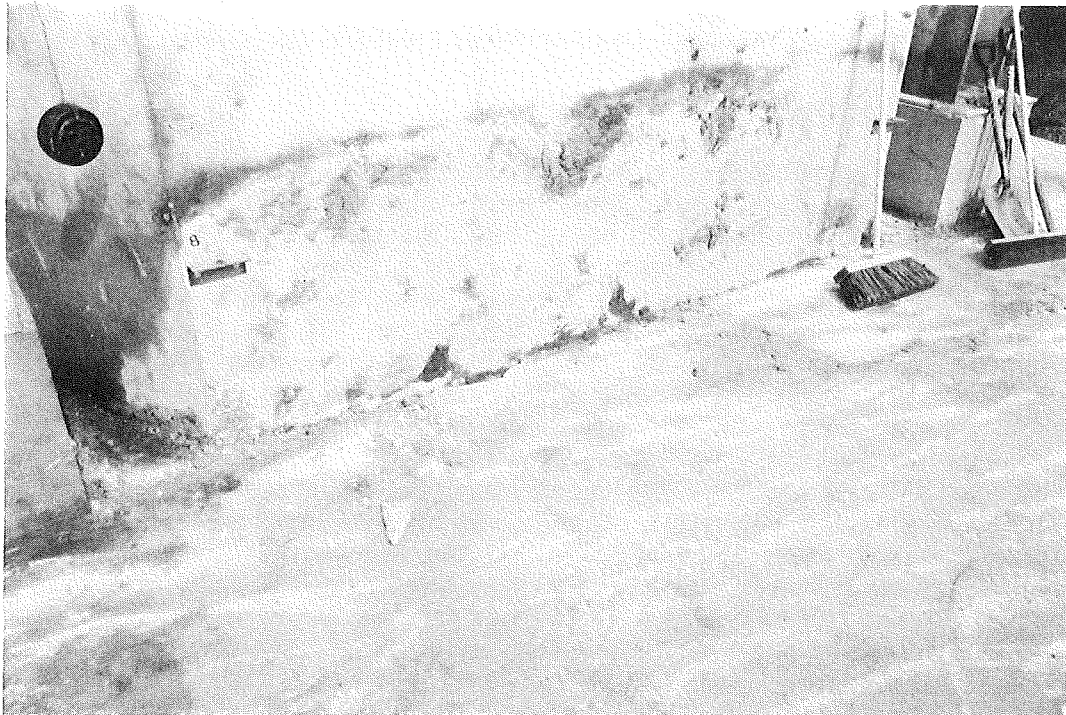
Figure 13. Fractures at column-footing intersection.

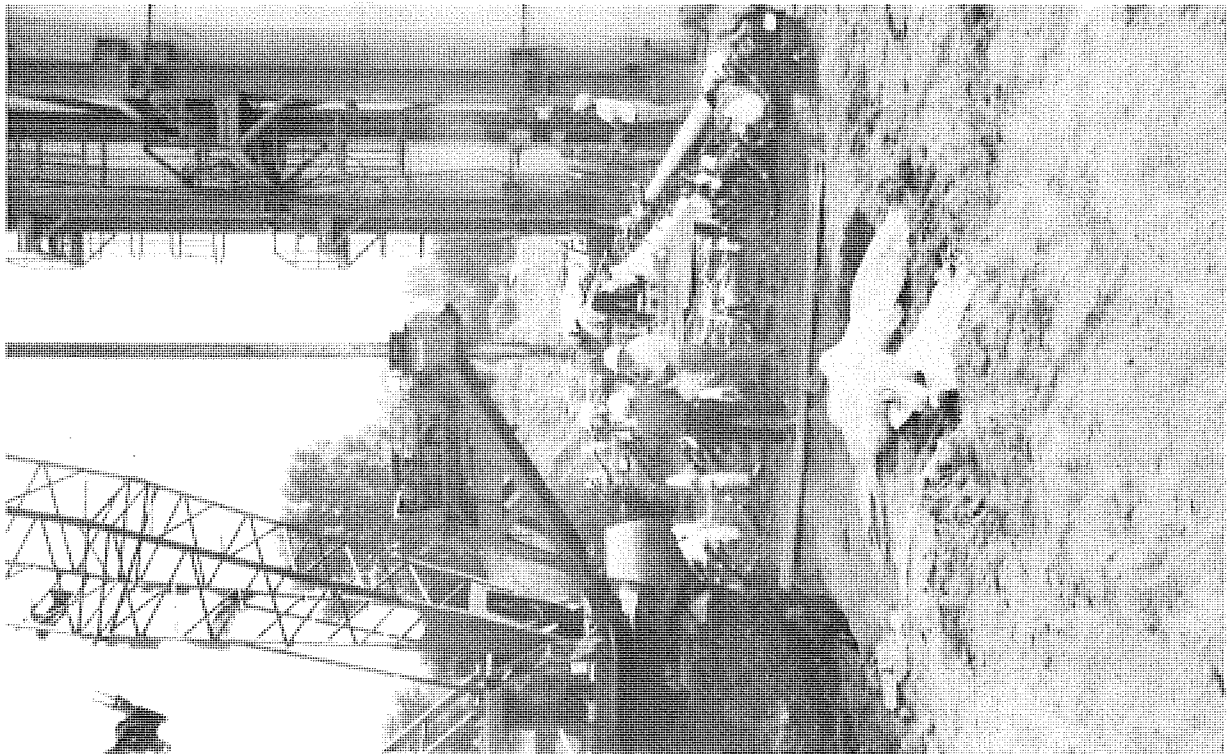
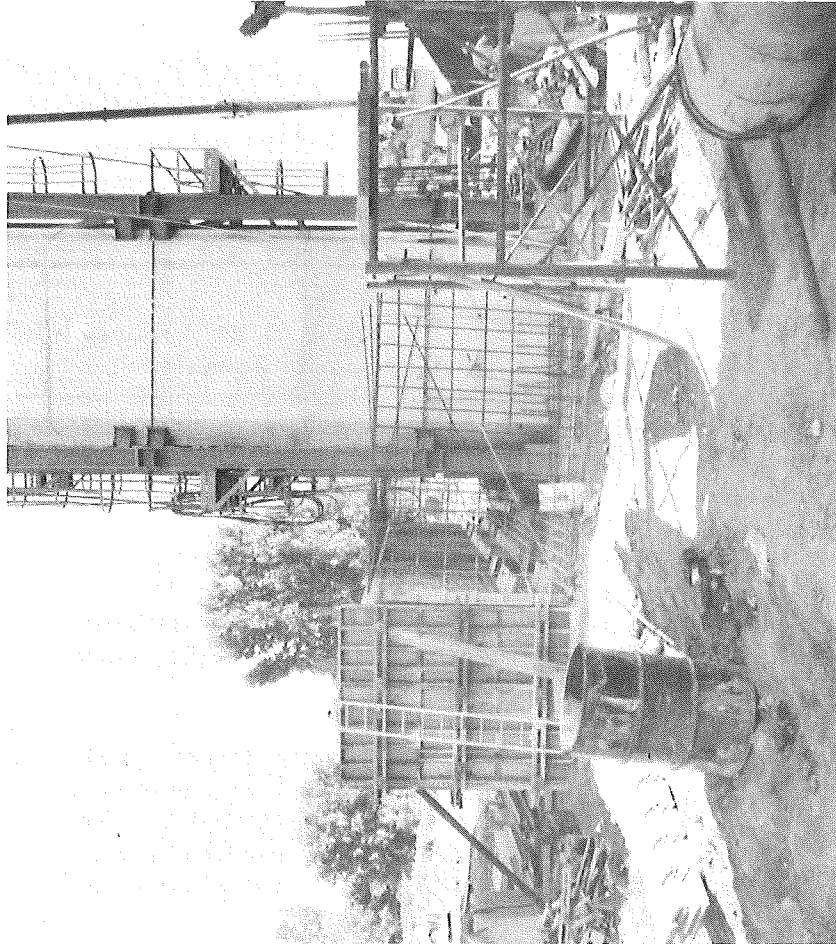
Figure 15. Footing site showing concrete caisson drilling (left). North portion of the new footing is shown after completion (above) with south portion ready for concrete placement.

This phase involved monitoring of movements during construction repair. Repairs consisted of installing freeze-pipes, freezing the ground to ensure stability, drilling and placing concrete filled caissons to bedrock, building a new footing on top of the caissons, fabricating and installing falsework and jacks, and building and installing the tie-down system under the expansion joint.

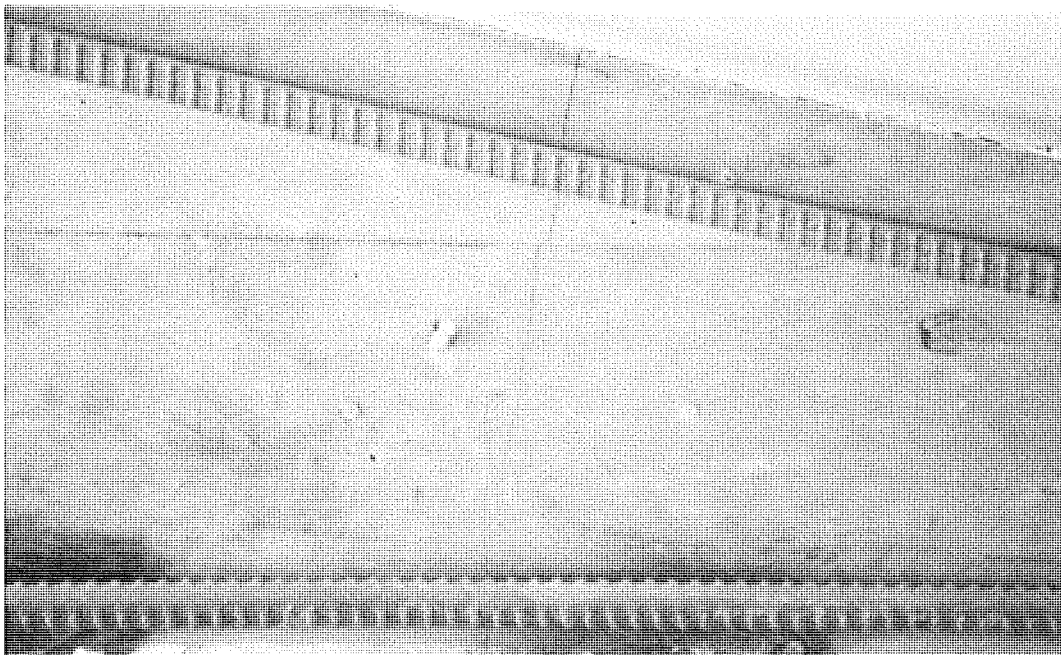
After the final jacking, it was discovered that the northeast bearing block was cracked (Fig. 28). Four of these epoxy blocks are located above the jacks (as shown in Fig. 26) and support the superstructure. Pins were

Figure 28. Cracked bearing block in northeast corner.

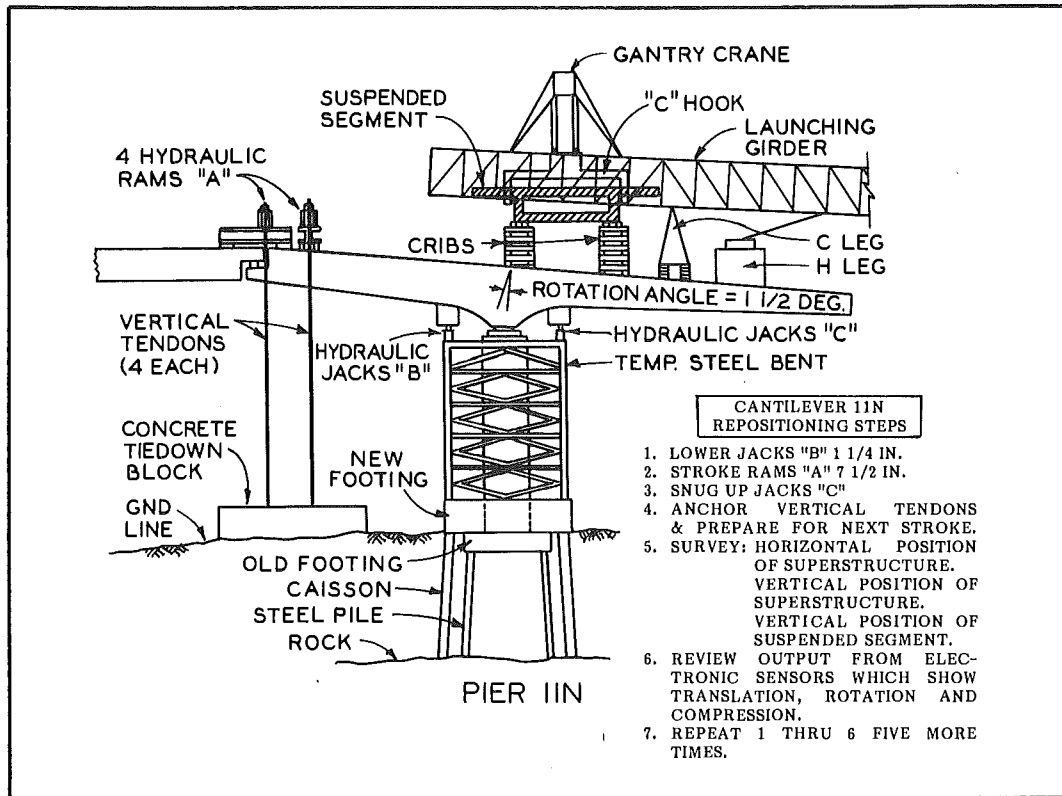
Figure 30. Diagram showing realignment procedure (after Ref. 1).

The process involved a five step procedure. First, the jacks on the north side of the falsework would be lowered 1-1/4 in. The hydraulic rams at the damaged expansion joint were then stroked 7-1/2 in., pulling down the expansion joint end of the superstructure and raising the south end. The jacks on the south side of the falsework were then raised to meet the new superstructure position. The vertical tie-down tendons were then anchored. The final step involved a survey and review of the data. This process was scheduled to be repeated six times and is illustrated in Figure 30.

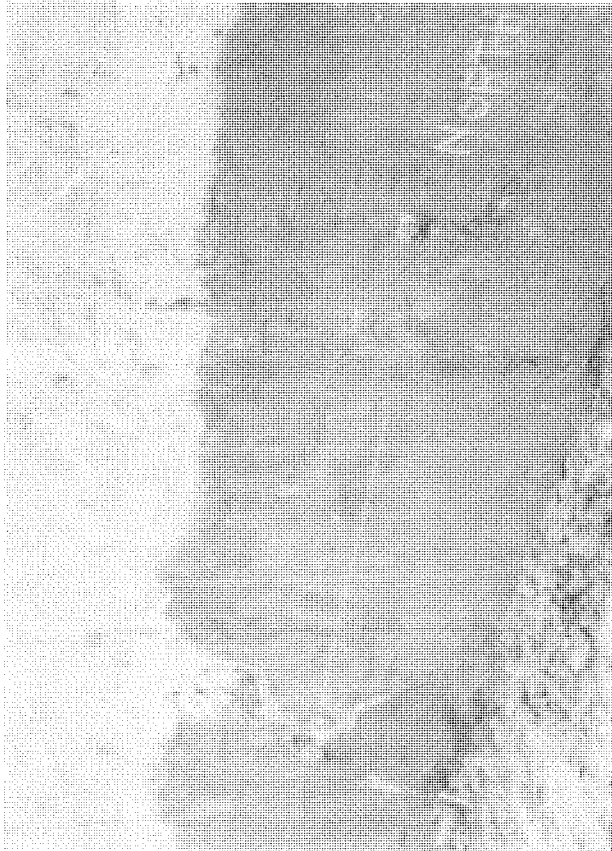
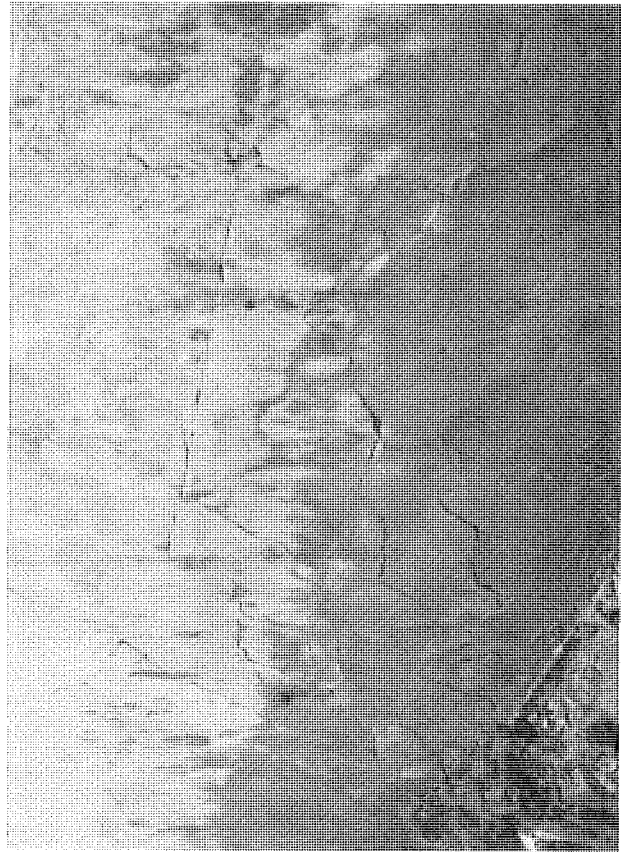
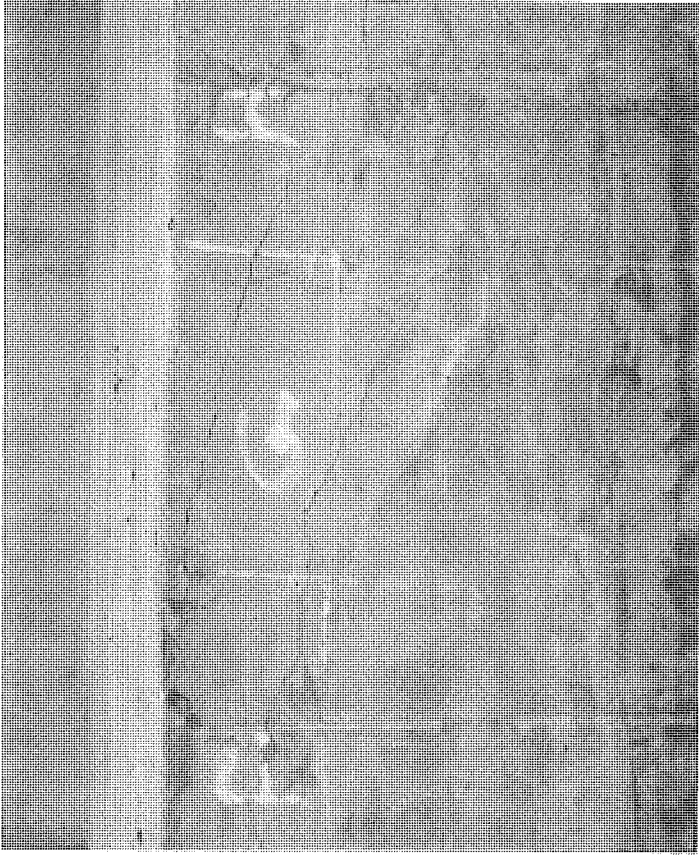
Because of these limited data, it was hard to draw any conclusions other than the crack openings were relatively stable. The average of all the readings of all the cracks was 0.000 in. with an average range from -0.004 in. to +0.007 in. One crack did show an opening of 0.018 in. when measured on a cool forty degree day. Since it was the intent of these measurements to determine whether the crack openings were getting increasingly wider, and they did not, the information was useful.

Figure B-12. Cracking in the original footing; north wall (upper left), west wall (lower left), and east wall (above).

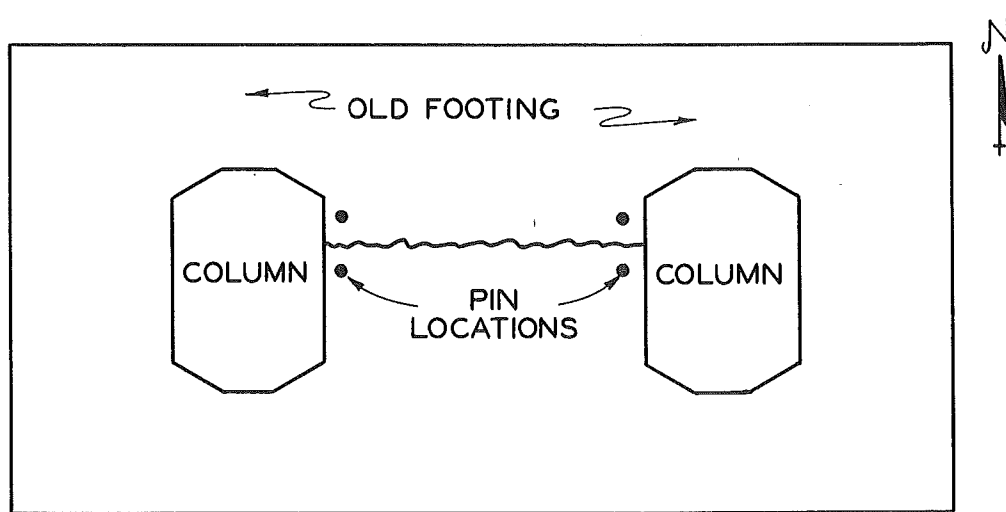
Figure B-13. Pin location for monitoring crack movement on top of footing.

Reference pins were set to indicate both vertical and horizontal movement of the major fracture between the columns in the top of the footing (see page 63 of Appendix B). Measurements were taken about every other week during Phase I starting November 9, 1982. During this monitoring, the crack opening exhibited very little net movement with the west side of the crack closing an average of 0.008 in. and the east side closing an average of 0.010 in. Both sides showed an average increase in faulting of less than 1/16 in. Here again, the intent was to monitor for changes that would indicate instability of the fractured base. Net movements were found to be extremely small.
