MICHIGAN
STATE HIGHWAY DEPARTMENT
JOHN C. MACKIE, COMMISSIONER

349
November 1, 1960

Subject: Performance of Non-Metallic Base Plates. Research Project 53 G-70.
Report No. 349.

Reported by L. T. Oehler and O. L. Lindy.

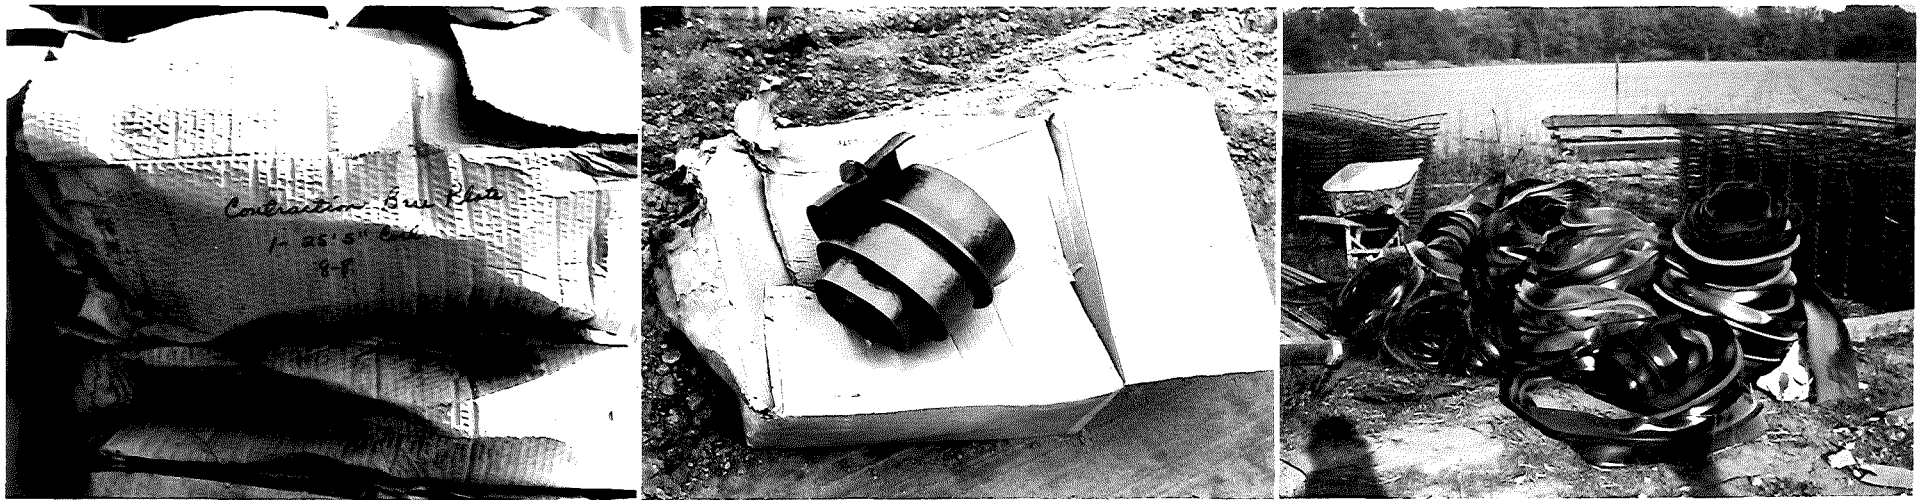
The problems and poor performance associated with these base plates are well illustrated by photographs taken at construction sites. Figs. 1 and 2 show some of the difficulties arising in shipping and handling non-metallic base plates. The tight coiling of the base plate into rolls results in a permanent set in the rolled position, making it very difficult to correct the wrinkling of the bottom plate and ruffling of the plane of weakness strip. Poor positioning of the end plate is caused to some extent by this difficulty in getting the base plate to lie straight and flat.

Figure 1. Base plates are received from the manufacturer in light-weight boxes (left), tightly coiled (center). The plates were found stored in the contractor's construction yard (right).

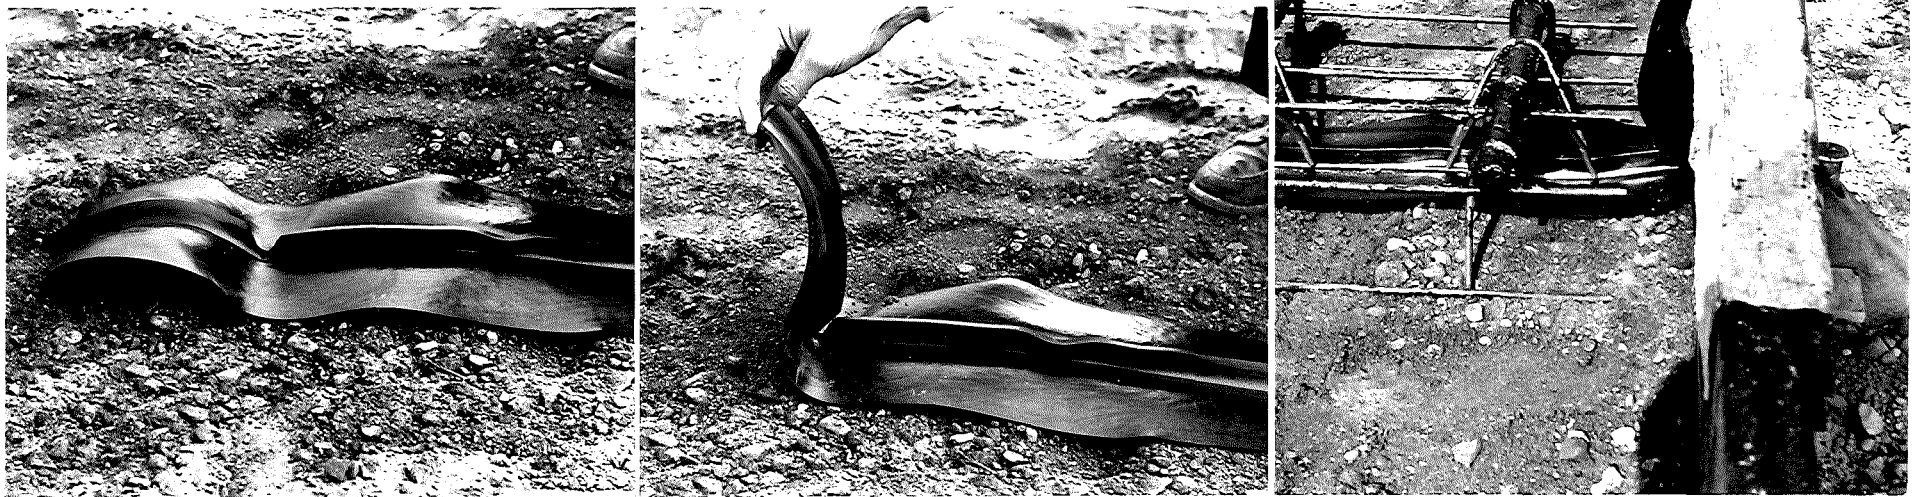
Figure 2. A typical wrinkled base plate, immediately before installation (left). The same plate is shown at center with the end plate turned up, and at right after installation as concrete is being poured.

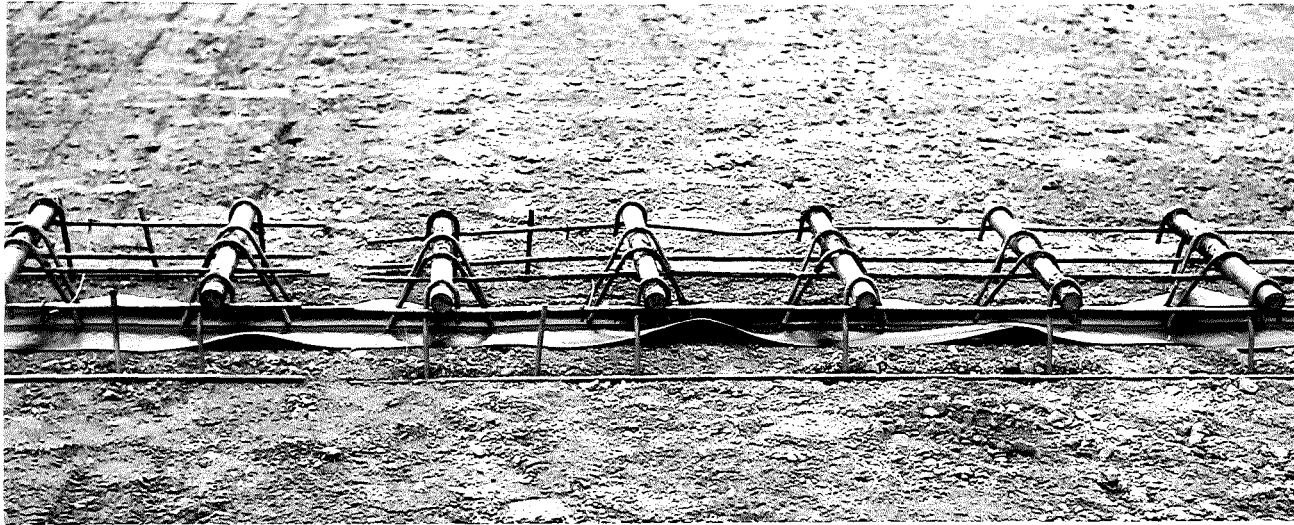
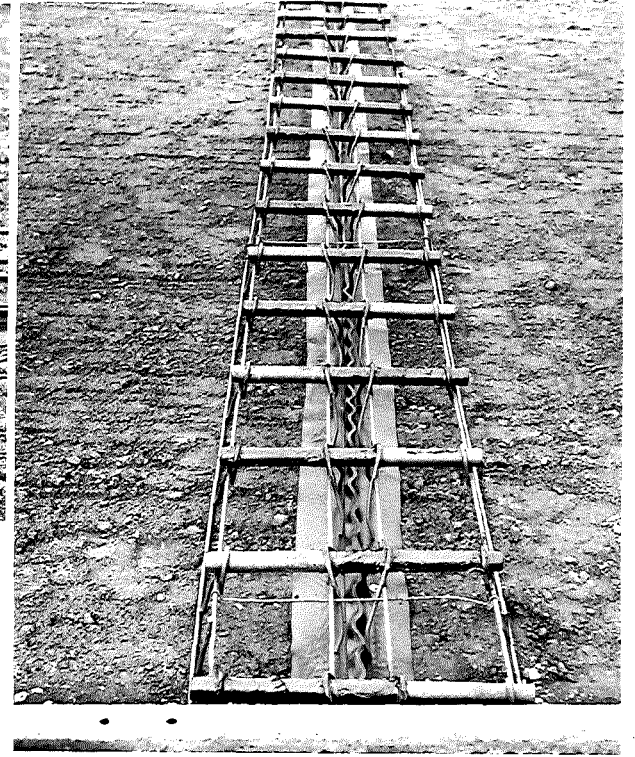
Figure 3. Typical warped plates in place in a joint assembly, showing poor contact with base (left). Overhead view (right) shows wrinkled plane-of-weakness strip, due to permanent stretching resulting from tight rolling of the plate during shipping.

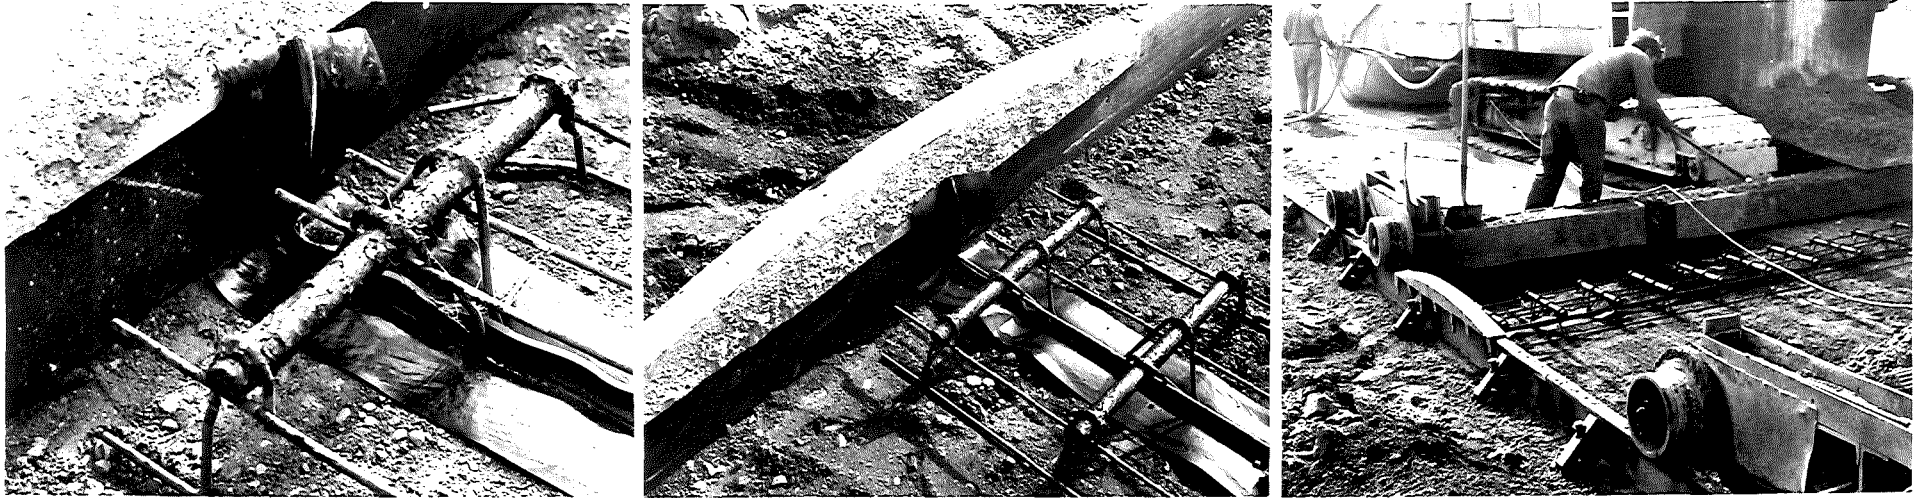
Figure 5. Views of the two ends of one wrinkled plate show poor contact with the base and paving forms (left and center). The same plate is shown at right as paving machine approaches.

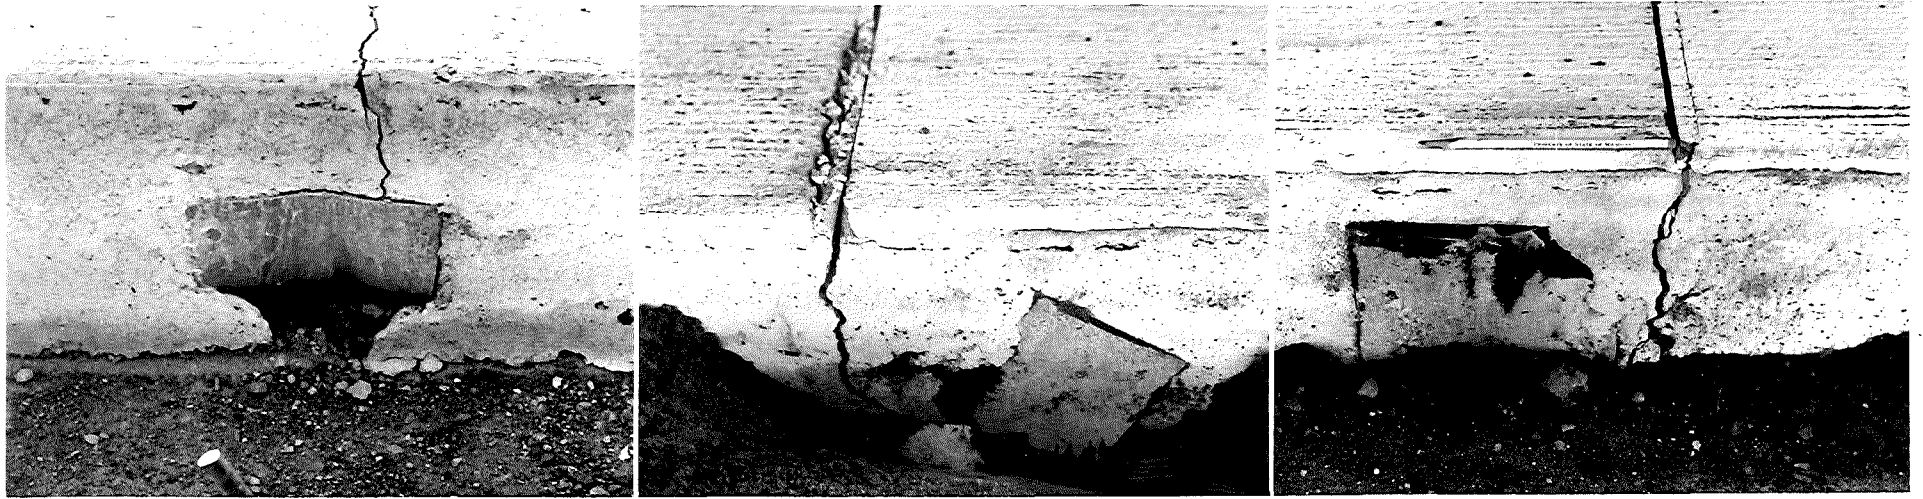
1. A large-radius curve of the base plate at the pavement edge, rather than a right-angle corner, results in a thinner slab at this most critical point and a possibility of a corner break (Fig. 7A).

2. A badly tilted end plate results from lack of stiffness of the material and from its wrinkled condition when uncoiled (Fig. 7B). The tilt prevents proper alignment with respect to the top joint groove.

3. A joint groove not properly placed with respect to the base plate and load transfer assembly, is a serious deficiency which, it has been noted repeatedly, may cause a broken joint on the side containing little or no dowel length (see letter from E. A. Finney to W. W. McLaughlin, 12-29-57). This trouble is not associated with the type of base plate material, but is caused by lack of care in placing the styrofoam strip above the joint (Fig. 7C).

Figure 7. The three most common types of incorrect placement for non-metallic base plates are formation of a curve rather than a right angle at the pavement edge (left); tilting of the plate during pouring operations (center); and misalignment of the top surface joint groove (right).

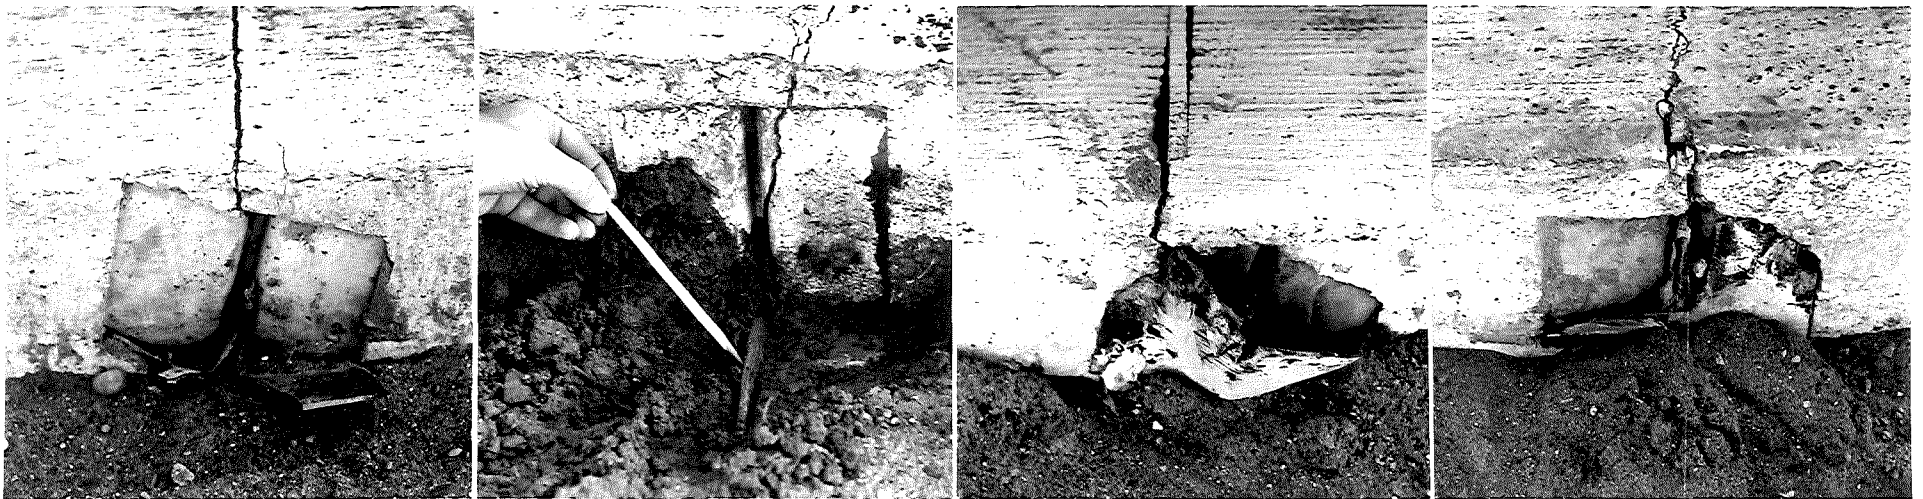
4. End plate material is often partially or completely torn off either during construction or subsequent grading operations (Fig. 8).

Figure 8. End plates are often torn or otherwise damaged, either during construction or subsequent grading operations.

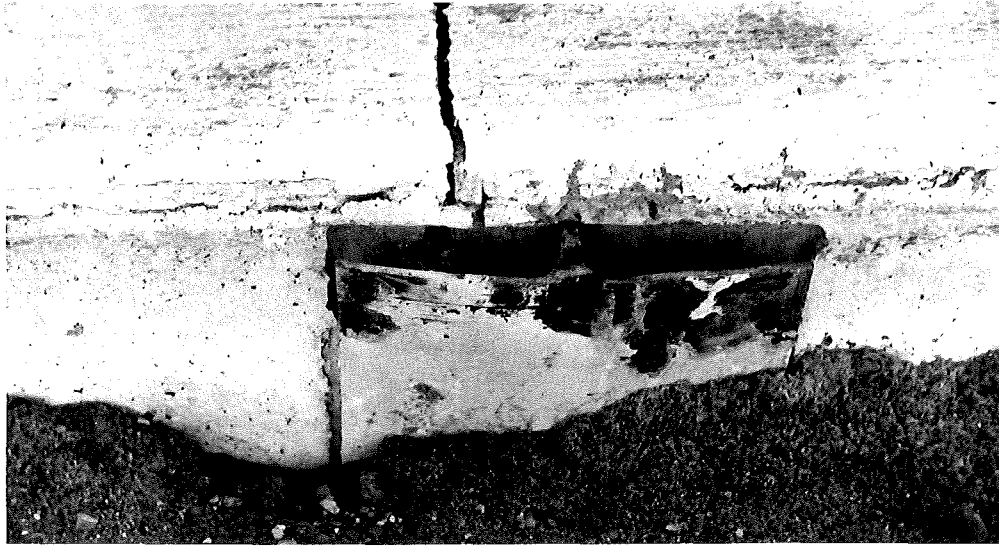
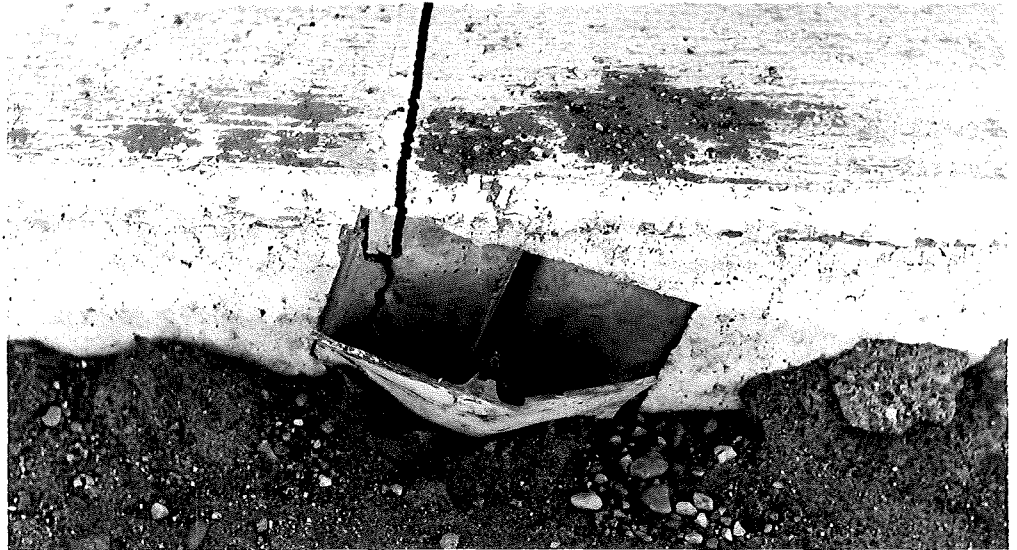
5. An end plate loose from the concrete permits side infiltration of foreign material into the joint crack (Fig. 9).

Figure 9. When non-metallic end plates fail to adhere to the slab edge, foreign material freely infiltrates into the joint crack.
