# OFFICE MEMORANDUM

MICHIGAN  
STATE HIGHWAY DEPARTMENT

Subject: Right-of-Way Fence Sagging Investigation. Research Project R-63 G-126.  
Research Report No. R-422.

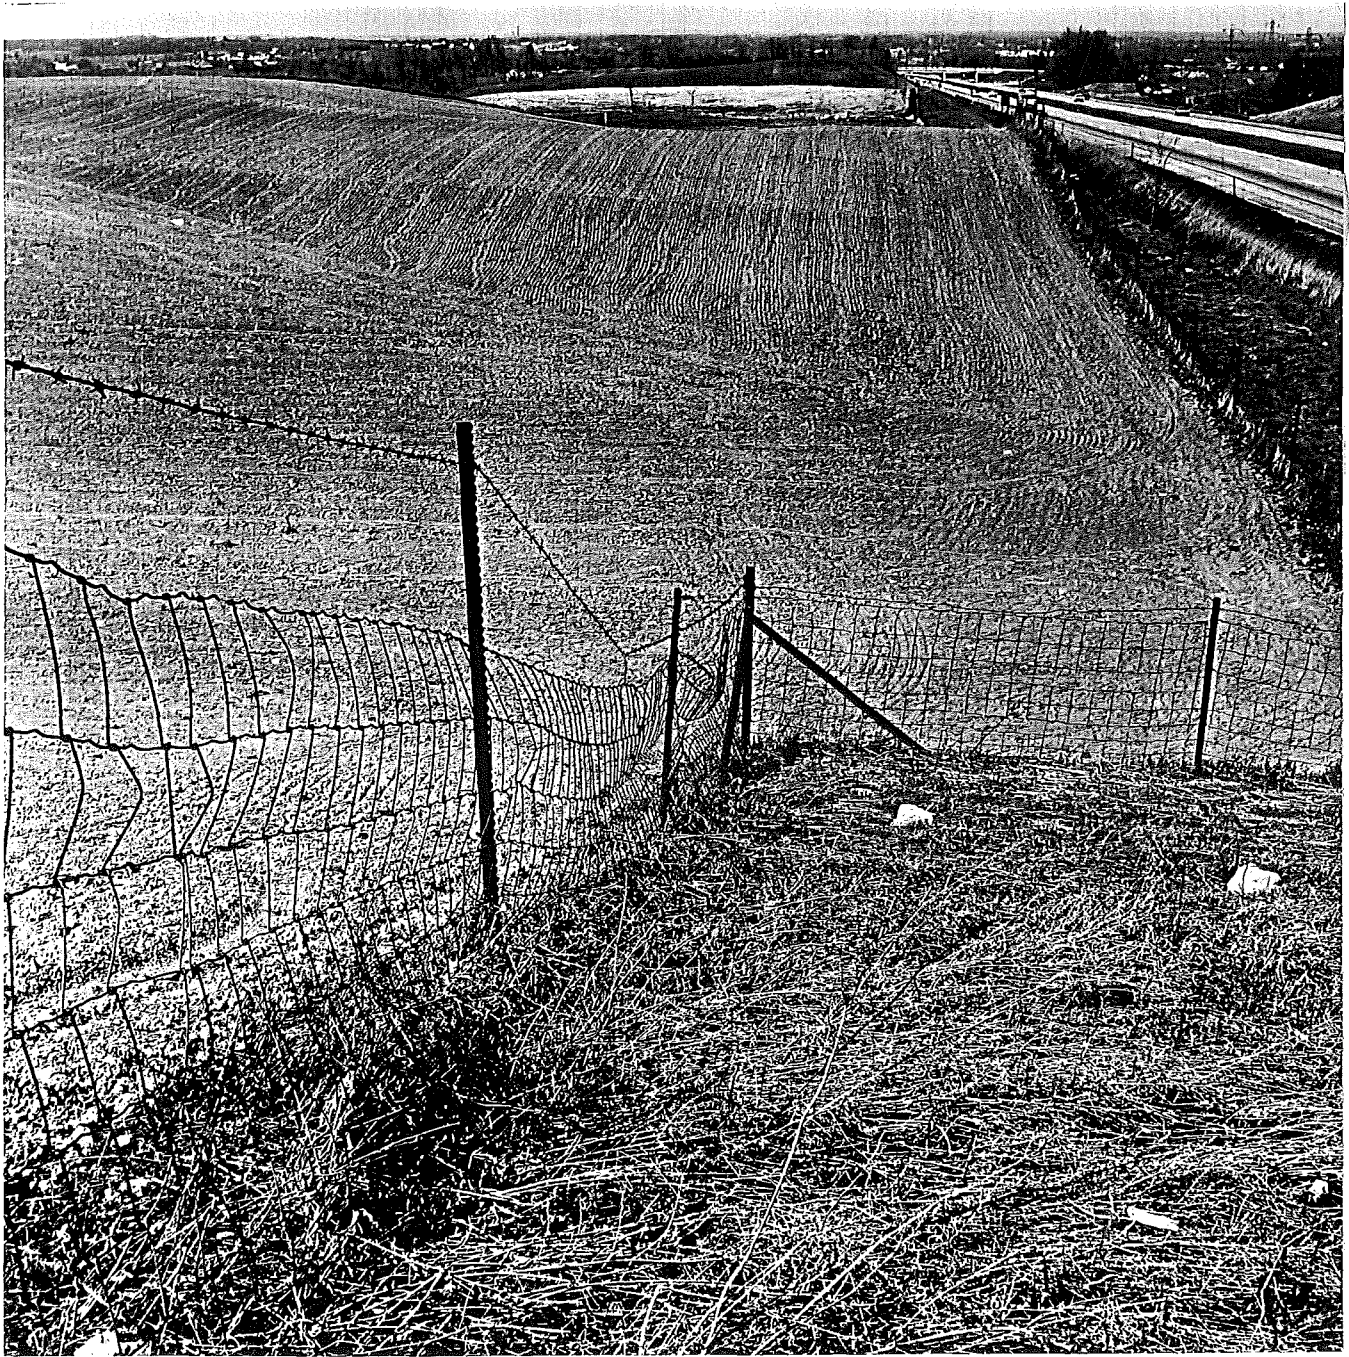
The first area noted involved two posts at the top of a hill. Several tie clips were missing. It is difficult to see how snow could have been involved at the top of a hill, unless pressure of snow further along toward the adjacent ravine created sufficient tension on the wires to pull the clips off. As shown in the accompanying photograph, the evidence suggests that damage may have been caused by farm machinery colliding with the fence. Note that a wire has been attached between the barbed wire and the upper wire of the fencing mat, to help hold the fencing up.

Sagging of fence wire of right-of-way fence on west side of US 131 about 10 miles north of Wayland. Note wire attached to barbed wire holding fence wire up, also type of bulging suggestive of collision with farm machinery.

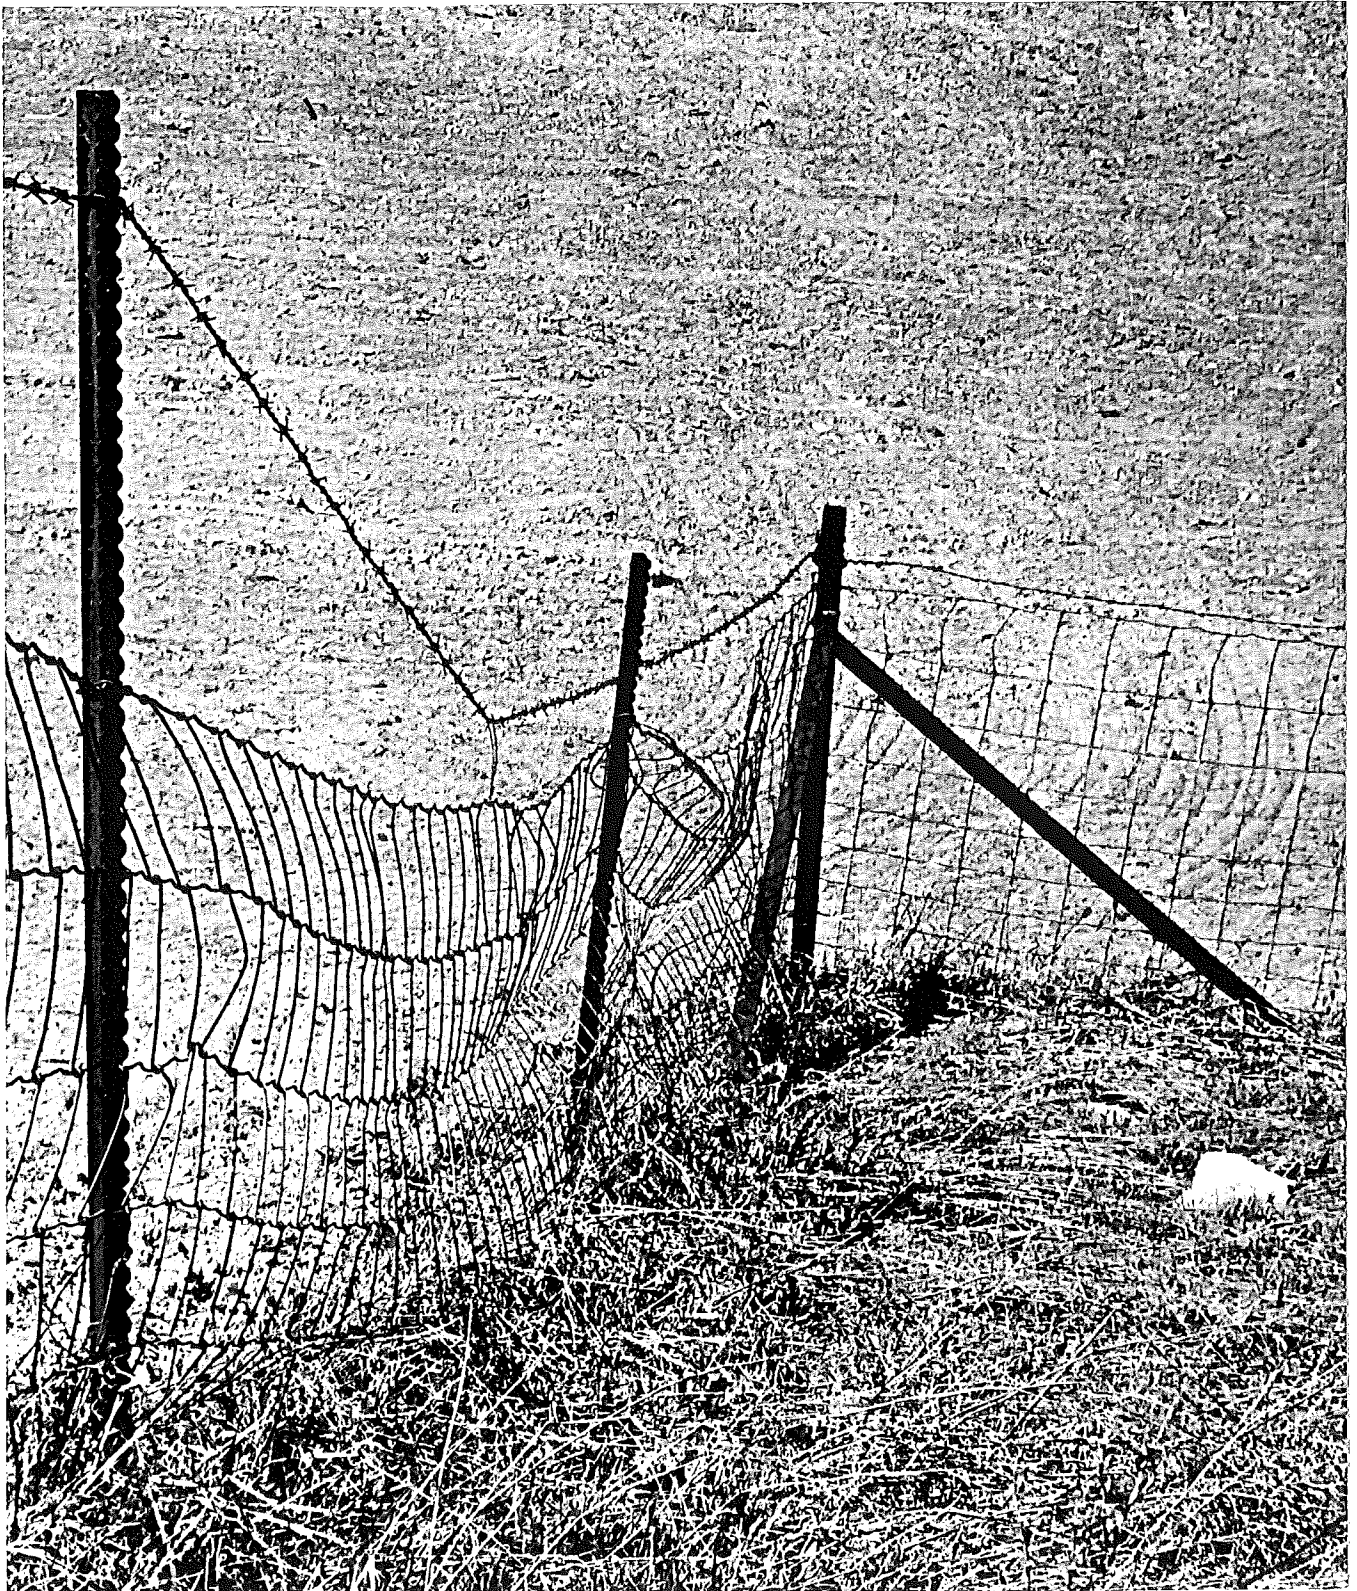
Enlargement made from preceding photograph to illustrate tie clips missing from posts.

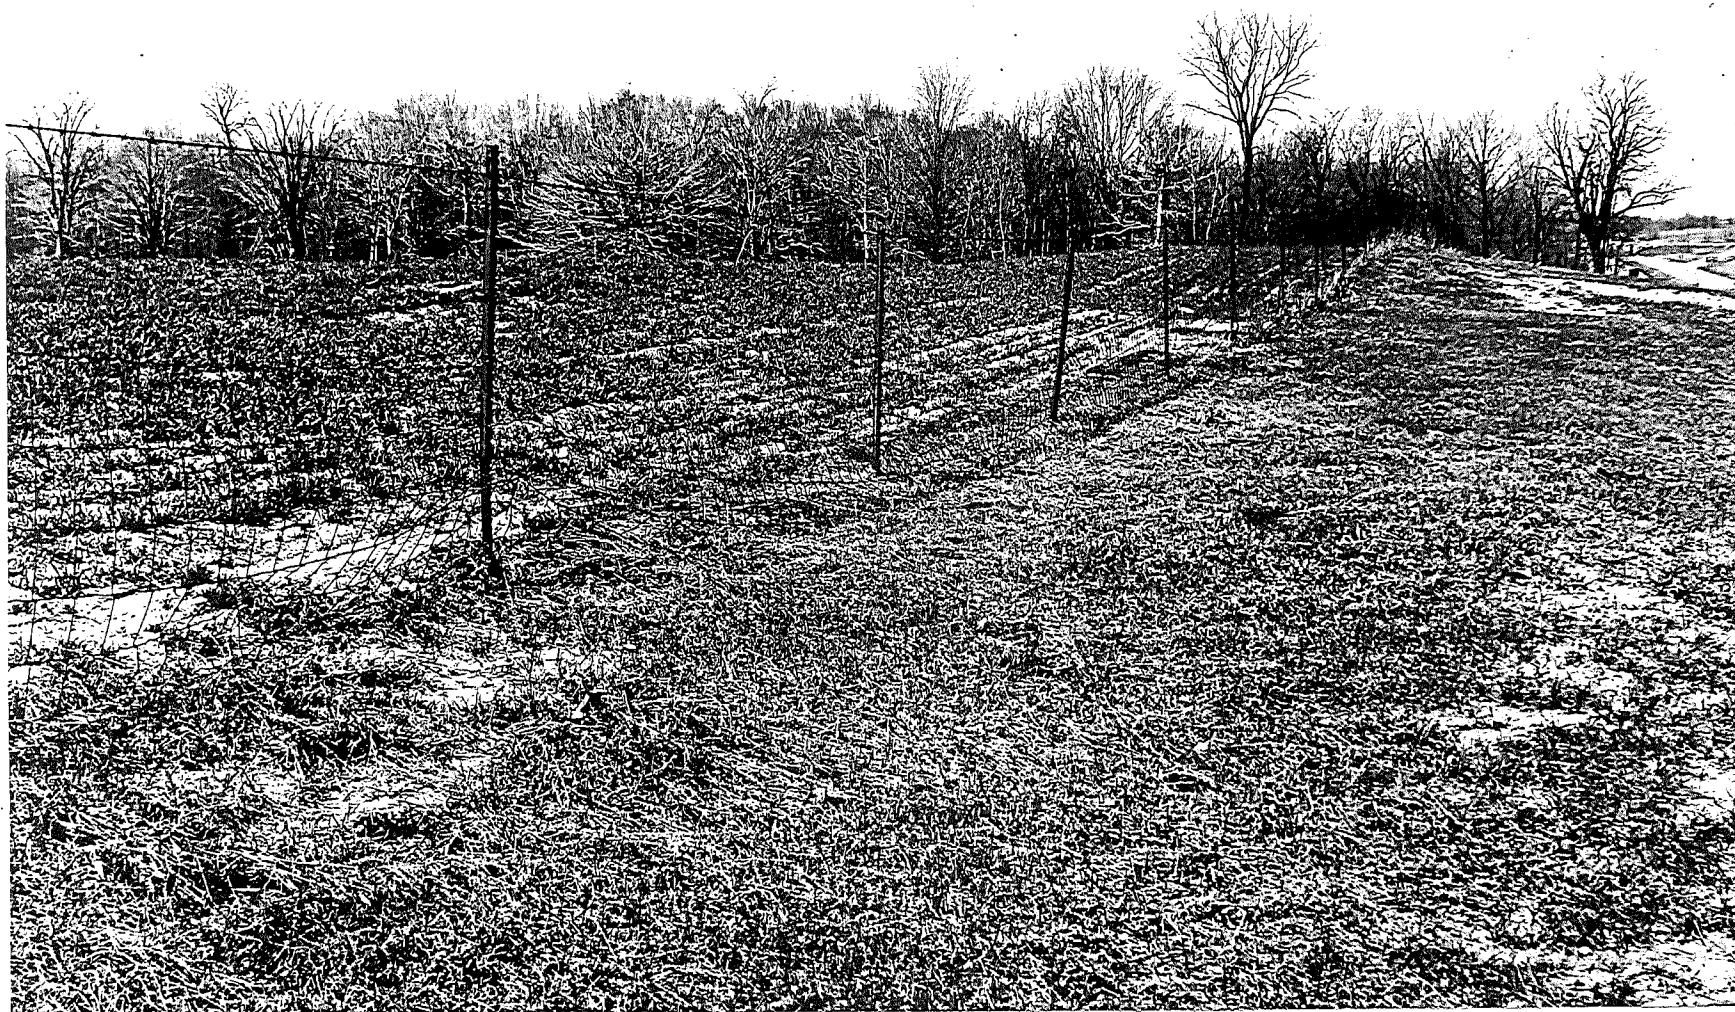
A little further south at 102+00 a section of 8 posts had most of the tie clips missing, with considerable sagging of the wire.

Severe sagging of fence wire involving 8 posts of right-of-way fence on west side of US 131 about 5 miles north of Wayland. Although this damage could have resulted from impact with farm machinery, the gradual contour of the bulges plus the ground slope suggest that movement of heavy snow masses may have been responsible.

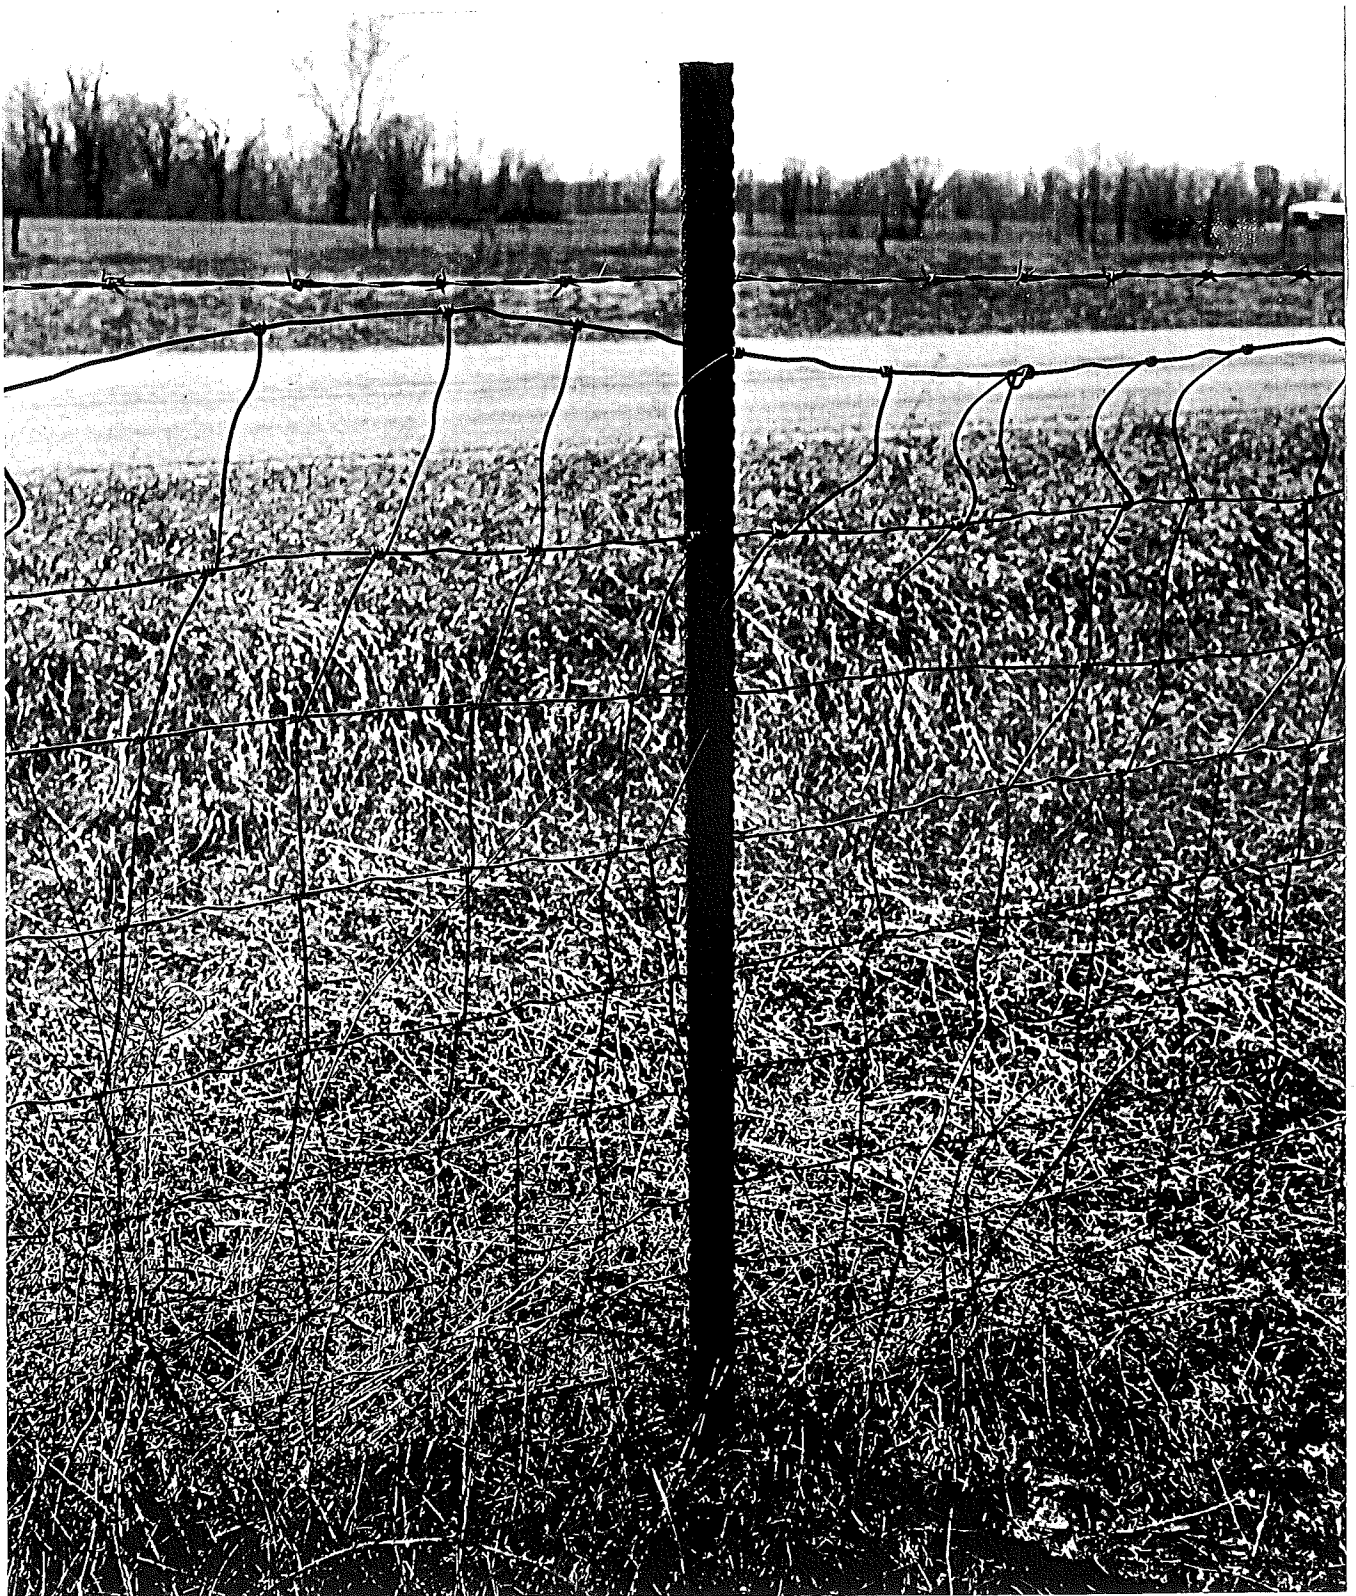
Close-up of post shown in preceding photograph shows that the tie clips are missing.

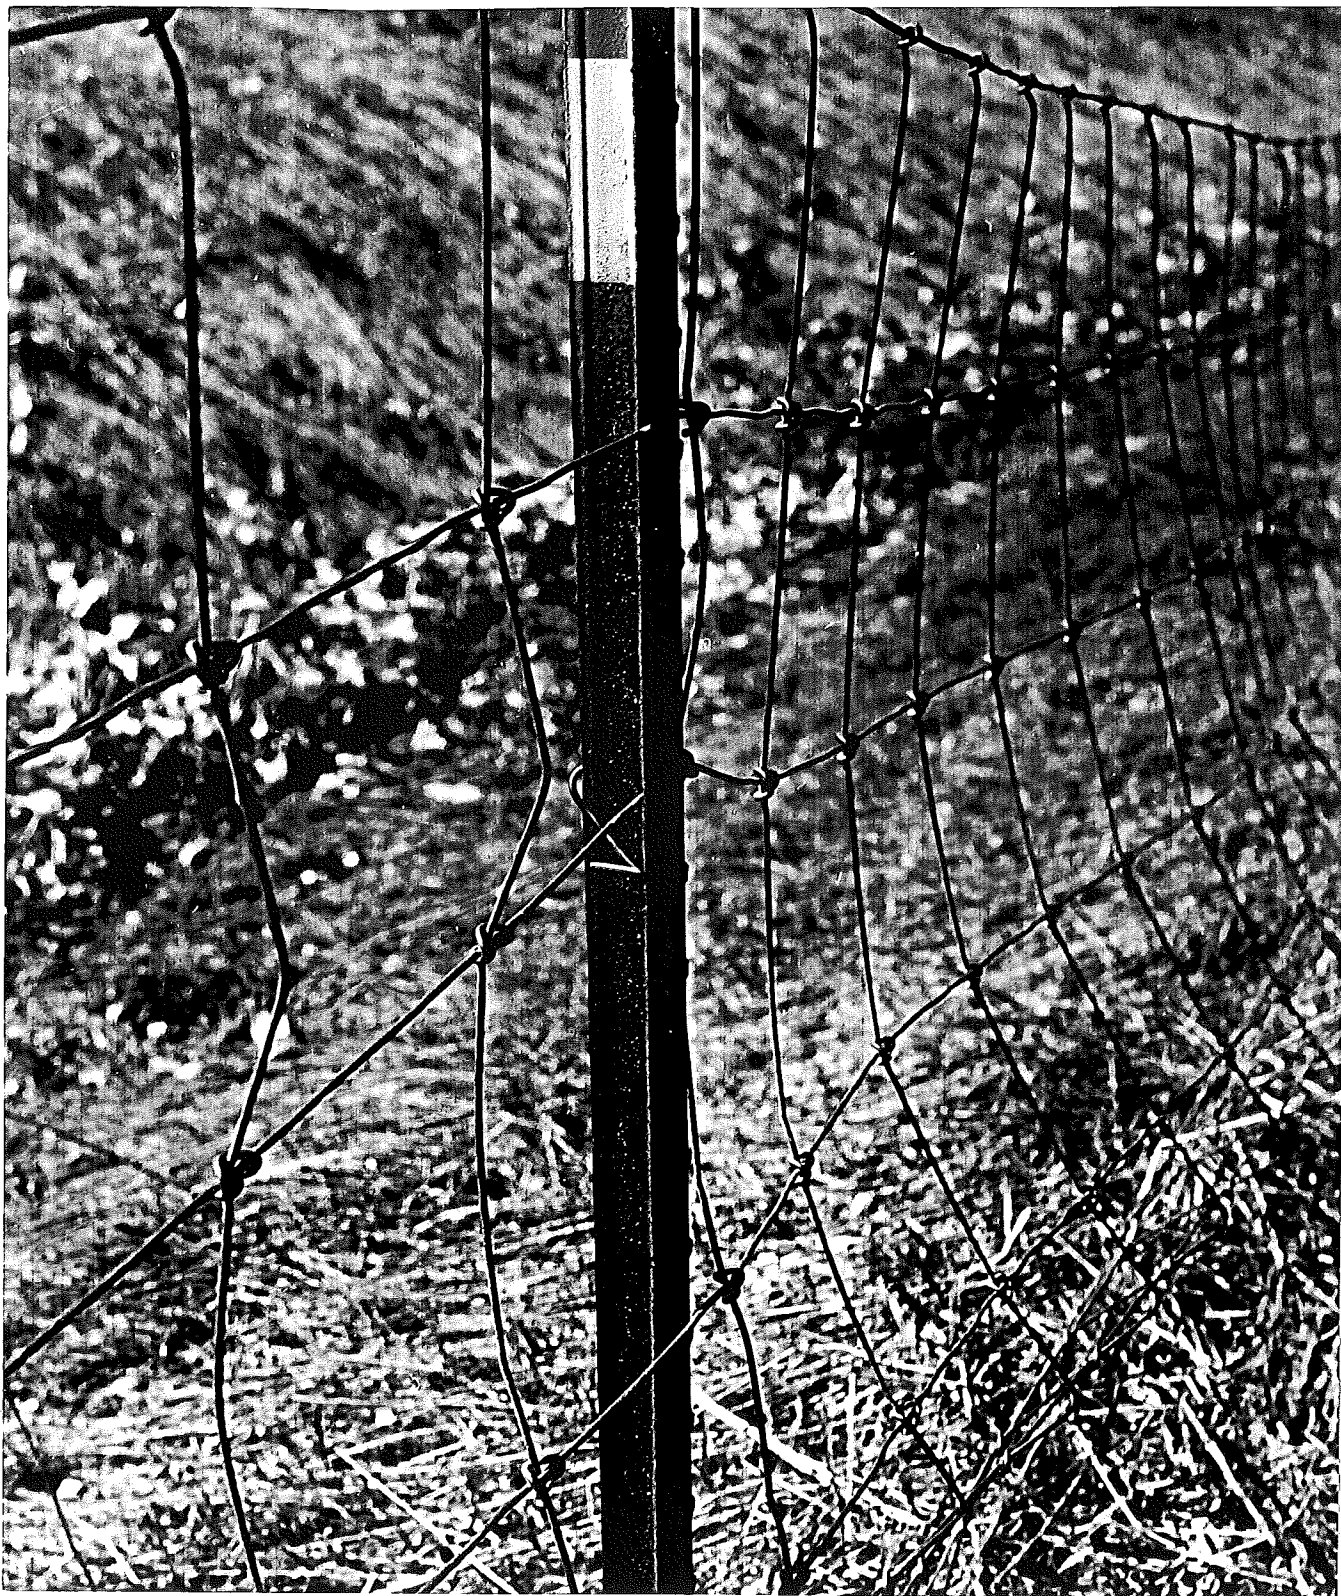
Just south of Wayland at 918+00 area several adjacent sections of wire were sagging greatly between the posts, but not at the posts. There was evidence of great force bulging the bottom of the fencing wire eastward, with one post actually bent toward the east at the ground line. One tie clip was found that had been pulled away from the fence at one end of the clip, and the wire itself had been broken. This was in the area having a ditch just west of the fence, and the old highway just west of the ditch. A maintenance crew operating out of Moline told me that this bulging is caused by snow, that it happens every year, that the fence is repaired every year, but had not been repaired yet this year.

Right-of-way fence post on west side of US 131 just south of Wayland. Note broken fence wire where tie clip is loose at one end.

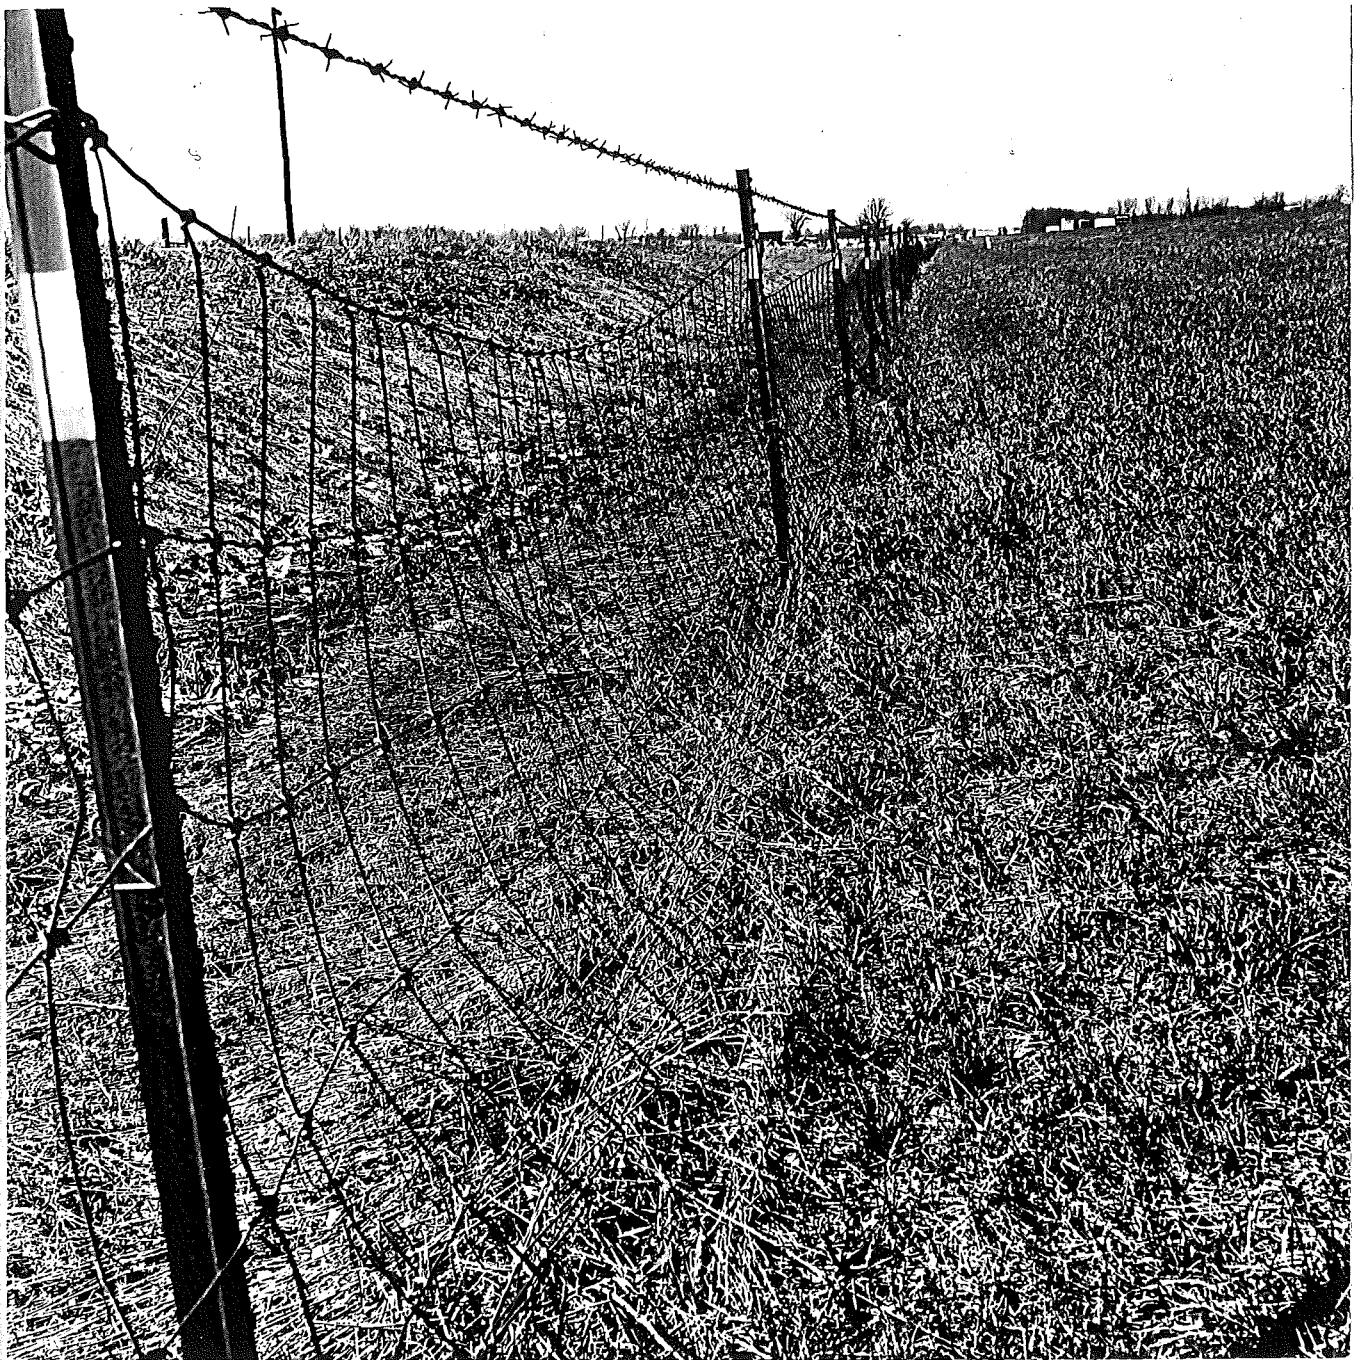
View of fence facing north from post shown in preceding photograph. Note bulging of fence wire at bottom, suggesting movement of heavy snow masses; also that post lugs in general have served their purpose well.
