EVALUATION OF BREAKAWAY CABLE
TERMINAL ENDINGS ON GUARDRAIL

Research Laboratory Section
Testing and Research Division
Research Project 82 TI-853
Research Report No. R-1221

Michigan Transportation Commission
William C. Marshall, Chairman;
Lawrence C. Patrick, Jr., Vice-Chairman;
Hannes Meyers, Jr., Carl V. Pellonpaa
Weston E. Vivian, Rodger D. Young
James P. Pitz, Director
Lansing, May 1983

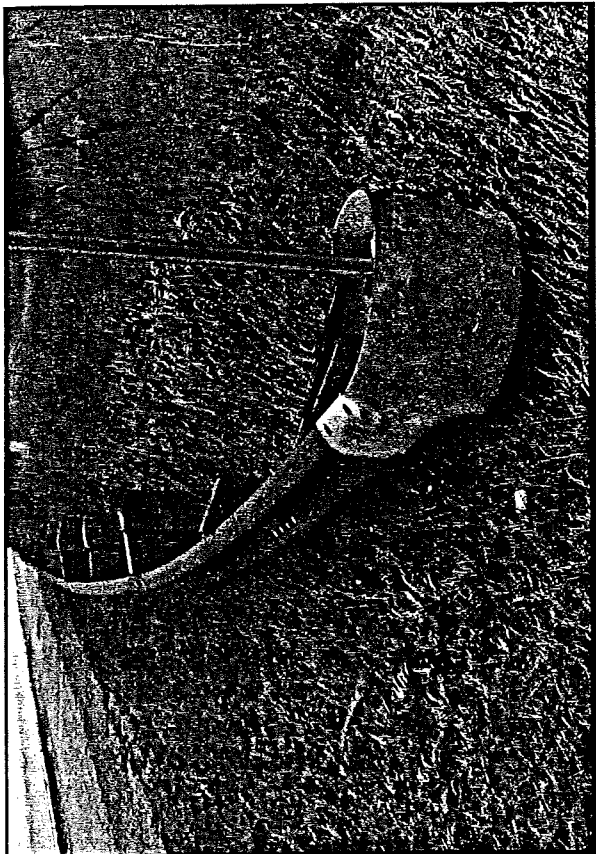
The table shows no consistent pattern for deficiency conditions with respect to control sections. The percentage of tight and loose cables is relatively constant for the three control sections of District 5, whereas the number of loose cables in Jackson, Livingston, and Shiawassee Counties is extremely high. Nonstandard bearing plates involving problems such as plates being too thin or upside-down (which would probably not happen if care were taken to install the plates and tighten the nuts properly) as shown in Figures 2, 7, and 9, appear frequently in Control Section 76023 of Shiawassee County, with 83 percent in nonconformance as well as 39 percent of the 2-in. pipe sleeves missing in this control section. This might indicate a lack of understanding by the contractor or enforcement by the Department when these endings were installed. Also, Jackson County (Control Section 38131) is missing 26 percent of the 2-in. pipe sleeves and 26 percent of the cables have all the threads used up at the anchor plate. In Calhoun County, 22 percent of the cables are gouging into the second post as shown in Figure 6 on Control Section 13082 which raises a question as to the accuracy of the post placement in the BCT ending flare along this section. Improper guardrail height at the end section was noted at 29 percent of the locations as shown in Figure 3 in Shiawassee County (Control Section 76011).

Figure 3. Shoe end installed too close to the ground.

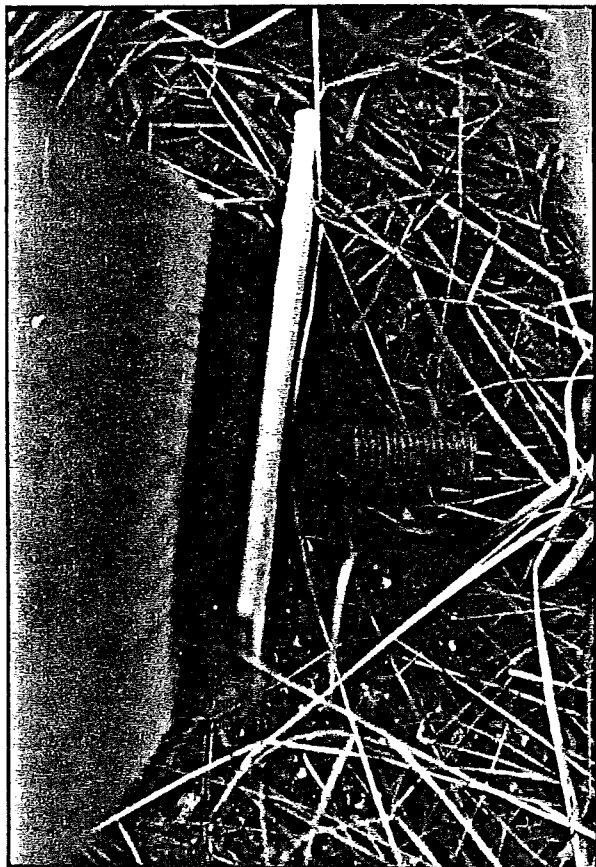
Figure 2. Bearing plate too thin and turned.

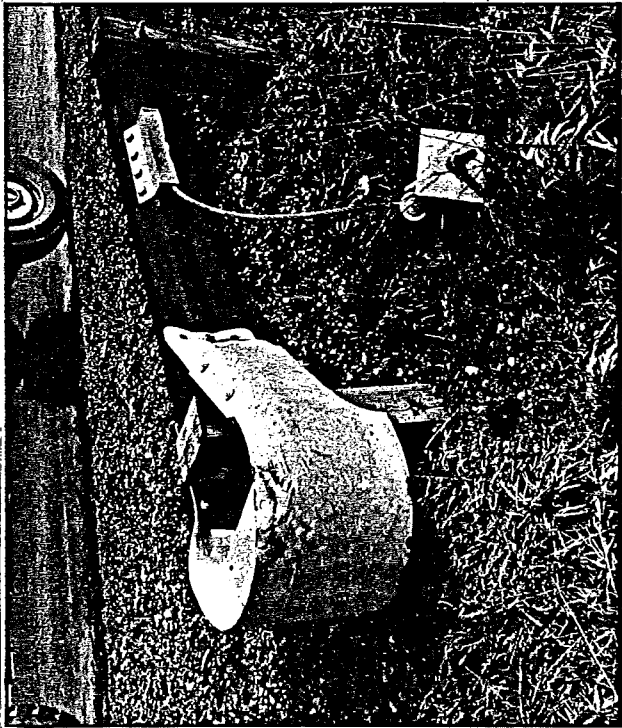
Figure 5. Cable lying on ground.

found to be loose. In some cases where the cable was disconnected, the hole in the post was found to be too small for the cable to fit through, and the cable was left lying on the ground as shown in Figures 4 and 5.

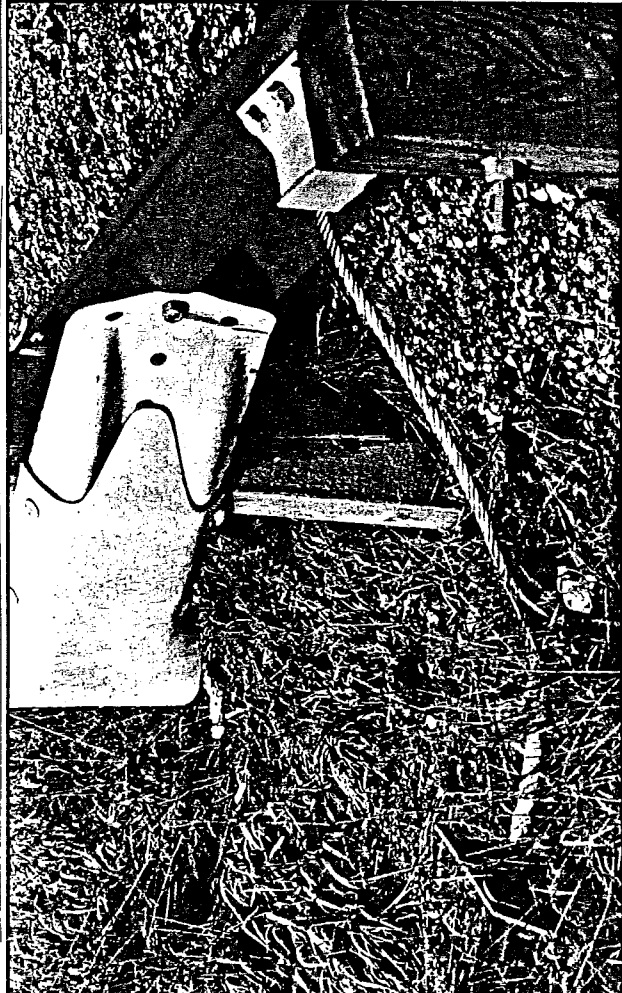
Figure 4. Hole in post is too small for cable.

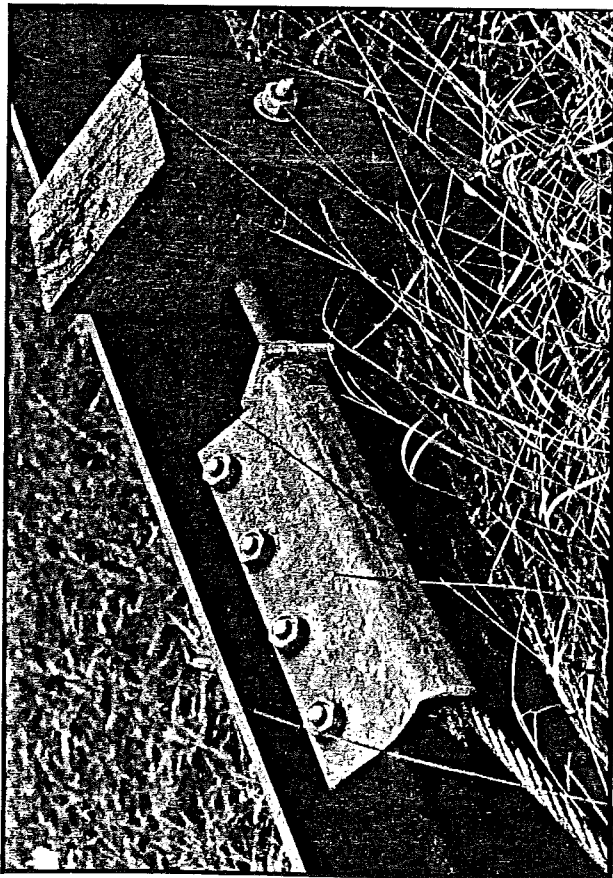
Figure 6. Cable gouged into second post.

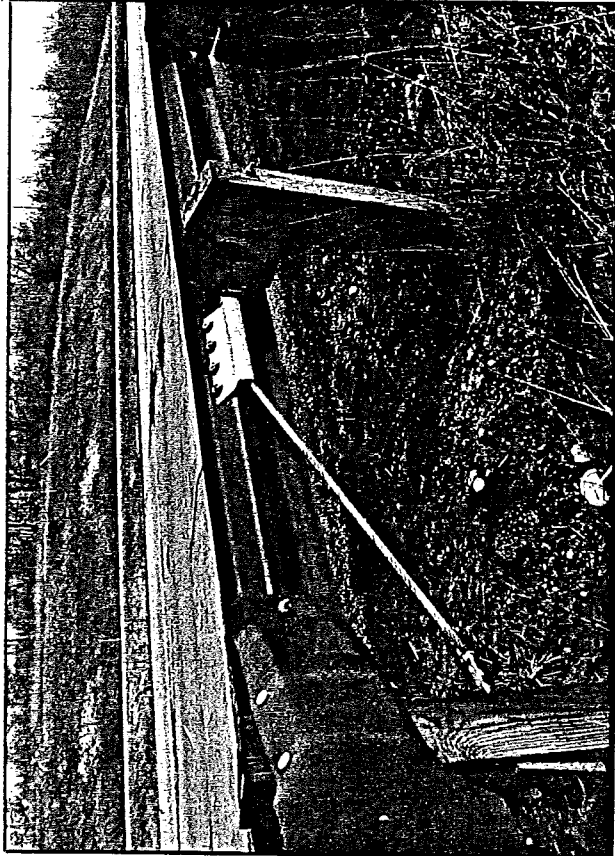
Figure 7. A588 guardrail; bearing plate upside down; second post blocked out.

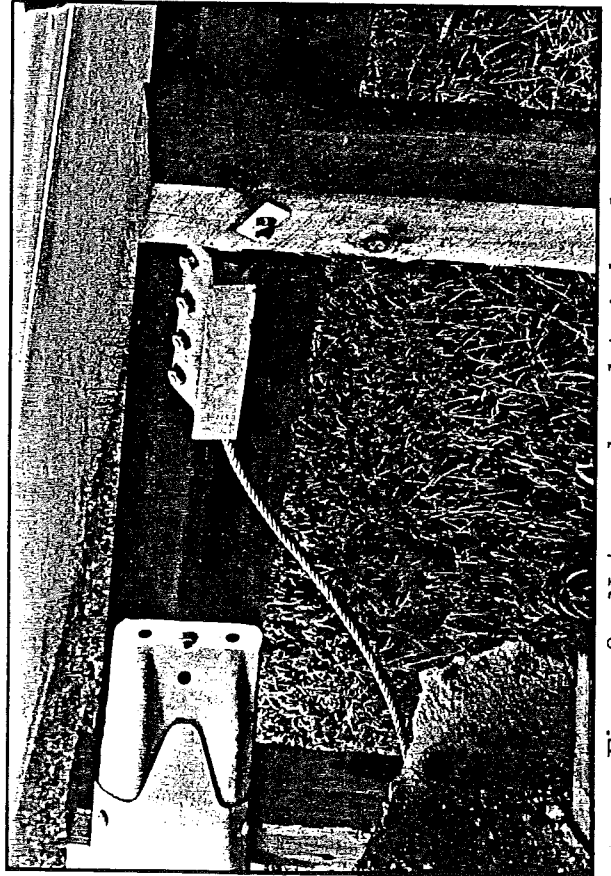
Figure 8. Nut on anchor plate is barely on.
