**REFLECTIVE SHEETING DETERIORATION  
ON PLYWOOD**

**M. H. Janson**

**Research Laboratory Section  
Testing and Research Division  
Research Project 69 G-170  
Research Report No. R-705**

**State of Michigan  
Department of State Highways  
Lansing, June 1969**

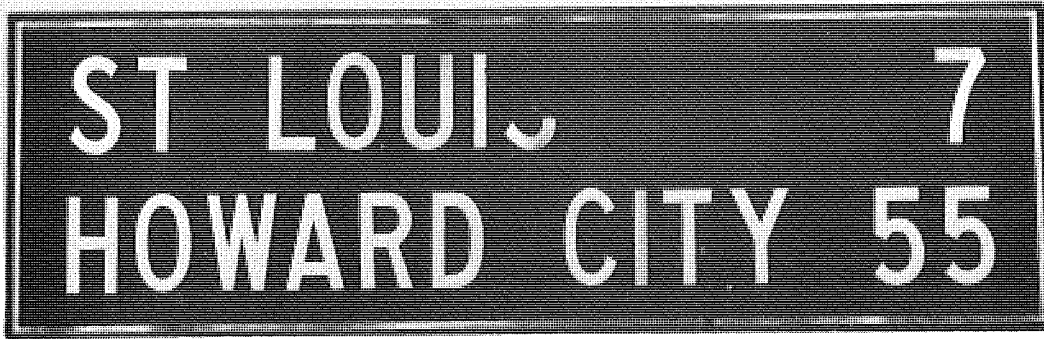
Figure 1. Sign showing reflective sheeting reflector coat corrosion. Note dark areas on top and bottom border.

On April 28 a plywood sign was brought to the Laboratory exhibiting loss of nighttime reflectivity (Fig. 1). The plywood had been identified as U. S. Plywood. The sheeting showed corrosion of the reflector coating. One bar from a barricade was received the same date showing a similar sheeting corrosion (Fig. 2).

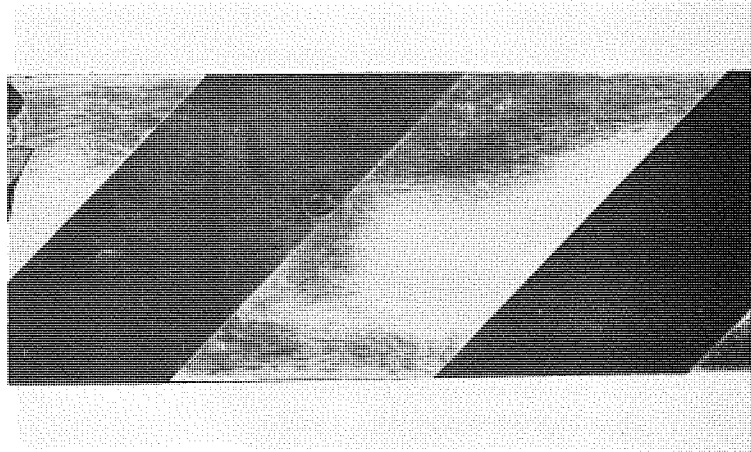
Figure 2. Portion of barricade bar showing reflective sheeting reflector coat corrosion. Note dark areas showing the plywood grain, indicating sheeting transparency.

2. The barricade-bar plywood could not be identified.

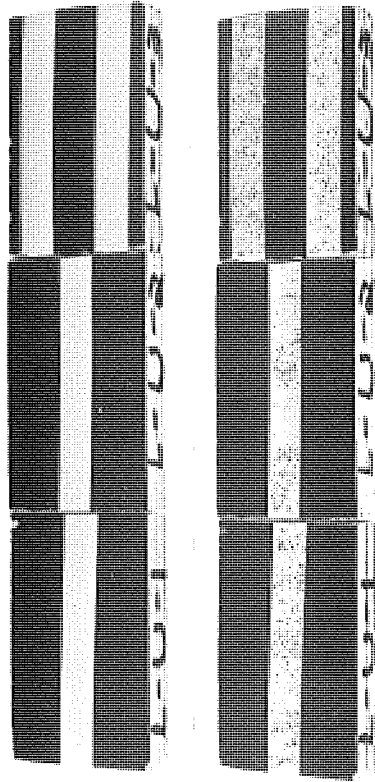
2. Wiped with a naphtha-dampened rag in the Laboratory. Immediately after surface treatment, sheeting was applied in the Laboratory (Fig. 5).

Figure 5. Specimens wiped with naphtha-dampened rag in the Laboratory (sheeting applied in Laboratory). Specimens are shown before test (top) and after test (below).

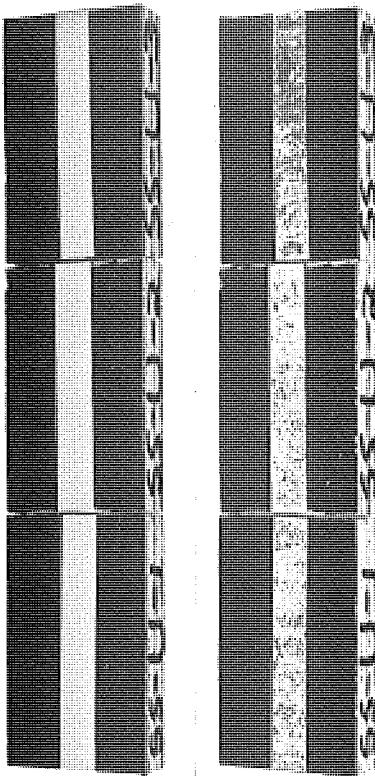
1. Wiped with a naphtha-dampened rag at the sign shop. Immediately after surface treatment, sheeting was applied at the sign shop using vacuum applicator (Fig. 4).

Figure 4. Specimens wiped with naphtha-dampened rag in the Lansing sign shop (sheeting applied in sign shop). Specimens are shown before test (top) and after test (below).

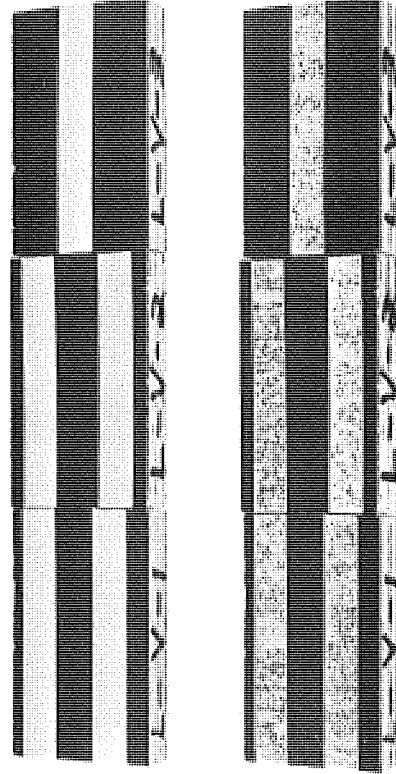
4. Scrubbed with naphtha-saturated cheesecloth in the Laboratory. Seventy-two hours after surface treatment, sheeting was applied in the Laboratory (Fig. 7).

Figure 7. Specimens scrubbed with naphtha-saturated cheesecloth in the Laboratory (sheeting applied in the Laboratory). Specimens are shown before test (top) and after test (below).

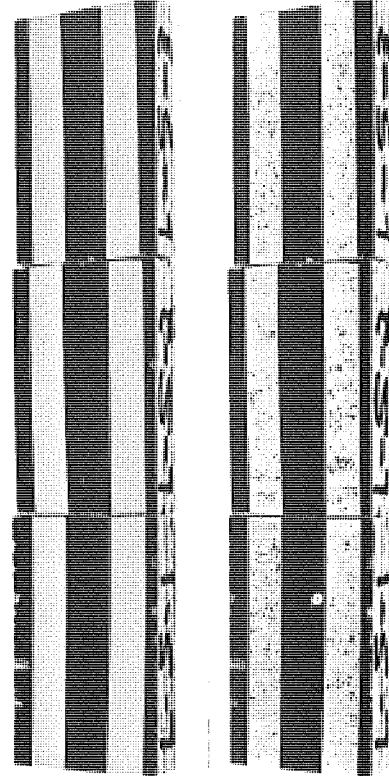
3. Lightly sanded and wiped with a naphtha-dampened rag in the Laboratory. Immediately after surface treatment, sheeting was applied in the Laboratory (Fig. 6).

Figure 6. Specimens lightly sanded and wiped with naphtha-dampened rag in the Laboratory (sheeting applied in the Laboratory). Specimens are shown before test (top) and after test (below).

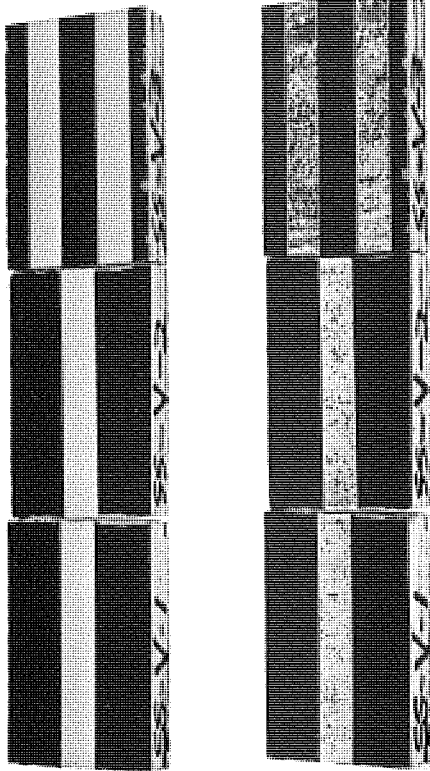
5. Scrubbed with naphtha-saturated cheesecloth in the Laboratory. Seventy-two hours after surface treatment, sheeting was applied at the sign shop (Fig. 8).

Figure 8. Specimens scrubbed with naphtha-saturated cheesecloth in the Laboratory (sheeting applied in the sign shop). Specimens are shown before test (top) and after test (below).

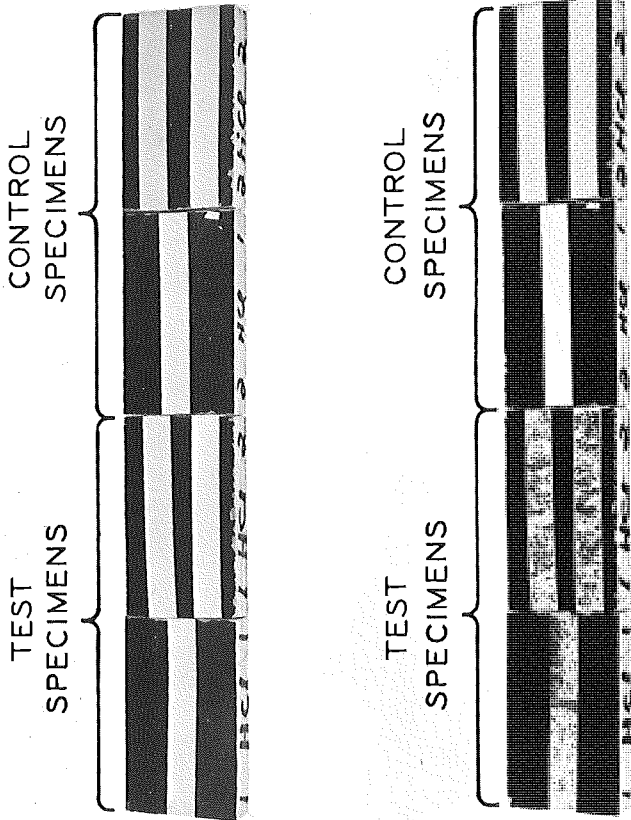
7. Swabbed with concentrated hydrochloric acid, rinsed, and wiped dry in the Laboratory. Six hours after surface treatment, sheeting was applied in the Laboratory (Fig. 9). Two specimens shown on the right in Figure 9, from plywood with the Simpson R-2 edge brand, were similarly treated in order to check the effects of the concentrated hydrochloric acid. The untreated Simpson R-2 plywood was tested and showed no corrosion effects.

Figure 9. Specimens swabbed with concentrated hydrochloric acid, rinsed, and wiped dry (sheeting applied in the Laboratory). The effects of hydrochloric acid were determined by treating specimens of plywood that had not shown corrosion effects in previous tests. Specimens are shown before test (top) and after test (below).

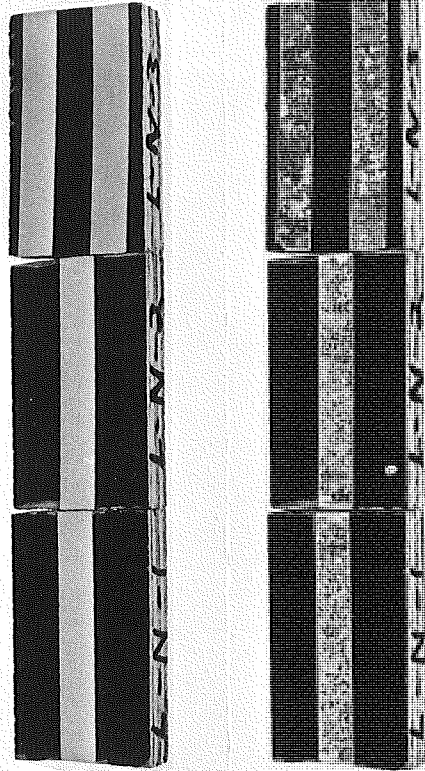
8. No surface treatment, sheeting applied in the Laboratory (Fig. 10).

Figure 10. Specimens with no surface treatment (sheeting applied in Laboratory). Specimens are shown before test (top) and after test (below).

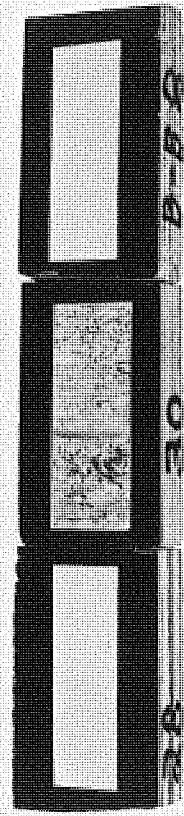
Figure 14. Appearance of specimens after test: U. S. Plywood (left), Simpson Mill No. 30 (center), and Georgia Pacific (right).

Appearances of specimens after testing from Simpson Timber Company Mill No. 30, Georgia Pacific, and U. S. Plywood are shown in Figure 14.

8. Other plywoods (Georgia Pacific and U. S. Plywood) did not show corrosion effects according to the test procedure but this does not guarantee the plywoods will perform satisfactorily in the field.

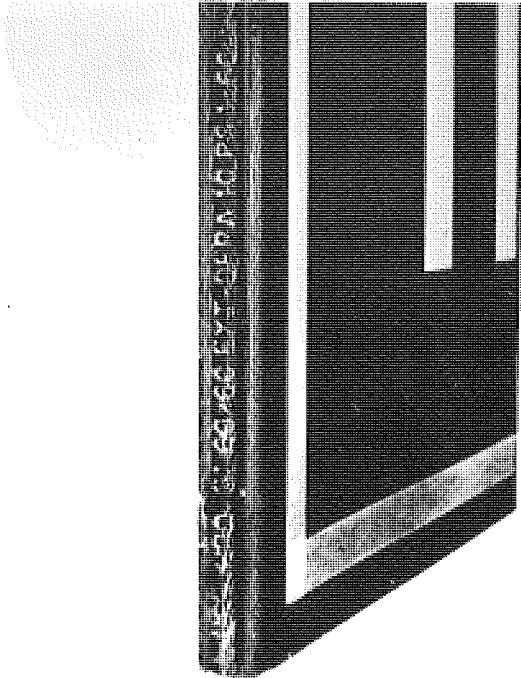
1. The plywood sign submitted on April 28 was made from plywood manufactured at Shelton, Washington by the Simpson Timber Company. Identification was made from the plywood edge brand as shown in Figure 15 and the knowledge that the numeral "10" following the letters DFPA is an American Plywood Association identifier for the Simpson mill. Simpson has another mill at McCleary, Washington which is identified by the numeral "30."

Figure 15. Edge brand of sign (see Fig. 1) submitted as U. S. Plywood. Numeral "10" after "DFPA" identifies plywood as a Simpson Mill No. 10 product.

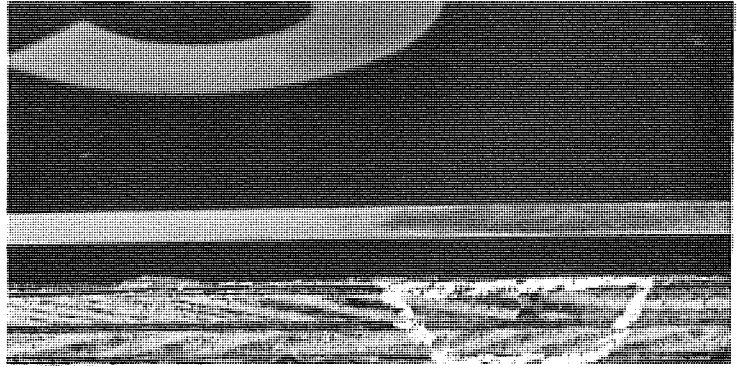
Figure 16. Upper left corner of sign (see Fig. 1) showing core void and associated reflective sheeting corrosion.

Reflective sheeting corrosion was most severe on the upper portion of the sign and especially near core voids as shown in Figure 16. This was expected on the basis of 3M information. Corrosion noted along the lower edge as shown in Figure 17 was probably promoted by the rough-sawed edge which retained surface run-off. Figure 18, also of the lower portion of the sign, shows another type of corrosion typically found on cut-out letters. The inside corners of the letters show the extension of knife cuts and small areas of corrosion on either side of the cut.

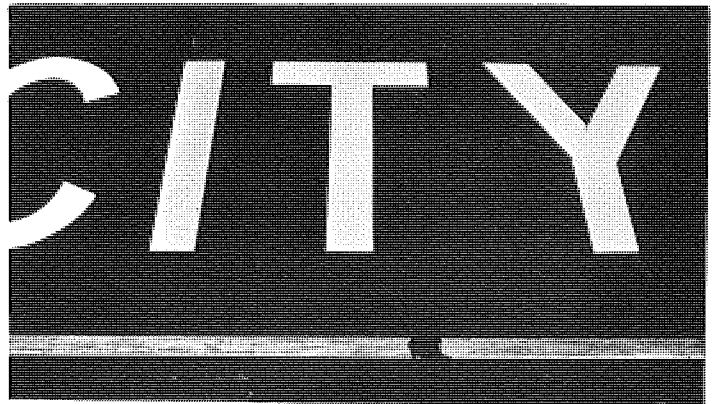
Figure 17. Corrosion of lower portion of sign (see Fig. 1).

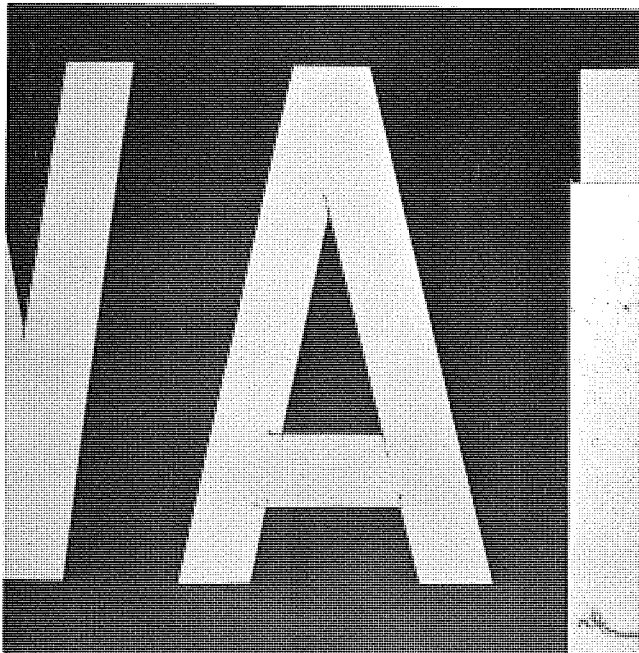
Figure 18. Inside corners of letters from sign showing knife cuts and early stages of corrosion of cuts. Detail view shows the lower portion of the letter "A."
