*EVALUATION OF MINIMUM SURFACE  
PREPARATION COATINGS  
FOR BRIDGE PAINTING*

**EVALUATION OF MINIMUM SURFACE  
PREPARATION COATINGS FOR BRIDGE PAINTING**

**Testing and Research Section  
Construction and Technology Division  
Research Project 94 G-0304  
Research Report R-1394**

**Michigan Transportation Commission  
Barton W. LaBelle, Chairman;  
Jack L. Gingrass, Vice-Chairman;  
Betty Jean Awrey, John W. Garside  
Ted B. Wahby, Lowell B. Jackson  
Gregory J. Rosine, Director  
Lansing, May 2001**

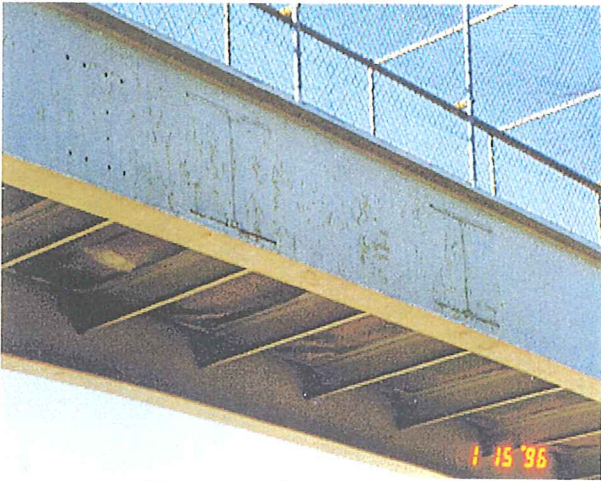
The pedestrian bridge is an eight span structure coated with a red lead alkyd system. The structural steel was fifteen percent corroded, with the east fascia beam being worse than the west fascia beam. In July of 1995, MDOT's Construction and Technology Division and Maintenance Division worked jointly to clean and coat the north half of the structure using MSP. The coating system used was a two-coat moisture cure urethane. The new coating started lifting the existing red lead coating around all of the repair areas after only six months (see Figures 1 and 2). After five years, the paint system has completely failed (see Figures 3 and 4).

**Figure 1 - P01 of 25085  
after six months**

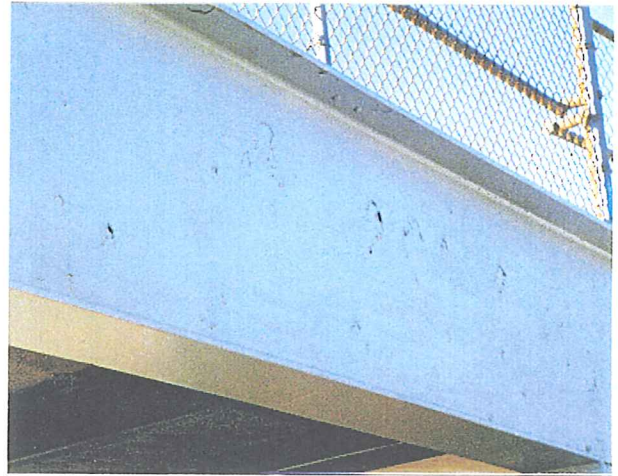
**Figure 2 - P01 of 25085 after six months  
(Close up of lifting coating)**

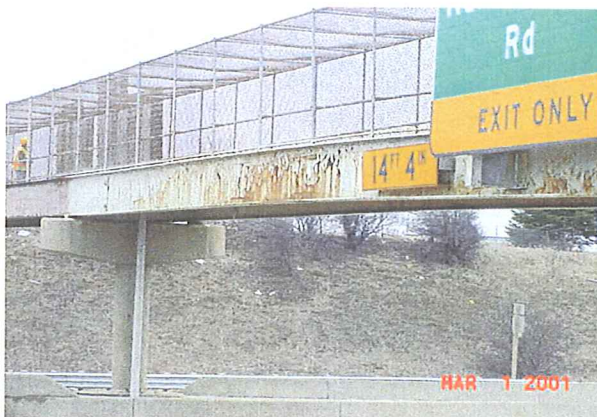
**Figure 3 - after 5 years**

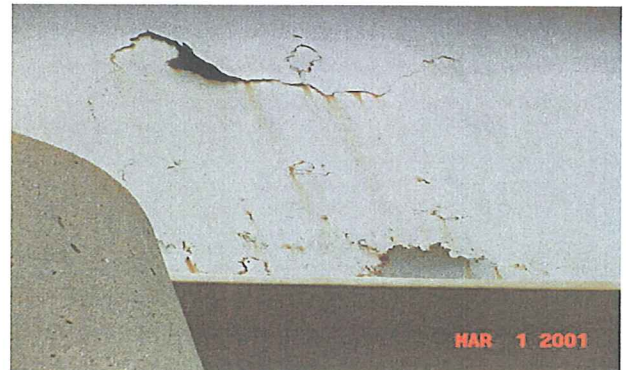
**Figure 4- after 5 years  
(Close up of lifting coating)**

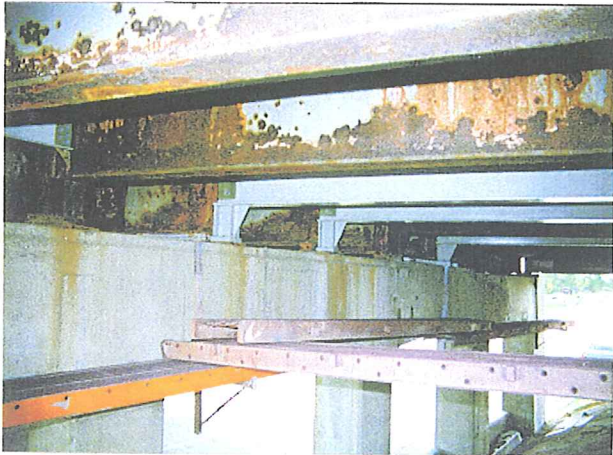
In November 1996, a second structure was coated with a MSP system. The original coating on the structure was a red lead alkyd system. The structure has four spans and the structural steel was 40 percent corroded. The steel of the structure was so badly corroded that three beams in span one were replaced prior to the coating (see Figure 5). Spans 2, 3 and 4 were power tool cleaned, while span one was brush blasted. The contractor was allowed to brush blast Span 1 in lieu of power tool cleaning, because an excessive amount of power tool cleaning that would have been required to prepare the span sufficiently. Spans 1 and 2 were coated with a three-coat urethane coating system with the primer being an aluminum urethane filled moisture cure. Spans 3 and 4 were coated with a three-coat zinc rich moisture cure primer system. The MSP system started failing after only 12 months of service. Figures 6 through 10 show the amount of corrosion after 4-1/2 years.

**Figure 5 - Pier 1 of S05 of 63022 prior to coating**

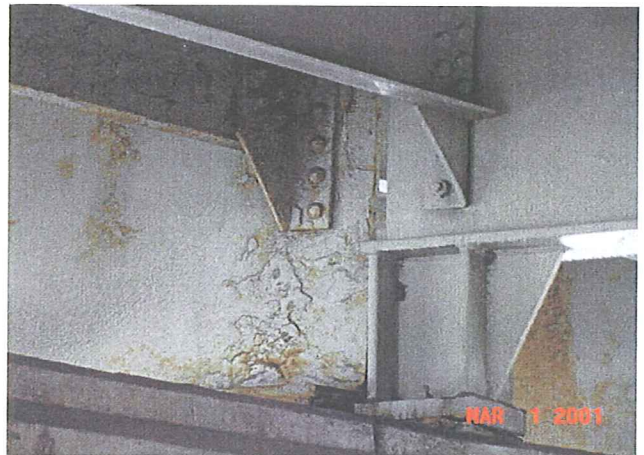
**Figure 6 - Beam G @ Pier 1 after 4 1/2 years**

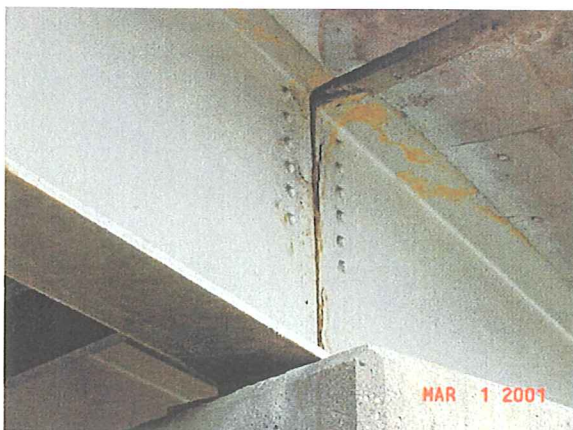
**Figure 7 - East Fascia over pier 1 after 4 1/2 years**

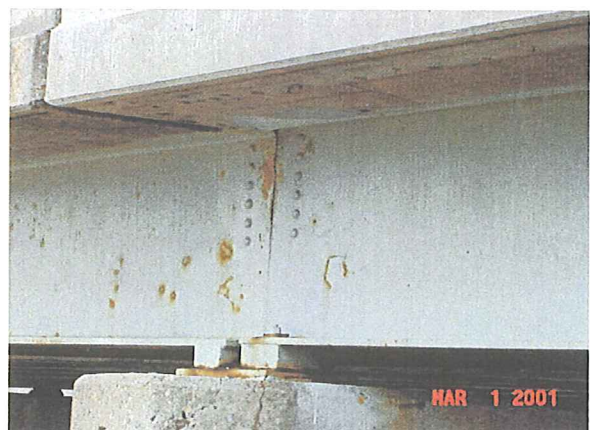
**Figure 8 - West fascia over pier 1 after 4 1/2 years**

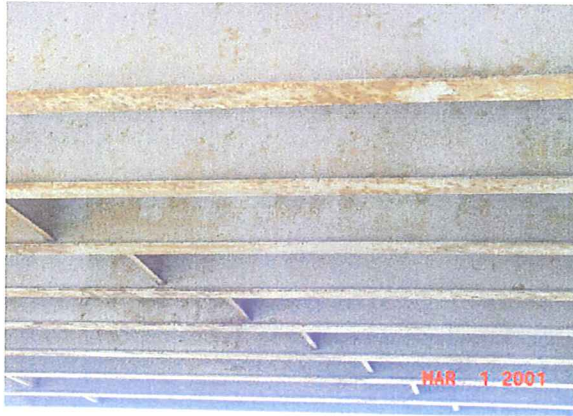
**Figure 9 - Over WB traffic lanes after 4 1/2 years**

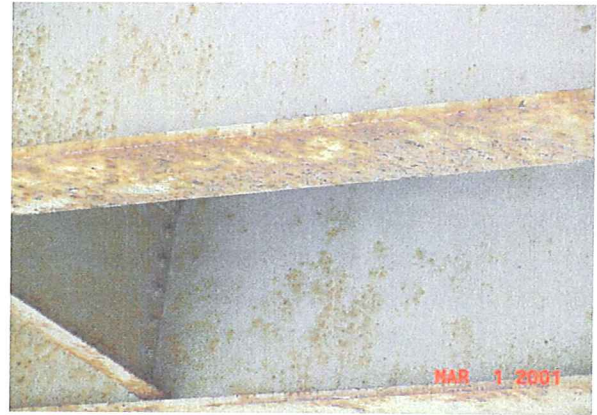
**Figure 10 - Close up over WB traffic lanes after 4 1/2 years**

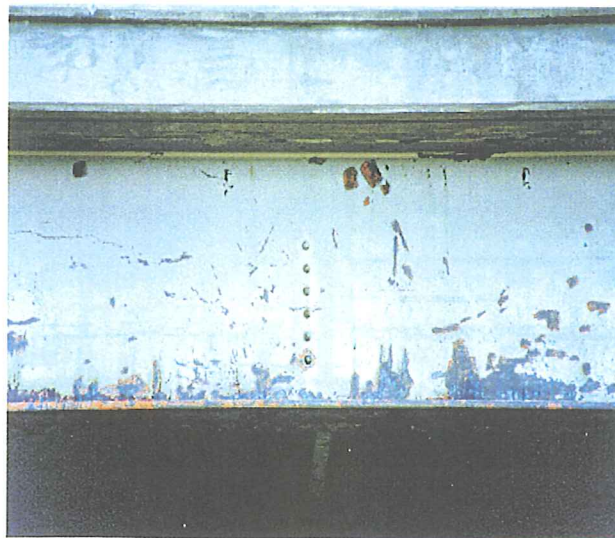
In August of 1997, the contractor worked on the minimal surface preparation of this structure. R01 of 33032 is a 15 span structure carrying traffic over South Street, the Red Cedar river and the GTW CR railroad in Lansing. The structure had less than 10 percent failure of the existing red lead alkyd coating system. The span adjacent to the railroad was abrasive blasted and coated using the department's standard three coat system. The areas coated using MSP were the outside face and bottom flange of the fascia beams in Spans 1 through 5 (the west fascia beam only) and Spans 14 and 15 (both fascia beams). These areas were power tool cleaned (see Figure 11) and overcoated with a three coat moisture cure urethane system with a zinc-rich primer. After three years, the coating system looks good over the existing red lead coating. However, the overcoating is not performing well over the previously corroded areas, mostly along the web and bottom flange interface (see Figures 12-14).

**Figure 11 - Cedar St fascia after power tool cleaning**

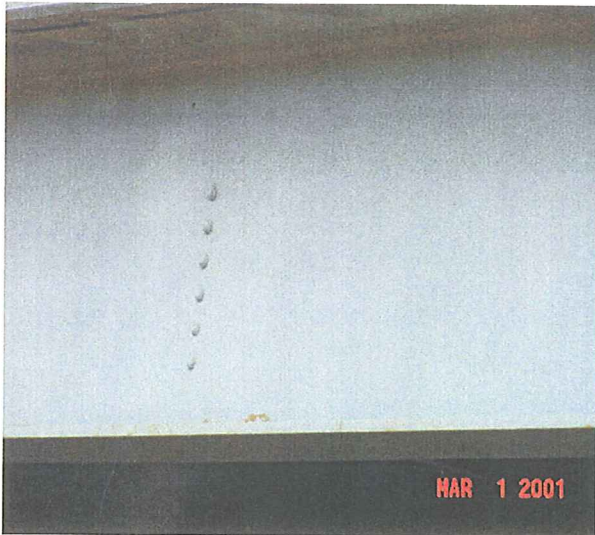
**Figure 12 - Cedar St fascia after 40 months**

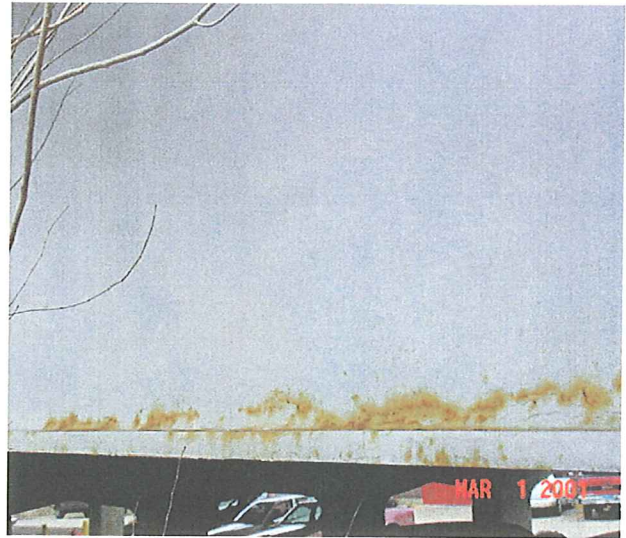
**Figure 13 - Corrosion on web and bottom flange of east fascia of span 1 after 40 months**

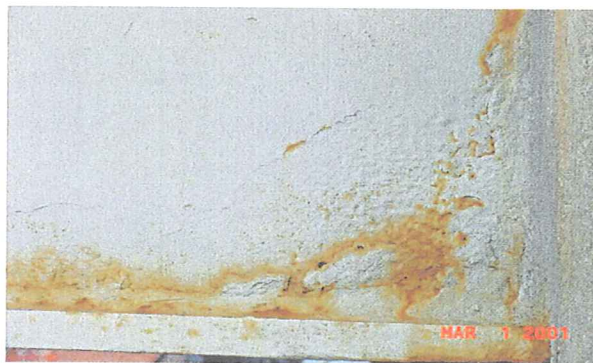
**Figure 14 - Corrosion on the east fascia beam at the abutment of span 1 after 40 months**

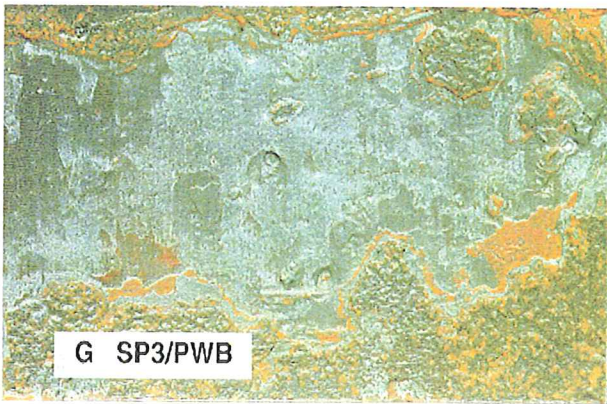
**Figure 15** - Painting system applied over mill scale, power tool cleaned by power wire brush.

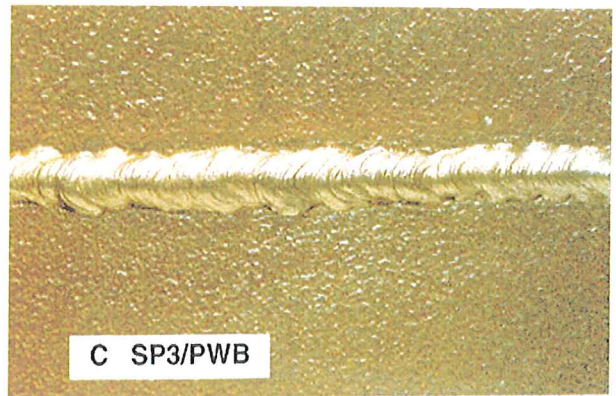
**Figure 16** - Rusted surface with minor pits, power tool cleaned by power wire brush.
