MICHIGAN
STATE HIGHWAY DEPARTMENT

November 13, 1962

Subject: "Compriband" Preformed Urethane Joint Sealer.
Research Project R-62 NM-62. Report No. R-401.

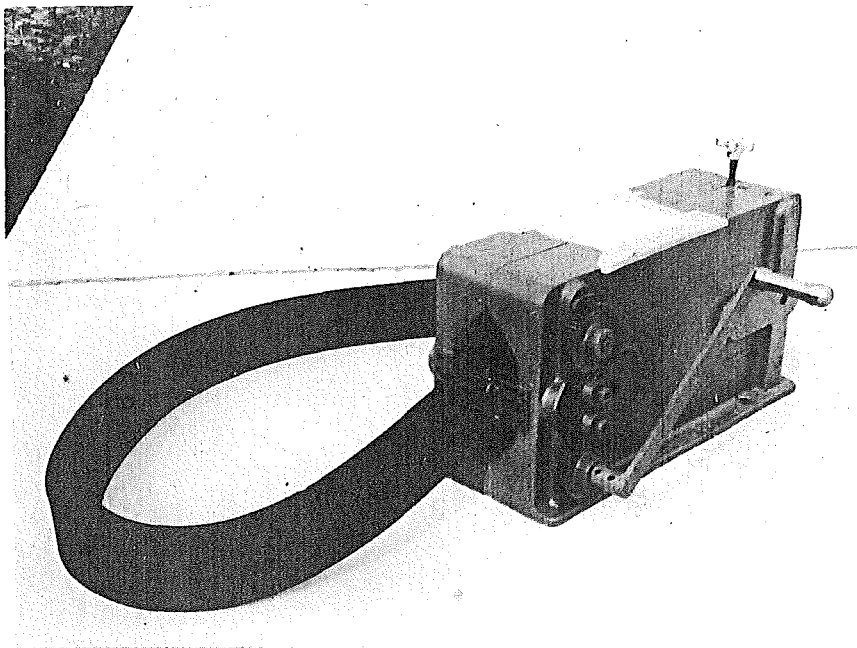
Mr. Pohlman brought a machine (Fig. 1) to compress the material approximately 6 to 1, but it would not compress the material enough for insertion into the 1/2-in. joint space without deforming the sealer. This deformation forced the material out of shape and made it unfit for use.

Figure 1. Front end of compression machine showing 1-1 2-by 3-in. Compriband on edge.

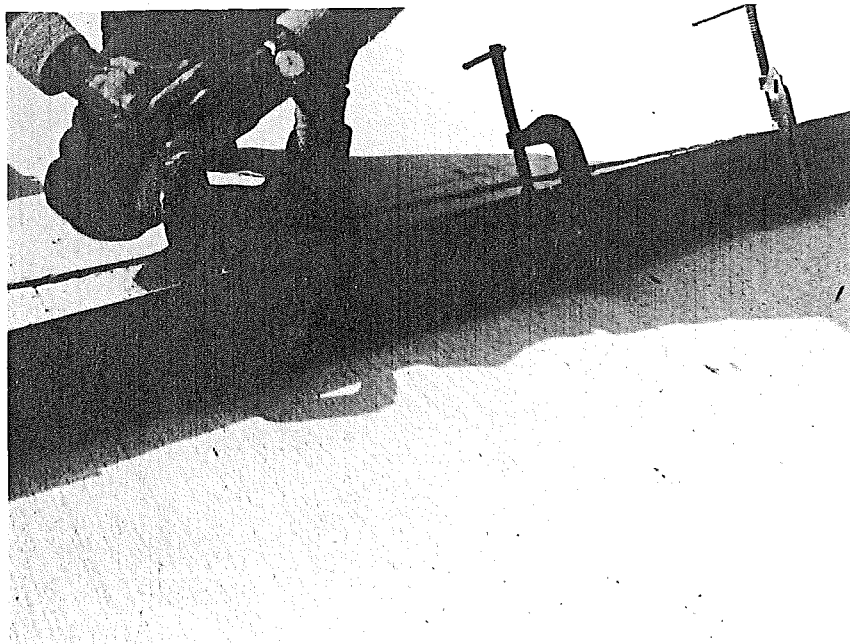
It then became necessary to compress the material between 2-by-4's using large C-clamps for pressure (Fig. 2). Four pieces of Compriband 1-1/2 in. deep by 3 in. wide and 6 ft long were used in each 24-ft joint.

Figure 2. Emergency method used to compress 3-in. Compriband to less than 1/2 in.

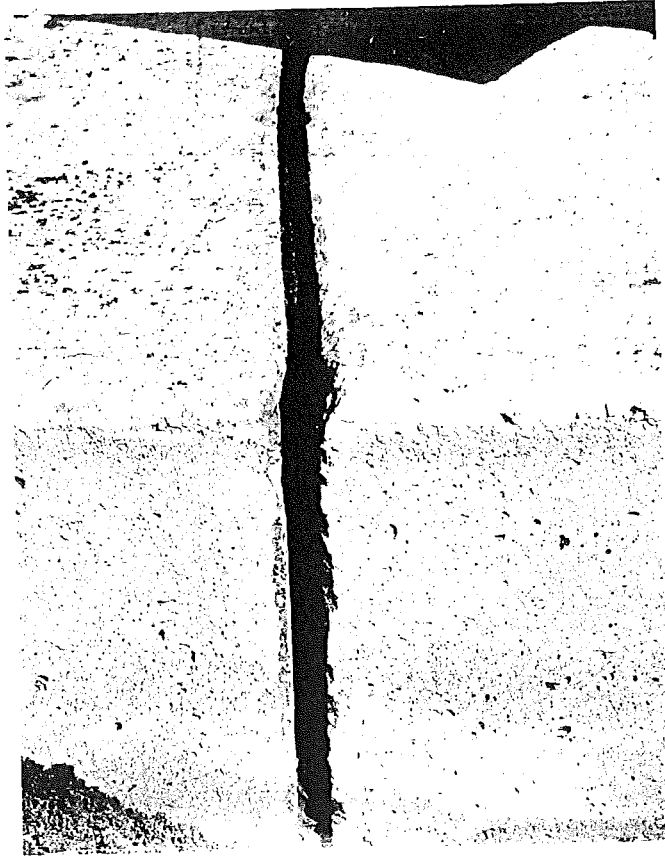
Fig. 3 shows how Compriband is installed to extend from the pavement surface down the slab edge which is normally covered by the end plate in joints sealed with hot poured material.

Figure 3. Top and edge of joint with Compriband in place (Station 595+11).

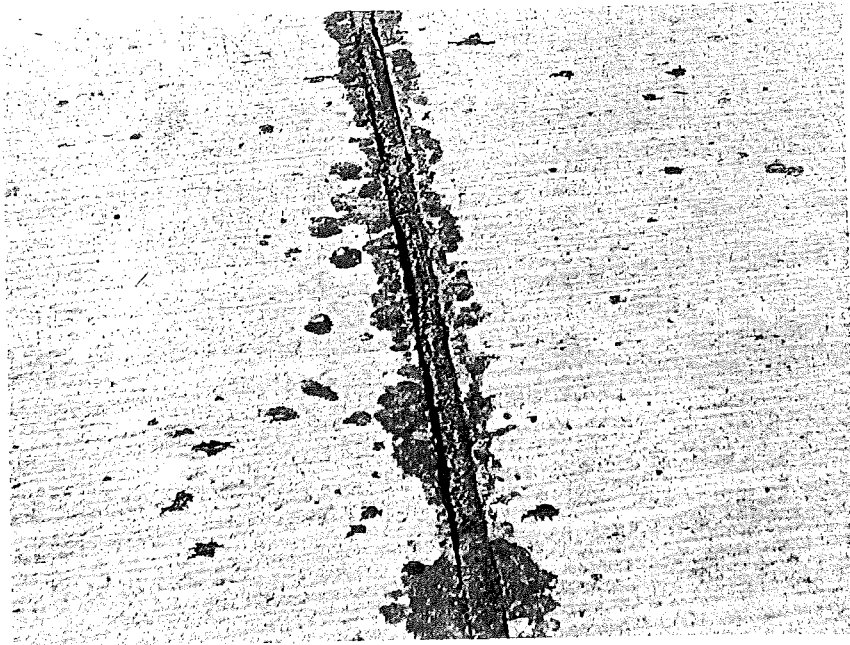
An inspection of the two test joints on October 31, 1962, after 1-1/2 months of service showed several gaps between the compressed foam and the joint face (Fig. 4). This may be due to the problems during insertion of the foam on September 17, or more probably, to inability of the sealer to expand and fill a widening joint when the temperature falls. When inspected, the air temperature was 38 F and the material was extremely stiff and solid. The indicated loss of recovery at a moderately cool temperature may be due to quality of the foam or of the asphalt saturant, or both. Laboratory tests indicate that loss of recovery is even greater at lower temperatures.

Figure 4. Primed joint after 1-1/2 months in service showing gaps between sealer and joint face.

The Laboratory has some material on hand for further installations, both 3- by 1-1/2 in. for new joints, and 4- by 1-1/2 in. for resealing old joints. In view of the condition of the two joints observed on October 31, 1962, it is doubtful that further installations of this material would be justified until these joints have been more completely evaluated. Inspection and observation of the installed sealer will continue until a definite indication is obtained.
