AN APPRAISAL OF TRANSVERSE JOINT BASE PLATES

Research Laboratory Division
Office of Testing and Research
Research Project 39 F-7 (14)
Research Report No. R-582

State of Michigan
Department of State Highways
Lansing, June 1966

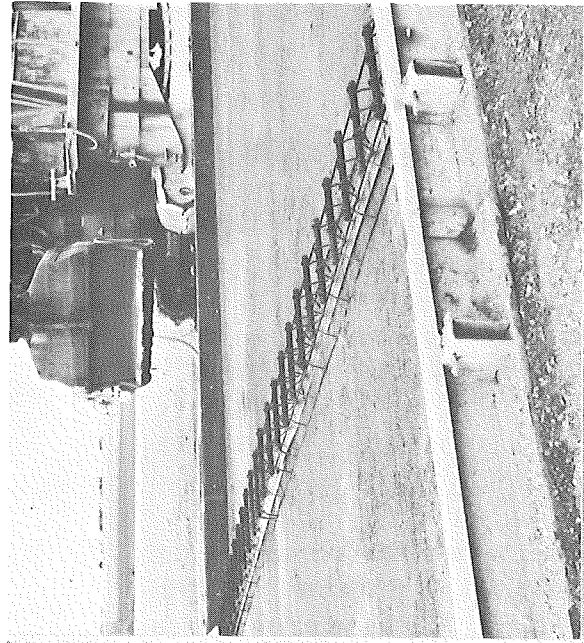
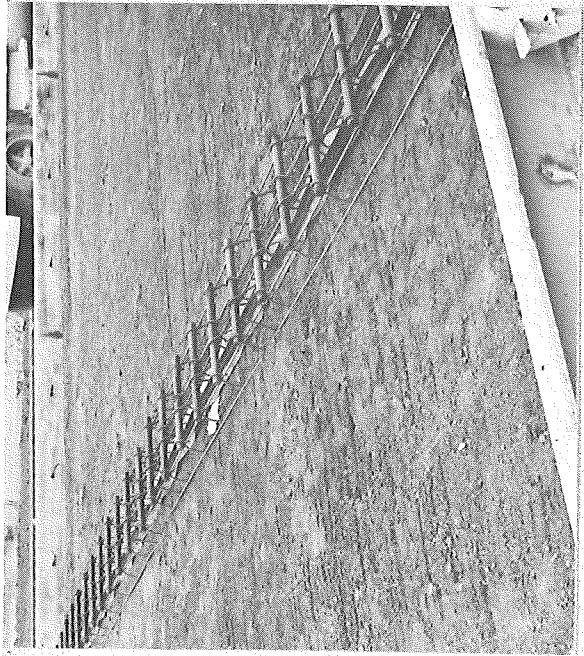
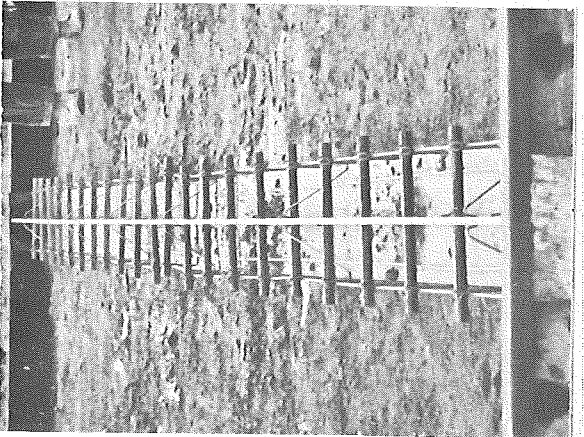
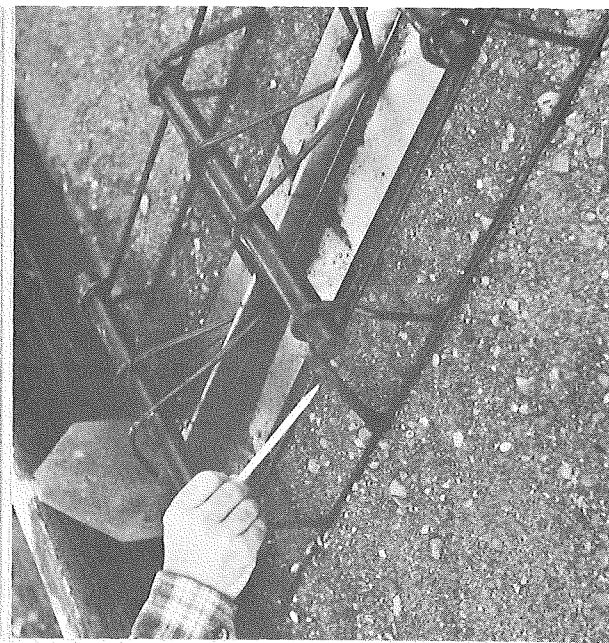
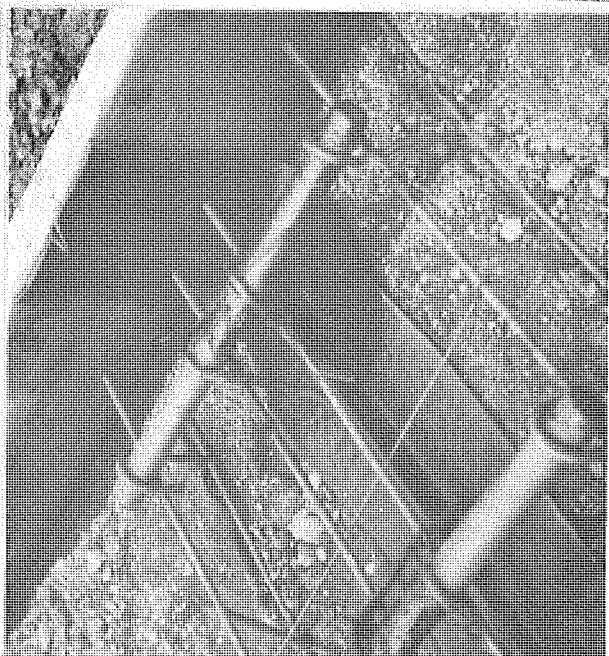
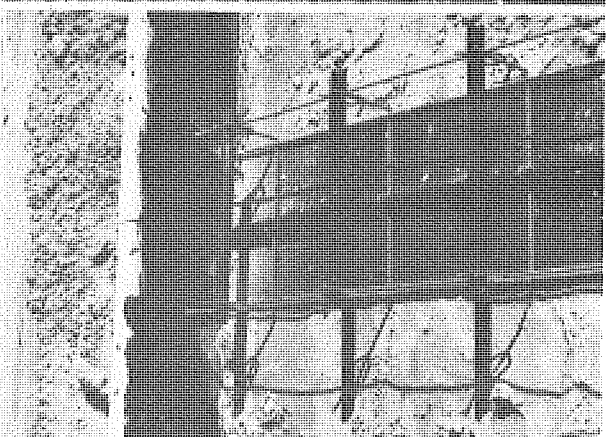
Figure 1. General view and close-up of base plate installations typical of the period 1947-1966. Note contrast in base soil texture between 1947 photos (left) and more recent photos (center and right).

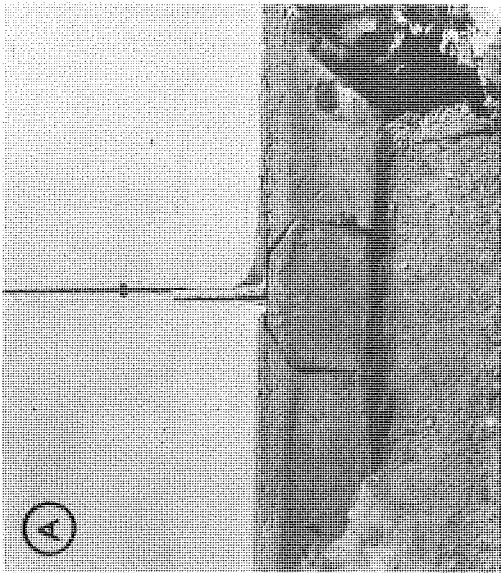
The shoulder face of a transverse joint was excavated.

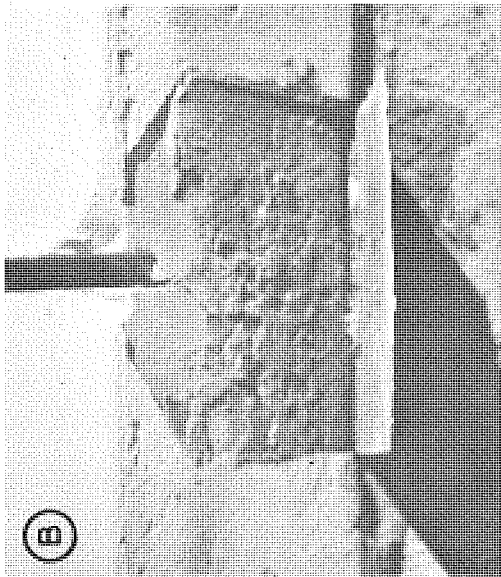
The steel end plate was turned down, revealing a deposit of packed fine sandy soil.

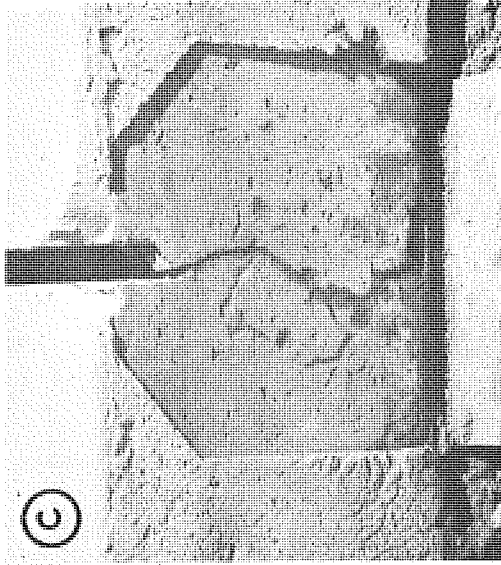
When this excess soil was removed, additional compacted soil was found in the joint crack.

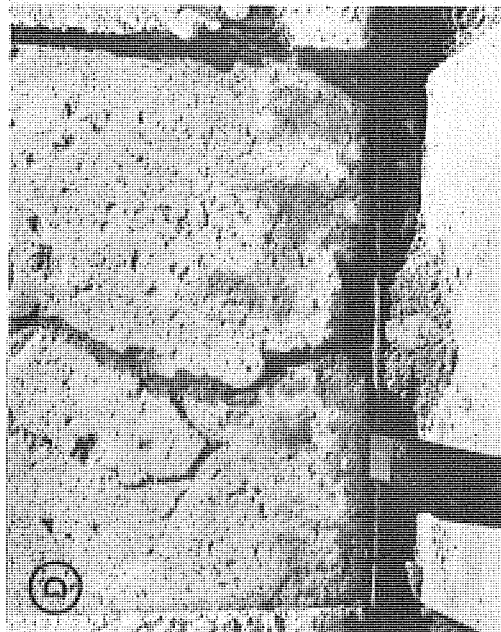
The base plate was found to be depressed, and the space between the plate and slab filled with fine soil.

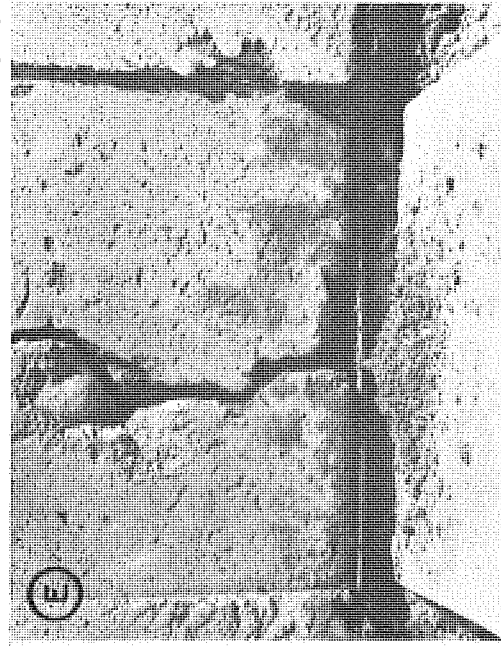
The joint crack after removal of soil material near the slab edge.

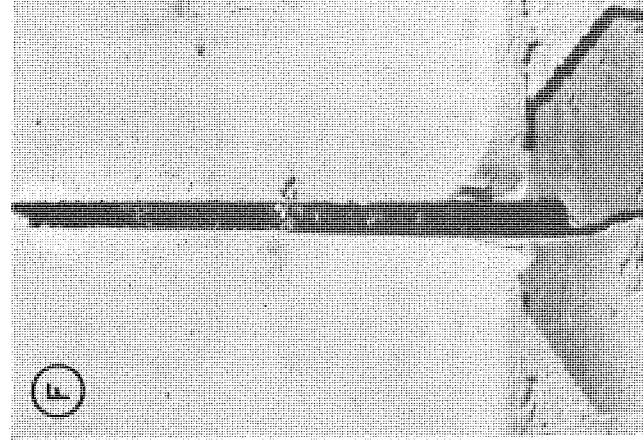
Field studies have also disclosed a contraction joint construction feature permitting early infiltration of fine solid materials--the use of preformed materials such as styrofoam to form the plane of weakness groove. Much fine material entered the joint by way of the opening that always developed alongside the preformed material, caused by normal shrinkage of the concrete, contraction due to temperature change, or both. This condition is clearly illustrated by the sequence of views in Figure 2 of a contraction joint in a new project which had stood over one winter without traffic and had still not been opened when the examination was made (3). Figure 2A shows the opening beside the styrofoam material, through which fine soil particles filtered downward to the base plate (Figs. 2B, C, D, E). The metal base plate was permanently depressed from the bottom of the slab, as much as 1/4 in. (Figs. 2D and E), and the void filled with fine soil particles. Figure 2F shows soil material found in the joint groove when the styrofoam was removed.

Additional material was found to have filtered in around the styro-foam material in the joint groove.

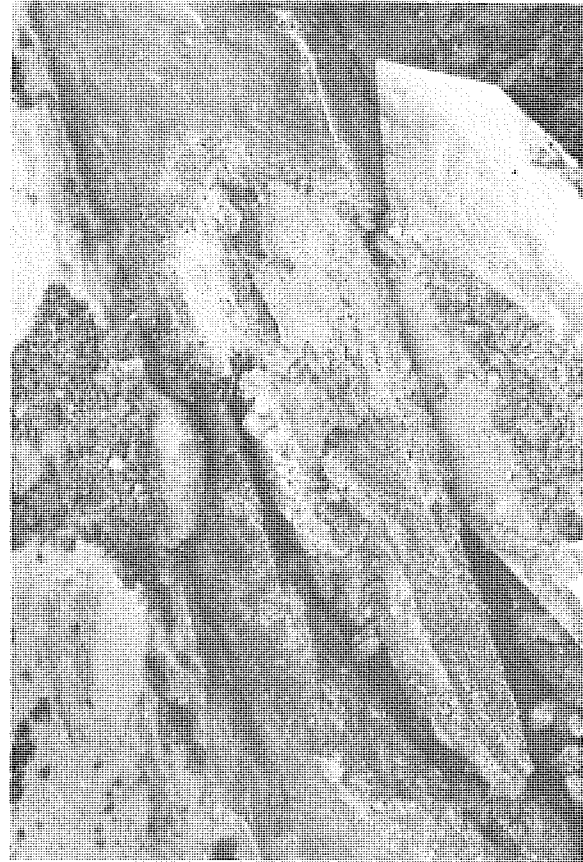
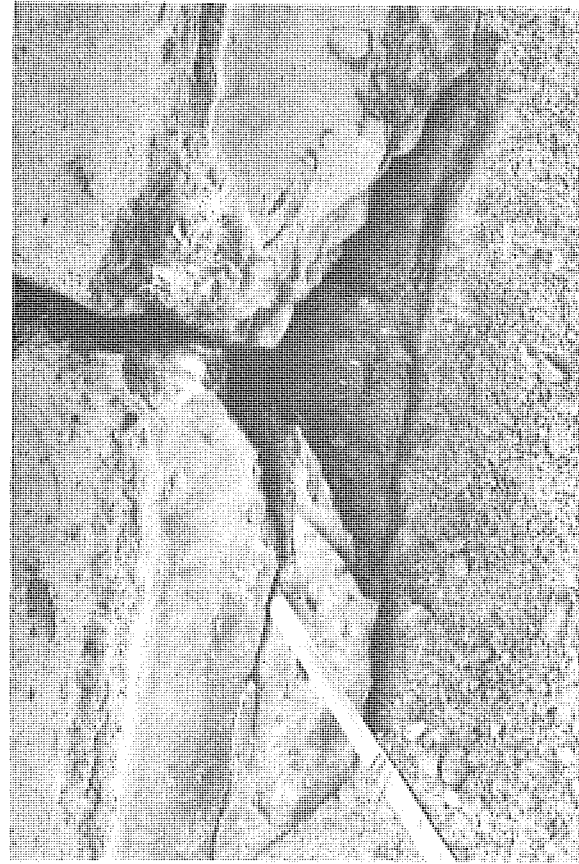
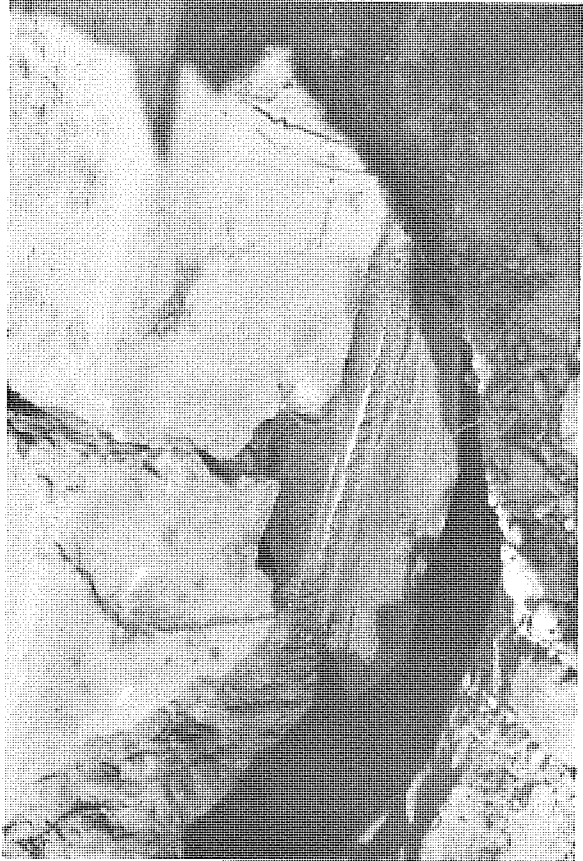
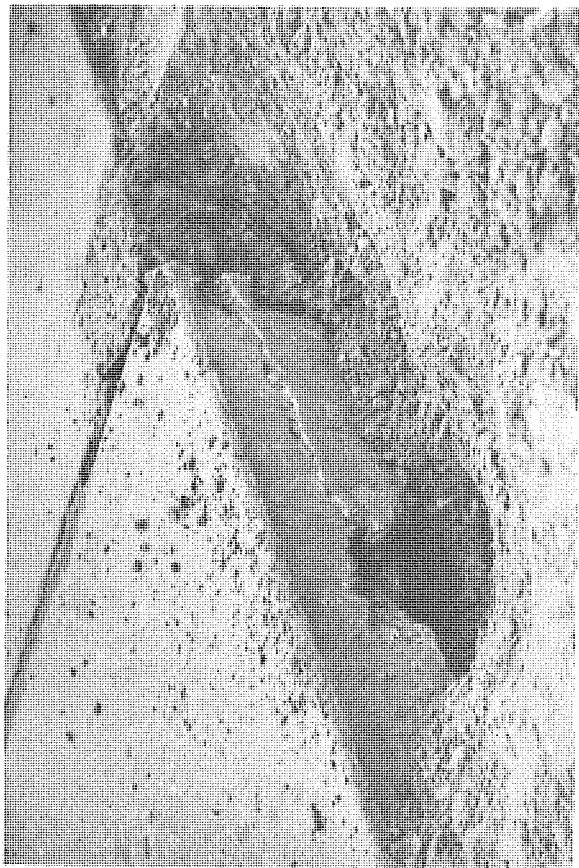
Examination of contraction joints on several projects (3), revealed various degrees of slab spalling and concrete deterioration at the bottom of the joint, as illustrated in Figure 3. In all cases, pavement condition above the base plate could not be surmised from physical appearance of the surface. The degree to which the base might have contributed to the situation in each case would be difficult to ascertain. However it is quite obvious that due to failure of the joint seal to accomplish its intended function, the joint space had become filled with soil material which was then trapped by the base plate. The characteristic cone or wedge shaped void at the bottom of the joint (at lower right in Fig. 3) evidently results from complete disintegration of concrete in the area, and has been observed on many other projects during field surveys.

Figure 3. Slab bottom spalling at four joints exposed by excavating; pavement ages of 3, 4, 7, and 8 years (from upper left).

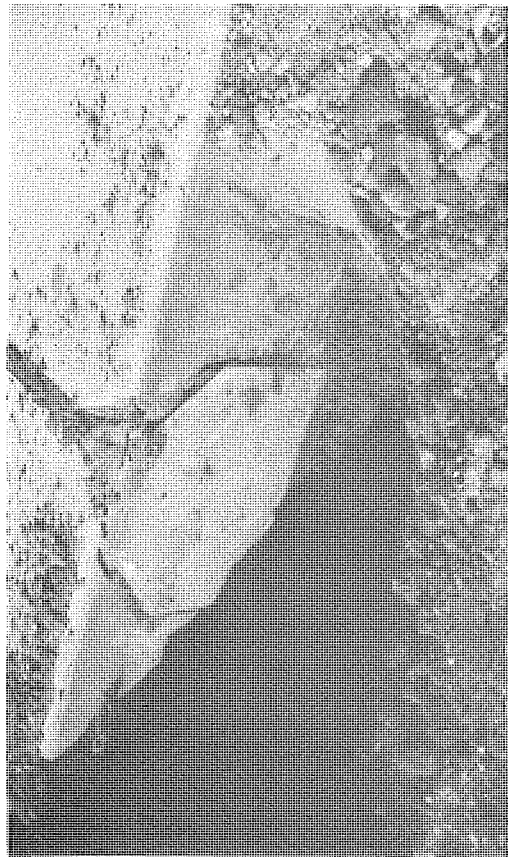
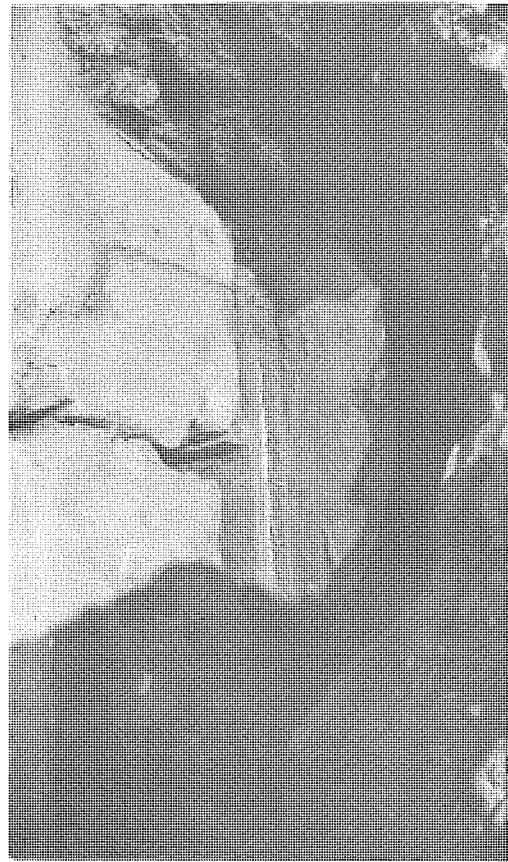
A 1963 survey of several construction projects to observe rusting of metal base plates revealed certain additional pertinent facts (4). Figure 4 shows condition of a joint after three years in service, before and after removing the end plate. When this plate was pulled away, the joint opening and void above the base plate were full of fine sand material, which was removed before the "after" picture was taken. Figure 5 shows a 6-year-old joint before and after removing the end plate. Although everything looks serene at the surface of this latter joint, deterioration has begun in the area above the base plate.

Figure 4. Three-year-old base plate; Project 39-40, C4; constr. 1953.

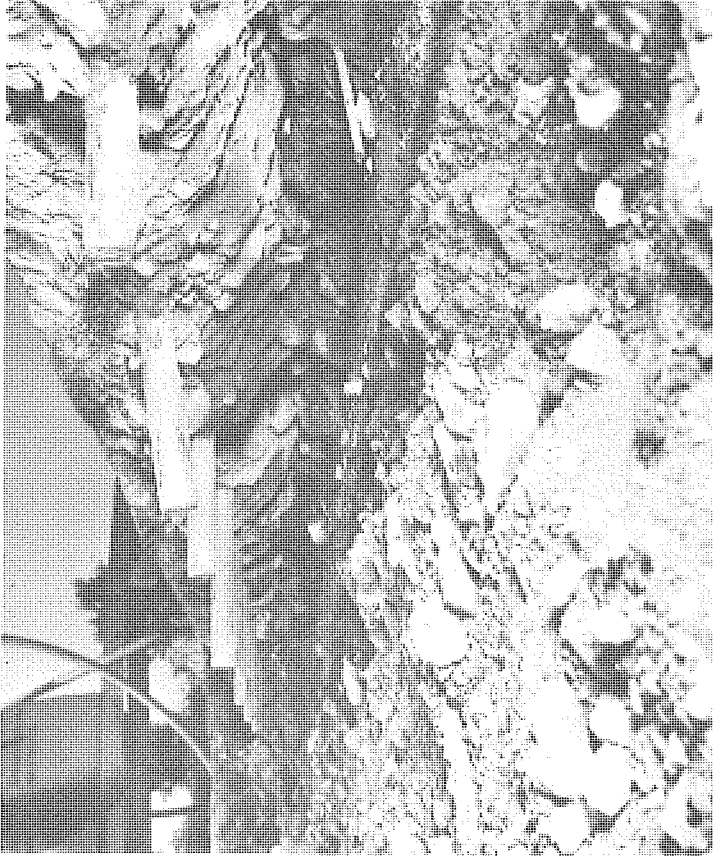
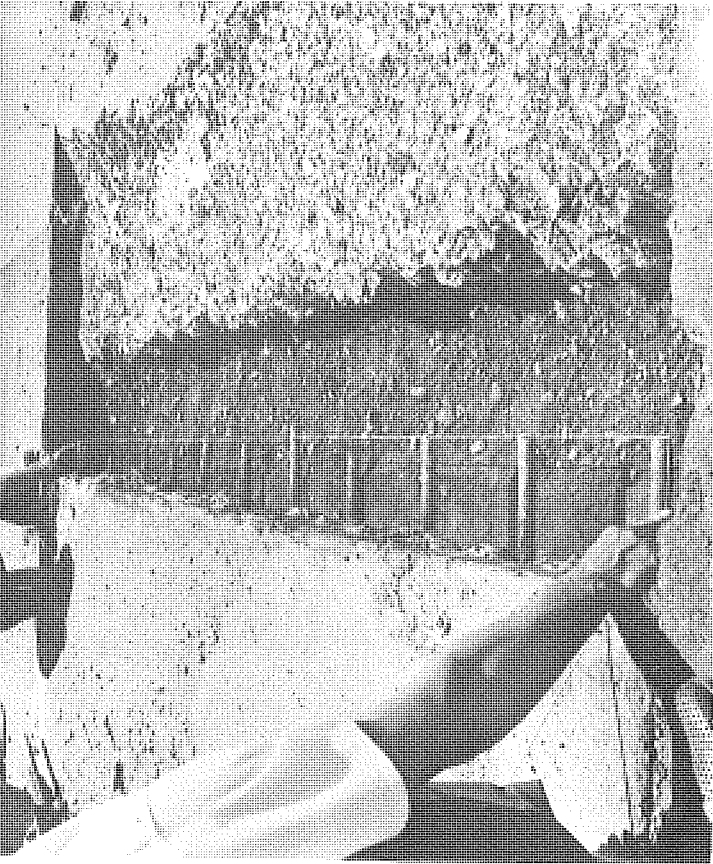
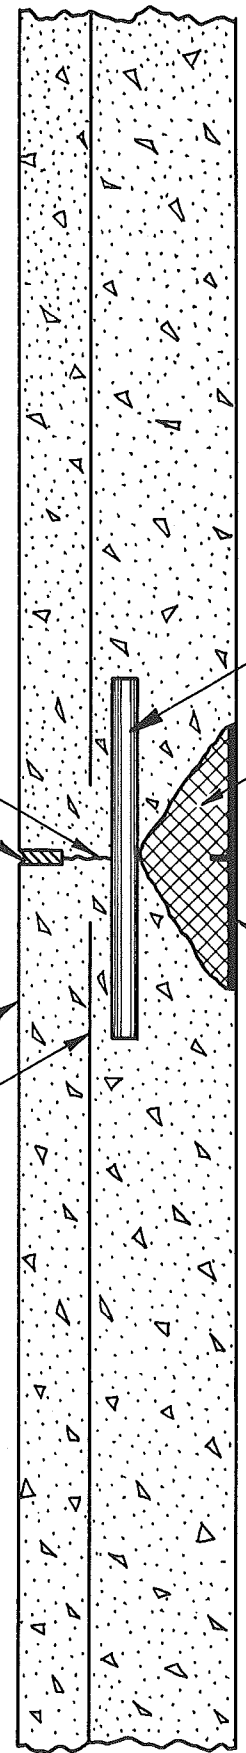
A 1965 survey of joint failures on a 12-year-old project (5) disclosed further evidence that base plates may contribute to deterioration of concrete at the bottom of a joint. Figure 6 shows photographically and schematically an area of complete deterioration below a dowel system, as observed during repair of numerous other failed joints.

DETERIORATED CONCRETE

Figure 6. Dowel and joint groove misalignment were observed during repair of this 12-year-old joint (upper left), and concrete deterioration below the dowel bars (upper right); Sta. 327+03 EB, Project 38-48, C9.

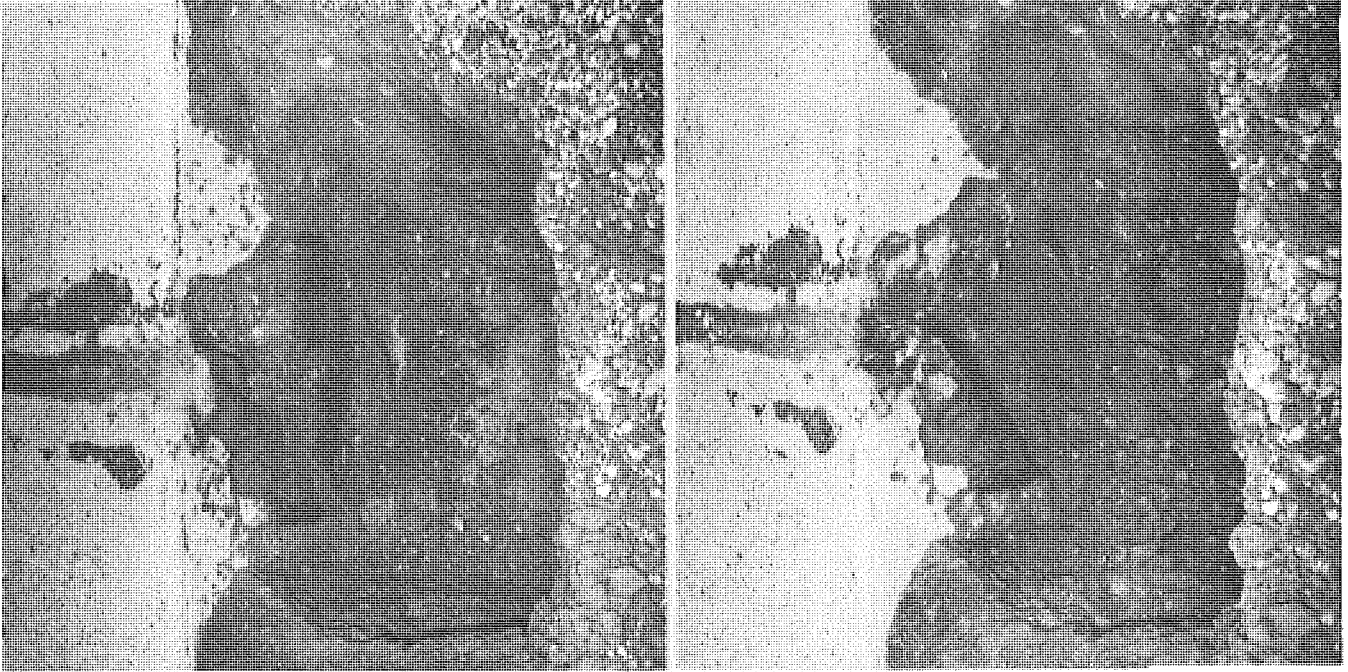
Another 1965 survey of joint failures (6), on US 127 between Hudson and the Ohio state line, revealed that in the case of the joints inspected, concrete above the base plate had disintegrated in the characteristic wedge shape, tapering to a point at the dowel bars. On a 1947 project there, Figure 7 shows that concrete above the dowels had also fractured into small pieces as though subjected to severe compressive stresses. In contrast, the joints on an adjoining 1949 project generally looked normal on the surface, but upon further examination the concrete immediately above the base plate was found to be badly disintegrated (Fig. 8).

Figure 7. Distressed 18-year-old joint with end exposed; Project 30-04, C3.

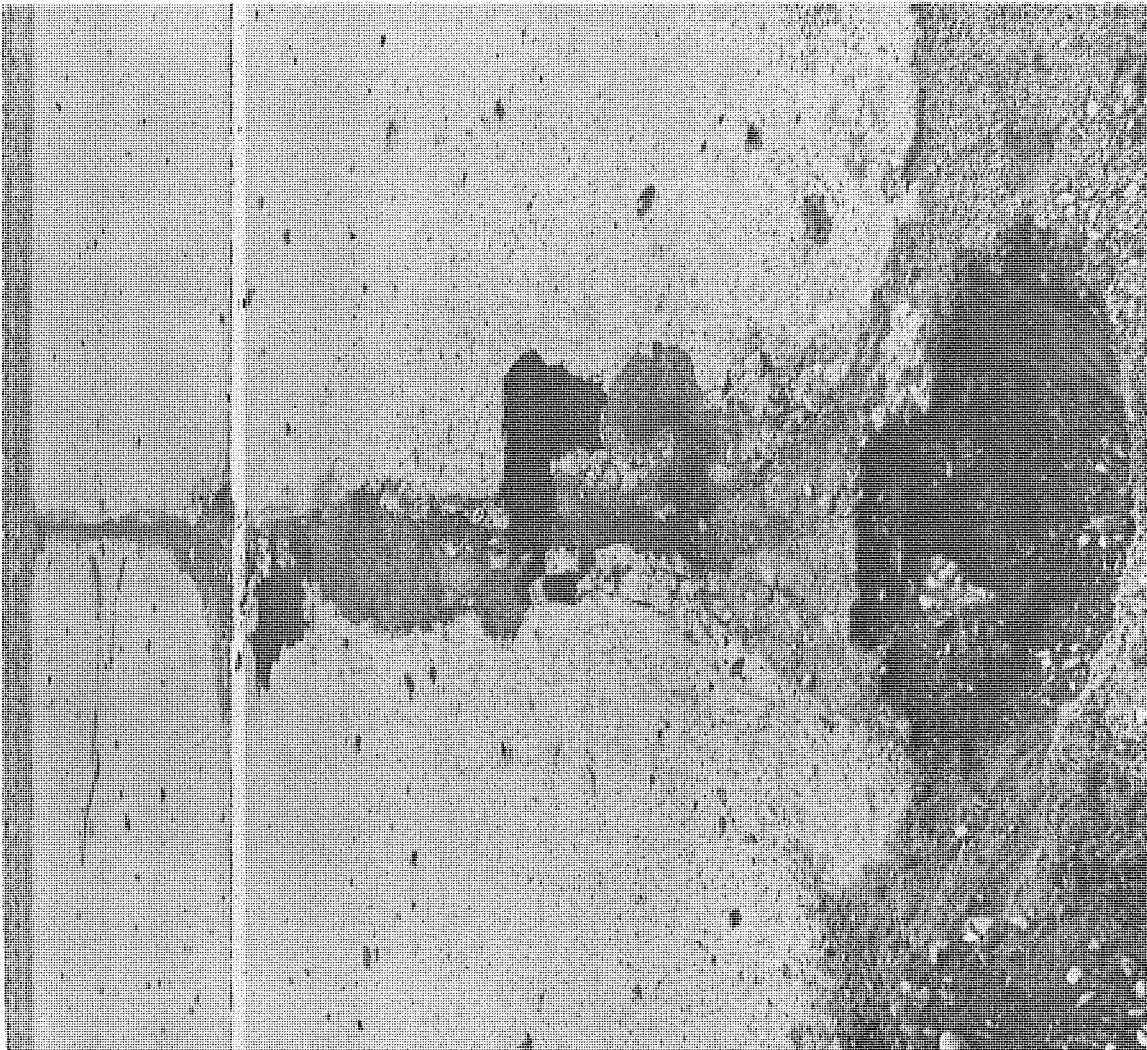
Samples of crumbly concrete material were taken from joints in both of these US 127 projects and analysis indicated 0.34 lb of free sodium chloride per ton of concrete in the 1947 project, and 0.62 lb per ton in the 1949 project. These results support the theory that concrete deterioration immediately above the base plate is aggravated by penetration of salt solutions from de-icing chemicals into the joint, due to faulty sealants, with subsequent impoundment on base plates.

Figure 8 (right). End view of sound 16-year-old joint in Project 30-04, C5, before removal of end plate (top) and after removal of end plate (bottom). Note disintegration of concrete above base plate.

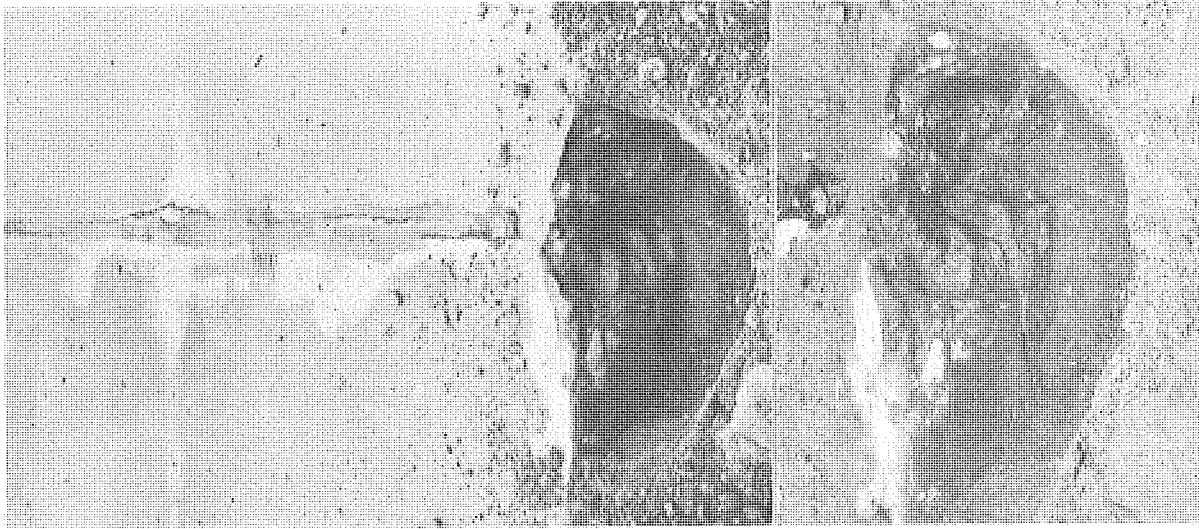
Figure 10. Two views of a deteriorating 18-year-old joint at Sta. 577+00 on Project 23-6, C4.

A joint on M 43 west of Grand Ledge, also constructed in 1947, is shown in Figure 10 as it appeared in an April 1966 inspection. Although the pavement surface appears sound, initial crushing of joint faces was evident, the worst area being immediately above the base plate. Also, note in the close view of the slab edge the two longitudinal cracks at left, running out from the joint face and indicating the presence of large internal forces at some time during the life of the pavement.

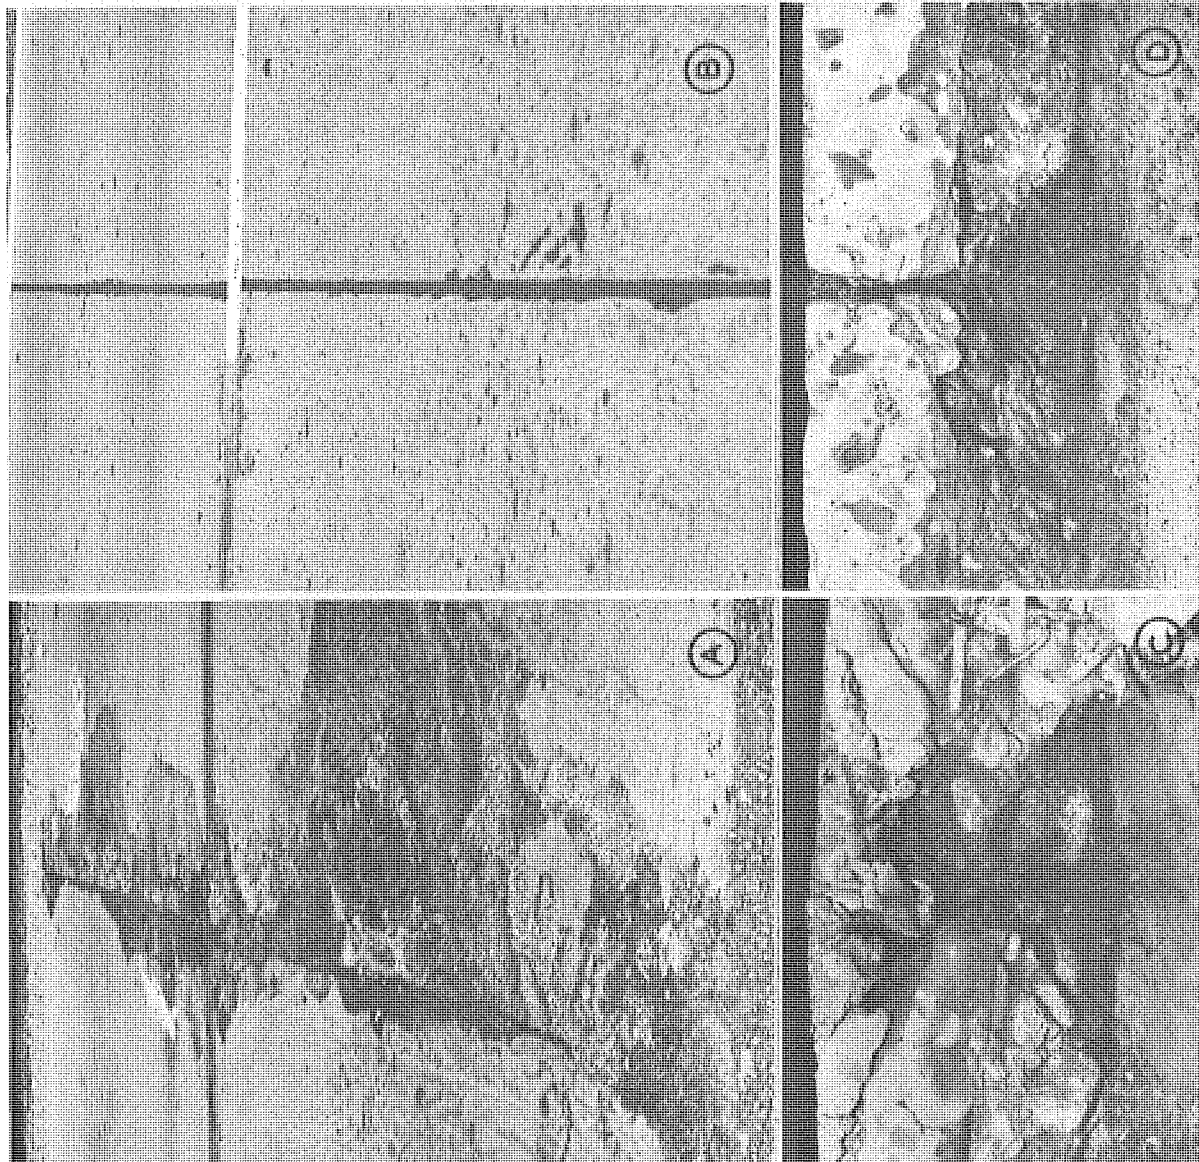
By arrangement with the Office of Maintenance, in September 1965 two joints were examined on M 46 just east of M 83 in Saginaw County. This pavement was constructed in 1947 and contained joints apparently in excellent condition, as well as many in the imminent failure category. The examination consisted of carefully removing concrete from both sides of two joints, one of which was in a bad state of disintegration (Fig. 9A), and the other apparently in good condition from the appearance of the surface (Fig. 9B). In Figure 9C, note the characteristic triangular wedge of completely deteriorated concrete immediately above the base plate. Concrete in the area of the dowels and above is badly crushed. In Figure 9D, showing the apparently good joint, also note the disintegrated triangular wedge of concrete immediately above the base plate, although concrete above the dowel system is still sound. Conceivably, with pres-

Figure 9. Characteristic deterioration above the base plate found in two 18-year-old joints, but not necessarily reflected in pavement surface condition (Project 73-30, C4).

sure buildup at the joint faces due to loss of bearing area, the sound concrete at the surface in Figure 9B would eventually have failed in the manner shown in Figure 9A.

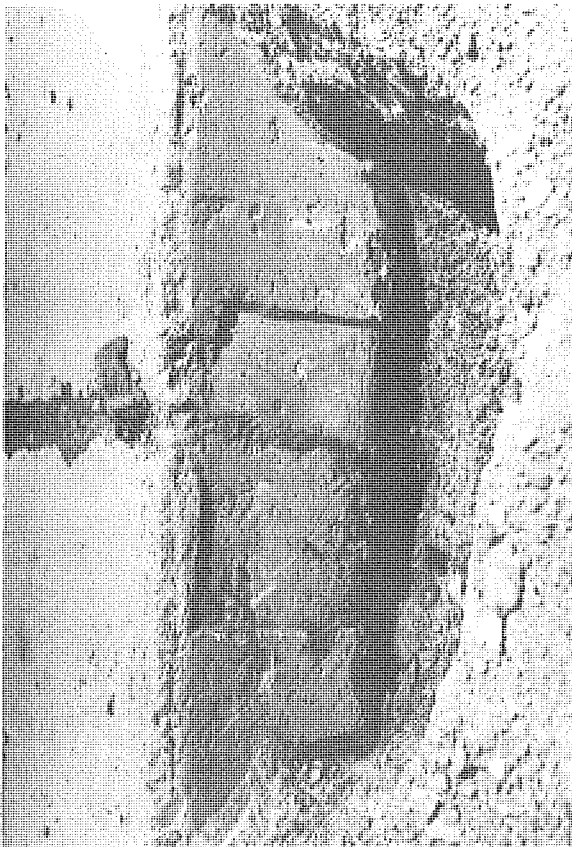
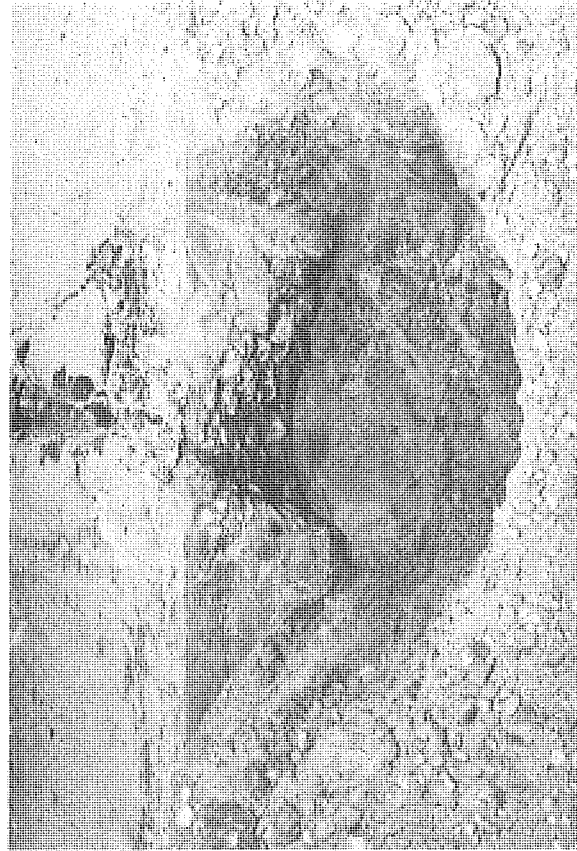
In May 1966, additional surveys were made to determine the state of concrete deterioration above the base plate at expansion joints as compared to contraction joints. First, on a 1946 project on US 27, Figure 11 shows concrete at a typical expansion joint to be in excellent condition the full depth of the joint and the filler material to be compressed practically to refusal. In the same figure, note typical concrete disintegration above the base plate at a contraction joint 100 ft north of the expansion joint.

Figure 11. Comparative performance of two 20-year-old joints on southbound US27 near the Looking Glass River bridge; Project 19-41, C1; constr. 1946.

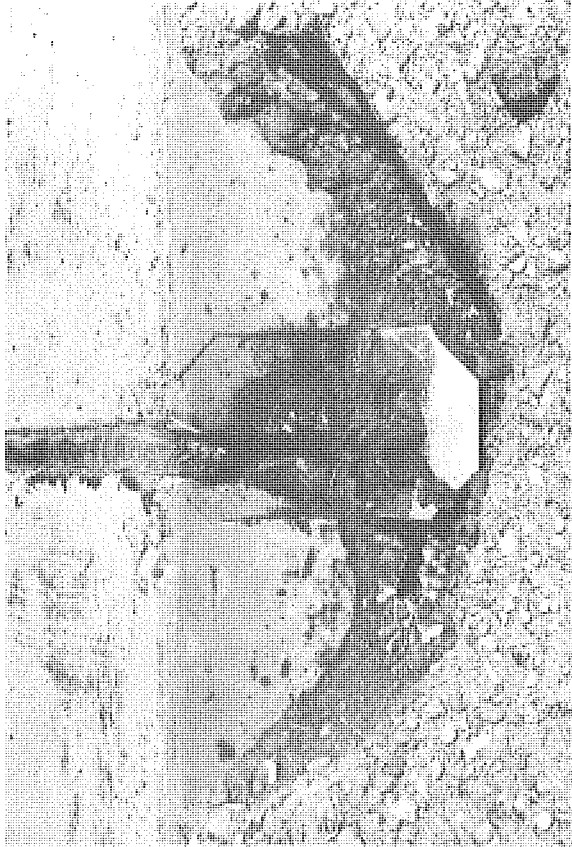
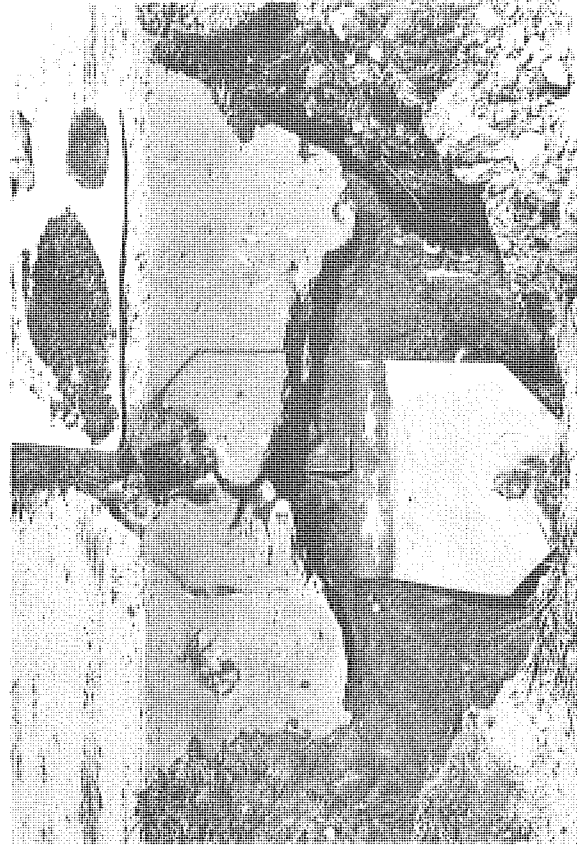
The same contrast was found on a more recent US 27 project, built in 1956. With reference to Figure 12, here again note the difference in concrete deterioration above the base plate in the two different types of joints. The fine concrete material (shown on the paper) taken from wedge area above the base plate was analyzed for chloride content and gradation. The sodium chloride content was 0.7 lb per ton of concrete, or 0.035 percent by weight. Approximately 96 percent of this material passed the 3/8-in. sieve and 19 percent the No. 200 sieve.

Figure 12. Comparative performance of two 10-year-old joints on northbound US27 near the Maple River bridge; Project 29-17, C9; constr. 1956.

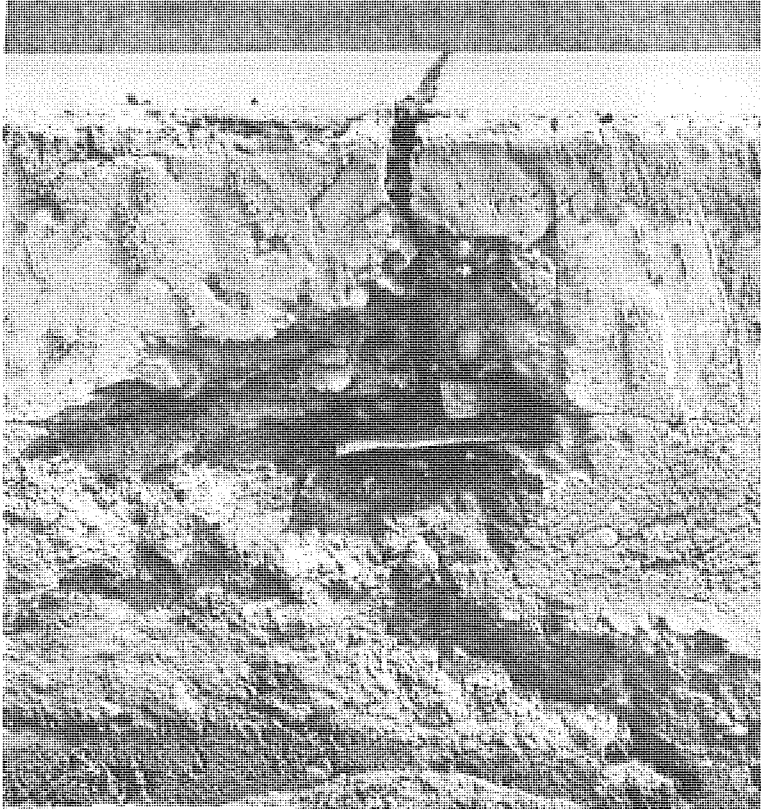
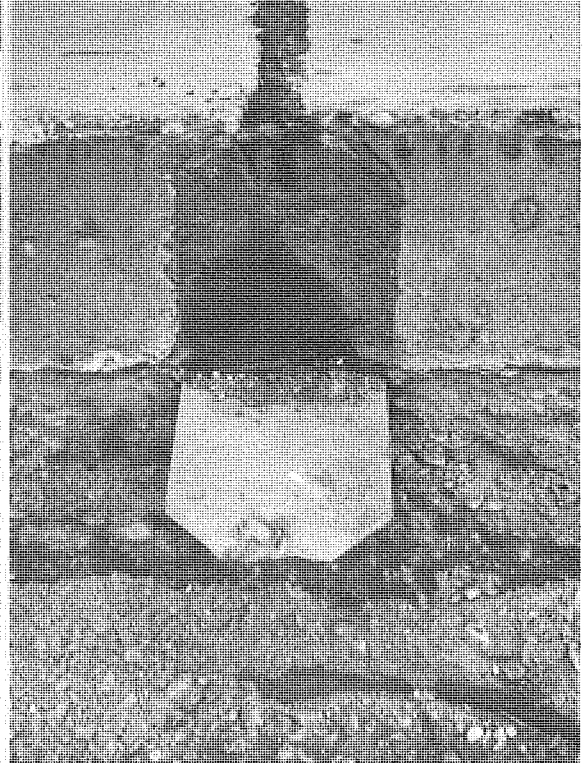
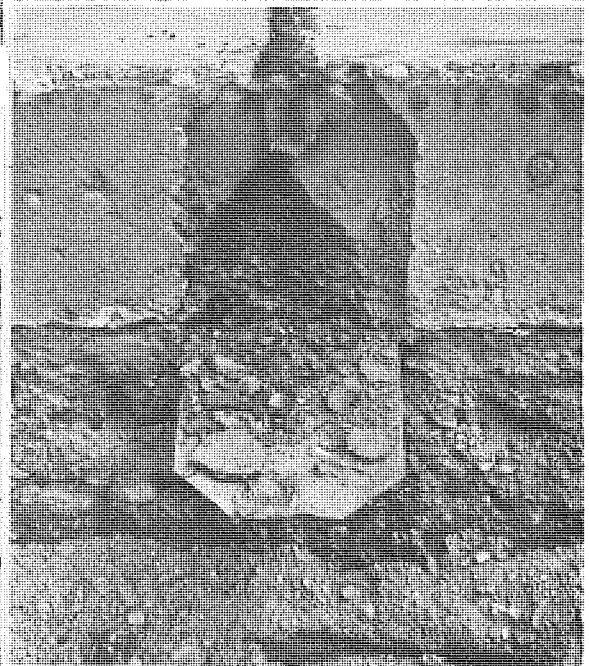
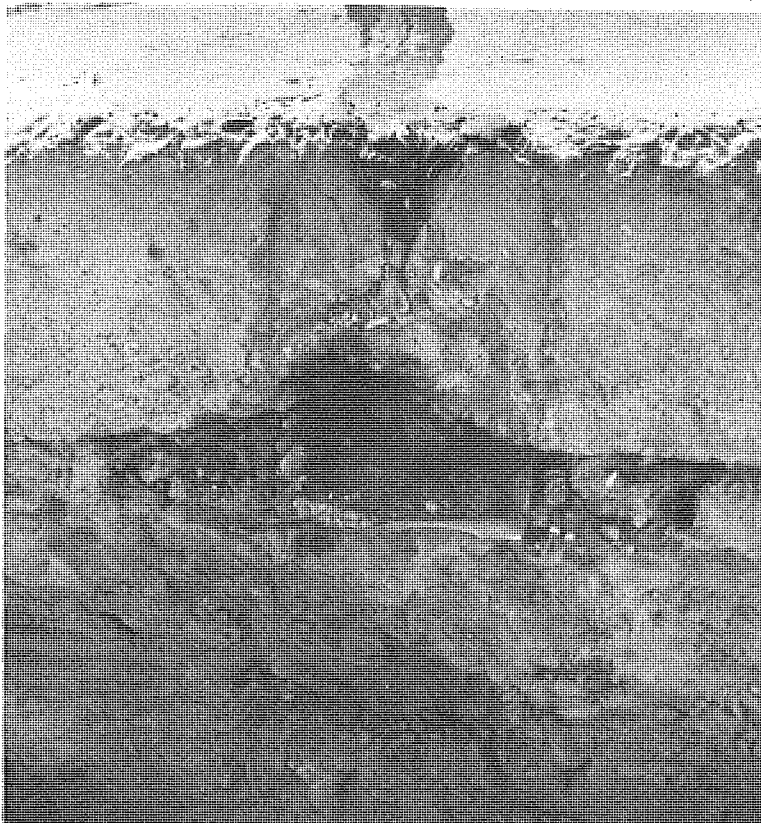
Widening operations on I 96 west of I 696 in May 1966 afforded an excellent opportunity to examine the condition of many joints exposed during earthwork operations. Figure 13 shows three contraction joints undergoing typical concrete deterioration above the base plate. A crack and an expansion joint with a base plate are shown in Figure 14, where the absence of concrete deterioration may be noted in both cases.

Figure 13. Characteristic deterioration above base plate at three 10-year-old I 96 contraction joints; note moistness and quantity of infiltrated, entrapped material held in place by end plate at Sta. 510+50 WB; Project IN 63-29, C10; constr. 1956.

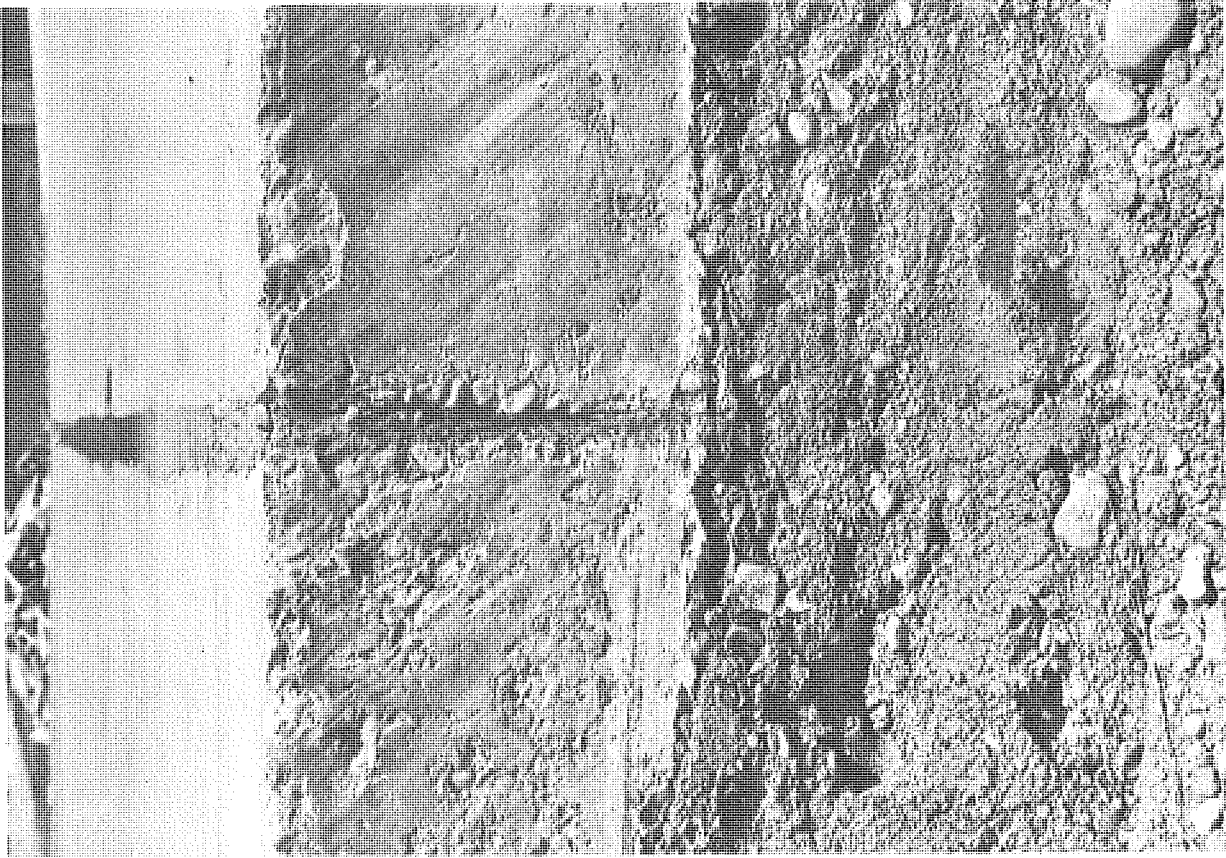
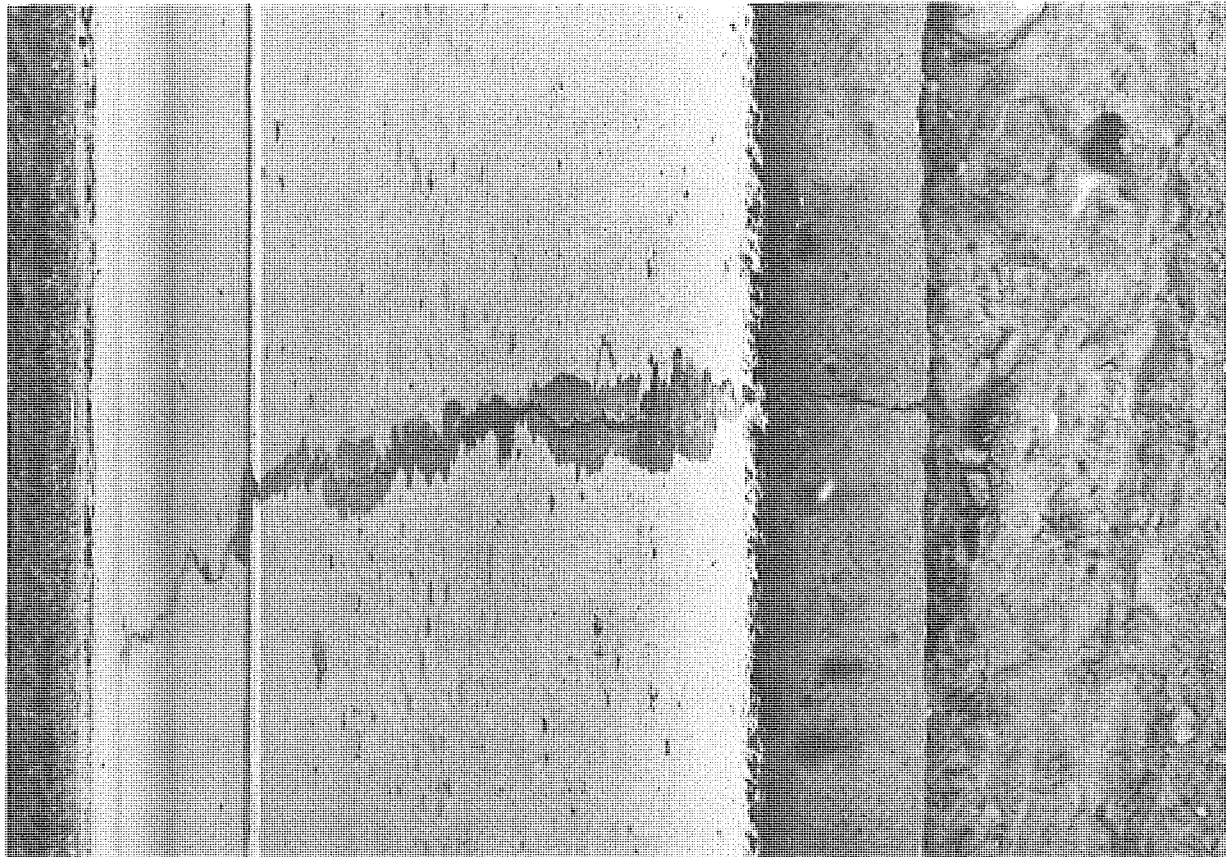
Figure 14. Note similar good condition of lower slab at crack and at expansion joint with base plate, both on 10-year-old I 96 pavement; Project IN 63-29, C10; constr. 1956.
