OFFICE MEMORANDUM

STATE HIGHWAY DEPARTMENT

July 1, 1965

Subject: Inspection of Neoprene Preformed Sealant Failures in Battle Creek Projects (I 13033D, C8 and U 13121E, C2, C3). Research Projects 62 G-116(1) and (2). Research Report No. R-530.

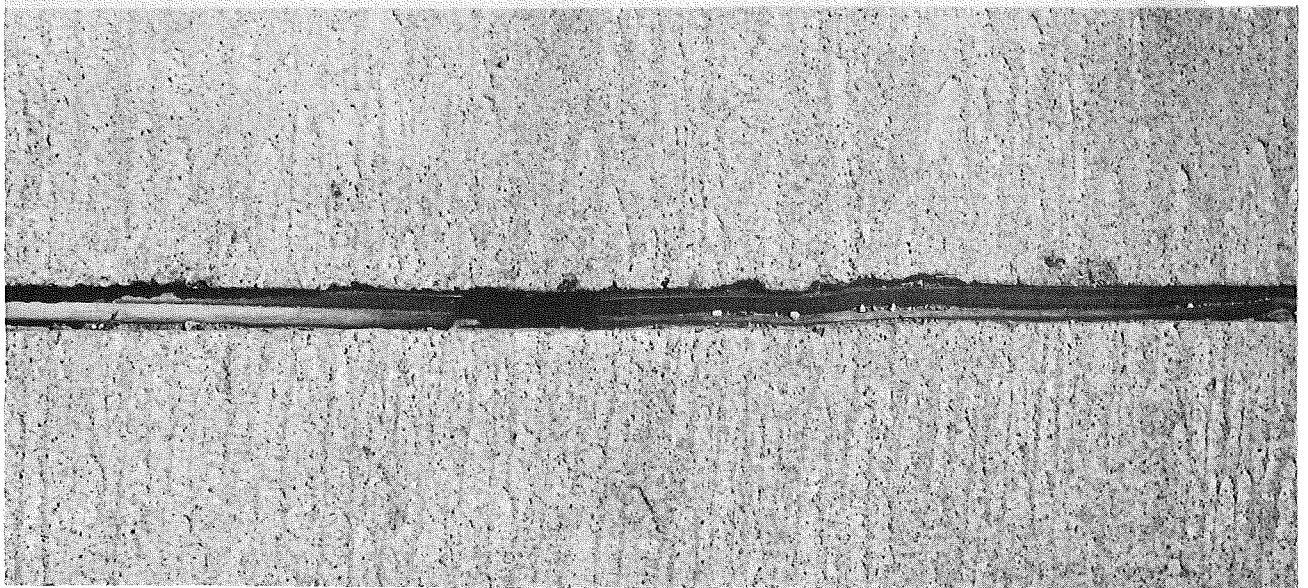
Several contraction joint seals had two to five breaks along their 24-ft length, indicating that they had been stretched during installation. Otherwise, contraction joints appeared to be in good condition. At each break, the open space ranged from 1 to 2 in. long (Fig. 1). Contraction seals were found in this condition on eastbound Columbia Ave. at Stas. 646+84, 645+90, and 635+63. Most expansion seals on Columbia Ave., and on I 194 approaching Columbia Ave. from the south, showed some degree of protrusion above the pavement surface. The following expansion joints were inspected:

1. Stretching of the neoprene sealant during installation caused it to break in the joint.
2. Improper forming of expansion joints (Fig. 9) caused sealant to extrude out of the joint when slabs expanded.
3. Excessive surface edging of expansion joints (Fig. 10) made it necessary to install seal too deep in the joint opening.

Figure 1. Contraction seal with 2-in. long break.

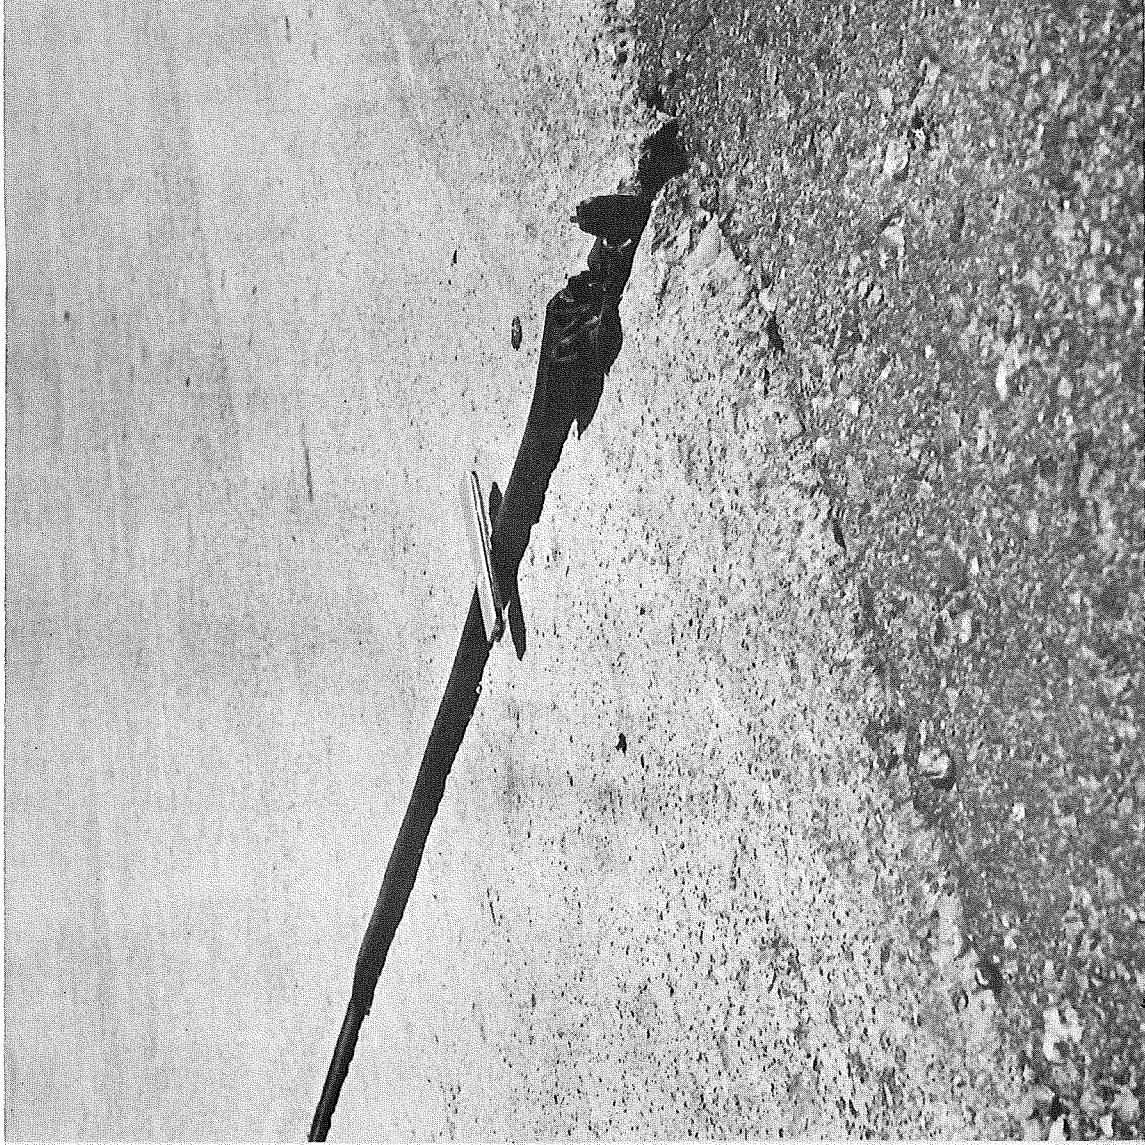
Sta. 648+00: Eastbound Columbia Ave. Most neoprene seal was flush with the pavement surface. The south end was completely protruded for a distance of about 6 in. The joint opening was 1/2 in. at this point and about 1 in. at the other end of the joint (Fig. 2).

Figure 2. Expansion seal with end partially expelled from joint, which is closed to 1/2-in. at this point (Sta. 648+00).

We understand all expansion joints on Project I 13033D, C8 are to be resealed, in which case we recommend that the joint grooves be reconditioned to original specification dimensions by appropriate procedures.

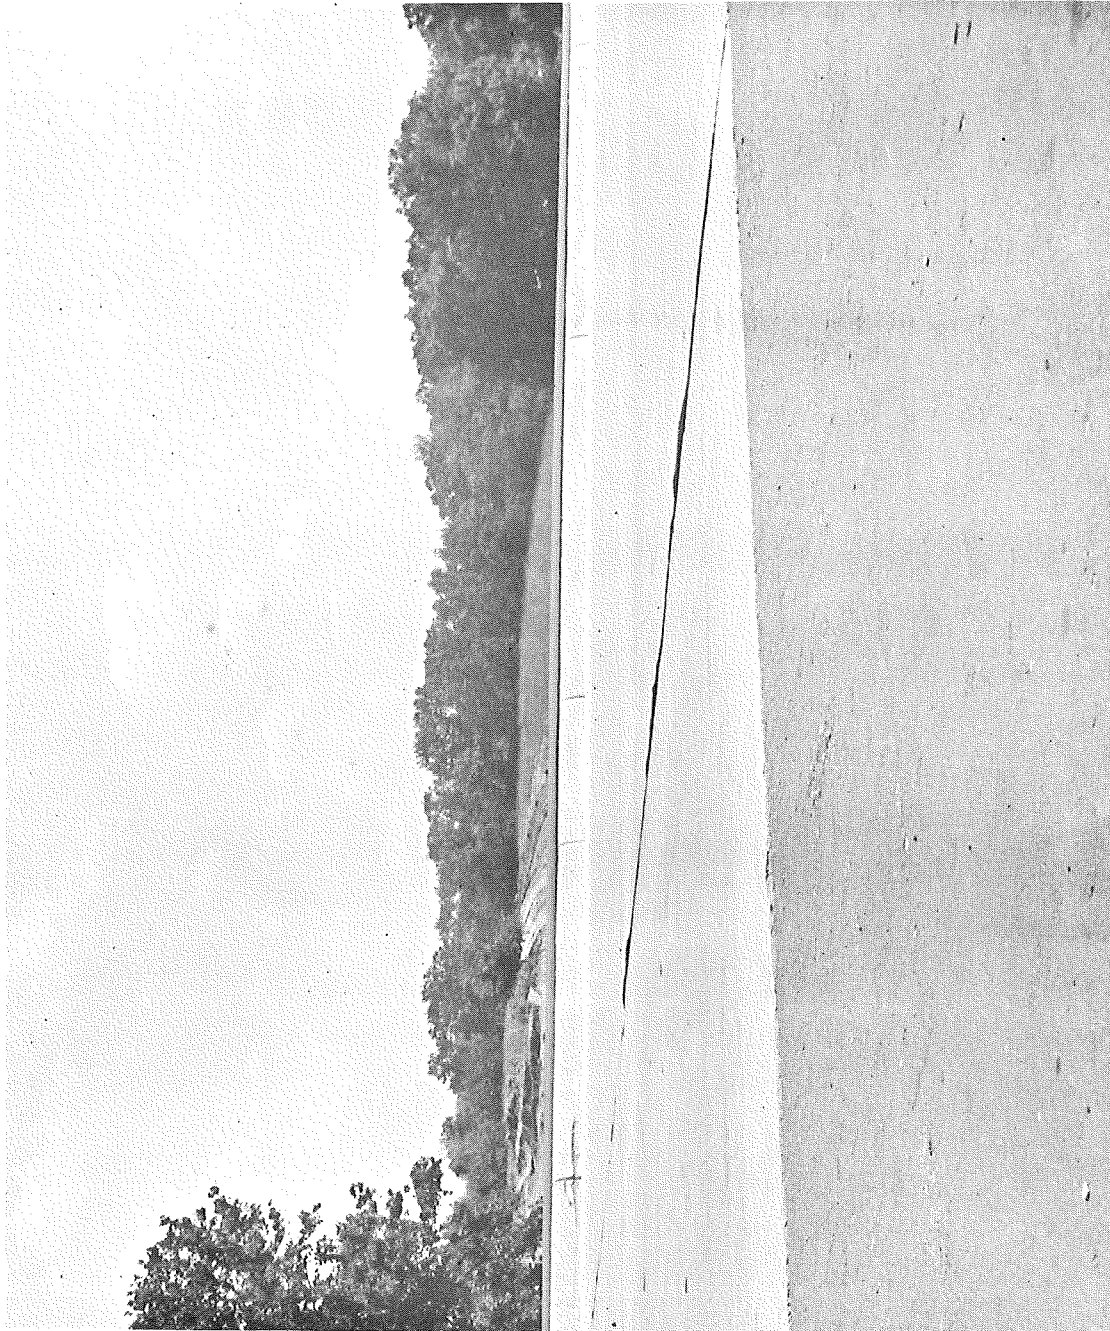
Sta. 636+33: Eastbound Columbia Ave. The seal in the outside lane had protruded uniformly to a maximum of 1/2 in. in one area, while the inside or passing lane was in satisfactory condition (Fig. 3). Mr. Dunn said the two lanes were paved at different times but sealed at the same time.

4. Lane-at-a-time construction created an installation problem when the entire joint was sealed after pouring of the second lane (Figs. 3 and 5).

Figure 3. Expansion seal raised in traffic lane (foreground) but not in passing lane (Sta. 636+33).

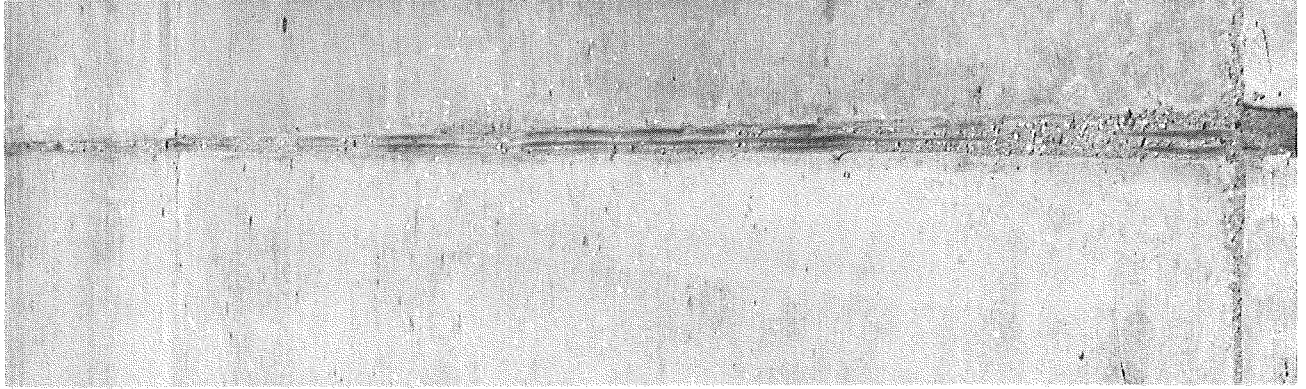
Sta. 643+30: Westbound Columbia Ave. This seal was in good condition and is shown in Fig. 4.

Figure 4. Expansion seal in good condition (Sta. 643+30).

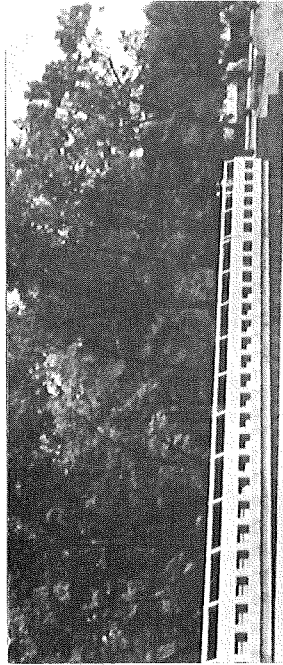
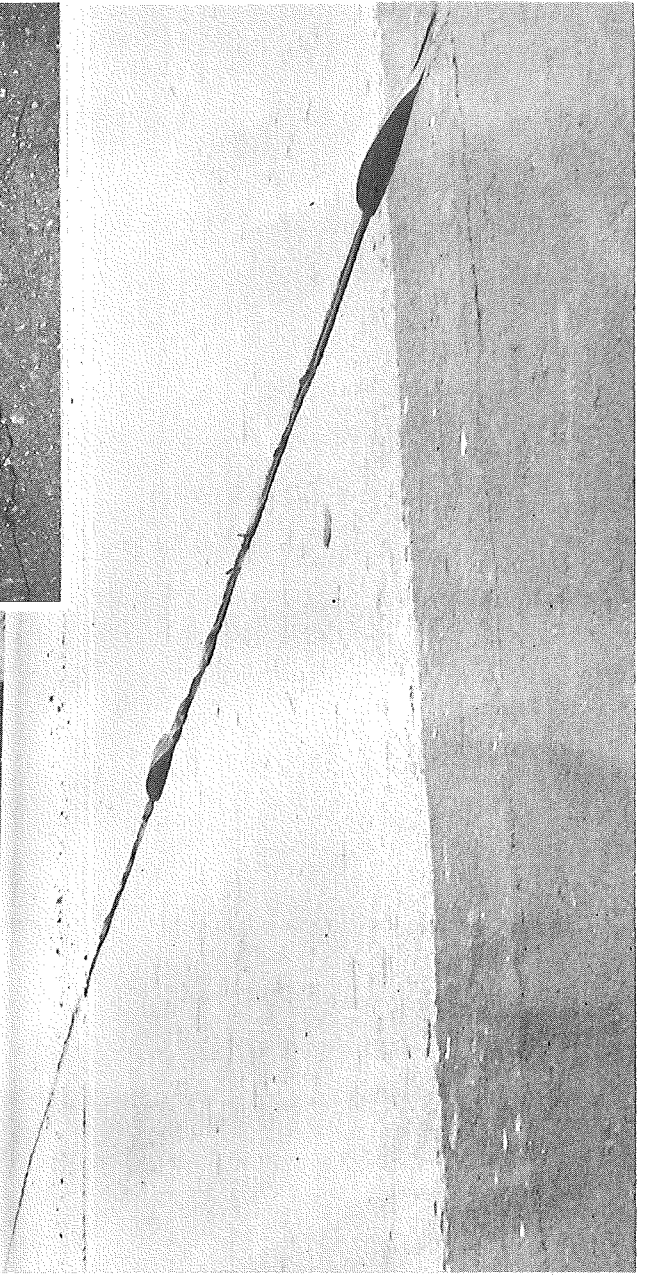
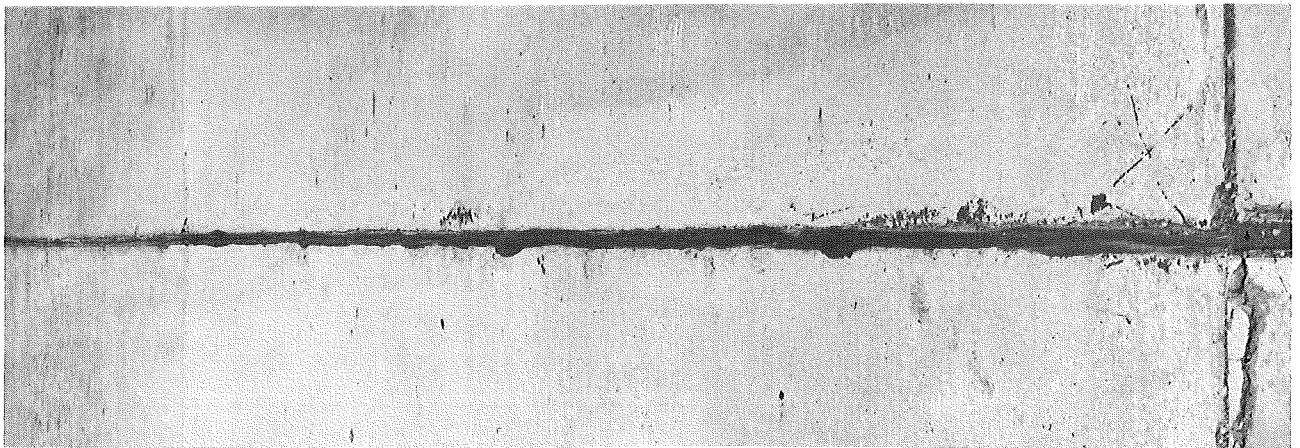
I 194 Ramp to Columbia Ave. An expansion seal was installed in the southbound lane and a contraction seal in the northbound lane. Part of the expansion seal at the west end had split longitudinally and horizontally in the joint, permitting the top portion of the seal to protrude out of the joint (Fig. 6). The joint opening at this point was $3/4$ in. at the top and somewhat narrower at the bottom.

Figure 6. Expansion seal in near lane raised, with contraction seal in far lane in good condition (below). In close view (right), top portion of expansion seal is lifted to show lower portion still in joint. Bituminous shoulder material in foreground extends 1-ft onto pavement (ramp from I 194 to Columbia Ave.).

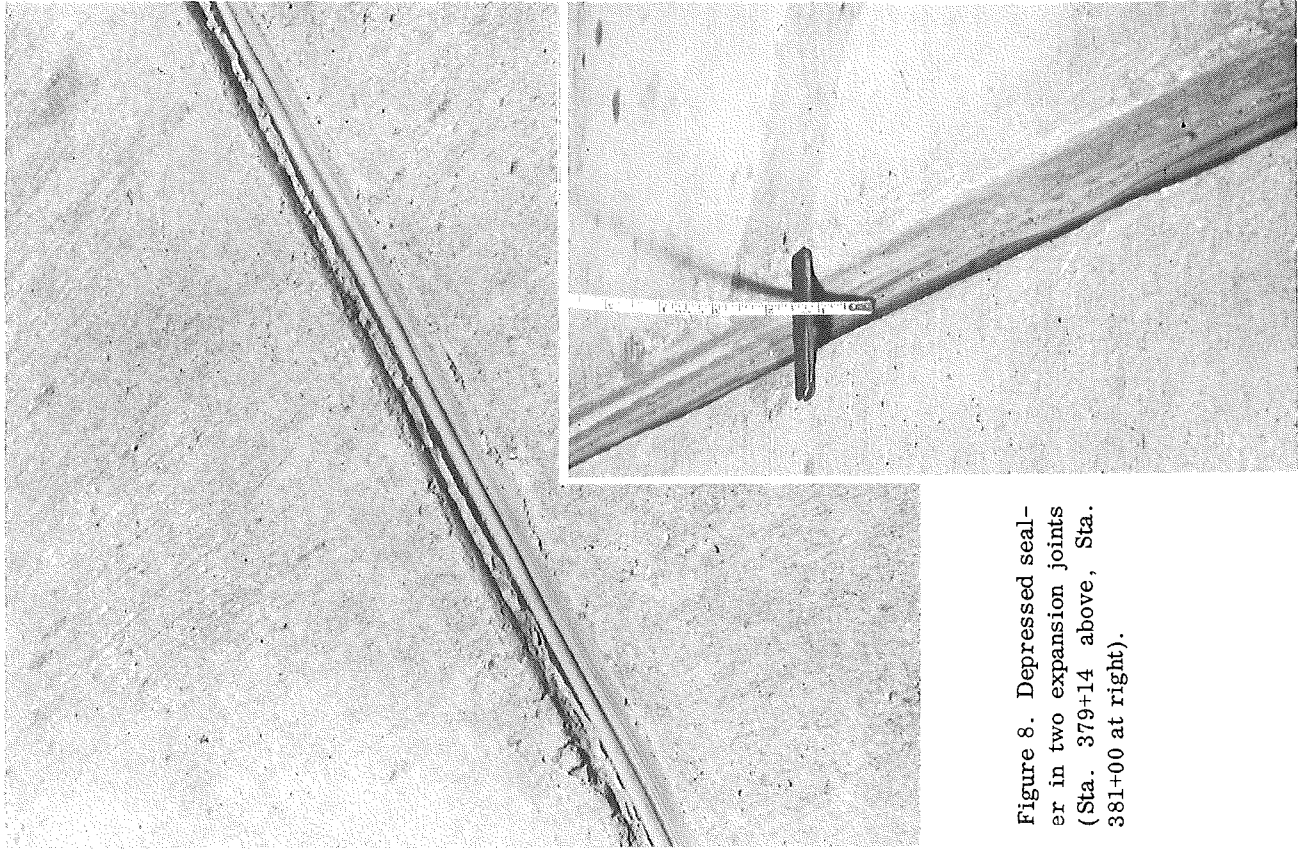
Sta. 381+00: Eastbound I 94 BL. Approximately one-third of the seal was $1-1/4$ in. below the pavement surface (Fig. 8). The edging tool formed a ledge 1 in. below the surface and about $7/32$ in. wide. The joint was $1-3/8$ in. wide above this ledge and $15/16$ in. wide below it. A cross-section view is given in Fig. 10.

Sta. 379+14: Eastbound I 94 BL. Seal condition here was similar to that at Sta. 643+30 westbound, and is also shown in Fig. 8.

Figure 8. Depressed seal-
er in two expansion joints
(Sta. 379+14 above, Sta.
381+00 at right).

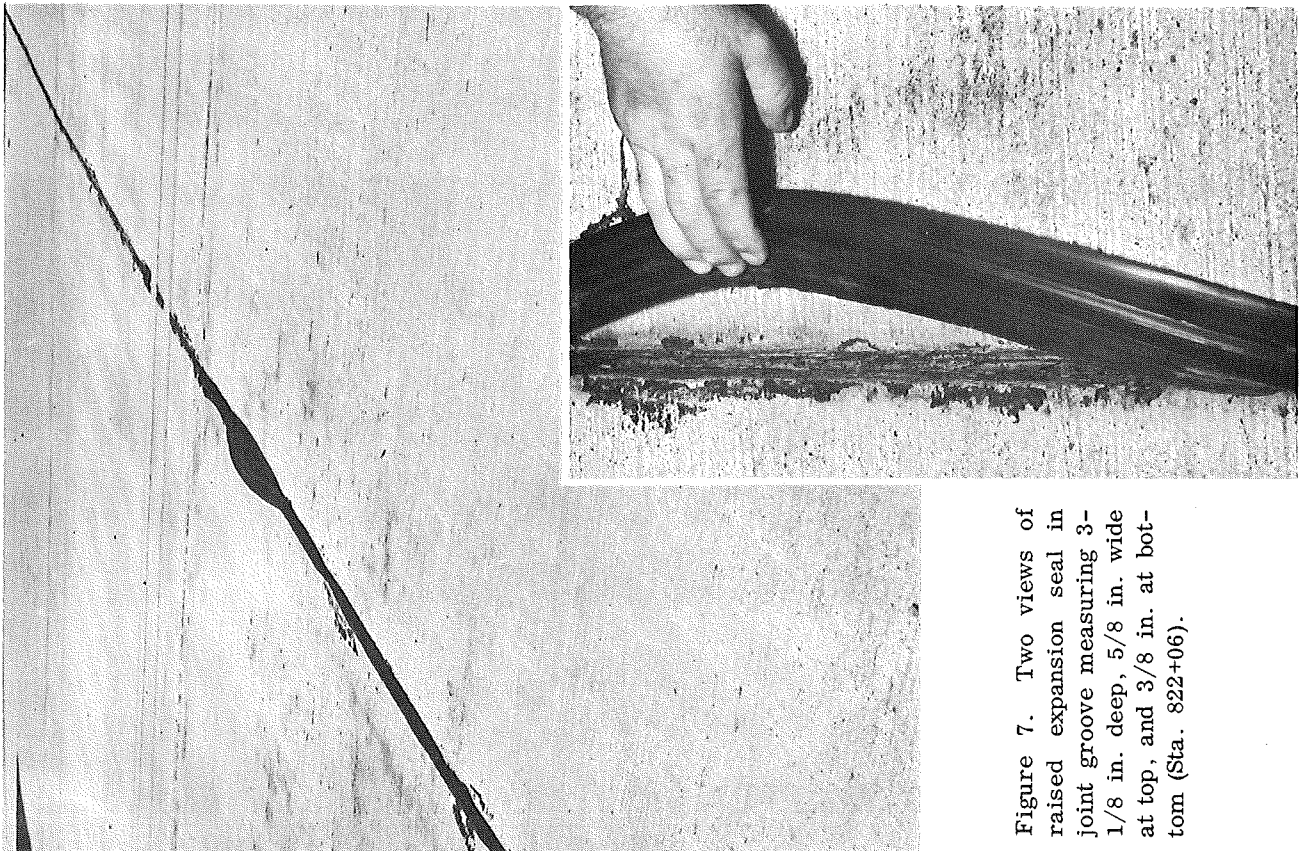
Sta. 822+06: I 194 south of Columbia Ave. Most of this seal was high, with 2 to 3 ft entirely protruded in the northbound lane. The joint at this point was $3-1/8$ in. deep, $5/8$ in. wide at the top, and $3/8$ in. wide at the bottom (Fig. 7). A cross-section drawing is given in Fig. 9.

a. Samples of sealant taken from the joint at Sta. 822+06 on I 94 south of Columbia Ave. were split on top and torn at the sides and bottom. This situation was discussed with a Du Pont representative, who stated that the material may have been overcured. He stated that other instances of this nature have been detected in material from the same source. This will be investigated further.

Figure 7. Two views of
raised expansion seal in
joint groove measuring 3-
1/8 in. deep, 5/8 in. wide
at top, and 3/8 in. at bot-
tom (Sta. 822+06).

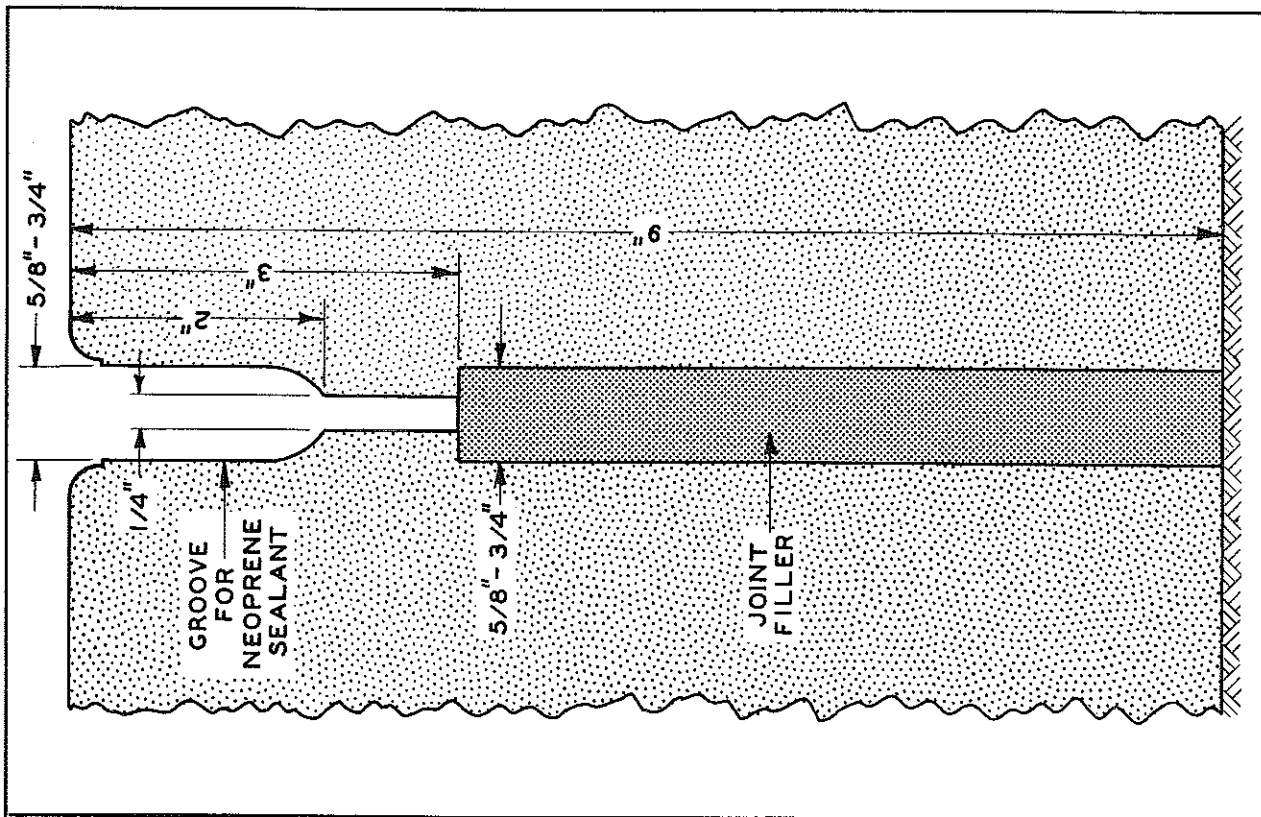
Figure 9. Cross-section of expansion joint shown in Fig. 7, from which neoprene sealer was extruded (Sta. 822+06).

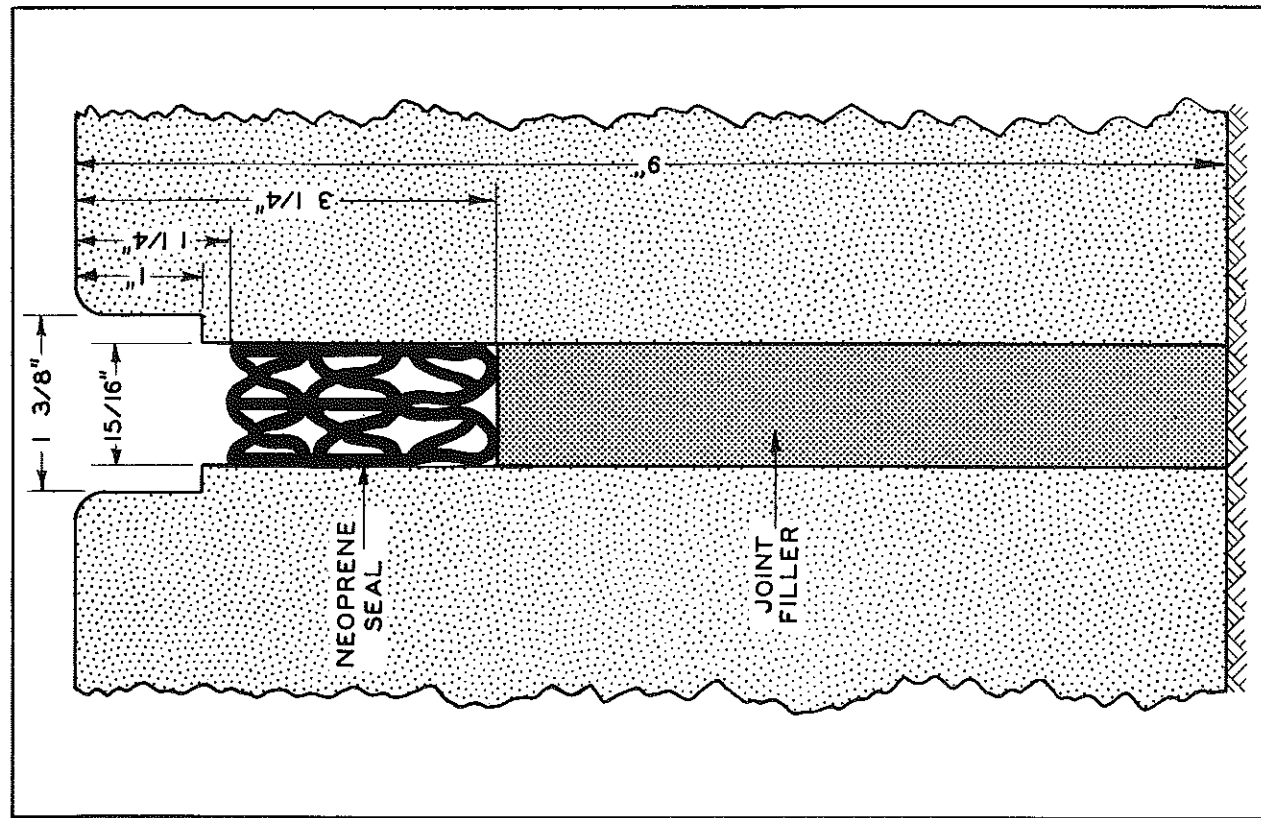
Figure 10. Cross-section of expansion joint shown in Fig. 8, indicating how depth of edging affects position of neoprene sealer (Sta. 381+00).
