**FRACTURE-PLANE DETERIORATION OF CONCRETE BRIDGE DECKS**  
Bridge S05 of 63022, Wixom Road over I 96

Research Laboratory Division  
Office of Testing and Research  
Research Project 61 B-58  
Research Report No. R-584

State of Michigan  
Department of State Highways  
Lansing, May 1966

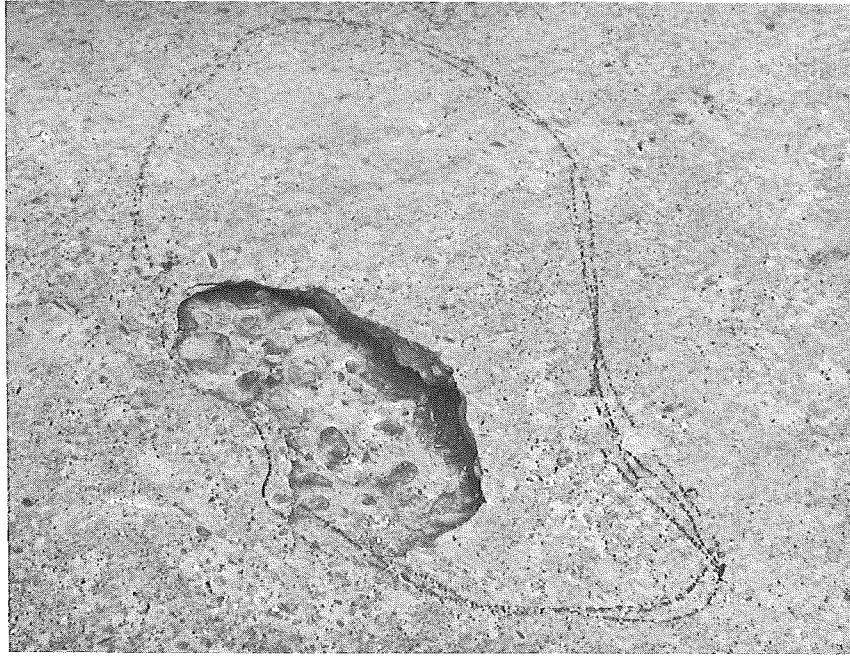
The entire concrete deck of the southbound passing lane in the north end span had been removed and replaced, and an area approximately 19 by 11 ft had been removed down to the upper layer of slab reinforcement in the northbound passing lane of the span over eastbound I 96. A typical isolated spall with adjoining hollow area outlined on the deck surface, as found on this latter span, is shown in Figure 1. On the same span, an

Figure 1. Typical pothole with limits of hollow area outlined in black.

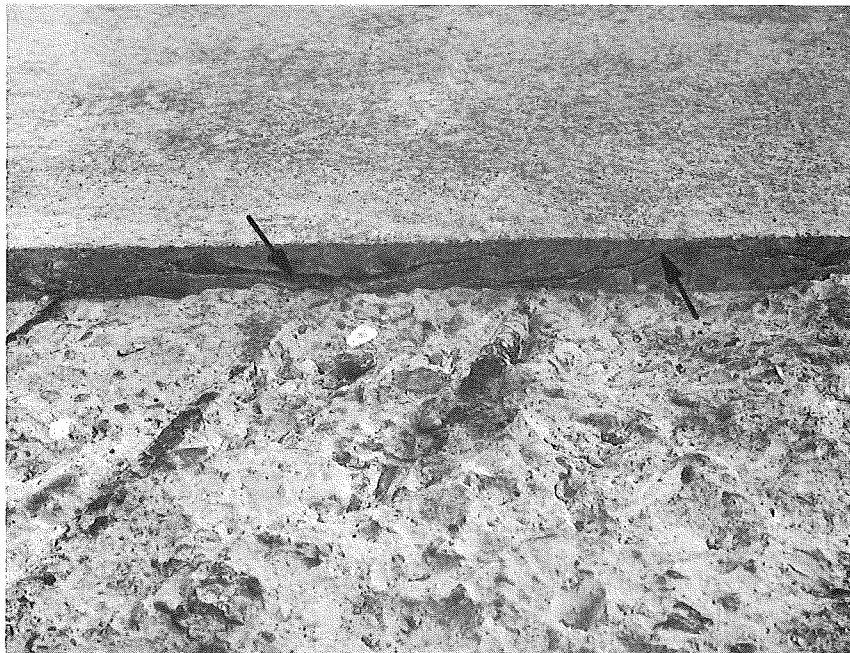
undulating fracture (Fig. 2) was noted on a cut section perpendicular to the deck's transverse steel. Examination of the steel reinforcement here showed extensive, intermittent corrosion throughout the entire exposed area (Fig. 3). In some spots, these bars were deeply corroded, with the attack confined primarily to the upper halves of the transverse bars. The longitudinal bars upon which the transverse bars were placed showed practically no corrosive attack. The depth of concrete cover over the transverse bars in this area varied from 1 to 1-1/4 in.

Figure 2. Sawed face of repair area perpendicular to transverse deck steel, with arrows indicating undulating fracture surface.

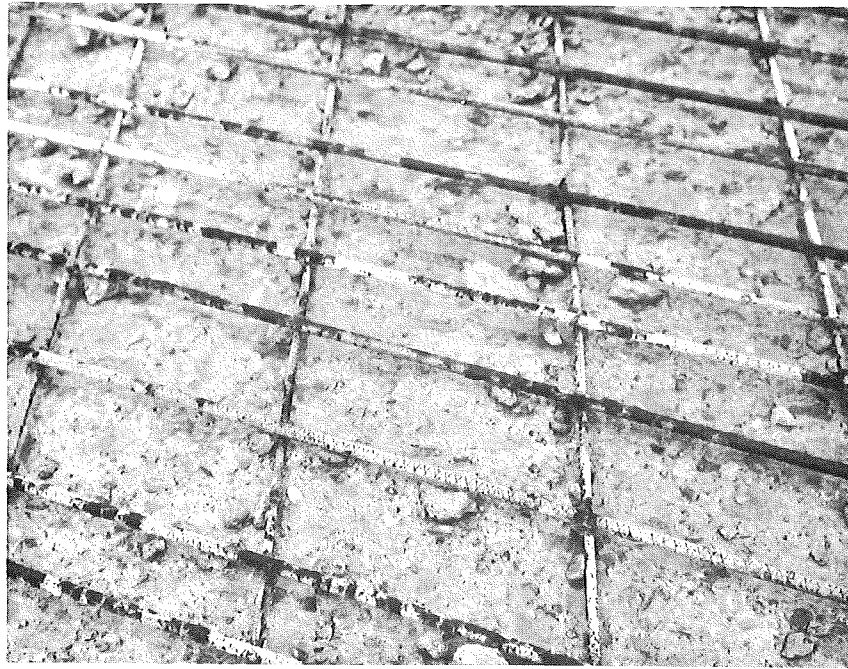
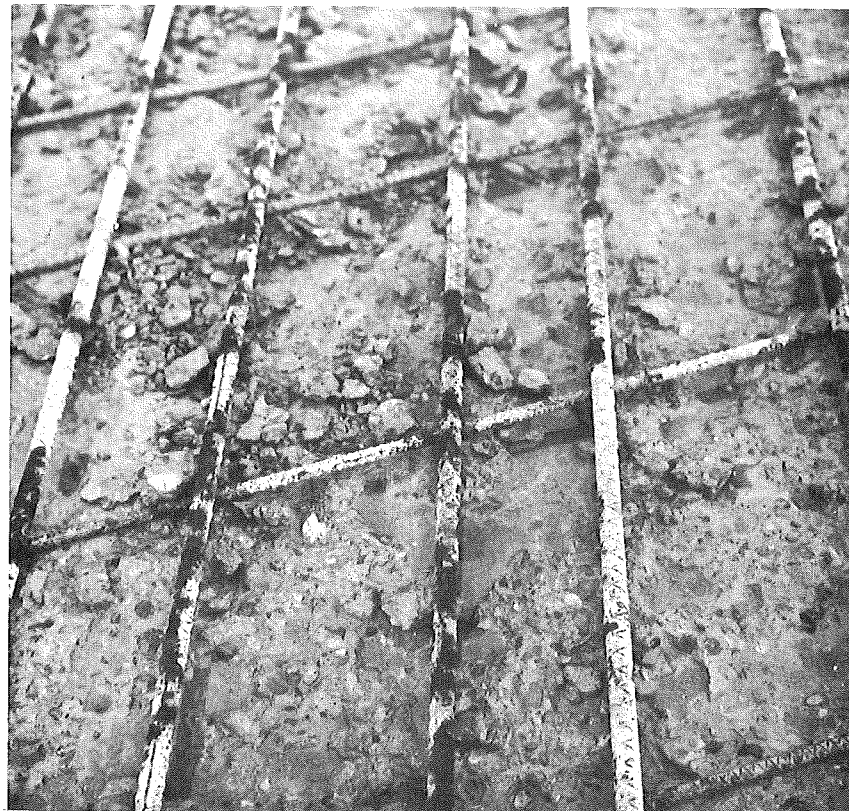
Figure 3. General condition (top) and close-up view of corroded transverse reinforcing bars in 19- by 11-ft area where deteriorated concrete was removed at surface of northbound passing lane.

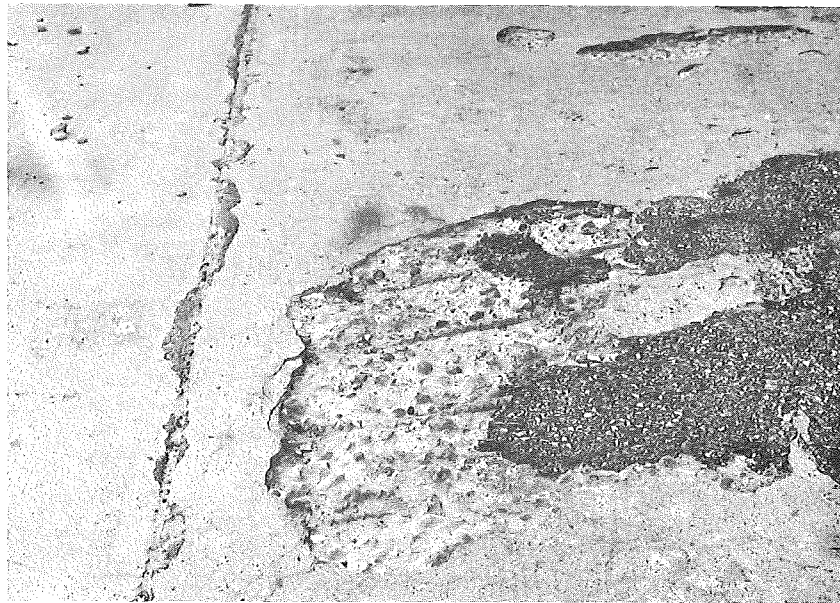
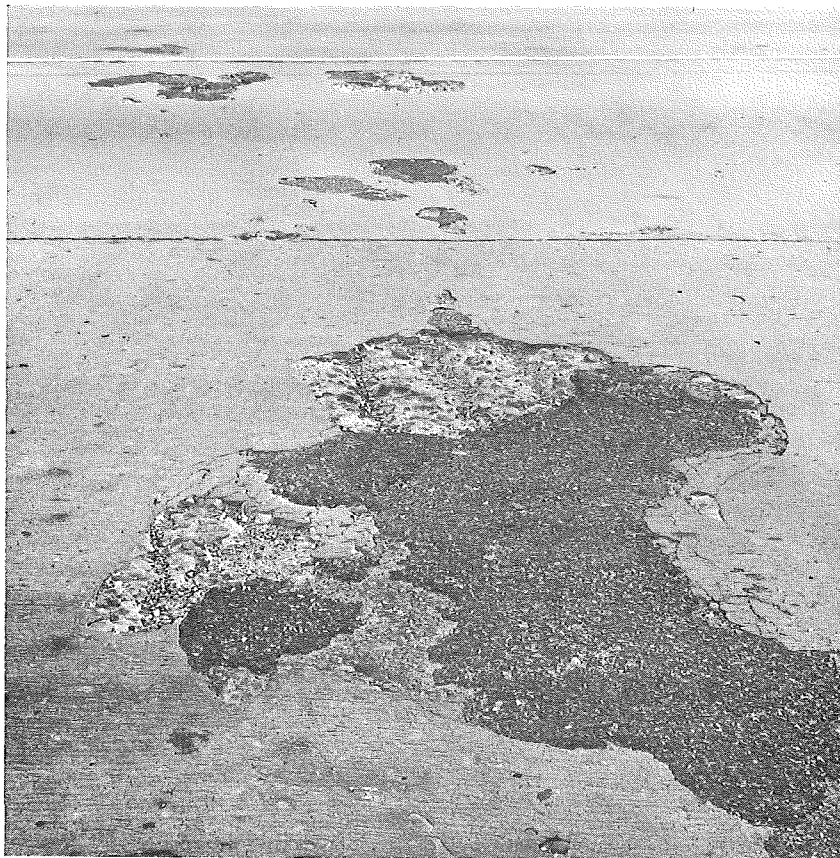
The type of deck deterioration exhibited here has been termed "fracture plane" deterioration and is a relatively common phenomenon on bridge decks throughout Michigan and other States. (See, for example, "A Study of Deterioration in Concrete Bridge Decks," Missouri State Highway Department, October 1965). Photographs of this same type of fracture-plane deterioration depicting the spalled area and the undulating fracture surface are shown in Figure 4, as taken on Bridge S02 of 63022, I96 over New Hudson Road. This type of defect is characterized by a separation

or fracture of a layer of concrete undulating from within 1/4 in. of the surface at points between transverse bars, down to the level of the transverse steel at points in line with the bars. When the fracture line extends to the surface, potholes result and ultimately breakup and removal of this surface layer occurs over large areas of the deck. The isolated pothole is also characterized by a larger hollow area, surrounding or adjoining the surface fracture outline.

Figure 4. Two views of typical fracture-plane deterioration, showing exposure of transverse steel (top) and undulating fracture surface (bottom), as encountered on Bridge S02 of 63022 (I 96 over New Hudson Road).
