JOINT REPAIR BY EPOXY INJECTION

MICHIGAN DEPARTMENT OF STATE HIGHWAYS

J. E. Simonsen

Research Laboratory Section  
Testing and Research Division  
Research Project 71 TI-81  
Research Report No. R-838

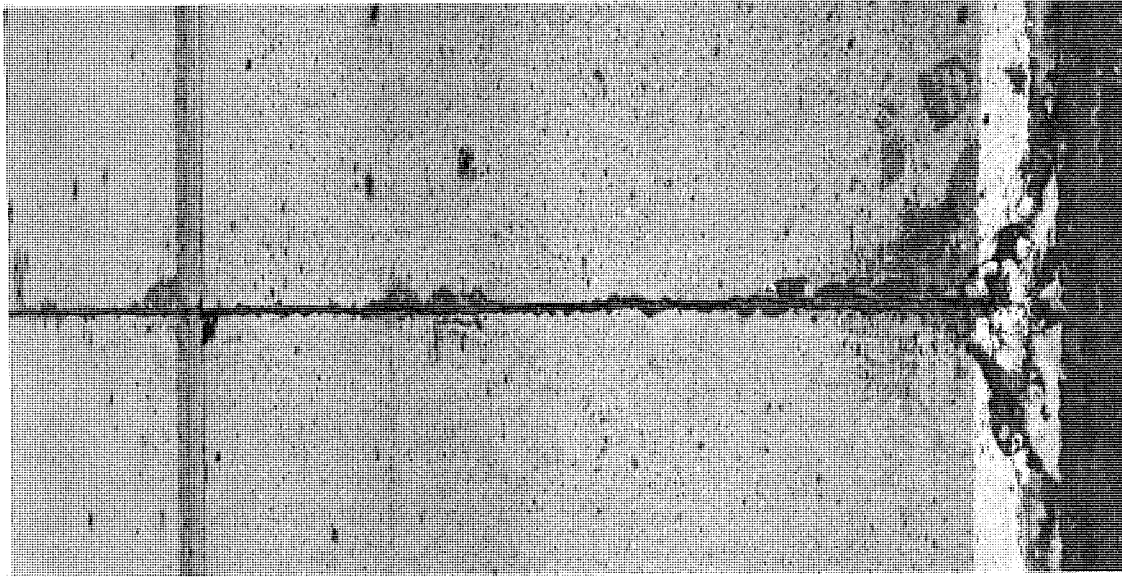
Sta. 639+59

The three joints selected for the experimental repair are located at Stations 639+58, 651+67, and 660+80 on the southbound roadway of US 127 just south of the Leslie exit. The pavement was constructed in 1957 and consists of two 11-ft lanes of 9-in. reinforced concrete. The joints are spaced 99 ft apart and contain 1-1/4-in. diameter steel dowels at 12-in. centers. Galvanized steel base plates and end plates were used on the slab bottom and edge, respectively, and the joint grooves were formed 1/2 in. wide by 2 in. deep. The joints were sealed with a hot-poured rubber-asphalt sealant. The pavement was constructed with expansion joints at 400-ft intervals. The surface condition of the selected joints is shown in Figure 1; the cores shown in Figure 2 were taken through the joint to check the deterioration at the bottom of the slab. Note that approximately 2 in. of concrete had deteriorated at the slab bottom.

Figure 1. Surface condition of joints selected for grout injection.

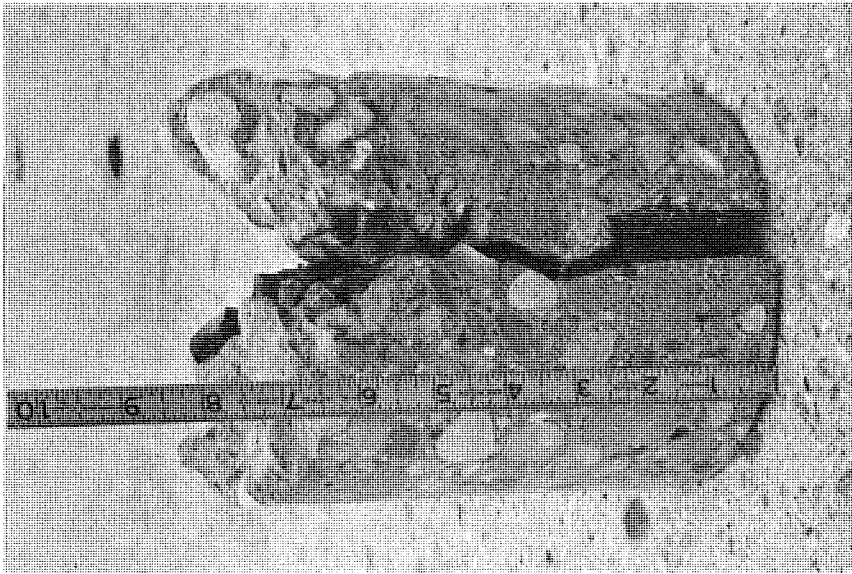
Sta. 639+59

Figure 2. Cores taken through the joints selected for grouting.

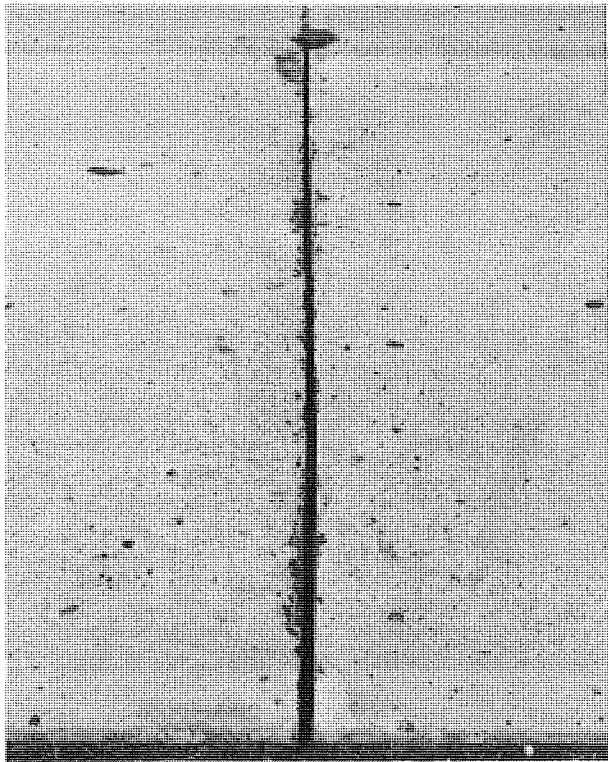
Figure 4. Sandblasting of joint groove.

2. The groove was sandblasted to remove dirt and sealant particles (Fig. 4).

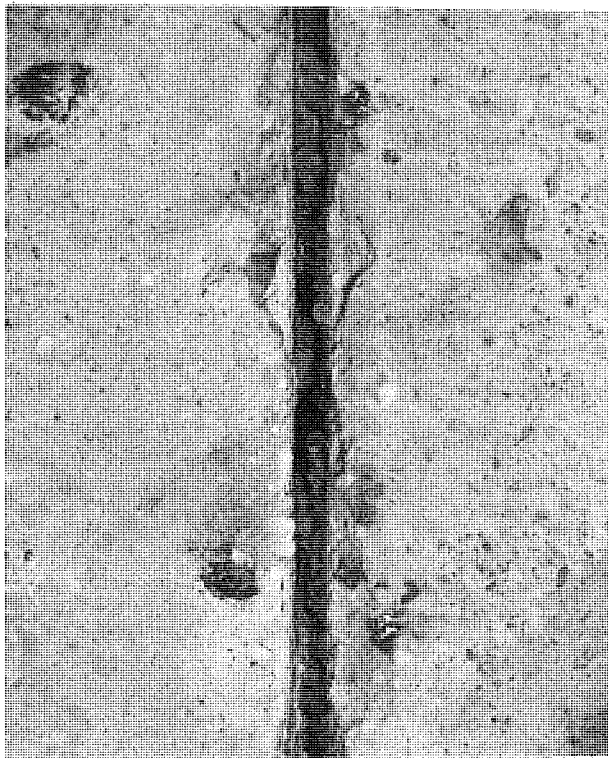
Figure 6. Close-up of groove nearly full of quartz sand.

4. The joint was filled to within about 1/2 in. of the surface with quartz sand (100 percent passing No. 4 sieve and 0-5 percent passing No. 16 sieve, Fig. 6).

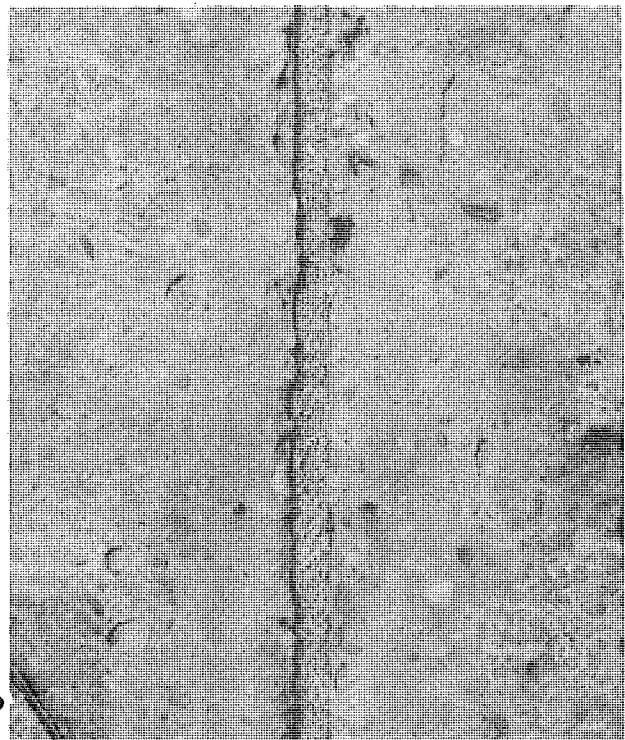
Figure 3. Condition of joint groove after removal of sealant.

1. The existing seal was removed from the joint groove using hand tools. Figure 3 shows a cleaned-out joint groove.

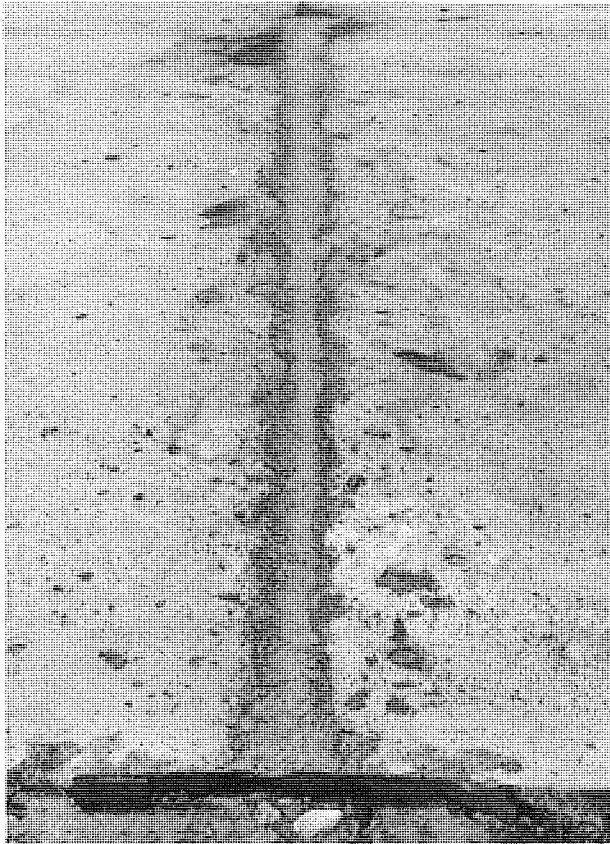
Figure 7. Condition of groove after applying epoxy mortar.

5. An epoxy mortar consisting of No. 1173 conpressive epoxy and sand was placed on top of the quartz sand as shown in Figure 7.

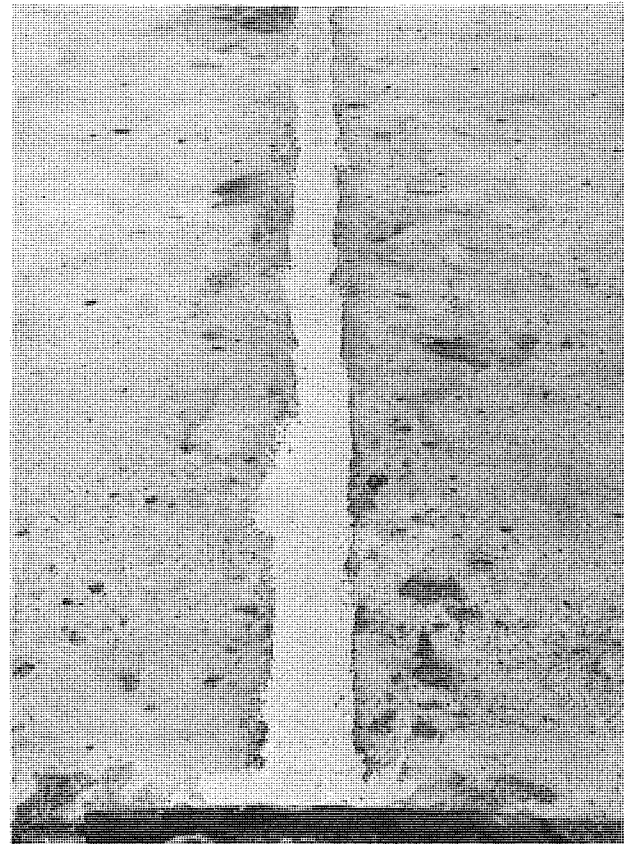
Figure 8. Condition of groove after thin layer of epoxy No. 1192 was placed on top of mortar.

6. A thin layer of fast-setting No. 1192 epoxy was placed on top of the epoxy mortar to shorten the time until injection could begin (Fig. 8).

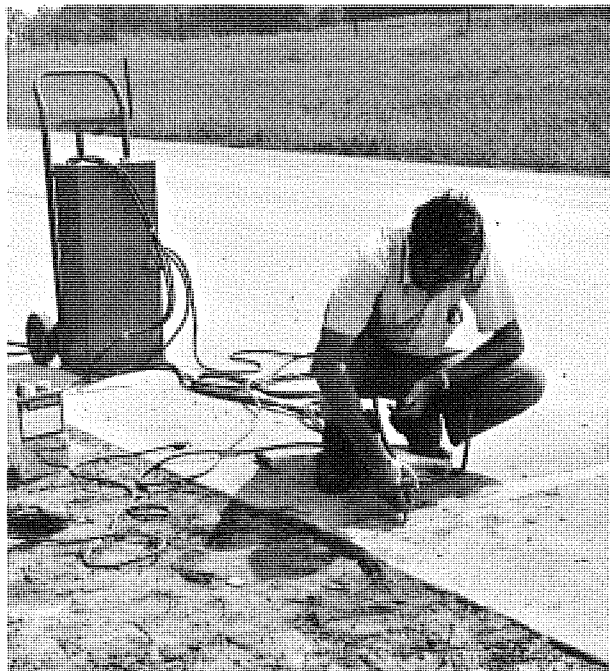
Figure 9. Injection of No. 1050 compressive epoxy.

7. A No. 1050 conpressive epoxy was injected into the joint through 1/4-in. holes spaced 2 ft apart. Figure 9 shows the injection pump and operator while Figure 10 is a close-up of the mixing nozzle and pressure gage. The pressure averaged 45 to 50 psi with a range of 15 to 100 psi. The injection began at the shoulder-edge hole and continued until epoxy was flowing up through the adjacent hole. The first hole was then plugged and injection begun in the second hole. This sequence was followed across the joint.

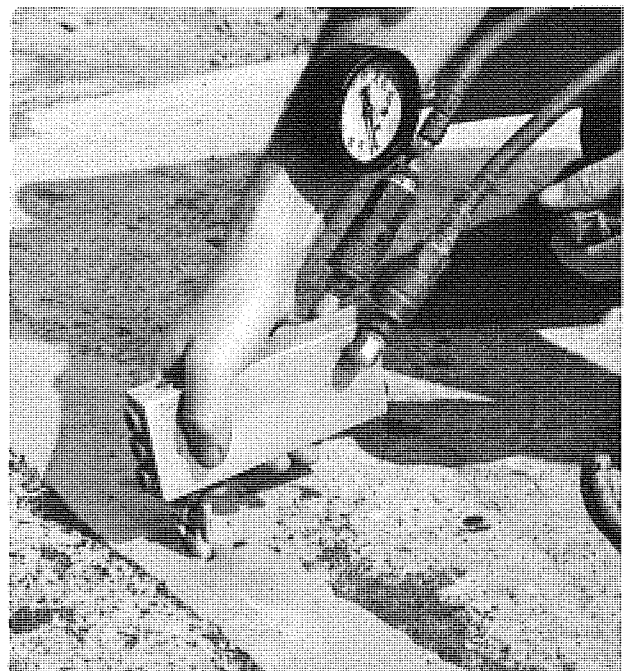
Figure 10. Close-up of mixing nozzle and pressure gage.

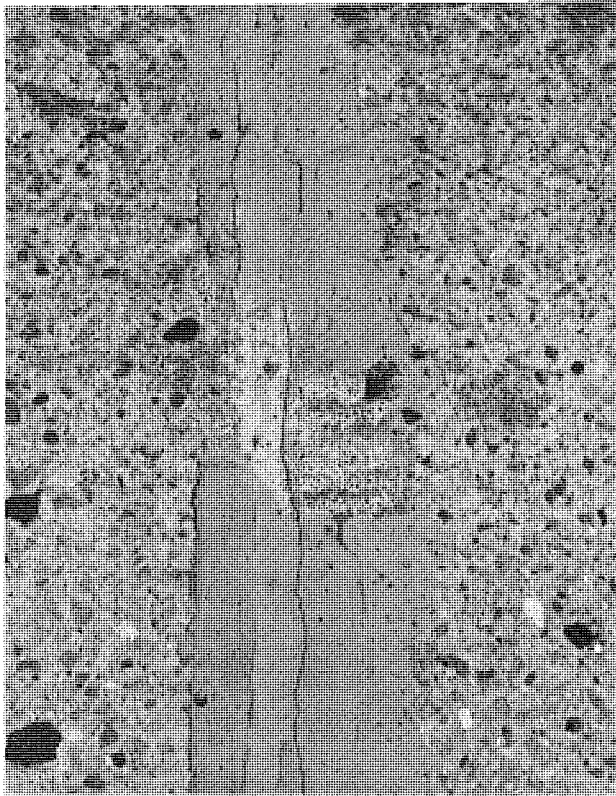
The success of the grouting was checked on September 18, 1972. First the joint surface was inspected and then 6-in. diameter cores were taken through the joint. The surface inspection revealed that the bond between the concrete and the epoxy had failed in some areas (Fig. 11), and at other locations the concrete adjacent to the groove had failed in tension (Fig. 12). A core taken through the bond failure area is shown in Figure 13 and one taken through the location of concrete failure is shown in Figure 14. Examination of both cores revealed that the epoxy had not penetrated through the plane-of-weakness crack and consequently the deteriorated concrete at the bottom of the joint was not bonded together.

On the basis of the results of this experiment it is concluded that grouting of pavement joints, coupled with the installation of a relief joint, is not feasible. The main reason for failure is attributed to the difficulty of removing the old sealant present in the plane-of-weakness crack in order to have clean surfaces to bond with. Even if bond of sufficient strength could be obtained in the plane-of-weakness crack it is apparent that the deteriorated concrete at the bottom of the joint cannot be successfully grouted because there is no way to clean the individual particles and the sound concrete surfaces in this area.

Figure 11. Bond failure between epoxy grouted groove and concrete surface.

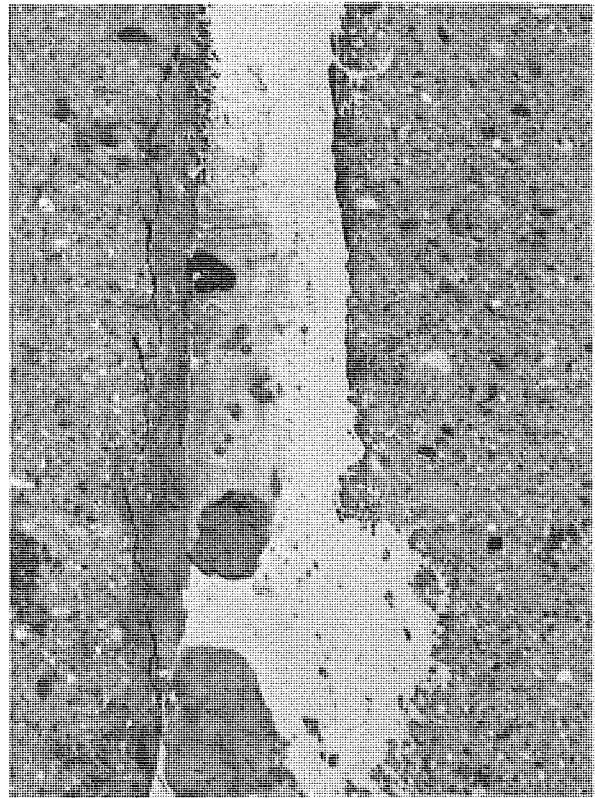
Figure 12. Failure in concrete adjacent to grouted groove.

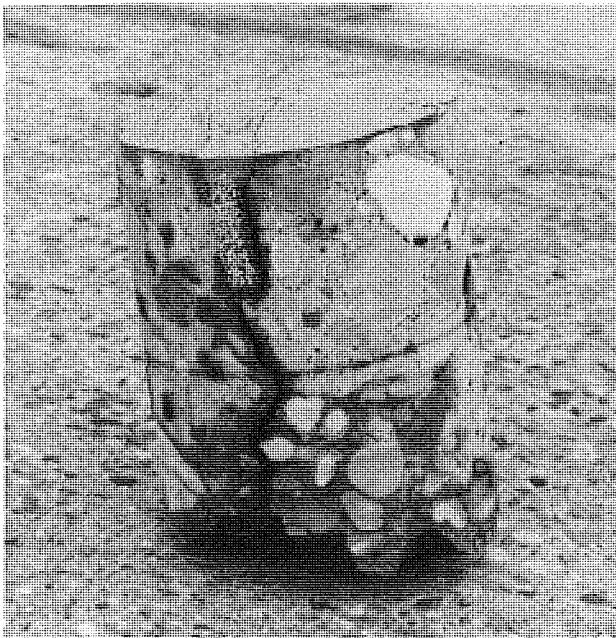
Figure 13. Core from area where bond failure between epoxy and concrete had occurred. No penetration of the epoxy into the plane-of-weakness crack was noted.

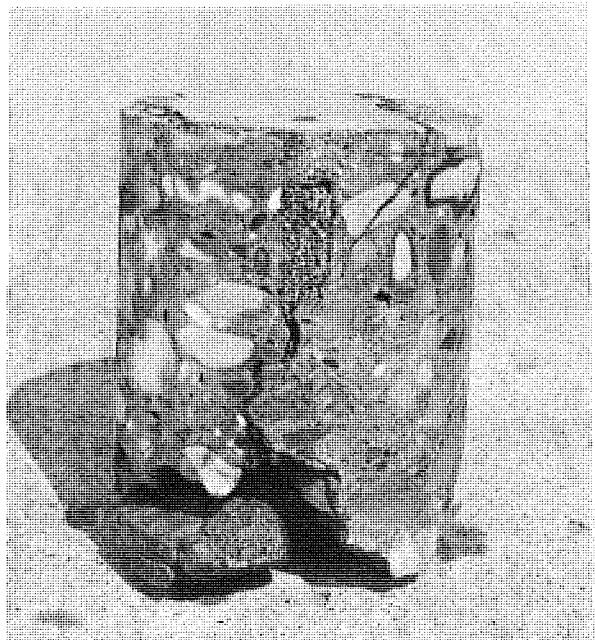
Figure 14. Core from area where the concrete had failed in tension. The epoxy had not entered the plane-of-weakness crack.
