OFFICE MEMORANDUM

STATE HIGHWAY DEPARTMENT

Subject: Evaluation of Preformed Rubber Sealer on M 46 West of Alma (Project F 29-23, C2). Research Project R-36 G-4(3b). Research Report No. R-435.

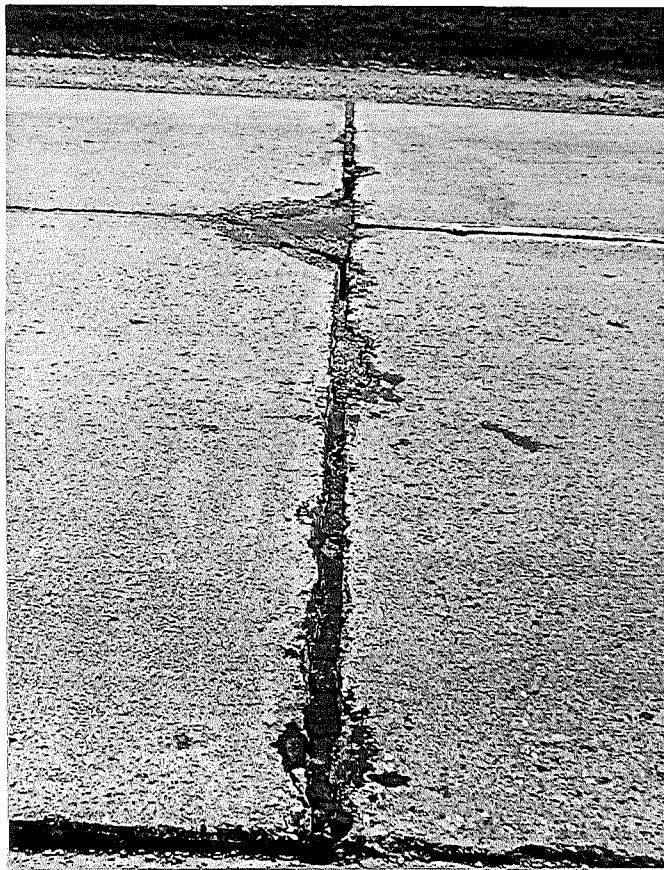
In the 1963 inspections, it was estimated that about one-third of the rubber sealer had completely disappeared (where joints had subsequently been resealed with hot-poured material as shown in Fig. 1). Another one-third of the sealer was in place, but ragged and torn, with evidence of some subsequent resealing (Fig. 2). Finally, about one third appeared still to be in position as placed, and had retained approximately its original shape (Fig. 3); this remaining sealer was still quite resilient.

During this inspection portions of preformed sealer were removed (Fig. 3), to determine the amount of infiltration into the joint space. Varying amounts of infiltrated material were found. This could have resulted from a) initial placement of preformed sealer 1/2 to 3/4 in. below the surface as noted in Report OR-29, allowing accumulation of road dirt atop the sealer and its subsequent blow-by, b) lateral spreading from such localized failures in the sealer and at the joint as may be seen in the spalling and corner breaks shown in Figs. 1 and 2, or c) inadequate adhesion of sealer to the joint face.

Figure 1. Joint resealed with hot-pour where original preformed sealer had disappeared. Note spall and center-joint break (Sta 249+30).

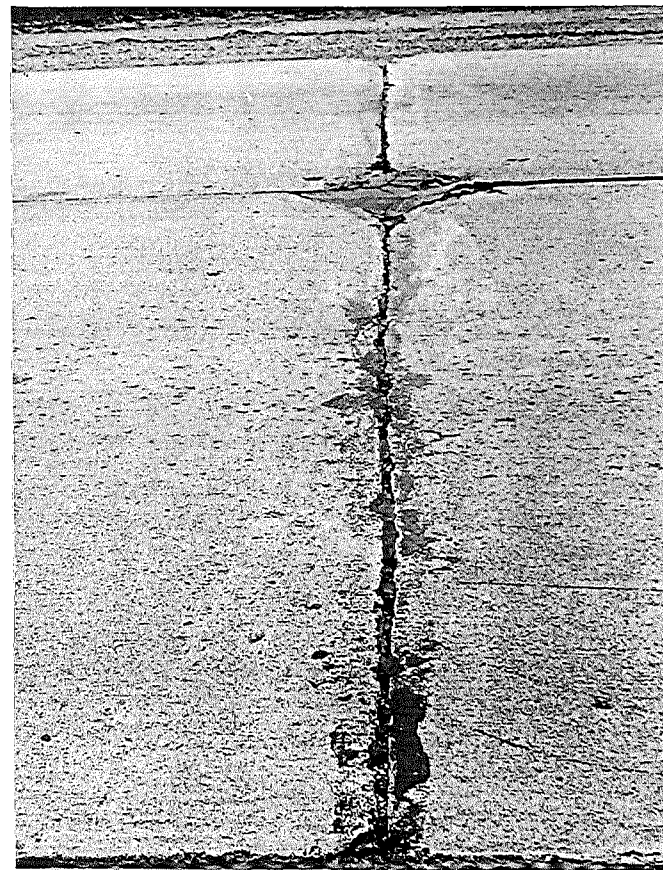
Figure 2. Test joint showing some re-sealing with hot-pour where original preformed sealer was torn and ragged (Sta 248+70).
