APPENDIX A: PHOTOGRAPHS

General Photographs

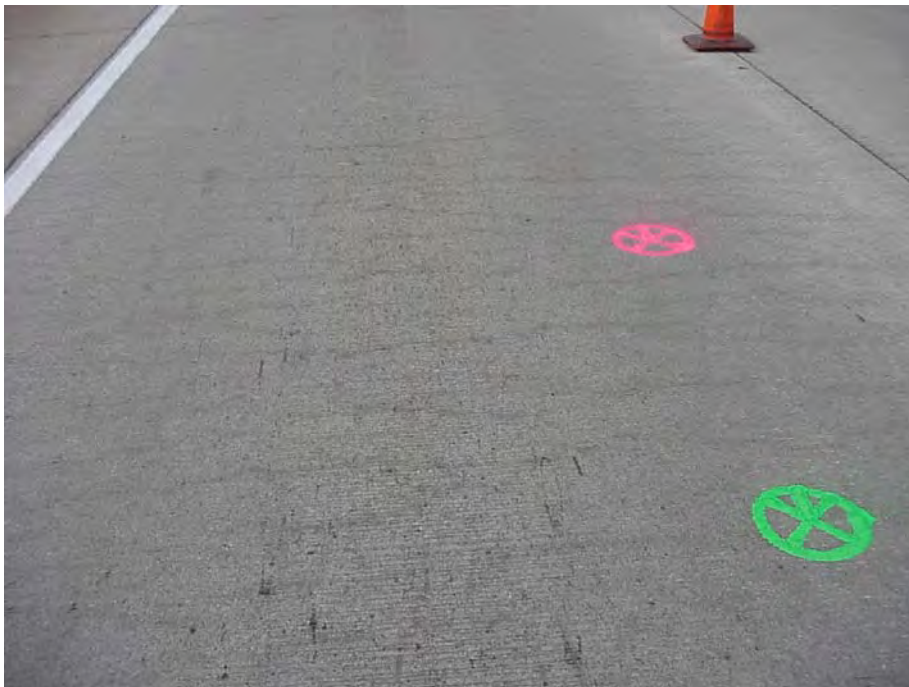
Site 0: US-23 SB, Section A of MDOT Aggregate Study. Four-inch core locations. Note the presence of shrinkage cracking in test slab.

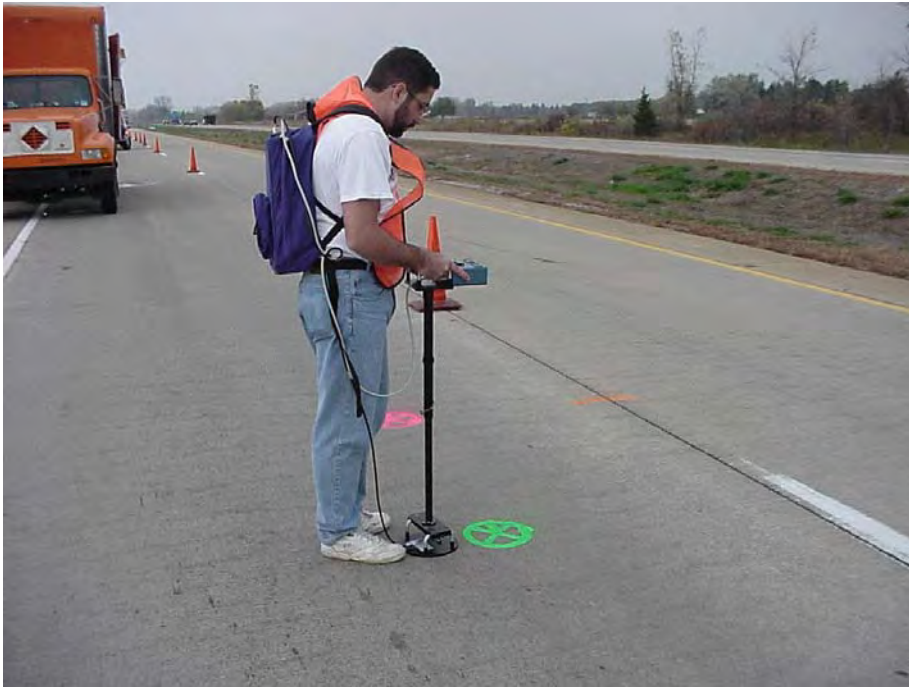
Site 0: US-23 SB, Section A of MDOT Aggregate Study.
Permeability testing using the air permeability field apparatus.

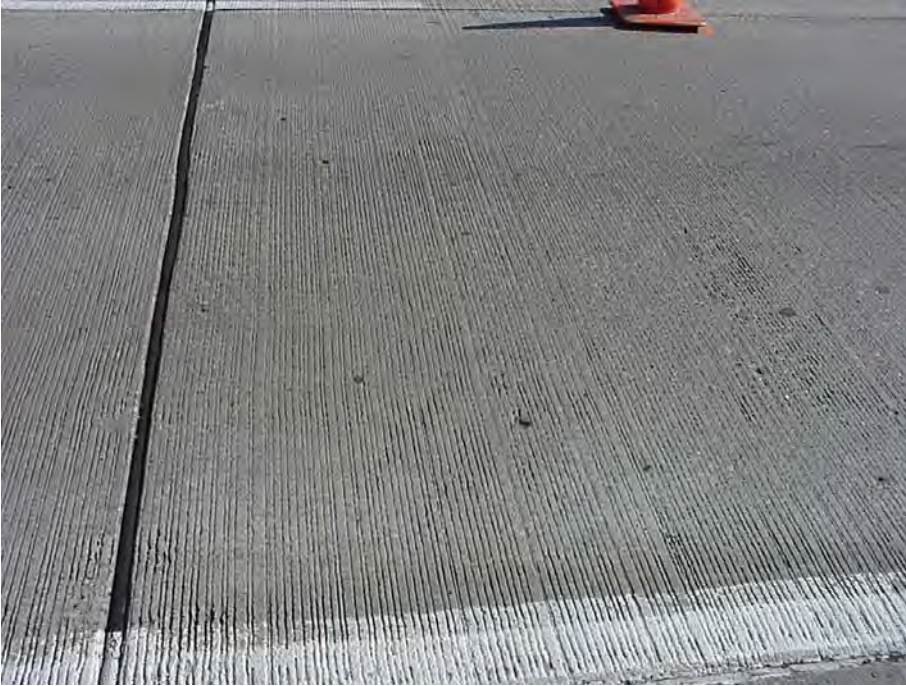
Site 2: US-23 SB, Section C of MDOT Aggregate Study. Surface of outside traveling lane including expansion joint. Note the excellent condition of the joint.

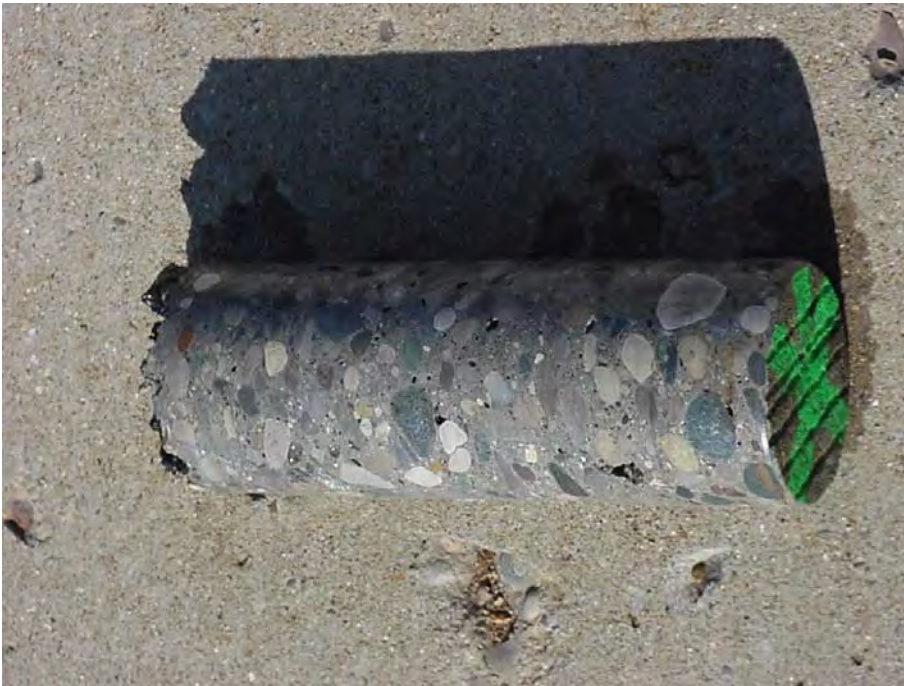
Site 2: US-23 SB, Section C of MDOT Aggregate Study. Four-inch core used for permeability and linear traverse testing.

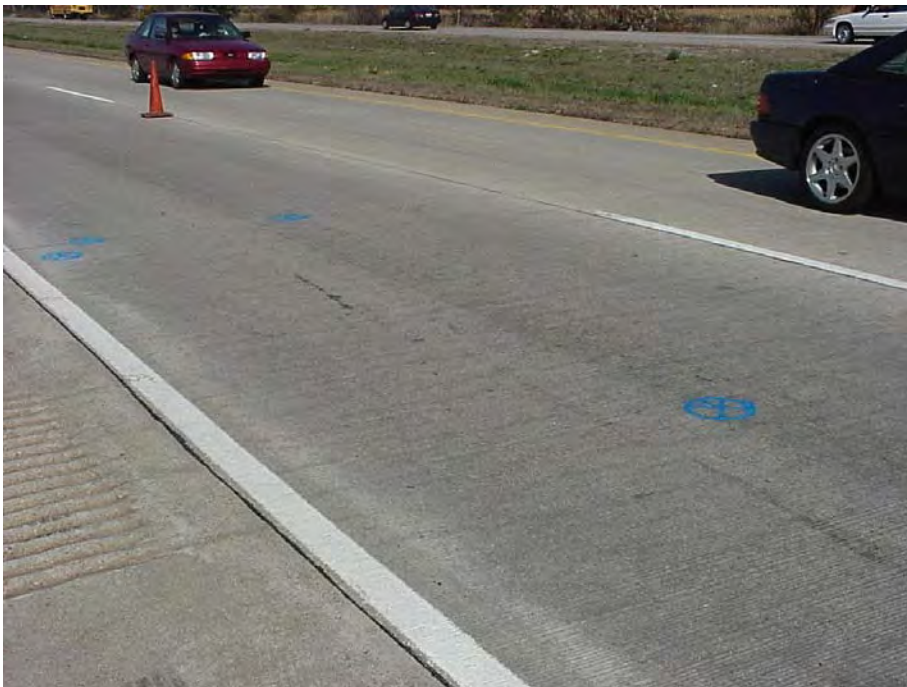
Site 3: US-23 SB, Section D of MDOT Aggregate Study. Surface of traveling lane showing the position of the six-inch cores. Note the shrinkage cracking throughout the site.

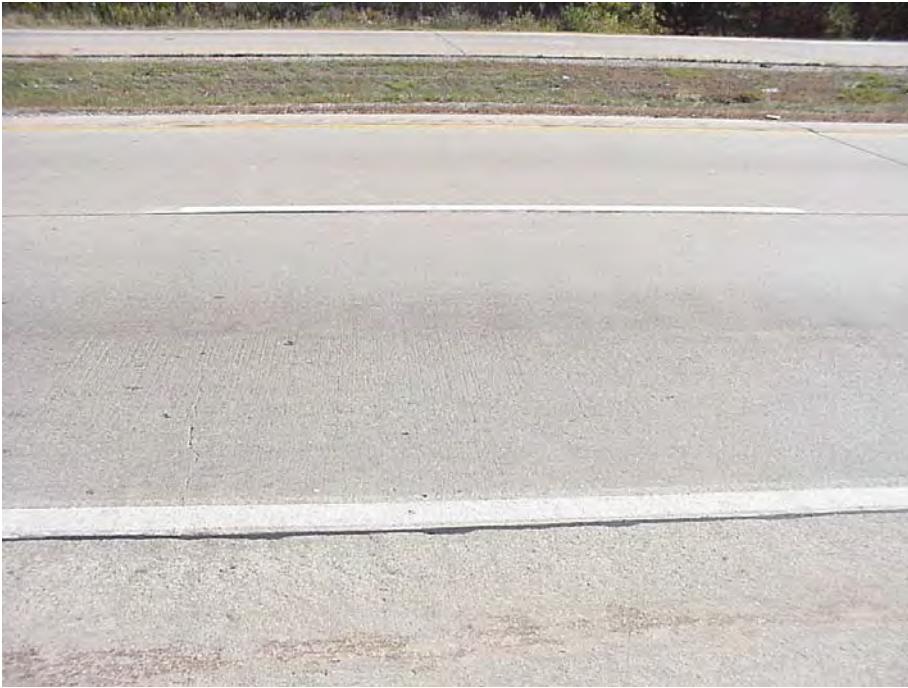
Site 4: US-23 SB, Sta 610+56. Surface of traveling lane showing transverse cracking, map cracking, and popouts.

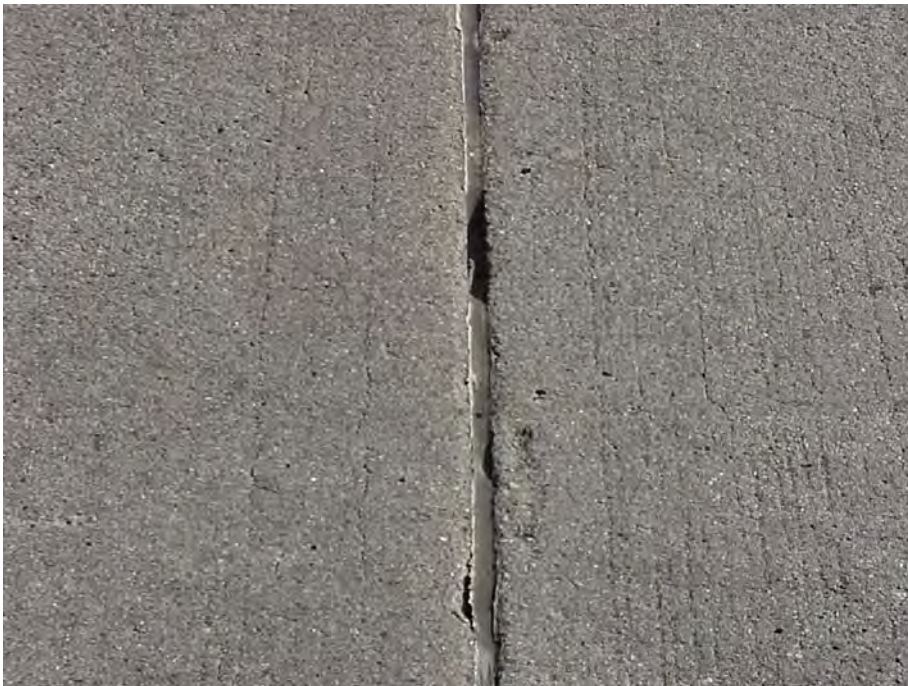
Site 4: US-23 SB, Sta 610+56. Pavement surface and transverse joint. Note the seal of the transverse joint is failing.

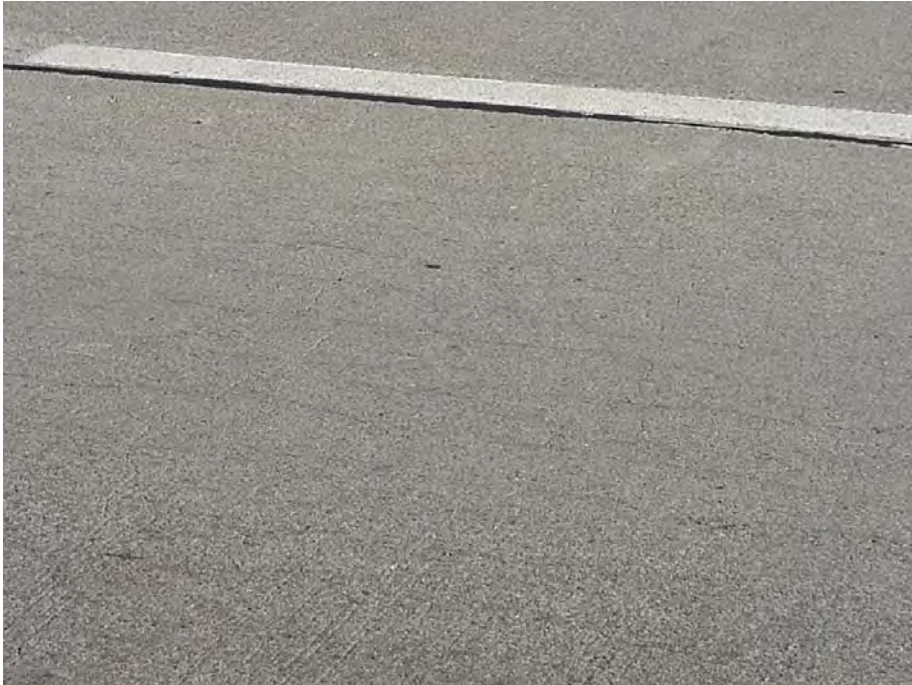
Site 4: US-23 SB, Sta 610+56. Surface of traveling lane showing map cracking.

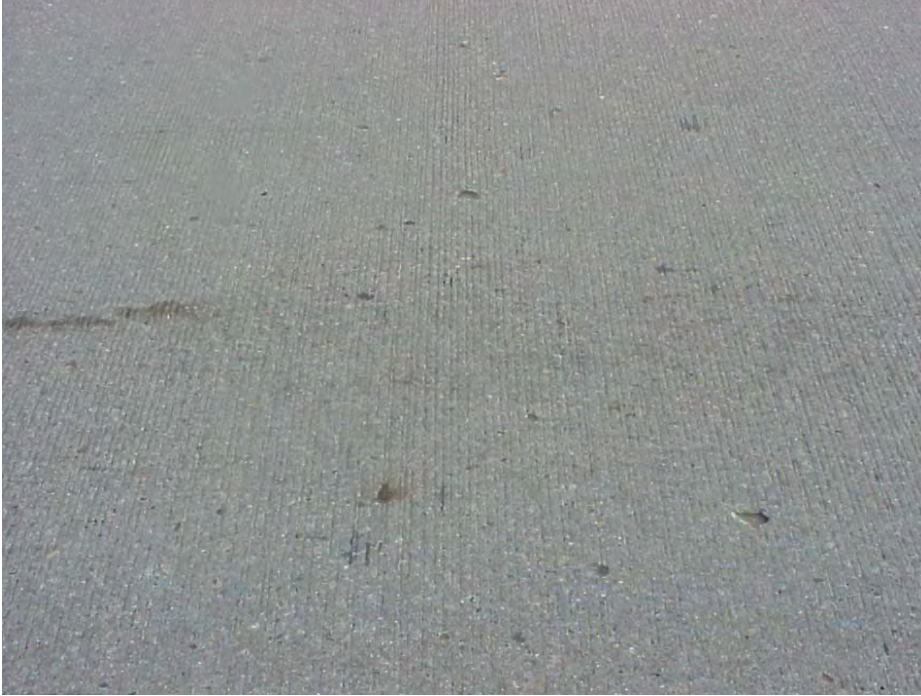
Site 4A: US-23 SB; Starts @ Sta 176+36. Surface of traveling lane-showing Popouts.

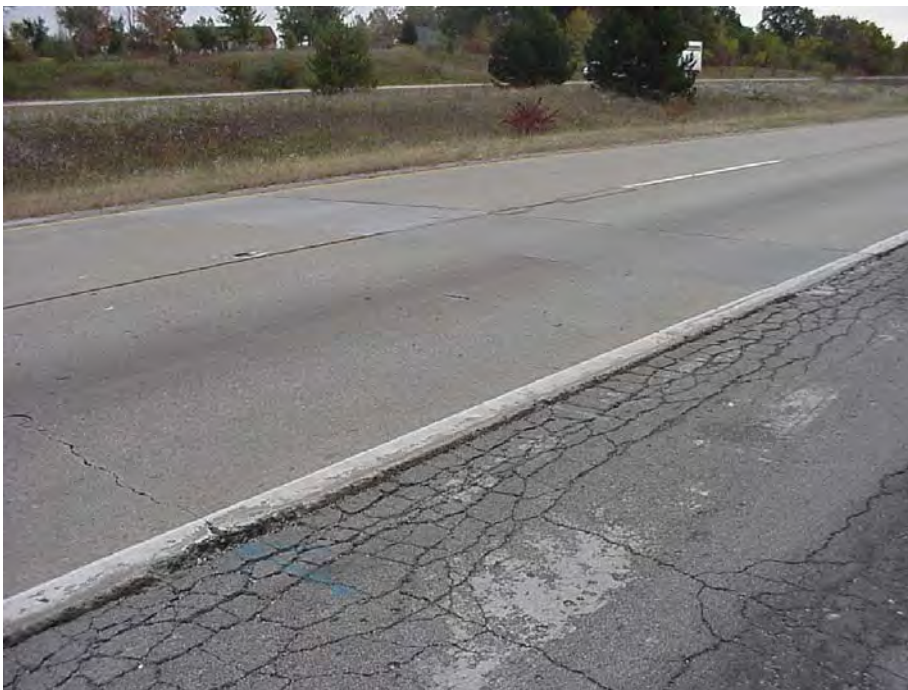
Site 6: I-69 EB, Sta 1534+93. View showing the pavement surface. Note the transverse crack (lower left) and the alligator cracking of the bituminous shoulder.

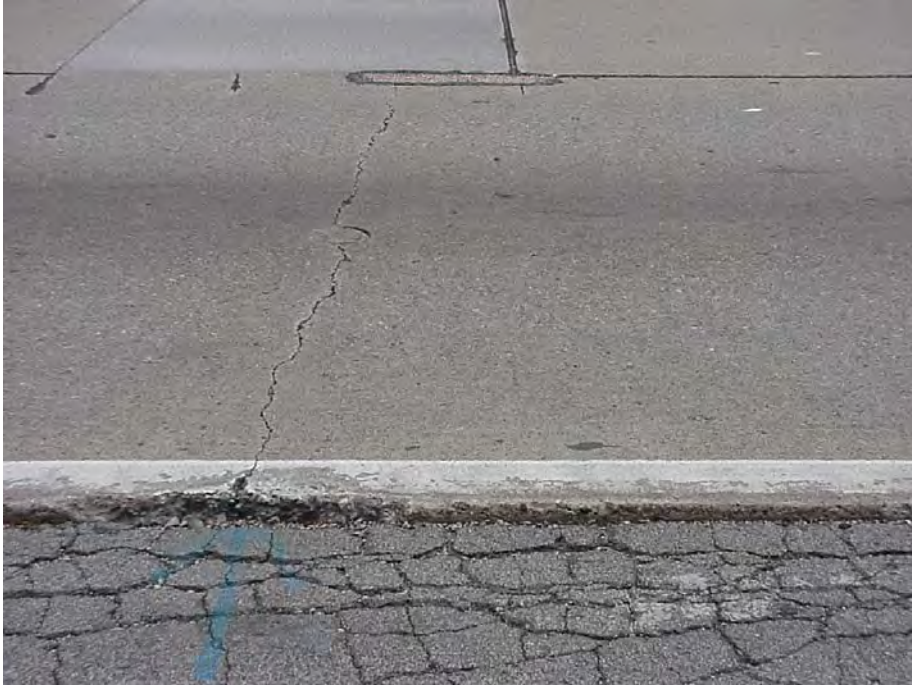
Site 6: I-69 EB, Sta 1534+93. View showing the pavement surface. Note the transverse crack, concrete patch, and the spalling at the lower right edge of the concrete patch.

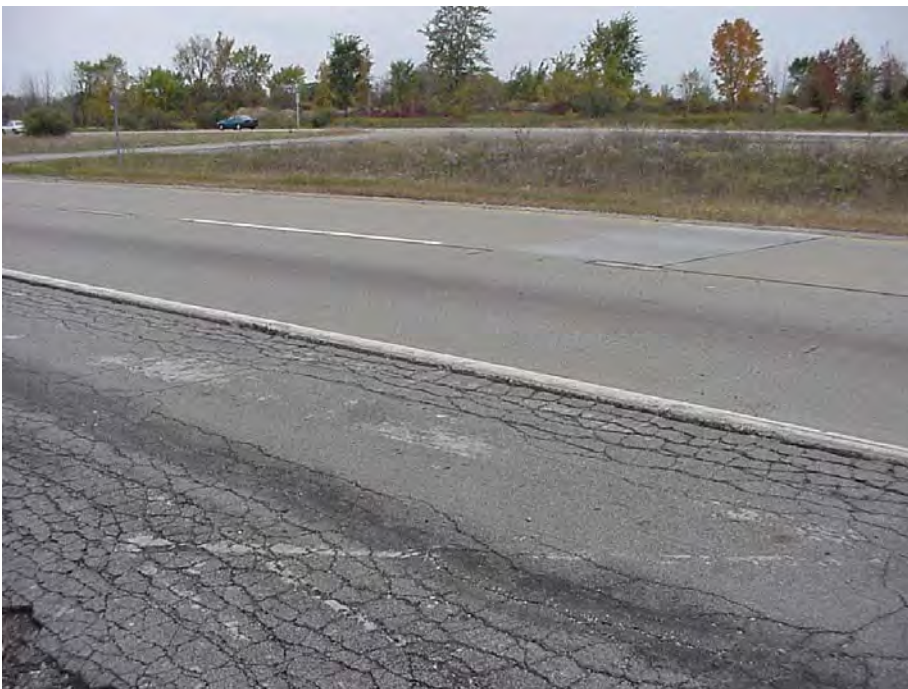
Site 6: I-69 EB, Sta 1534+93. View showing the pavement surface. Note the vertical separation between the traveling lane and the bituminous shoulder.

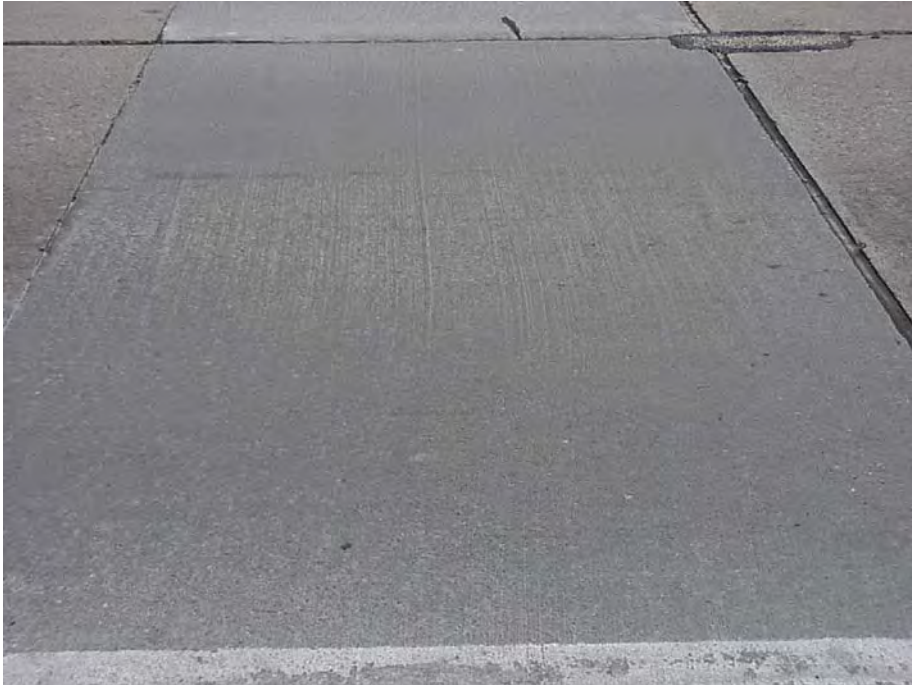
Site 6: I-69 EB, Sta 1534+93. View showing a concrete patch. Note the expansion joint on the right side of the patch and the spalling at the upper right corner.

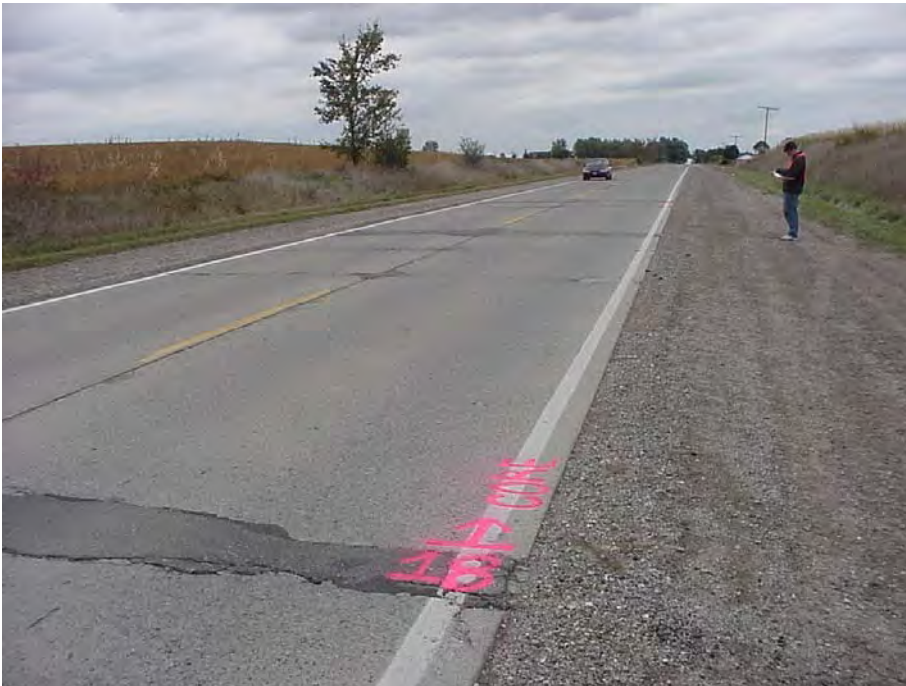
Site 14: M-81 EB. View showing the pavement surface, gravel shoulder and several joint repair patches.

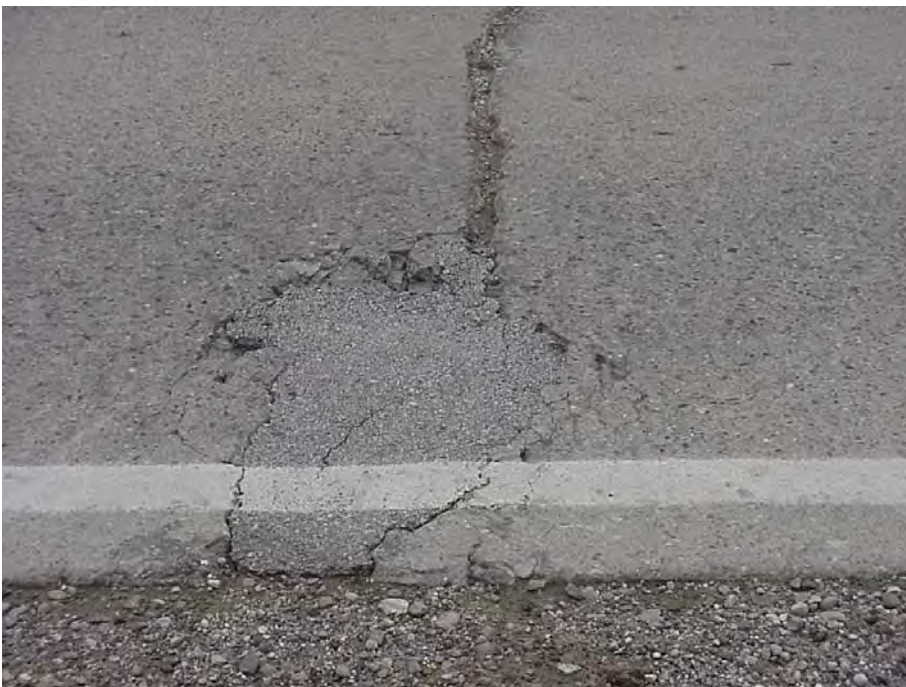
Site 14: M-81 EB. View showing spalling at the end of a transverse crack.

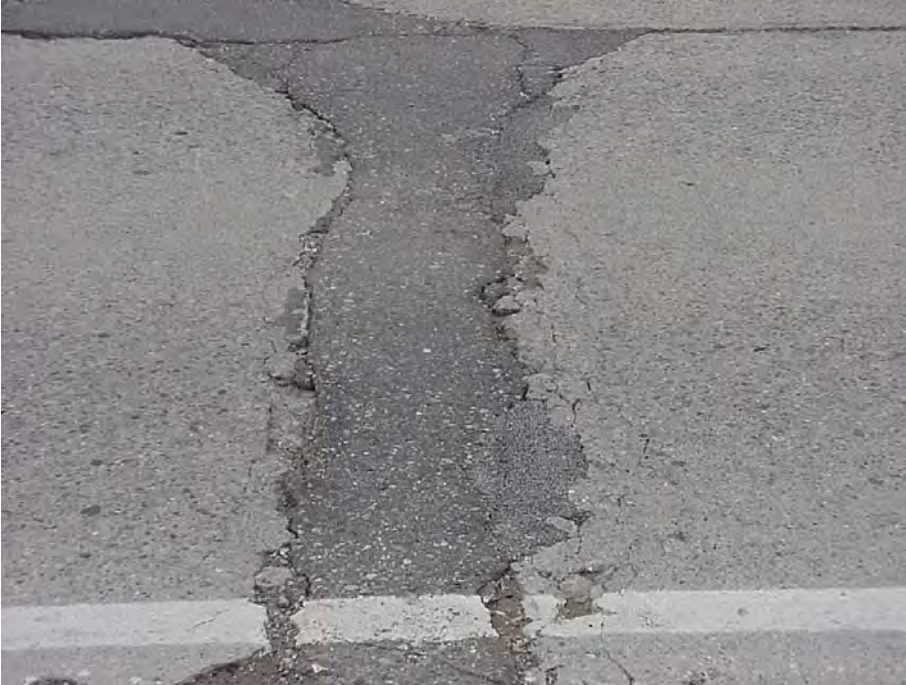
Site 14: M-81 EB. View showing spalling along a severe transverse crack.

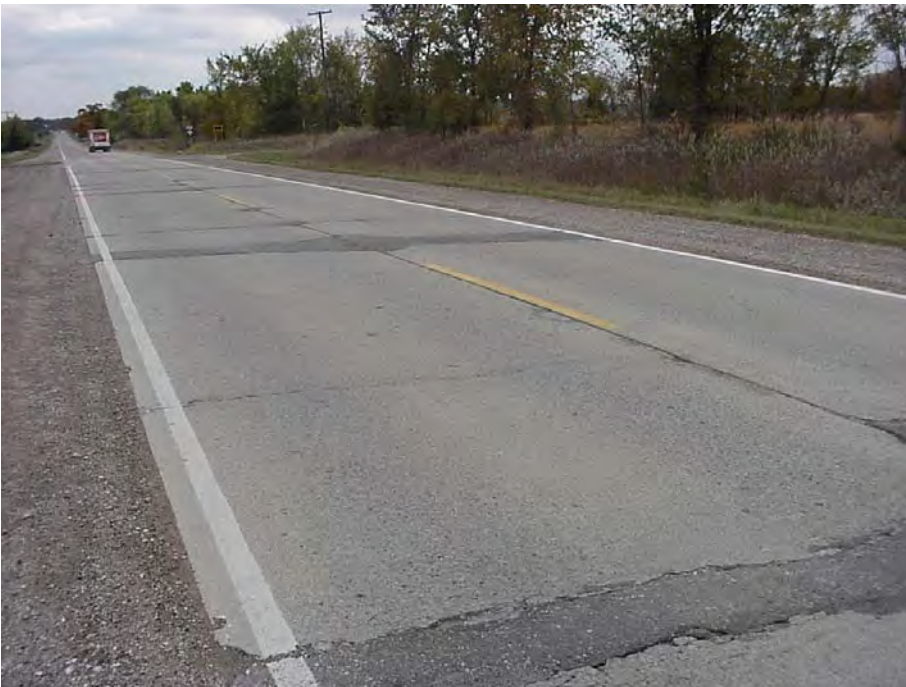
Site 14: M-81 EB. View showing the pavement surface, gravel shoulder, transverse cracks and several joint repair patches.

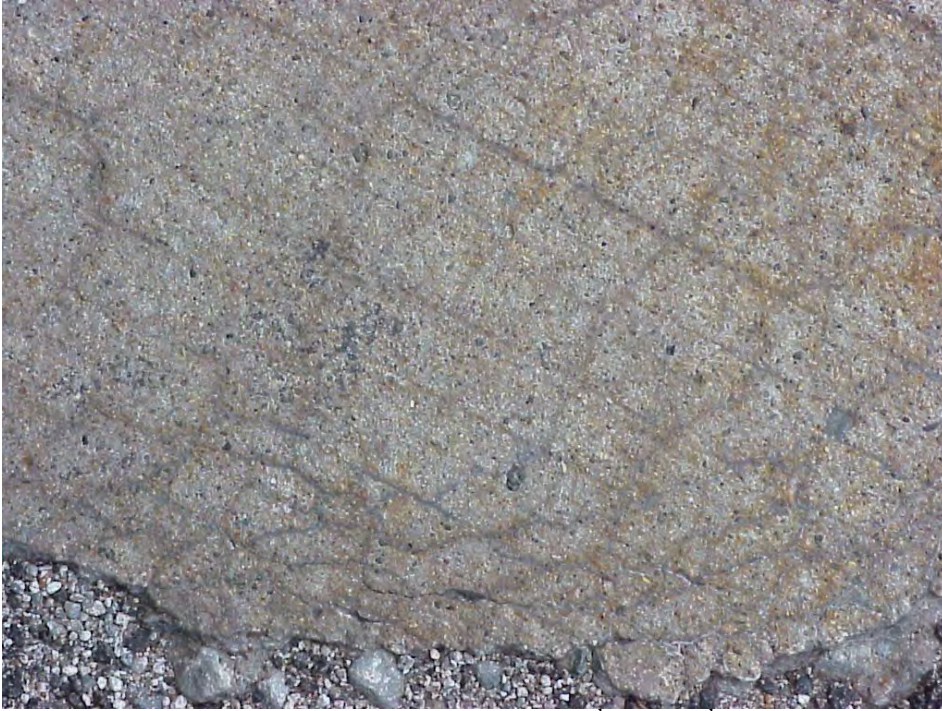
Site 19: M-53 NB @Station 520. Between 17th and 18th Mile road, view showing the cracking pattern near a transverse joint.

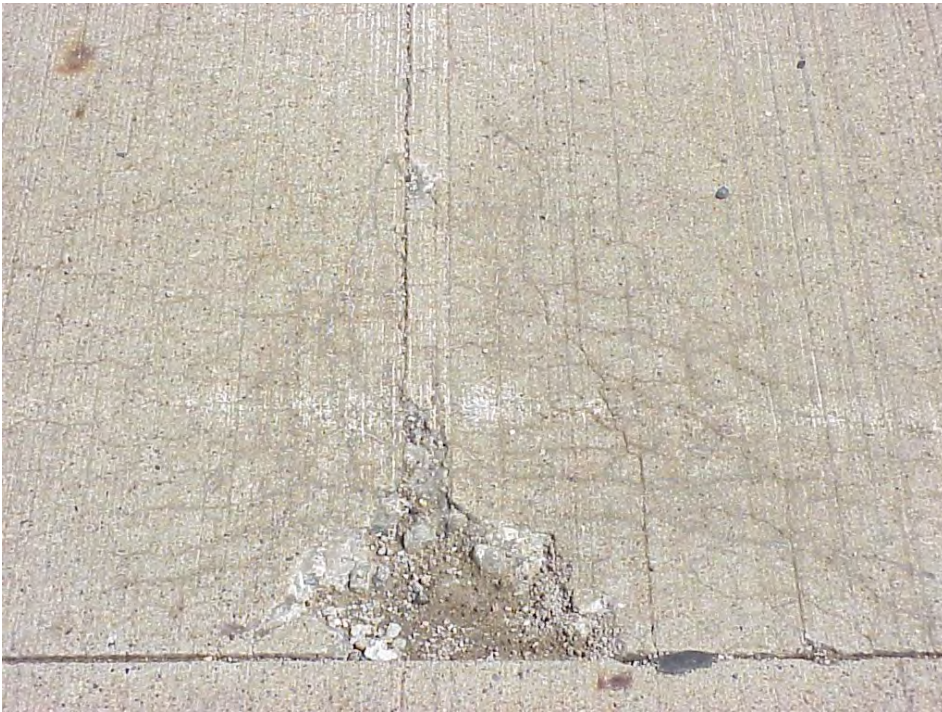
Site 19: M-53 NB @Station 520. Between 17th and 18th Mile road, view showing the cracking pattern near a transverse joint.

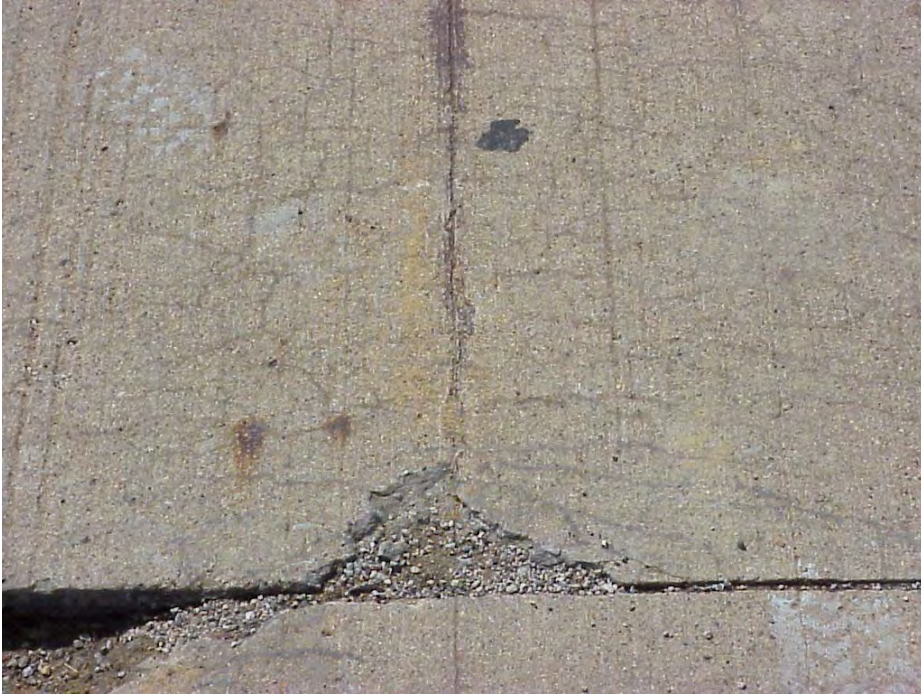
Site 19: M-53 NB @Station 520. Between 17th and 18th Mile road, view showing the cracking pattern near a transverse joint.

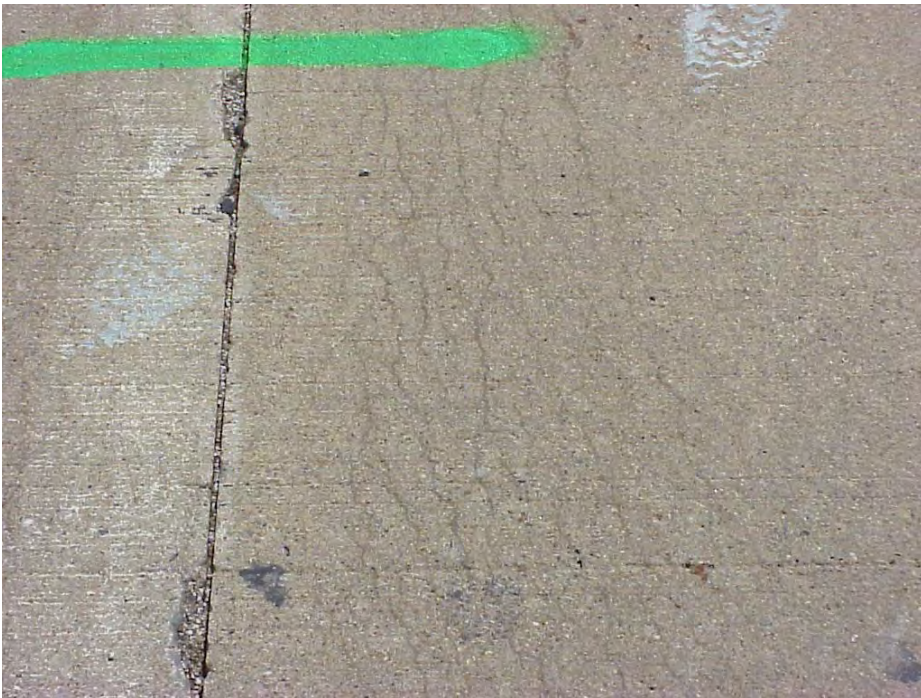
Site 19: M-53 NB @Station 520. Between 17th and 18th Mile road, view showing the cracking pattern near a transverse joint

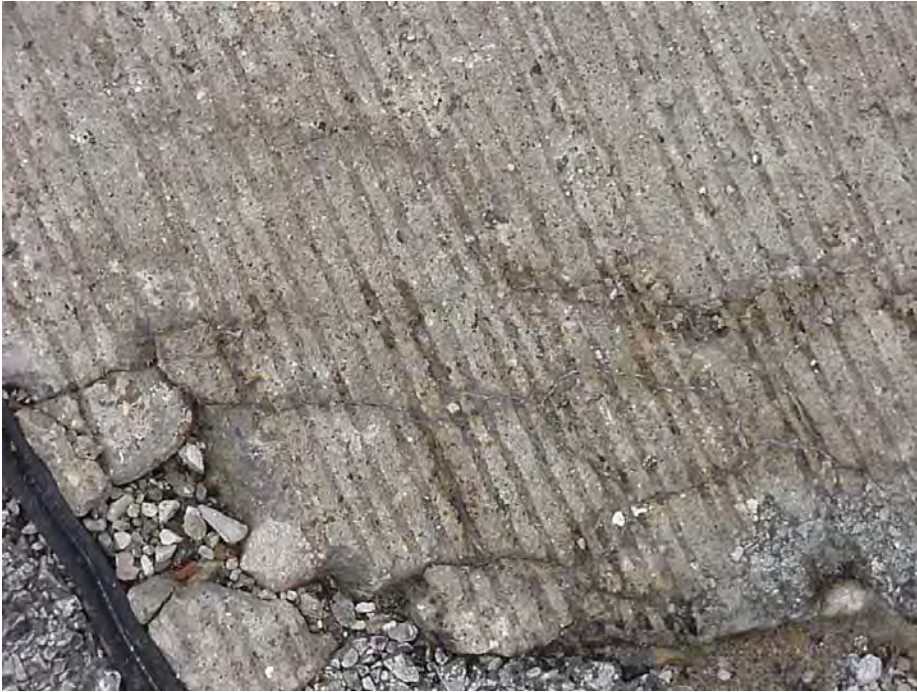
Site 26A: US-10 WB, Sta 137+08. View showing the cracking pattern pavement surface and loose particles.

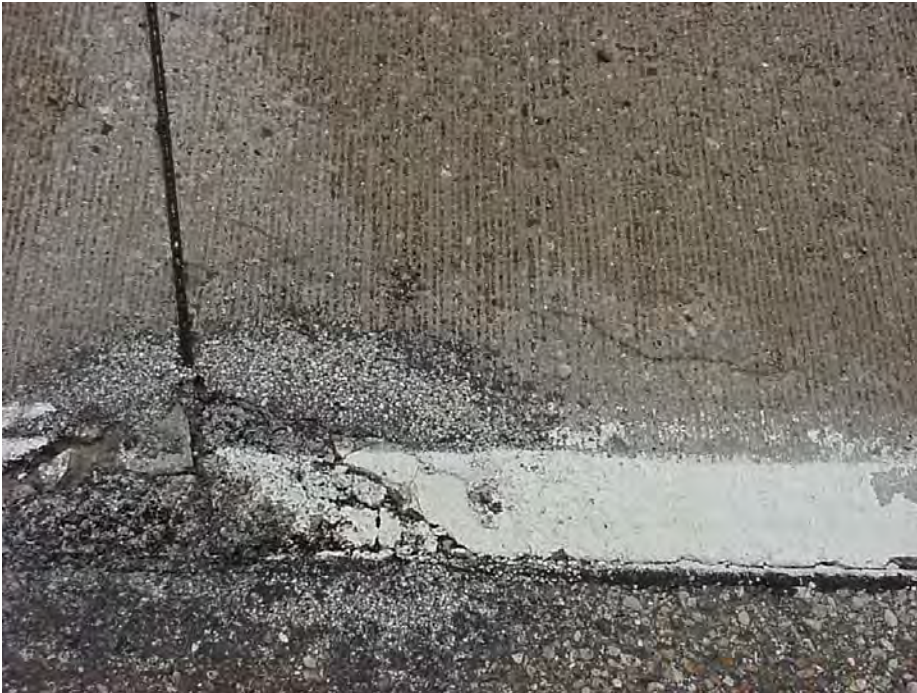
Site 26A: US-10 WB, Sta 137+08. View showing the popouts, cracking pattern and spalling on the pavement. The spalling has already been patched with asphalt.

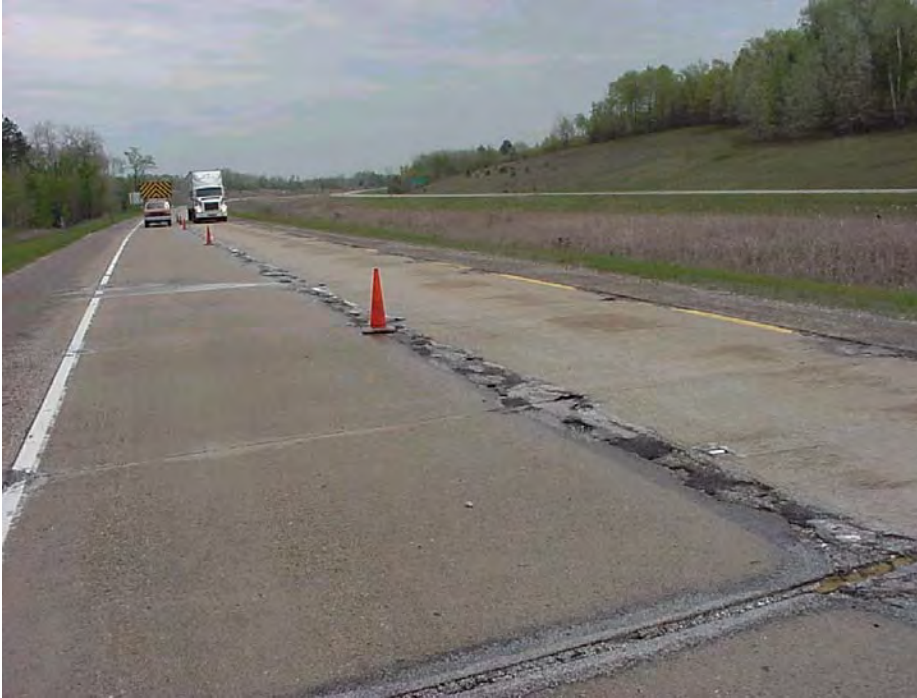
Site 26A: US-10 WB, Sta 137+08. View showing the spalling along the longitudinal joint which has been patched by asphalt. Lower right corner shows a view of expansion joint.

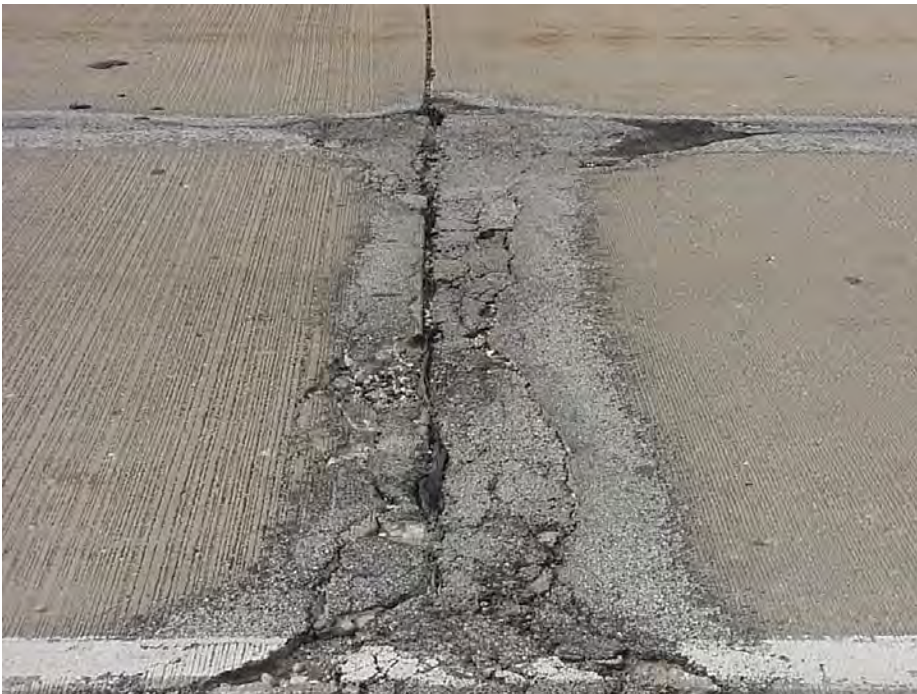
Site 26A: US-10 WB, Sta 137+08. View showing the transverse joint completely spalled and patched with asphalt.

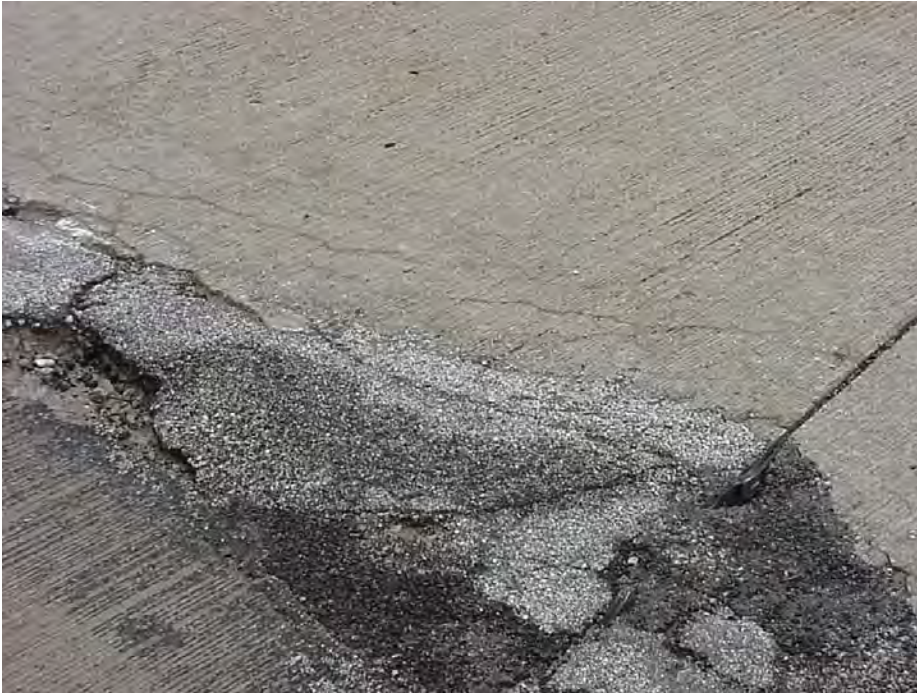
Site 26B: US-10 WB, Sta 137+08. View showing the cracking pattern pavement surface and completely spalled longitudinal joint.

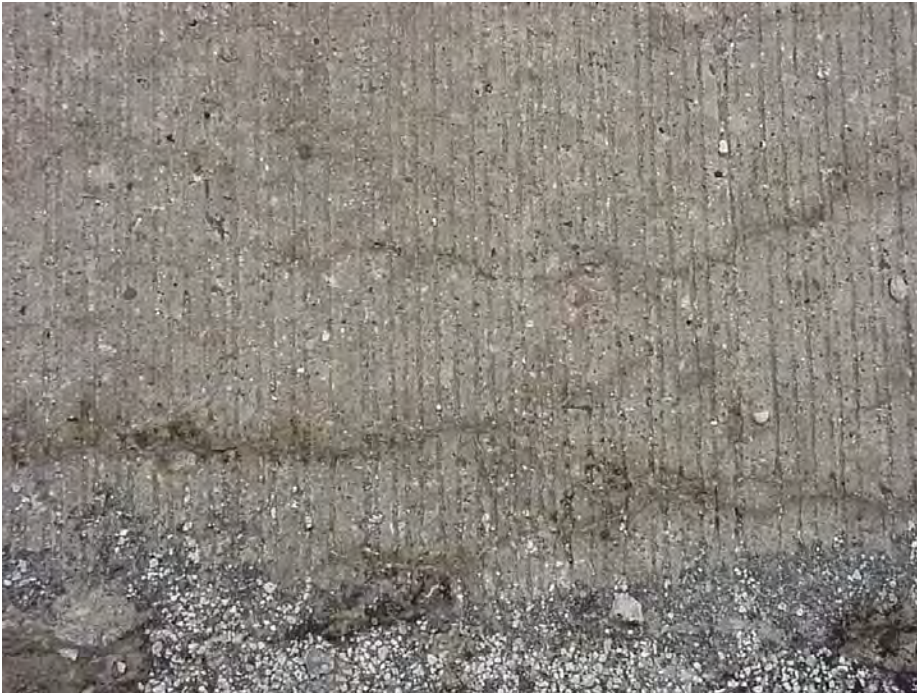
Site 26B: US-10 WB, Sta 137+08. View showing the popouts, cracking pattern and loose particles.

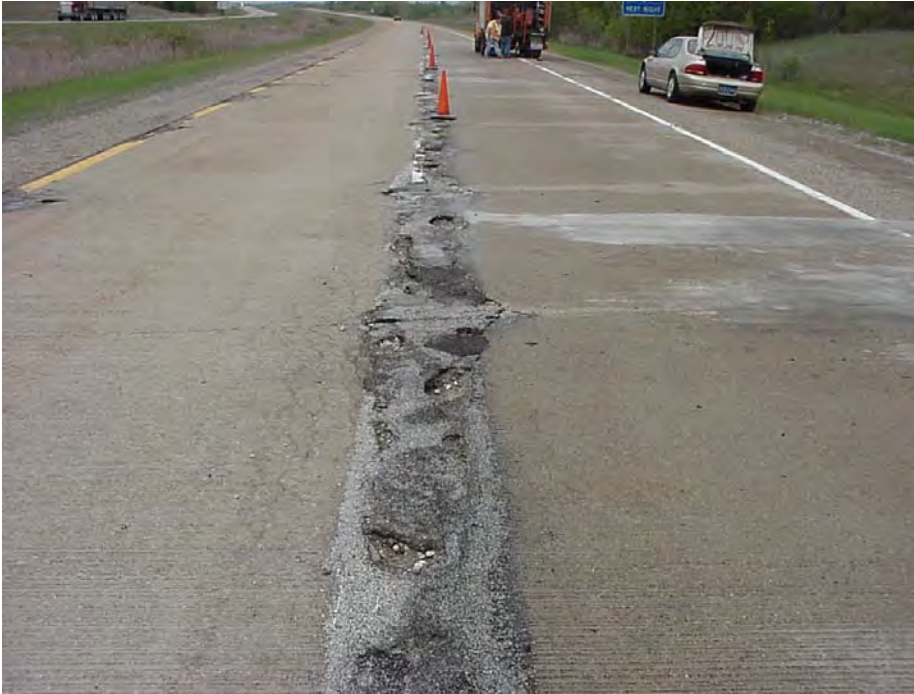
Site 26B: US-10 WB, Sta 137+08. View showing spalling along the longitudinal joint which has been patched by asphalt.

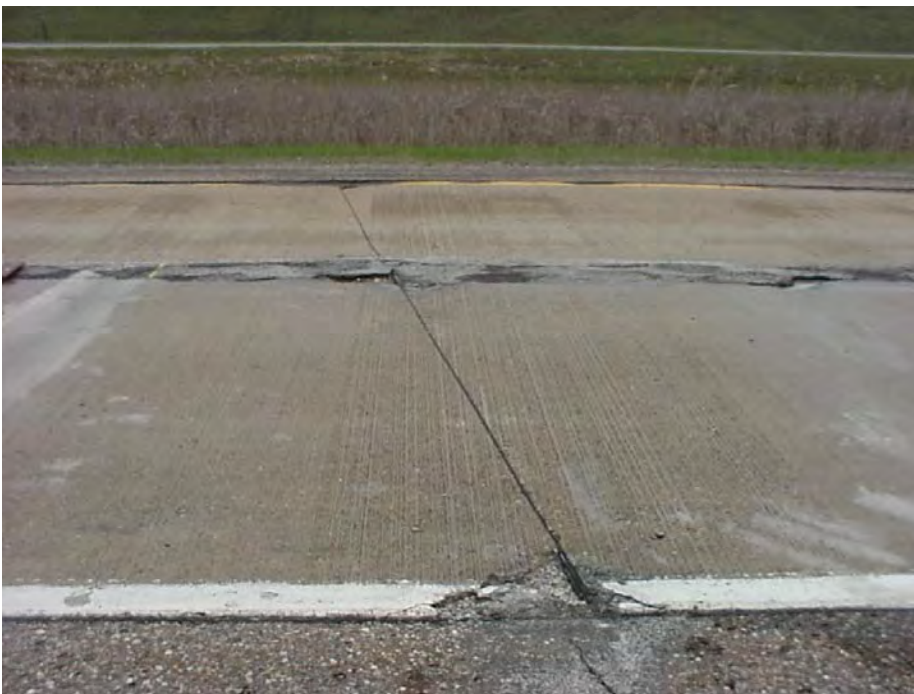
Site 26B: US-10 WB, Sta 137+08. View showing the skewed joint. Also showing spalling at the corners of joint.

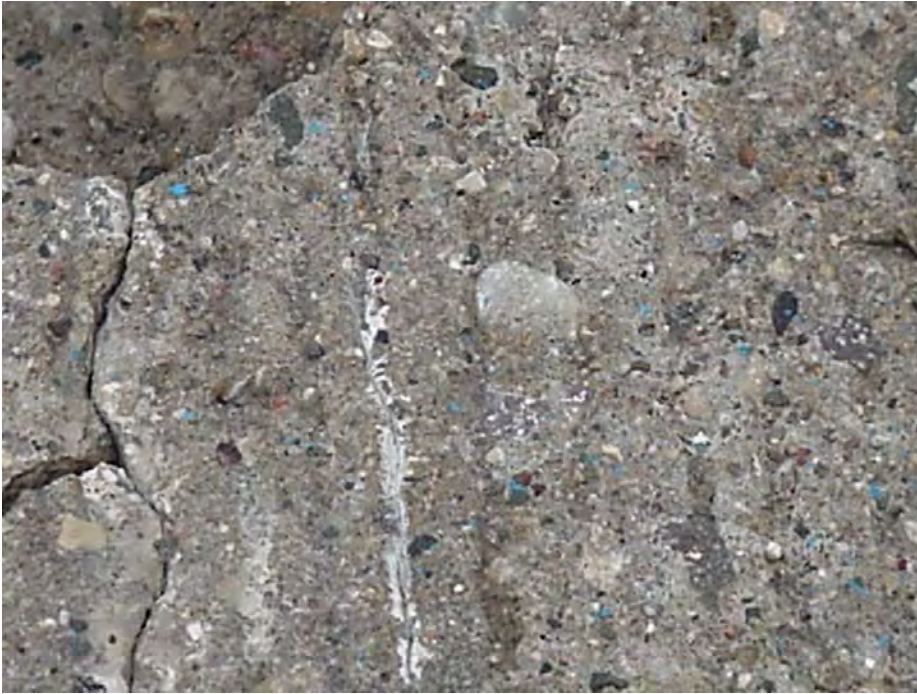
Site 27: US-10 WB, Sta 114+00. View showing the cracking pattern on pavement surface with breakup of the pavement.

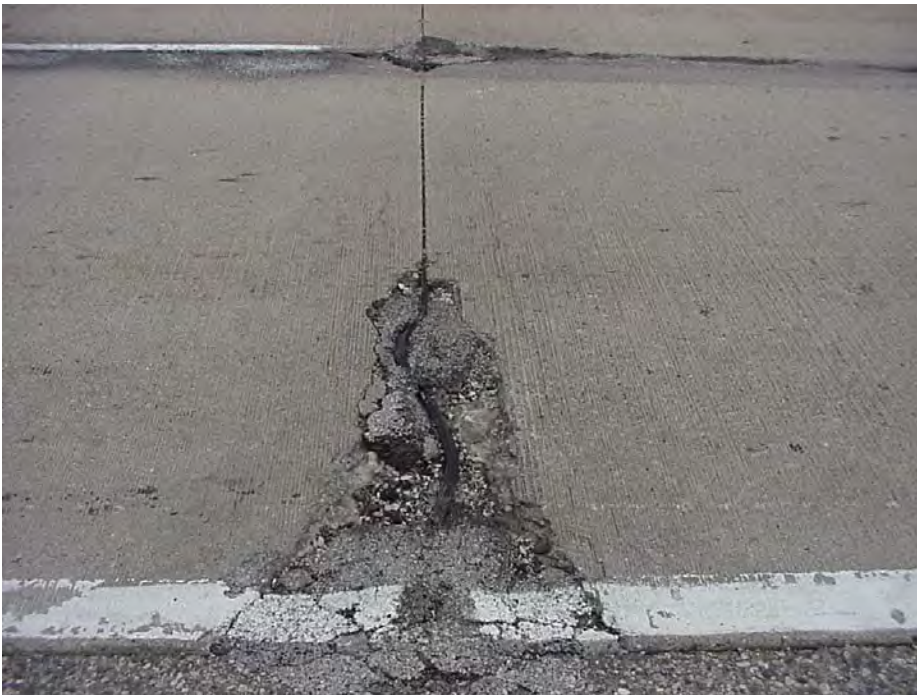
Site 27: US-10 WB, Sta 114+00. View showing the Popouts, cracking pattern and spalled transverse joint.

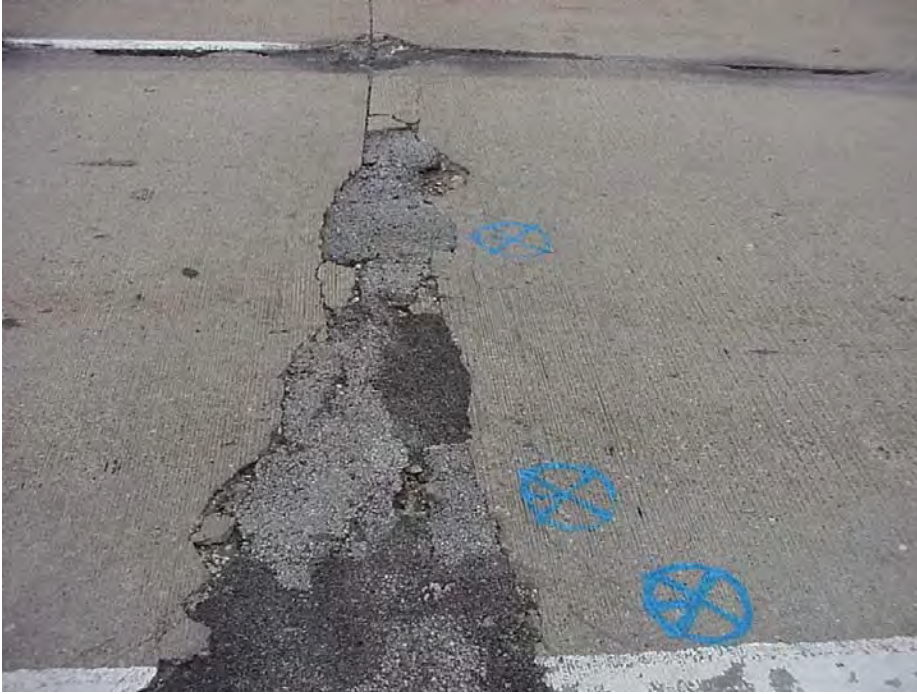
Site 27: US-10 WB, Sta 114+00. View showing spalling along the transverse joint and coring locations for petrographic analysis.

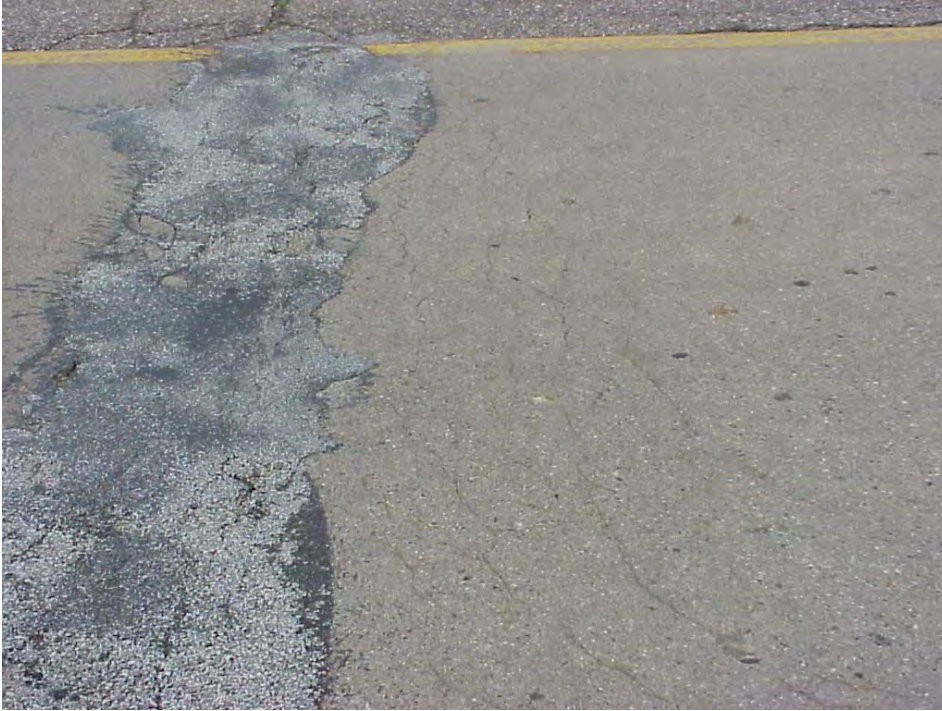
Site 28: US-27 SB Starts @ Station 519+07, View showing the cracking pattern along the poorly done asphalt patching.

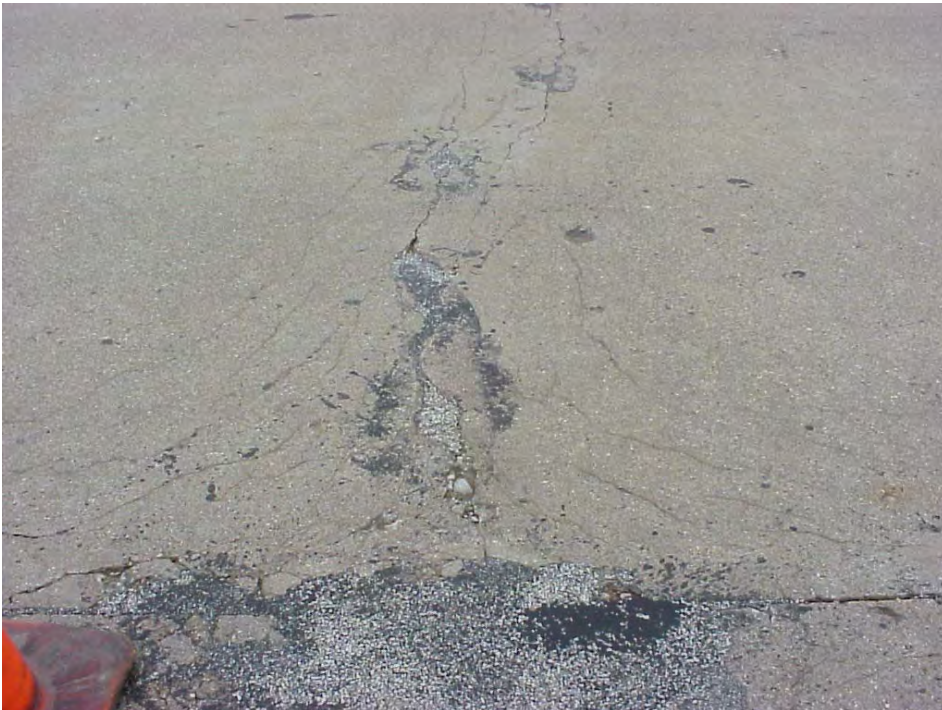
Site 28: US-27 SB Starts @ Station 519+07, View showing the cracking pattern along the transverse cracking.
