APPENDIX A: PHOTOGRAPHS

General Photographs

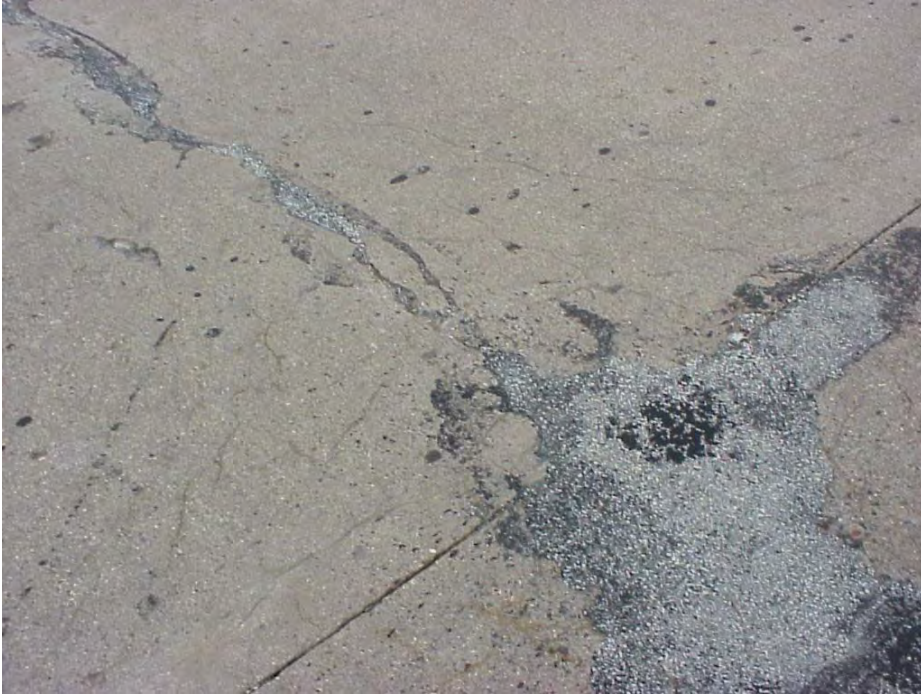
Site 28: US-27 SB Starts @ Station 519+07, View showing the cracking pattern near the longitudinal joint.

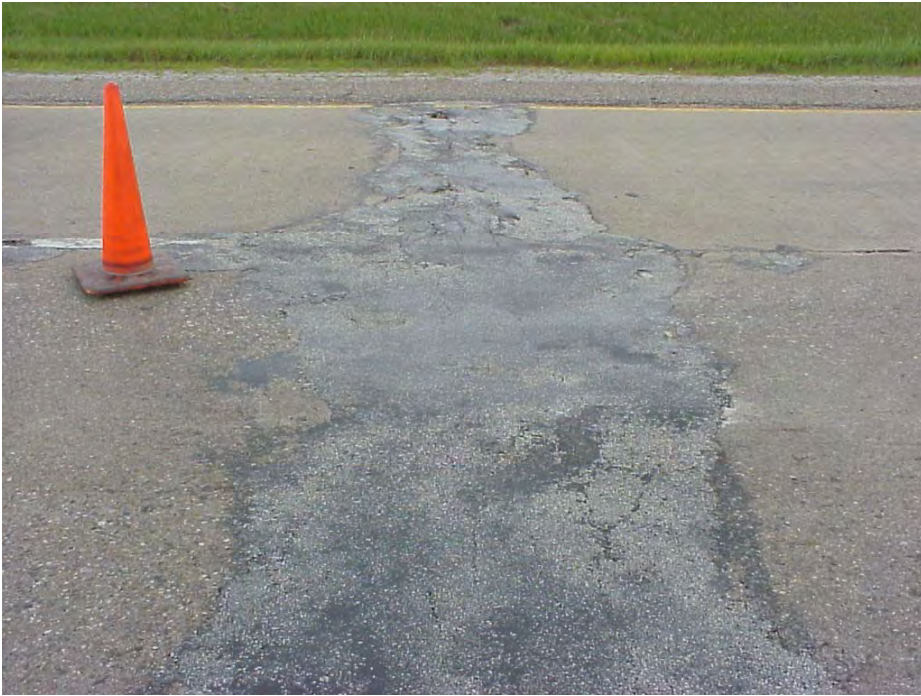
Site 28: US-27 SB Starts @ Station 519+07, View showing the asphalt patching done on transverse joint.

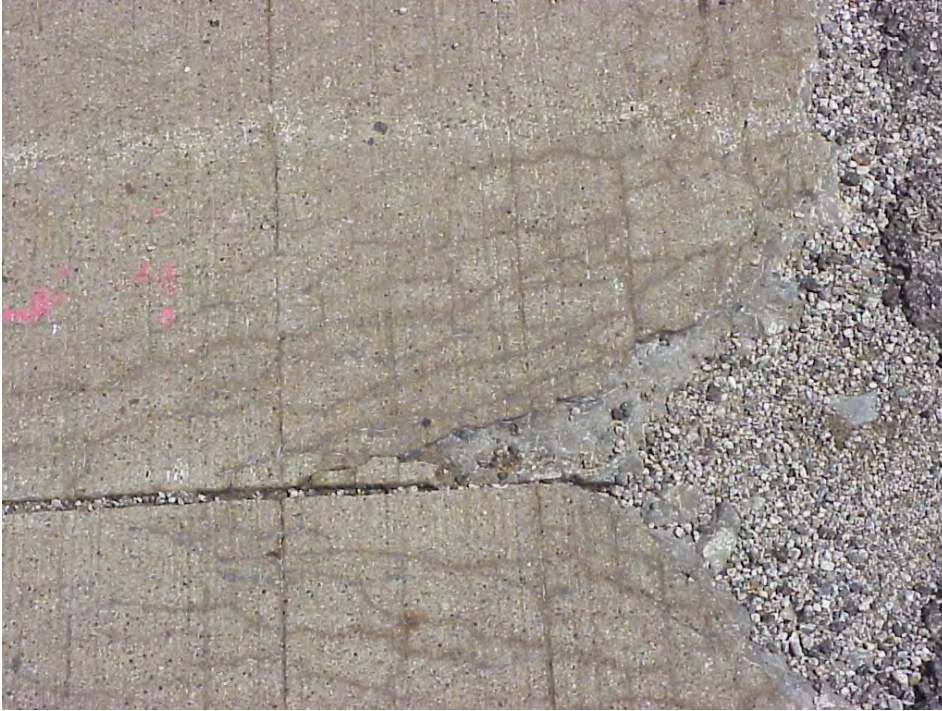
Site 29: I-275 SB, View showing the cracking pattern pavement with white staining coming out of the cracks. Also showing poorly done asphalt patching.

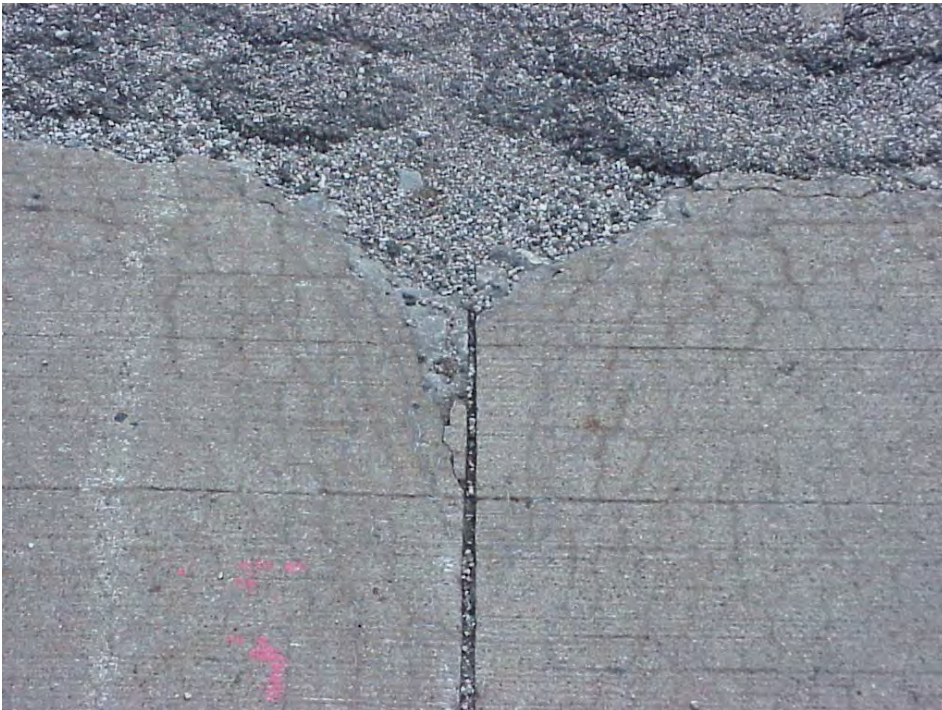
Site 29: I-275 SB, View showing the cracking pattern and asphalt patching at the transverse joint.

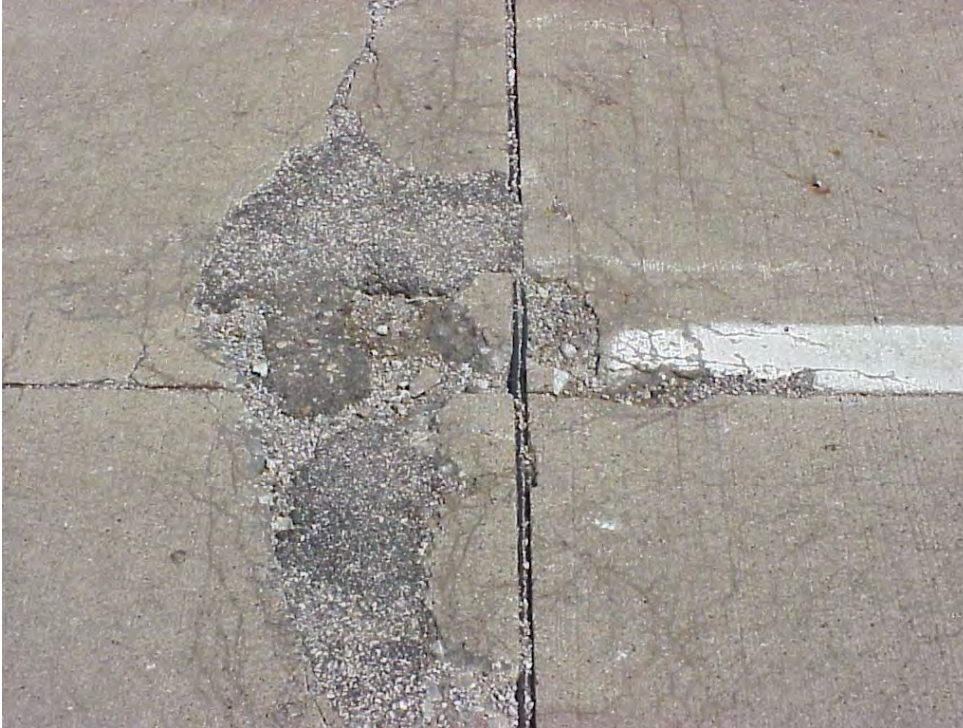
Site 29: I-275 SB, View showing asphalt patching along the transverse joint and also the cracking pattern.

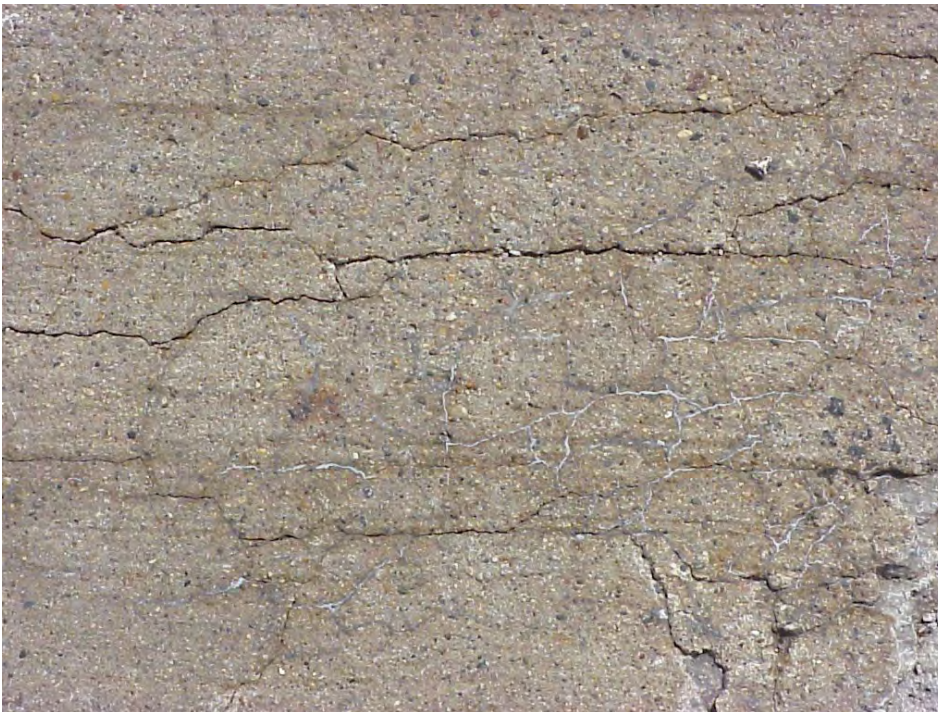
Site 29: I-275 SB, View showing cracking pattern with white exudate coming out of the cracks.

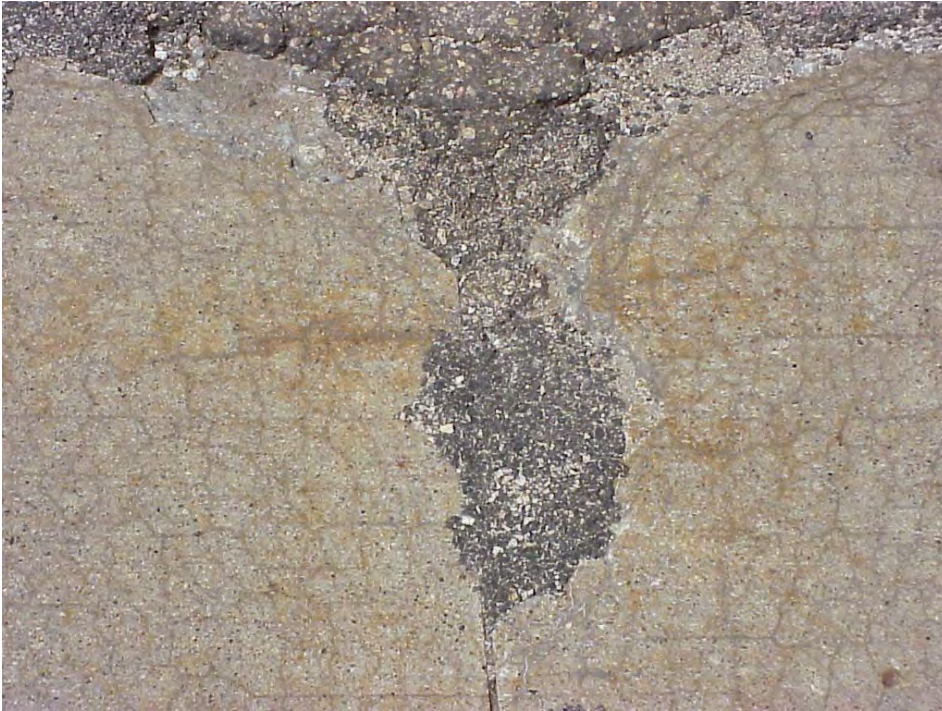
Site 29: I-275 SB, View showing the cracking pattern near the asphalt patching.

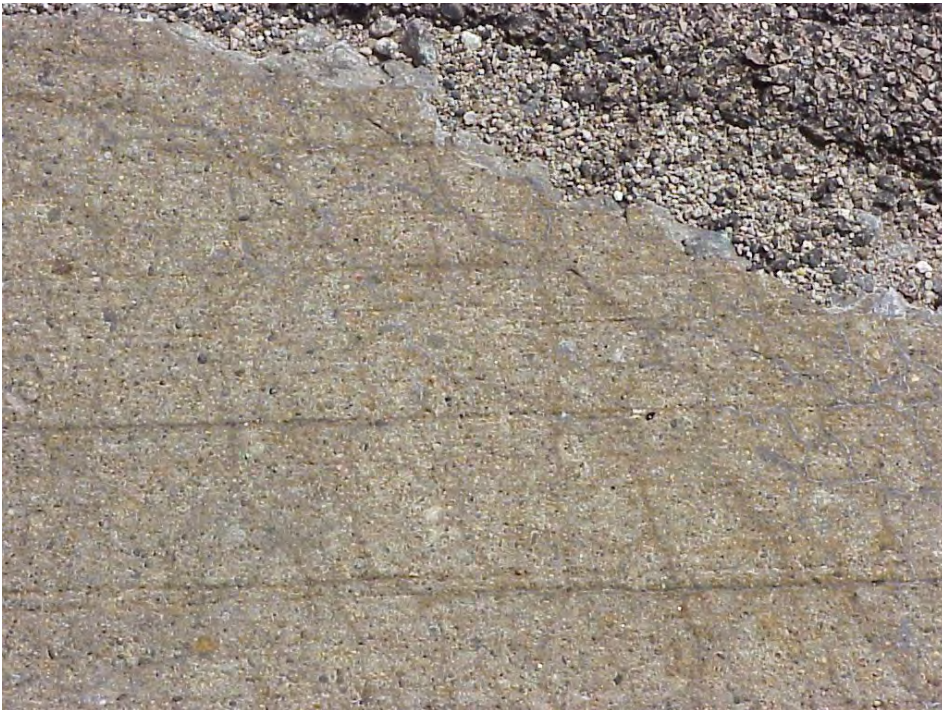
Site 29: I-275 SB, View showing the cracking pattern with white exudate coming out of the cracks (right side of the picture).

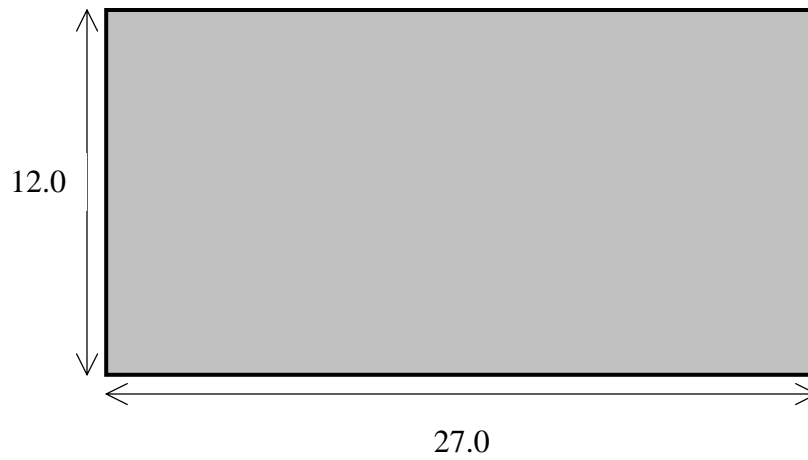
COMMENTS: Shrinkage cracking typically 6-8" apart and very tight, predominantly transverse; No Popouts.

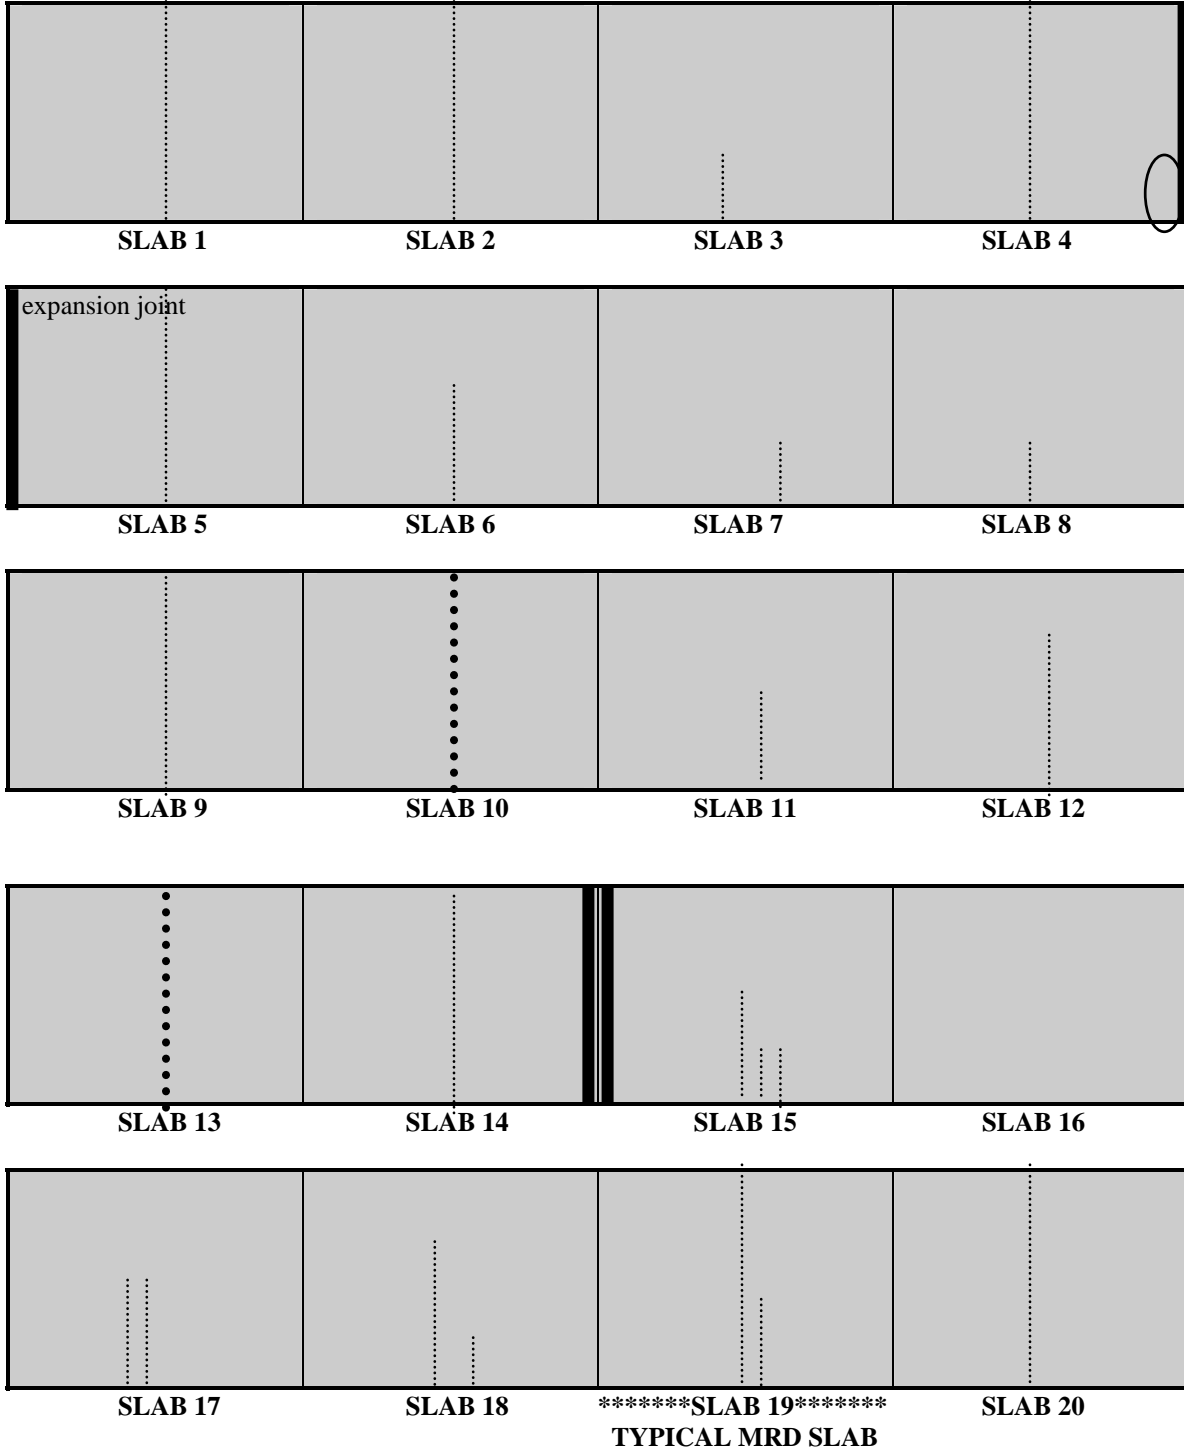
KEY: Transverse Cracking

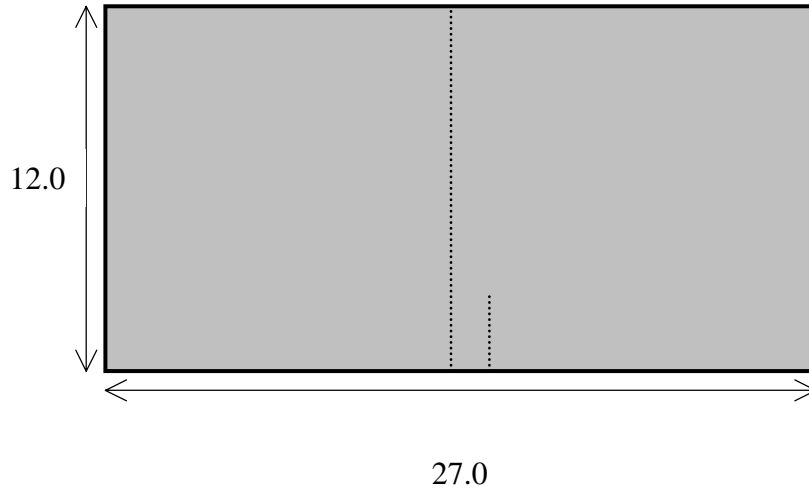
COMMENTS: A slight amount of staining on Crack 2

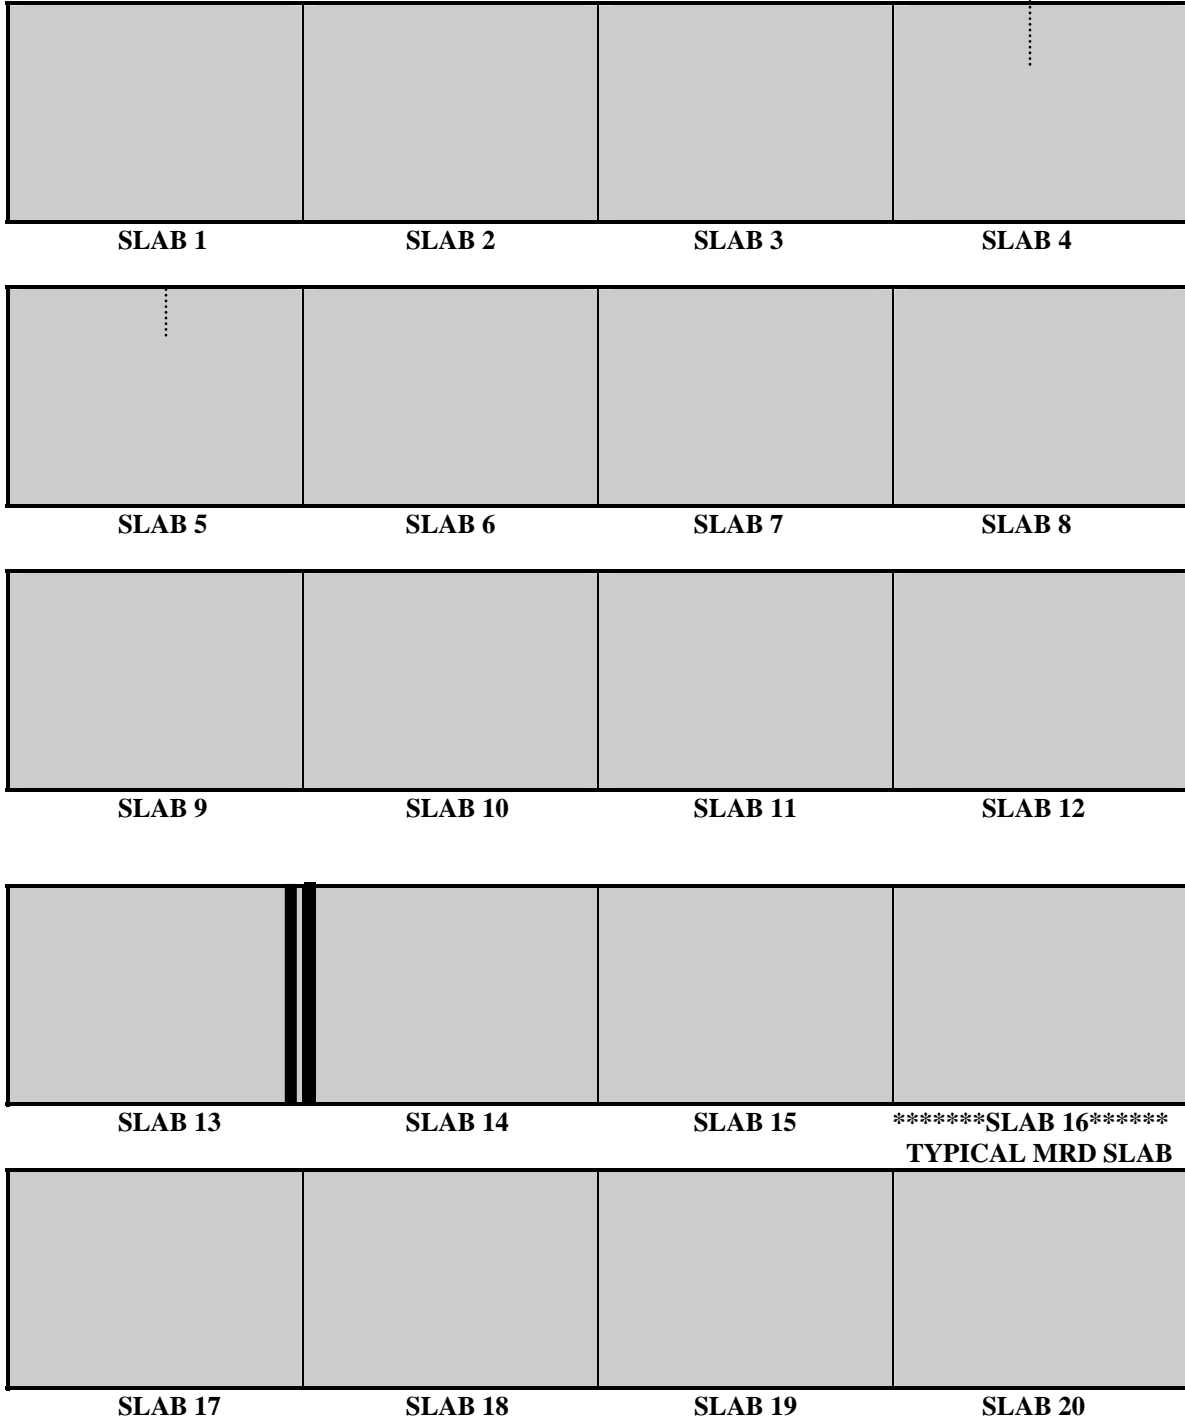
KEY: Transverse Cracking

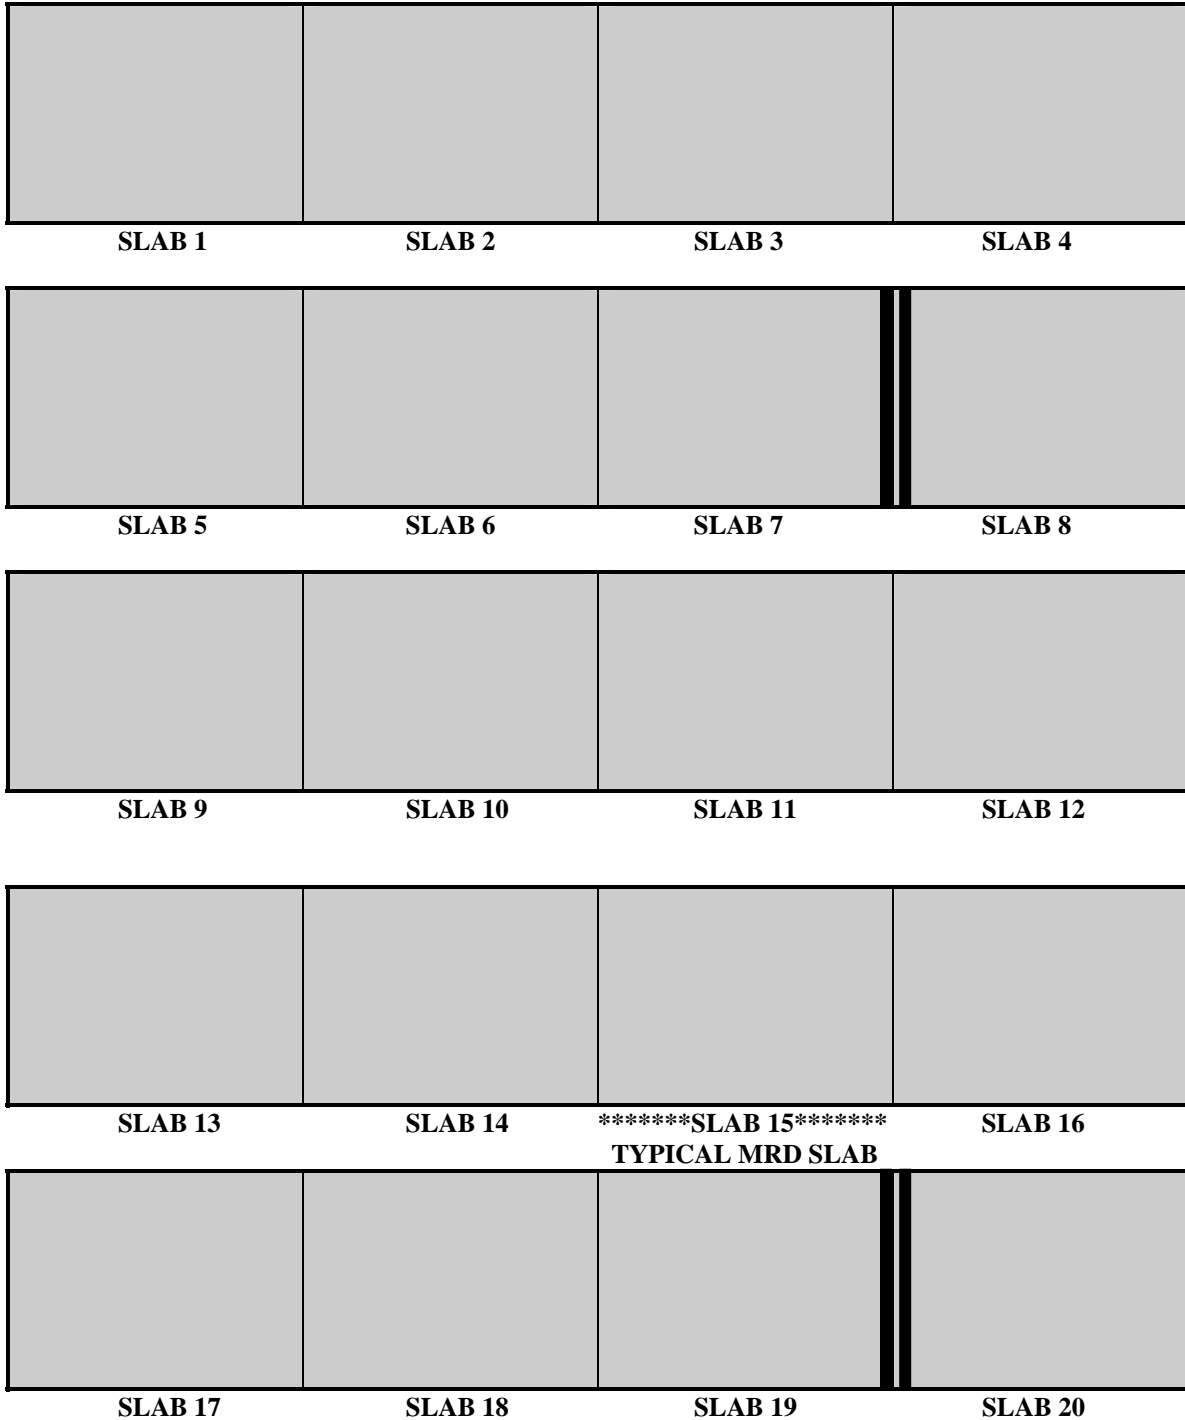
KEY: Transverse Cracking

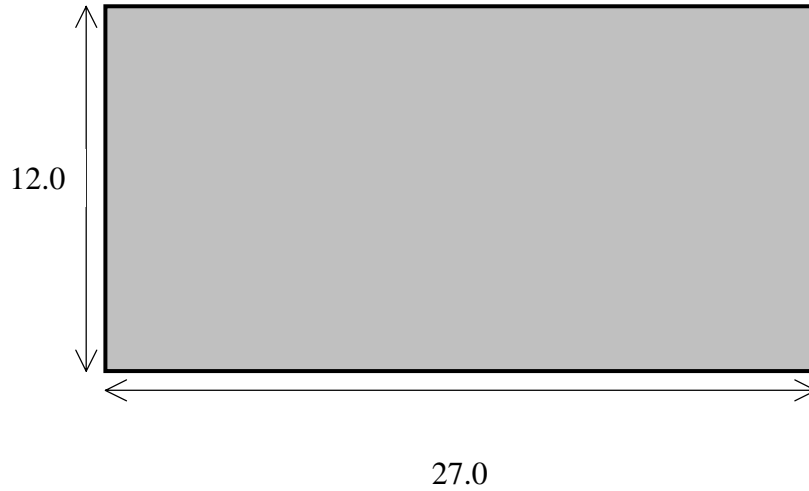
COMMENTS: Shrinkage cracking typically 6-8" apart and very tight, predominantly transverse;
Popouts: ~ 1 per m²

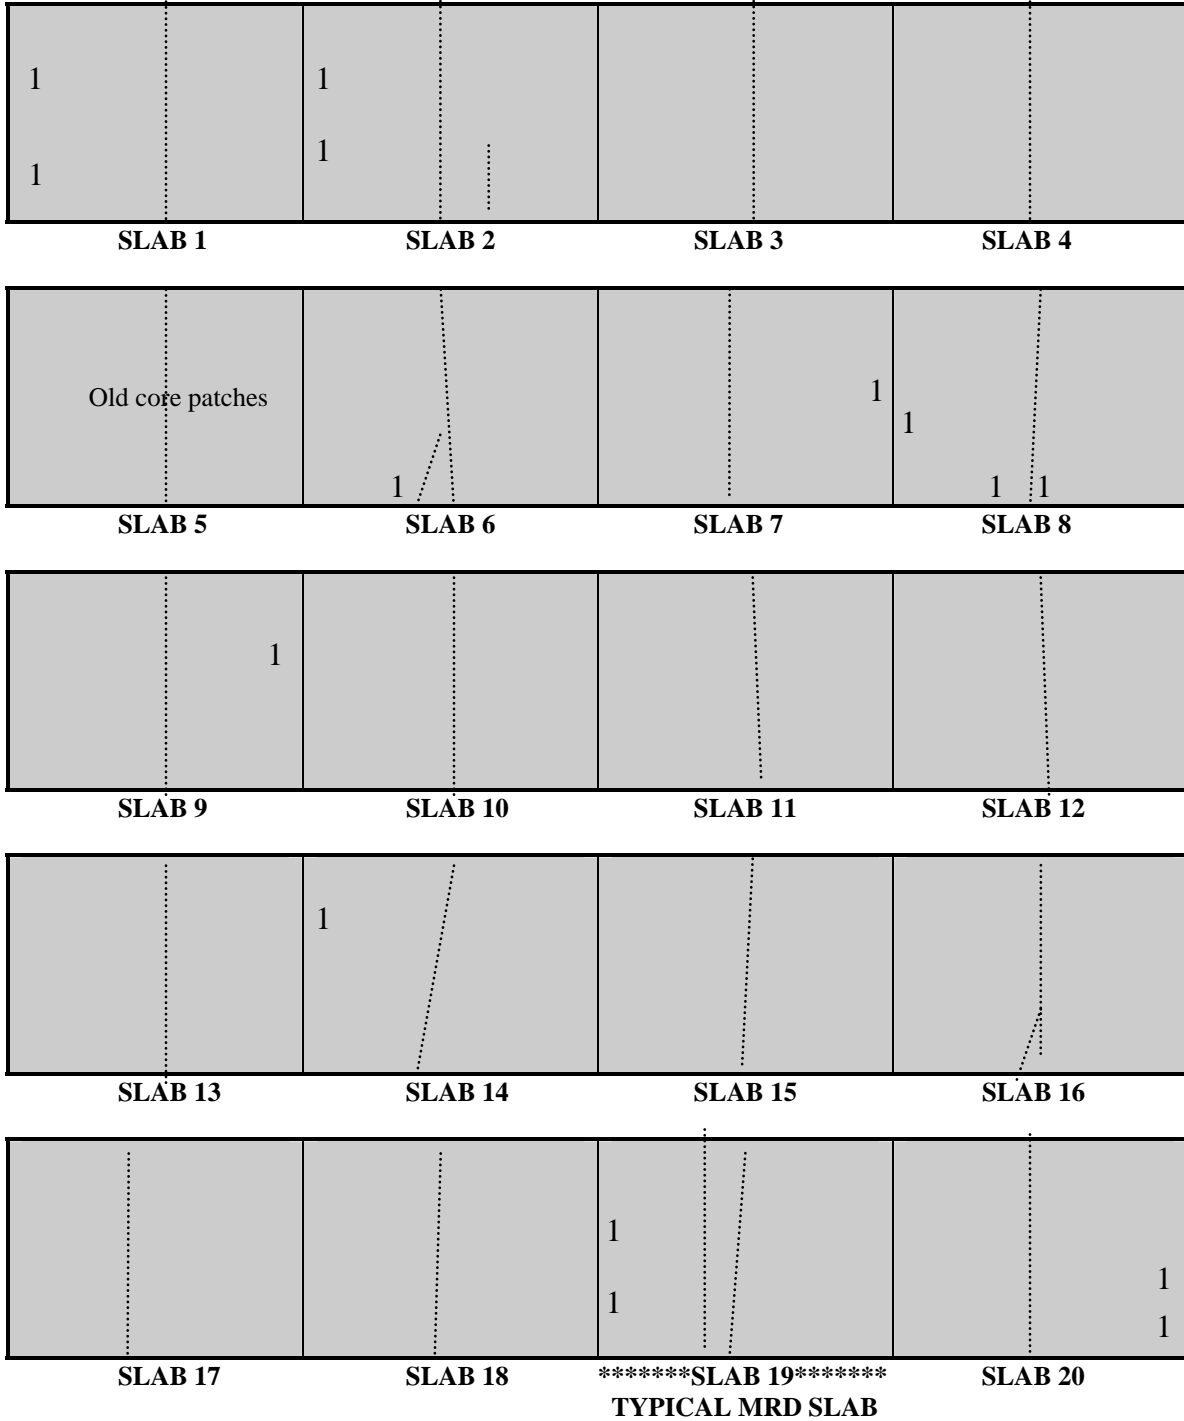
KEY: <i>Transverse Cracking</i>	<i>Patching</i>

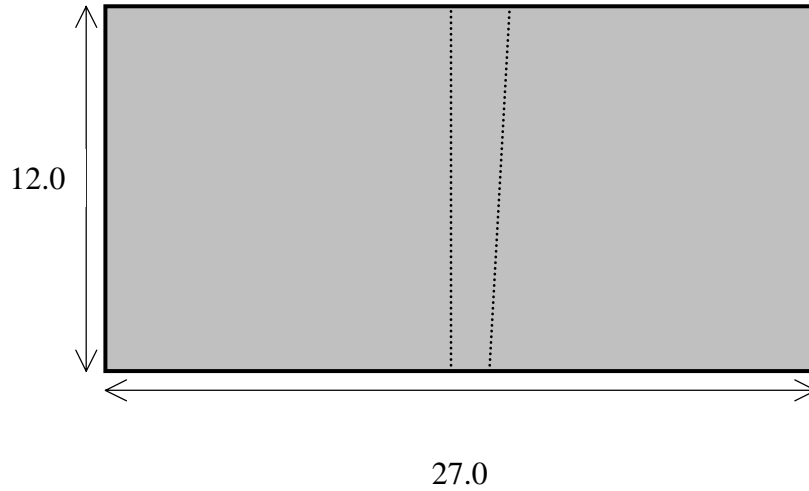
COMMENTS: Longitudinal cracking (~ 6" spacing) in slab due to connecting ASR-like cracks; Severe ASR-like cracking throughout entire slab; Popouts: 0.5 per m²

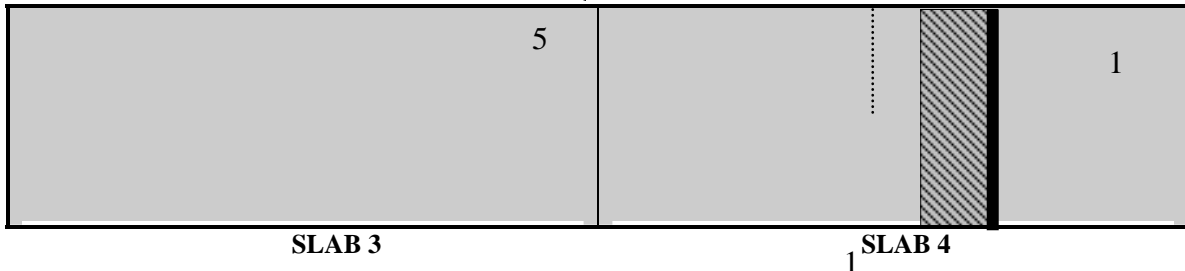
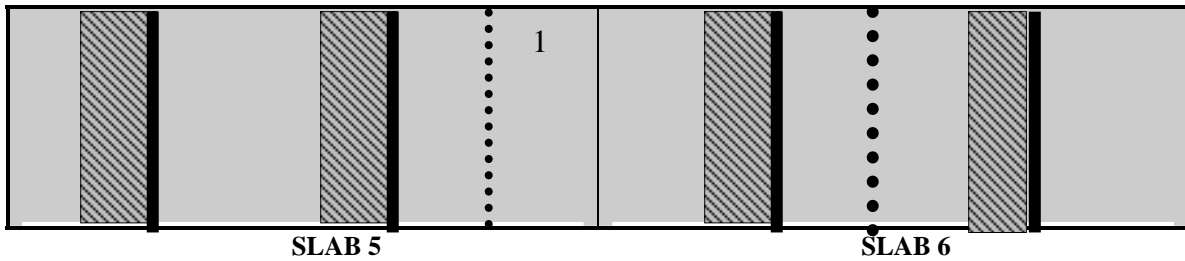
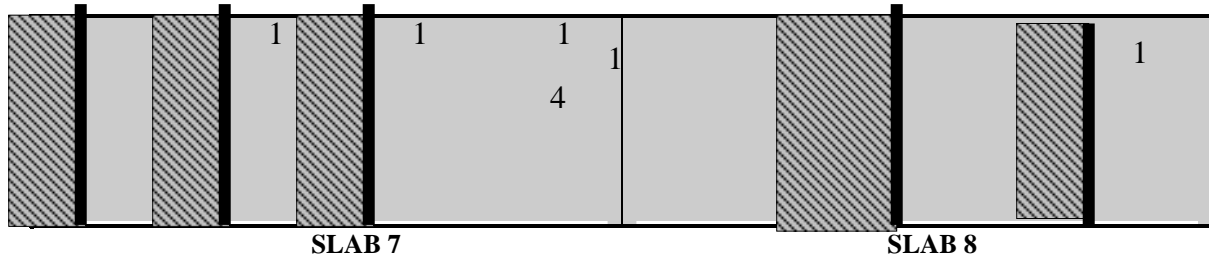
KEY: <i>Transverse Cracking</i>	<i>Patching</i>		1. Spalling	5. High steel
Low 	Full-depth Concrete

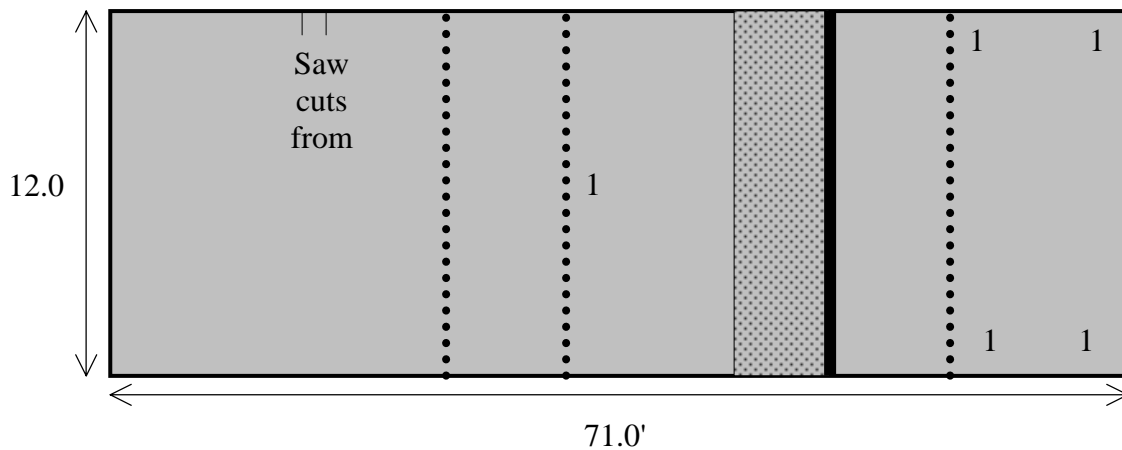
COMMENTS: General comments apply; Chip and seal repairs extensive along longitudinal joint; Polished agg (severe) in wheelpath; Popouts: ~ 2.5 per m²

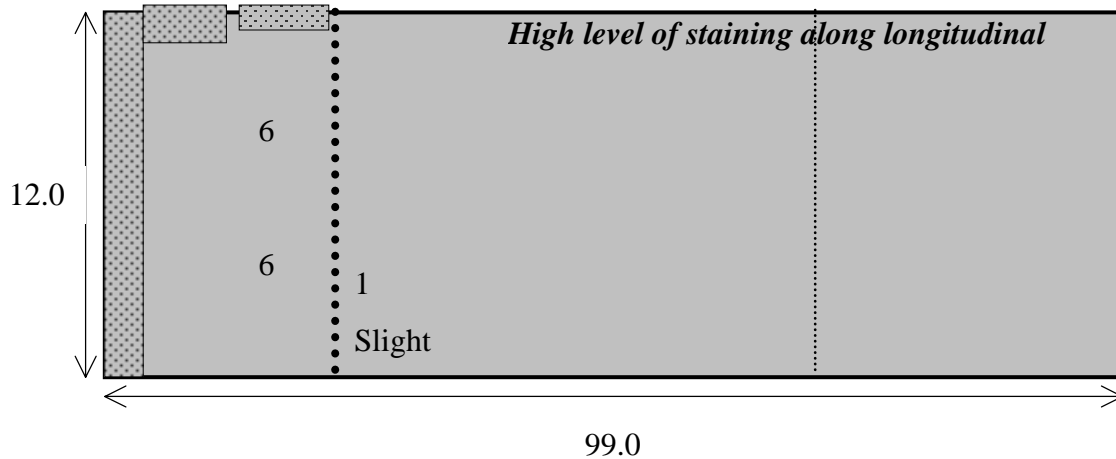
COMMENTS: Shrinkage-like cracking which is very tough to see, predominantly transverse; Polished agg (severe) in wheelpath; Popouts: ~ 2-3 per m²

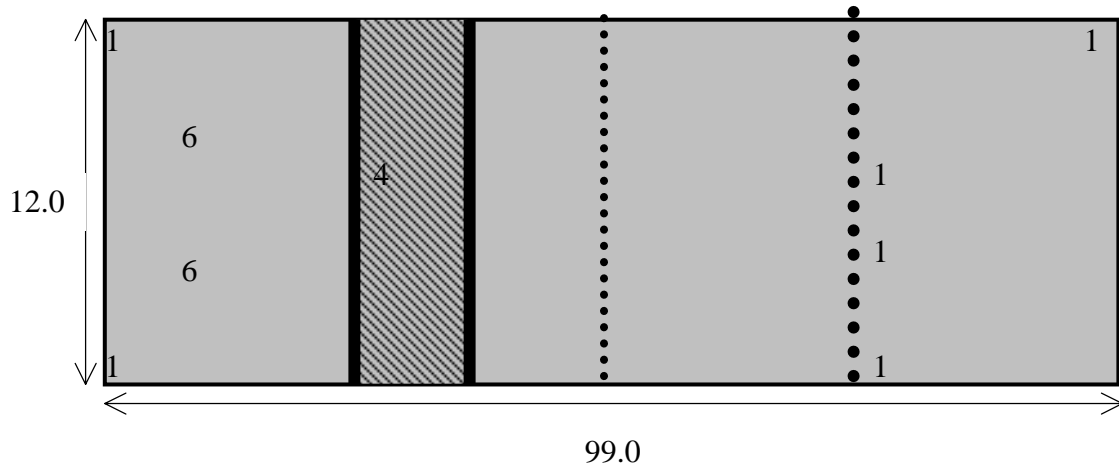
COMMENTS: Shrinkage-like cracking which is very tough to see, predominantly transverse; Popouts: ~ 3 per m²

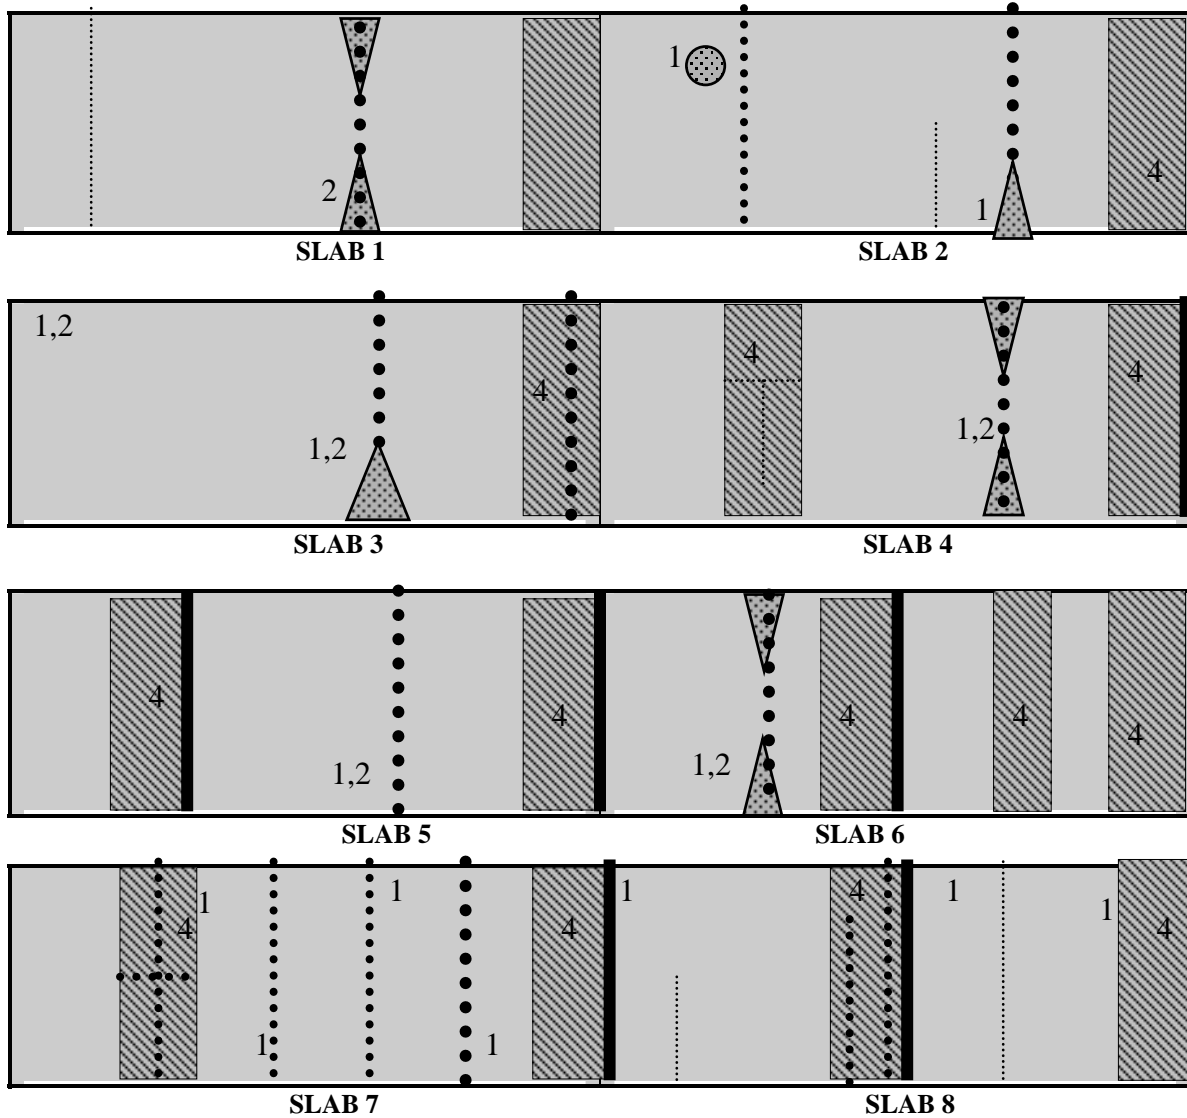
KEY: <i>Transverse Cracking</i>	<i>Patching</i>

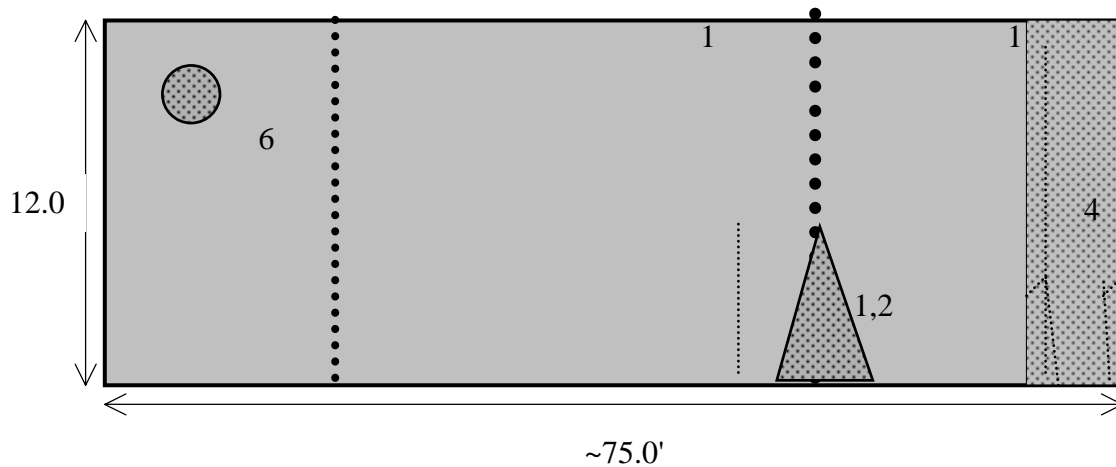
COMMENTS: ASR in patch; D-cracking near major crack; Polished agg (severe) in wheelpath; Popouts: ~ 3 per m²

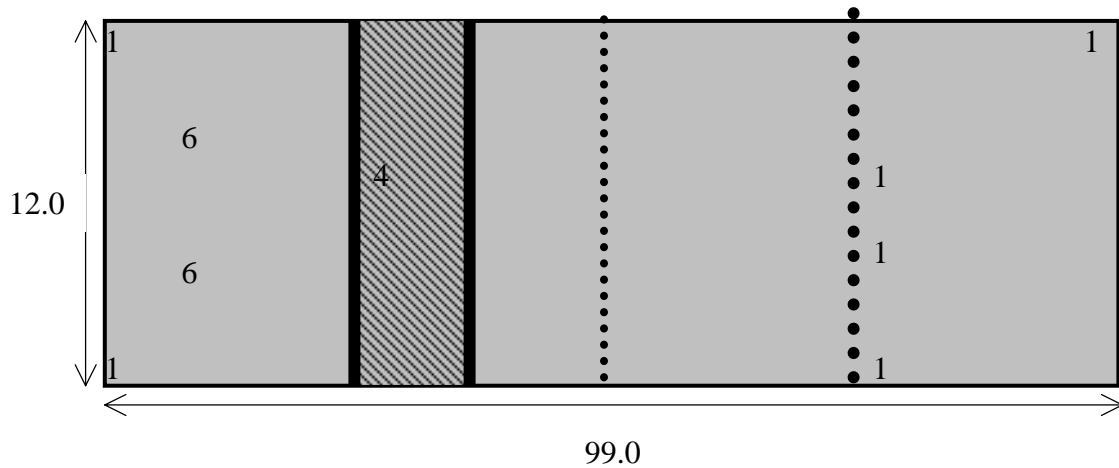
COMMENTS: Shrinkage-like cracking, which is very tough to see, predominantly transverse; Popouts: ~ 3 per m²

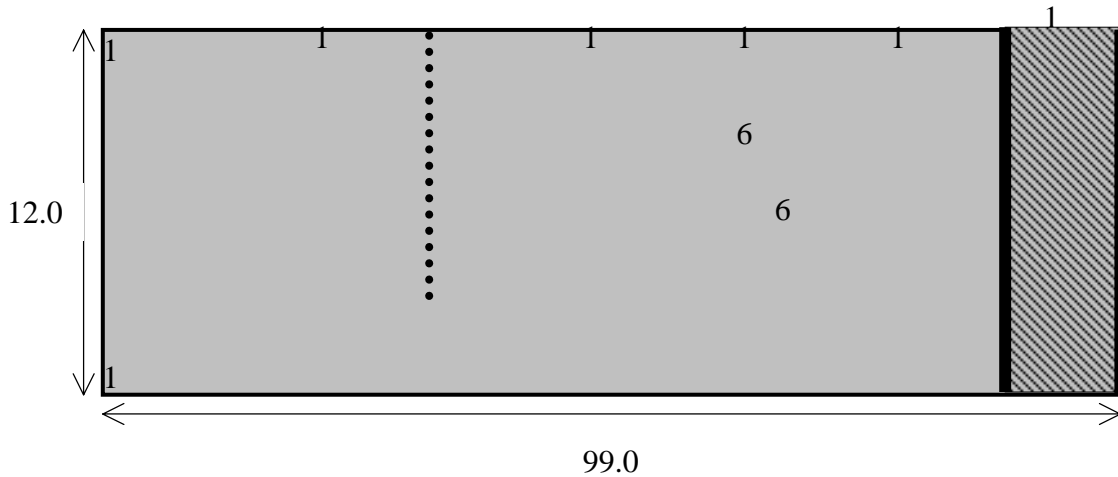
COMMENTS: Shrinkage-like cracking throughout slab; Popouts: ~ 1.5 per m² - could be due to diamond grinding; joint before patch is completely missing sealant.

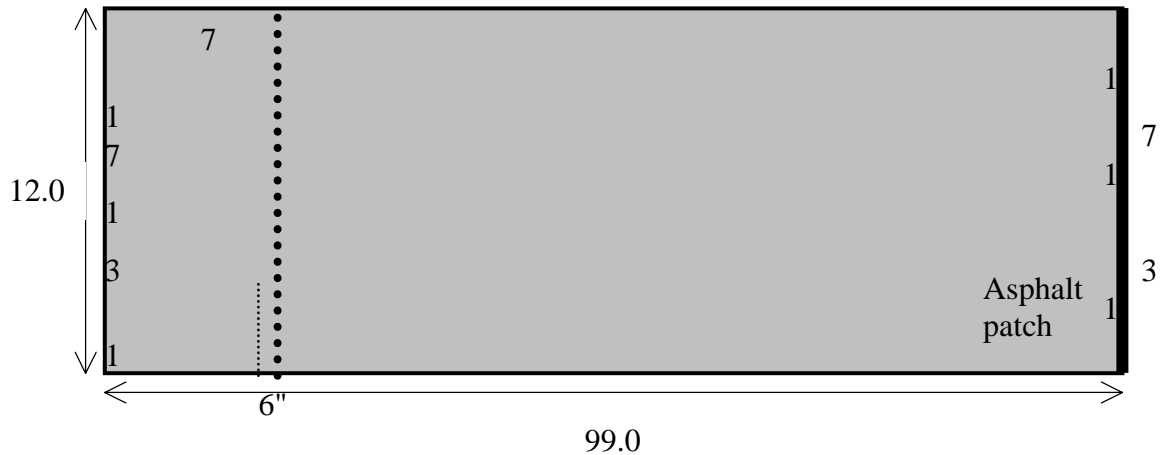
COMMENTS: Shrinkage-like cracking throughout slab; Popouts: ~ 0.5 per m²; Polished agg in wheelpath

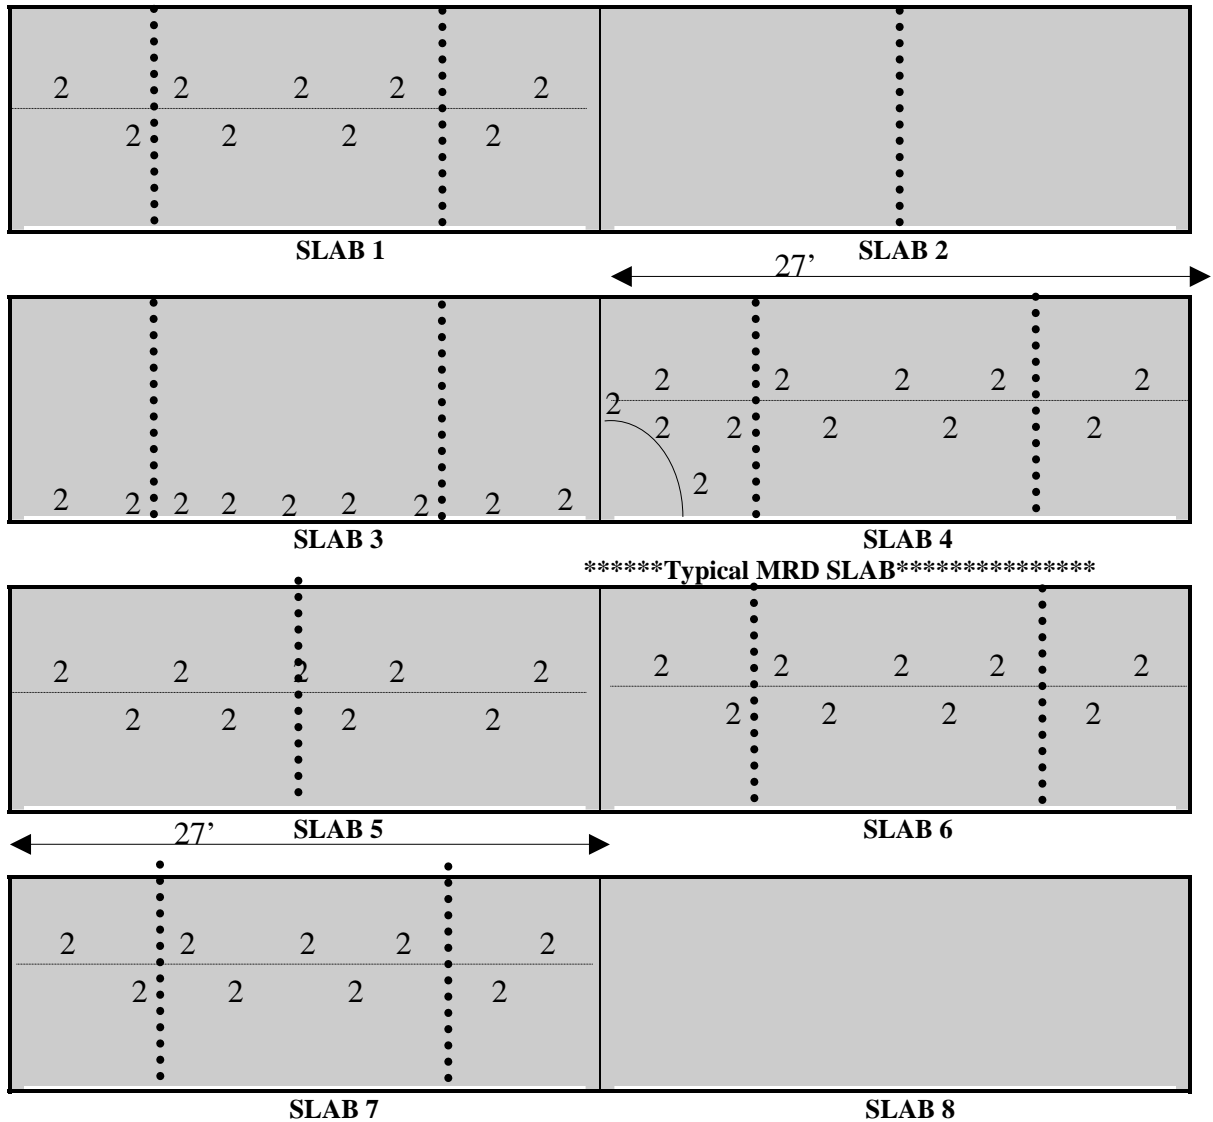
KEY: <i>Transverse Cracking..</i>	<i>Patching</i>		1. Spalling	5. High steel
Low	Full-depth Concrete

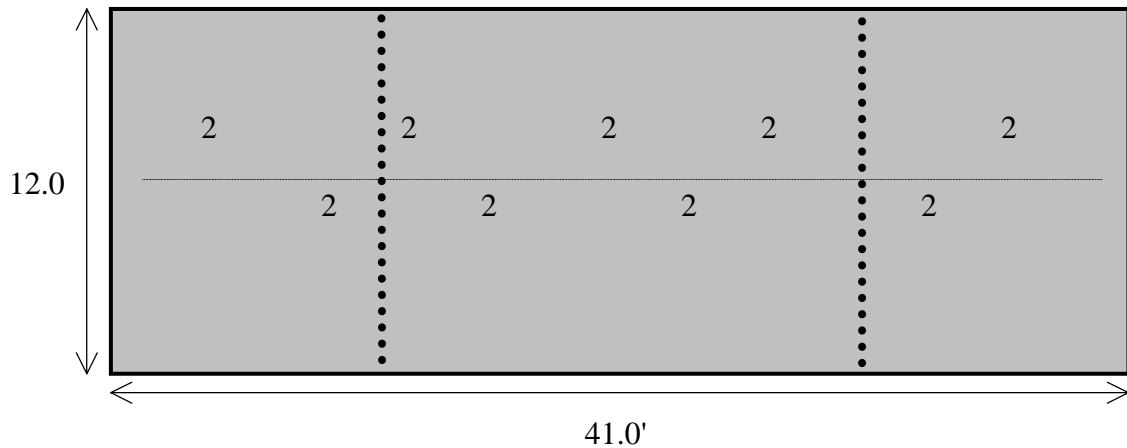
COMMENTS: General comments apply. Longitudinal crack at the middle of the slab and D-cracking is observed along the longitudinal crack.

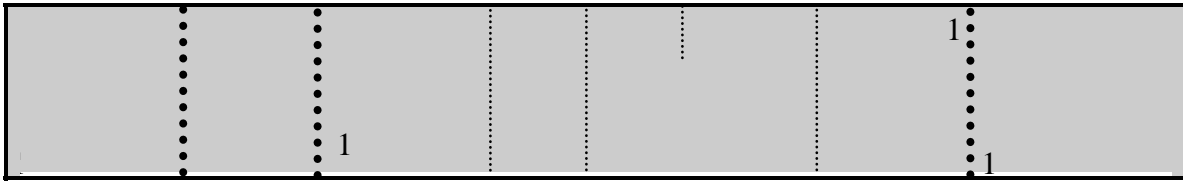
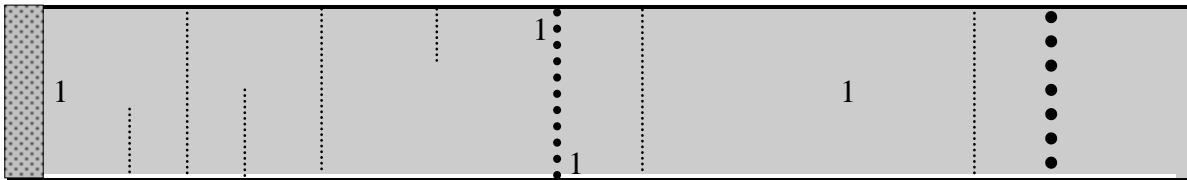
KEY: <i>Transverse Cracking</i>	<i>Patching</i>		1. Spalling	5. High steel
Low 	Full-depth Concrete

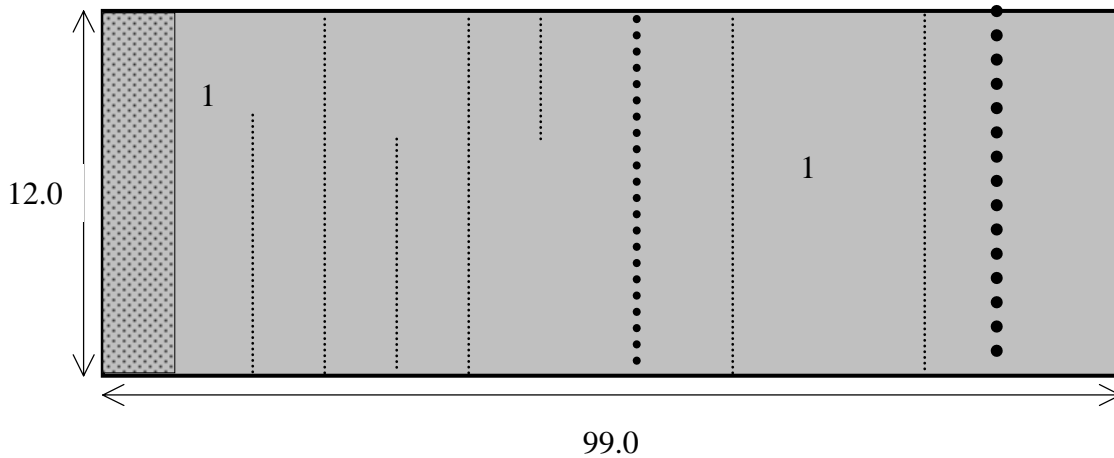
COMMENTS: Shrinkage-like cracking which is very tough to see, predominantly transverse; Polished agg (severe) in wheelpath; Popouts: ~ 1 per m²
