APPENDIX A: PHOTOGRAPHS

General Photographs

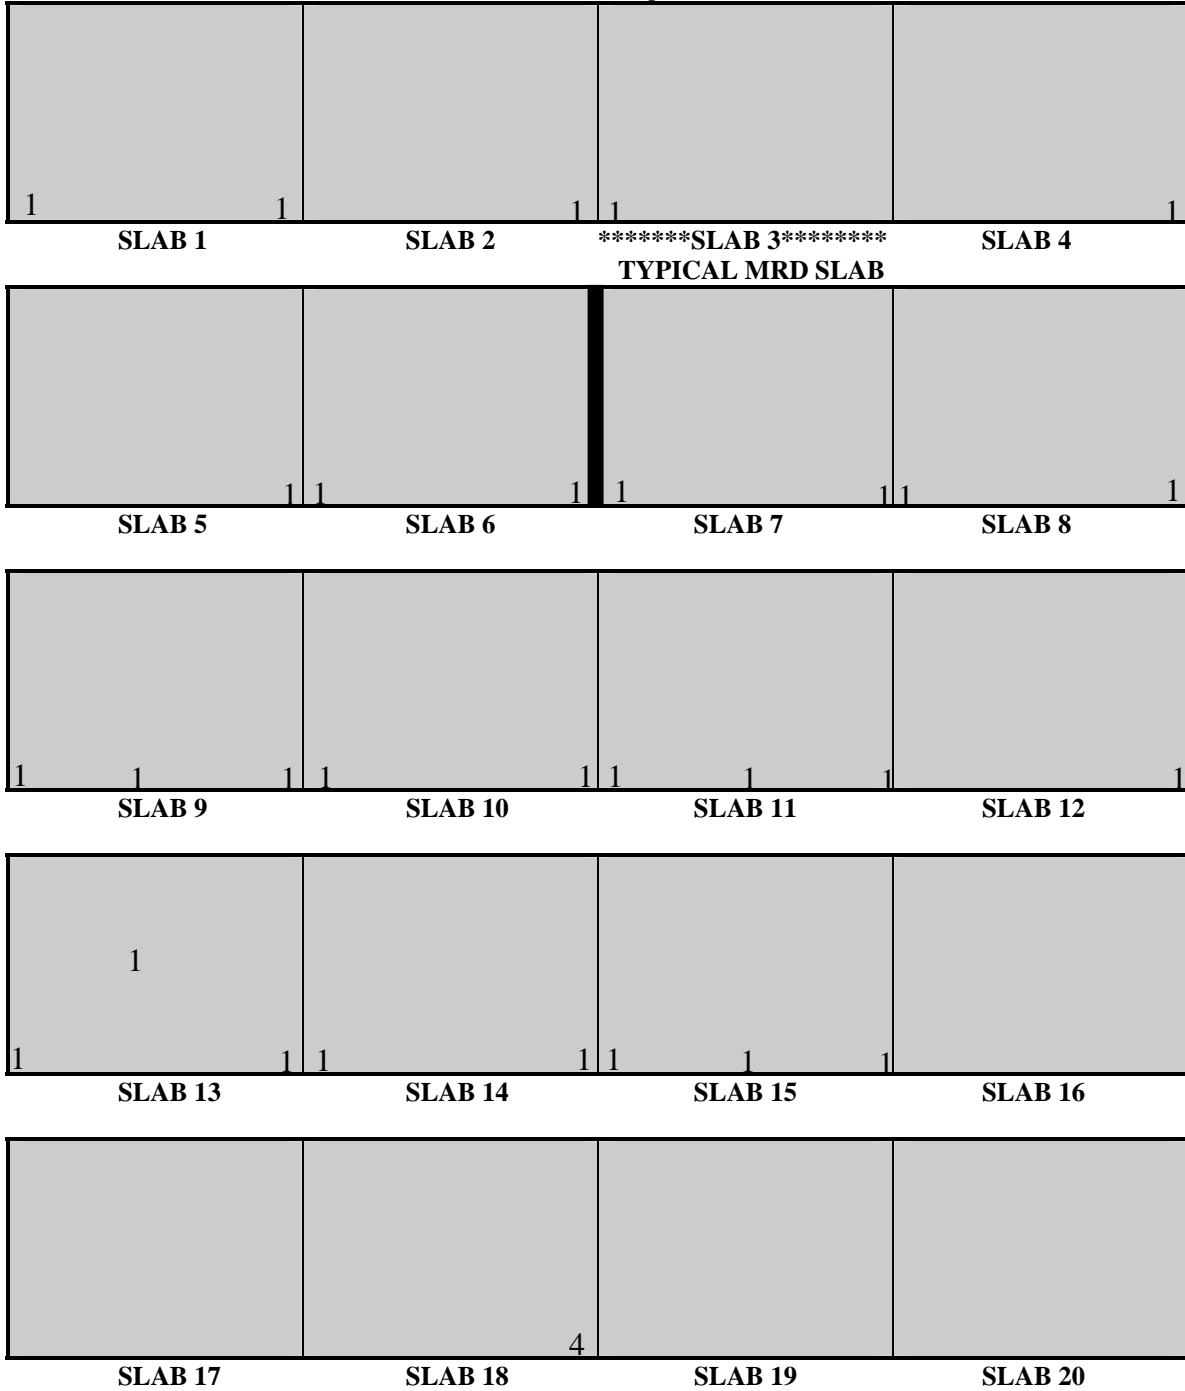
KEY: <i>Transverse Cracking</i>	<i>Patching</i>

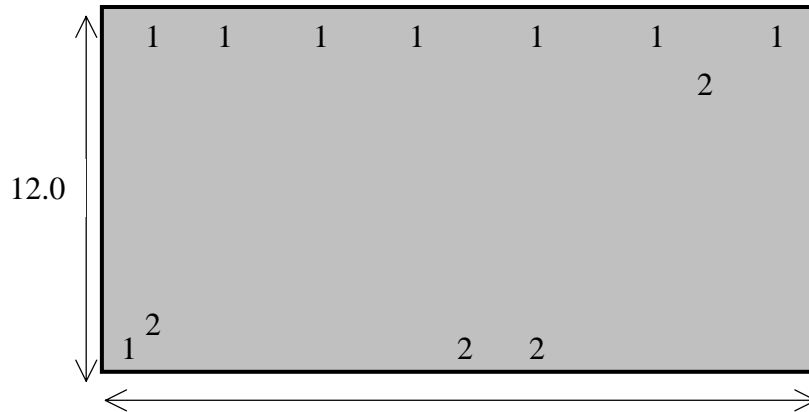
TYPICAL MRD SLAB: Slab 3

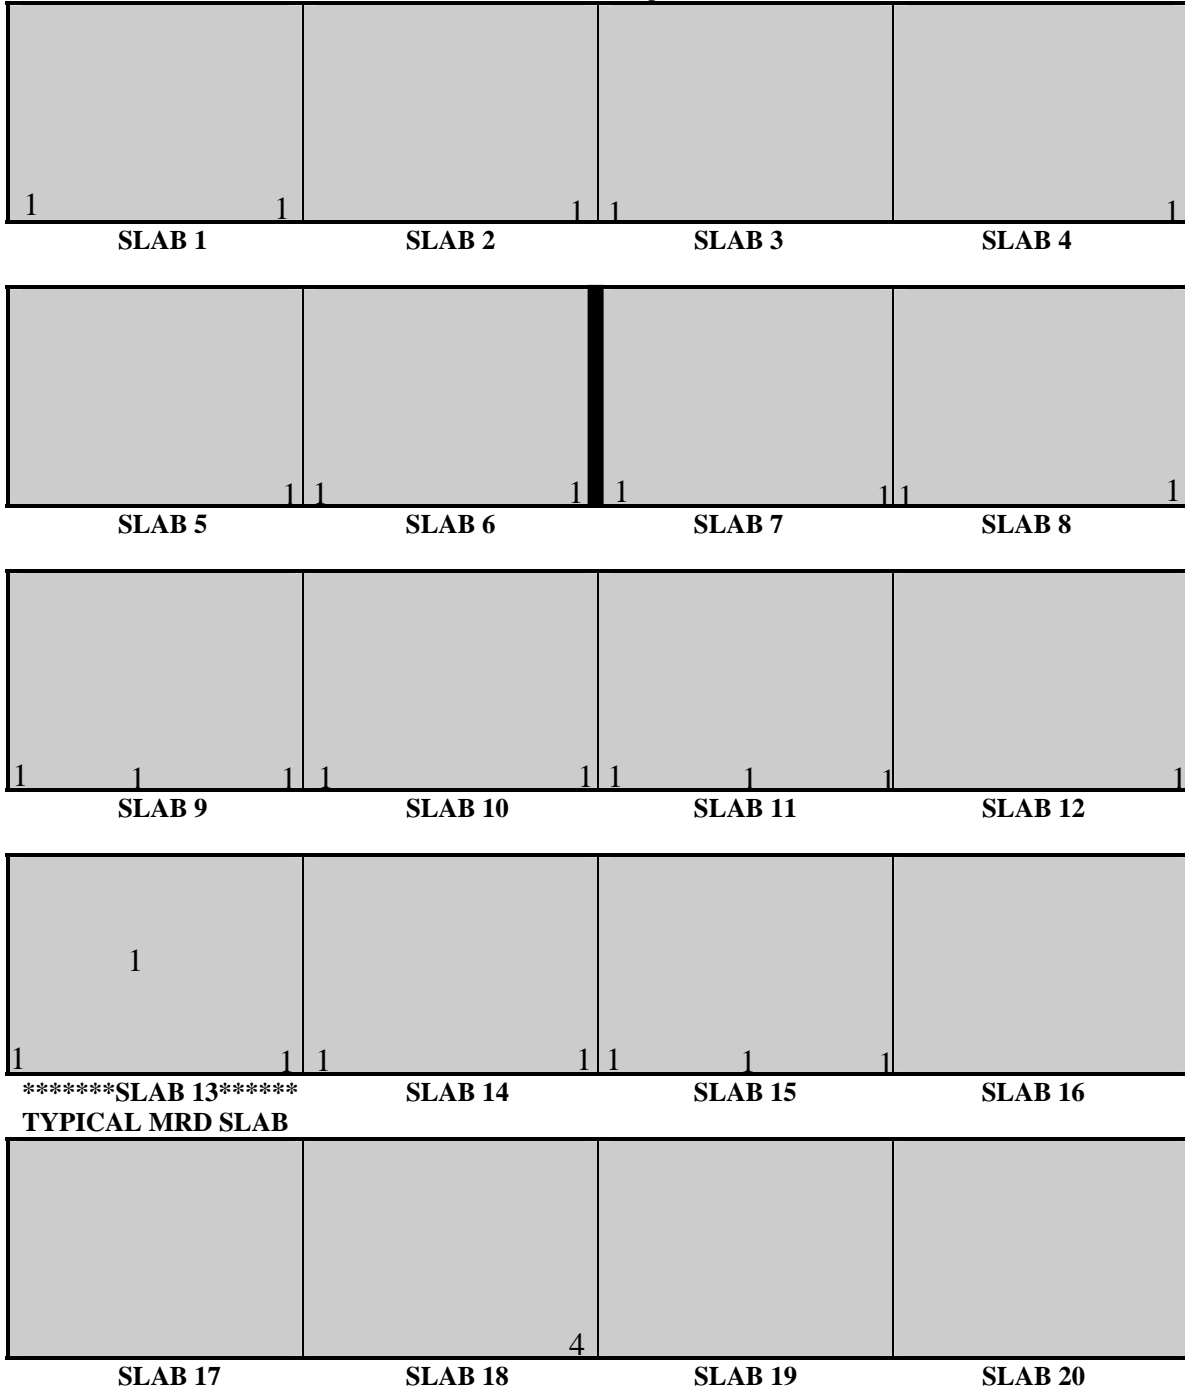
KEY: <i>Transverse Cracking</i>	<i>Patching</i>		1. Spalling	5. High steel
Low 	Full-depth Concrete

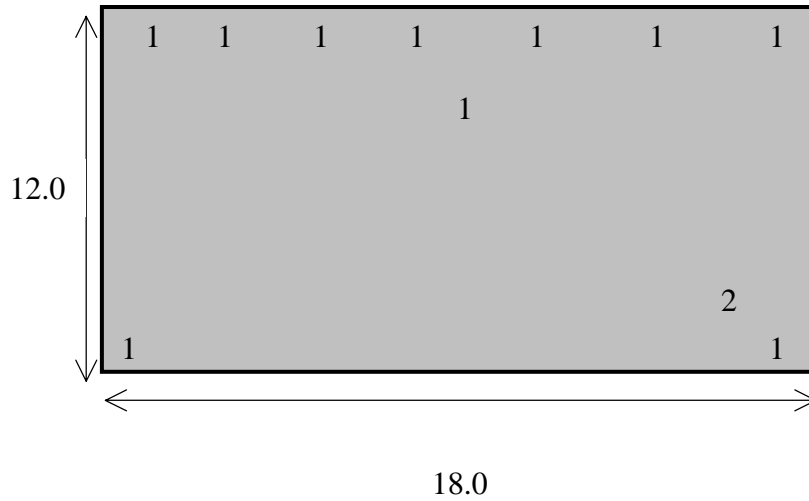
COMMENTS: Longitudinal joint completely spalled; Possible D-cracking at joints; Map cracking near joint and shoulder; Popouts: ~2 per m²

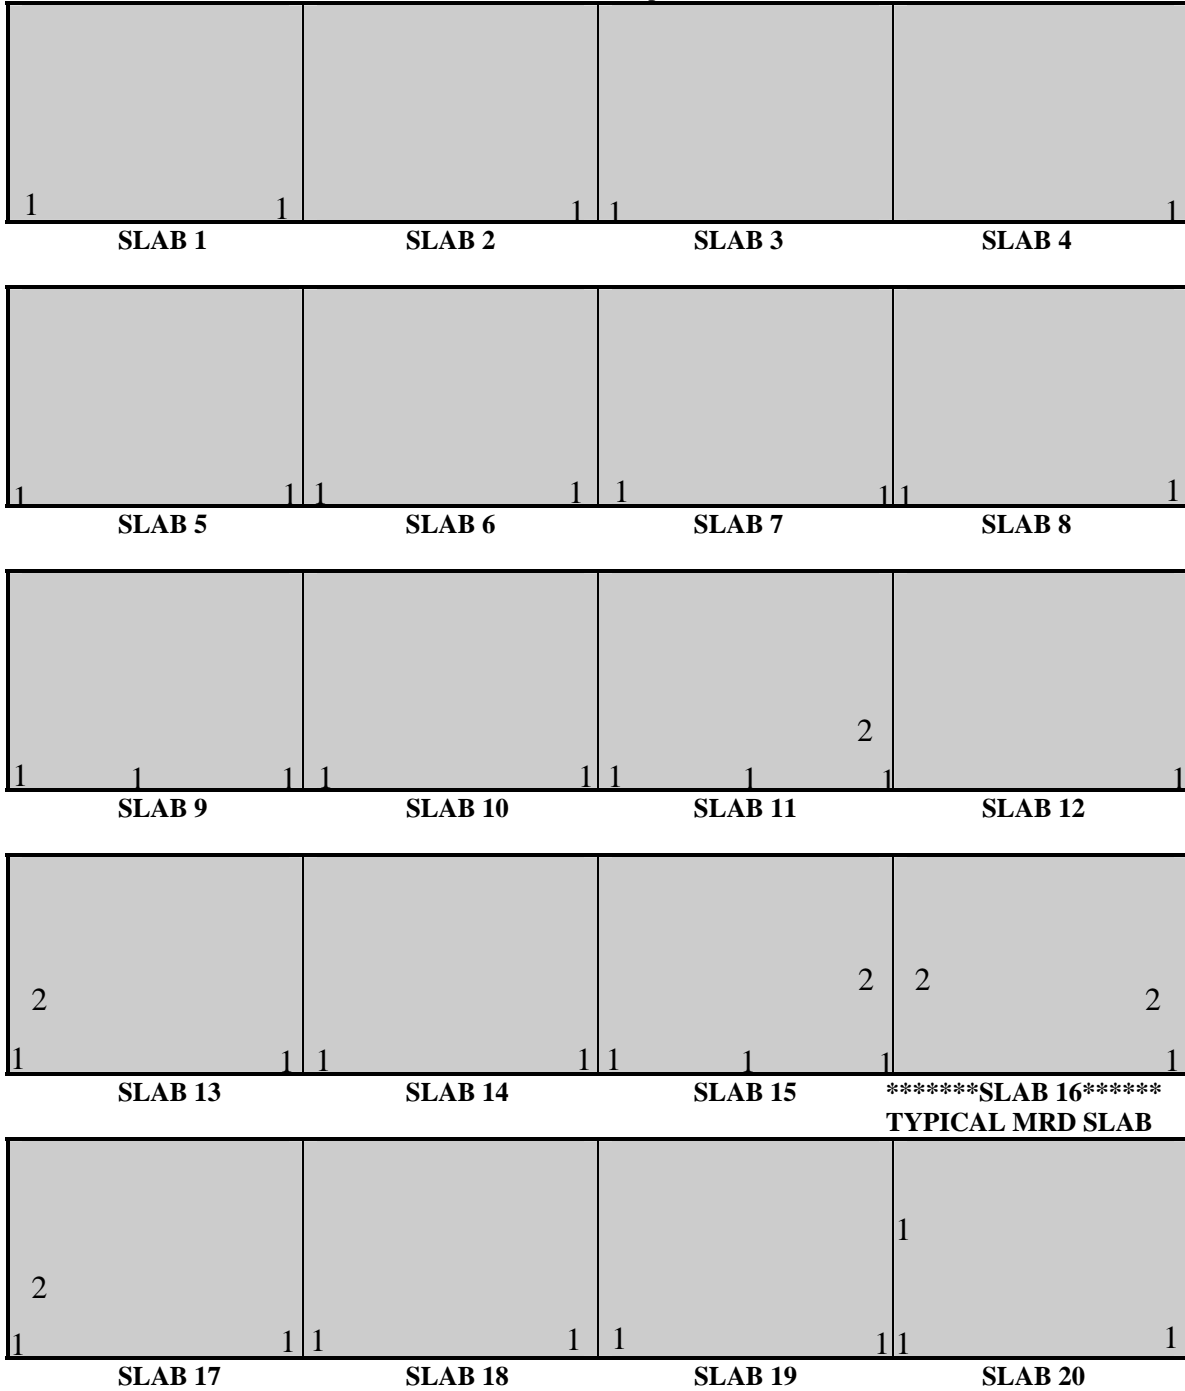
KEY: <i>Transverse Cracking</i>	<i>Patching</i>

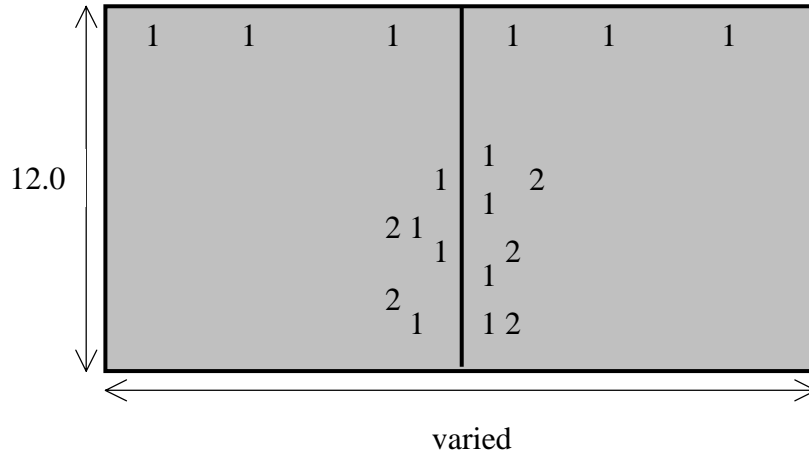
COMMENTS: Same as 26A and B although the spalling is more severe.

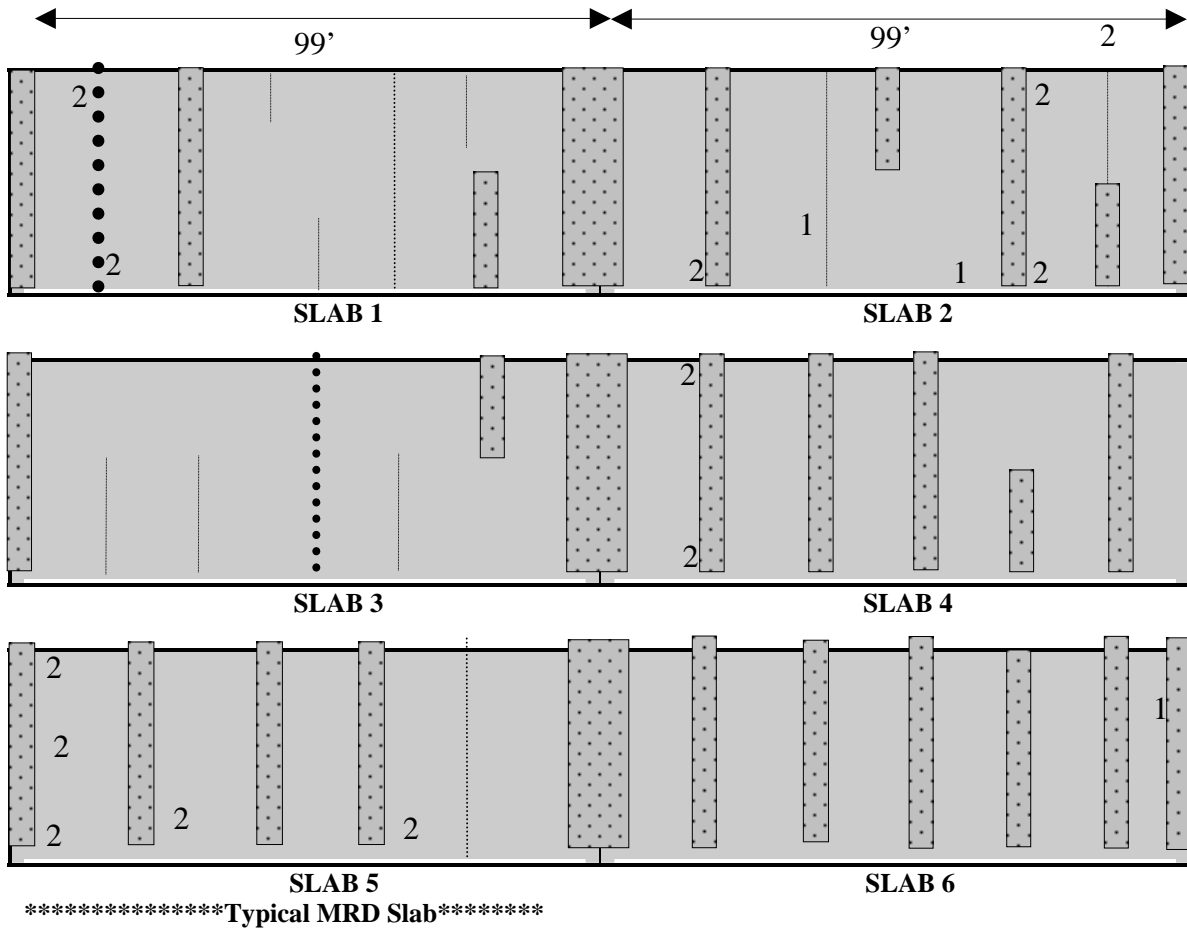
KEY: Transverse Cracking	Low ●●●●●	Patching

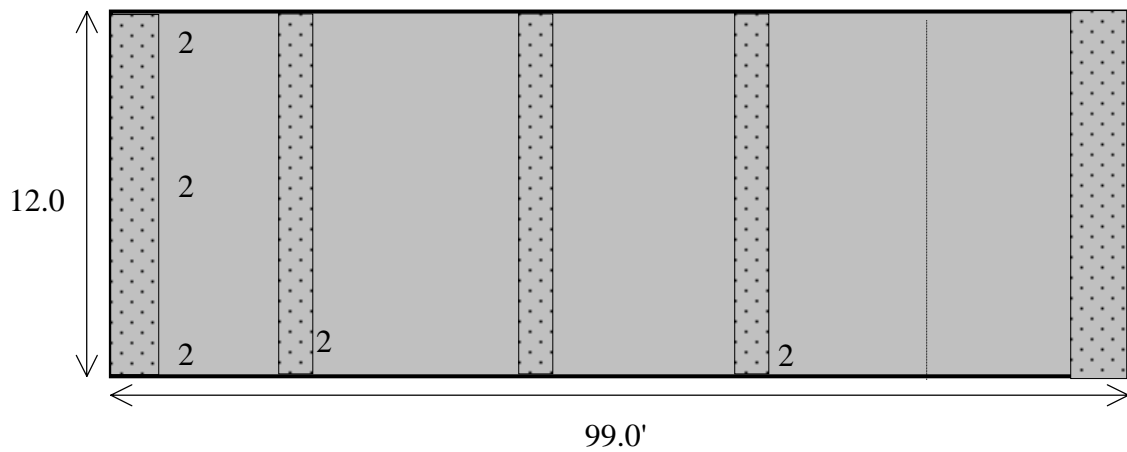
COMMENTS: General comments apply; Chip and seal repairs extensive along longitudinal joint; Polished agg (severe) in wheelpath; Popouts: ~ 1-2 per m²

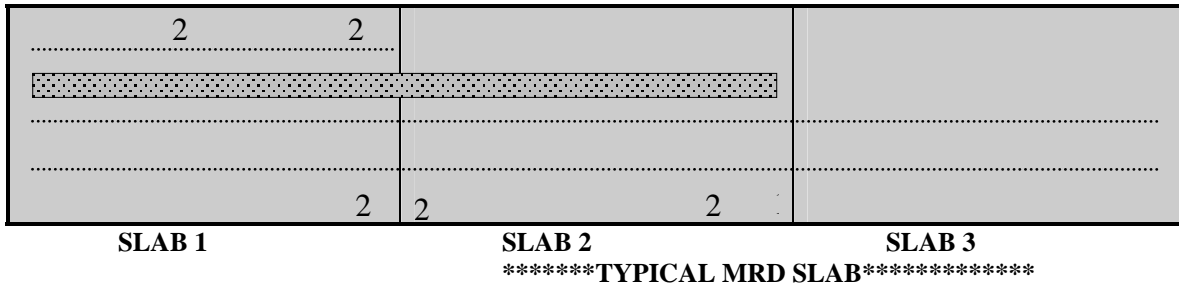
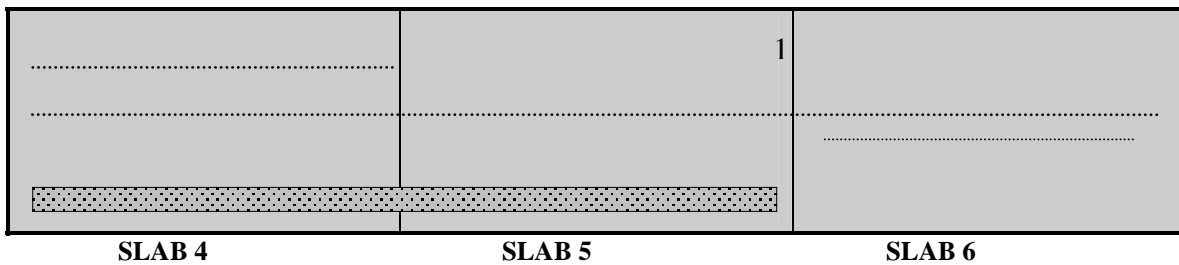
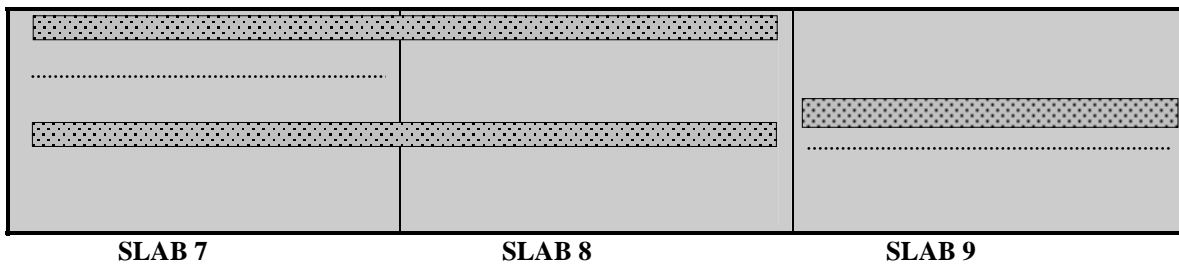
KEY: <i>Trans./Lon. Cracking</i>	<i>Patching</i>

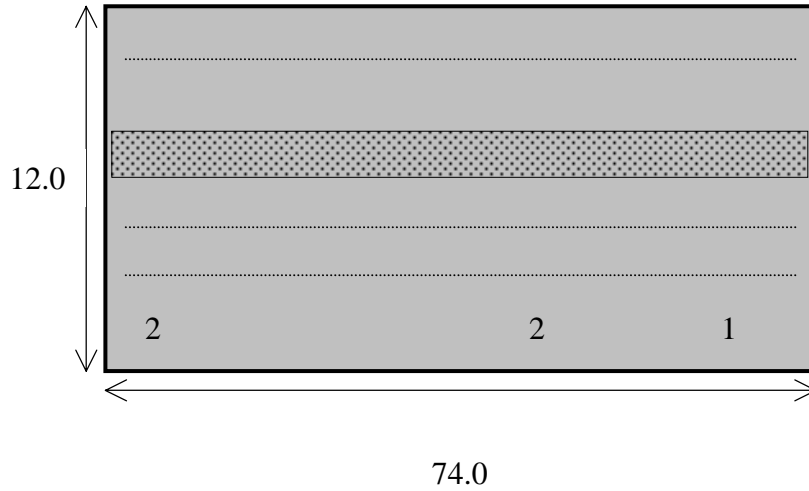
COMMENTS: Longitudinal cracking in slab due to connecting ASR-like cracks; Severe ASR-like cracking throughout entire slab; Popouts: 0.5 per m².

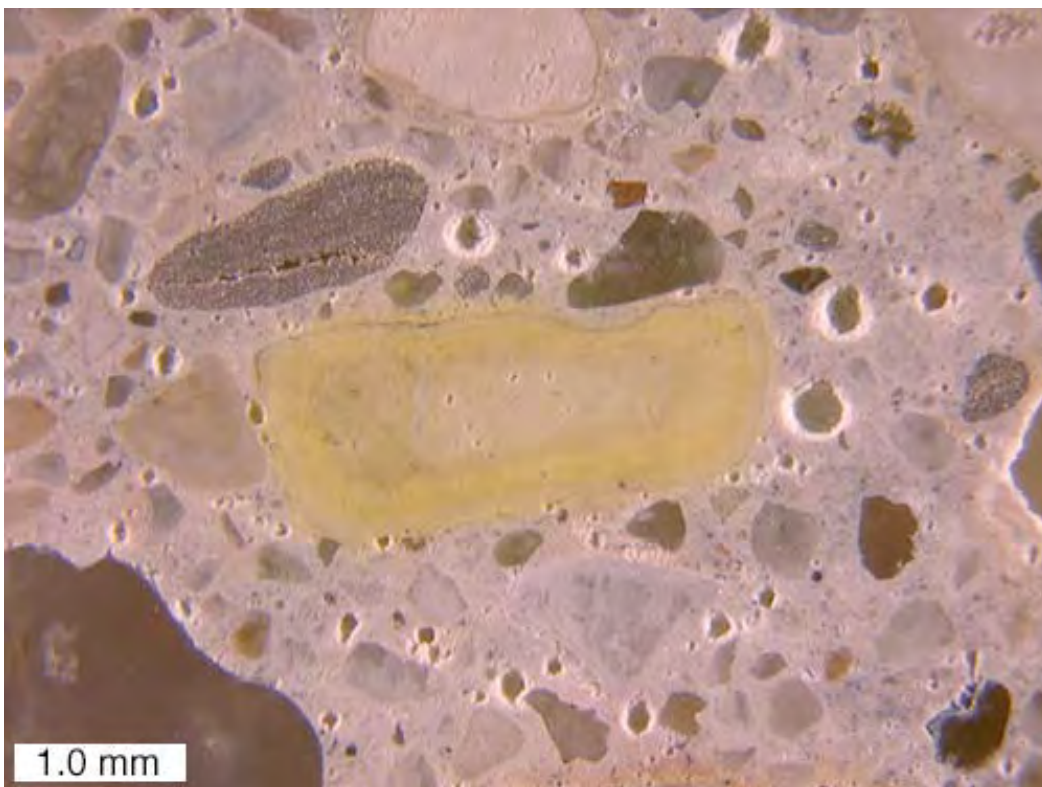
Figure D-7. Yellow stained chert sand particle from Core O-A.

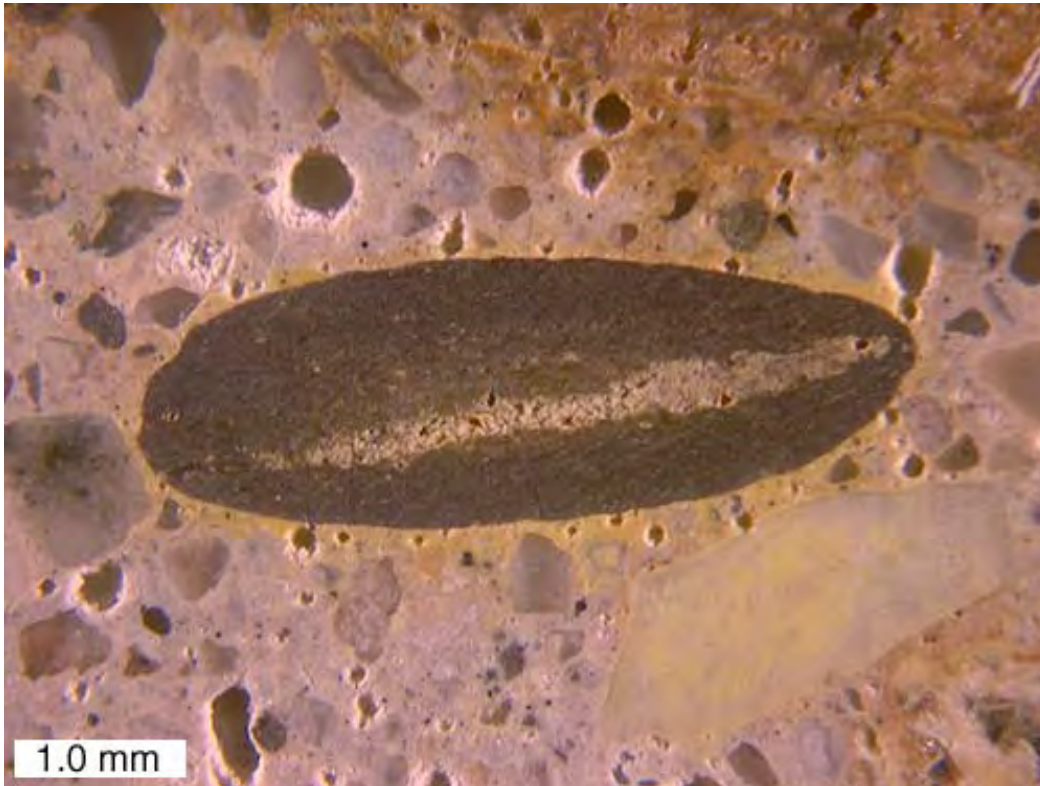
Figure D-8. Yellow stained siltstone sand particle from Core 3-A.

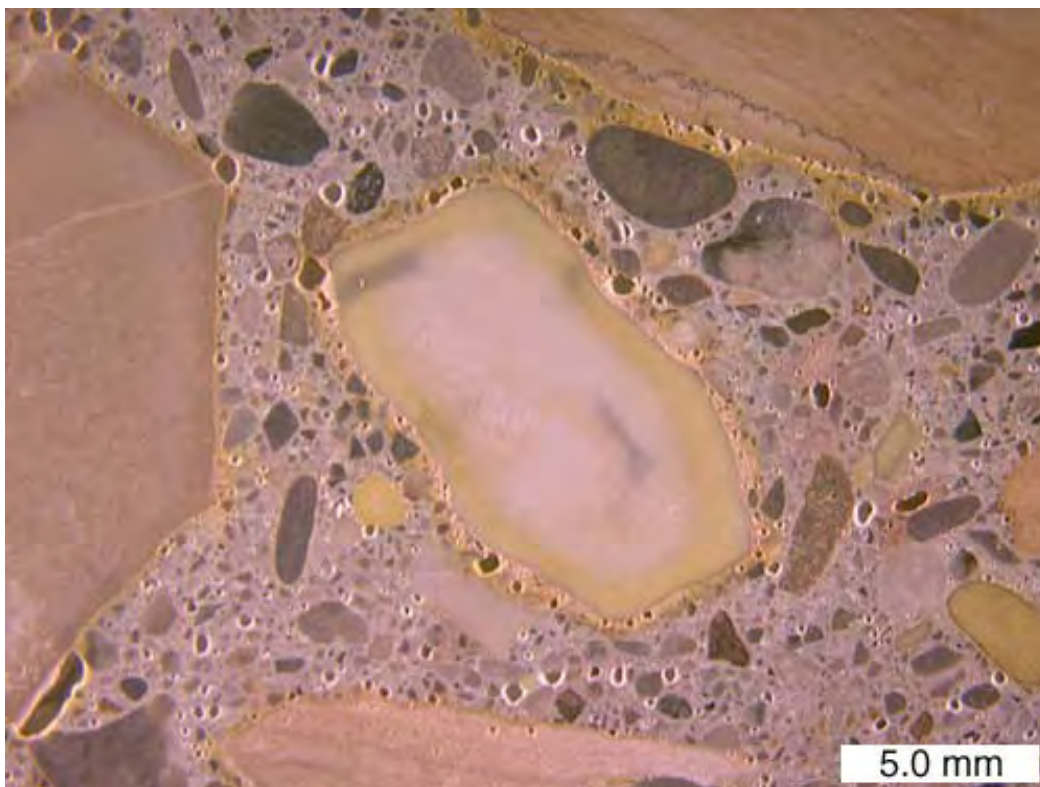
Figure D-9. Yellow stained dolomite coarse aggregate particle from Core 3-A.

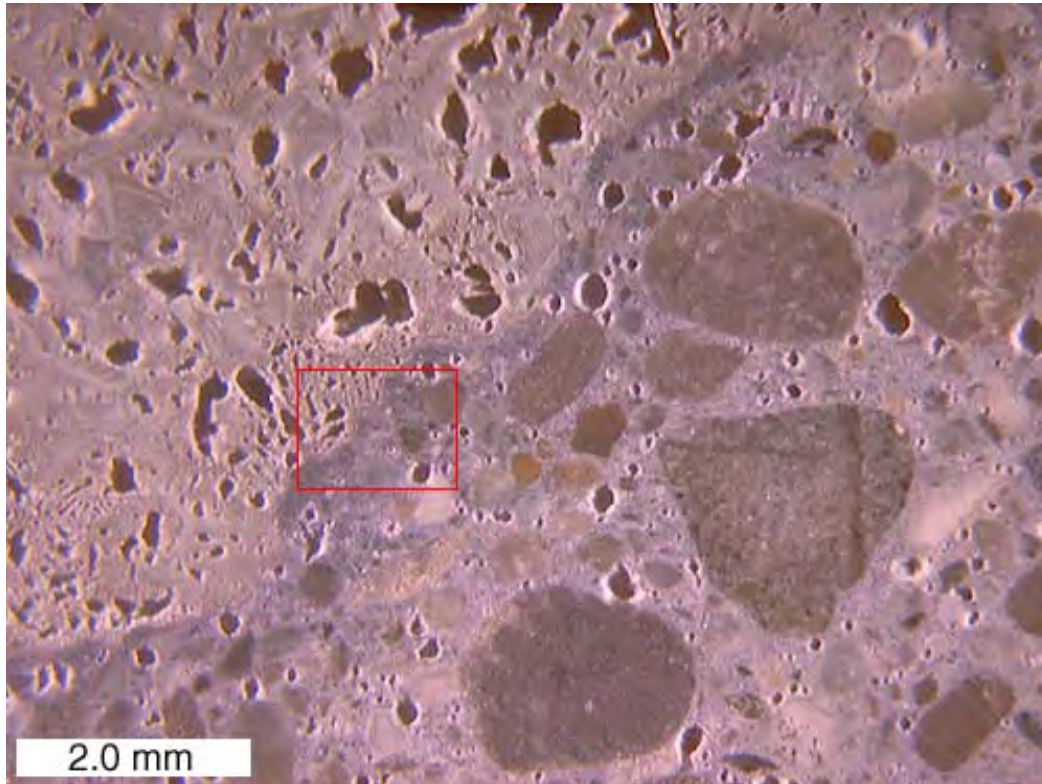
Figure D-10. A polished surface stained for sulfate minerals from Core 1-A. The red box shows the location of the close-up in Figure D-11.

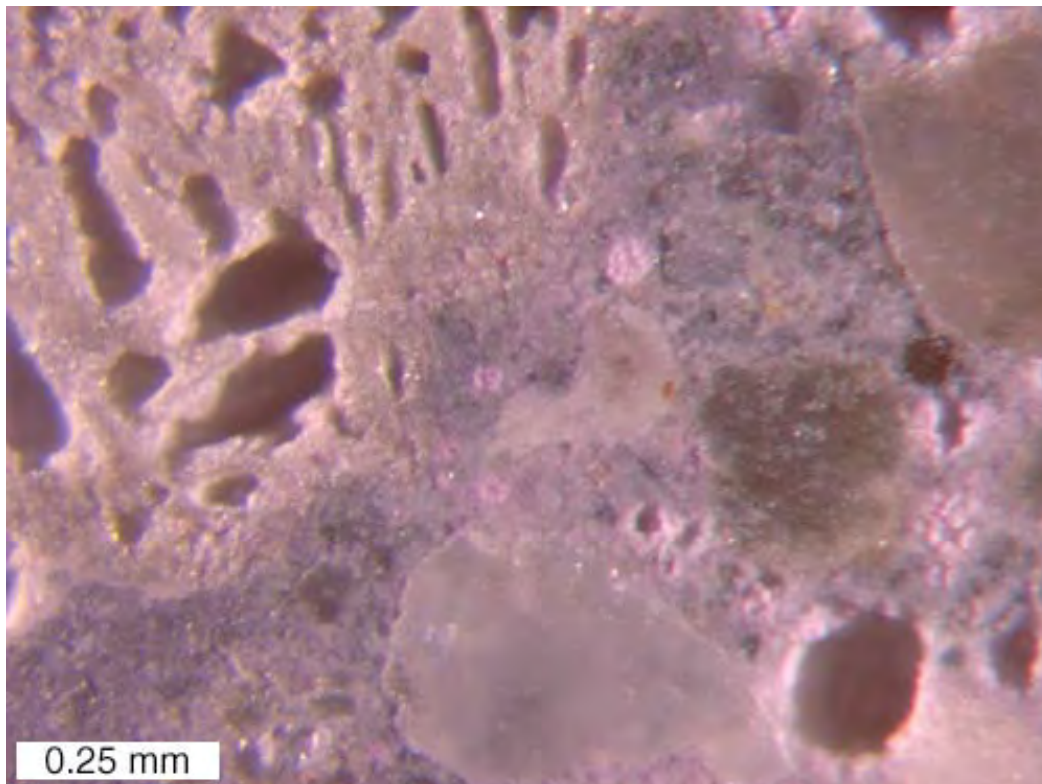
Figure D-11. Close-up of area from Figure D-10 showing ettringite filled air voids.

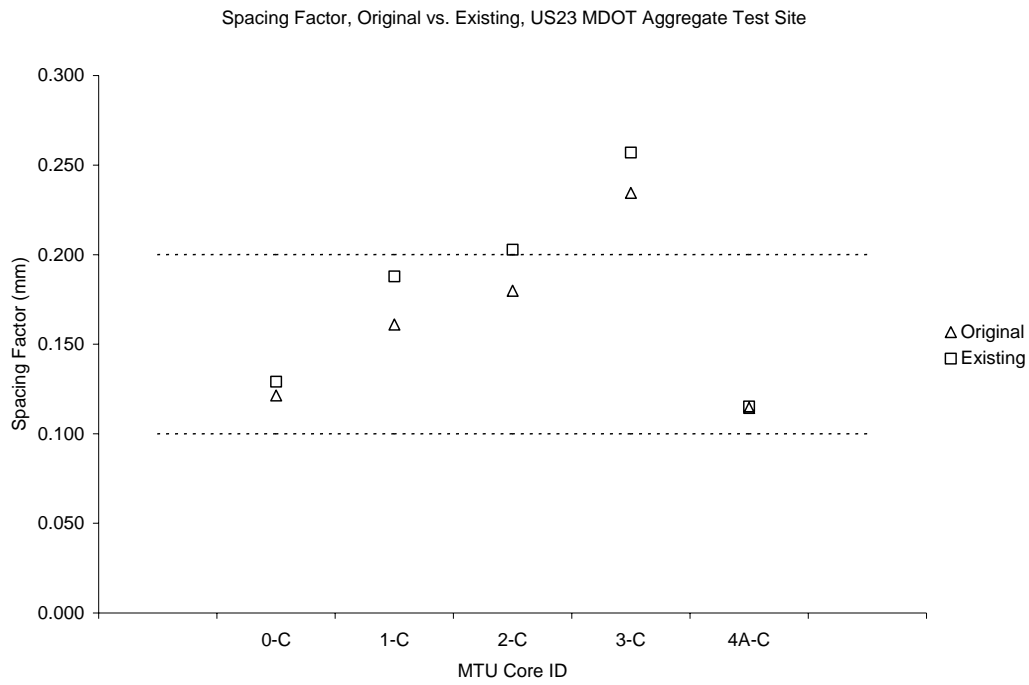
Figure D-23. Spacing factors plotted with dotted lines showing suggested values from ASTM C457.

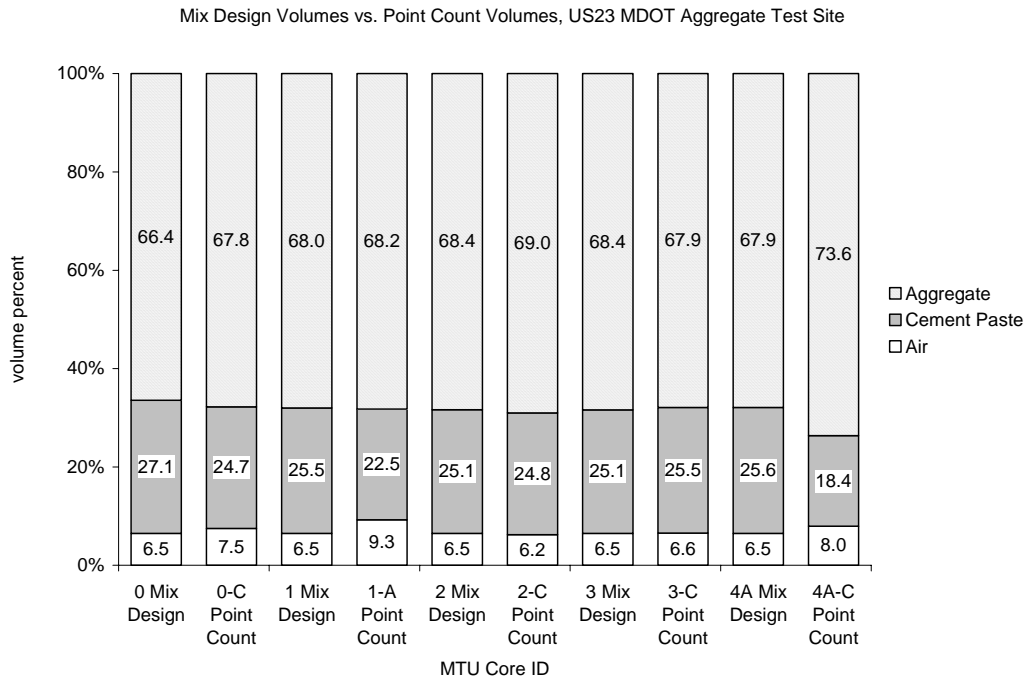
Figure D-25. Volume percentages from point counts compared to volume percentages computed from mix designs.

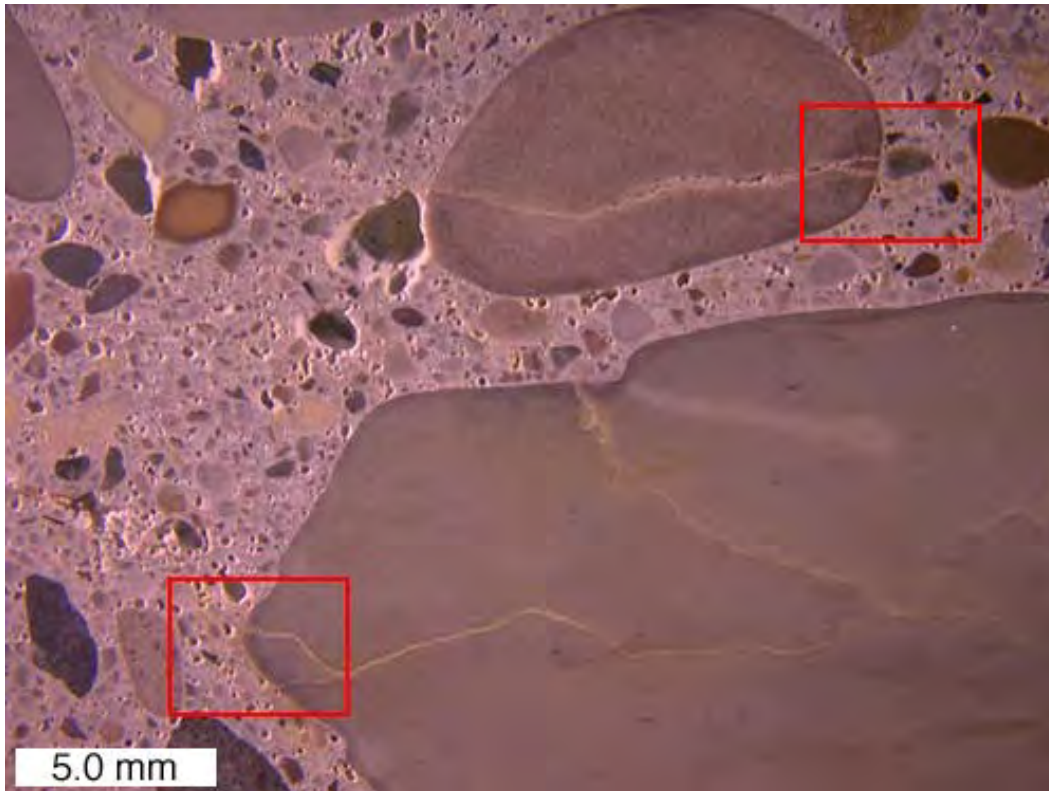
Figure D-26. Cracked coarse aggregates where alkali-silica gel product in the cracks has picked up the yellow sodium cobaltinitrite stain in Core 27-B. Red boxes show close-up areas depicted in Figures D-27 and D-28.

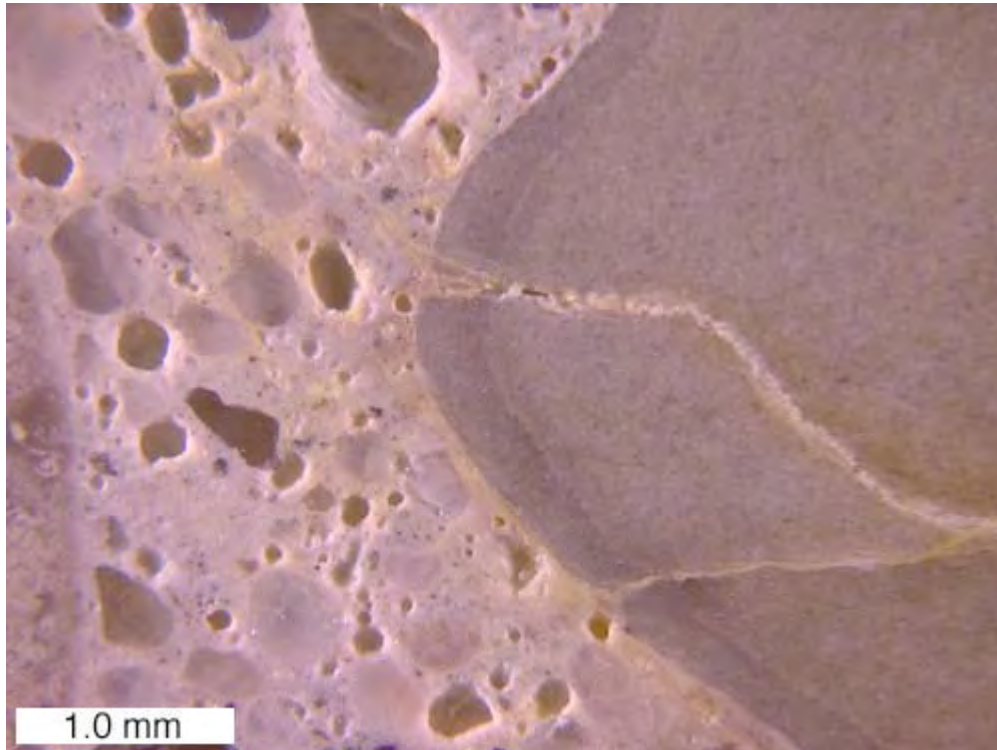
Figure D-27. Alkali-silica reaction product in cracks that has picked up the yellow sodium cobaltinitrite stain, close-up of area outlined in red in Figure D-26.

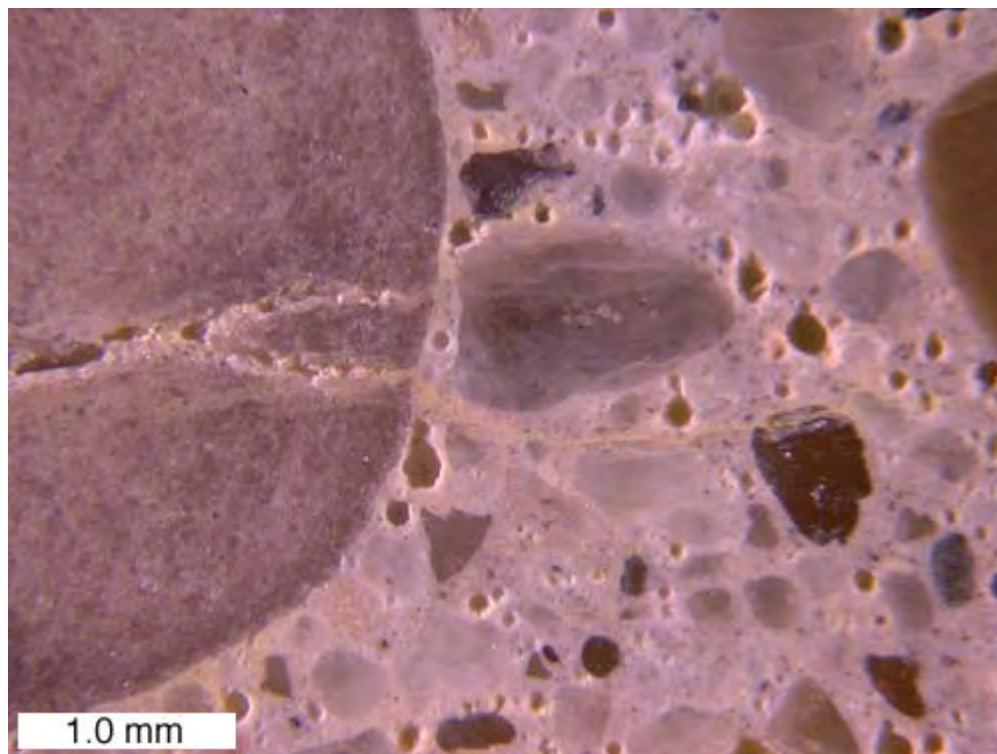
Figure D-28. Alkali-silica reaction product in cracks that has picked up the yellow sodium cobaltinitrite stain, close-up of area outlined in red in Figure D-26.

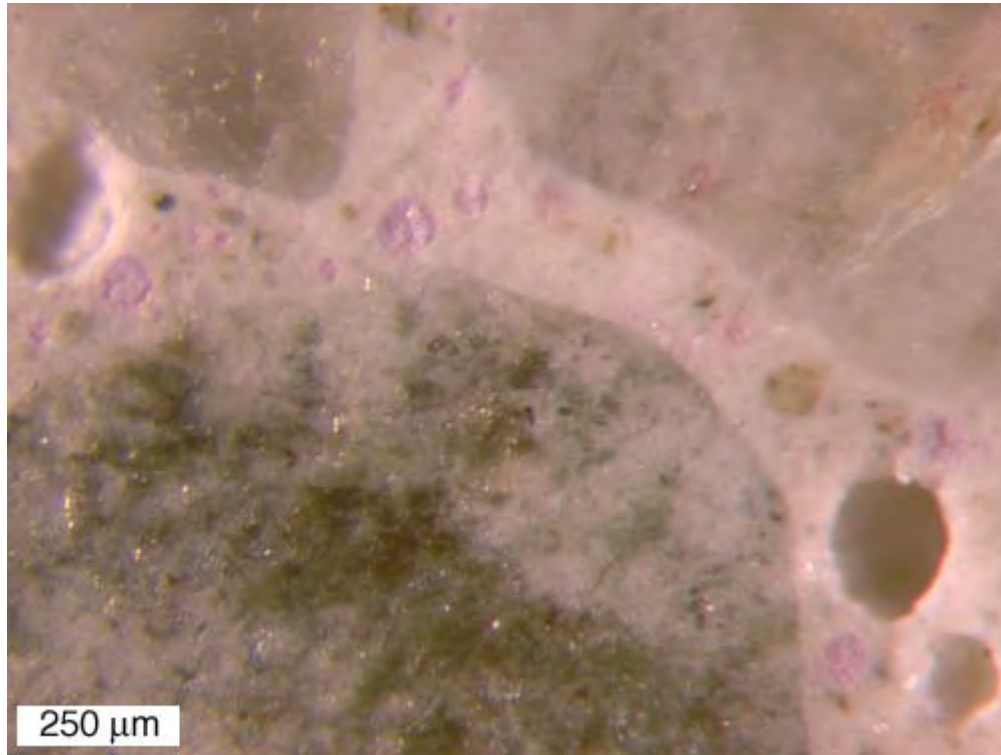
Figure D-29. Ettringite filled entrained air voids stained pink from core 27-B.

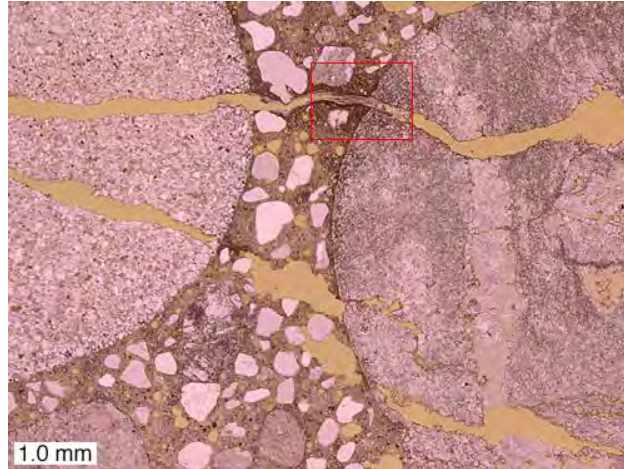
Figure D-30a. Thin-section view of cracked coarse aggregates from Core 26B-C, plane-polarized light. Red box shows area of close-up view in Figure D-31a.

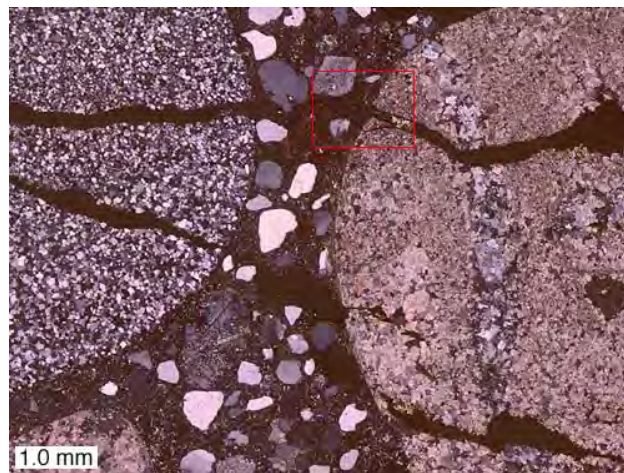
Figure D-30b. Thin-section view of cracked coarse aggregates from Core 26B-C, cross-polarized light. Red box shows area of close-up view in Figure D-31b.

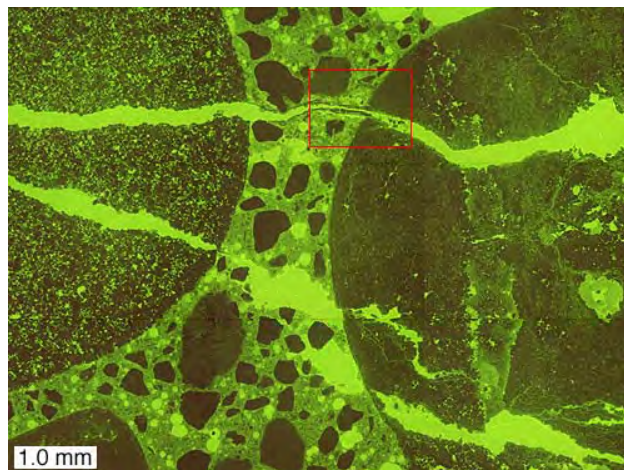
Figure D-30c. Thin-section view of cracked coarse aggregates from Core 26B-C, epifluorescent mode. Red box shows area of close-up view in Figure D-31c.

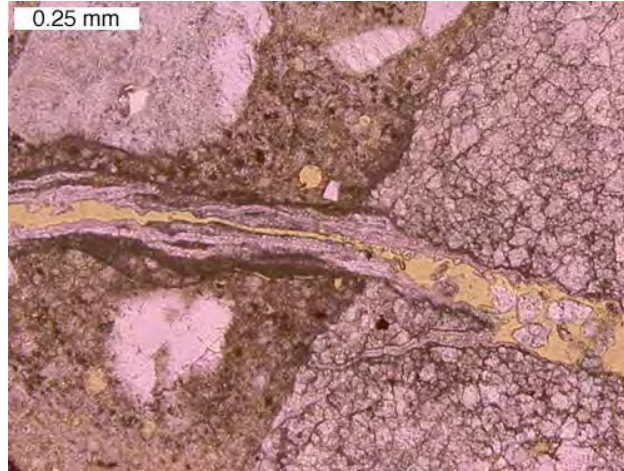
Figure D-31a. Thin section view of alkali-silica reaction product in crack, plane-polarized light, close-up of area outlined in red in Figure D-30a.

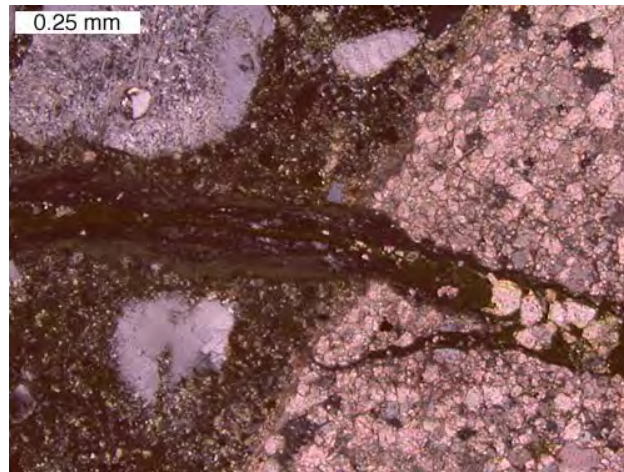
Figure D-31b. Thin section view of alkali-silica reaction product in crack, cross-polarized light, close-up of area outlined in red in Figure D-30b.

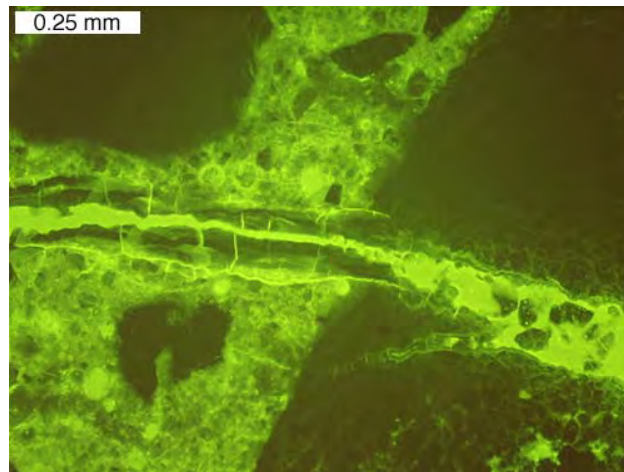
Figure D-31c. Thin section view of alkali-silica reaction product in crack, epifluorescent mode, close-up of area outlined in red in Figure D-30c.

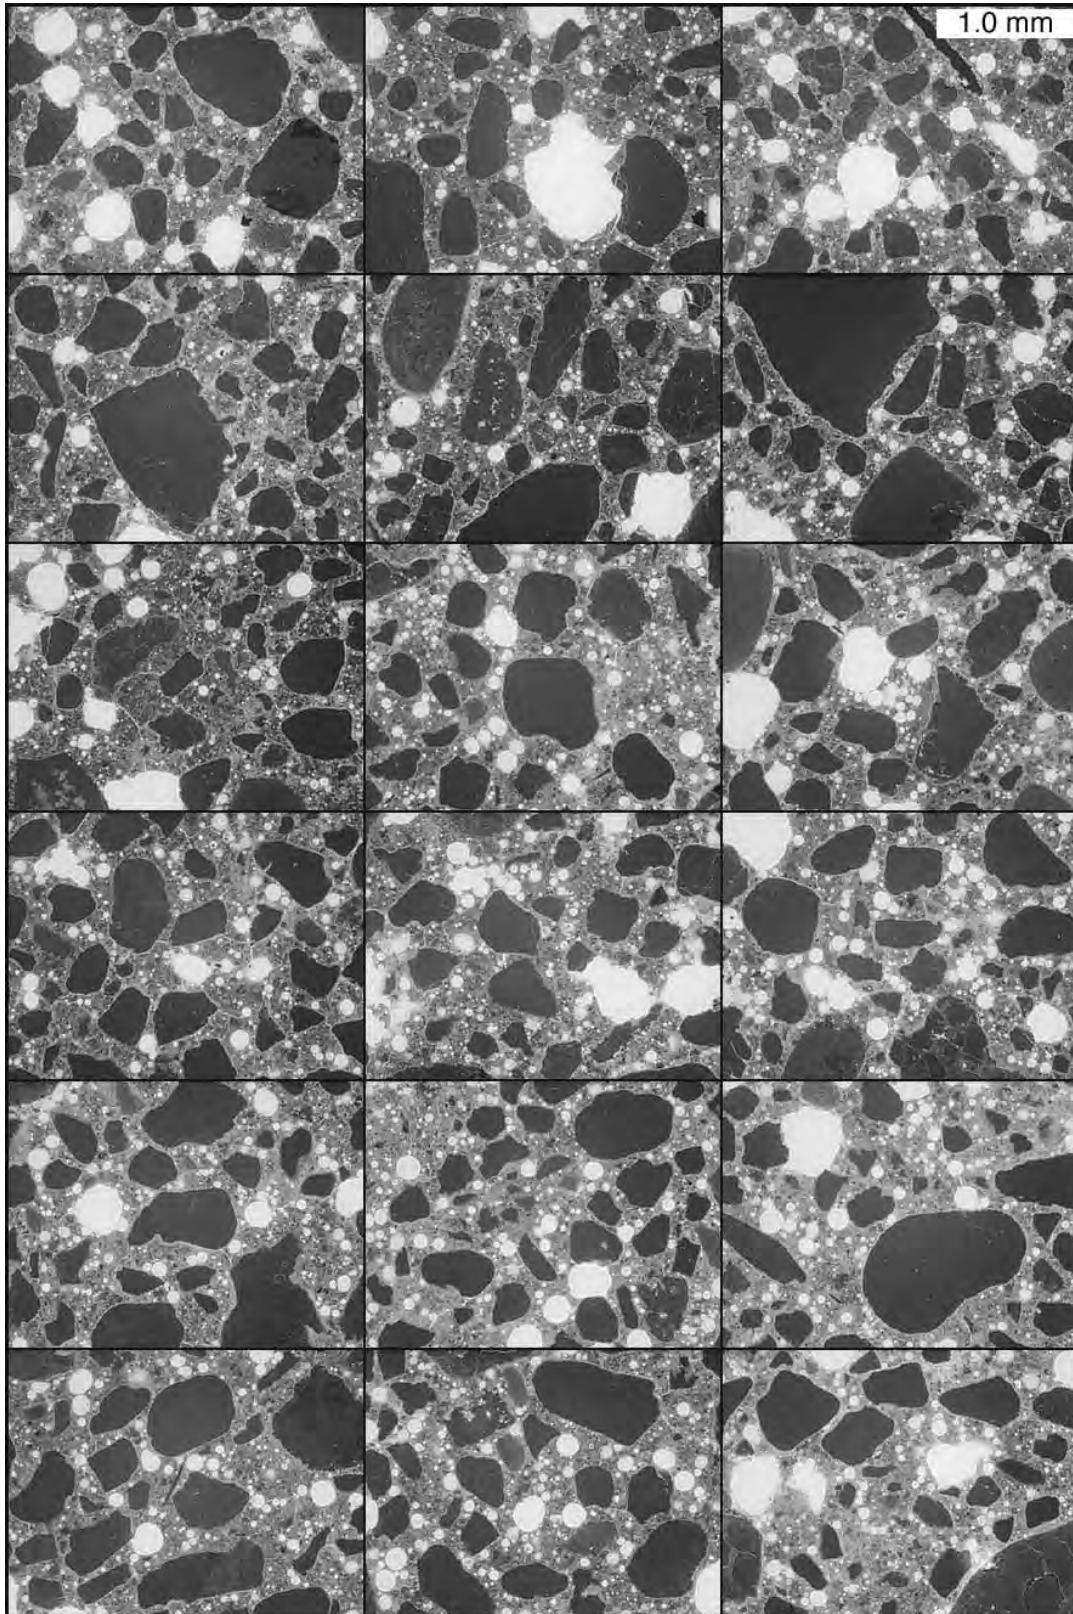
Figure D-32. Composite of 18 epifluorescent mode images used to measure cement paste capillary porosity in Core 26A-C.

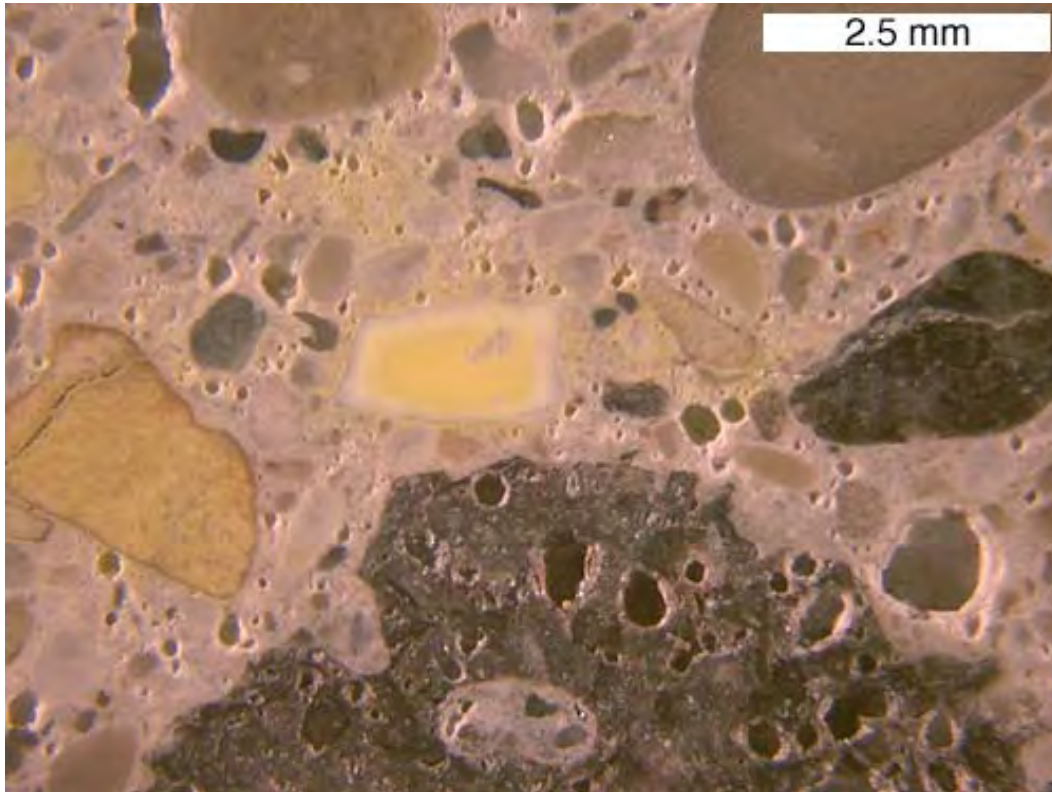
Figure D-39. Yellow stained chert sand particle from Core 4-A.
