APPENDIX A: PHOTOGRAPHS

General Photographs

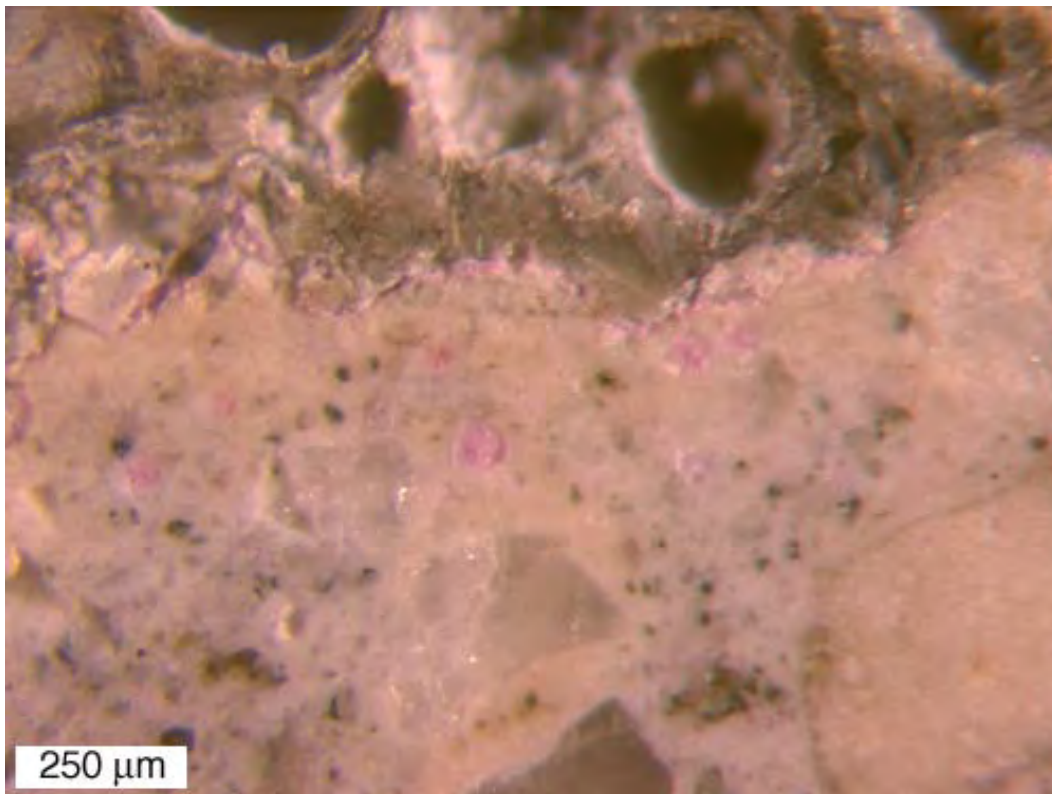
Figure D-40. A polished surface stained for sulfate minerals from Core 19-B.

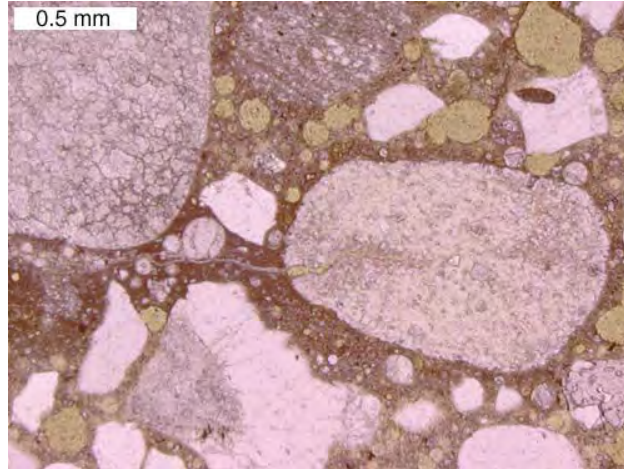
Figure D-41a. Thin-section view of a reactive chert sand particle from Core 4-A, plane-polarized light.

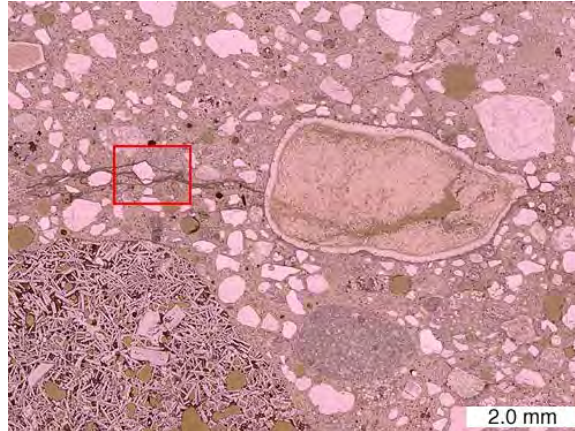
Figure D-43a. Thin-section view of a reactive chert sand particle with cracks extending into surrounding cement paste, Core 19-B, red box shows area of close-up in Figure D-44a, plane-polarized light.

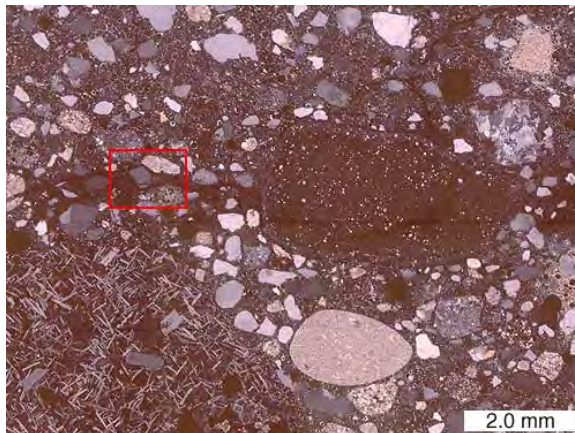
Figure D-43b. Thin-section view of a reactive chert sand particle with cracks extending into surrounding cement paste, Core 19-B, red box shows area of close-up in Figure D-44b, cross-polarized light.

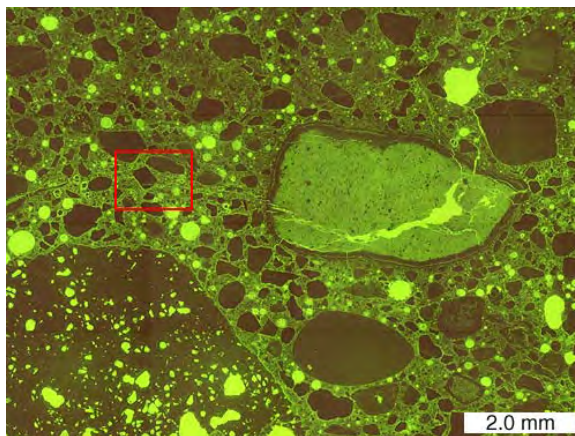
Figure D-43c. Thin-section view of a reactive chert sand particle with cracks extending far into the surrounding cement paste, Core 19-B, red box shows area of close-up in Figure D-44c, epifluorescent mode.

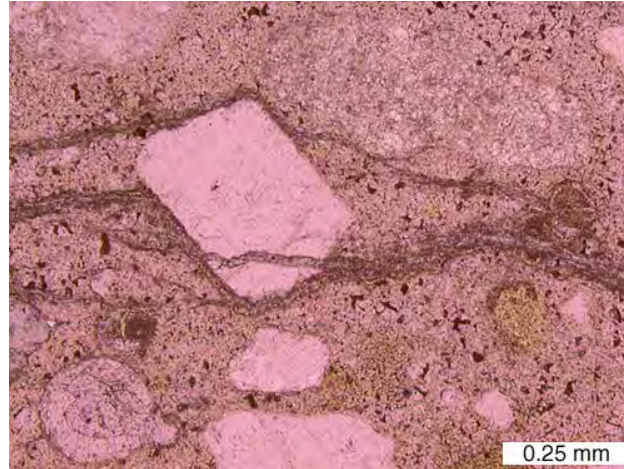
Figure D-44a. Close-up of area shown in Figure D-43a showing alkali-silica reaction product filled cracks and voids, Core 19-B, plane-polarized light.

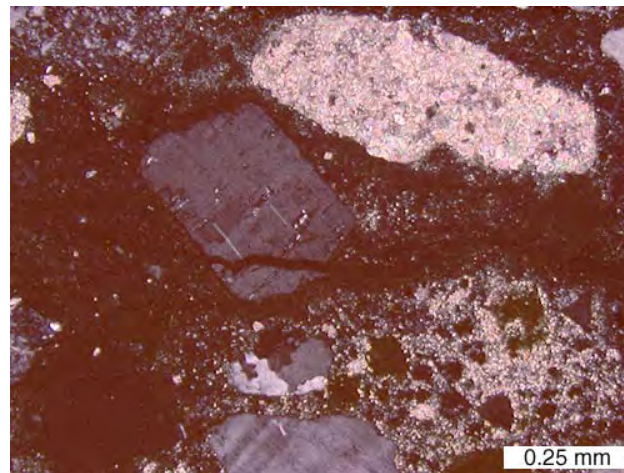
Figure D-44b. Close-up of area shown in Figure D-44b showing alkali-silica reaction product filled cracks and voids, Core 19-B, cross-polarized light.

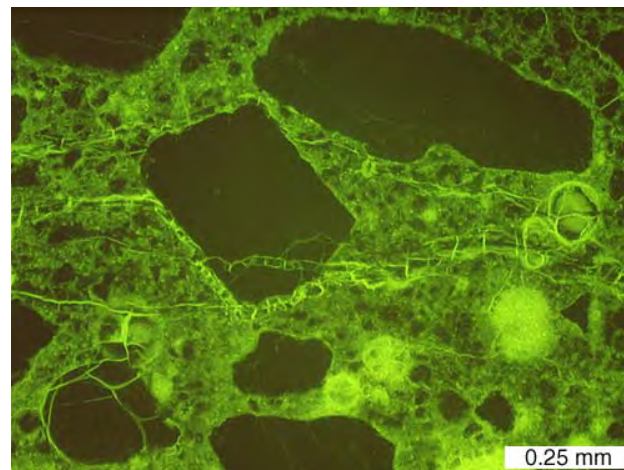
Figure D-44c. Close-up of area shown in Figure D-44c showing alkali-silica reaction product filled cracks and voids, Core 19-B, epifluorescent mode.

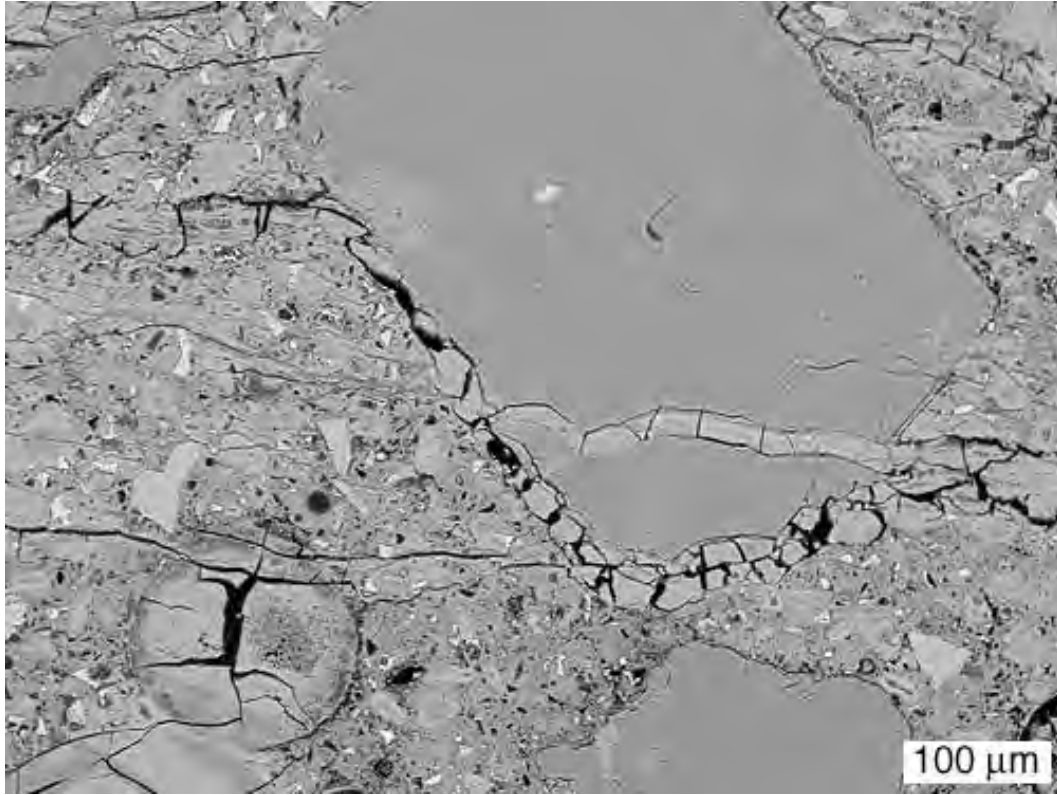
Figure D-45. Back-scattered electron image of cracks and void filled with alkali-silica reaction product, Core 19-B.

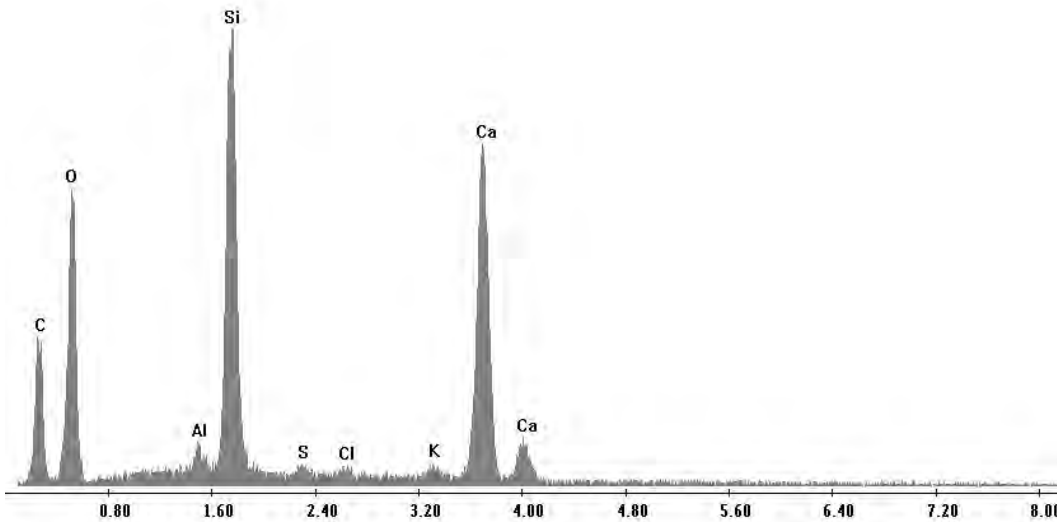
Figure D-46. X-ray energy spectrum collected from alkali-silica reaction product shown in Figure D-45.

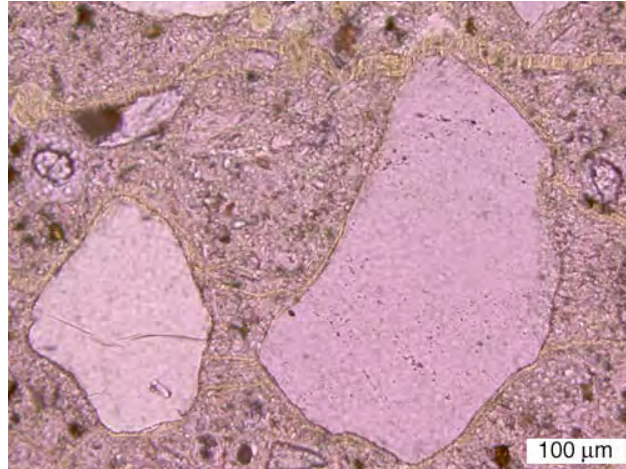
Figure D-47a. Thin-section view of ettringite filled crack along slag aggregate/cement paste interface, Core19-B, plane-polarized light.

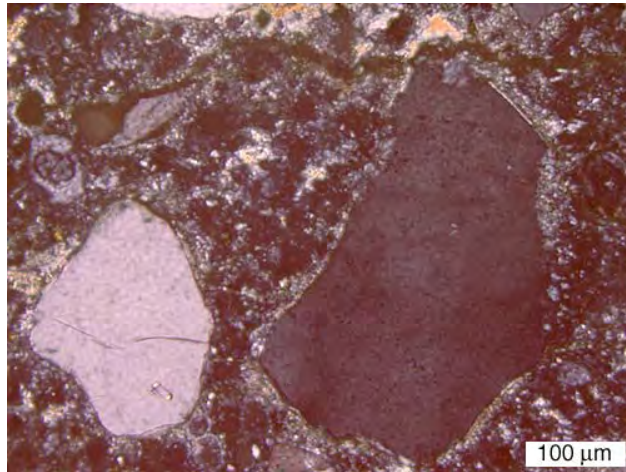
Figure D-47b. Thin-section view of ettringite filled crack along slag aggregate/cement paste interface, Core19-B, cross-polarized light.

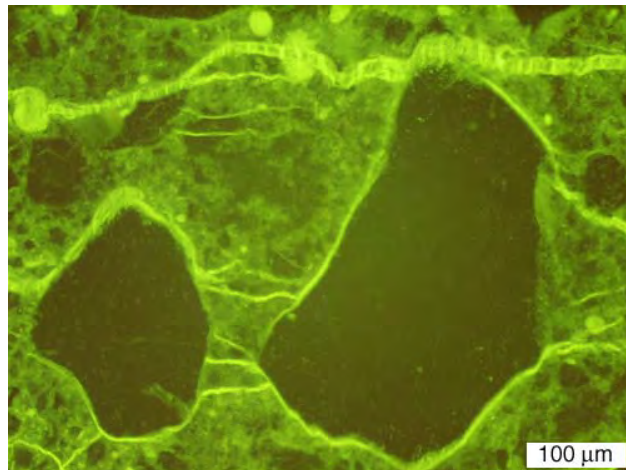
Figure D-47c. Thin-section view of ettringite filled crack along slag aggregate/cement paste interface, Core19-B, epifluorescent mode.

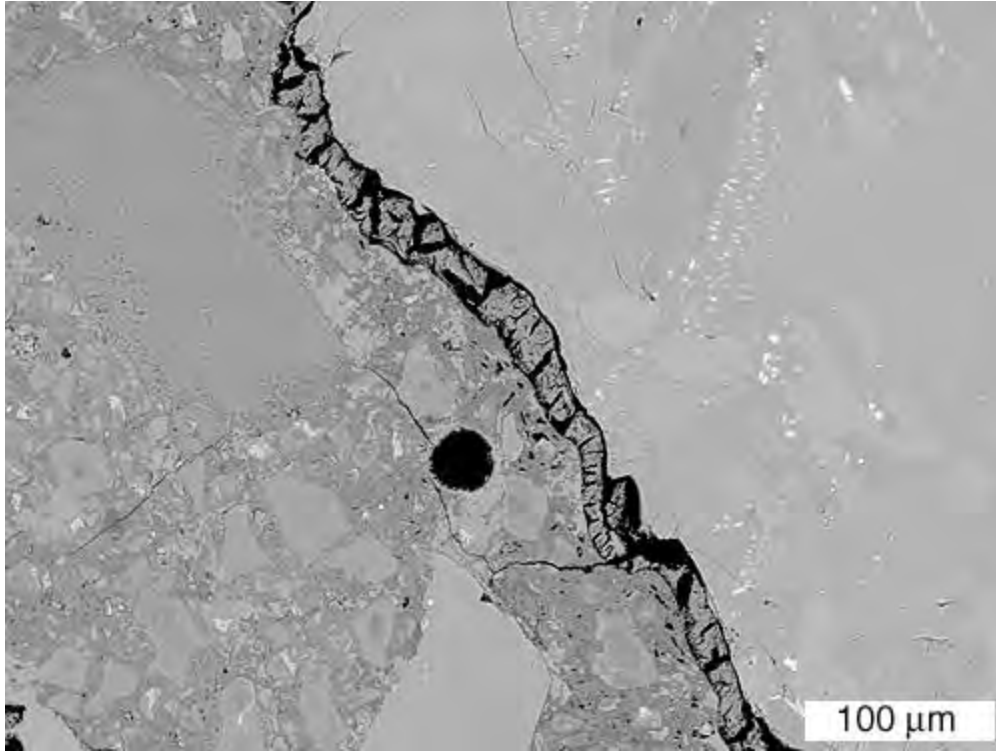
Figure D-48. Back-scattered electron image of ettringite filled crack along slag aggregate/cement paste interface, Core 19-B.

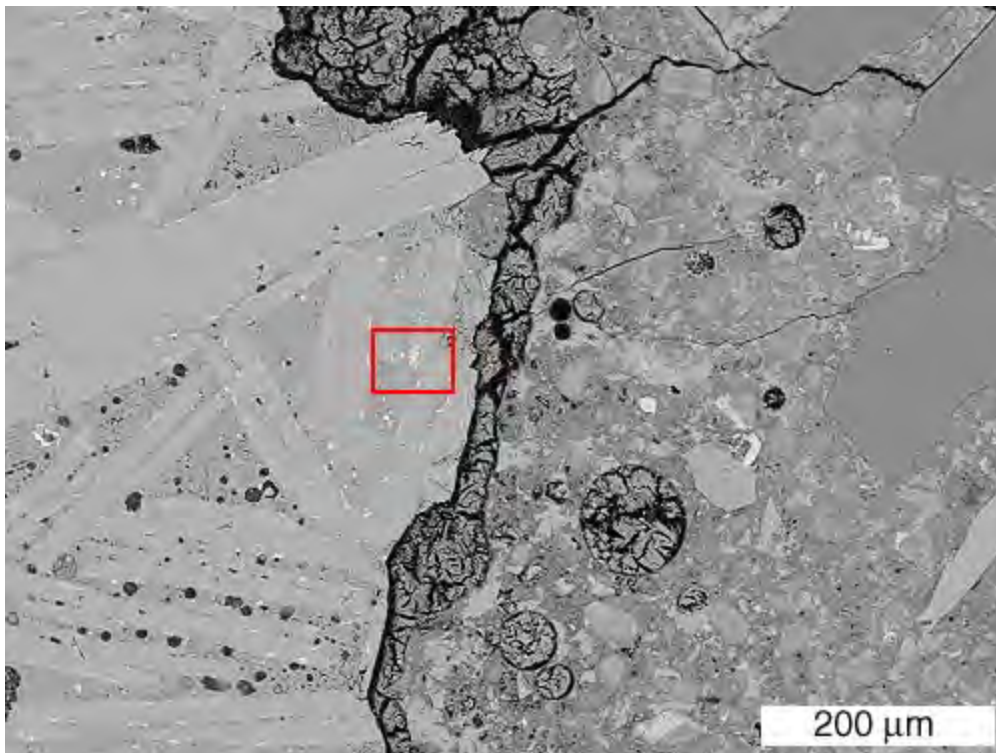
Figure D-49. Back-scattered electron image of ettringite filled crack along slag aggregate/cement paste interface in Core 19-B, red box shows area of close-up in Figure D-51.

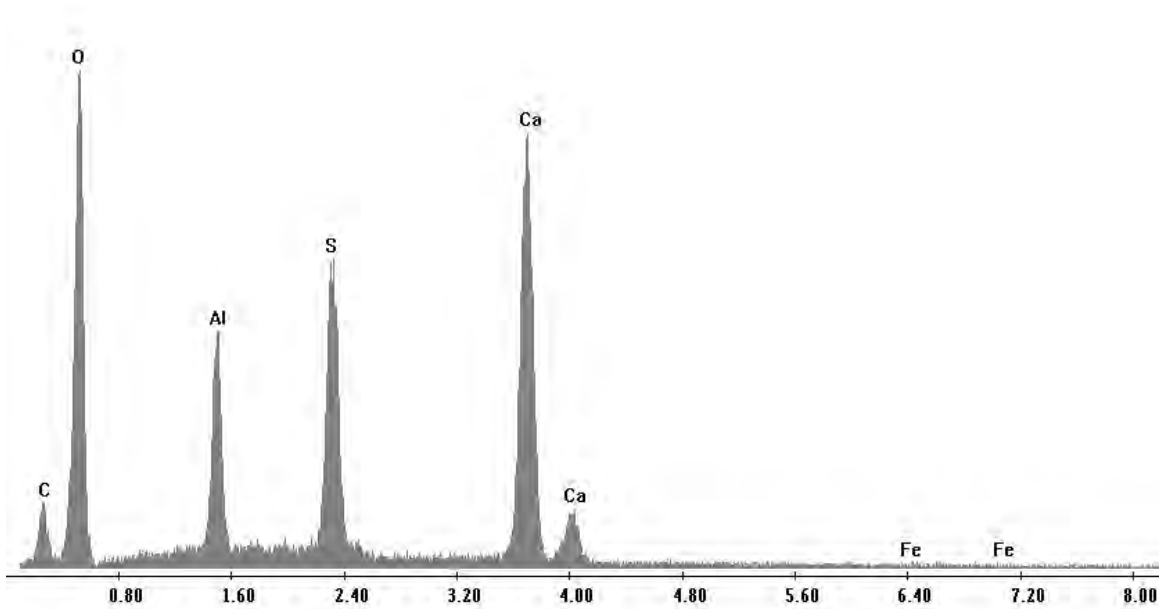
Figure D-50. X-ray energy spectrum collected from ettringite filled crack shown in Figure D-49.

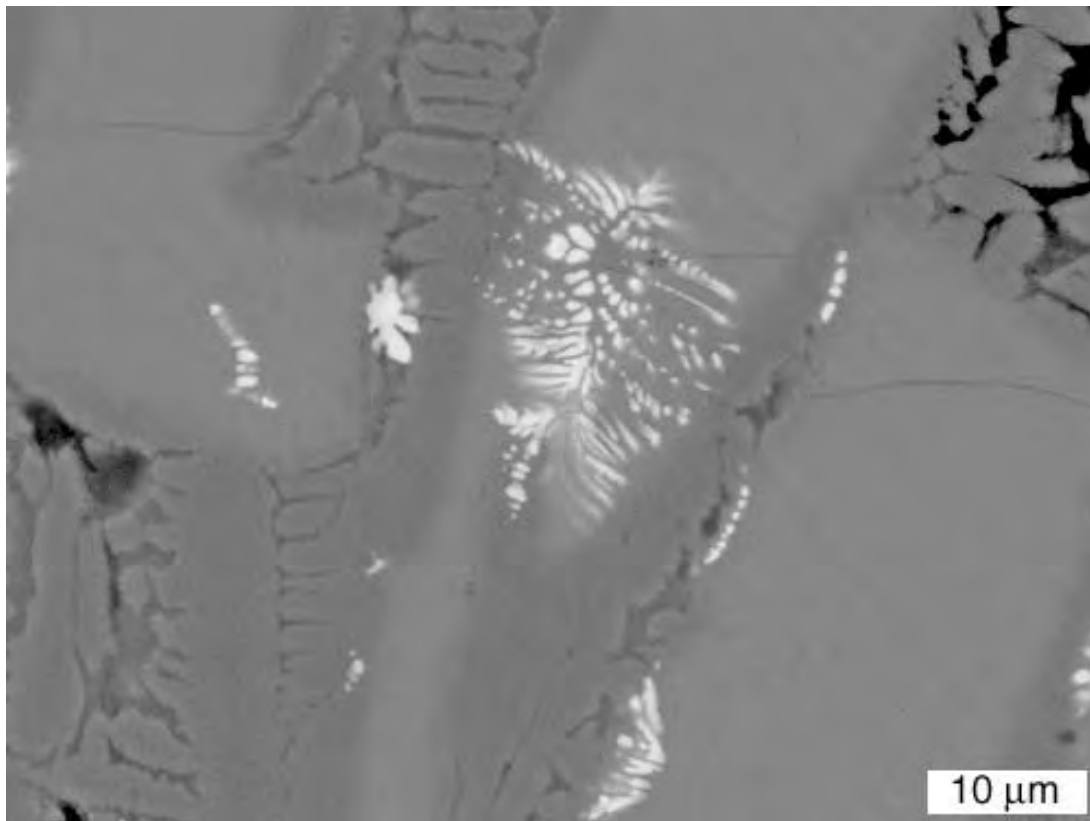
Figure D-51. Close-up of area outlined in red in Figure D-49 with calcium sulfide dendrites in slag aggregate, Core 19-B.

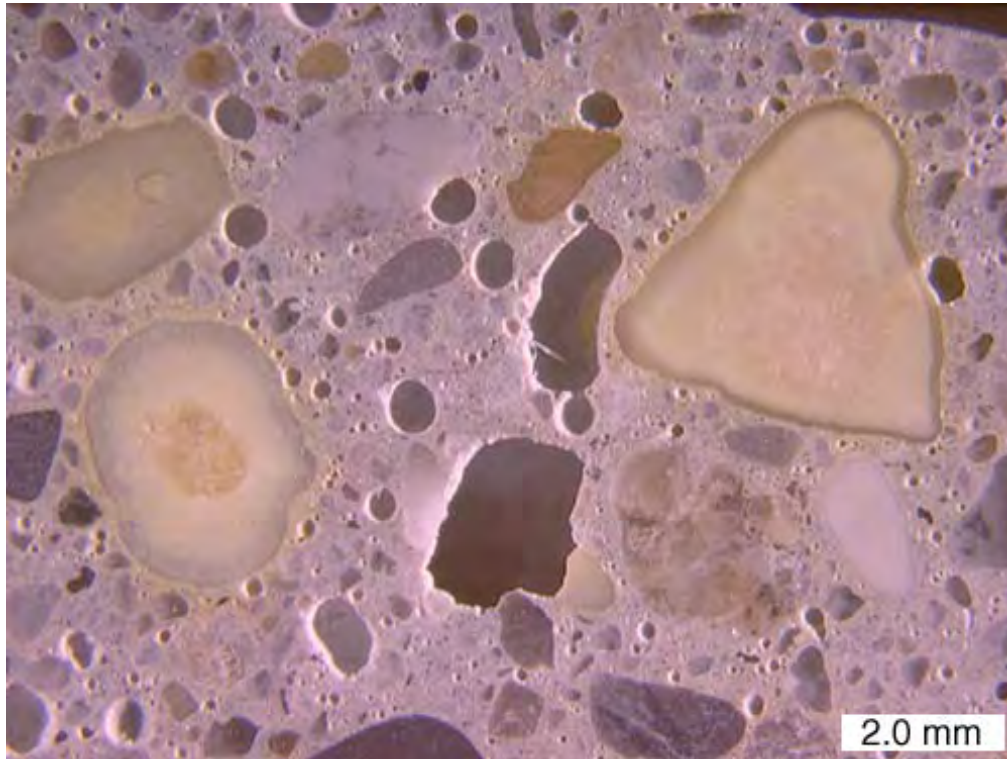
Figure D-62. Yellow stained chert fine aggregate particle, Core 28-B.

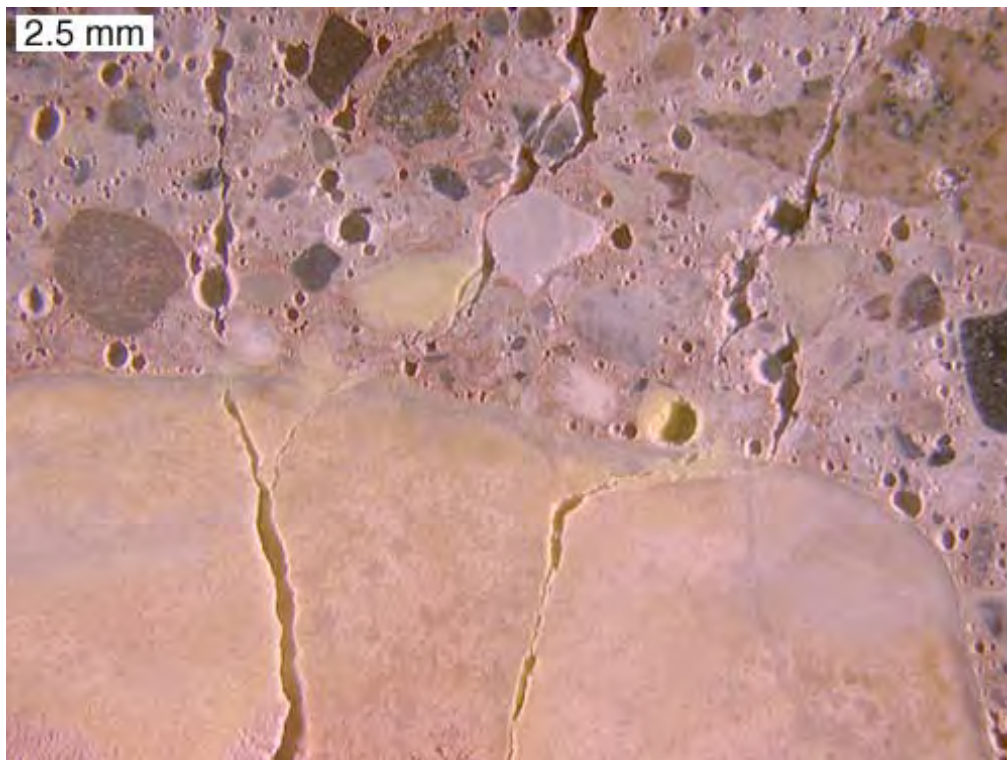
Figure D-63. Yellow stained chert coarse aggregate with cracks, core 12-C.

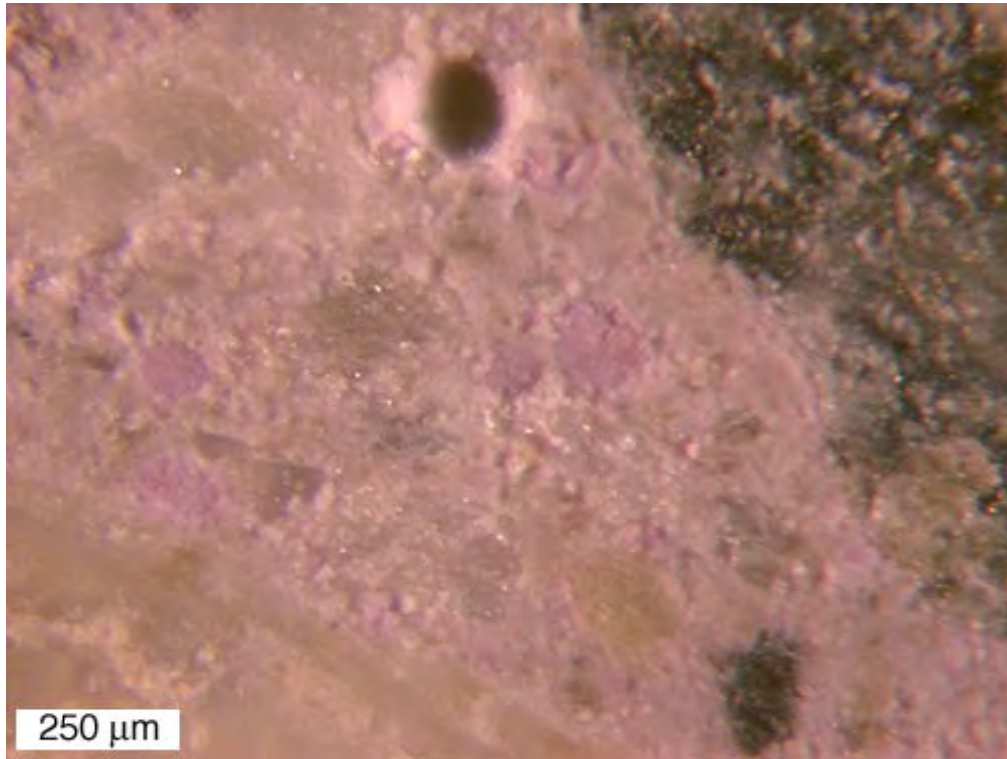
Figure D-64. Pink stained ettringite deposits in entrained air voids, Core 12-B.

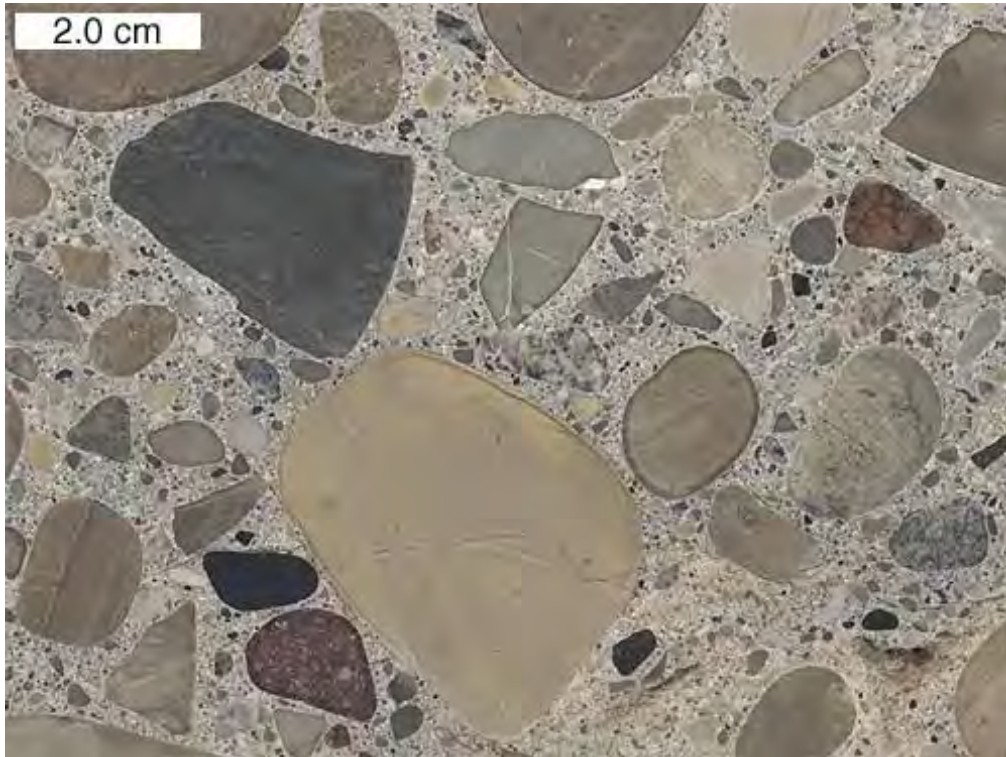
Figure D-65a. View of polished slab with cracked carbonate coarse aggregates, Core 22-B.

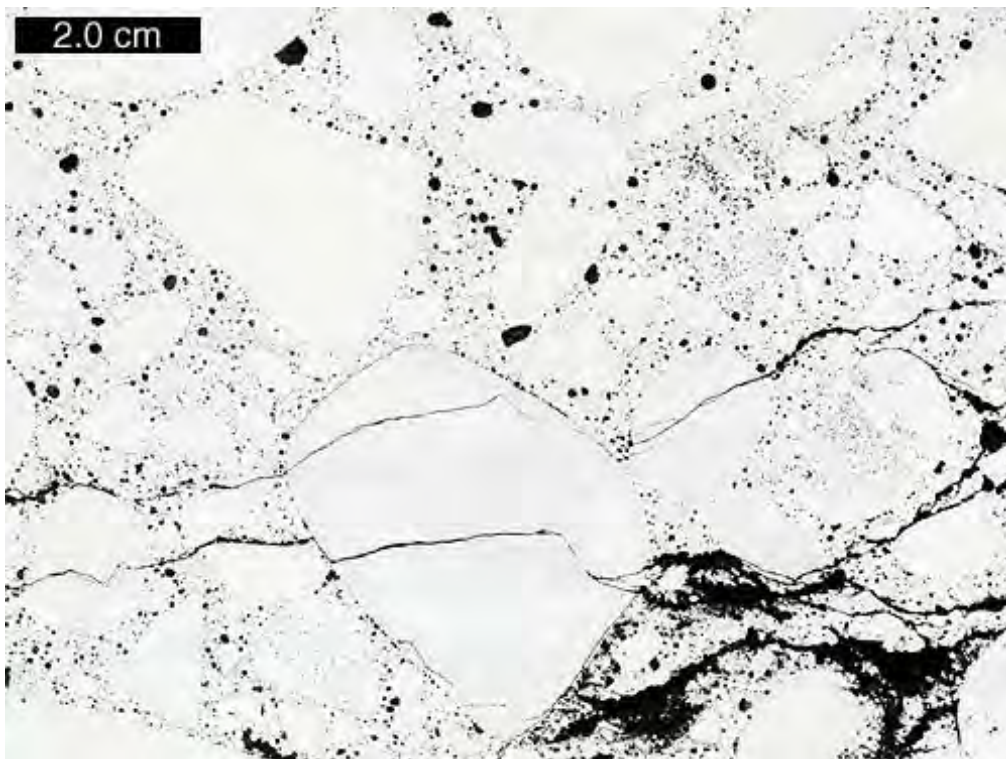
Figure D-65b. Negative image of area shown in Figure 7a after painting surface black and pressing with white powder to enhance cracks, Core 22-B.

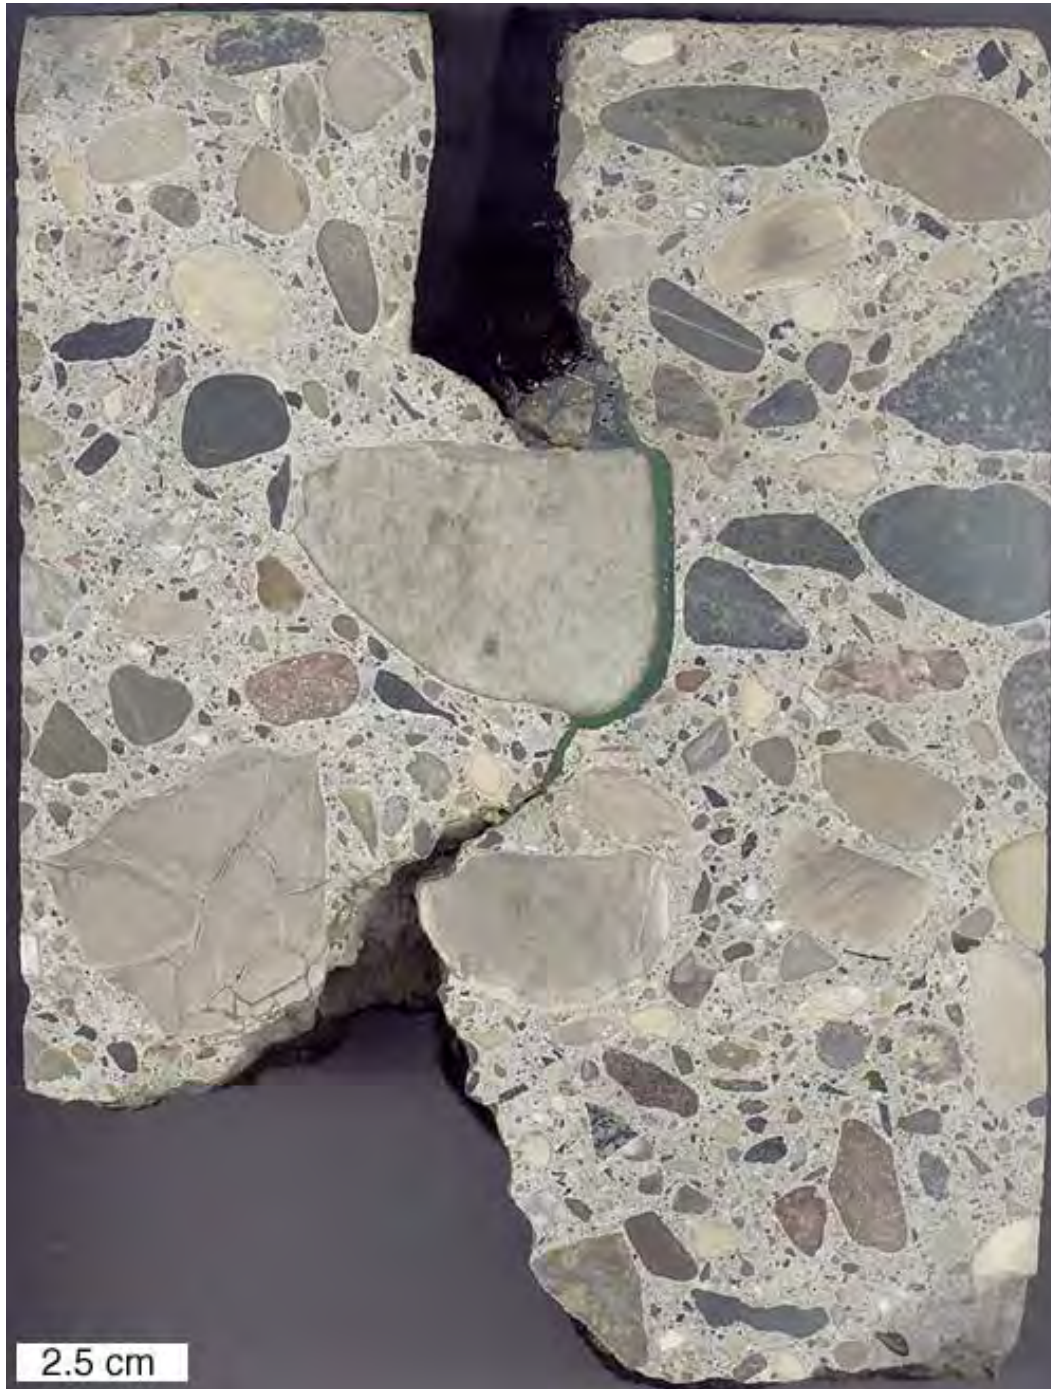
Figure D-66a. View of polished slab with cracked carbonate coarse aggregates, Core 12-B.

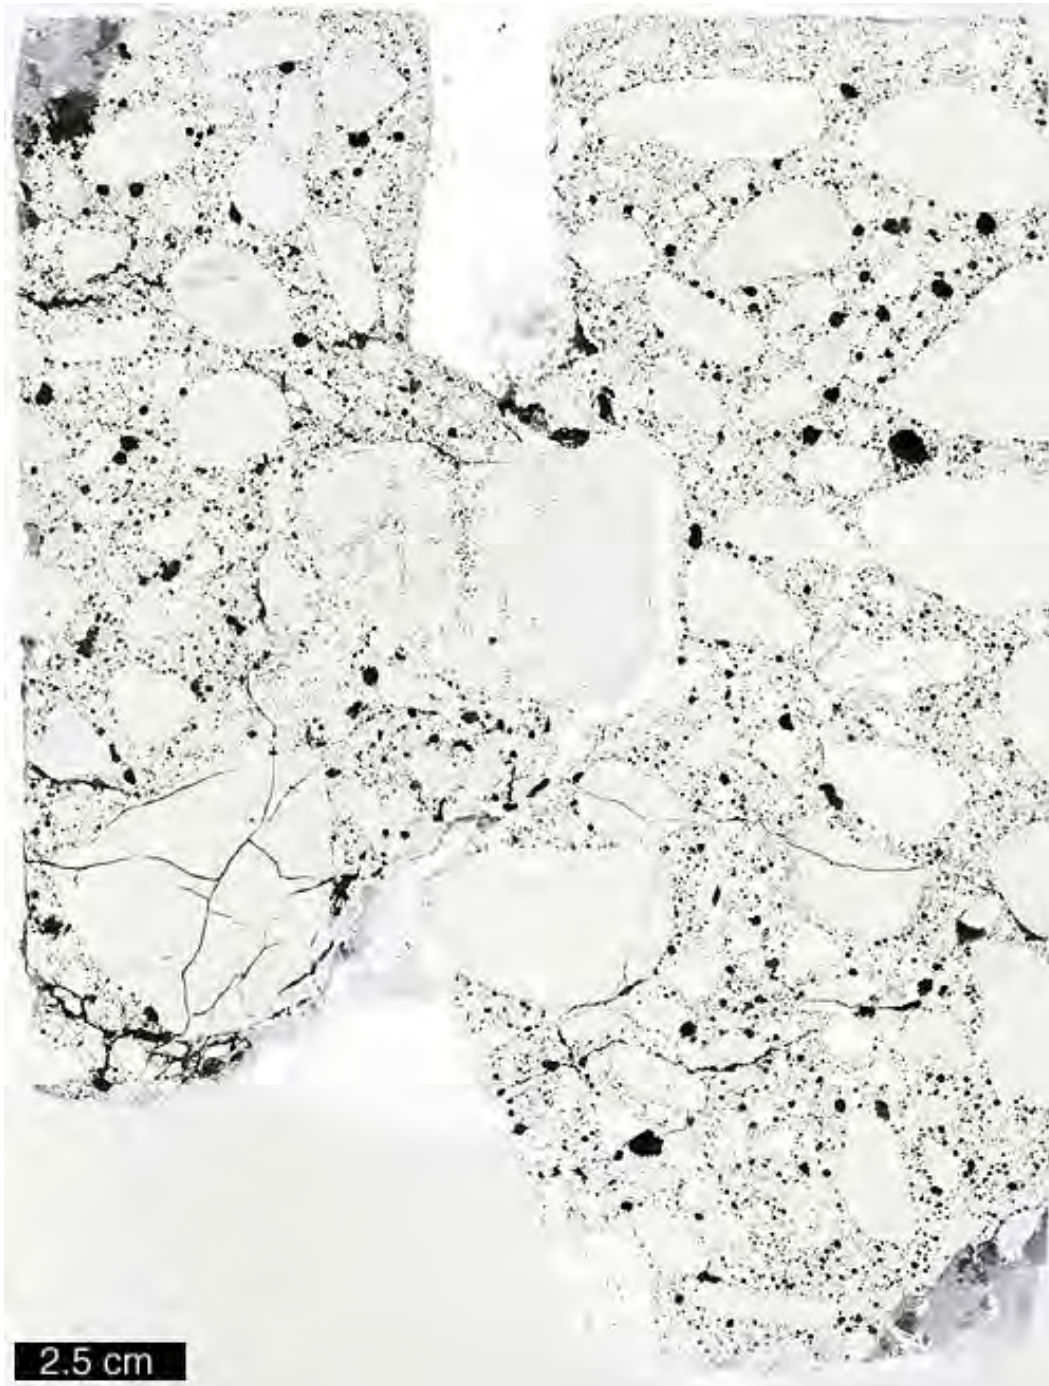
Figure D-66b. Negative image of area shown in Figure 8a after painting surface black and pressing with white powder to enhance cracks, Core 12-B.

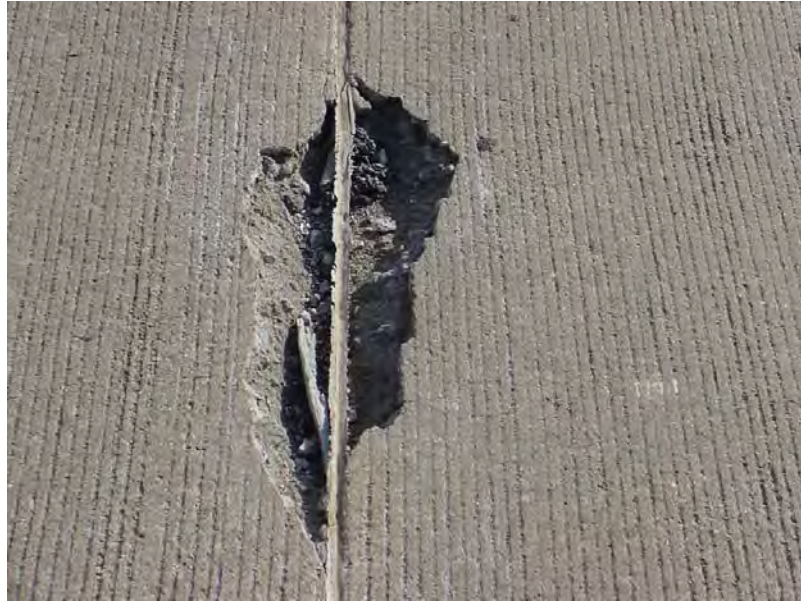
Figure 1. Spall at transverse joint (note paste disintegration).

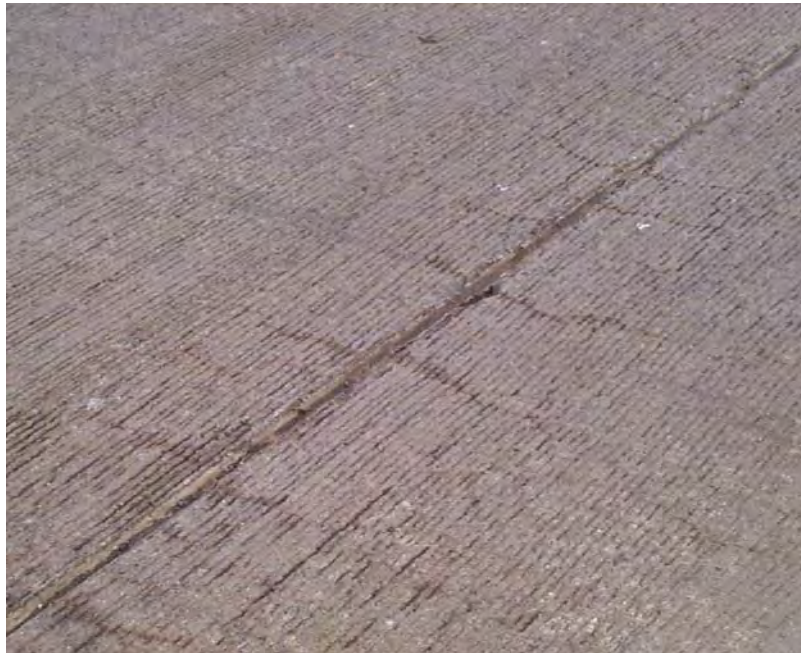
Figure 2. Cracking running perpendicular to transverse joint.

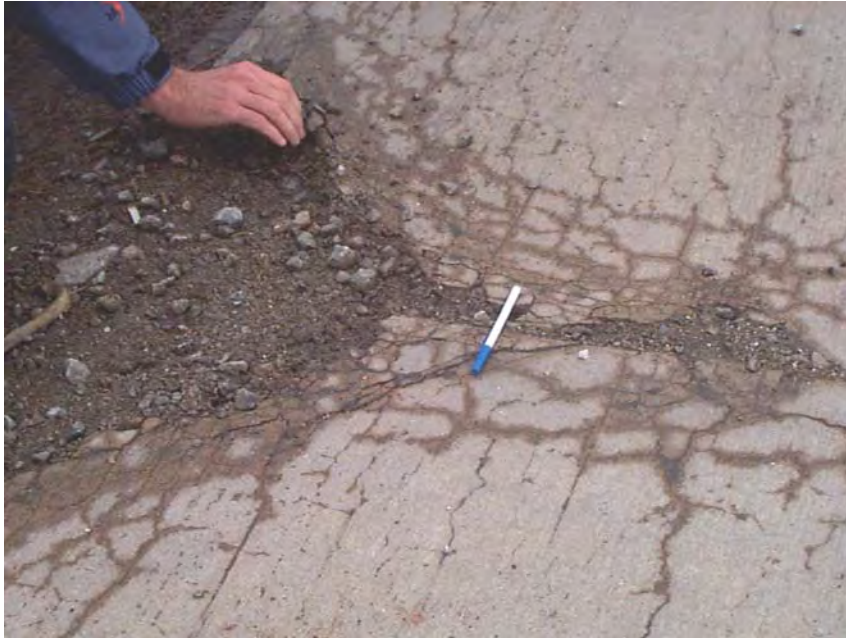
Figure 3. Complete disintegration of shoulder at transverse joint.

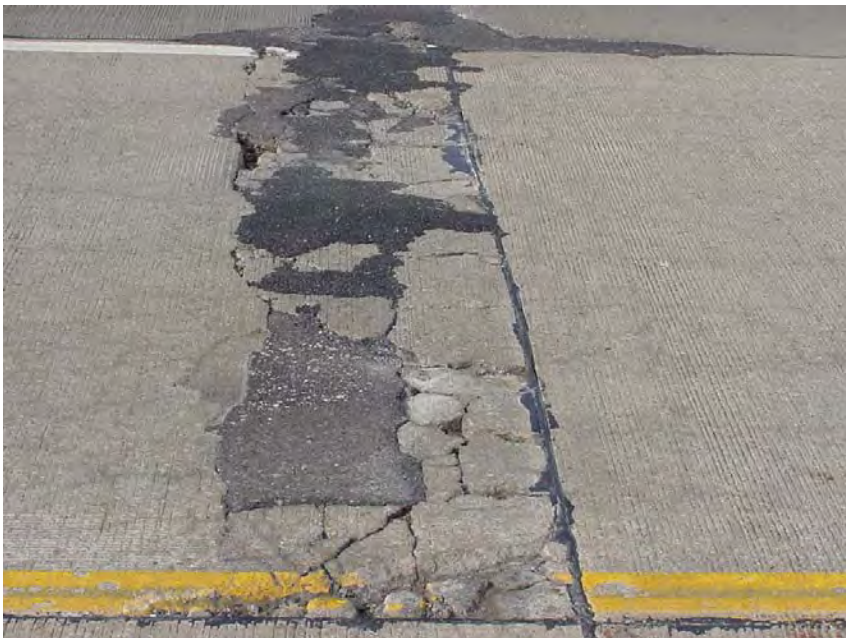
Figure 4. Transverse joint deterioration and map cracking.

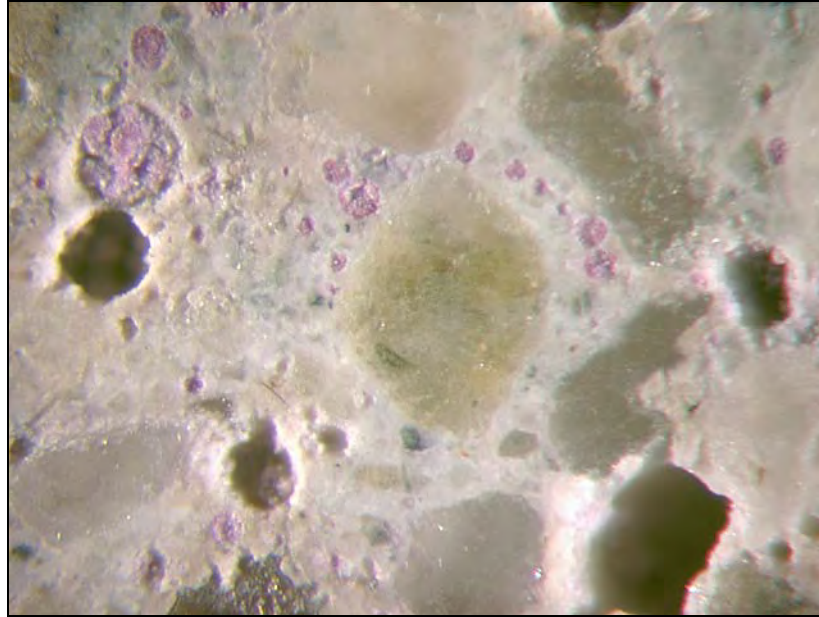
Figure 7: Microscope image of polished slab surface from core 29a (CS 82291) stained for sulfate minerals. Ettringite filled air voids are stained pink, magnified 83x.

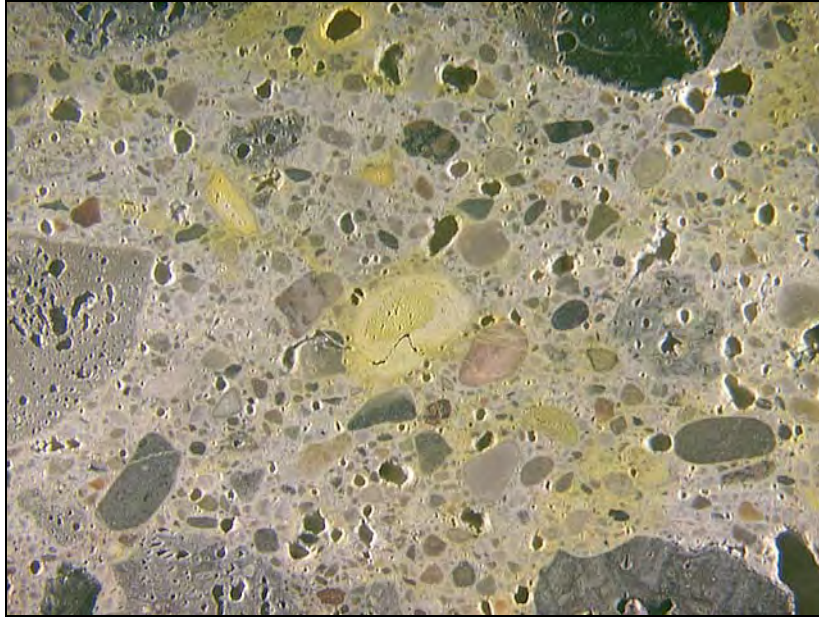
Figure 8a: Close-up of a polished and stained surface from core 22 (CS 25031-30798A). Alkali-silica reactive stained particles appear yellow and exhibit cracking, magnified 6x.

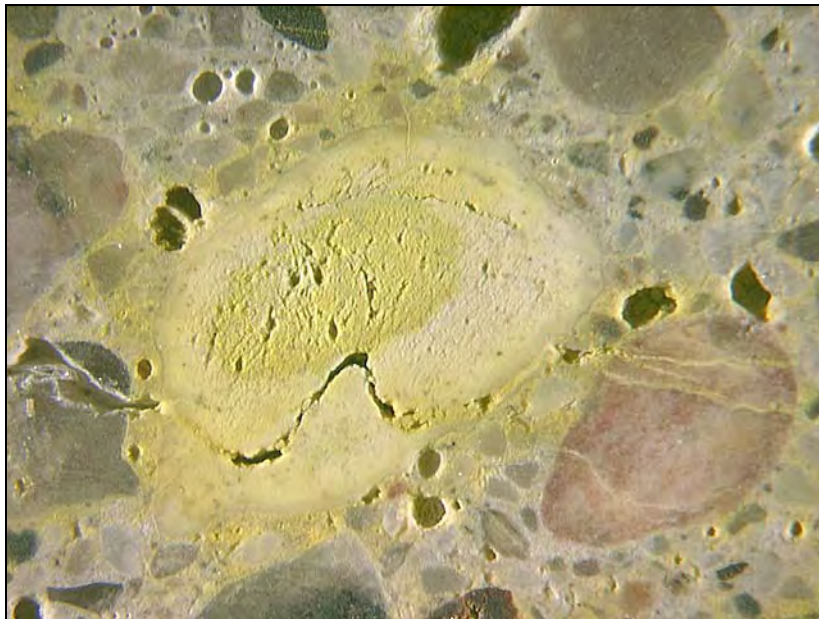
Figure 8b: A close-up of Figure 8a, showing cracked reactive chert particle, with cracks propagating through neighboring non-chert sand particles, magnified 15x.

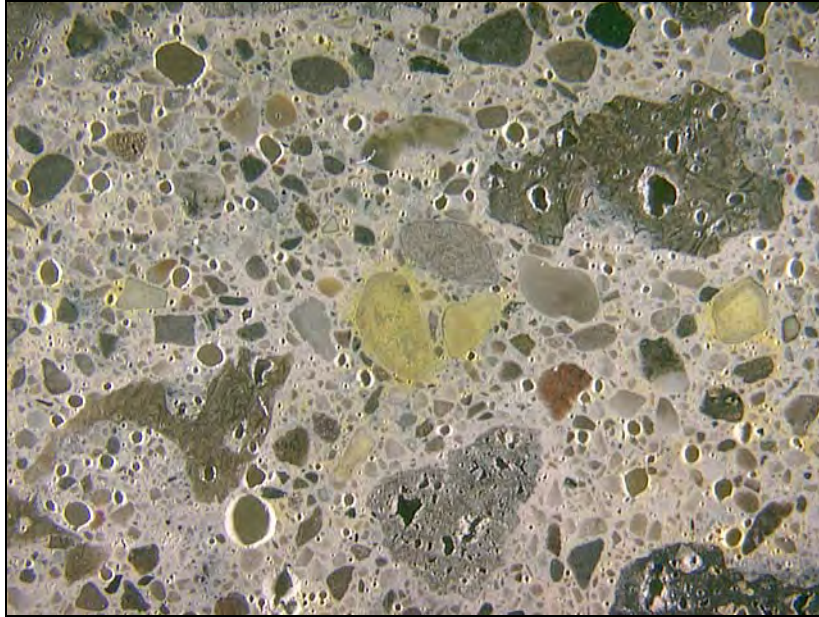
Figure 9a: Close-up of a polished and stained surface from core 9 (CS 25031-31018A). Alkali-silica reactive stained particles appear yellow but do not exhibit cracking, magnified 6x.

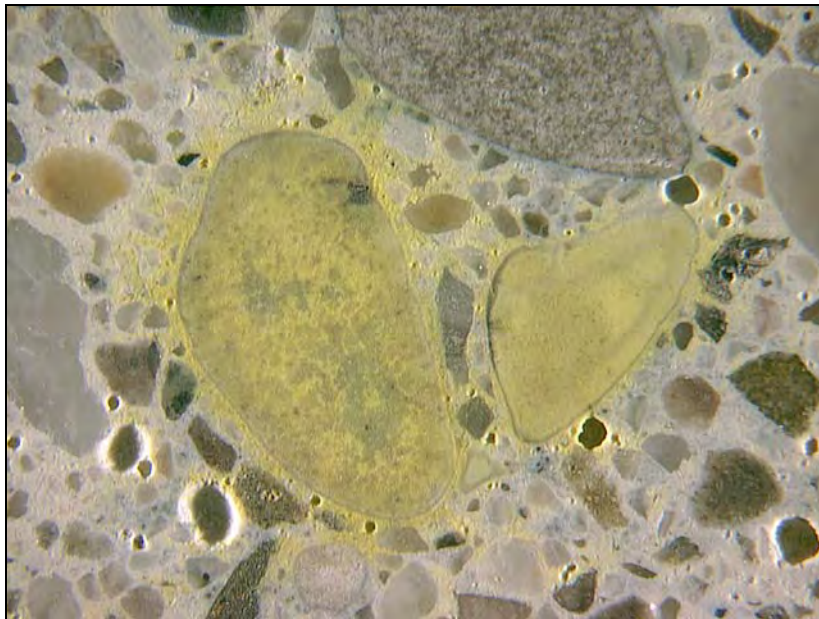
Figure 9b: A close-up of Figure 9a, showing yellow stained reactive chert particle, and the absence of any related cracking, magnified 15x.

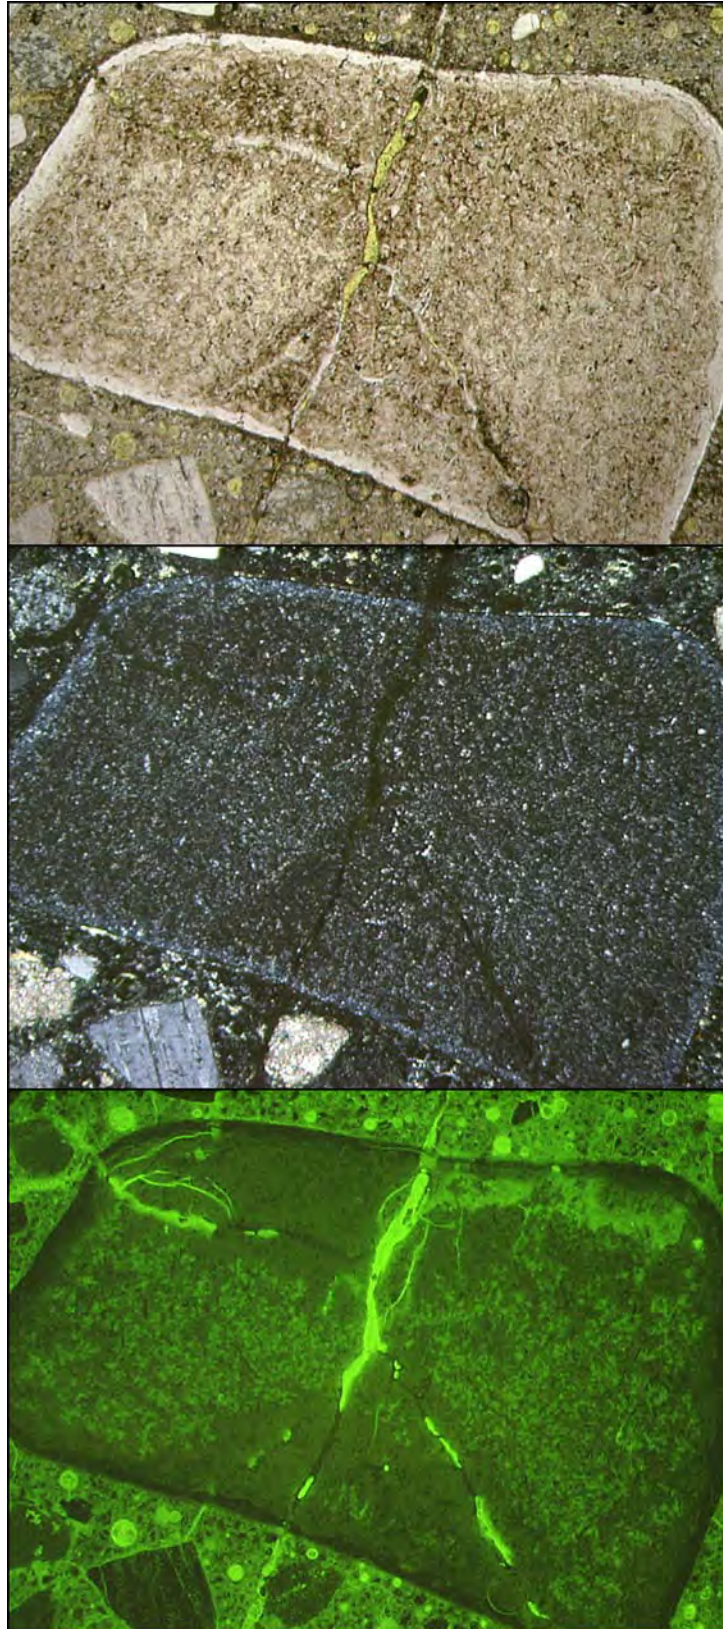
Figure 10: Example of cracked reactive chert from core 19b (CS 50011), magnified 40x. From top to bottom, plane polarized light, cross polarized light, and epifluorescent illumination.

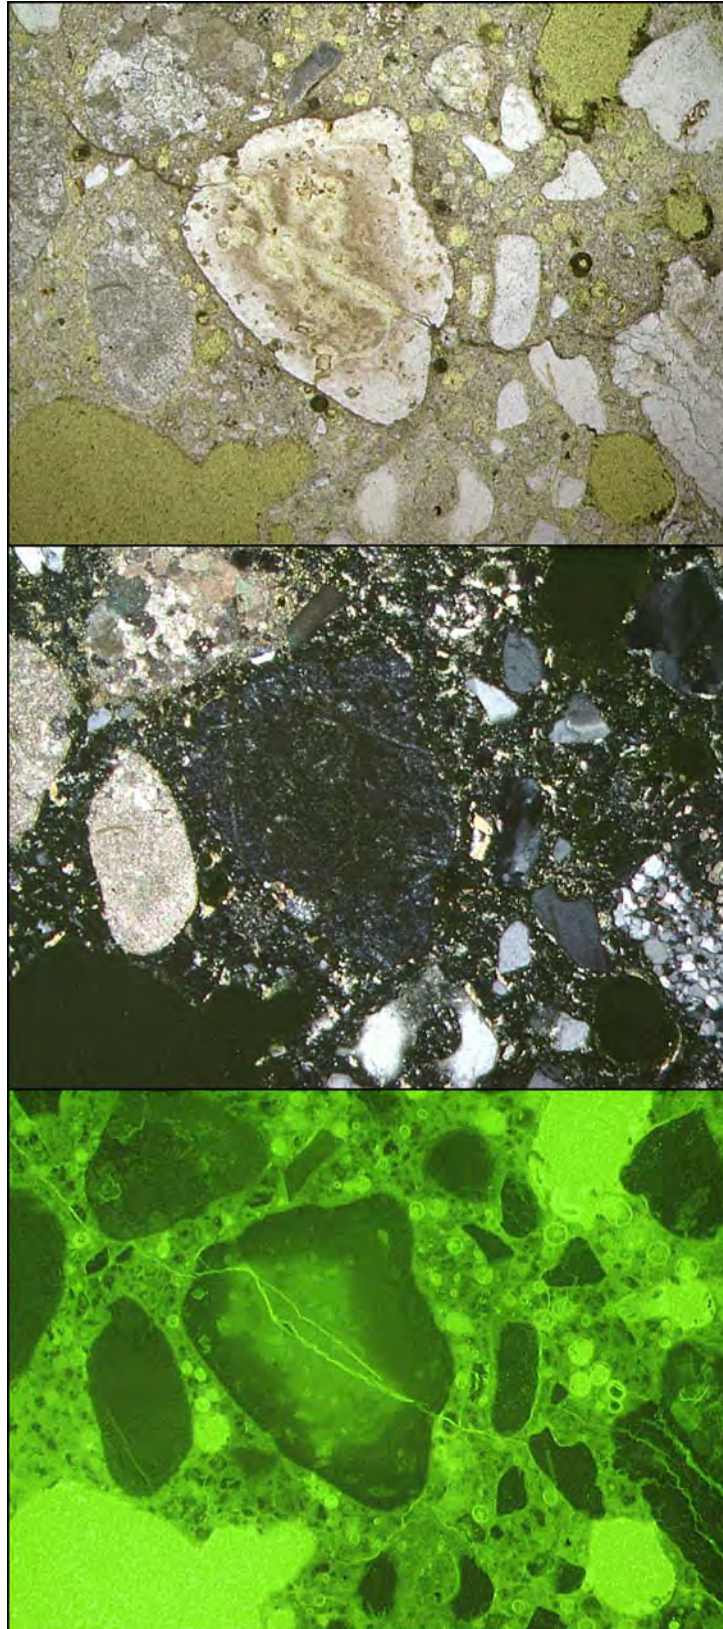
Figure 11: Example of cracked reactive chert from core 29a (CS 82291), magnified 40x. From top to bottom, plane polarized light, cross polarized light, and epifluorescent illumination.
