APPENDIX A: PHOTOGRAPHS

General Photographs

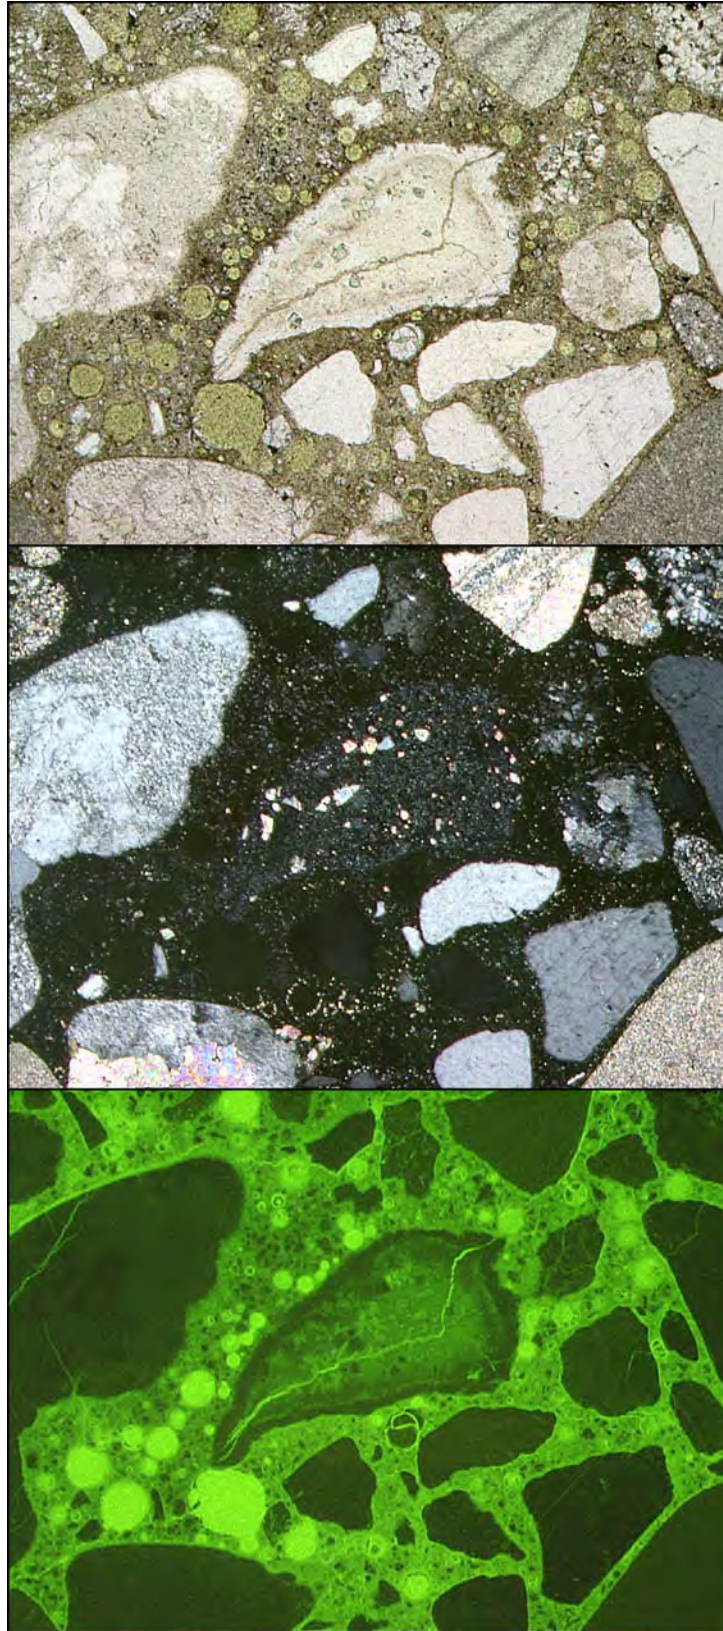
Figure 12: Example of cracked reactive chert from core 4a (CS 25031-30798A), magnified 40x. From top to bottom, plane polarized light, cross polarized light, and epifluorescent illumination.

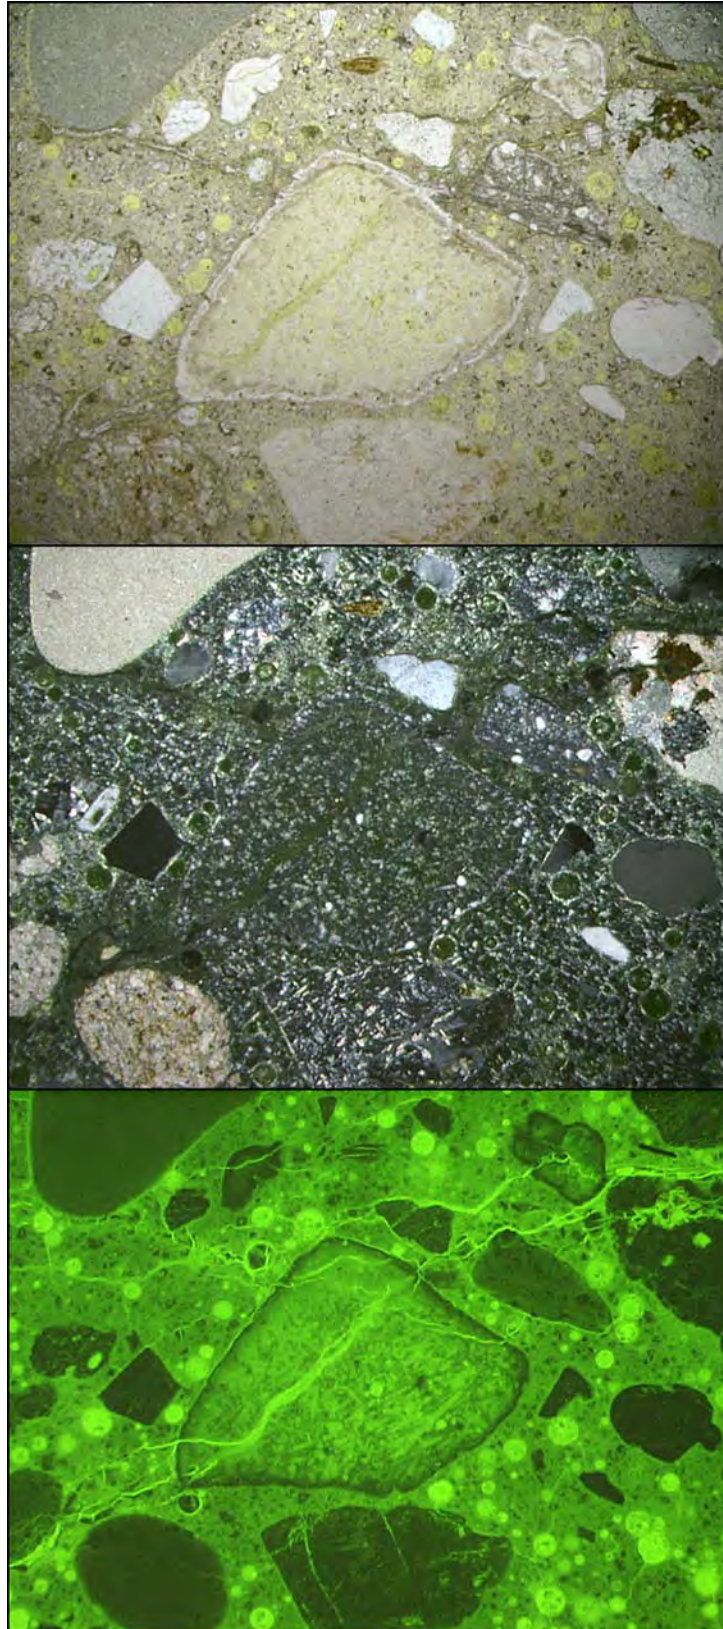
Figure 13: Example of cracked reactive chert from core 15 (CS 25031-30798A), magnified 40x. From top to bottom, plane polarized light, cross polarized light, and epifluorescent illumination.

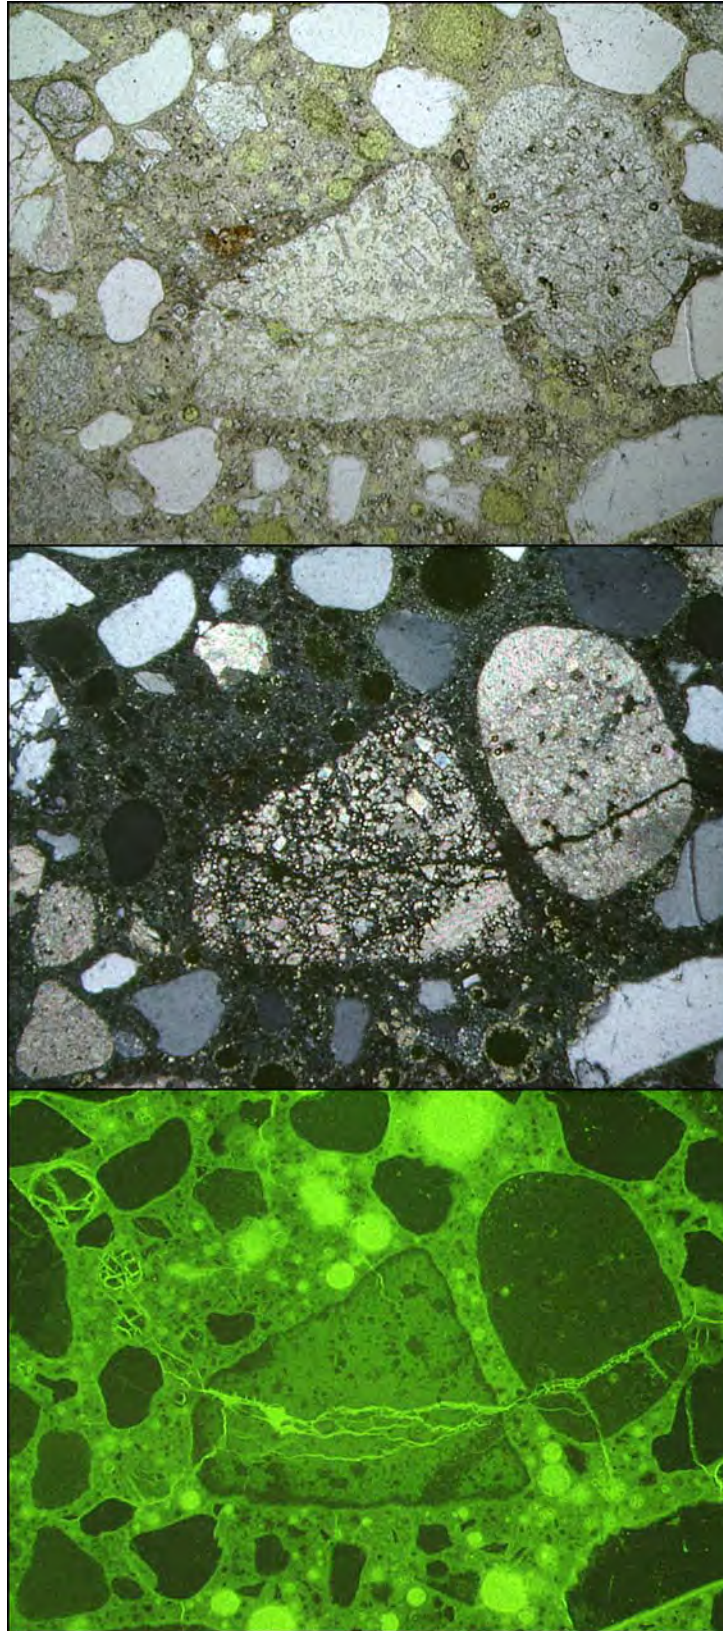
Figure 14: Example of cracked reactive chert from core 22 (CS 25031-30798A), magnified 40x. From top to bottom, plane polarized light, cross polarized light, and epifluorescent illumination.

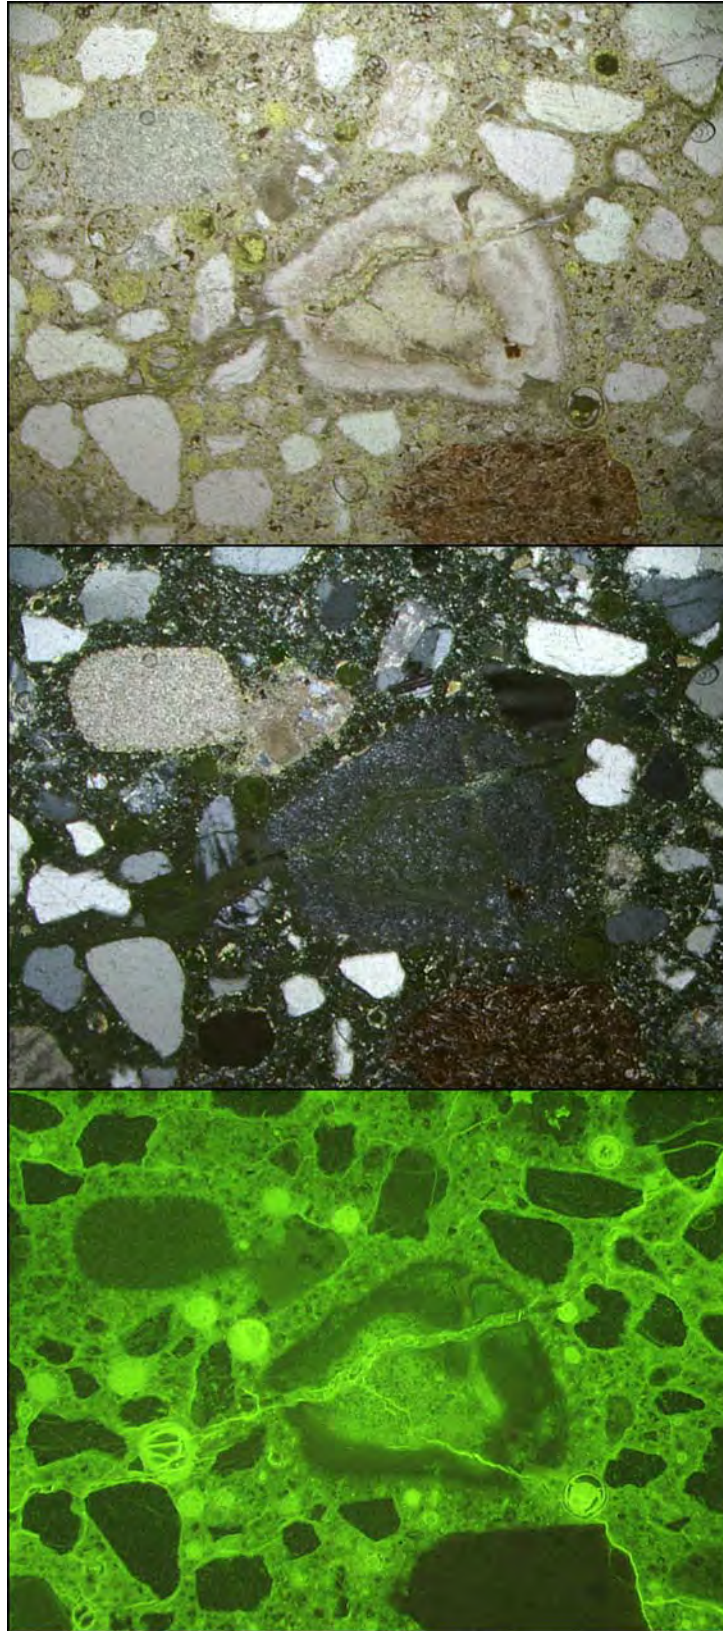
Figure 15: Example of cracked reactive chert from core 32 (CS 25031-30798A), magnified 40x. From top to bottom, plane polarized light, cross polarized light, and epifluorescent illumination.

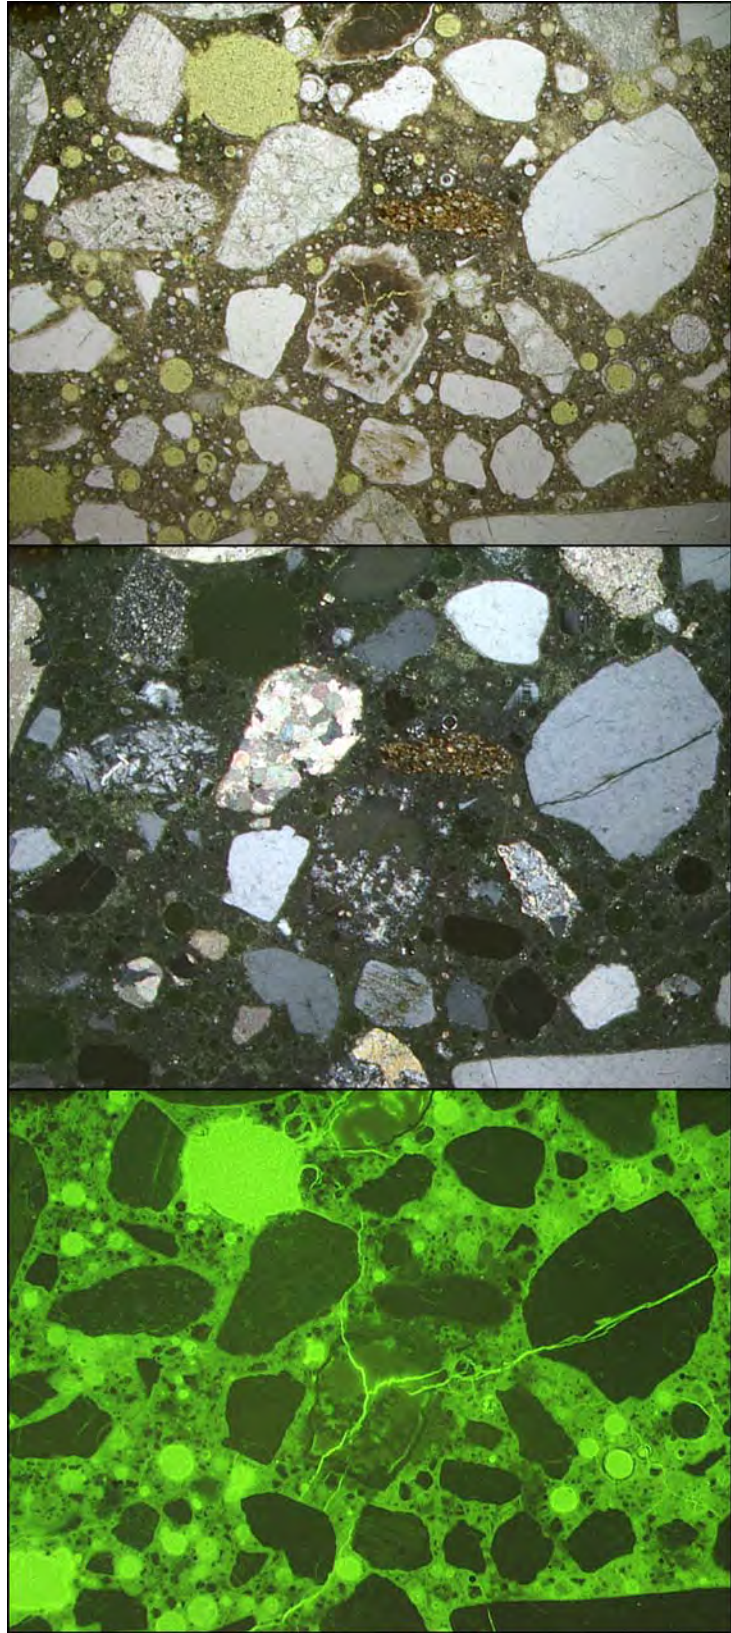
Figure 16: Example of cracked reactive chert from core 38 (CS 25031-30798A), magnified 40x. From top to bottom, plane polarized light, cross polarized light, and epifluorescent illumination.

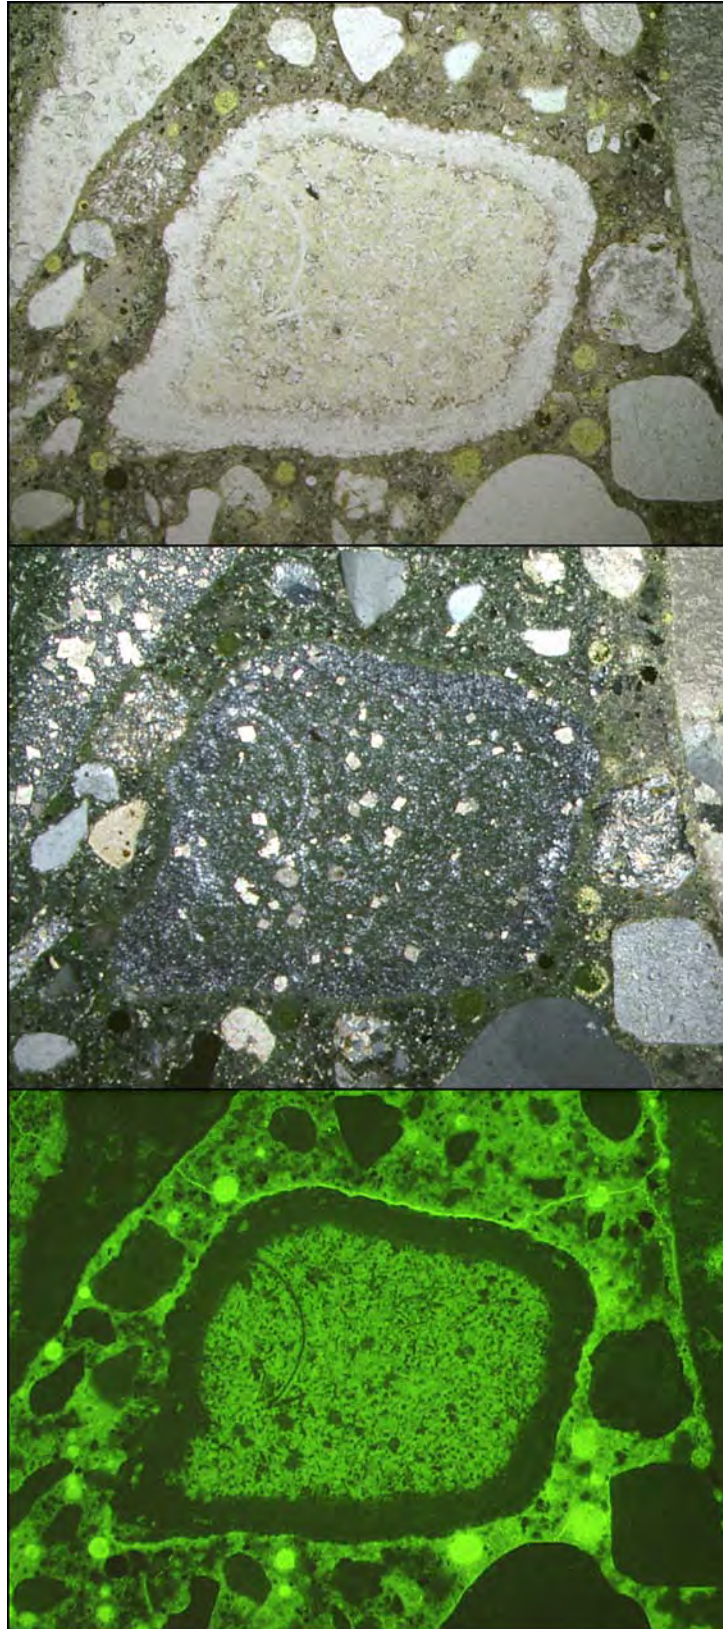
Figure 17: Example of reactive chert from core 1 (CS 25031-31018A), magnified 40x. From top to bottom, plane polarized light, cross polarized light, and epifluorescent illumination.

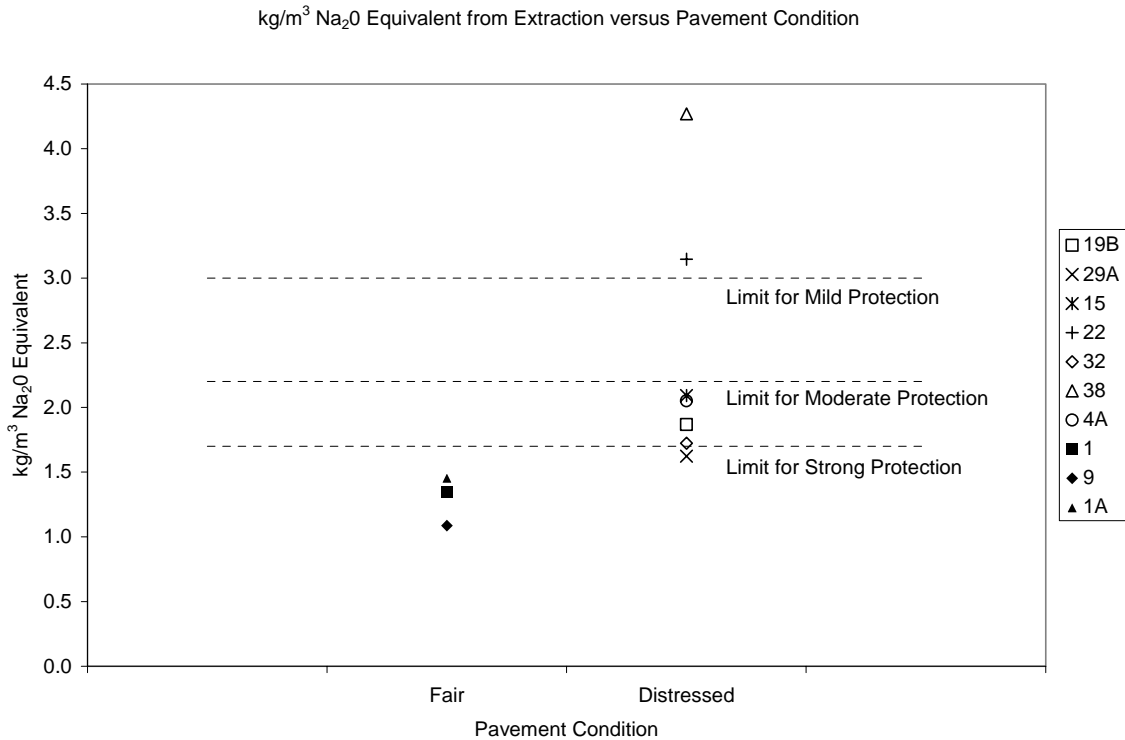
Figure 20: Available alkalis plotted against pavement condition.

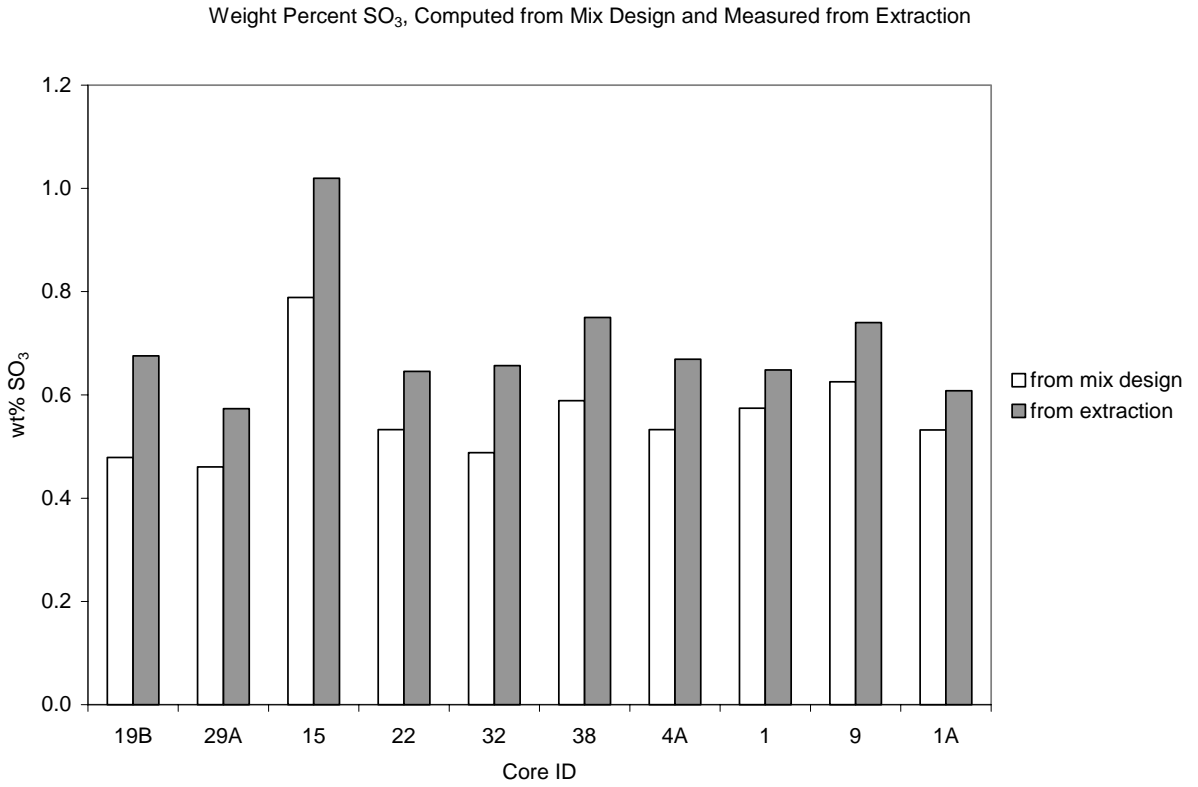
Figure 21. Results of sulfate analysis.

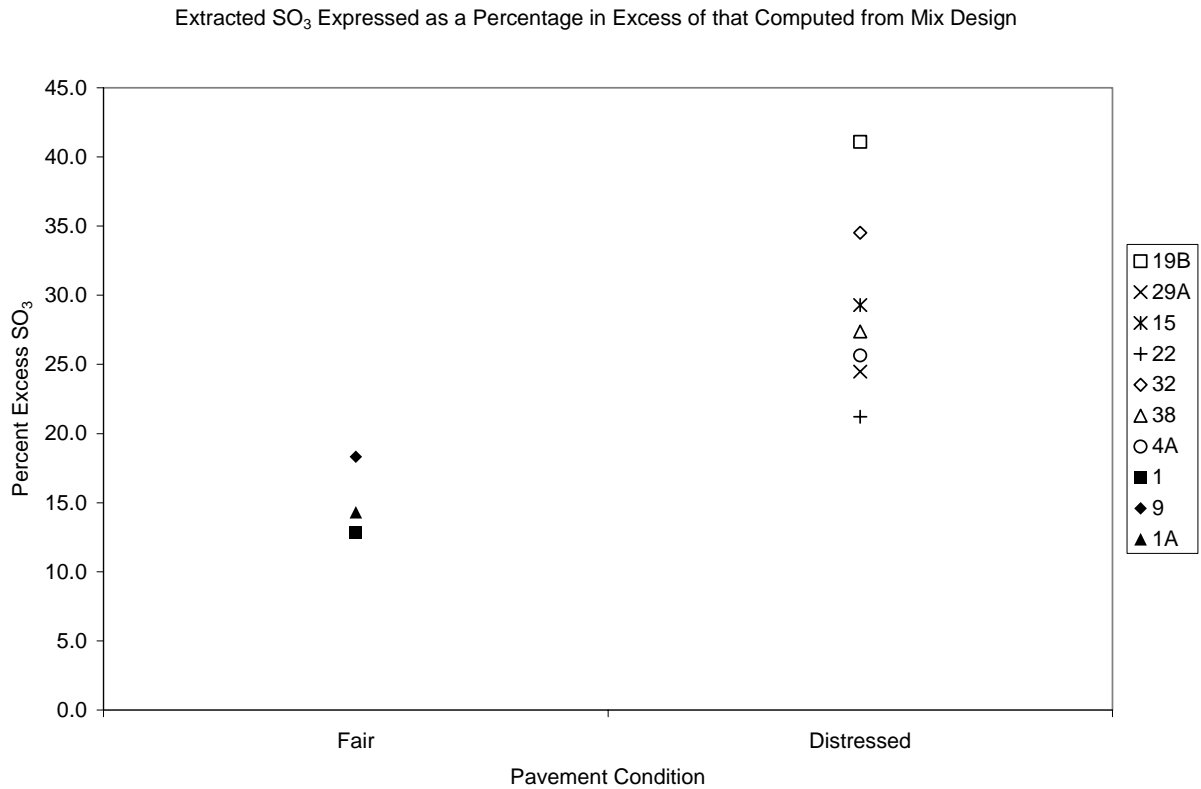
Figure 23. Percent excess SO₃ versus pavement condition.
