MDOT Research Report RC-1443

Petrographic Evaluation of Cores from the Mosel Avenue Bridge

Final Report

March 31, 2004

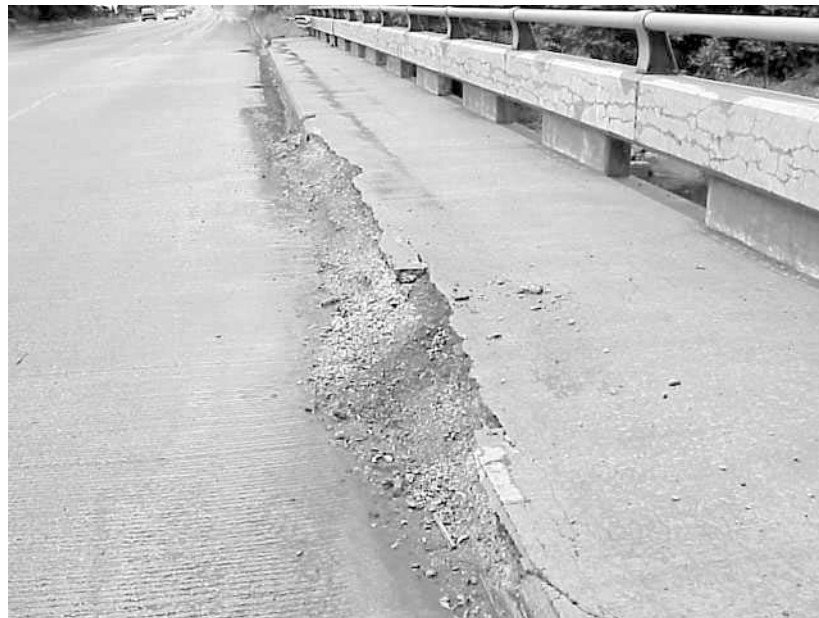
It was observed that the Mosel Avenue bridge located in Parchment, Michigan near Kalamazoo was undergoing some unexpected distress, with the sidewalk suffering severe deterioration. Figure 1 shows the condition of the sidewalk on the western portion of the north side of the bridge. A total of four 100-mm diameter cores were obtained through the sidewalk and into the deck and sent to Michigan Tech for examination. Each core included the full depth of the sidewalk (approximately 250 mm) and approximately 80 mm of the underlying deck concrete. The cores labeled "1" and "2" came from the north fascia sidewalk of the bridge at a distance of 0.9 m from the curb. The cores labeled "3" and "4" came from the south fascia sidewalk of the bridge at a distance of 0.3 m from the curb.

Figure 1: North fascia sidewalk of Mosel Avenue bridge showing deterioration of sidewalk.

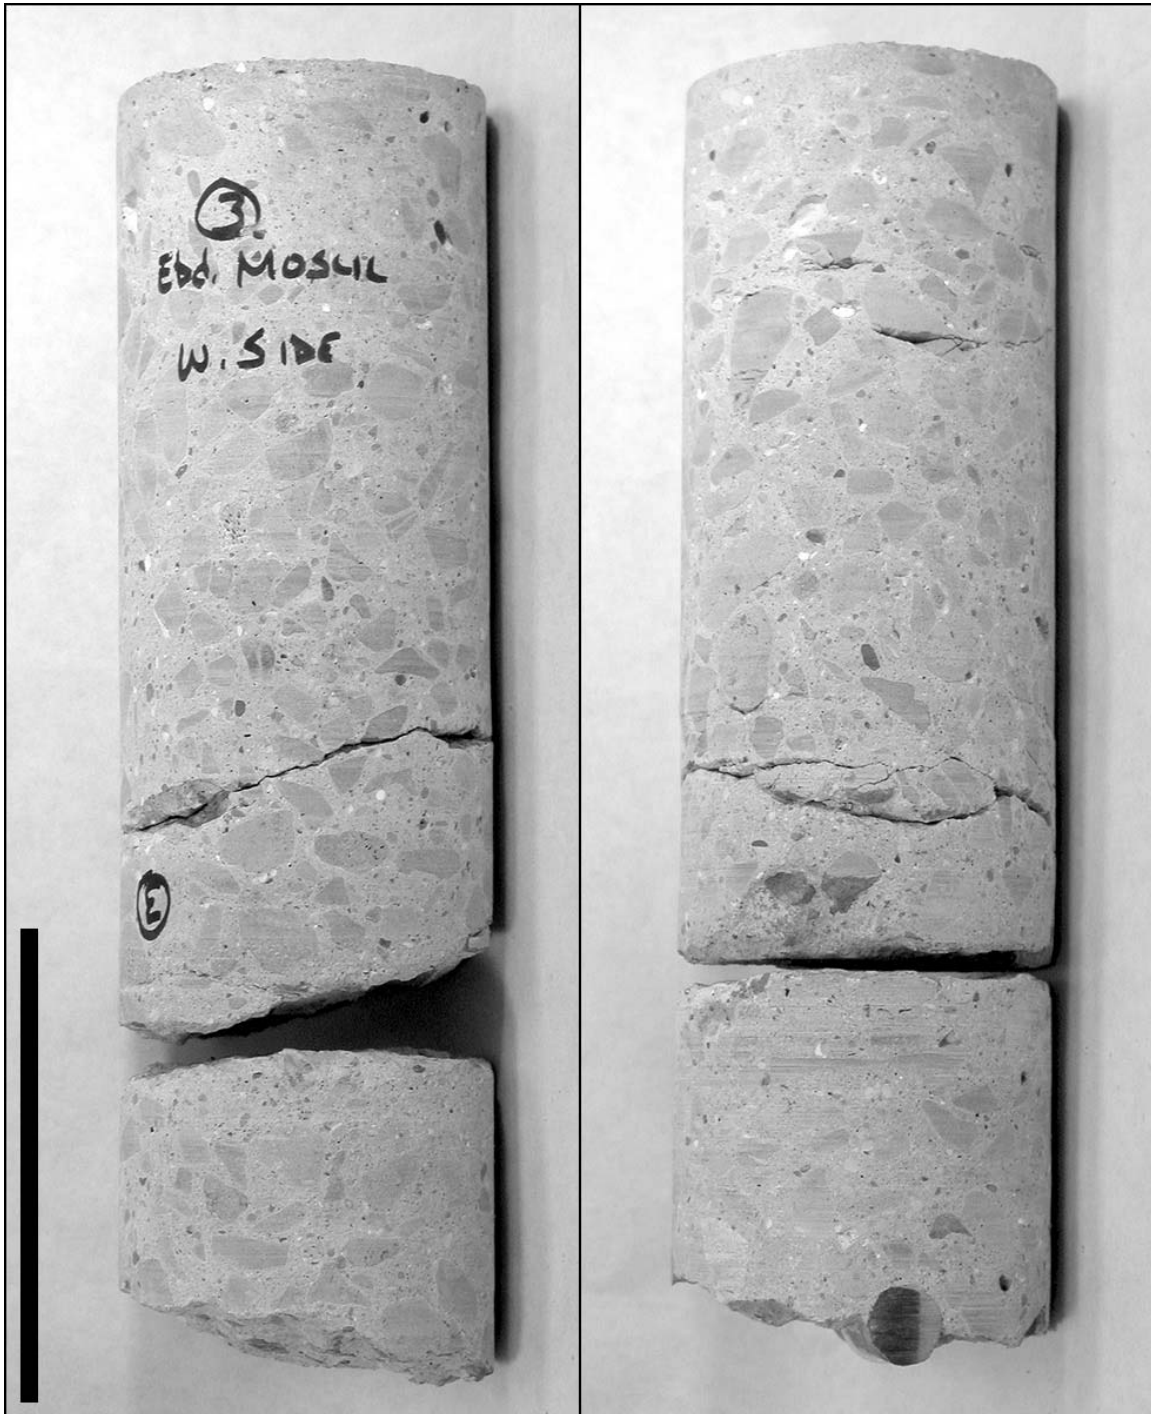
Figure 2 shows the cores as retrieved from the south fascia sidewalk of the bridge. Both demonstrate cracking planes oriented parallel to the pavement surface throughout the depth of the cores. The deformed reinforcing bar at the base of the deck portion of core "4" shows no sign of corrosion. Figures 3 and 4 show polished slabs cut from the cores retrieved from the north fascia sidewalk of the bridge. The slabs show cracks running sub-parallel to the pavement surface as well as from the surface downward vertically into the cores. To enhance the appearance of the air voids and cracks, the polished slabs were colored black and a very fine white powder was forced into the air voids and cracks. The negative images (air voids and cracks appear black) are presented on the right side of figures 3 and 4. Figures 5 through 10 show more highly magnified images of the same slabs. A modified point count was performed in accordance with *ASTM C 457 Standard Test Method for Microscopical Determination of Parameters of the Air-Void System in Hardened Concrete* on the polished slabs from cores "1" and "2", both for the sidewalk concrete and for the concrete obtained from the deck. Thin sections were prepared from core "2" and examined with a petrographic microscope and a scanning electron microscope.

Figure 2: From left to right, cores "3" and "4" from the south fascia sidewalk of the Mosel Avenue bridge, scale bar measures 10 cm.

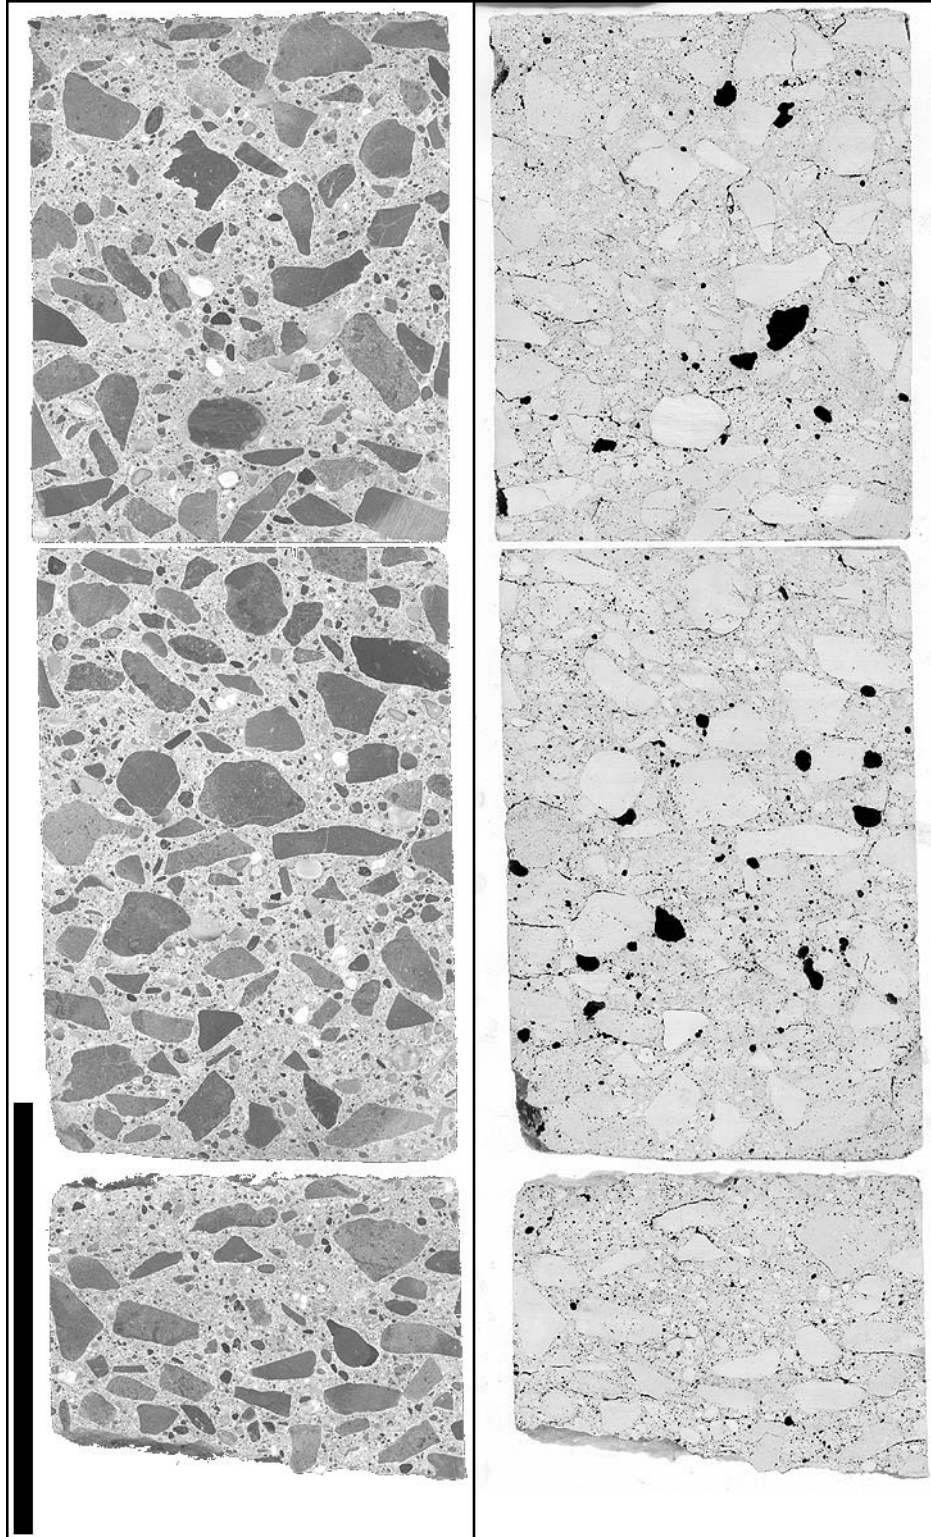
Figure 3: Polished slabs from core "1", left side shows slabs as-polished, right side shows slabs after treatment to enhance air voids and cracks, scale bar 10 cm.

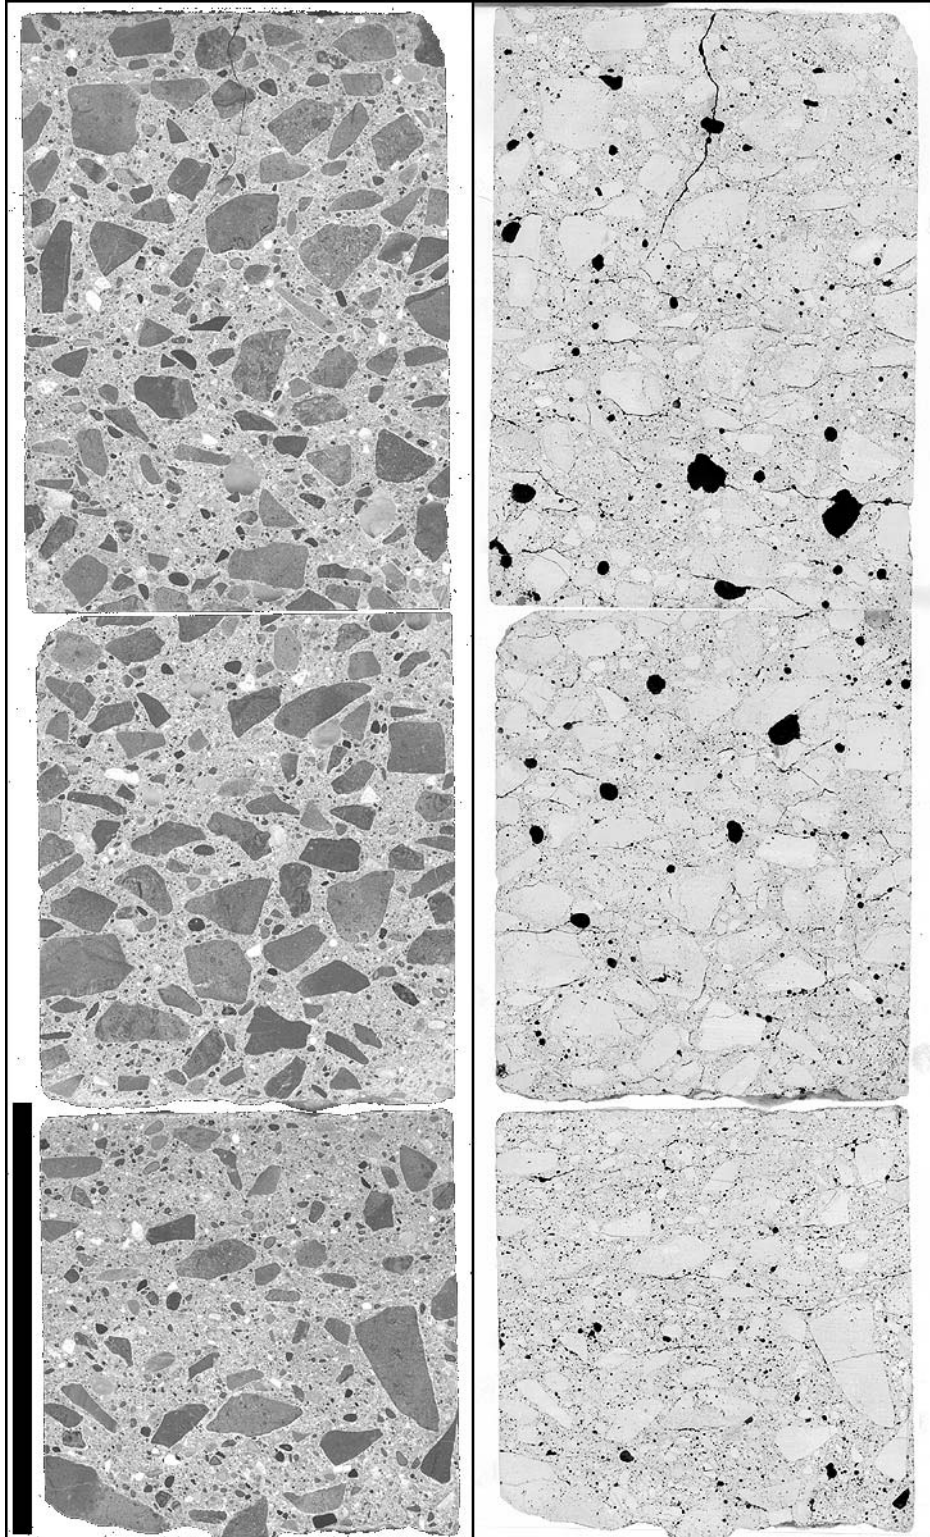
Figure 4: Polished slabs from core "2", left side shows slabs as-polished, right side shows slabs after treatment to enhance air voids and cracks, scale bar 10 cm.

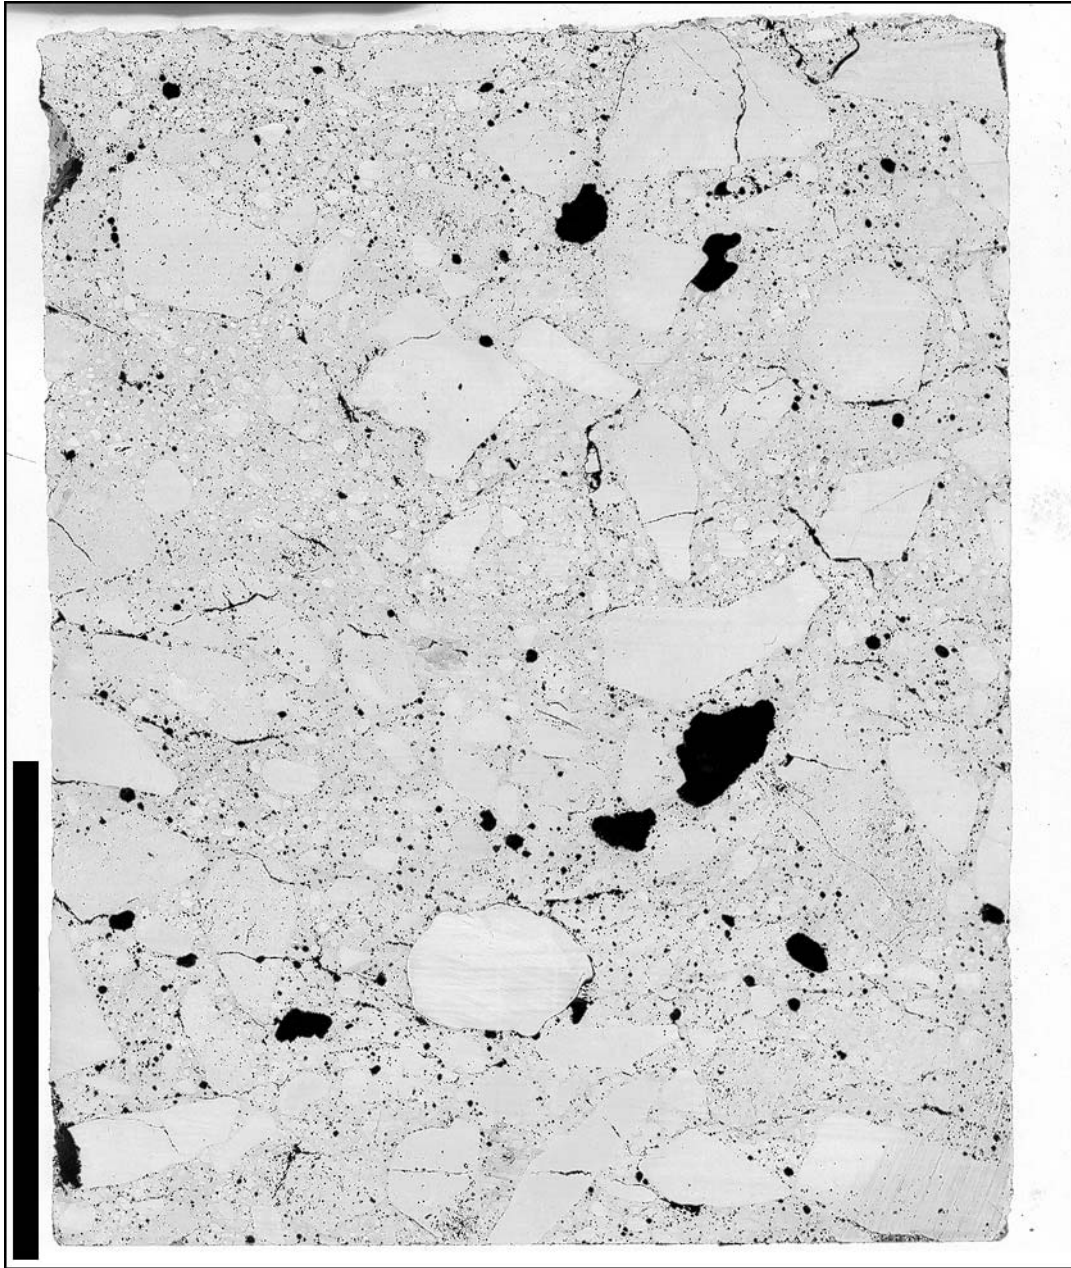
Figure 5: Close up of top half of sidewalk portion of core "1" to show cracks, scale bar 5 cm.

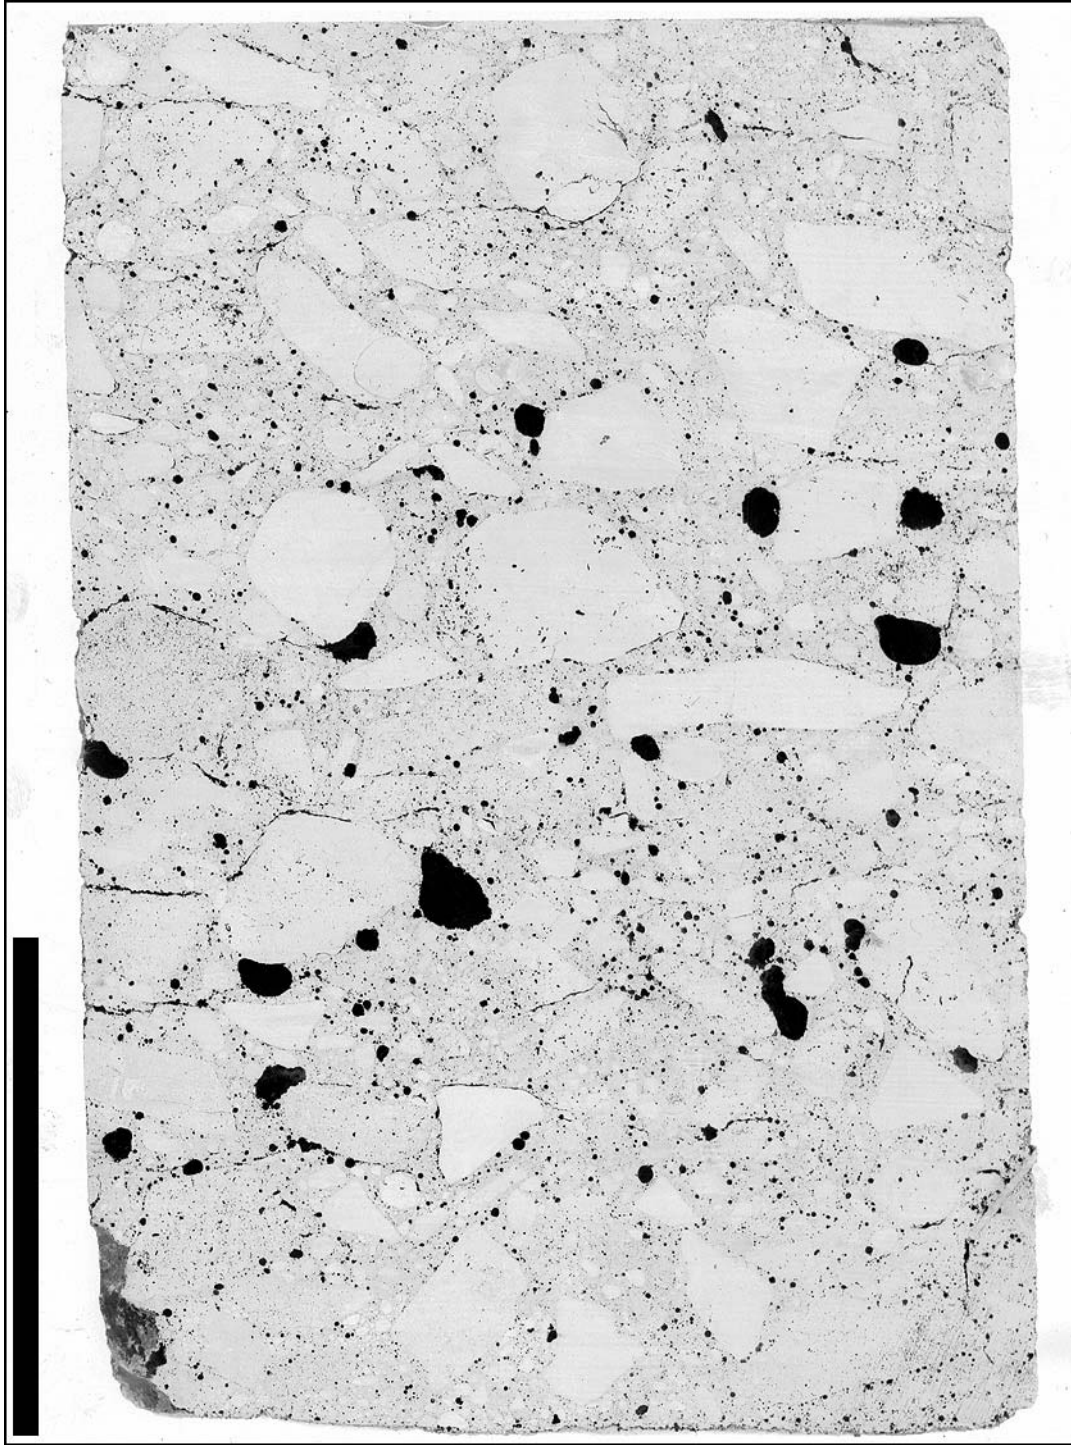
Figure 6: Close up of bottom half of sidewalk portion of core "1" to show cracks, scale bar 5 cm.

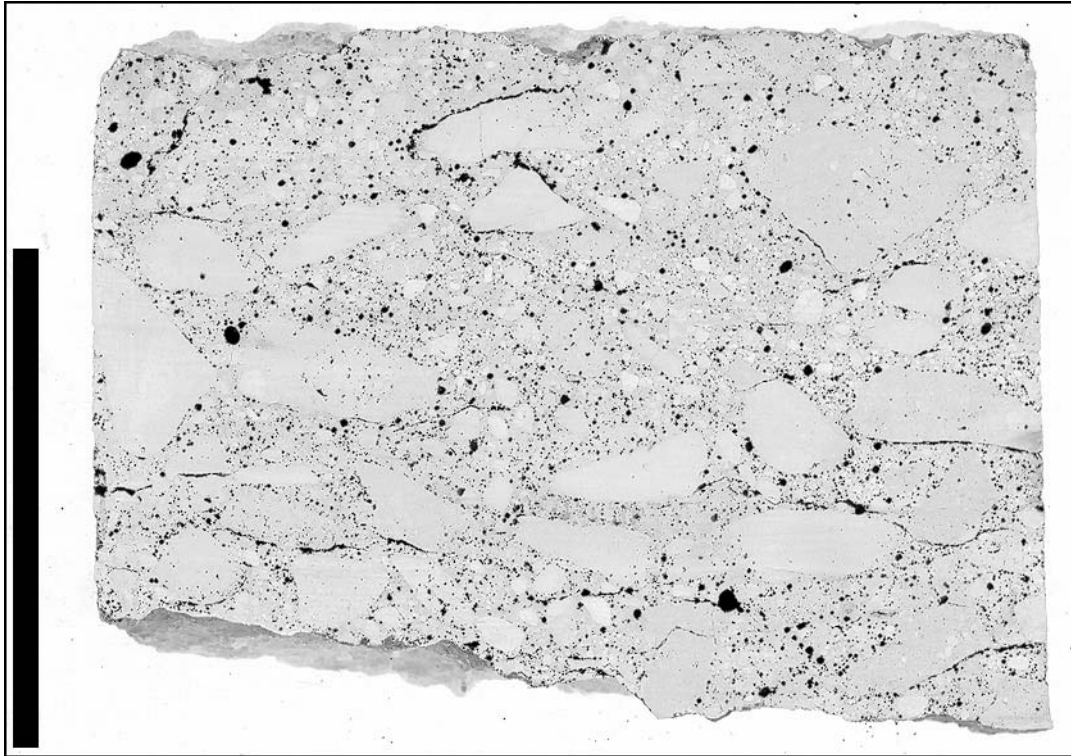
Figure 7: Close up of deck portion of core "1" to show cracks, scale bar 5 cm.

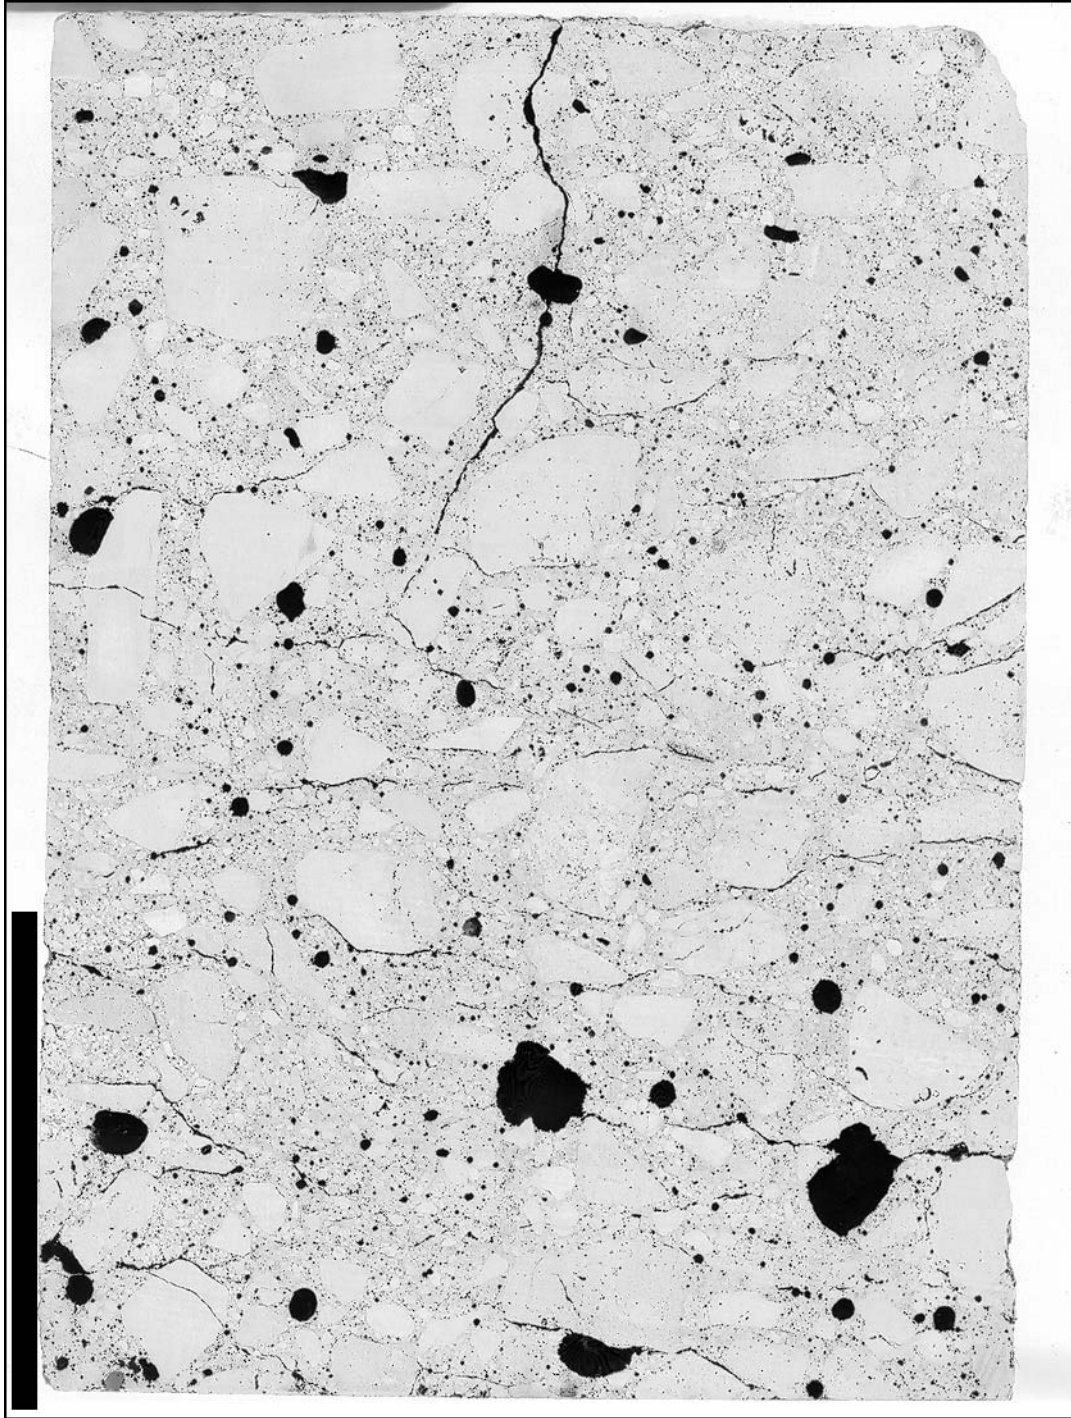
Figure 8: Close up of top half of sidewalk portion of core "2" to show cracks, scale bar 5 cm.

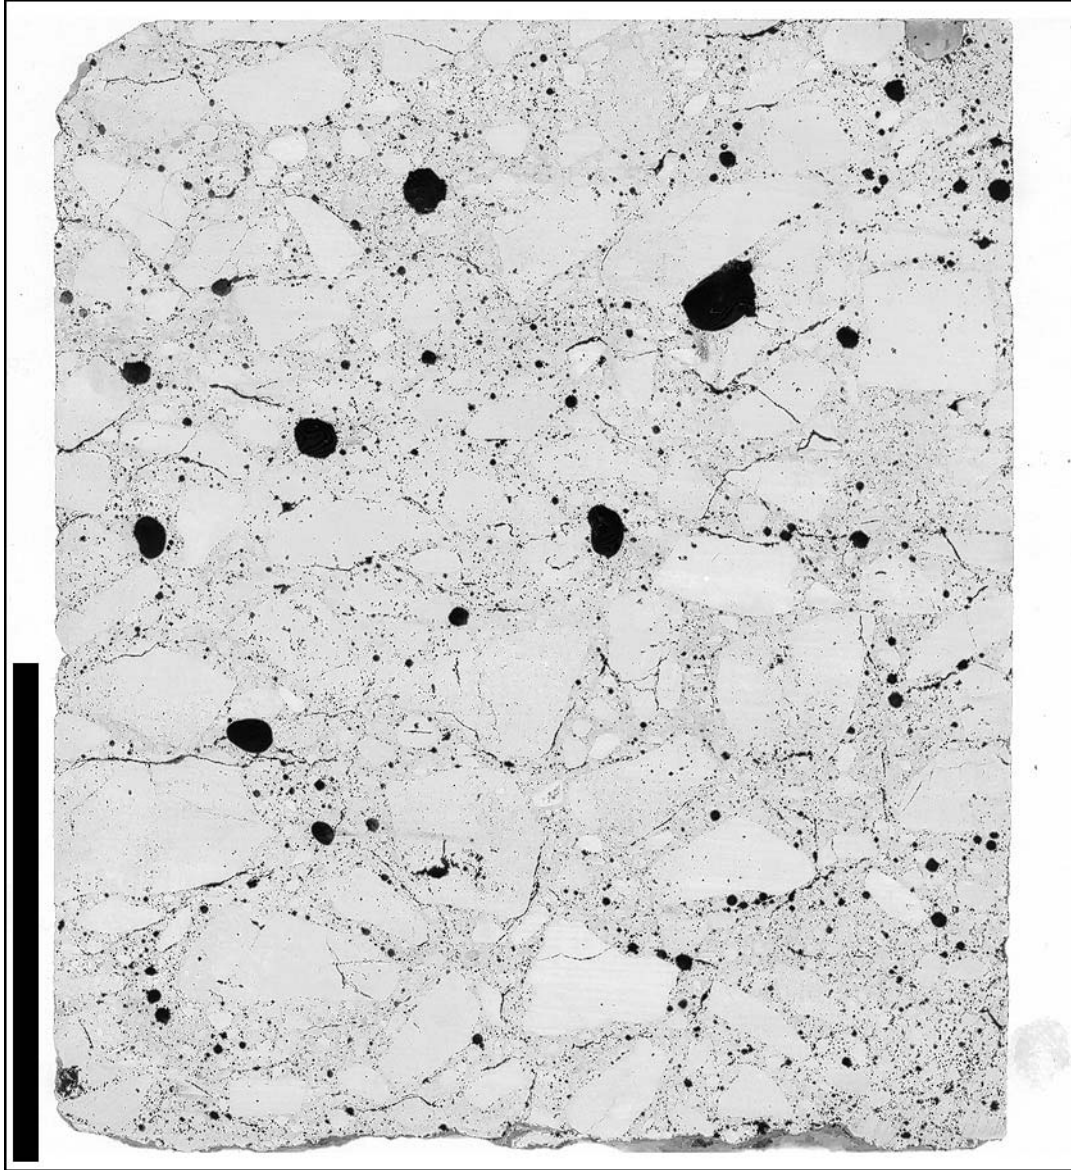
Figure 9: Close up of bottom half of sidewalk portion of core "2" to show cracks, scale bar 5 cm.

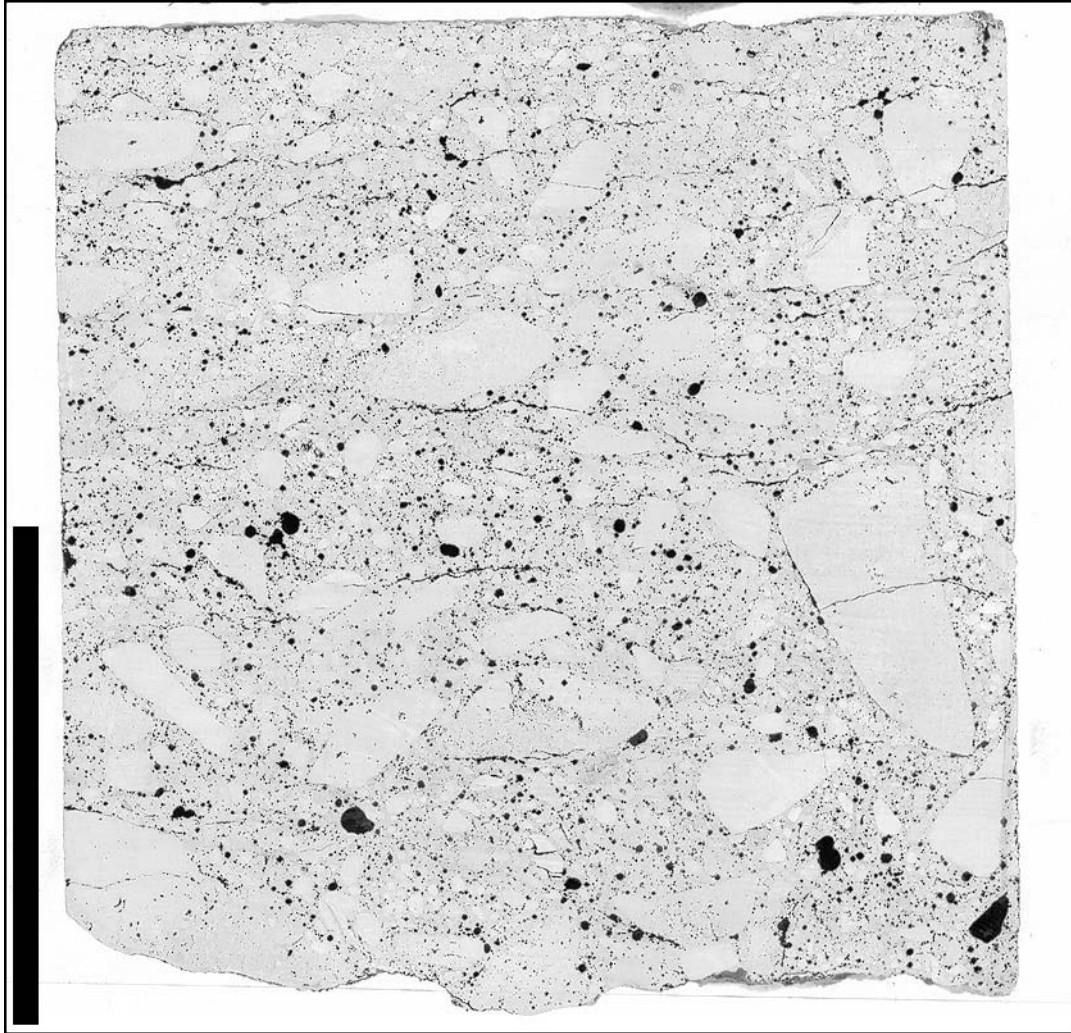
Figure 10: Close up of deck portion of core "2" to show cracks, scale bar 5 cm.

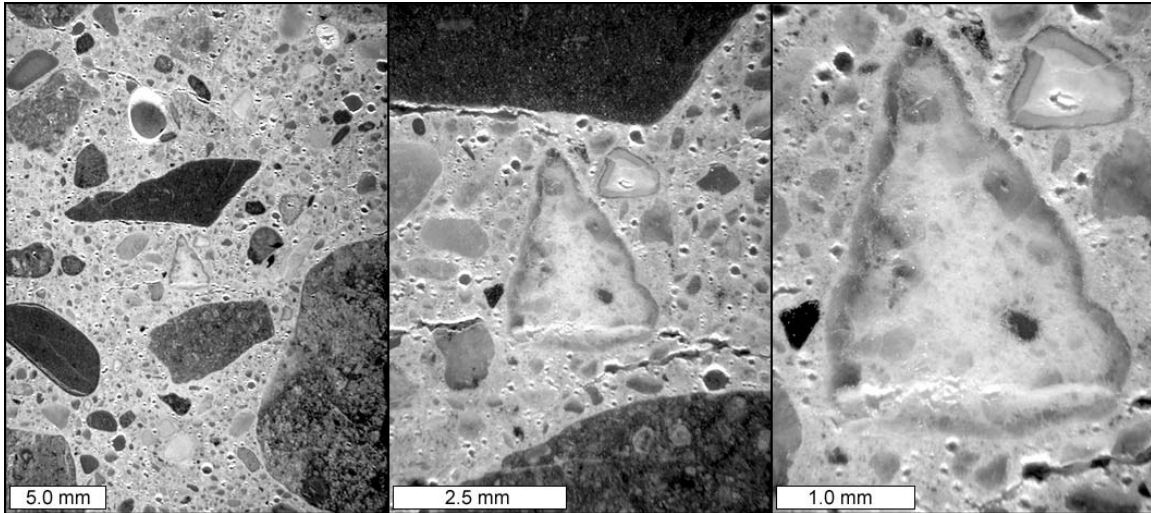
Figure 11: Stereo microscope images showing reactive chert on polished slab from sidewalk portion of core "2".

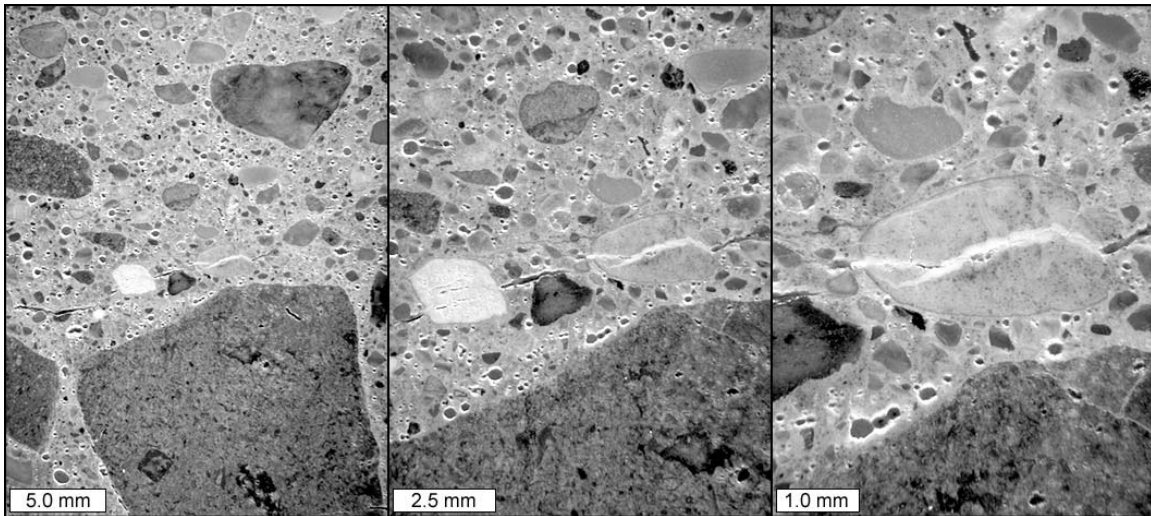
Figure 12: Stereo microscope images showing reactive chert on polished slab from deck portion of core "2"

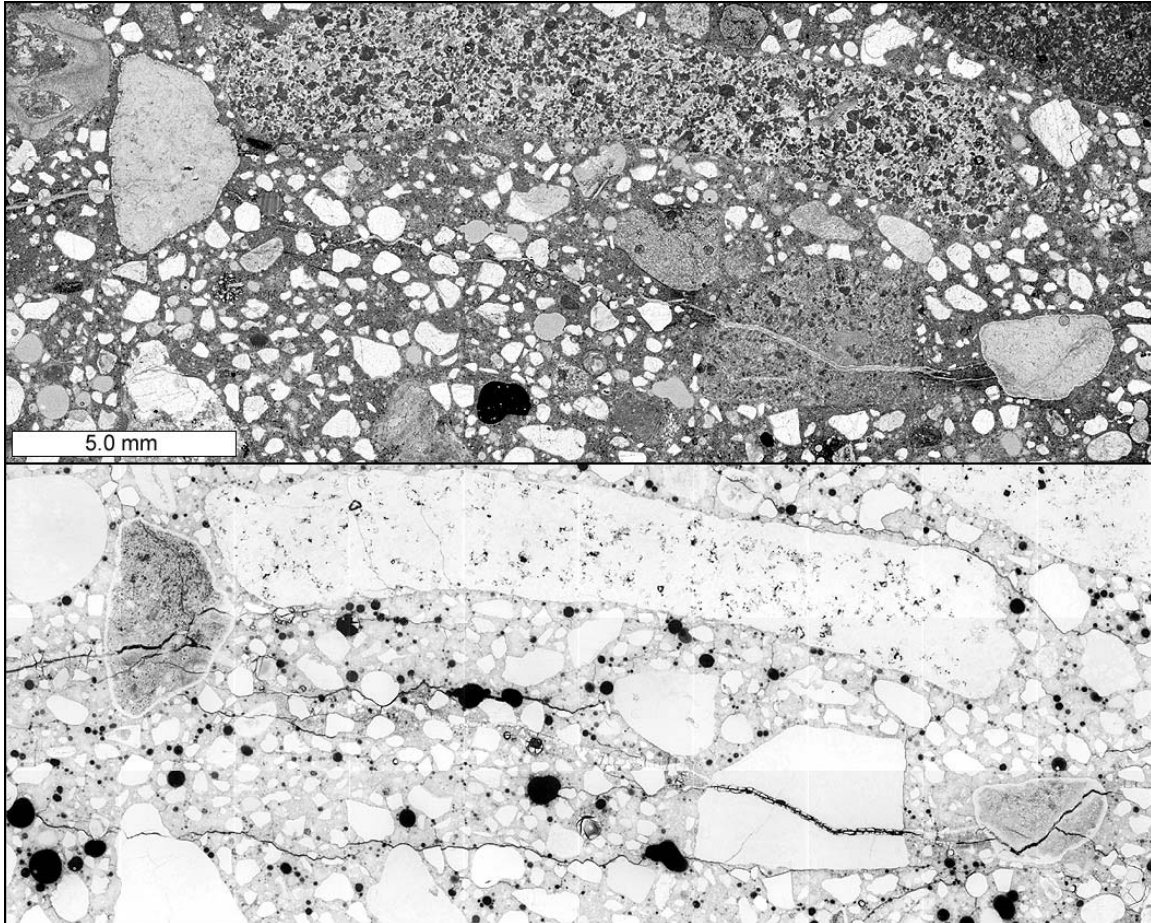
Thin sections were prepared from core "2" to confirm the presence of alkali-silica reaction products. Figure 13 shows a crack that intersects several reactive fine aggregates that contains deposits of alkali-silica reaction products. Figure 14 shows further close-

Figure 13: Petrographic microscope images of thin section showing cracks and reactive fine aggregate, top half, plane polarized light, bottom half, epifluorescent mode.

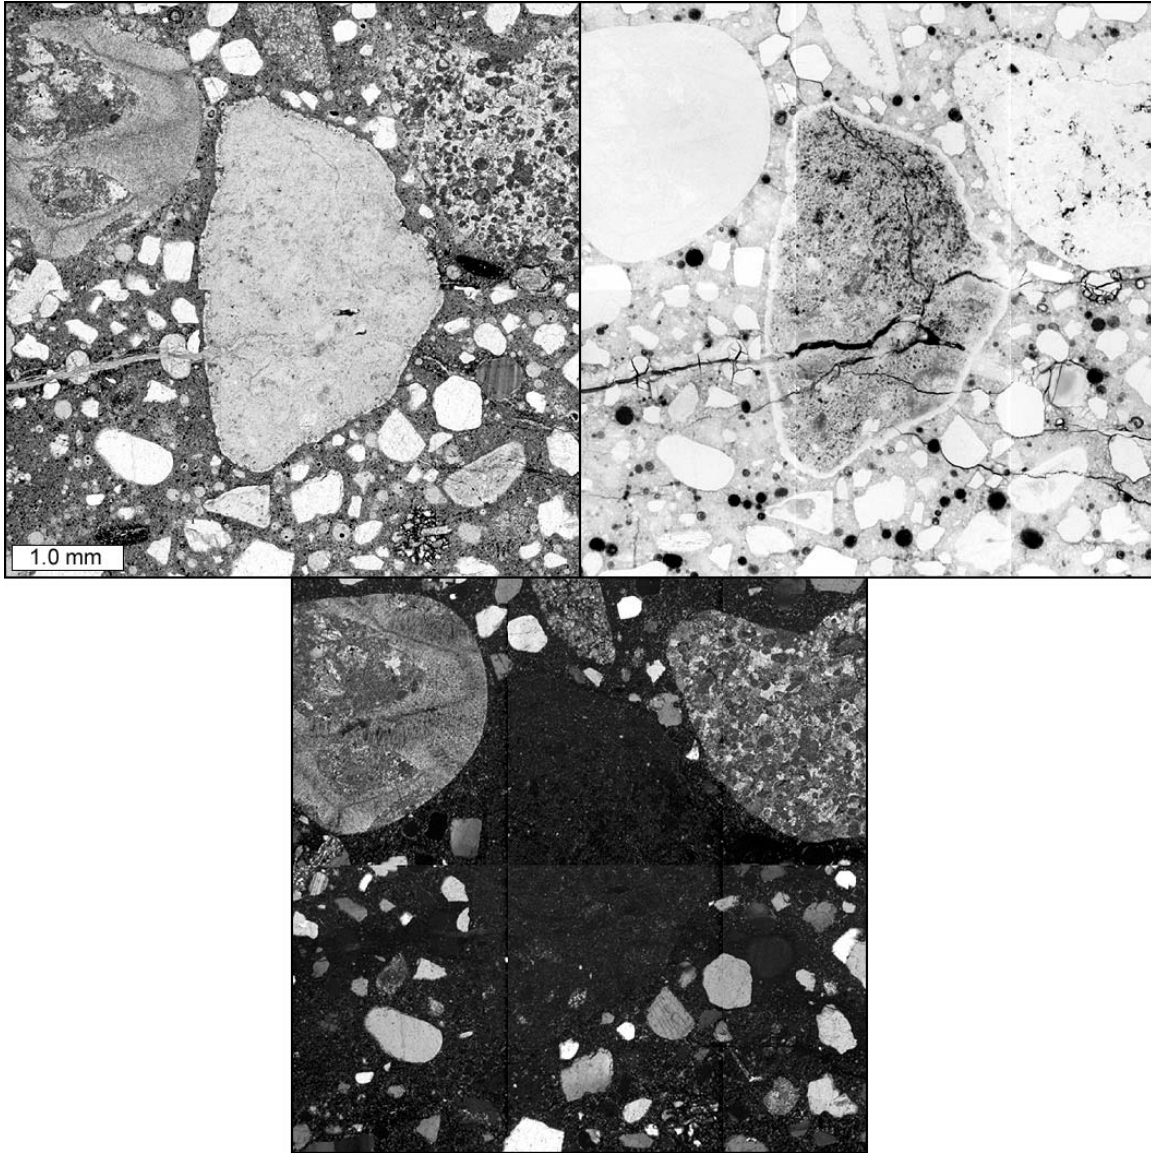
ups of the reactive chert particle from the upper left hand corner of figure 13. Figure 15 shows backscatter electron images of the alkali-silica reaction product from the same chert particle. The alkali-silica reaction product contains both amorphous and crystalline bladed phases. Figure 16 shows elemental maps of the same area shown in figure 15. The alkali-silica reaction product contains silicon, calcium, potassium, and sodium.

Figure 14: Close-up of reactive chert particle from upper left hand corner of Figure 13, clockwise from upper left: plane polarized light, epifluorescent mode, and crossed polarized light.

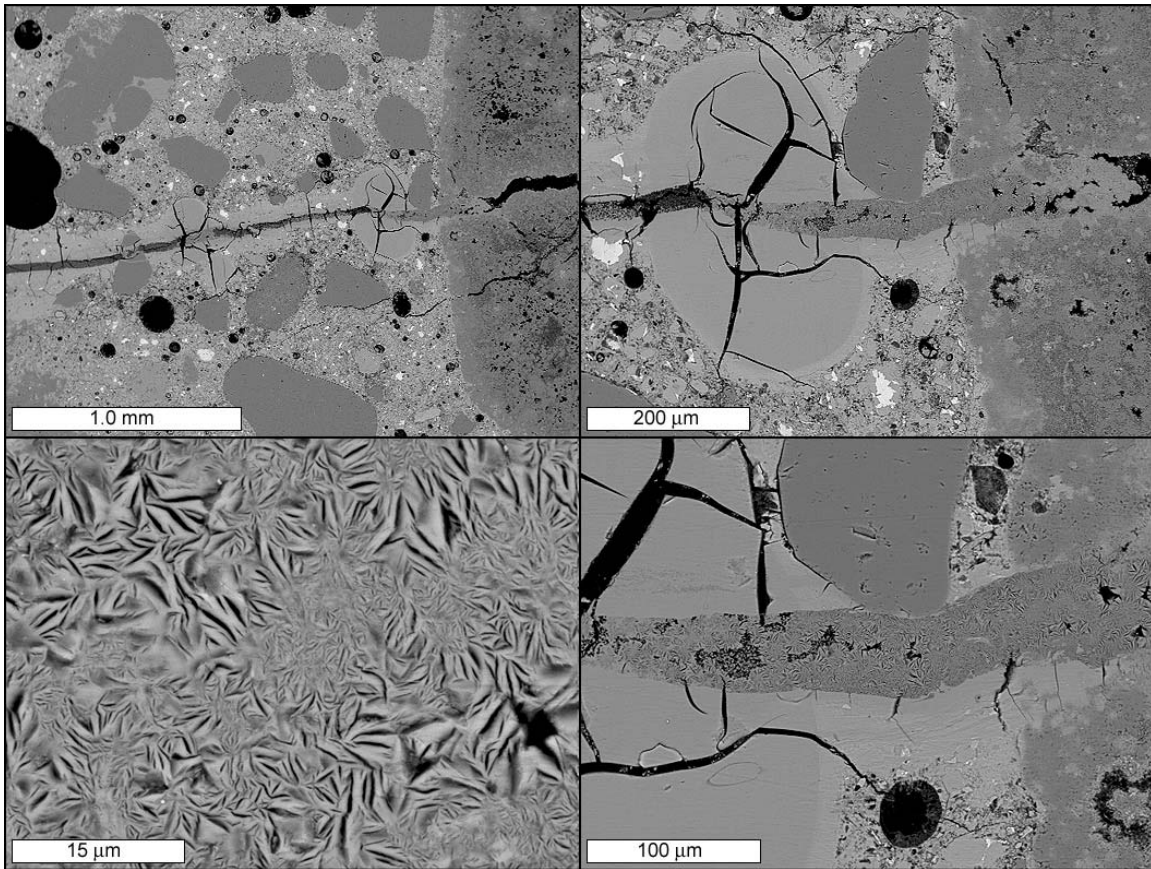
Figure 15: Backscattered-electron images of alkali-silica reaction product in crack from Figures 13 and 14, with successive close-ups to illustrate both the crystalline bladed and amorphous phases.

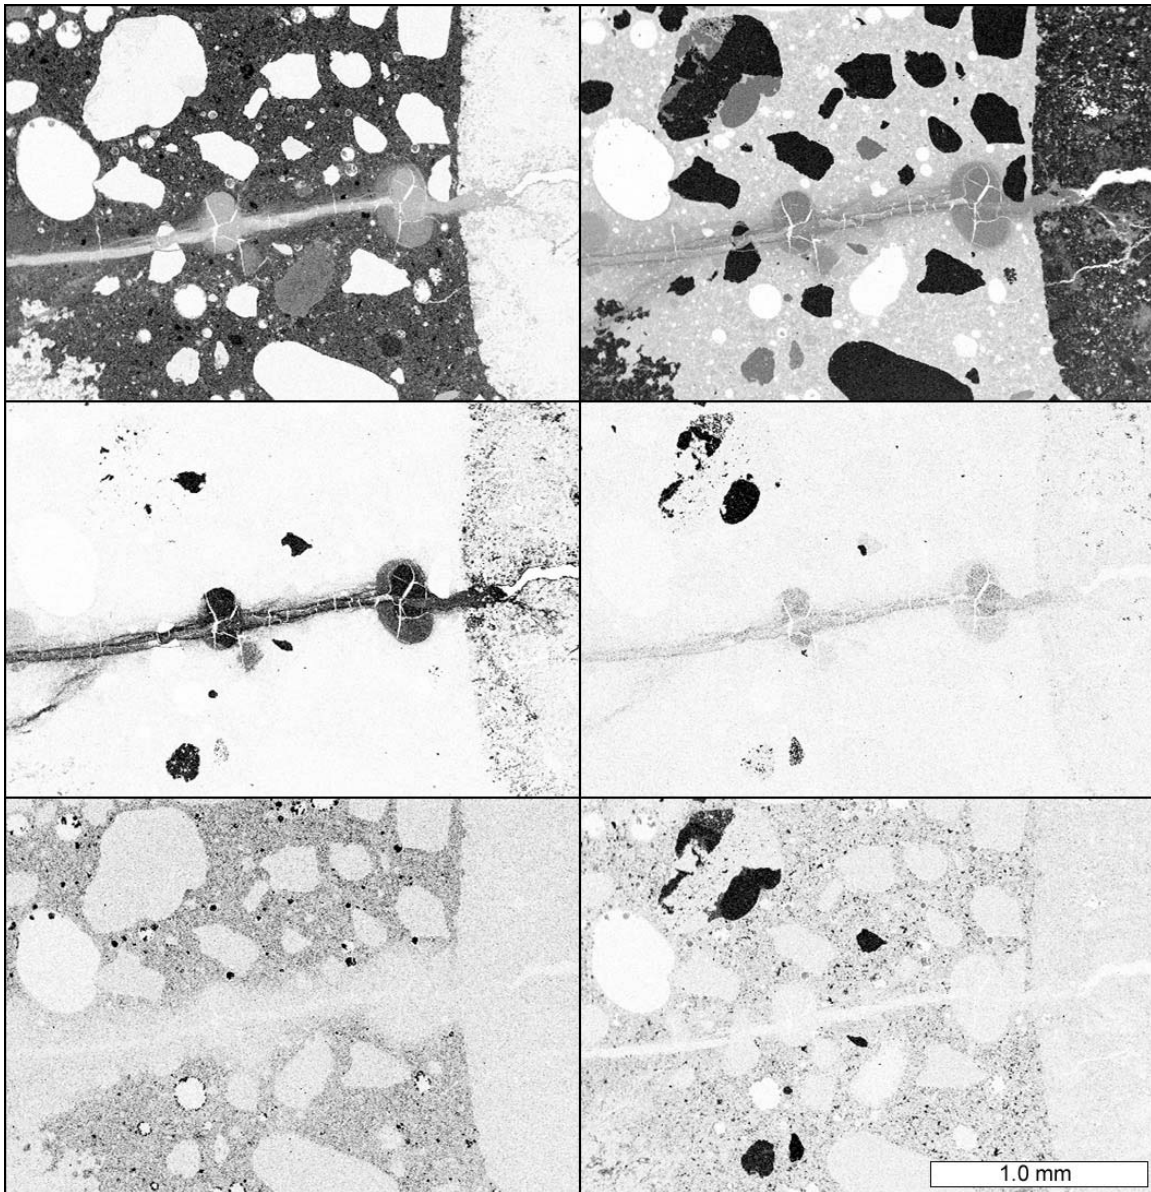
Figure 16: Elemental maps of characteristic $K\alpha$ radiation, darker regions indicate higher counts for radiation, top row, from left to right, calcium and silicon, middle row, from left to right, potassium and sodium, bottom row, from left to right, sulfur and aluminum.
