**JOINTED CONCRETE PAVEMENTS  
DESIGN, PERFORMANCE AND REPAIR**

**C. J. Arnold  
M. A. Chiunti  
K. S. Bancroft**

**Research Laboratory Section  
Testing and Research Division  
Research Projects 68 F-101, 70 F-113,  
70 F-116, 71 F-122, 73 F-136, and 74 F-140  
Research Report No. R-1169**

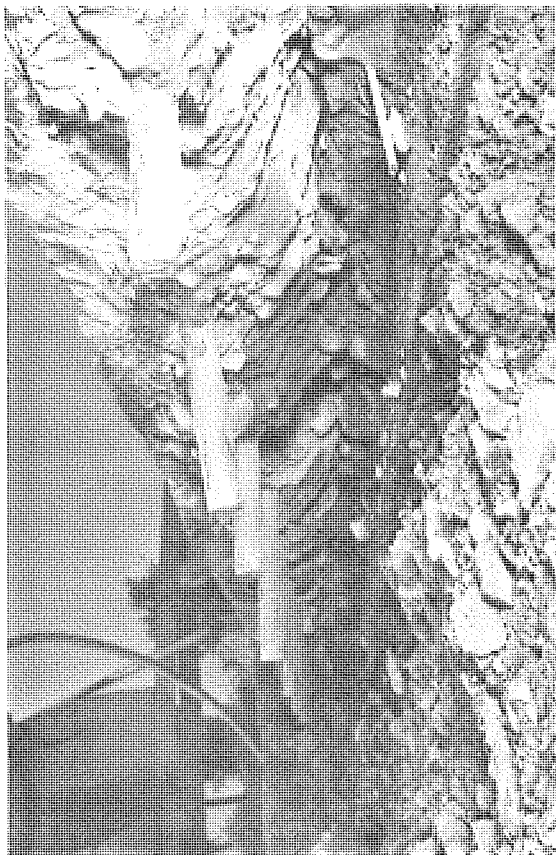
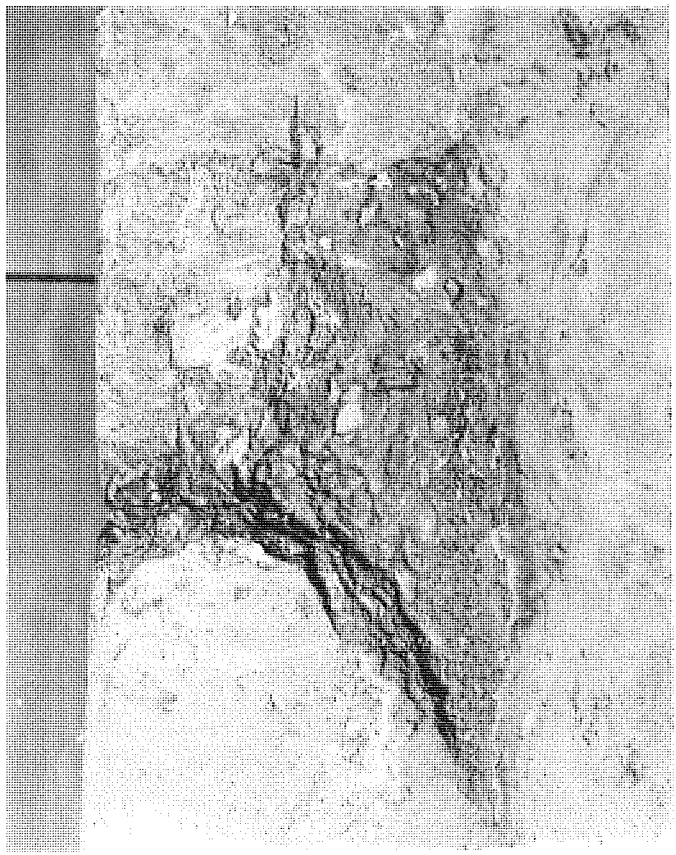
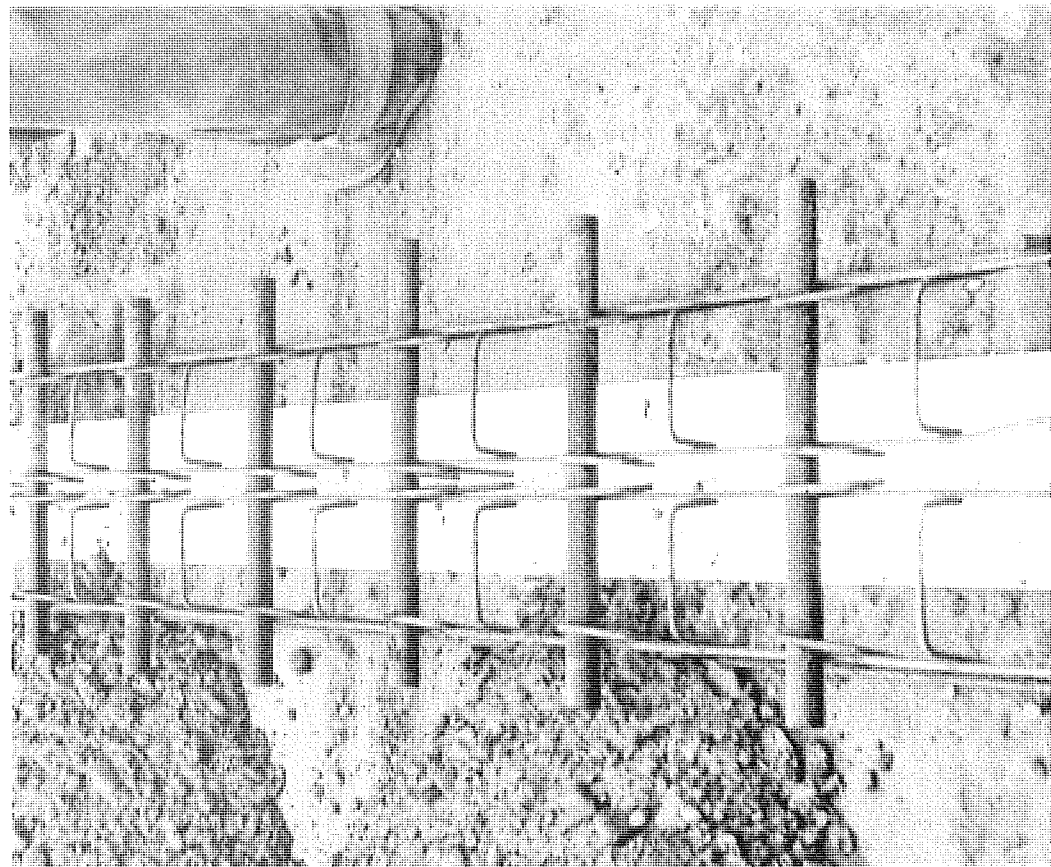
Base plates under the joints in the older pavements accelerated the deterioration of the lower faces of the joints as shown in Figure 2. Ineffective joint seals allowed infiltration of incompressible materials and de-icing chemicals into the joints when the slabs contracted during cold weather. Subsequent expansion of the slabs caused by spring's moisture and high temperatures caused crushing of the joint faces and, in many cases, severe joint blow-ups occurred (Fig. 3). These caused traffic disruptions and required emergency repairs that were quite expensive. This type of failure in the older pavements usually occurred at about 12 to 16 years after construction. The same compressive forces sometimes caused damage to bridges. Pressure relief joints about 4 in. wide, filled with foamed-in-place urethane, were installed in bridge approach slabs in the Detroit area during the late 1960's. Subsequent discussions within the Department involved the use of such joints at intervals in pavements to prevent blow-ups.

Figure 2. Base plates in new construction (left) were placed to keep aggregates out of the joint and to provide support for the load transfer basket during construction. The photos at right, however, show the long-term effects of increased joint face deterioration that resulted when salt and moisture were trapped in the joint.

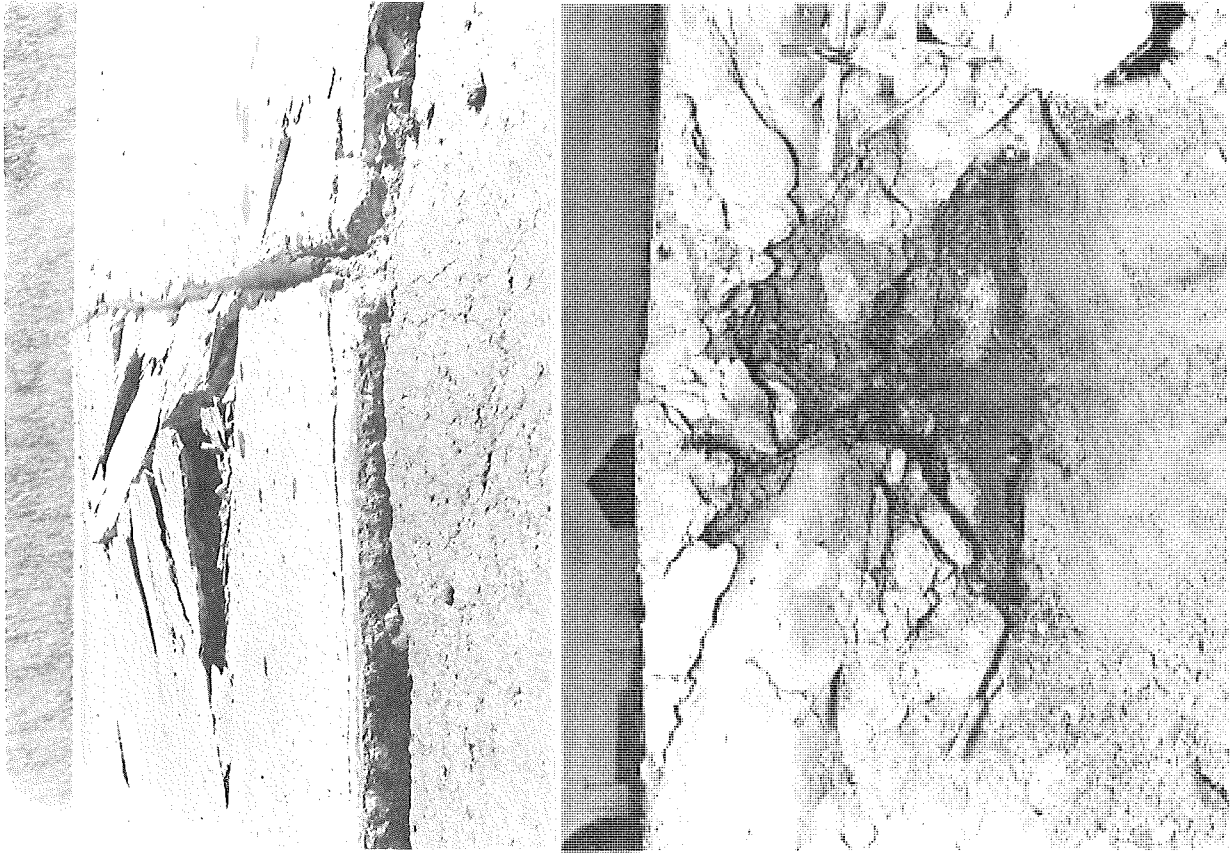
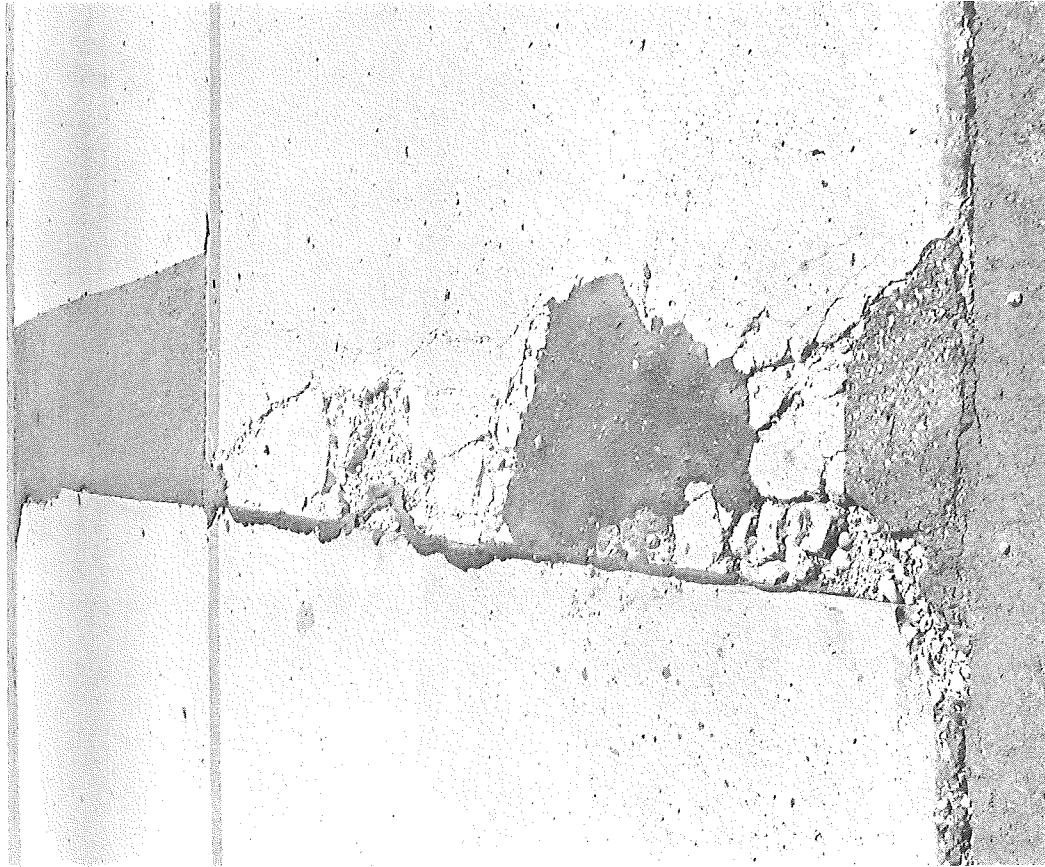
Figure 3. Joint crushing (left) or sometimes severe blow-ups (right) developed at the deteriorated joints when hot spring and summer weather and moisture caused expansion of the pavement slabs.

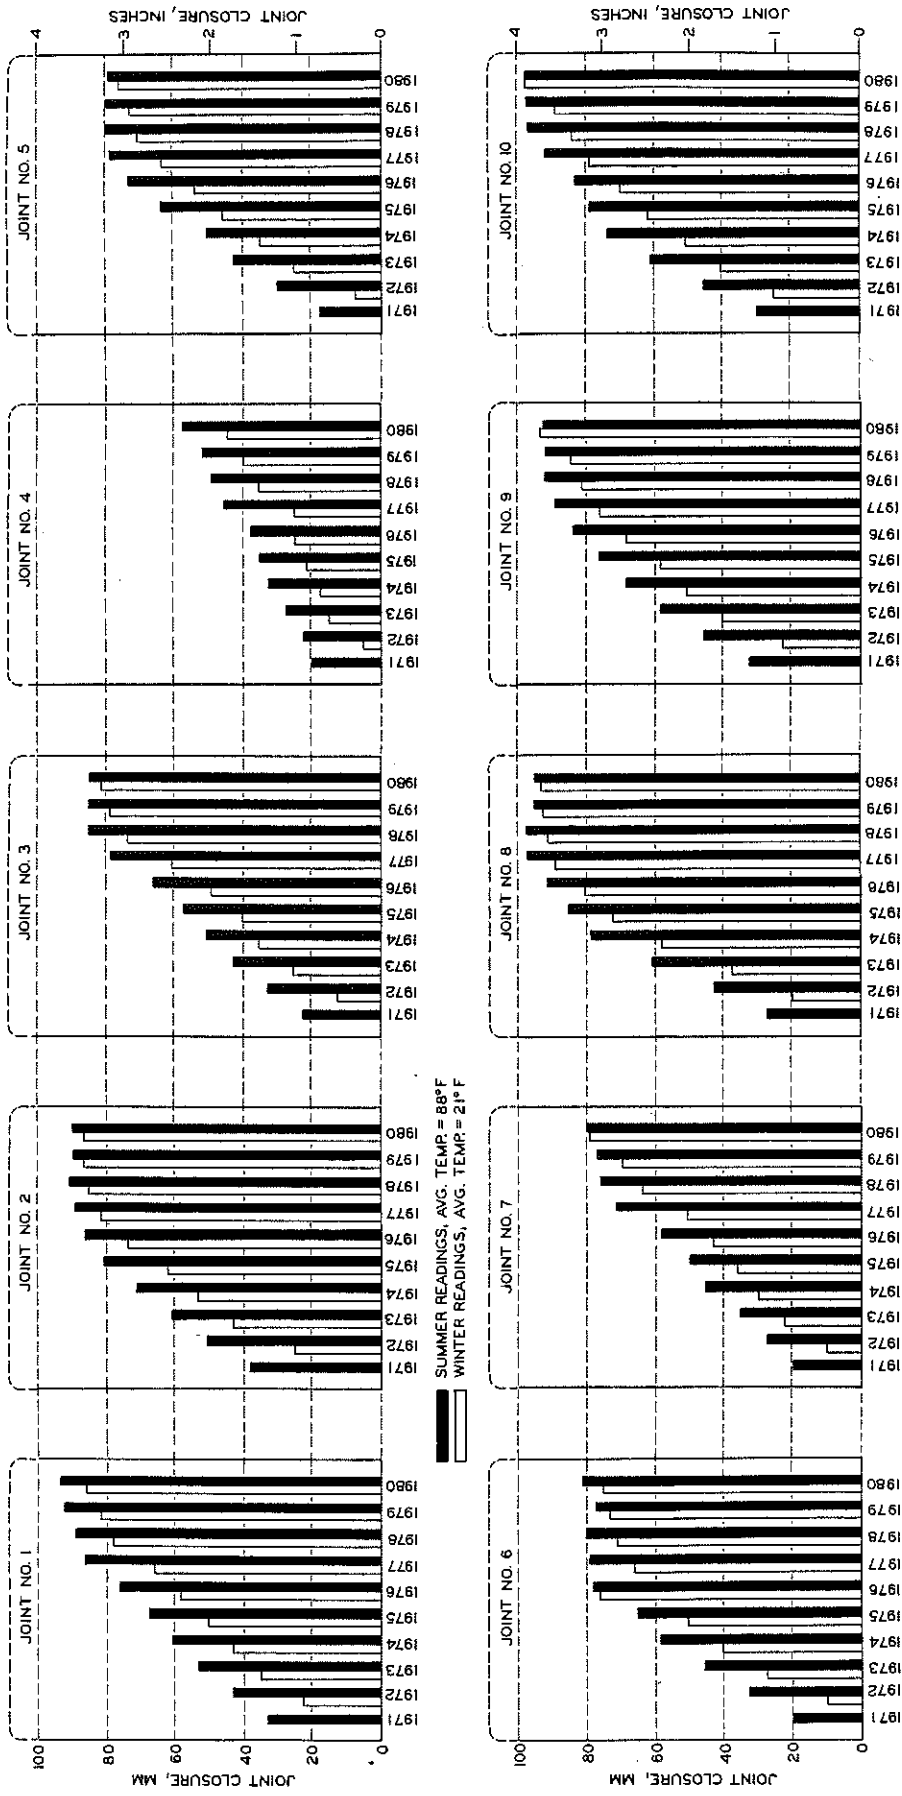
Results of the pressure relief joint width measurements are shown in Figure 4. The data show quite rapid closure of the joints, so that much of the expansion space provided is utilized by the pavement during the first few years after installation. A corresponding increase in width occurs at nearby joints and 'working' cracks. Note that this pavement was one without effective seals, and with several full-width cracks where the reinforcement had failed; such joints should not be placed in pavements with preformed compressive type seals, as joint opening will allow the adjacent seals to come out.

Figure 4. Location of pressure relief joints and total closure (US 23).

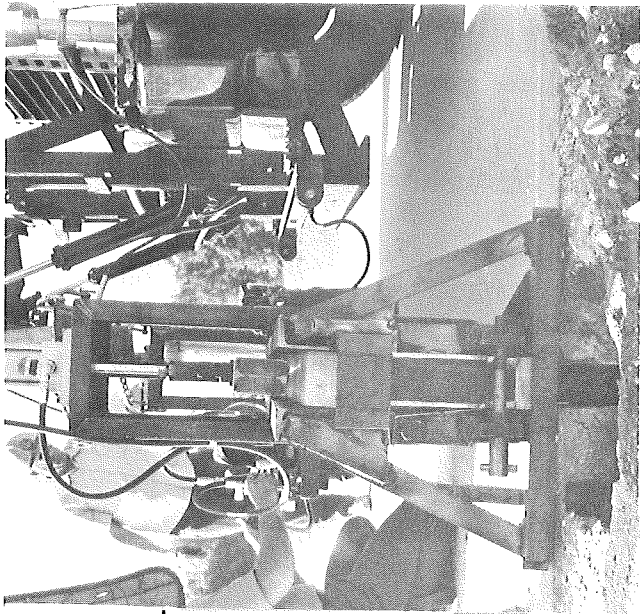
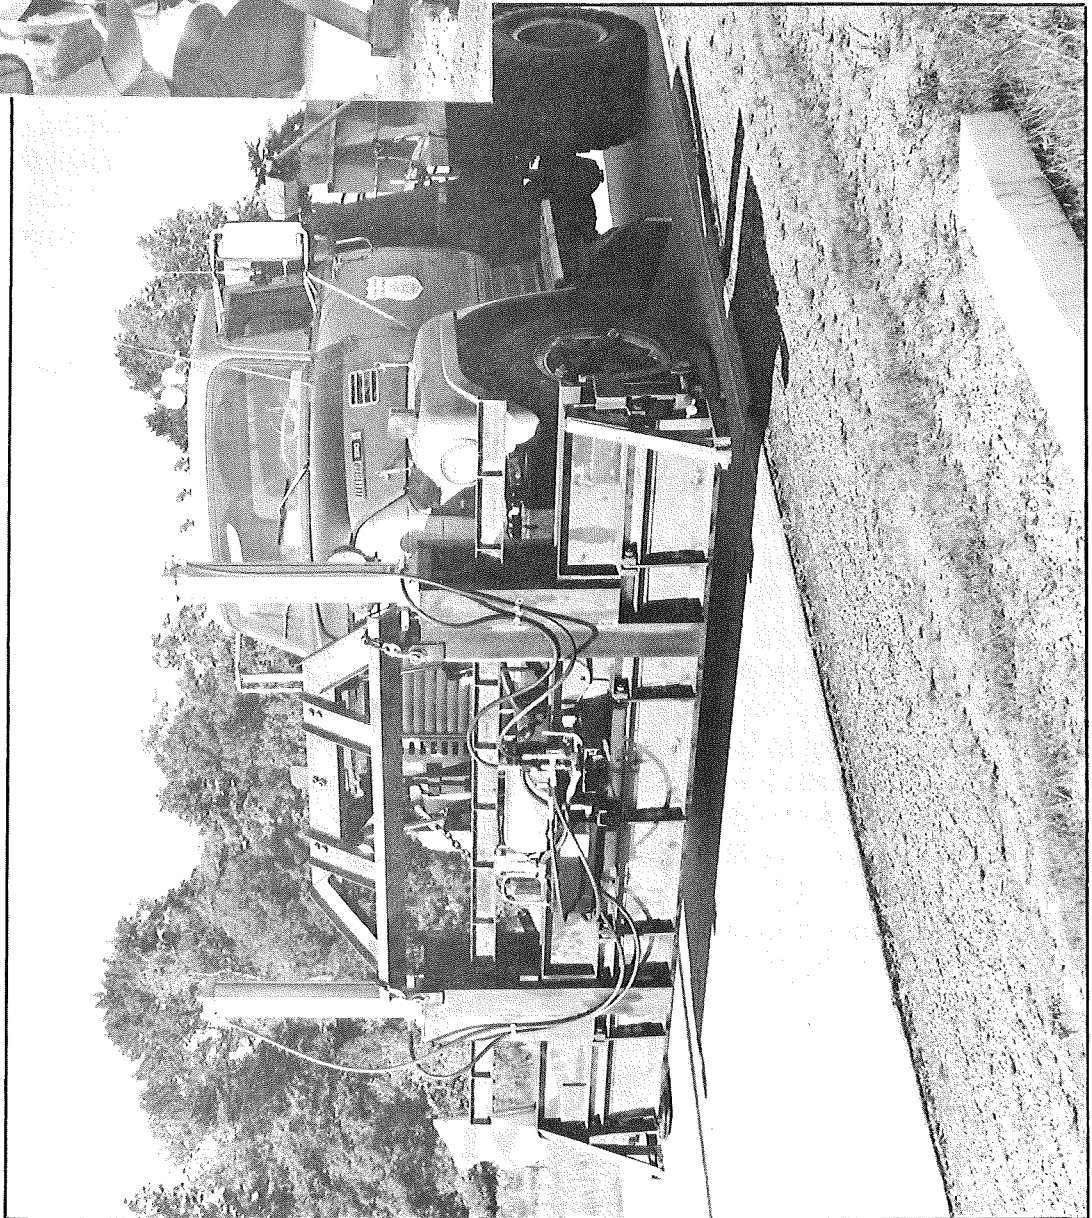
Figure 5. Ethafoam pressure relief joint installation device, mounted on snowplow lift, on heavy duty maintenance vehicle. Punch approaching filler (right).

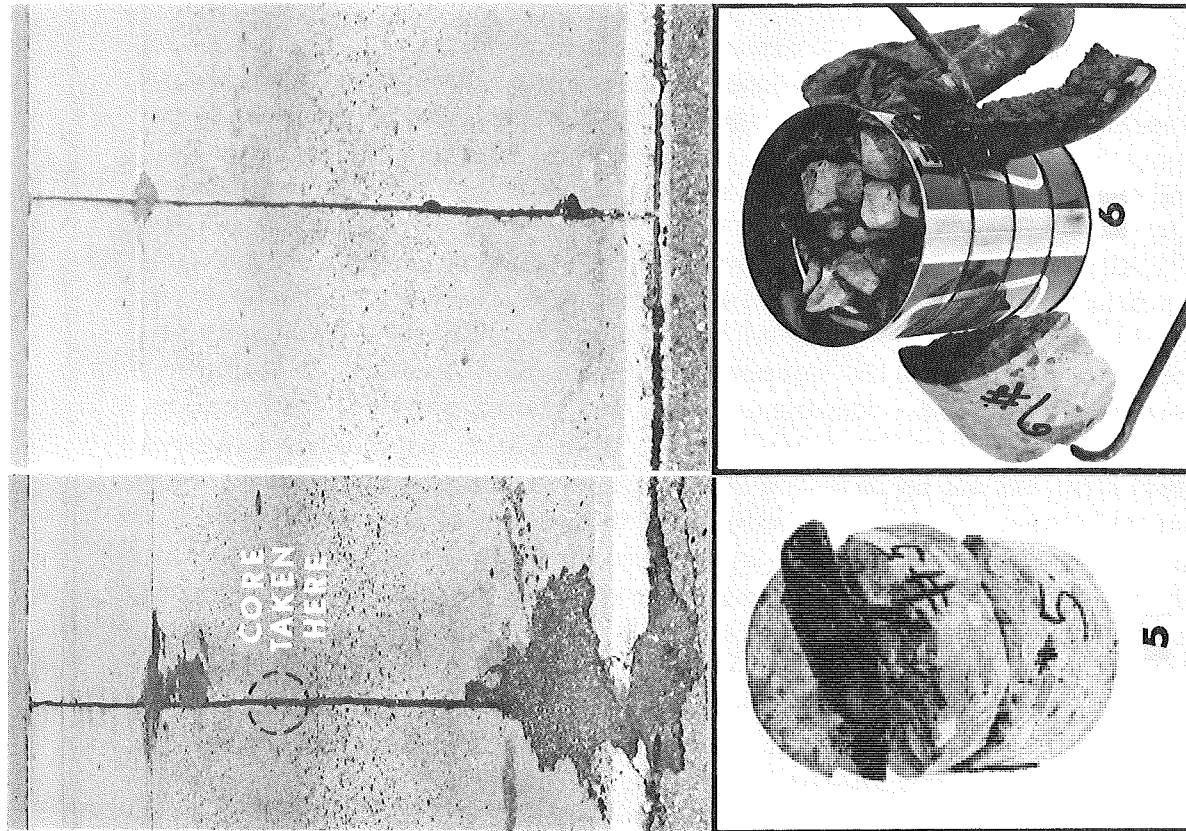
Figure 7. Joints and cores from I 96 near Portland. These are contraction joints (cores shown upside down), constructed 1958, 99-ft slab with base plates. After 21-1/2 years' service on this rural Interstate route the joint faces are badly deteriorated and are fairly typical of pavements of this design and age.

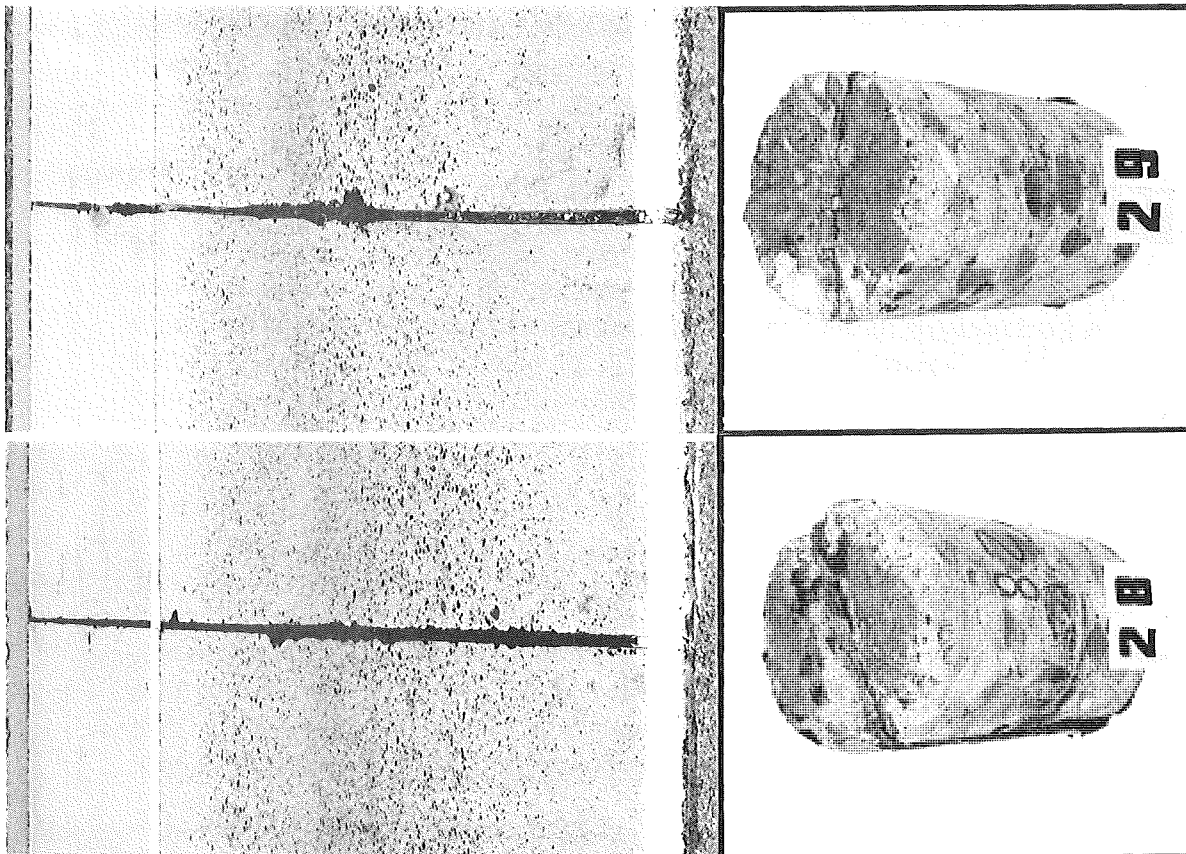
Figure 6. Typical joints and cores from I 96 near Portland. Expansion joints, cores (shown upside down) are typical of the condition of expansion joints in the area. Constructed in 1958, 50-ft slab with base plates, as a relief section for continuously reinforced pavement. After 21 years' service on this rural Interstate route the concrete is in good condition full depth.

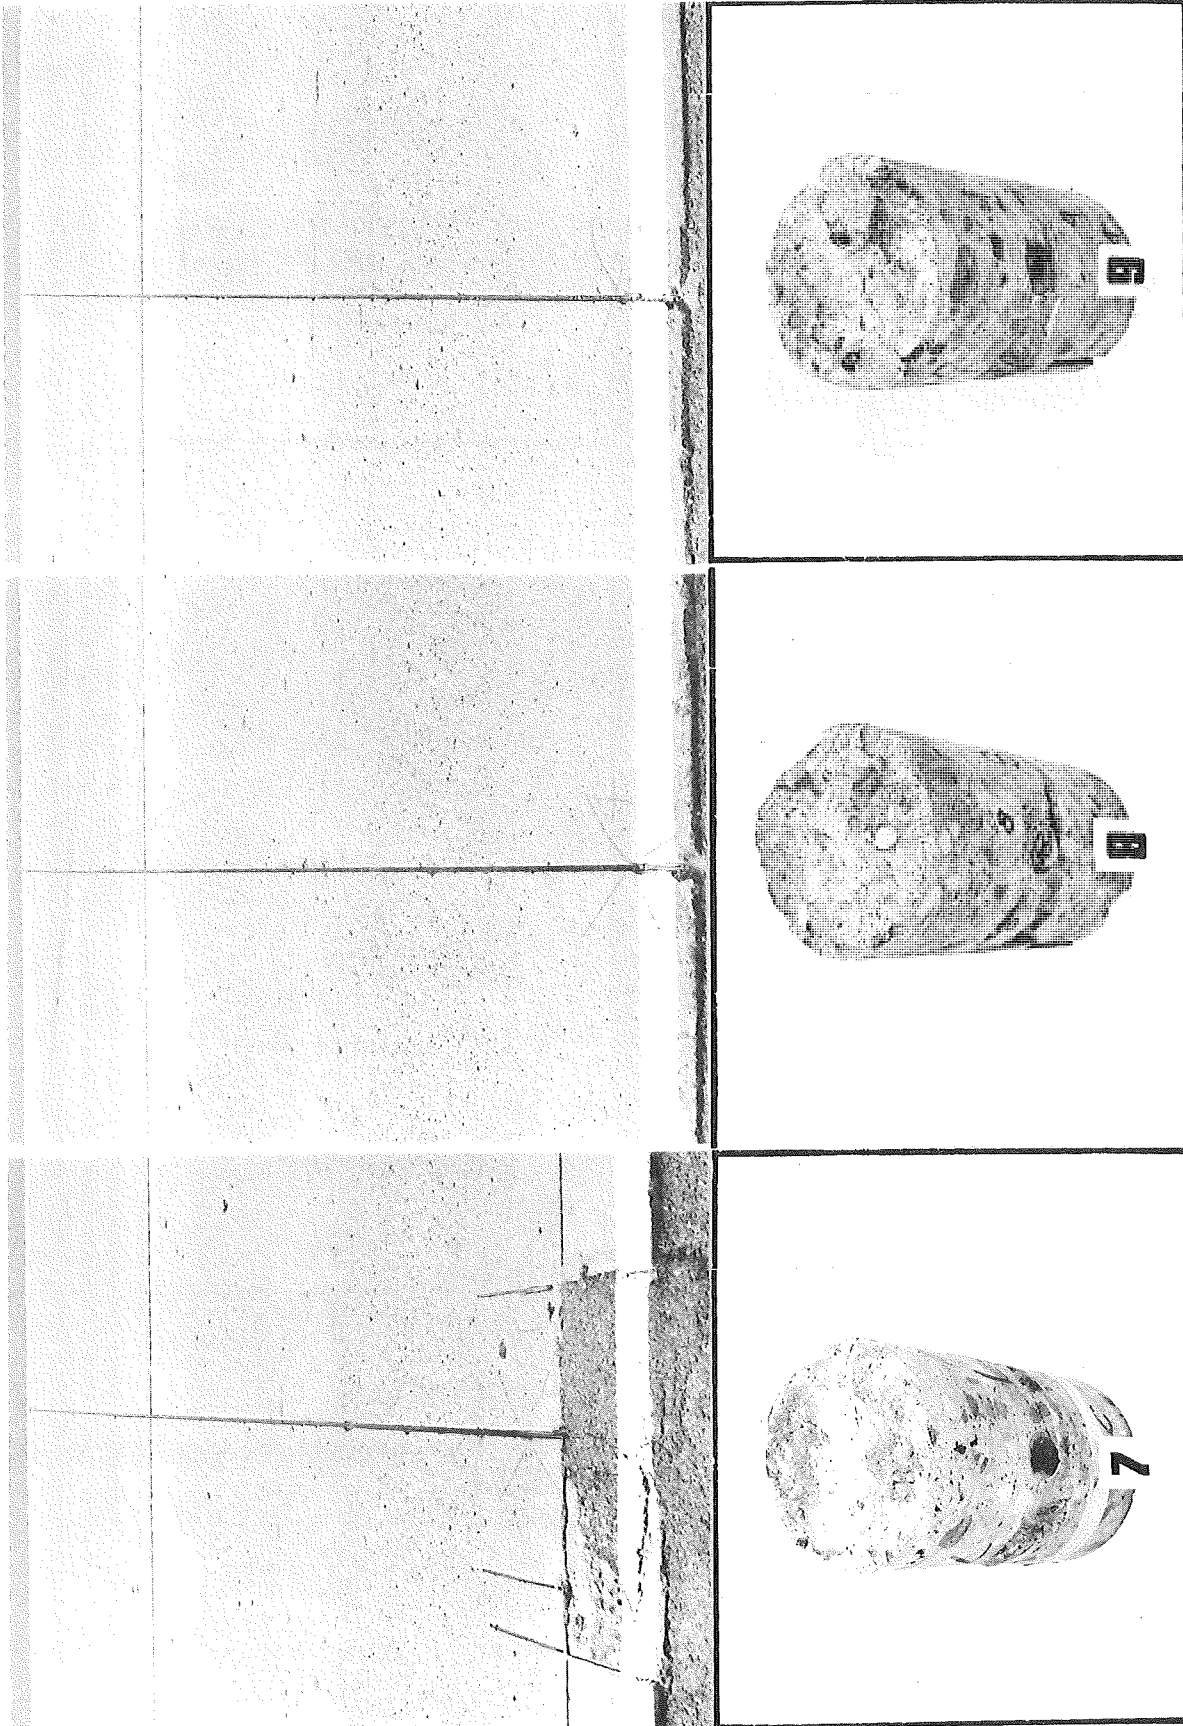
Figure 8. Typical joints and cores from M 52 near Owosso. Contraction joints (cores shown upside down) constructed 1969, 71-ft slabs, no base plate, neoprene seal. After 10 years' service on this rural two-lane trunkline, minor deterioration is seen at bottom slab and horizontal cracks at bar level.

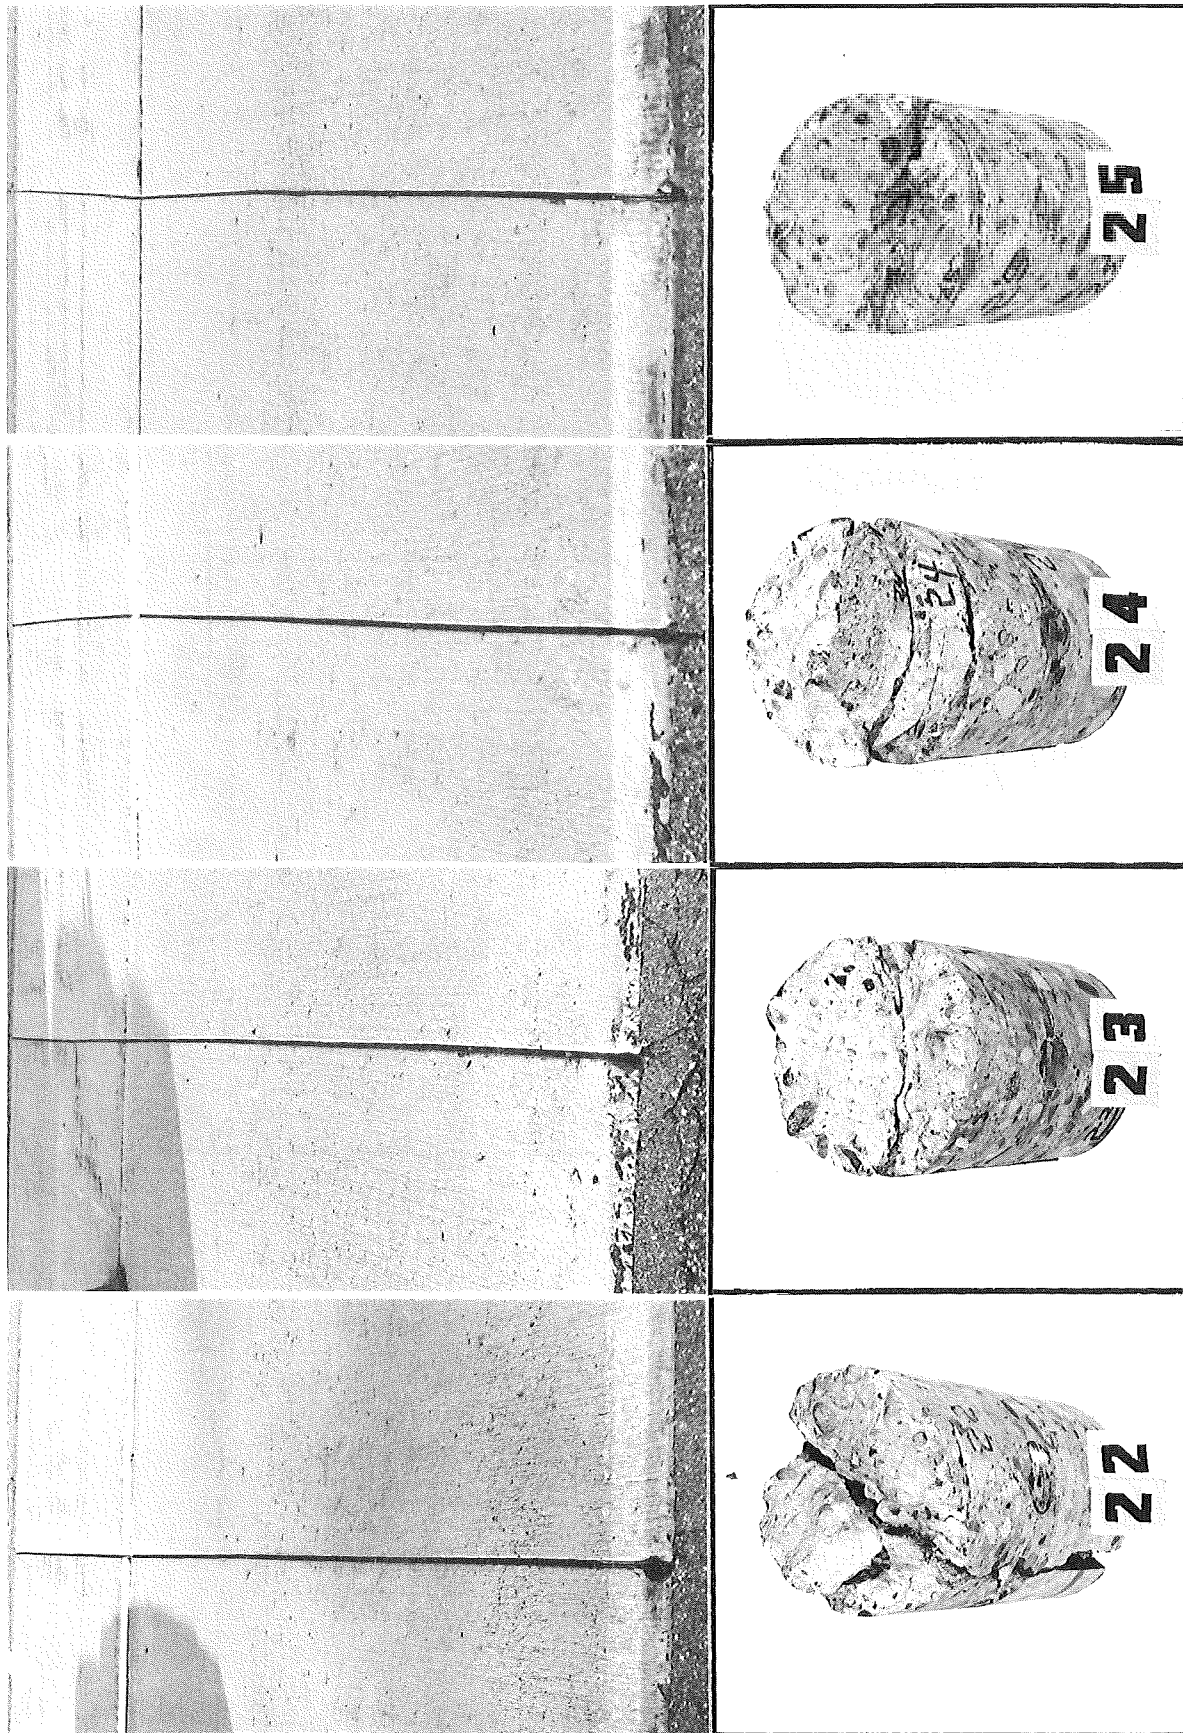
Figure 9. Contraction joints and cores (shown upside down) from I 75 near West Branch. Constructed 1973, specimens 22, 23, 25 and 26 are from 71-ft slabs, specimen 24 from a 57-ft slab, and specimen 27 from a 43-ft slab, with no base plates and neoprene seals. This rural freeway had been in service for six years when sampled; all show moderately severe deterioration at the bottom of the joints.

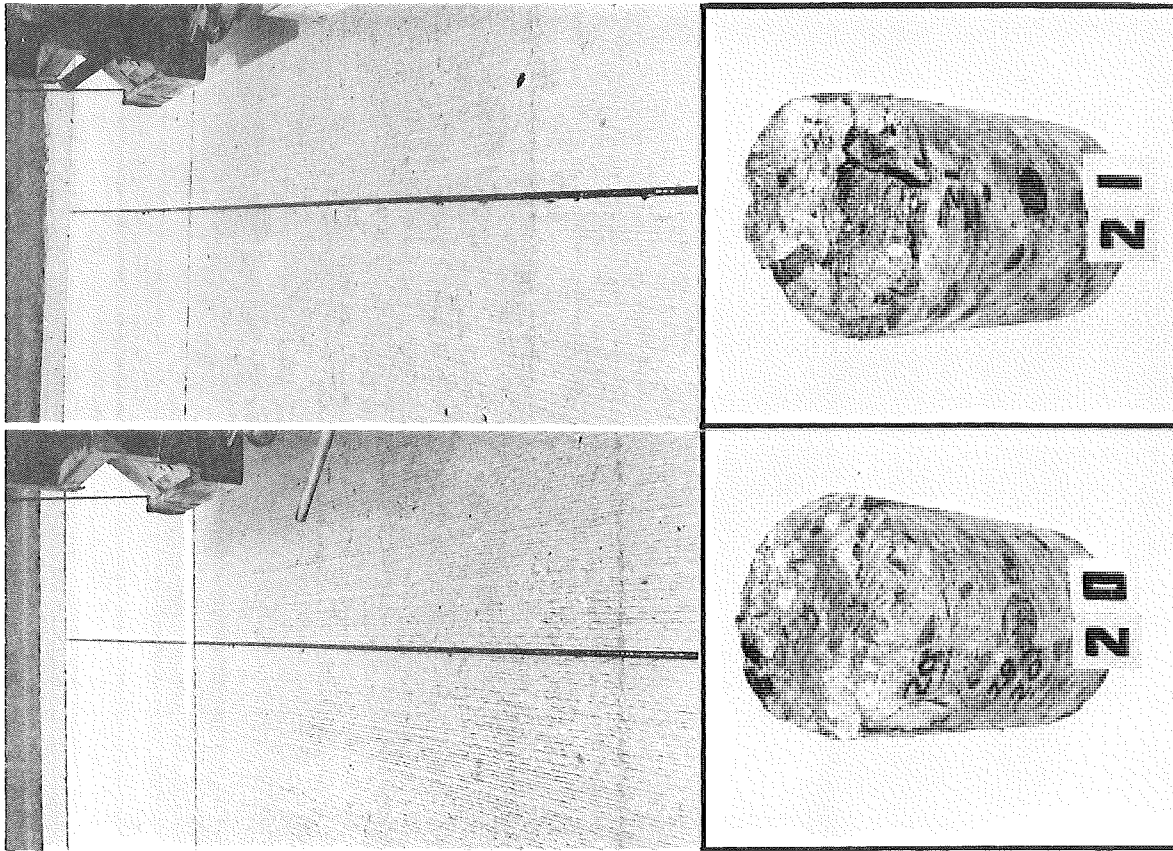
Figure 10. Contraction joints and cores (shown upside down) from US 10 north of Clare. Constructed 1974 (but only in service four years when sampled), 71-ft slab, no base plates, preformed neoprene seals. These rural freeway samples displayed moderate concrete deterioration at the bottom of the joint.

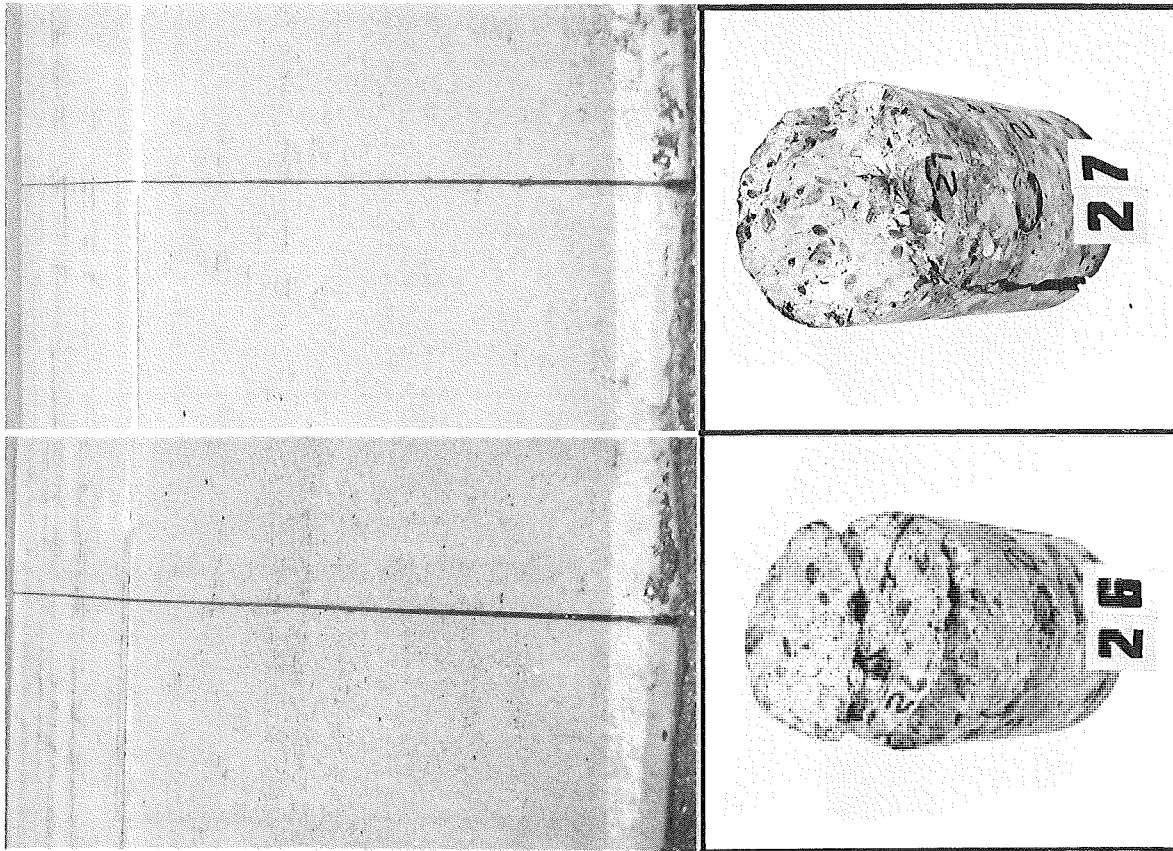
Figure 9 (Cont.). Contraction joints and cores (shown upside down) from I 75 near West Branch. Constructed 1973, specimens 22, 23, 25 and 26 are from 71-ft slabs, specimen 24 from a 57-ft slab, and specimen 27 from a 43-ft slab, with no base plates and neoprene seals. This rural freeway had been in service for six years when sampled; all show moderately severe deterioration at the bottom of the joints.

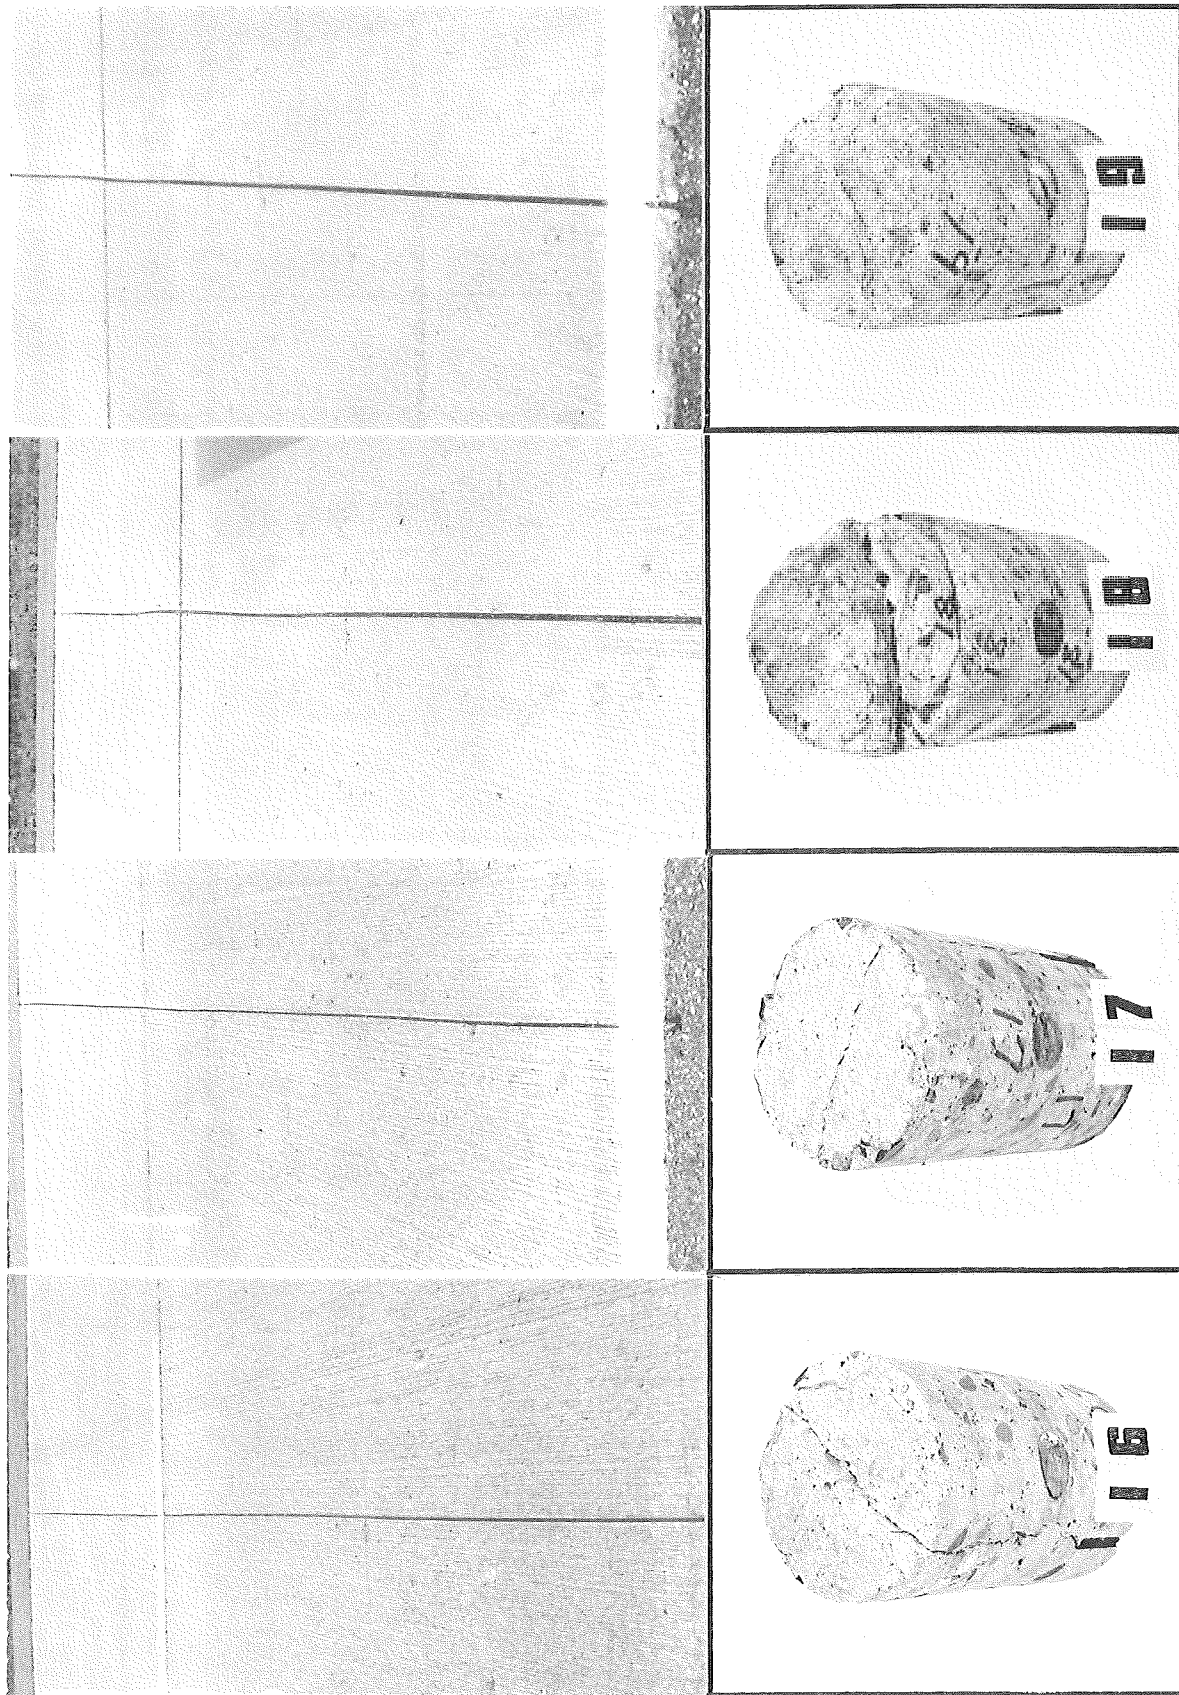
may not be highly significant. The trend, however, is interesting. Additional cores from arbitrarily selected joints of these two pavements, taken in 1980, showed the same situation to exist as shown in Figure 11. Bashore and Price also found indications that the rate of attack on the bottom of the joints may decrease at least temporarily, for this type of pavement, as age of the pavement increases beyond the first few years. If true, this suggests perhaps that the height and duration of standing water within the joint may be such that the very bottom of the joint is affected more than the materials higher on the joint face. Drainability of the base, therefore, could play an important role, as well as the susceptibility of the coarse aggregate particles in the mix to this type of deterioration.

Figure 11. Contraction joints and cores (shown upside down) from the gravel base sections of the experimental installation on US 1.0 north of Clare. Constructed 1975 (in service four years), specimens 16 and 17 from 13 to 17-ft slabs, specimens 18 and 19 from 71-ft slabs of the control section, no base plates, with neoprene seals. Note the much greater concrete deterioration in the core from the longer slab from this rural freeway.

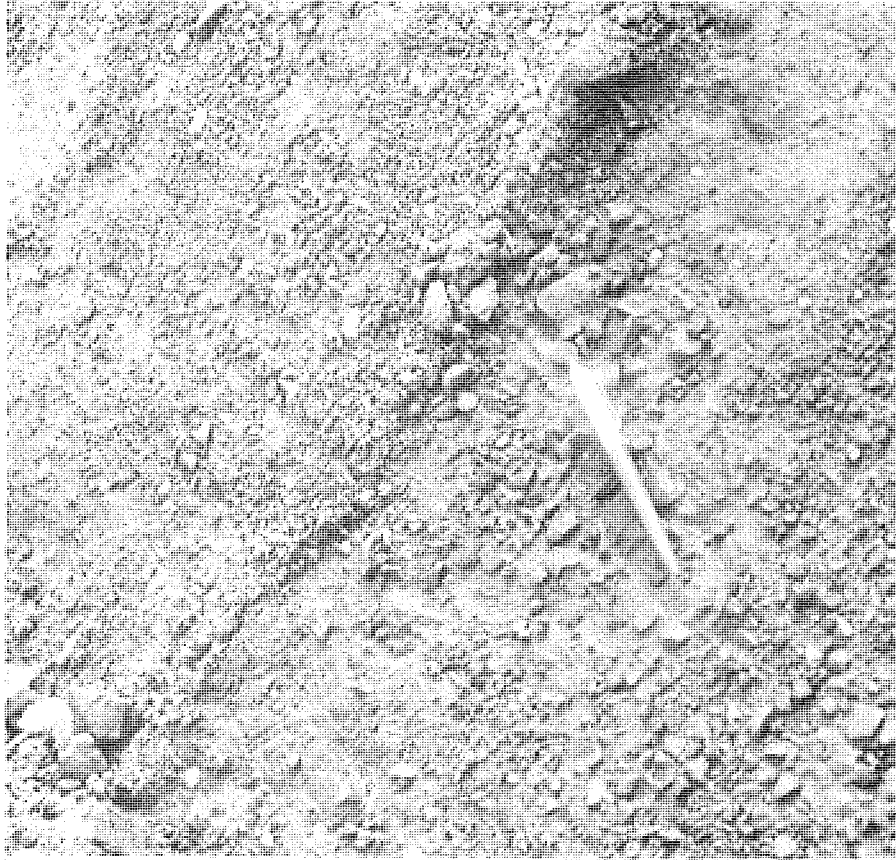
Although truck traffic was very light on this rural road, joint faulting developed early. When slabs were removed, spanning a joint, it was found that water pumped by trucks had caused a void under the 'leave' slab due to the movement of the finer limestone particles back under the 'approach' slab. Some of the so-called 'finer' particles exceeded 0.1 in. in diameter, demonstrating the power of the fluid pump that works beneath the pavement. Figure 12 shows the faulted pavement joint, faulted base after pavement removal, and the eroded area beneath the sunken slab. Therefore, one must not conclude that the absence of ultrafine particles will prevent faulting in cases where water is retained beneath the pavement for long periods of time, and truck traffic is present.

Figure 12. Removal of faulted pavement slab from Route 151 revealed the faulted limestone base with a void under the sunken slab. Note the exposed coarse aggregate particles where all finer material has been transported back under the other slab. Particles larger than 0.1 in. were moved.

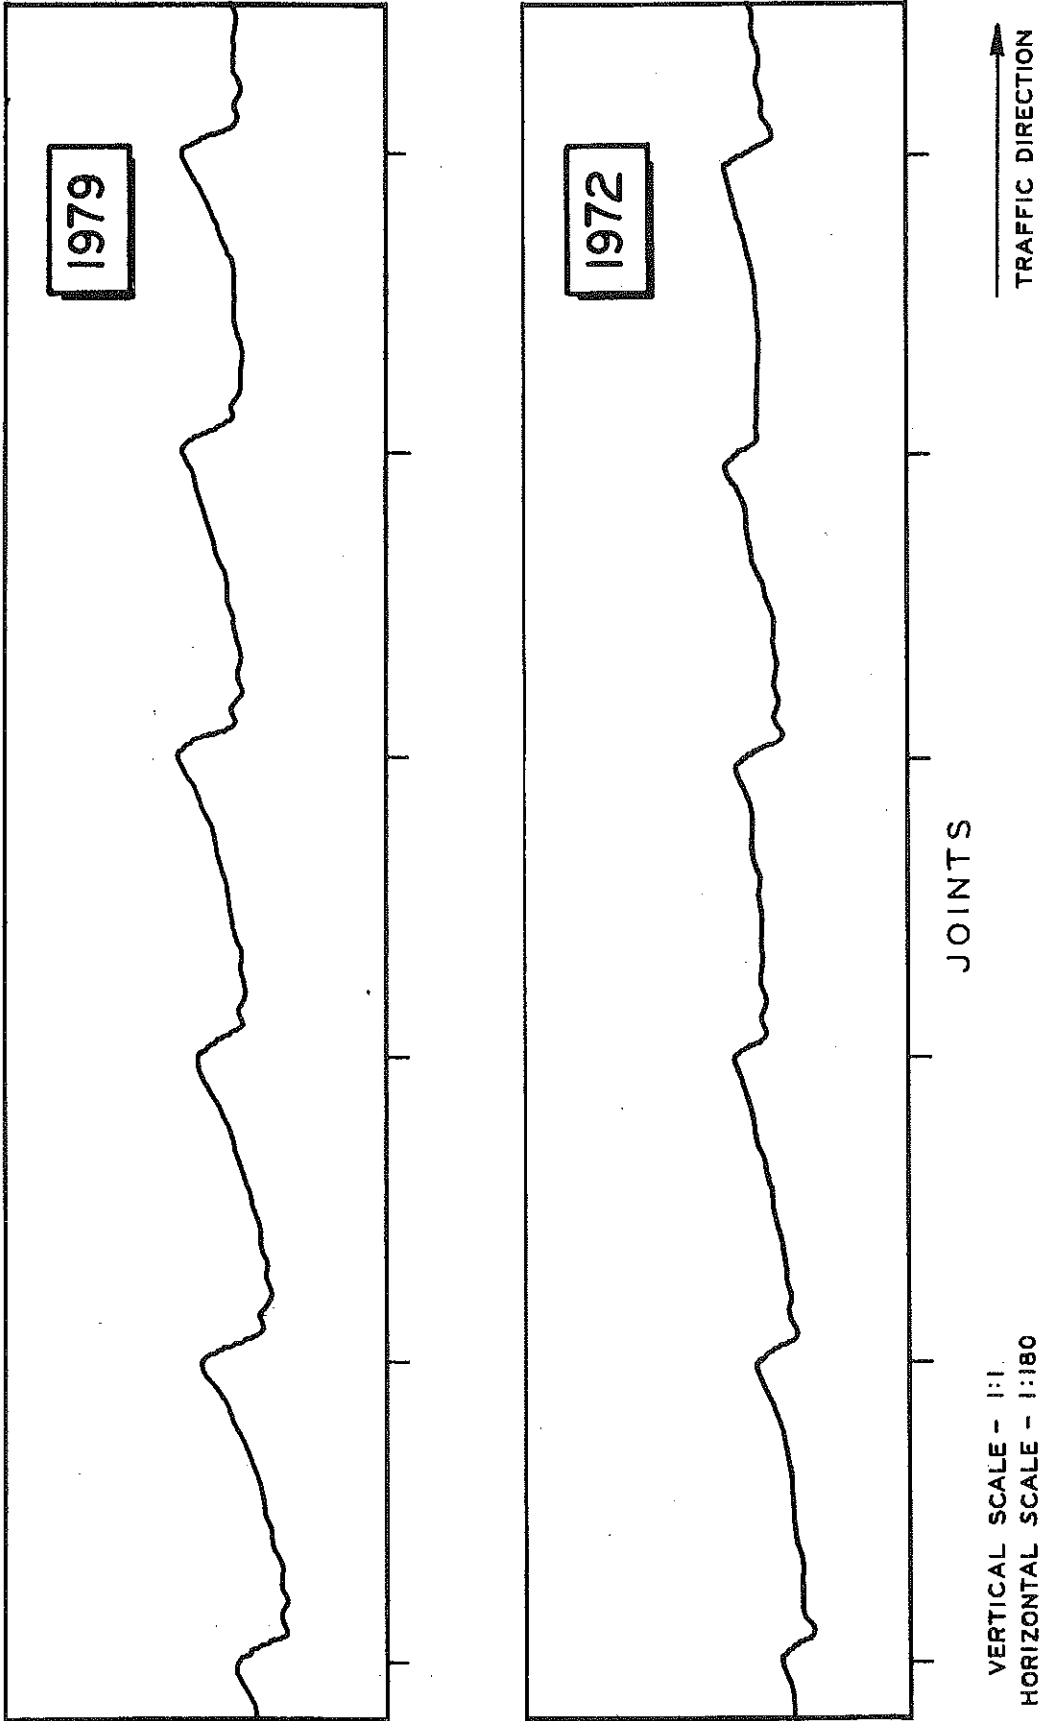
Figure 13 shows portions of Rapid Travel Profilometer traces made in 1972 and again at the same location in 1979. Notice that the size of the faults has continued to increase as the pavement age increases, and at the present level have had a significant effect on the rideability of the pavement, especially for stiffly suspended vehicles. Portions of the 'wartime' plain concrete pavements on the old Detroit Industrial Expressway, built up joint

Figure 13. Rapid Travel Profilometer traces showing increase in faulting of short slabs, plain concrete pavement after seven additional years of light traffic.
