**JOINTED CONCRETE PAVEMENTS  
DESIGN, PERFORMANCE AND REPAIR**

**C. J. Arnold  
M. A. Chiunti  
K. S. Bancroft**

**Research Laboratory Section  
Testing and Research Division  
Research Projects 68 F-101, 70 F-113,  
70 F-116, 71 F-122, 73 F-136, and 74 F-140  
Research Report No. R-1169**

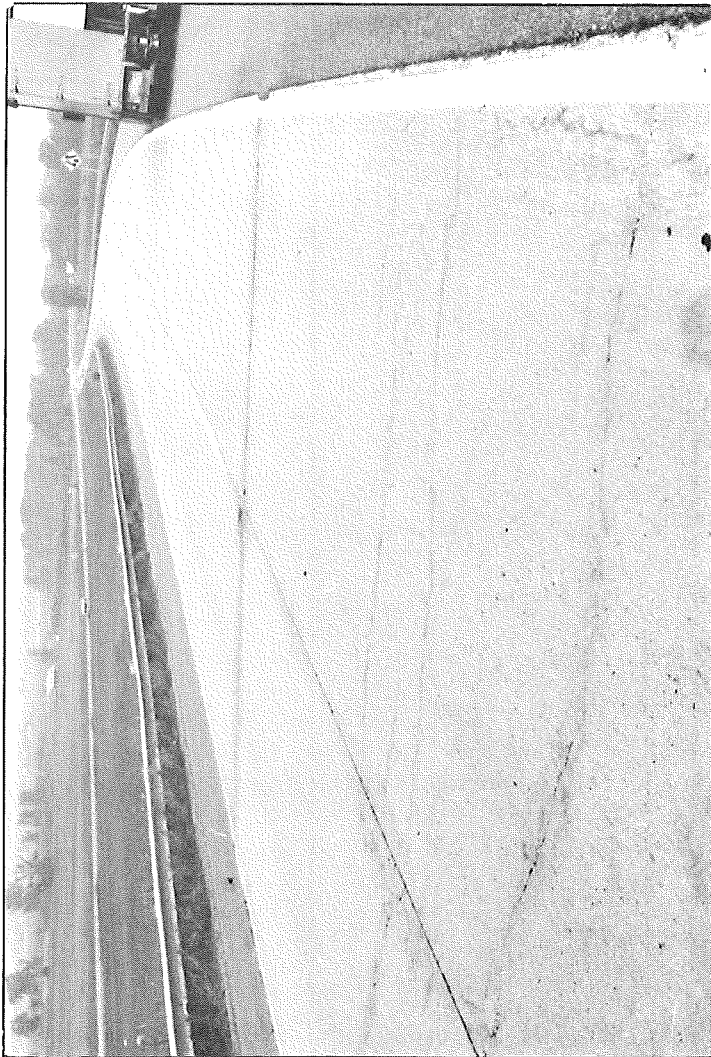
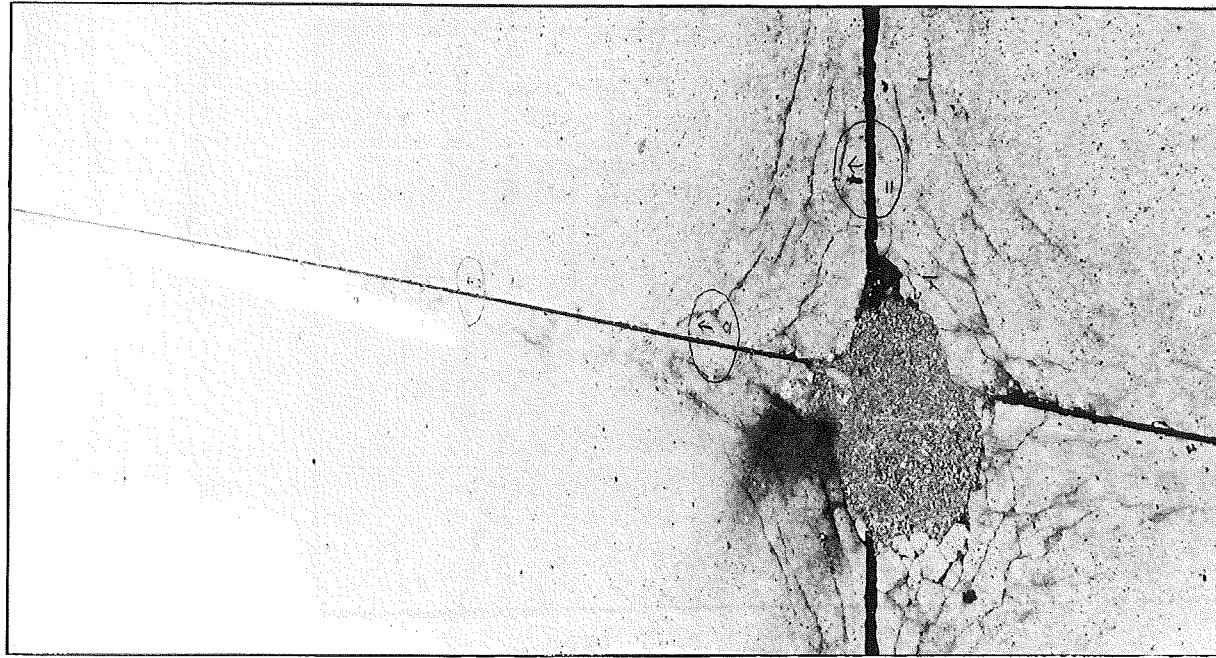
Figure 14. General view of the US 27 ramp near Mt. Pleasant. Note staining of surfaces near joints and cracks. Pavement was built in 1961, and was 18-1/2 years old when photographed. It has 99-ft slabs, base plates, and poured sealants. A close-up view of the joint is also shown. The nearby ramp, shown in the back-ground, contained a premium grade coarse aggregate and shows no D-cracking at the surface.

Figure 14 shows a general view of a ramp pavement on US 27 southeast of Mt. Pleasant. This pavement is fairly typical of some of the mainline pavement in the vicinity. Departmental records indicate that it was built early in 1961, and that the locally available coarse aggregates were known to be susceptible to freeze-thaw deterioration. Specifications of that time required equal parts of 4A and 10A coarse aggregate (gradations given in Table 1). Design life of the pavement was 20 years. Commercial traffic is relatively light. Slab length is 99 ft with poured joint sealants and base plates. The adjacent ramp shown in the background of Figure 14 was built the previous fall with a premium quality coarse aggregate in the 4A fraction and is in excellent condition after 20 years of service. The only difference between the good and poor performing pavements was that the 4A fraction only of the coarse aggregate in the good pavement was dolomite, while another source was used for the 4A in the poorer example. The 10A and fine aggregates were the same for both the good and bad sections. This project and subject are covered more extensively in a recent research report (14).

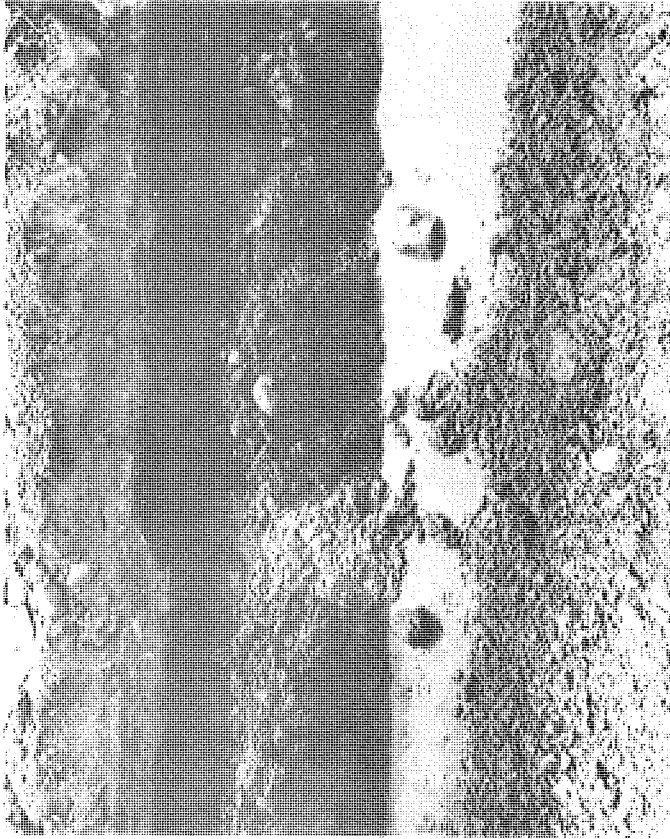
Figure 15. Edge view of pavement on demolition job where shoulder material has been bladed away. The small mud slides caused by water running out of the joints mark the joint's location.

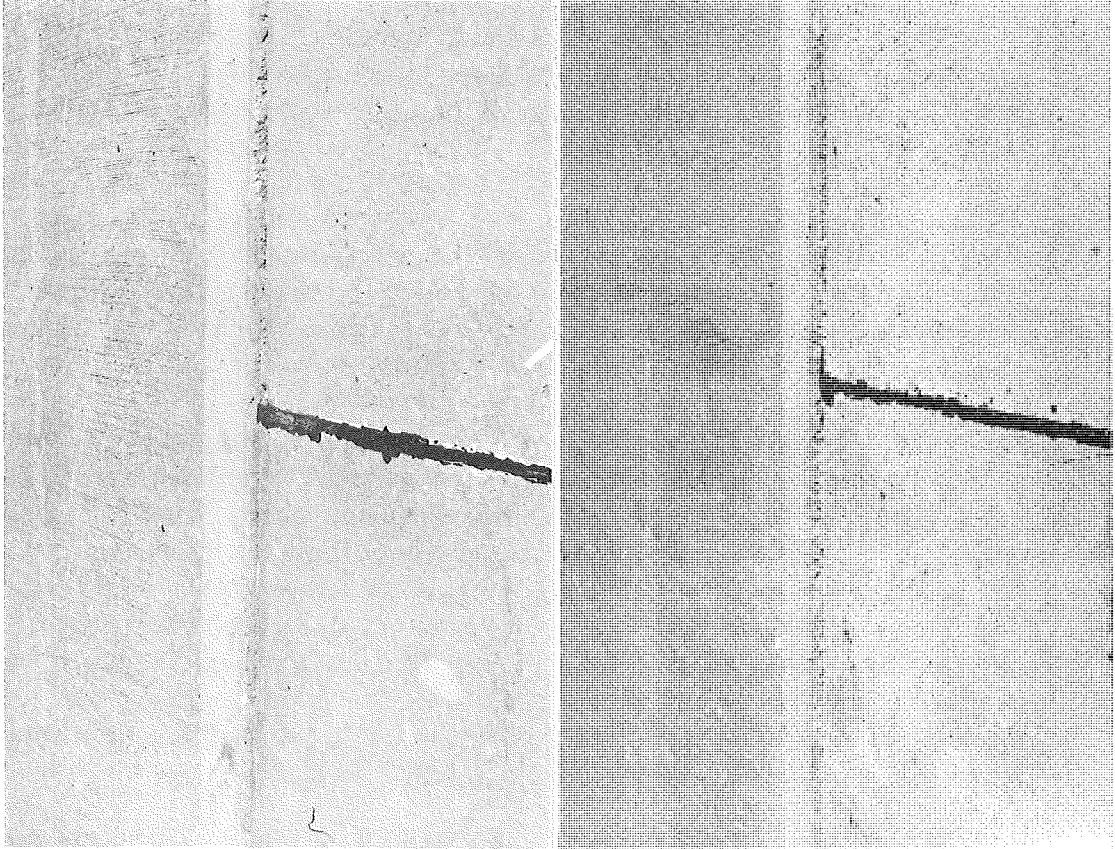
Figure 16. The combination of two stress concentrations. I 75 near Birch Run. The two far lanes are old, while the near lane and shoulder were added later in a single pass. Pavement is reinforced with 99-ft slab length and shoulder is unreinforced with slabs about 18 ft long. Shoulder joint plus old slab fracture combine to fracture the newer lane. Obviously, the fractured old pavement has greater effect than the shoulder joint.

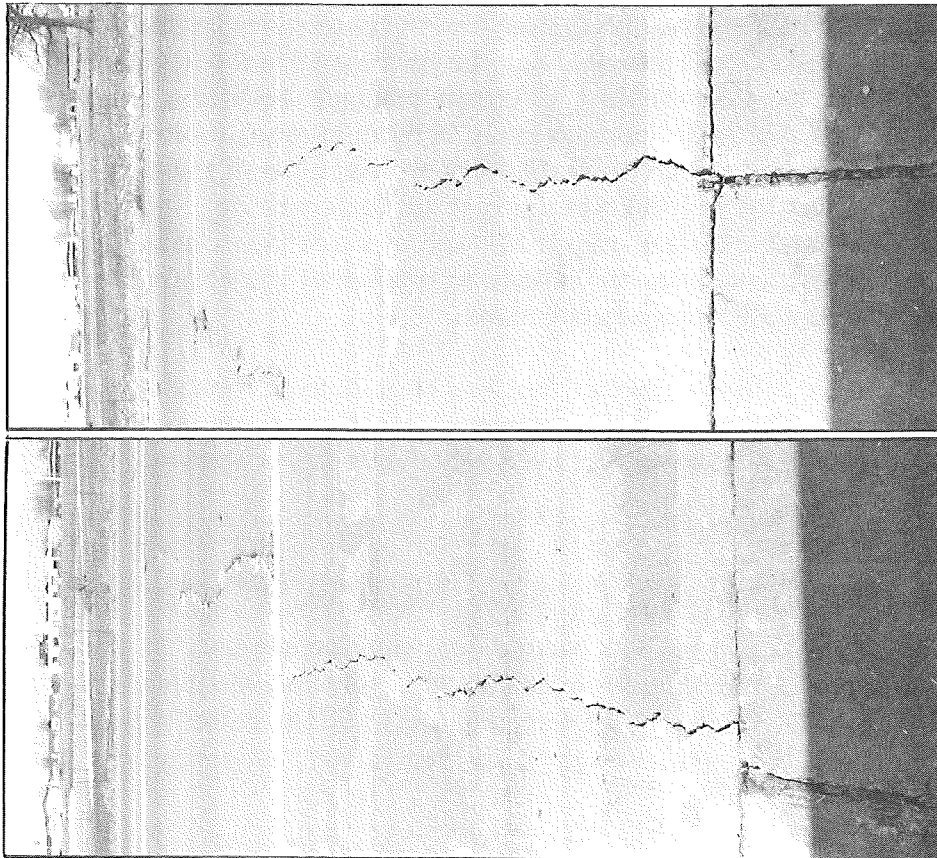
Figure 17. Widening slab above and shoulder slabs below were placed separately. The stress concentration at shoulder joints still affects cracking in the adjacent longer slab, but naturally to a lesser degree than when integrally cast (I 75 near Birch Run).

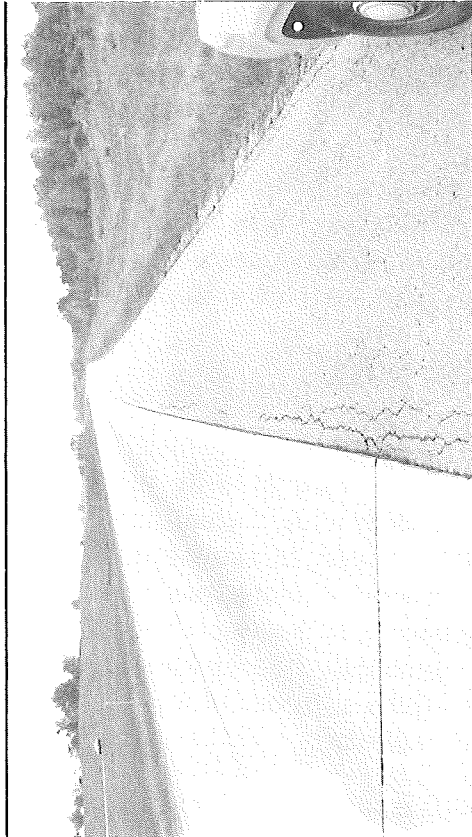
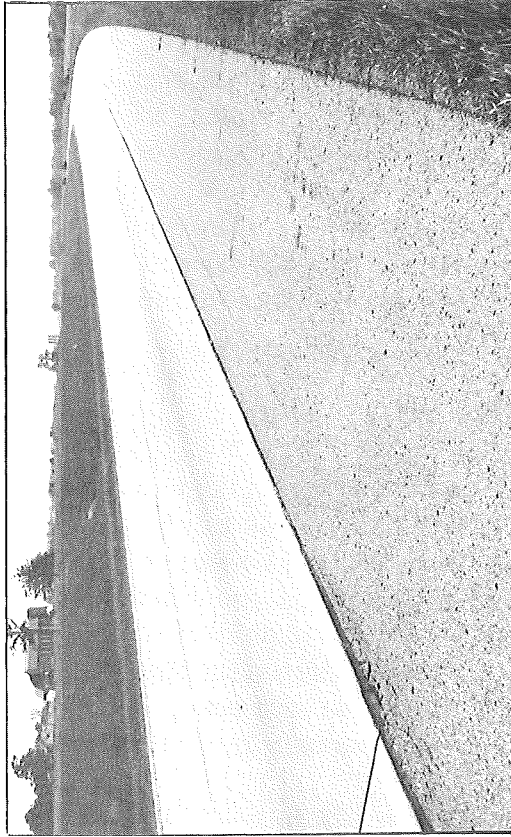
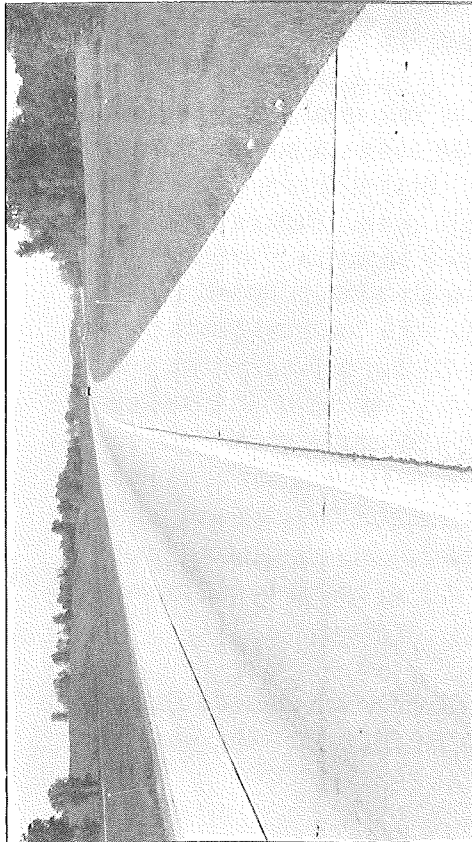
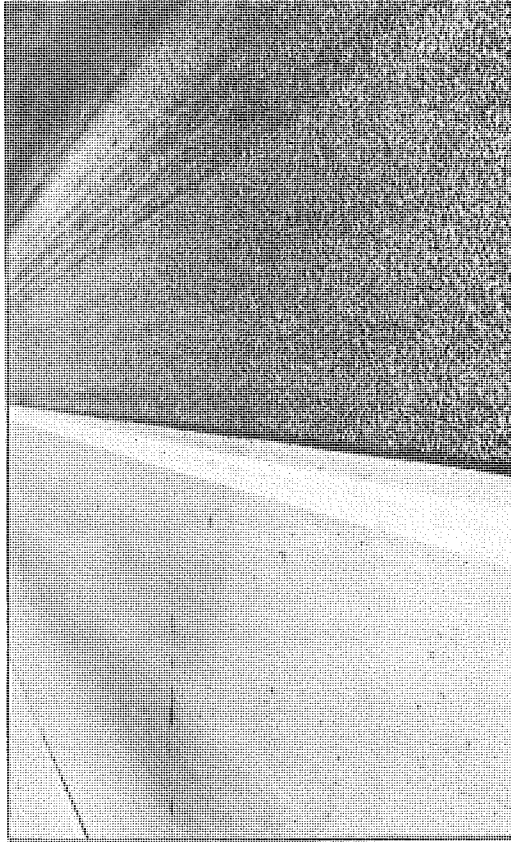
Figure 18. Experimental concrete and bituminous shoulder installation, I 69 near Olivet. All three bituminous type shoulders have separated from the concrete pavement, and settled to varying degrees, especially near transverse joints. The concrete is in good shape, except for some localized problems with poorly made expansion joints. Commutative cracking of pavement slabs opposite concrete shoulder joints can be seen in many locations on this project, but the cracks still are quite narrow at most locations.

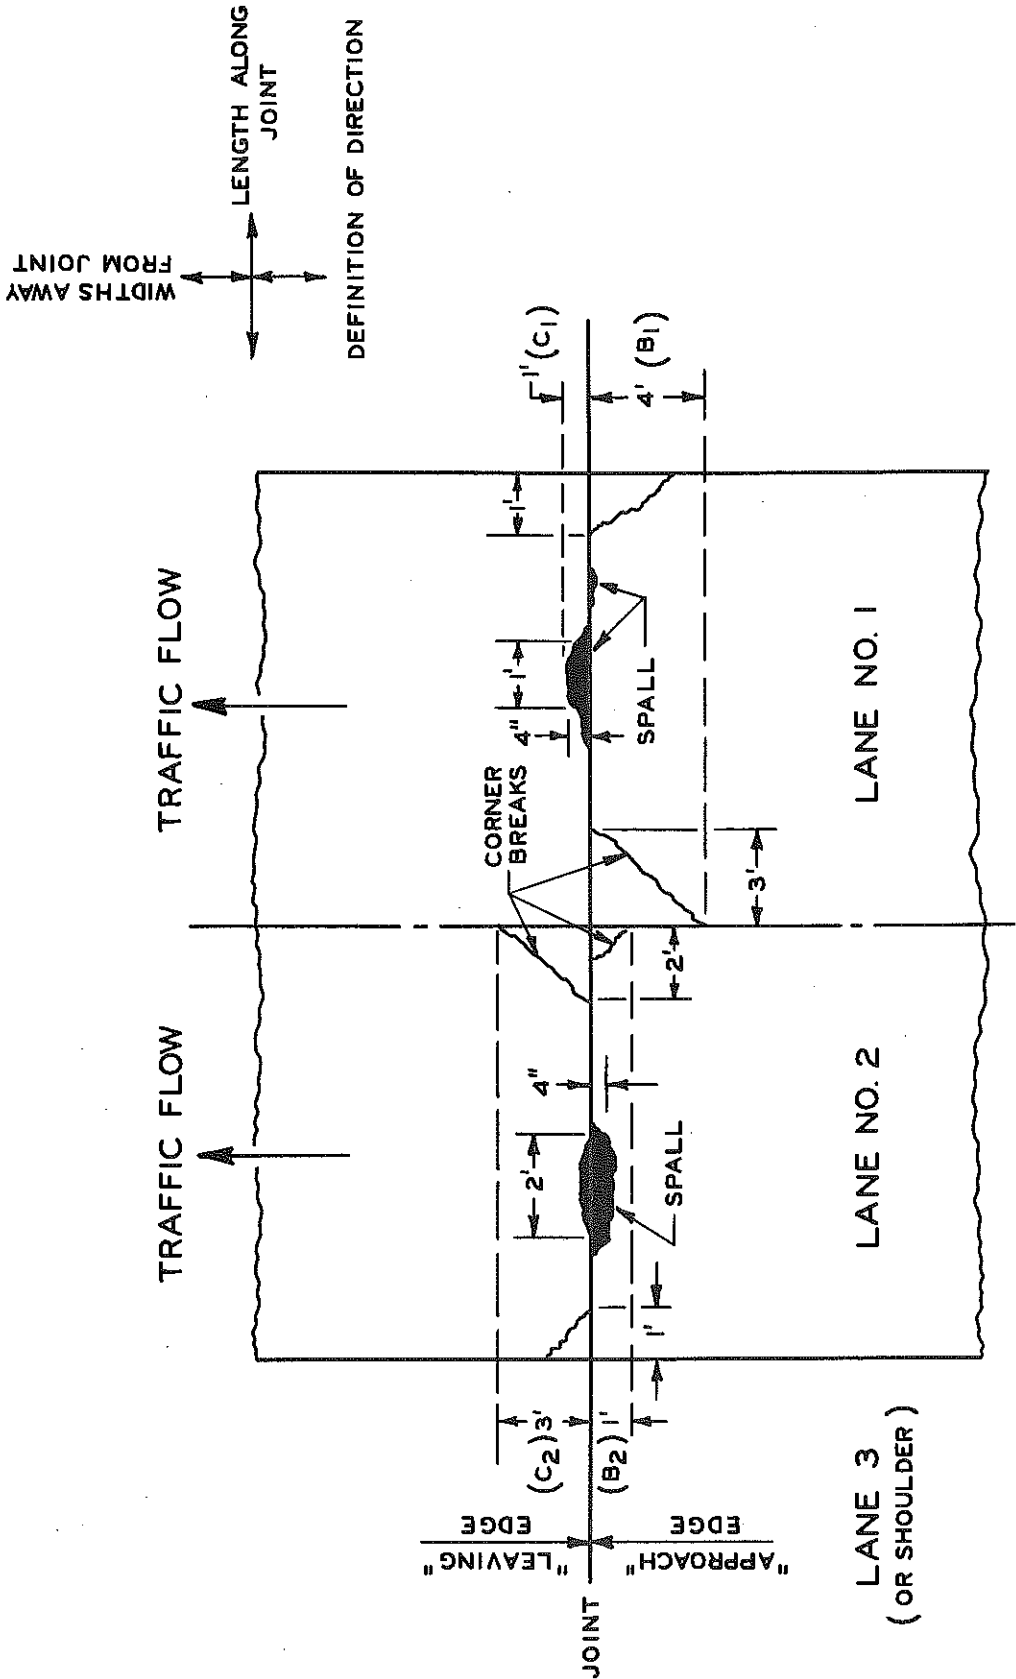
RATING - LANE 1, 1 + 1 + 3 = 5 (A1)  
 LANE 2, 2 + 2 + 1 = 5 (A2)

Example of deteriorated joint in two-lane one-way road.
