FAILURES OF CONTINUOUSLY REINFORCED PAVEMENT
I 96, Portland Road to M 66

Research Laboratory Division
Office of Testing and Research
Research Project R-57 F-46
Report No. R-397

Michigan State Highway Department
John C. Mackie, Commissioner
Lansing, November 1962

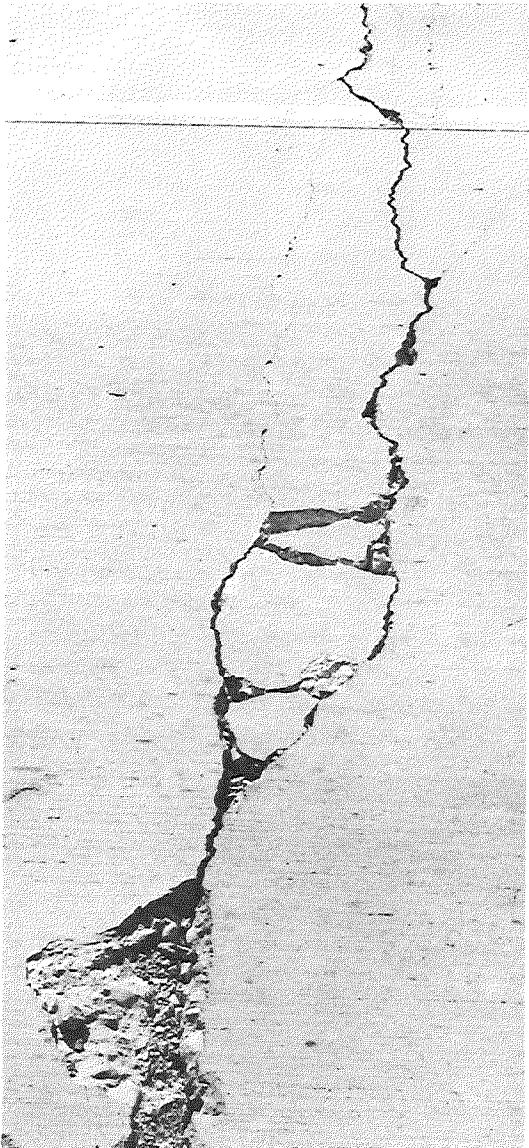
Sta 1071+90, westbound roadway
(photo: October 1960)

Sta. 1071+90, Westbound Roadway. The failure crack originated at the outer edge of the traffic lane, where the reinforcement steel was found to be in two different horizontal planes for a distance of 2 ft from the edge. In addition, the lap was found to be insufficient across the full width of the roadway. Fig. 4A shows the condition of the lap at the time of repair. The steel depth across the roadway in the failure area varied from 2-1/2 to 3-1/2 in. and the slab thickness from 7-3/4 to 8-1/4 in. A core taken through the failure crack at approximately the center of the traffic lane (Fig. 4B) indicates a Type 2 failure. The core shown in Fig. 4C, taken through a section at the crosswire location, was broken to verify that the weld had failed. A Type 1 failure was found to have occurred in the inner 3-1/2 ft of the traffic lane, as illustrated by the core in Fig. 4D. Since the traffic lane failed first, the increased stress induced in the steel in the passing lane, coupled with the rusting of the steel at the failure crack, caused this reinforcing steel to fracture. A core (Fig. 4E) taken in the center of the passing lane through the crack verified that the steel was badly rusted or broken. In addition, as the opening of failure crack increased the broken steel became visible through the crack.

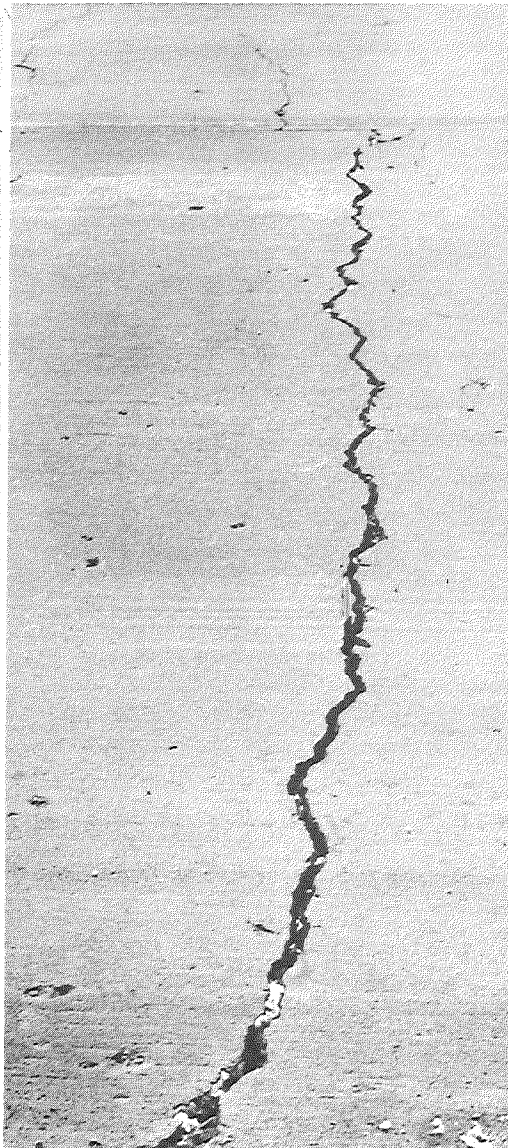
Sta 1045+75, westbound roadway
(photo: January 1962)

Sta. 1045+70, Westbound Roadway. The failure at this location was confined to the traffic lane only. Cores taken through the failure crack indicated a Type 2 failure similar to that observed at Sta. 1071+90, except the vertical failure crack occurred at the end of the top mat and the weld connection in the bottom mat had failed. The top reinforcing mat remained well bonded to the concrete while the lower mat was not. It was also noted

that the longitudinal wires of the lower reinforcing mat were shiny, indicating sliding. Fig. 5A is a core taken through the failure crack in the center of the lane and Fig. 5B shows a core that has been broken to show the weld failure. Fig. 5B also indicates poor consolidation of the concrete in the lap area; thus water entering through the vertical crack would have easy access to the weld and would increase the possibility of weld failure by rusting of the steel. The steel depth across the lane varied from 2 to 3 in. and the slab thickness varied from 7-3/4 to 8-1/4 in. The lap in the reinforcement was sufficient the full width of the lane.

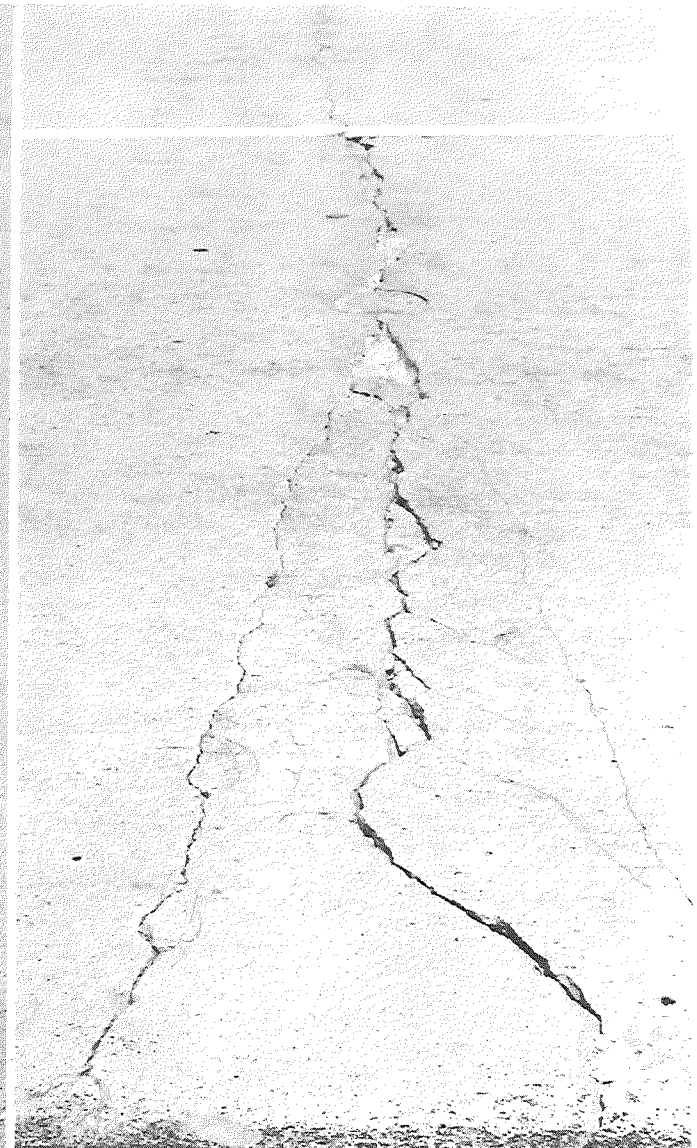
Sta 875+90, eastbound roadway
(photo: April 1962)

Sta. 875+90, Eastbound Roadway. A Type 1 failure was observed to have occurred in the traffic lane, where the failure crack originated. An insufficient lap of the reinforcement in this lane probably aggravated the formation of a failure crack at this location. Fig. 6A shows a core taken through the failure crack 3 ft from the outside edge of the traffic lane. Although the core broke horizontally during removal it can be seen that the bottom of the core is not cracked vertically and the lower steel reinforcement is still bonded to the concrete, whereas the bond in the top part of the core has failed. The core in Fig. 6B, taken at a section through the point of ending of the lap, shows the horizontal failure crack extending to the center of the core, and also the vertical crack that completes a failure of this type. Again, as observed at Sta. 1071+90 on the westbound roadway, the passing lane apparently failed due to excessive stress and rusting of the reinforcing steel. Fig. 6C shows the condition of reinforcement in the passing lane adjacent to the traffic lane edge. At the time of repair it was observed that seven longitudinal wires had failed completely, 14 were near the point of failure and the remaining 25 toward the inside shoulder were rusted to a lesser extent. The steel depth below slab surface was measured to vary from 3 to 4 in. in the area of failure, and slab thickness varied from 8 to 8-1/4 in.

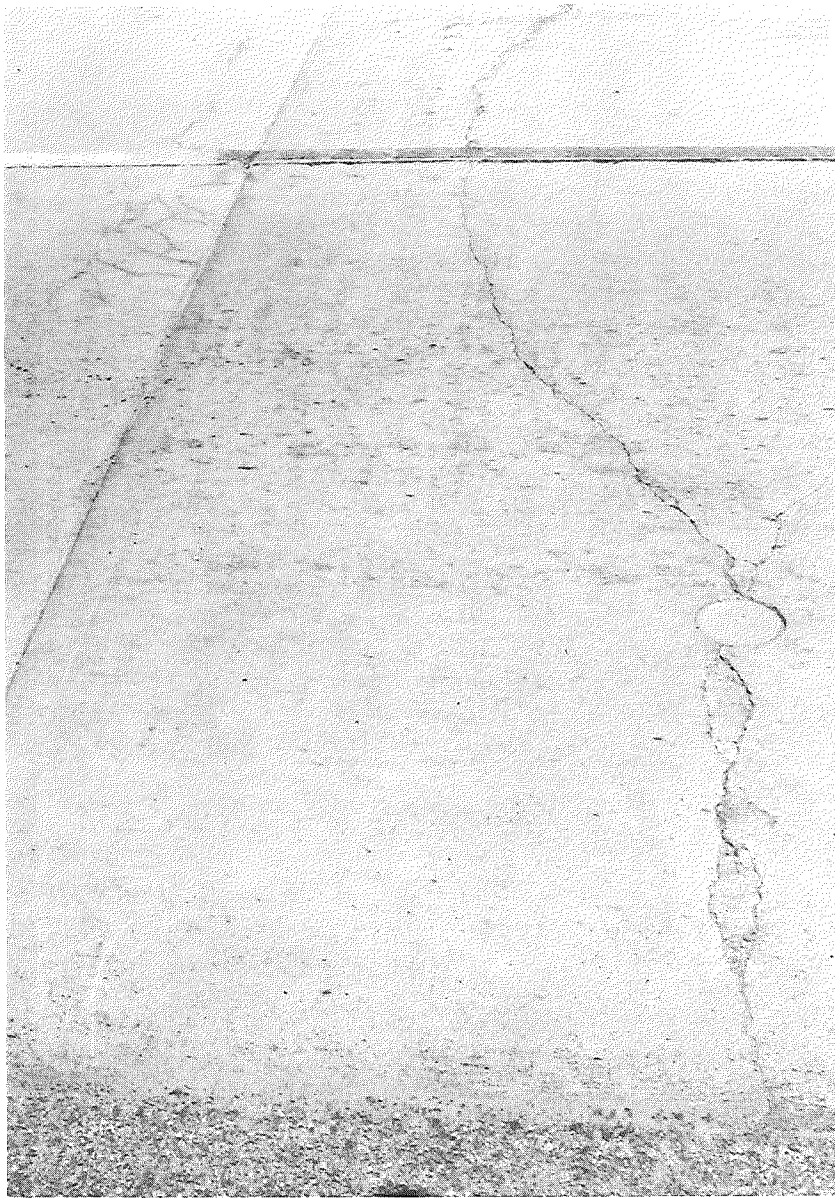
Sta 1044+66, eastbound roadway (photo: April 1960)

2. Station 1044+66. Three of the eight cores which could be tested had a mean ultimate compressive strength of 3450 psi, with a high of 3860 and a low of 3030 psi.

Sta. 1044+66, Eastbound Roadway. The steel extended 7 ft through the construction joint. At the point where this steel ended, its depth below the slab surface was measured to be 6-1/4 in. Again, this dip caused a vertical difference in the reinforcement at the lap of about 2 in. The concrete in this area showed evidence of poor consolidation and the concrete in the bottom layer was of poor quality. Pockets of unmixed aggregates ranging in diameter from 6 to 12 in. were found at various locations throughout the distressed area.

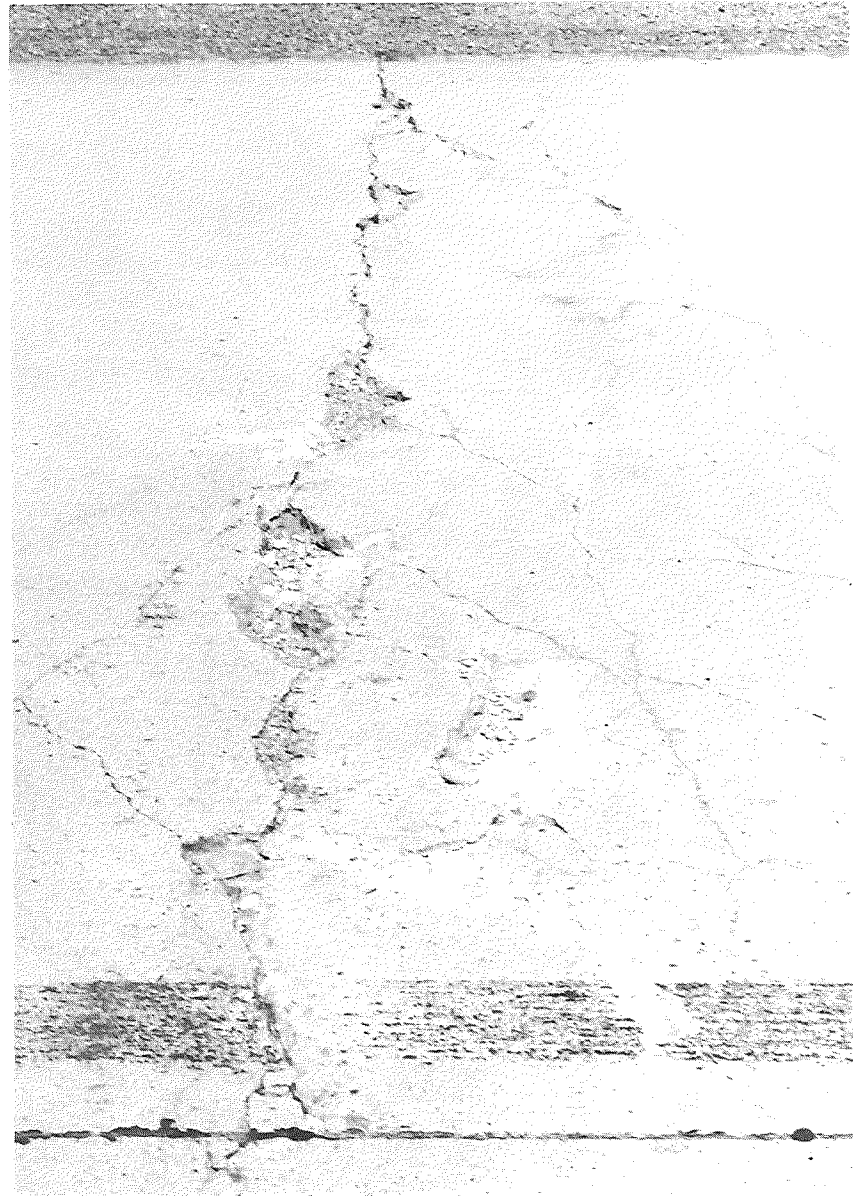
Sta 1017+03, eastbound roadway (photo: April 1960)

1. Station 1017+03. Four of the seven cores which could be tested had a mean ultimate compressive strength of 3660 psi, with a high of 6140 and a low of 2450 psi.

Sta. 1017+03, Eastbound Roadway. The reinforcement extended 5 ft 4 in. through the construction joint. The steel depth below the slab surface at the end of the extended steel through the joint was measured to be 5-3/4 in. The dipping of the steel caused a vertical offset in the steel of better than 2 in. at the lap. Poor consolidation of the concrete was indicated throughout the area by the fact that while concrete was removed during repair, the mortar broke away from the aggregate quite readily.

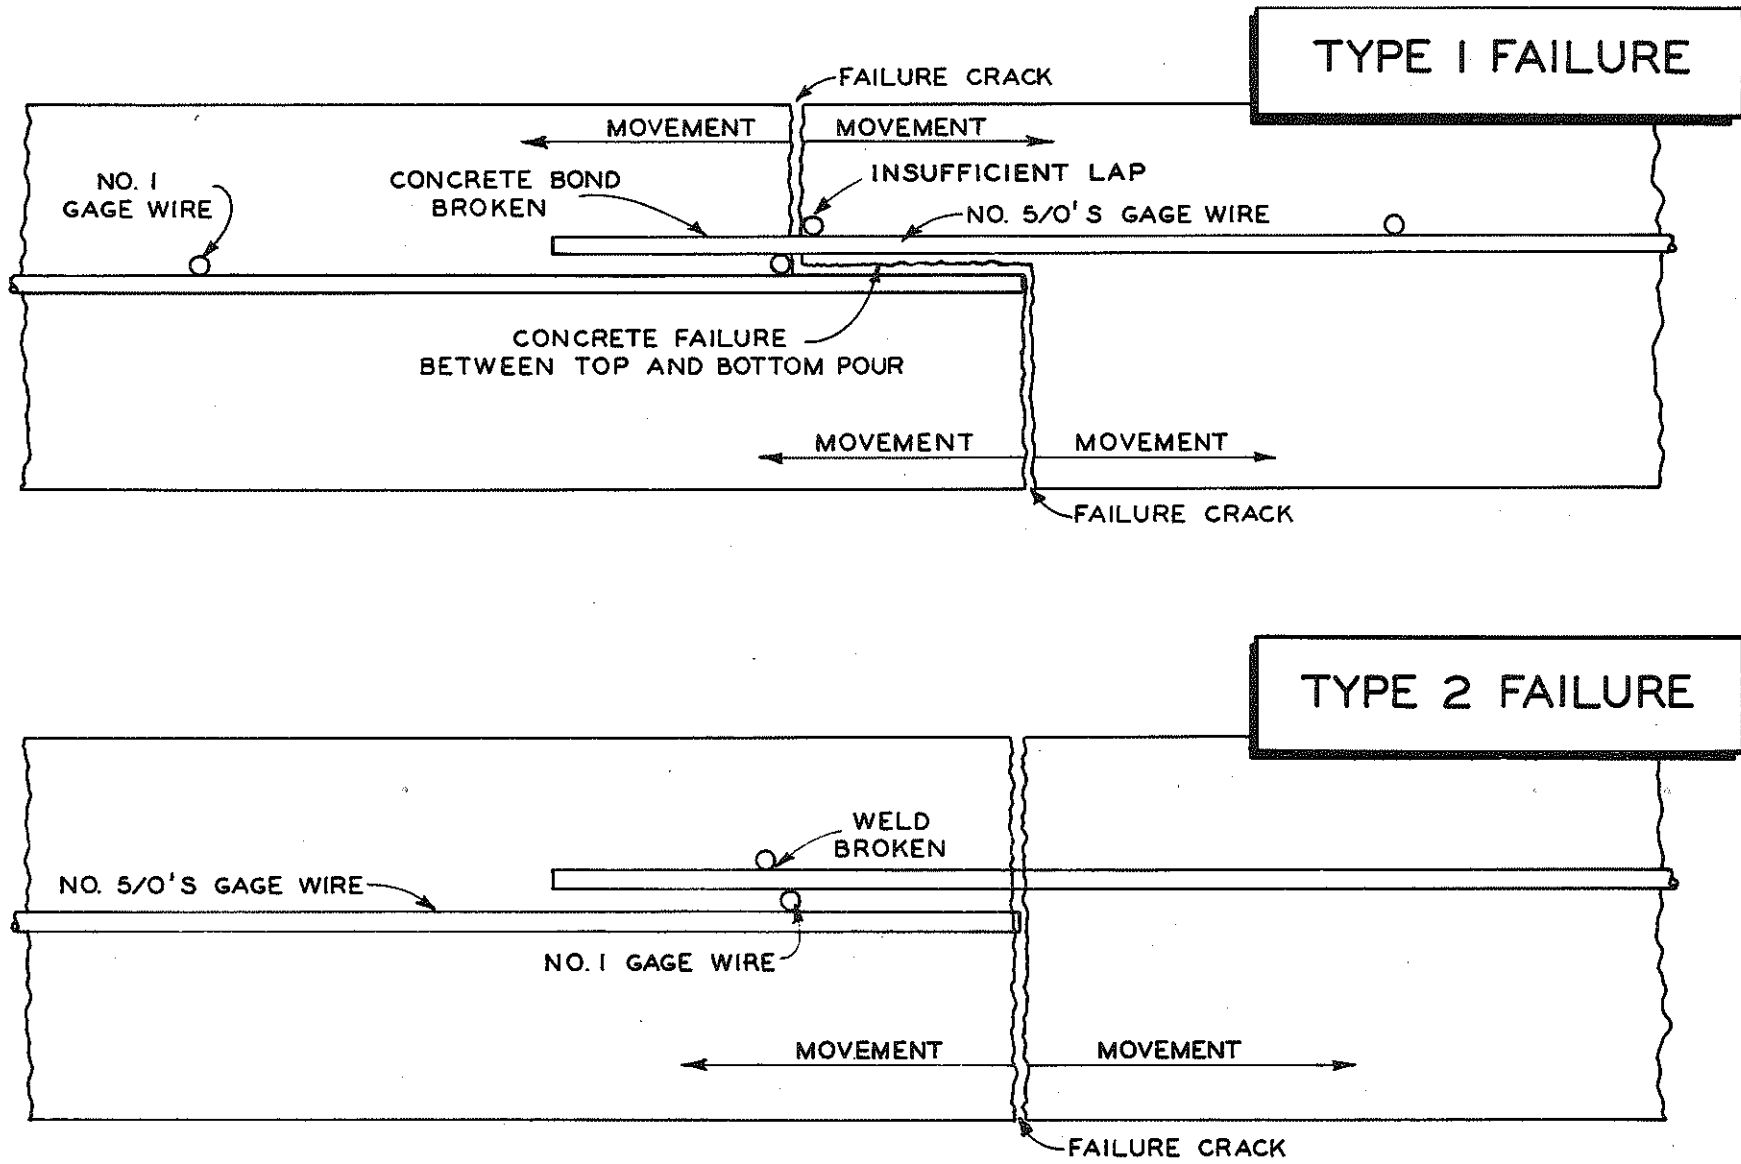
Type 1 Failure is characterized by a vertical crack extending from the slab surface to the depth of the reinforcing steel; then by a horizontal crack or separation of the concrete between the steel mats to the end of the lower mat, where a vertical crack extends to the bottom of the slab. Because of an insufficient lap--the first crosswire in the upper mat being placed ahead of the last crosswire of the lower mat so that the longitudinal wires are not properly anchored--the bond resistance of the plain wire is broken and movement is possible as shown in Fig. 3. Poor consolidation of the two concrete layers, as was observed in the areas where this type of failure existed, facilitates the formation of the horizontal crack at the steel level.

Type 2 Failure is distinguished by a vertical crack extending the full depth of the slab through a section at the end of the reinforcing mat. The weld at the crosswire connection in the lap fails as well as the bond to the

Figure 3. Two types of failure in wire mesh reinforced pavement.

longitudinal steel extending through the vertical failure crack. The slab is then free to move as shown in Fig. 3. Cores taken in the slab at sections through the failed crosswire connection indicate that the presence of moisture causes rusting of the reinforcement steel in the weld area, which undoubtedly increases the possibility of weld failure. Poor consolidation between the two concrete layers in the lap area apparently allows moisture to progress along this plane as water seeps down through the vertical crack. Although the exact nature of the initial cause of the weld failure is not known, it is believed that improper welding or rusting of welds causes some of the crosswire connections to fail before the maximum forces induced by shrinkage and temperature are developed. As a result, the stress normally taken by the failed welds is transferred to the remaining crosswire connections, causing them to be overstressed and a progressive failure to occur across the slab.

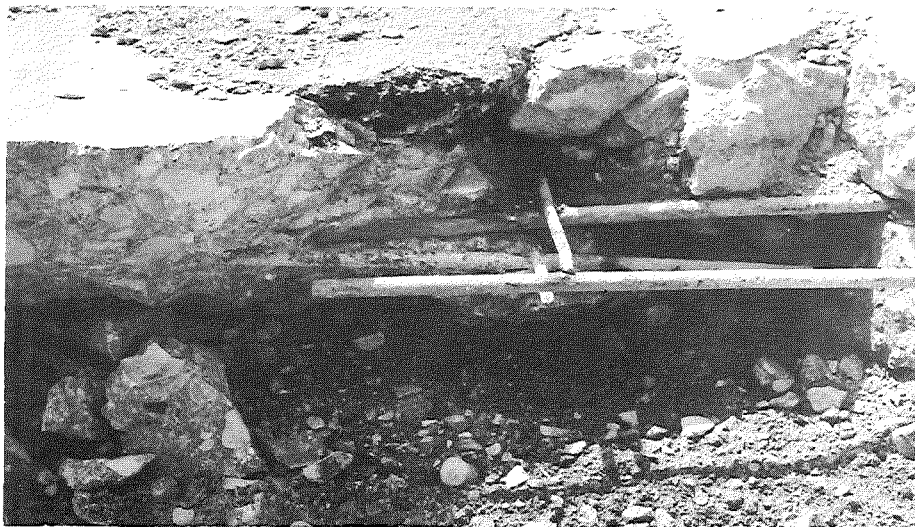
A. Insufficiently lapped wire mesh in the passing lane.

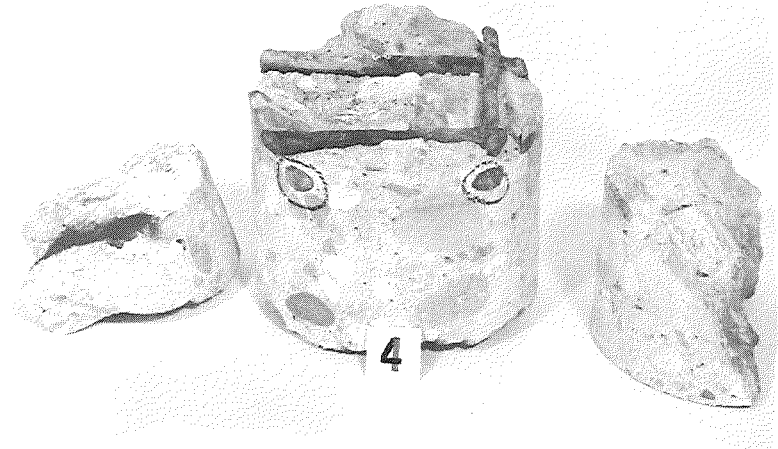
D. Core through traffic lane failure crack, indicating a Type 1 failure.

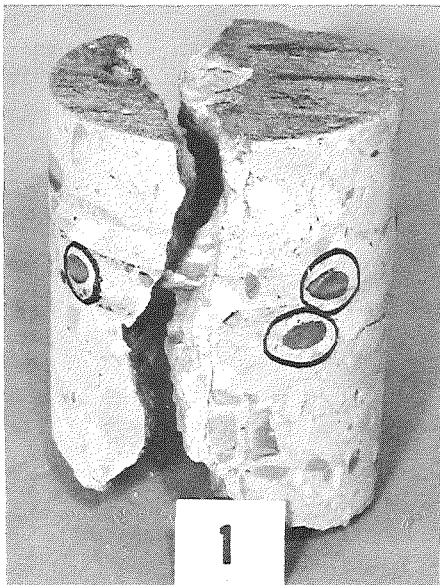
B. Core through traffic lane failure crack, indicating a Type 2 failure.

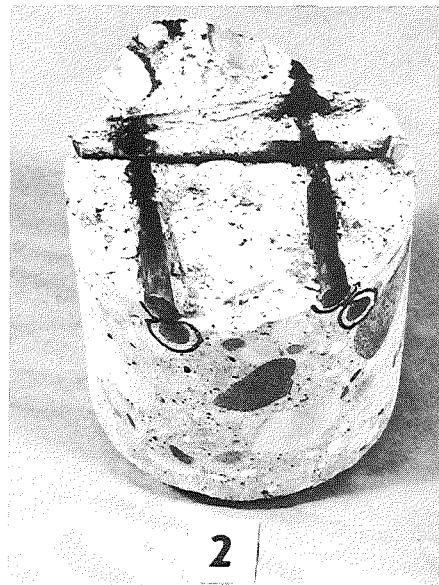
C. Core through section at crosswire in traffic lane, broken at steel level to show failure of crosswire weld.

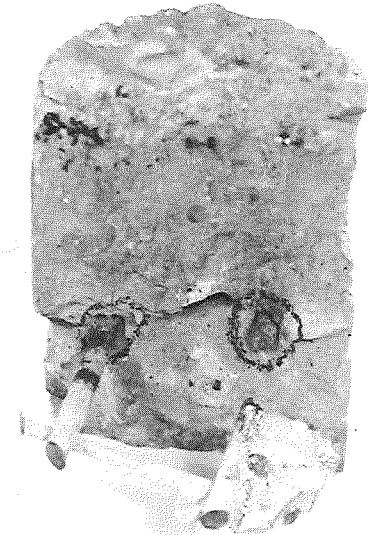
E. Core through passing lane failure crack, broken to show fracture of longitudinal steel.

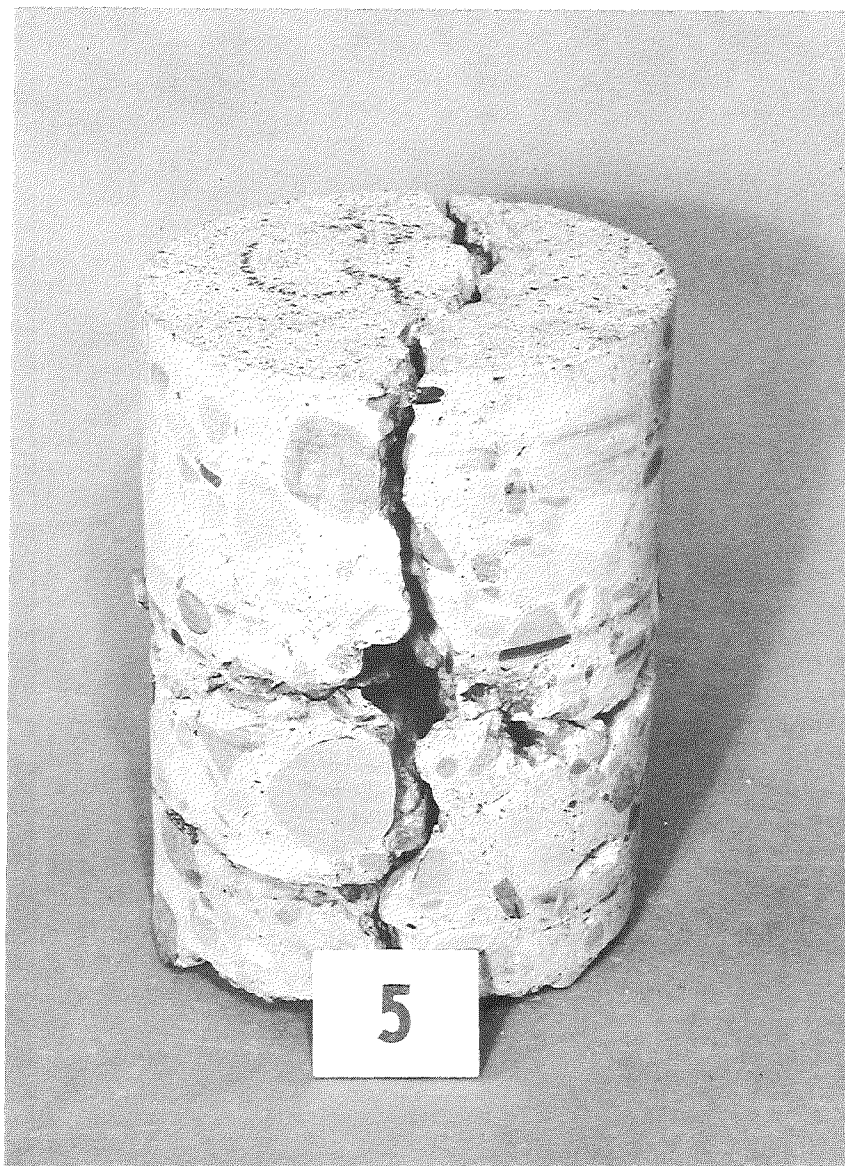
A. Core at failure crack, indicating a Type 2 failure.

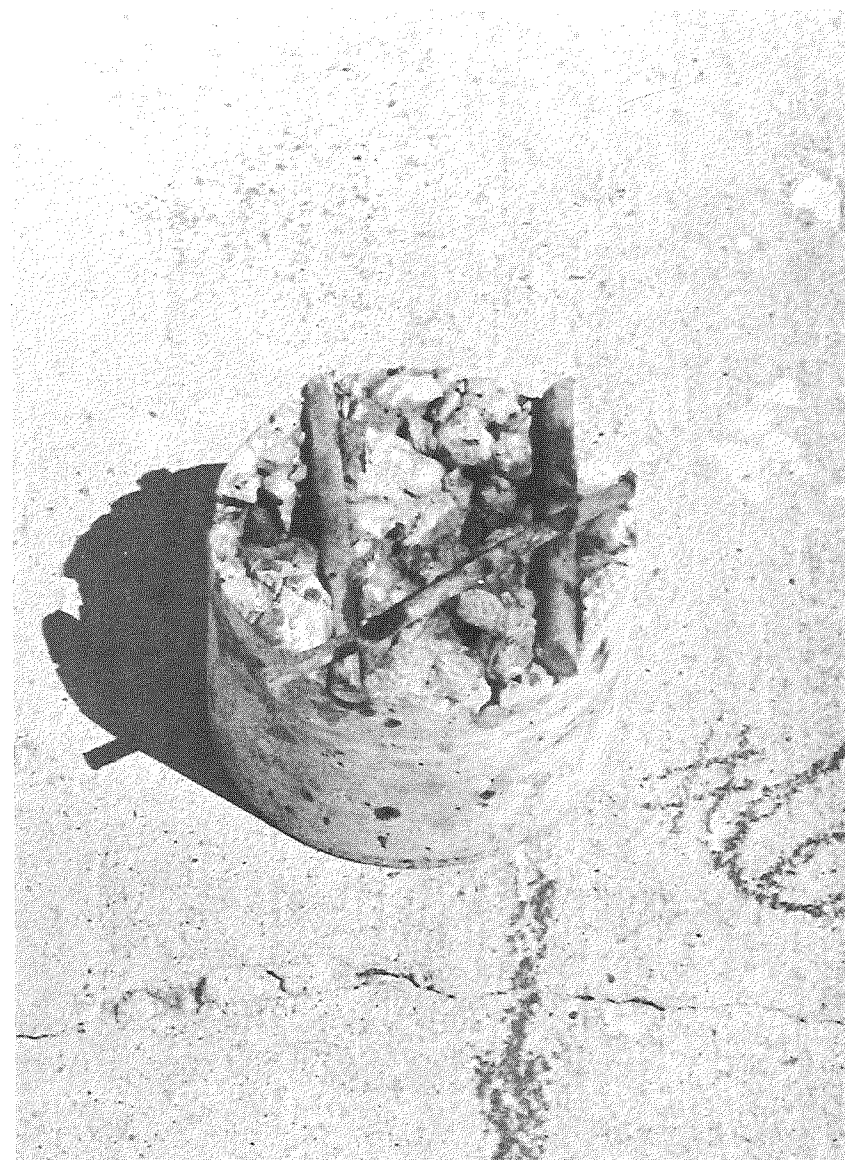
B. Core through section at crosswire, broken at steel level to show failure of crosswire weld.

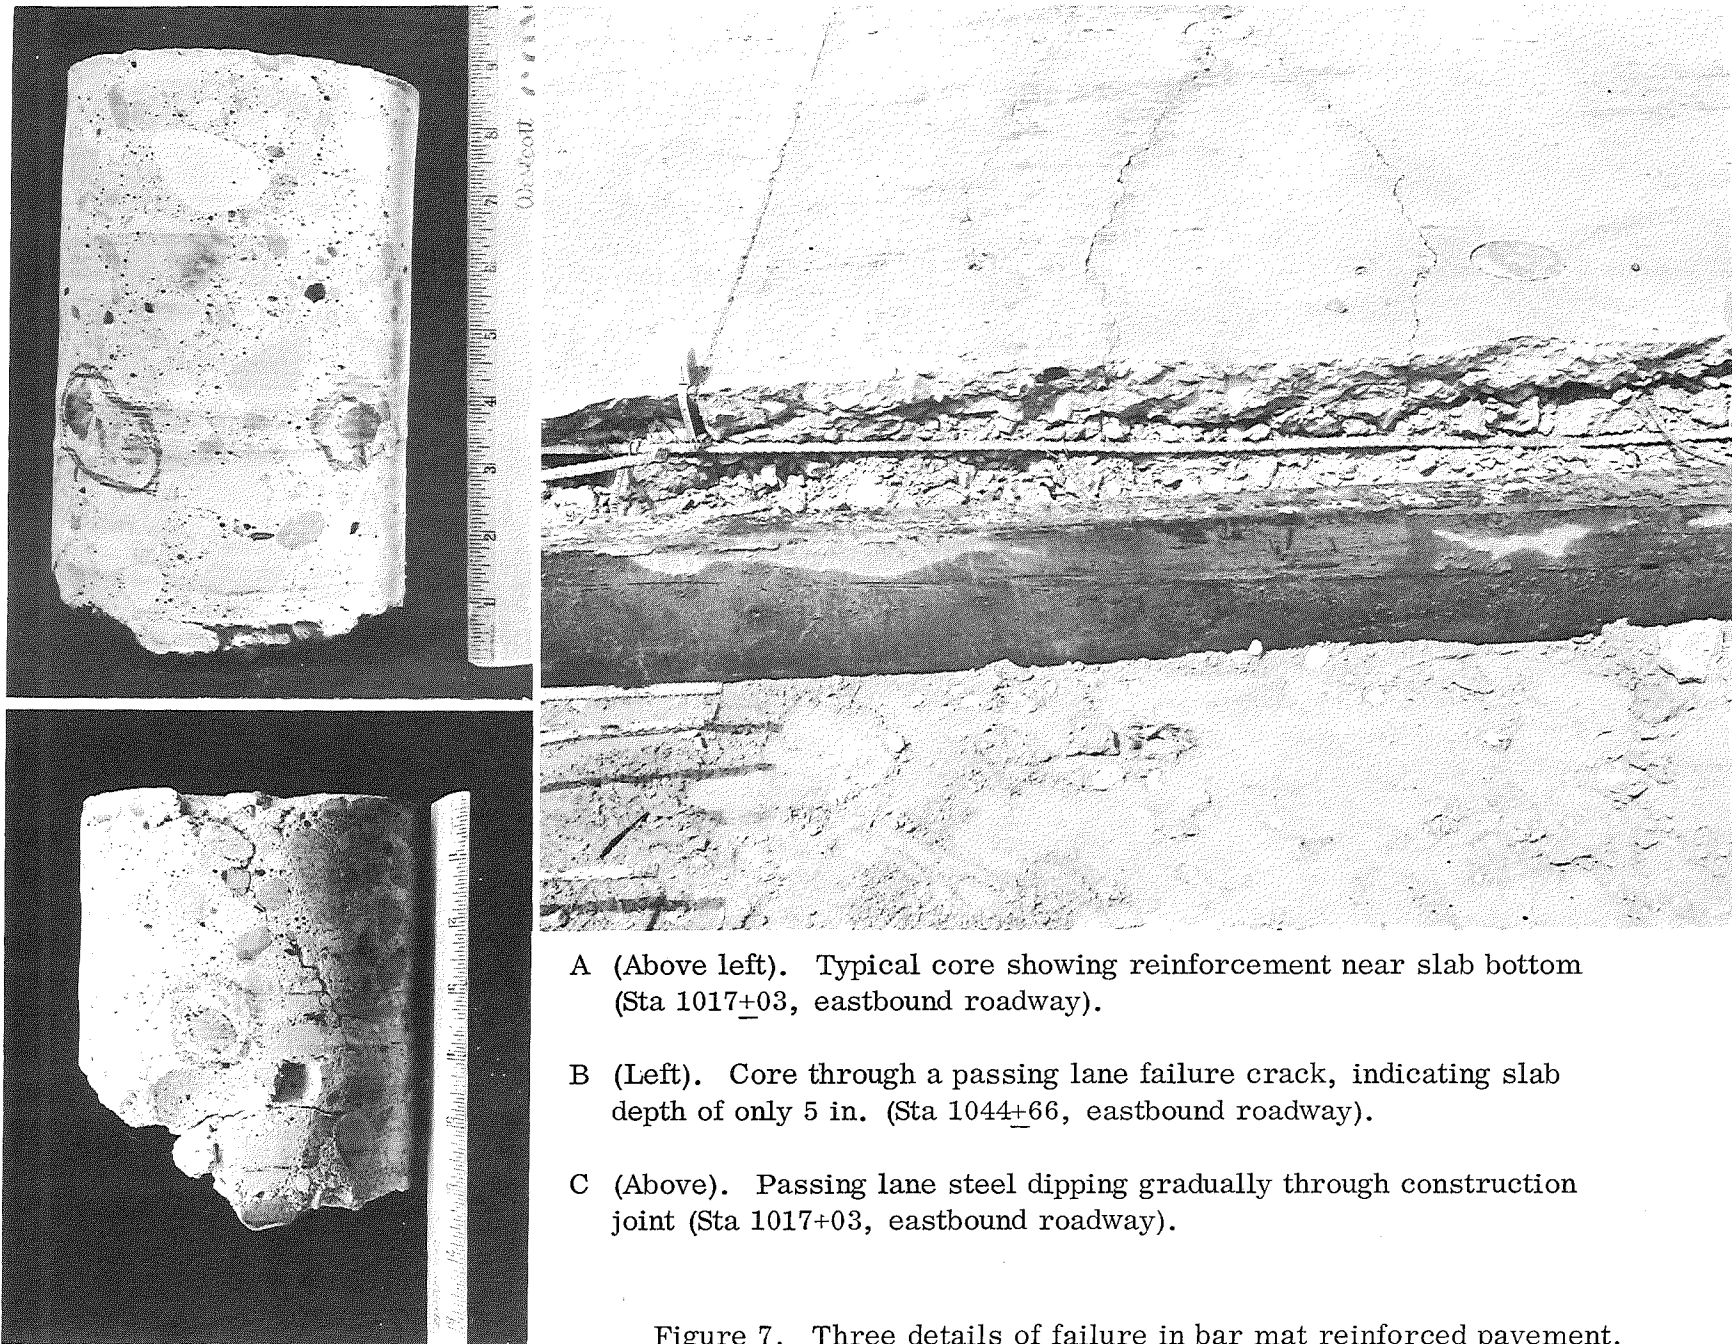
Observations during repair of the two failed areas and information obtained from test cores revealed that the failures were caused by poor consolidation of concrete in the area and a discontinuity in the steel reinforcement as a result of the reinforcement being placed in different horizontal planes at the lap following the construction joint. Typical cores taken from these two areas showing poor consolidation and placement of steel are shown in Figs. 7A and 7B. A view of the depressed condition of the reinforcement through the construction joint at Station 1017+03 is shown in Fig. 7C. Compression tests of cores taken from these areas

A (Above left). Typical core showing reinforcement near slab bottom (Sta 1017+03, eastbound roadway).

B (Left). Core through a passing lane failure crack, indicating slab depth of only 5 in. (Sta 1044+66, eastbound roadway).

C (Above). Passing lane steel dipping gradually through construction joint (Sta 1017+03, eastbound roadway).
